Mitigation Assessment Team Report

Hurricane Ike in Texas and Louisiana

Building Performance Observations, Recommendations, and Technical Guidance

FEMA P-757 / April 2009

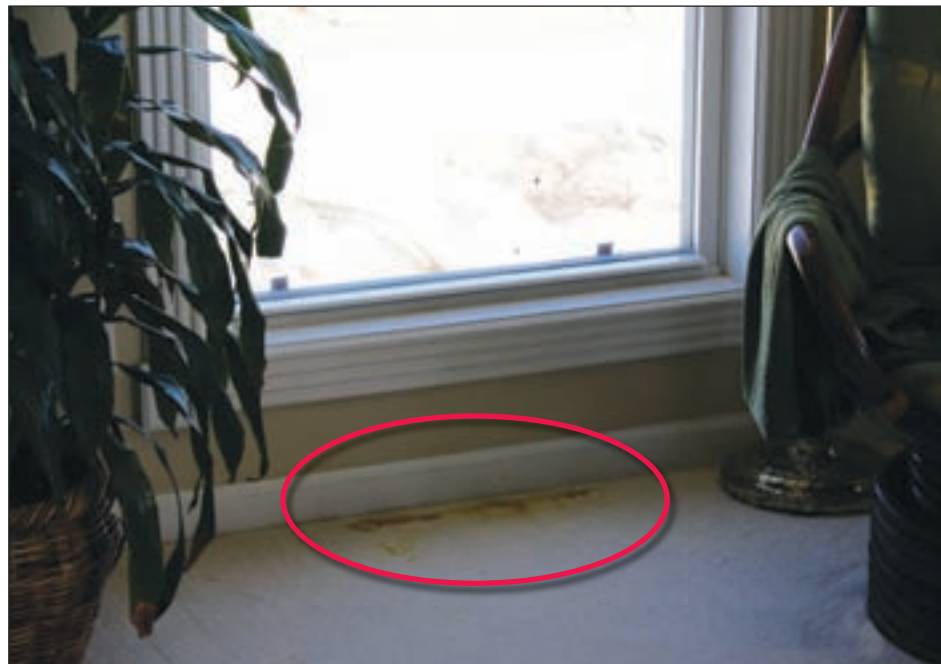
Windows and Shutters. The MAT observed interior water damage due to window leakage (Figure 7-2). The current minimum test pressures used to assess the resistance of windows to wind-driven rain are substantially below the design wind pressures. Hence, current minimum testing is inadequate to evaluate leakage potential during hurricanes.

Figure 7-2.
Several windows at this house on Bolivar Peninsula leaked and wetted the carpet

Recommendation #42: It is recommended that the window/curtain wall industry re-evaluate the test pressures that are currently used to assess resistance to wind-driven rain.

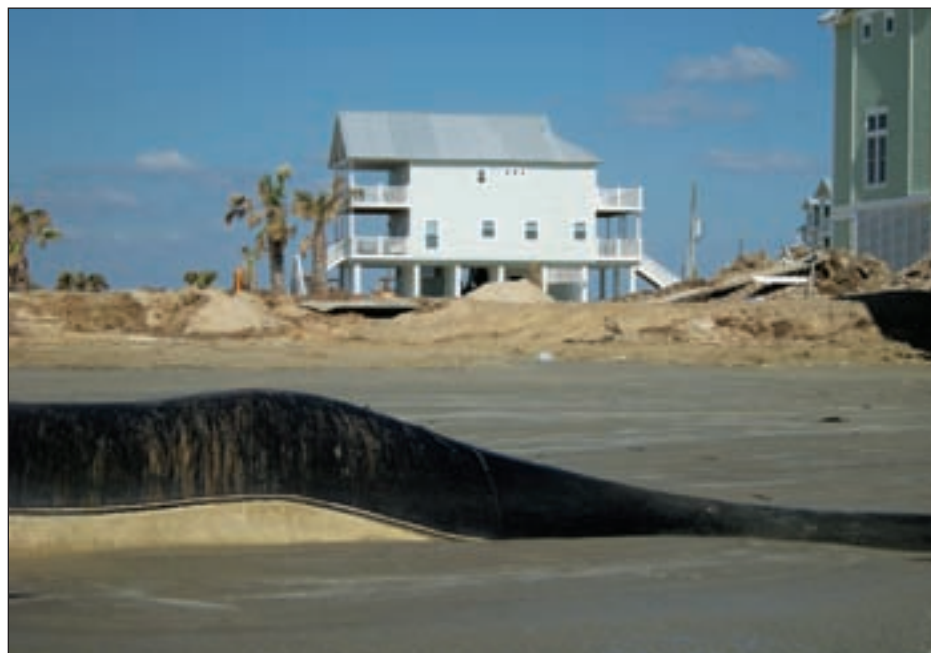
Figure 8-4.
Broken geotextile tube at
Beachside Drive, Galveston
Island, TX

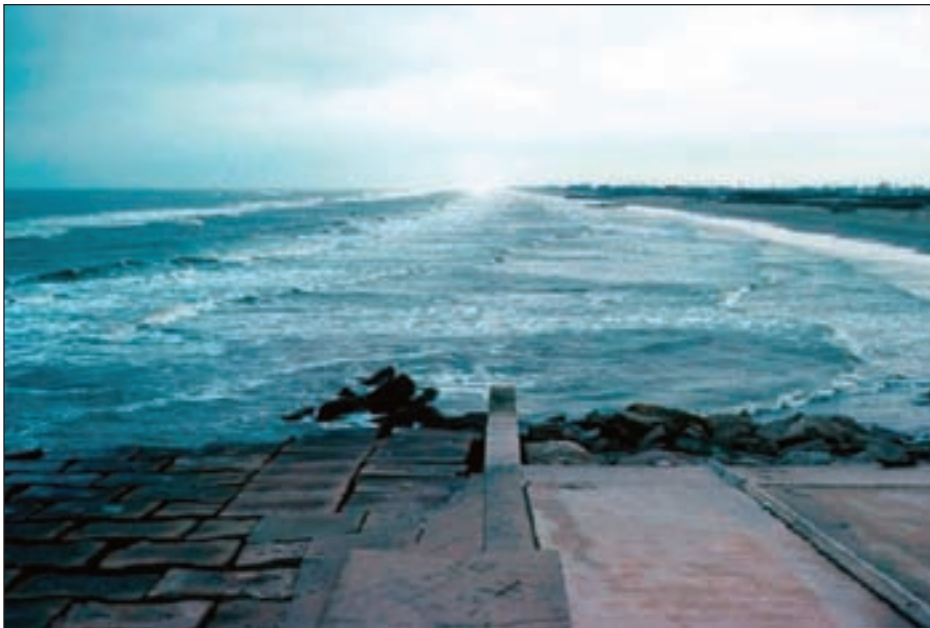
In the past decades, installation of jetties and seawalls/groins have affected the shoreline on the barrier island (Figure 8-5). Sand accumulates on the south side of the south Bolivar Roads jetty on Galveston Island, and established foredunes are abundant in that area. West of the 10-mile-long Galveston Island seawall and groin (constructed to protect the City of Galveston from storm events), the beaches are retreating, with rates of erosion at the west end of the seawall reaching 12 feet per year.

Figure 8-5.
West end of the seawall at Galveston, TX. The concrete ramp (right foreground) was the road leading to the beach in the mid-1960s. Since then, the beach has eroded more than 492 feet.

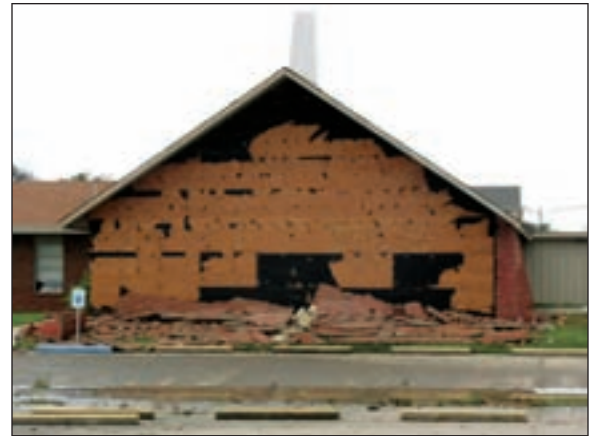
Figure 1. Failed brick veneer over plywood. Many of the ties are still attached to the substrate, but several of the tie fasteners pulled out of the substrate and the ties are embedded in the collapsed veneer. Estimated wind speed: 107 miles per hour (peak gust, Exposure C, at 33 feet).

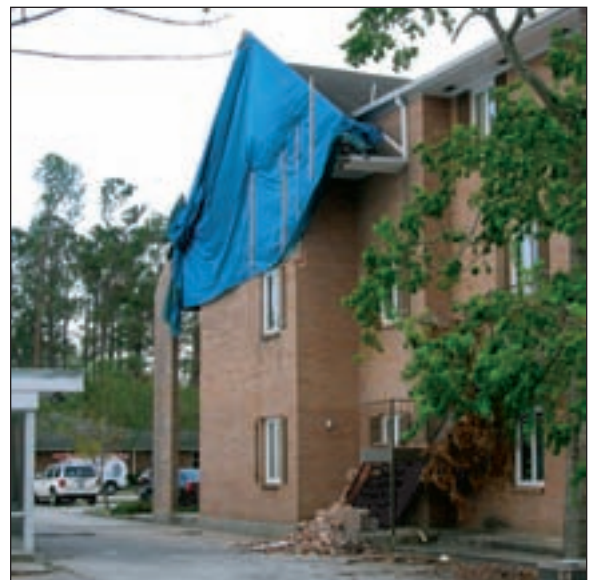
Figure 2. The upper portion of the brick veneer at this apartment building collapsed. Pedestrian and vehicular traffic in the vicinity of the damaged wall are vulnerable to injury and damage if remaining portions of the wall were to collapse during subsequent storms.

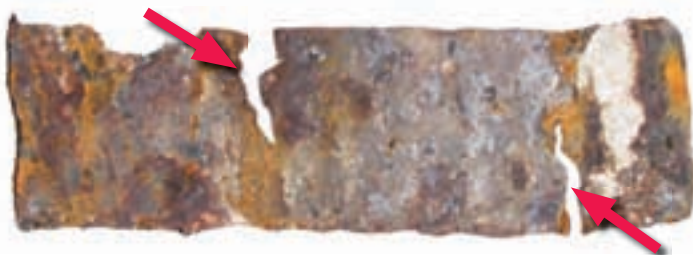
Figure 3. Significant tie corrosion caused the brick at a fire station to fail, even though the building is not near the coast. Note that metal is missing for half of width of the tie at two locations (red arrows). The left end of the tie was still embedded into a concrete masonry unit back-up wall. The right end is where the tie failed in tension, thus leaving a portion of the tie embedded in the collapsed brick.

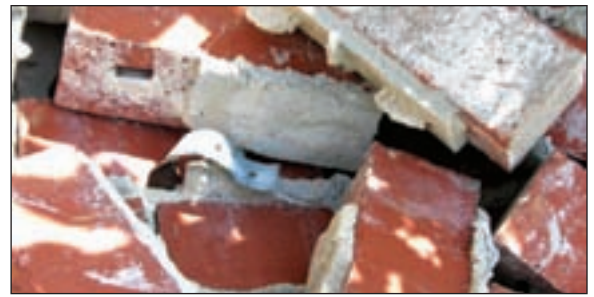
Figure 4. This tie remained embedded in the mortar joint while the smooth-shank nail pulled out from the stud.

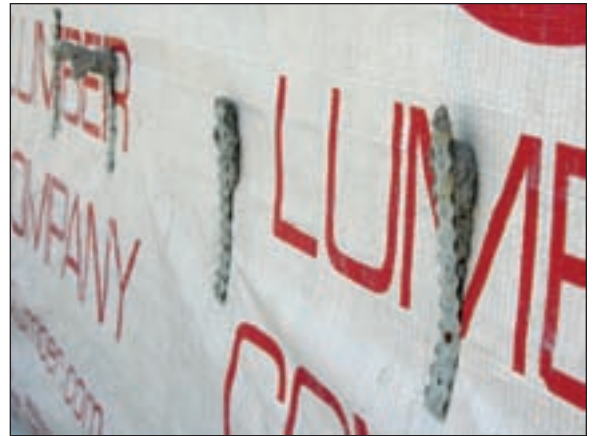
Figure 5. These four ties were never embedded into the mortar joint.

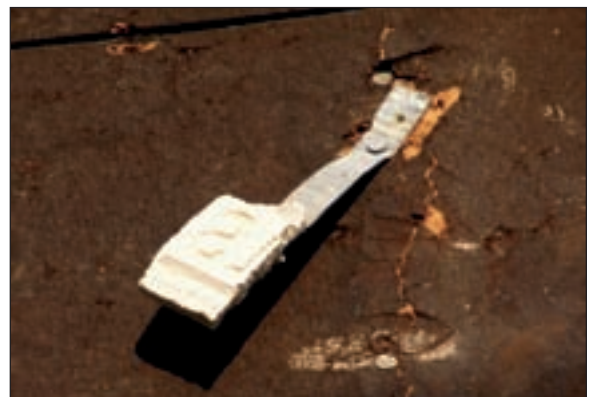
Figure 6. This tie was embedded in the mortar, but the bond was poor.

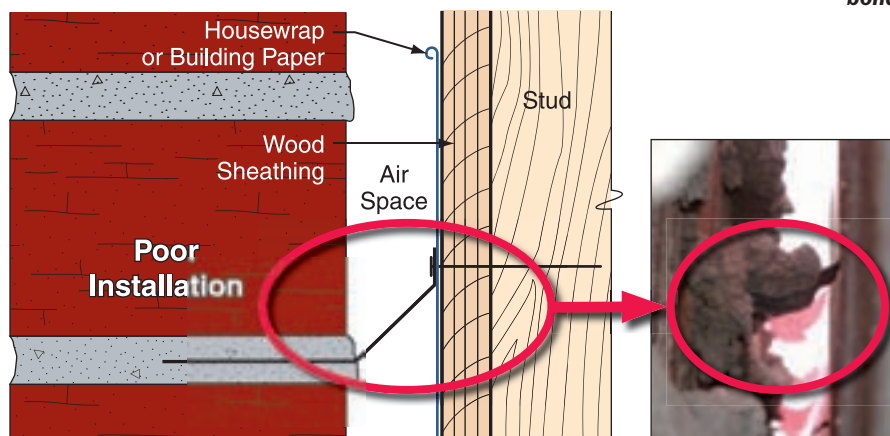
- Ties are often installed before brick laying begins. When this is done, ties are often improperly placed above or below the mortar joints. When misaligned, the ties must be angled up or down in order for the ties to be embedded into the mortar joints (Figure 7). Misalignment not only reduces embedment depth, but also reduces the effectiveness of the ties because wind forces do not act parallel to the ties themselves.

Figure 7. Misalignment of the tie reduces the embedment and promotes veneer failure.

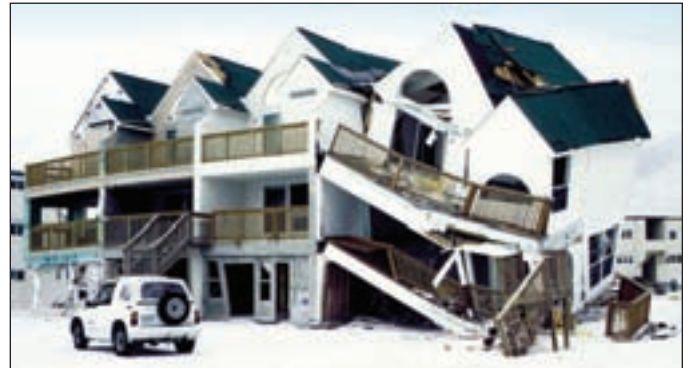
- Coastal A-zone buildings that employ typical residential and light commercial walls to elevate and support habitable space above the flood level will be susceptible to flood damage (Figure 1). Laboratory tests and recent field investigations confirm that breaking wave heights as small as 1.5' will cause failure of these types of walls (Figure 2).

Figure 1. Failure of wood-frame walls used to support a coastal building, which was subjected to shallow flooding, small waves, and floating debris (Fort Walton Beach, FL, Hurricane Opal).

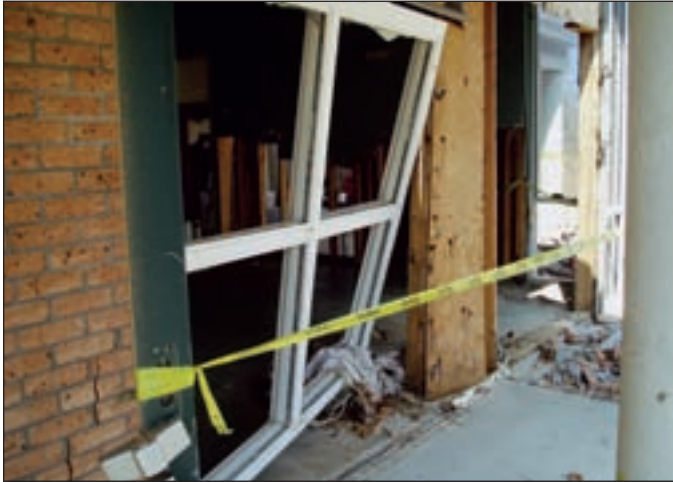
Figure 2. Failure of wood-frame wall, brick veneer, and windows as a result of 4' of stillwater flooding and small waves (Bay St. Louis, MS, Hurricane Katrina).

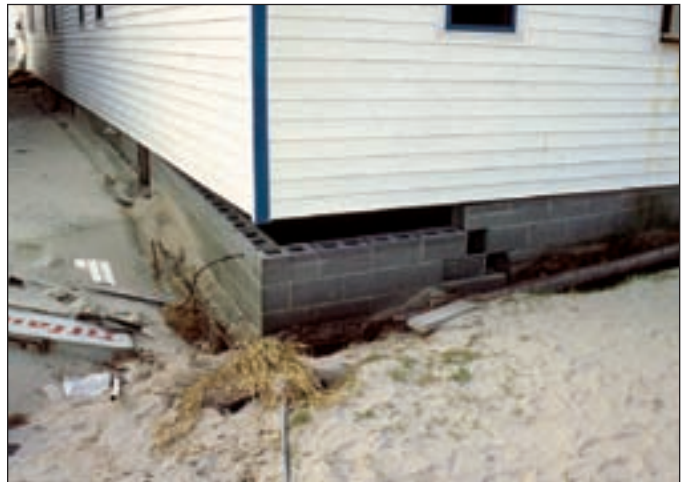
- Other flood hazards associated with coastal waves (e.g., floating debris, high velocity flow, erosion and scour) also damage A-zone type construction in coastal areas (Figure 3).

Figure 3. Failure of A-zone type foundation in coastal area, not subject to V-zone conditions (Topsail Island, NC, Hurricane Fran).

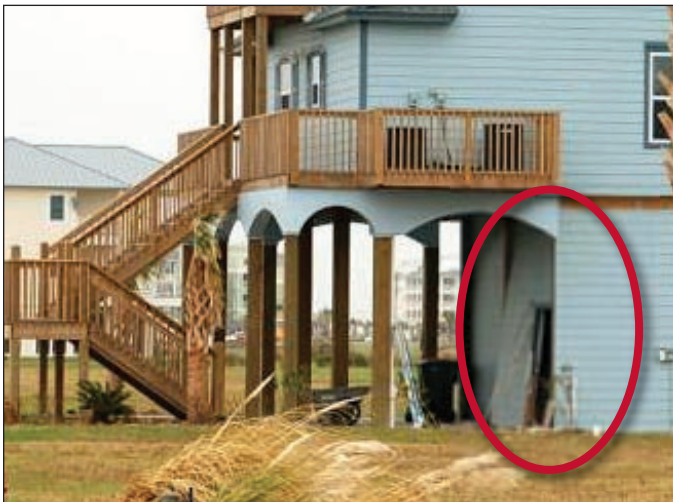
The Hurricane Ike Mitigation Assessment Team (MAT) observed small wave damage consistent with Coastal A-zone conditions throughout the area affected by Ike, including portions of west Galveston Island (Figure 4), communities situated along portions of Galveston Bay (Figure 5), Orange County (Figure 6), and portions of coastal Louisiana (Figure 7).

Figure 4. Coastal A-zone flood conditions are sufficient to cause failure of solid breakaway walls and garage doors (west Galveston Island, TX, Hurricane Ike).

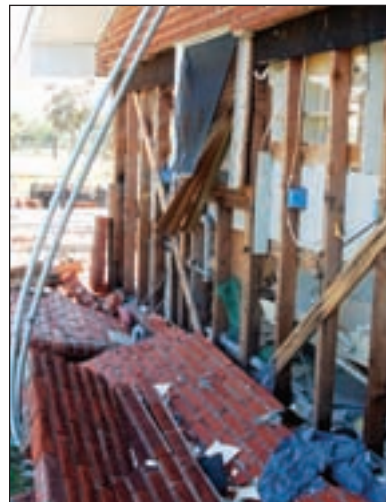
Figure 5. Damage to brick veneer walls due to shallow flooding, floating debris, and small waves. The damaged home was on a sheltered bay shoreline (Baytown, TX, Hurricane Ike).

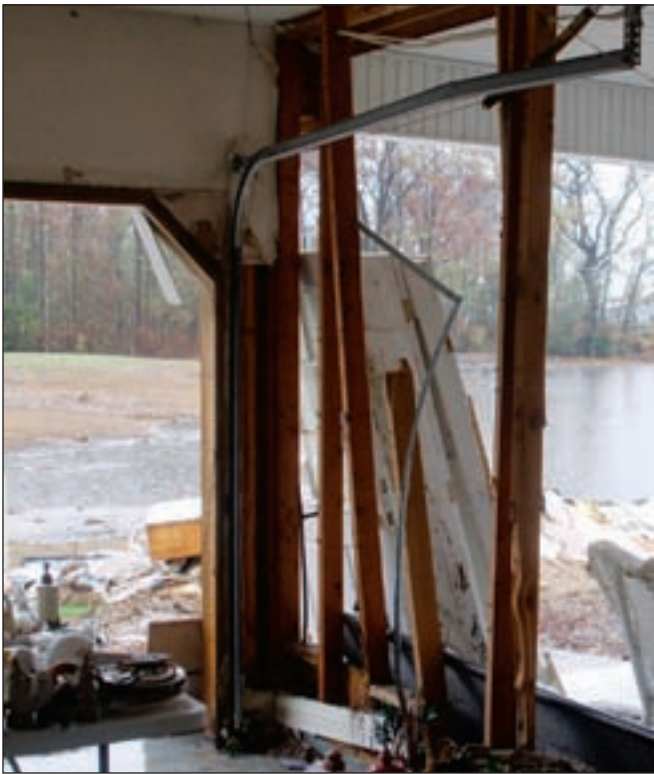
Figure 6. Damage attributed to small waves and approximately 5' of stillwater depth (Bridge City, TX, Hurricane Ike).

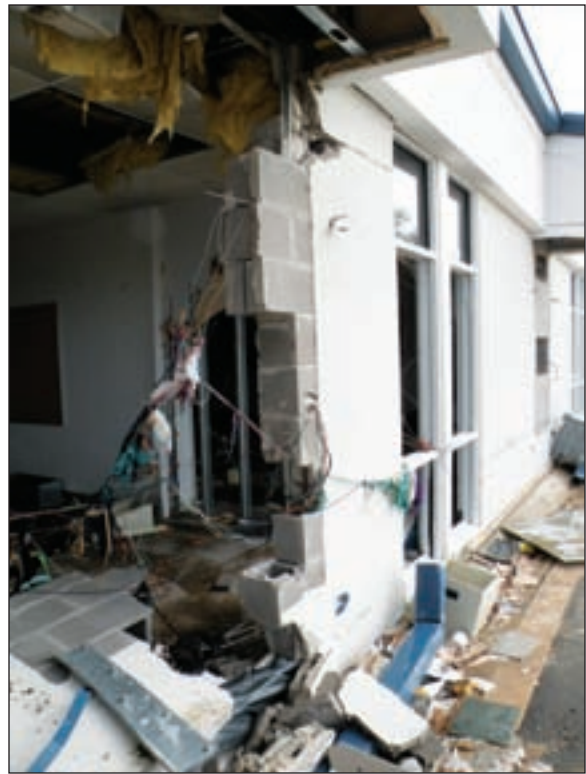
Figure 7. Damage believed to have resulted from Coastal A-zone conditions (Johnson Bayou, LA, Hurricane Ike).

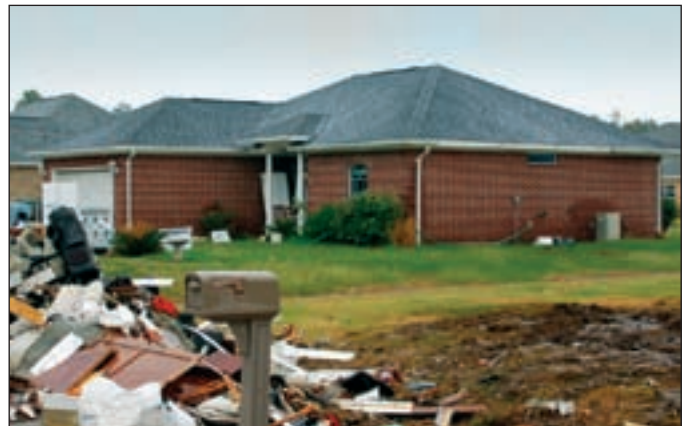
- Flood levels during some recent storms have exceeded BFEs depicted on the Flood Insurance Rate Maps (FIRMs), sometimes by several feet. In many communities, flooding extended inland, well beyond the 100-year floodplain (Special Flood Hazard Area (SFHA)) shown on the FIRM (see Figure 1).

Figure 1. Bridge City, TX, homes were flooded during Ike, even though they were constructed outside the SFHA and in Zone B. The flood level was approximately 4' above the closest BFE.

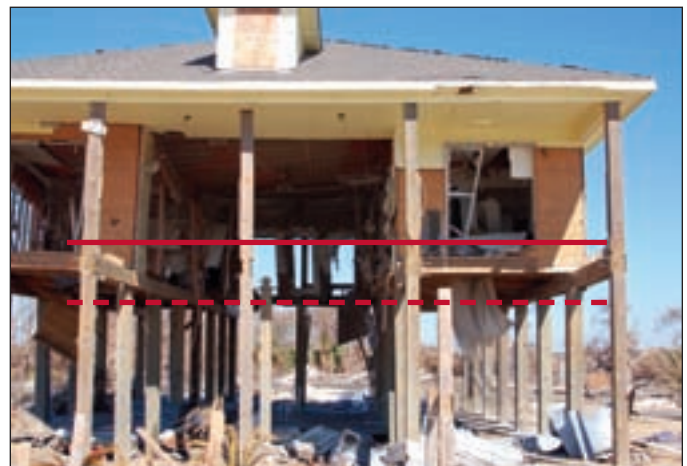
- Flood damage increases rapidly once the elevation of the flood extends above the lowest floor of a building, especially in areas subject to coastal waves. In a V zone, a coastal flood with a wave crest 3 to 4' above the bottom of the floor beam (approximately 1 to 2 feet above the walking surface of the floor) will be sufficient to substantially damage or destroy most light-framed residential and commercial construction (see Figure 2).

Figure 2. Bolivar Peninsula, TX, V-zone house constructed with the lowest floor (bottom of floor beam) at the BFE (dashed line). The estimated wave crest level during Ike (solid line) was 3 to 4' above the BFE at this location.

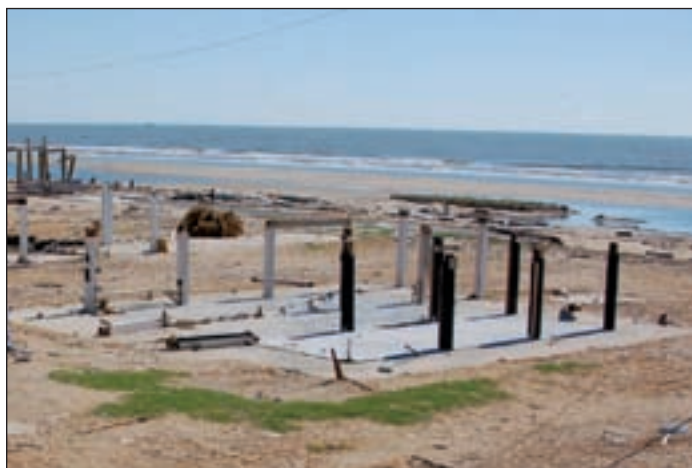
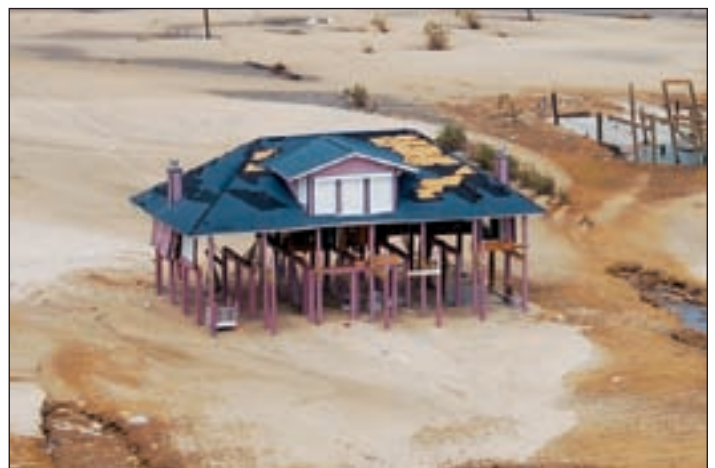
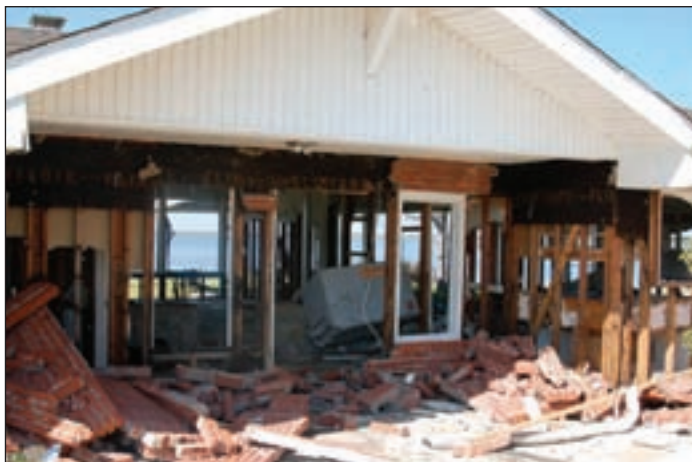
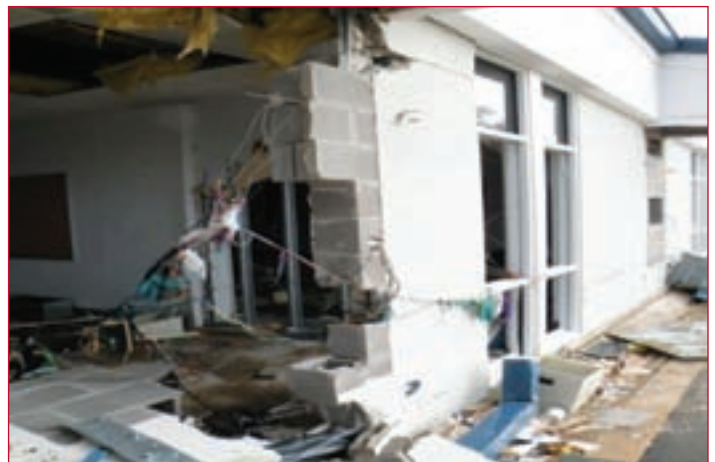
One striking difference between the two curves is that a V-zone flood depth (wave crest elevation) 3 to 4' above the bottom of the floor beam (or approximately 1 to 2' above the top of the floor) is sufficient to cause substantial (>50 percent) damage to a building. In contrast, A zone riverine flooding (without waves and high velocity) can submerge a structure without causing substantial damage. This difference in building damage is a direct result of the energy contained in coastal waves striking buildings – something obvious to those who saw the wave damage that Hurricane Ike caused in Texas and Louisiana (see Figure 5).

Figure 5. Hurricane Ike damage to buildings. The upper left and upper right photos are of buildings that were close to the Gulf of Mexico shoreline and subjected to storm surge and large waves above the lowest floor. The lower left photo is of a building close to Galveston Bay shoreline and subjected to storm surge and small waves. The lower right photo is of a Cameron Parish, Louisiana, school that was approximately 1.3 miles from the Gulf shoreline, but subjected to storm surge and small waves.

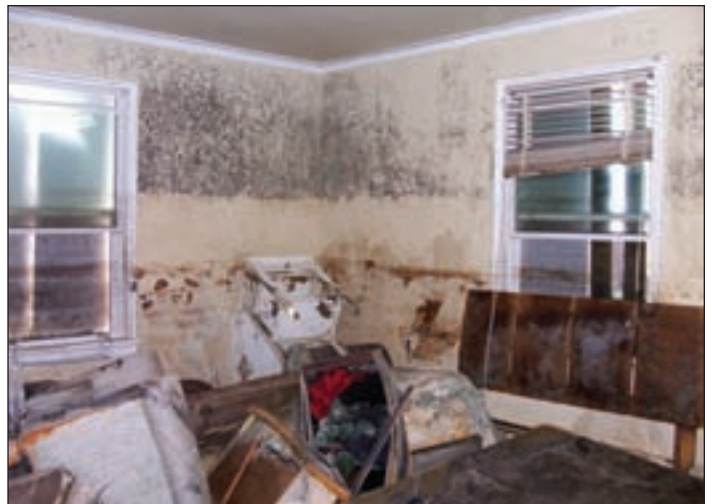
Figure 6. Other concerns when flood levels rise above the lowest floor are mold and biological/chemical contamination. These may render an otherwise repairable building unrepairable, or will at least make the cleanup, restoration, and repairs much more expensive and time-consuming.

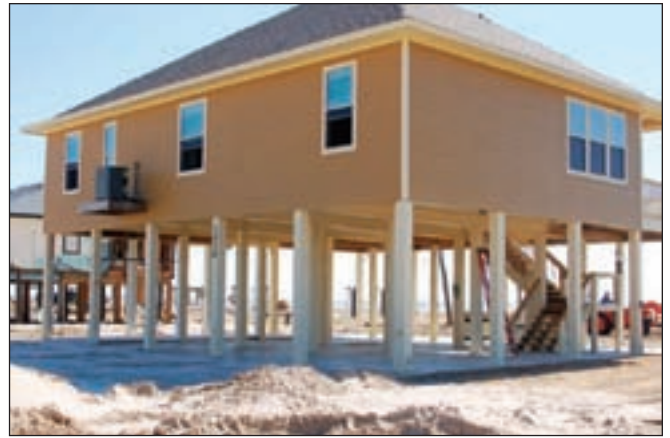
Figure 2. Breakaway walls beneath this building failed as intended under the flood forces of Hurricane Ike.

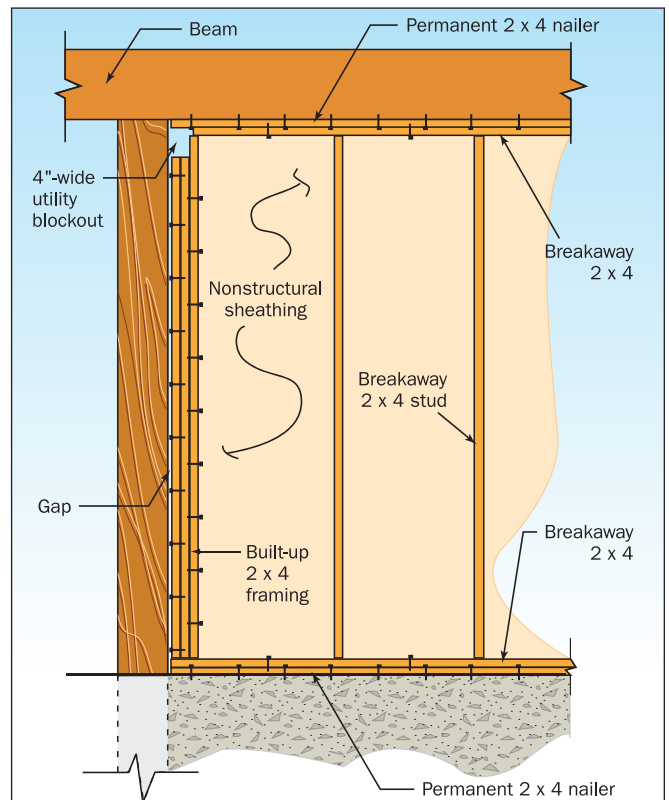
Breakaway walls must be designed to break free under the larger of: 1) the design wind load, 2) the design seismic load, or 3) 10 pounds per square foot (psf), acting perpendicular to the plane of the wall (see Figure 3 for an example of a compliant breakaway wall). If the loading at which the breakaway wall is intended to collapse exceeds 20 psf, **the breakaway wall design must be certified**. When certification is required, a registered engineer or architect must certify that the walls will collapse under a water load associated with the base flood and that the elevated portion of the building and its foundation will not be subject to collapse, displacement, or lateral movement under simultaneous wind and water loads. **Breakaway walls must break away cleanly and must not damage the elevated building when they do so** (Figure 4). **Utilities should not be attached to or pass through breakaway walls**. See FEMA (2008a) Technical Bulletin 9, Design and Construction Guidance for Breakaway Walls for more information.

Figure 3. NFIP-compliant breakaway wall construction.

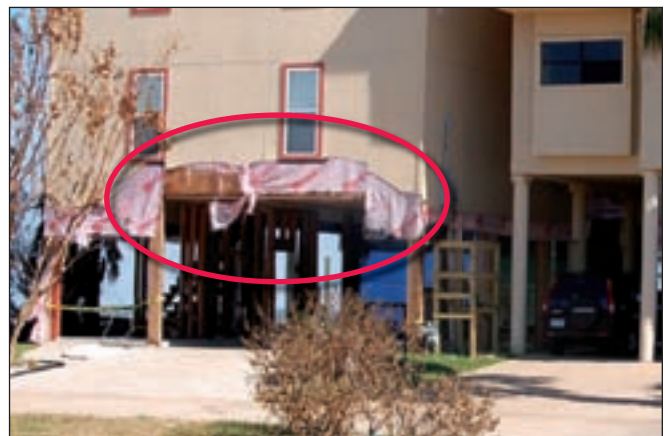
Figure 4. Building siding extended down and over the breakaway wall. Lack of a clean separation allowed damage to spread upward as the breakaway wall failed.

- Siding used on the elevated portions of a building should not extend down over breakaway walls. Instead, a clean separation should be provided so that any siding installed on breakaway walls is structurally independent of siding elsewhere on the building. Without such a separation, the failure of breakaway walls can result in damage to siding elsewhere on the building (see Figure 4).

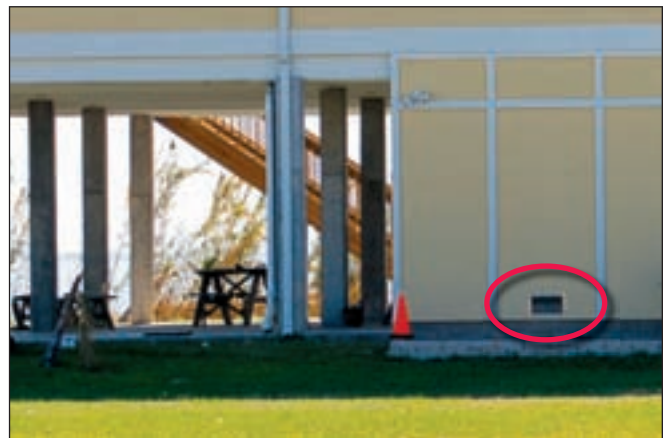
Foundation walls and other enclosure walls of A-zone buildings (including Coastal A-zone buildings) must be equipped with openings that allow the **automatic entry and exit of floodwaters** (Figure 5).

Figure 5. Flood opening in a below-BFE enclosure wall.

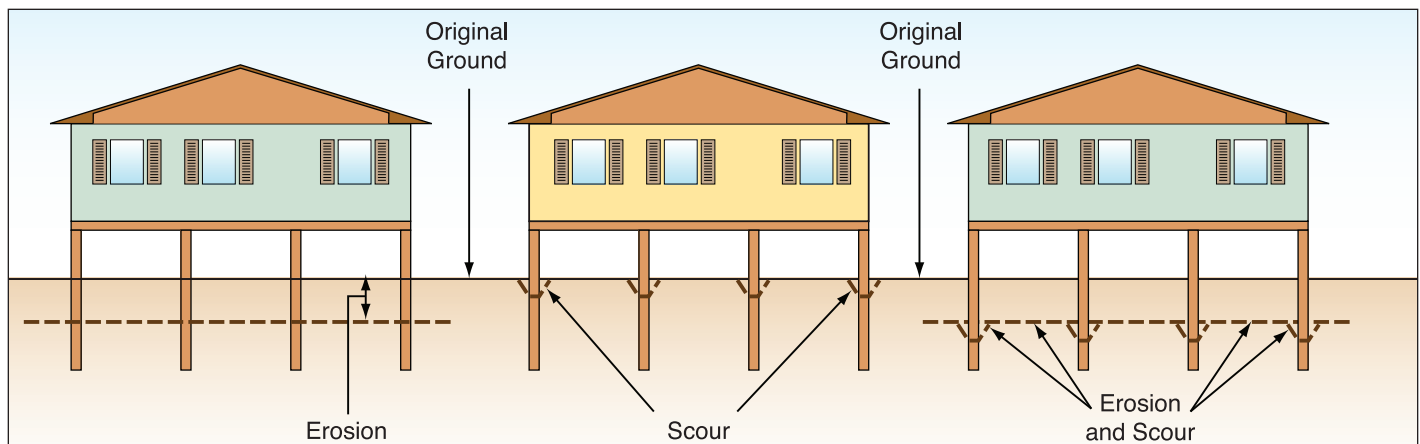
Figure 1. Distinguishing between coastal erosion and scour. A building may be subject to either or both, depending on the building location, soil characteristics, and flood conditions.

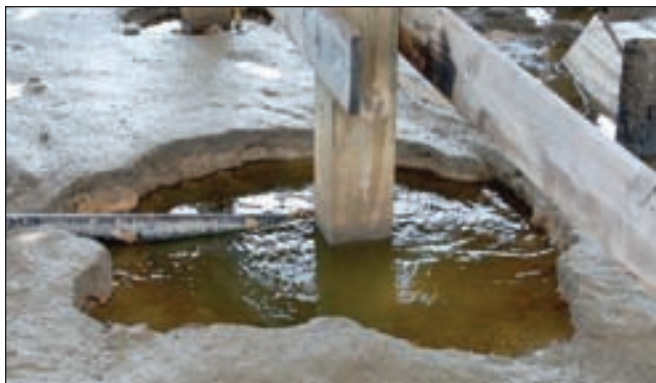
Scour effects are generally **localized**, ranging from small, shallow conical depressions in the sand around individual piles (Figure 4) to larger and deeper depressions around individual piles (Figure 5), to a building-sized shallow depression around a group of piles (Figure 6), to a large and deep depression around a building foundation (Figure 7). Scour depressions like that shown in Figure 7 were observed frequently following Hurricane Ike, and many of these reportedly were 6 to 10' deep and required hundreds of cubic yards of soil to fill. The presence of large, non-frangible concrete slabs and deep grade beams under the buildings may be a contributing factor to the large local scour depressions observed.

Figure 5. Local scour around foundation piles (Holly Beach, LA, Hurricane Ike).

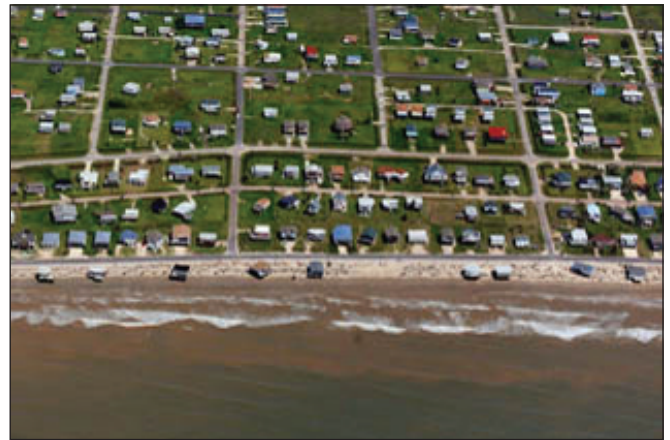
Figure 2. Long-term erosion has caused the shoreline to retreat and has left homes standing on the beach (Surfside Beach, TX). July 2007 Texas General Land Office photo.

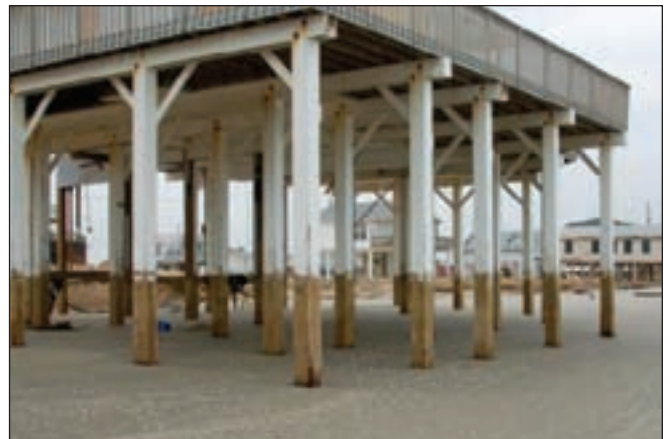
Figure 3. Storm-induced erosion beneath an elevated coastal building (Galveston Island, TX, Hurricane Ike).

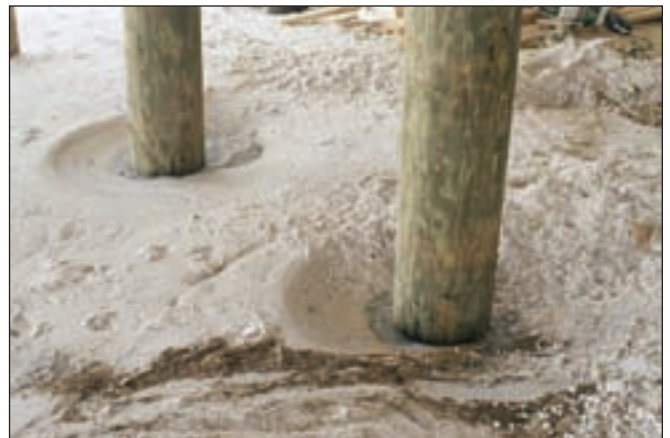
Figure 4. Local scour around foundation piles (Pensacola Beach, FL, Hurricane Ivan).

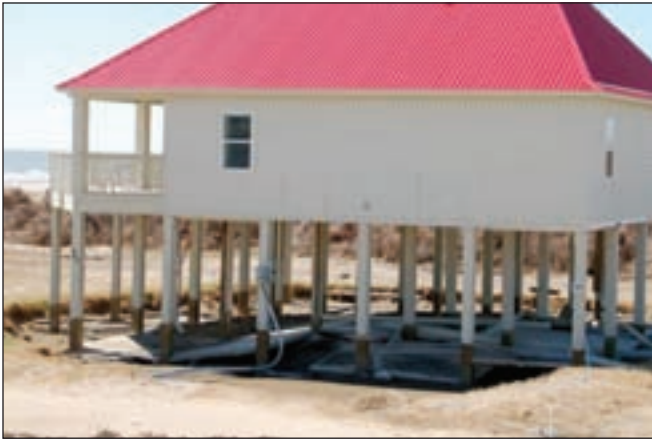
Figure 6. Local scour around a 3rd row house's pile foundation (Bolivar Peninsula, TX, Hurricane Ike).

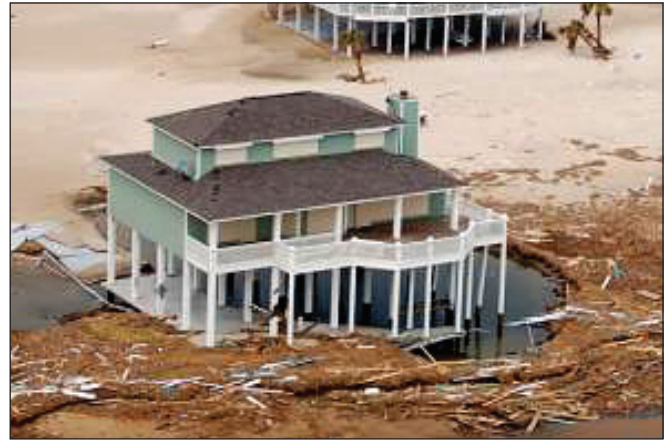
Figure 7. Extreme local scour around a Gulf-front pile foundation (Bolivar Peninsula, TX, Hurricane Ike).

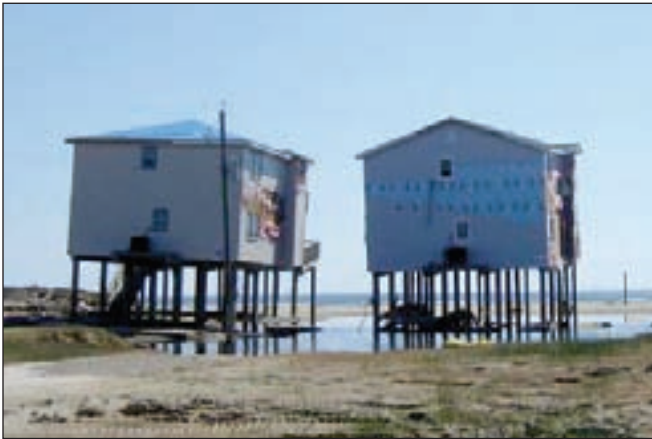
In some cases, buildings may settle due to inadequate pile embedment, coupled with some combination of erosion, scour, and soil liquefaction that leads to loss of bearing. This type of failure was observed by the Hurricane Ike FEMA Mitigation Assessment Team (MAT) at Surfside Beach, TX (Figure 8) and Holly Beach, LA.

Figure 8. Differential settlement of buildings thought to be a result of inadequate foundation embedment coupled with erosion, scour, and/or soil liquefaction (Surfside Beach, TX, Hurricane Ike).

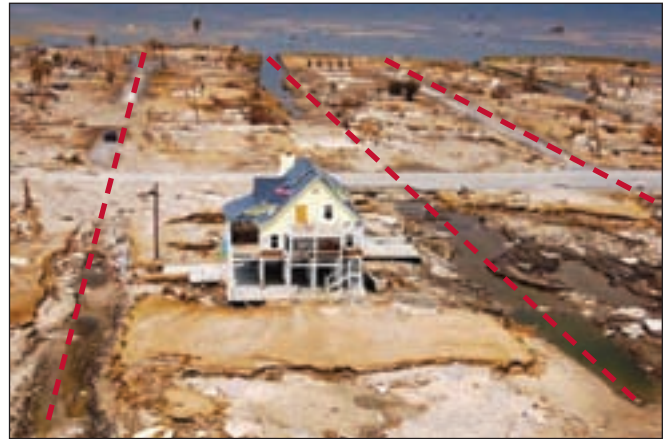
Figure 9. Linear scour and erosion patterns aligning with canals and roads (Bolivar Peninsula, TX, Hurricane Ike).

There is one other erosion and scour scenario to consider in foundation design – the loss of soil around or under a building as a result of storm surge flow being channeled or directed across a building site. This process usually takes place where storm surge flow is constrained between large buildings or gaps in shore protection, or when return flow to the sea follows paths of least resistance, such as along canals and roads (Figure 9).

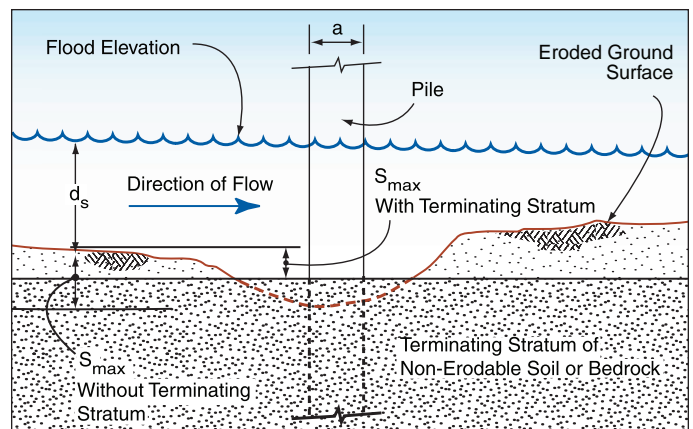
Figure 11. CCM Figure 11-12 illustrating scour estimate around a single pile - Hurricane Ike showed this method may underestimate local scour.

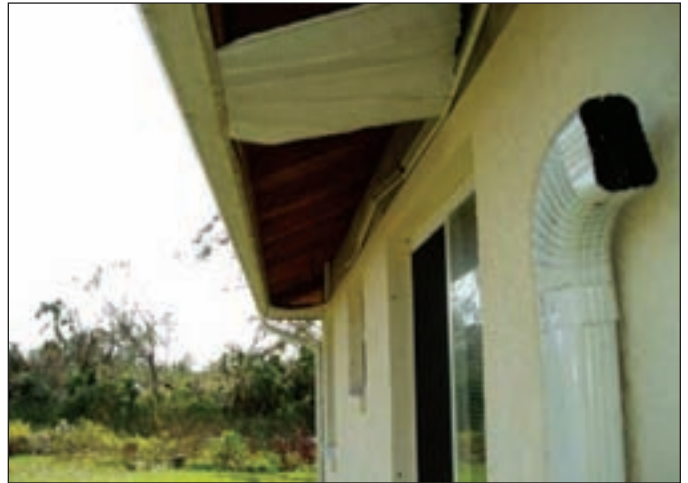
- First and foremost, it is important to keep the soffit material in place. While some water can be blown into the attic through almost any type of soffit vent, the amount of water intrusion increases dramatically when the soffit material is missing (Figure 1).
- Plywood or wood soffits are generally adequately anchored to wood framing attached to the roof structure and/or the walls. However, it has been common practice for vinyl and aluminum soffit panels to be installed in tracks that are frequently very poorly connected to the walls and fascia at the edge of the roof overhang. When these poorly anchored soffits are blown off, water intrusion increases significantly. Properly installed vinyl and aluminum soffit panels are fastened to the building structure or to nailing strips placed at intervals specified by the manufacturer.

Figure 1. Missing soffit material.

If the inspection indicates a poorly attached soffit, the best way to ensure that the soffit material is adequately anchored in place is to remove it and install adequate wood blocking to allow solid anchorage of the soffit material. In some cases, it may be possible to remove the soffit material and reinstall it. However, it is also likely that some or all of the material will need to be replaced, so make sure that it can be matched before it is removed. Short of removing and properly reinstalling the soffit material, testing has shown that the anchorage can be greatly improved by applying a bead of sealant (Figure 3) along the bottom edge of the wall channel to adhere it to the wall surface below followed by applying large dabs of sealant in indentations between the soffit panels and the wall channel at one end (Figure 4) and the fascia flashing at the other end. Surfaces receiving sealant should be cleaned in order to facilitate bonding. Extra resistance can be gained by installing screws that mechanically tie the soffit panels to both the fascia flashing and to the wall channel (Figure 5). Note that use of sealant is a remedial measure only and is not a substitute for proper installation and fastening of soffits in a new installation.

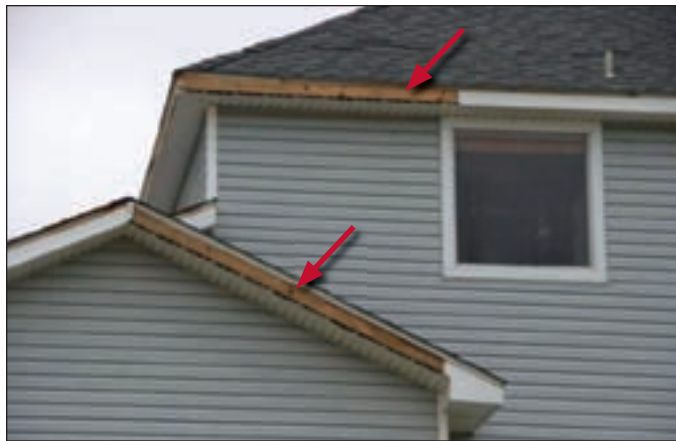
Fascia cover: Field investigations after Hurricane Ike showed many cases where the aluminum fascia cover (fascia cap) from the fascia board was blown off (Figure 7). The fascia cover normally covers the ends of vinyl and aluminum soffits. When the fascia cover is blown off, the ends of the soffit panels are exposed to wind and wind-driven rain.

Figure 7. Loss of fascia cover exposes ends of vinyl soffit to direct entry of wind-driven rain.

The IRC currently has no guidelines for the installation of fascia covers. Aluminum fascia covers are typically tucked under the roof drip edge and face-nailed every few feet. More frequent nailing would help secure the fascia cover, but would also inhibit normal thermal movement, which can cause unattractive warping and dimpling of the cover. Vinyl fascia covers are available, which are attached to a continuous strip of utility trim placed underneath the drip edge. This provides a somewhat more secure, continuous attachment and allows for thermal movement. Aluminum fascia covers can also be field-notched and installed with utility trim.

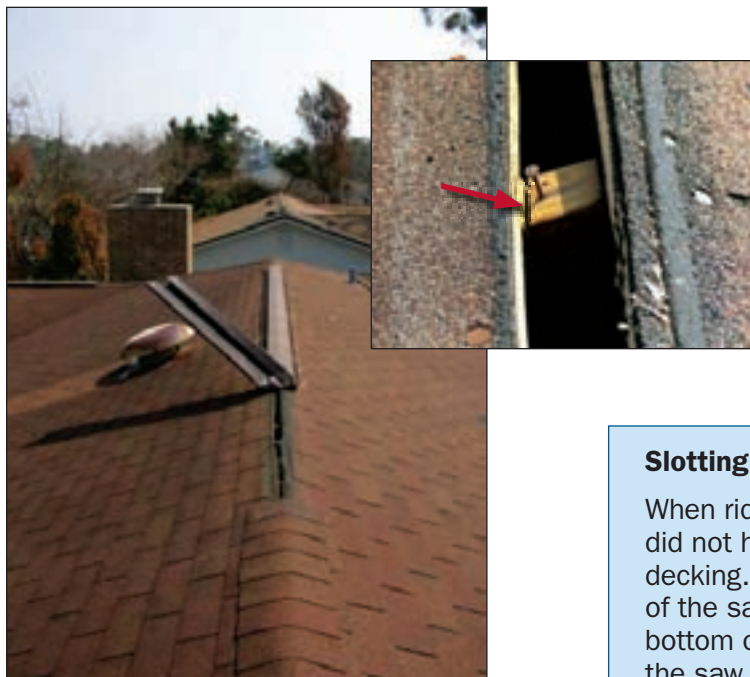
Figure 8. This metal ridge vent was attached with widely spaced roofing nails.

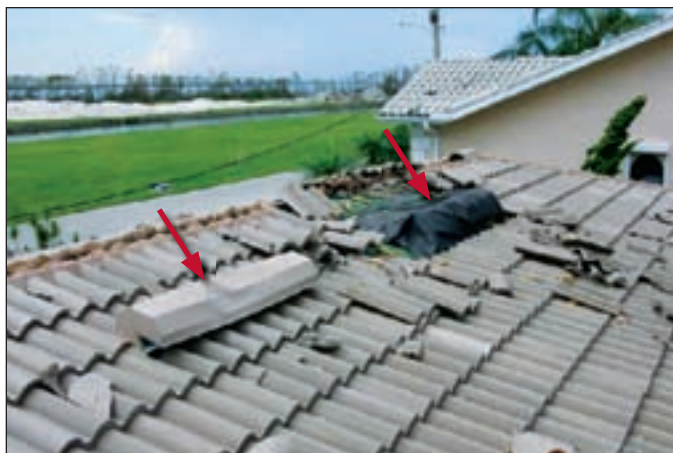
- Poorly anchored off-ridge vents can flip up and become scoops that direct large amounts of wind-driven rain into the attic (Figure 11).

Figure 11. Two off-ridge vents are shown in this photograph. The vent that is covered with roofing felt flipped up and allowed a substantial amount of water to enter the residence. Carpeting, kitchen cabinets, and a large amount of gypsum board had to be replaced because of the water intrusion.

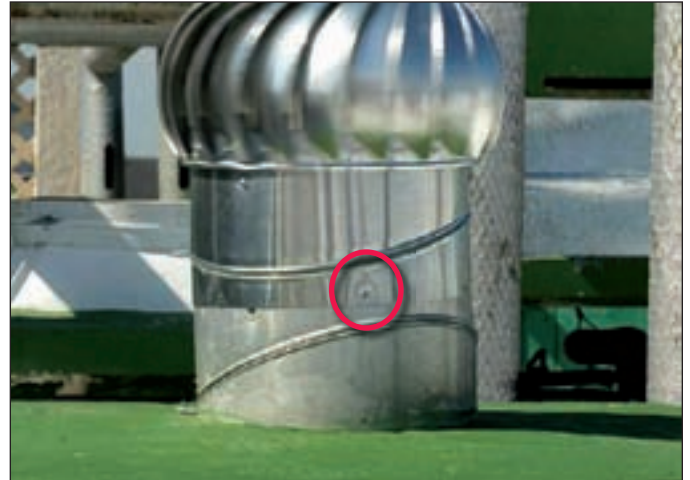
Check any turbines to make sure that the stand pipes are not loose and that the turbine head is anchored to the stand pipe by sheet metal screws and not simply by a friction fit (Figure 13).

Figure 13. This turbine head is attached to the standpipe with dimple punches. Sheet metal screws should be added to strengthen the connection.

Loose standpipes should be securely anchored to the roof sheathing. If the standpipe is attached to the roof sheathing with long, thin nails, it may be possible to improve the anchorage by cinching the nails (bending them over against the underside of the roof sheathing). However, if they are short and/or thick, trying to bend them over may cause more harm than good. Some homeowners have had covers made that can be installed from the inside of the attic over the hole where the standpipe is installed. This will be easiest if the standpipe is larger than the hole and the cover can be attached to the sheathing in an area where the fasteners can't be driven through the roof cover. Otherwise, it will be important to ensure that the fasteners are short enough that they won't extend through the roof sheathing and damage the roof cover. If the edge of the hole in the roof deck is flush with the inside edge of the standpipe, it may be possible to install metal straps that are screwed into the walls of the standpipe and attached with short screws to the bottom surface of the roof sheathing. Again, it is critical to use screws that are short enough that they won't extend through the roof sheathing and damage the roof cover. The strapping should be connected to the walls of the standpipe with short stainless steel sheet metal screws. Beyond any remedial measures taken to anchor the standpipe to the roof sheathing or to plug the hole from the attic side, it is also important to try and seal the standpipe from the outside so that water doesn't build up in the pipe and leak into the roof sheathing around the hole. The best approach is to have a qualified person remove the top active portion of the turbine vent before the storm and plug the hole at the top of the standpipe. A wooden plug can be used that covers the entire hole and has blocks that rest against the walls of the standpipe where screws can be installed to anchor the plug to the standpipe. Some homeowners have had the entire turbine wrapped in plastic to keep water out during a storm (Figure 14). This can work as long as the turbine or wrapping doesn't get dislodged. The smaller area provided by removing the turbine top and plugging the hole is considered preferable.

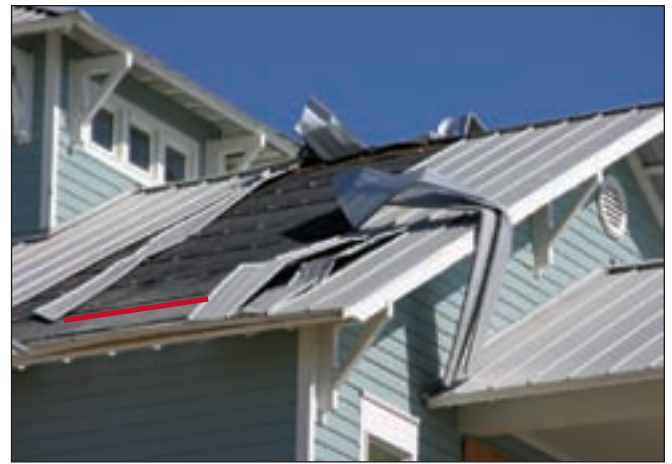
Figure 1. This architectural panel system has concealed clips. The panels unlatched from the clips. The first row of clips (just above the red line) was several inches from the end of the panels. The first row of clips should have been closer to the eave.

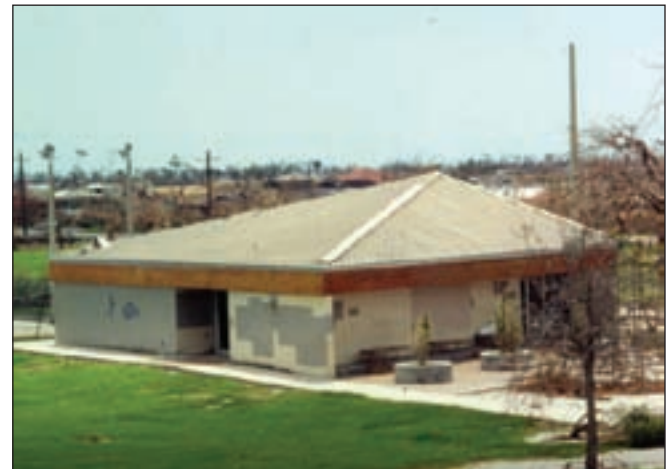
Figure 2. This structural standing seam roof system survived Hurricane Andrew (Florida, 1992), but some hip flashings were blown off. The estimated wind speed was 170 mph (peak gust, Exposure C at 33 feet).

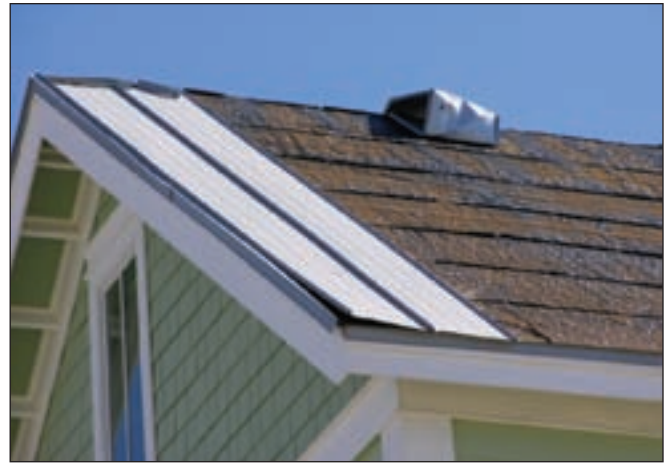
Figure 3. These architectural panel system have snap-lock seams. One side of the seam is attached with a concealed fastener. Although a large number of panels blew away, the underlayment did not.

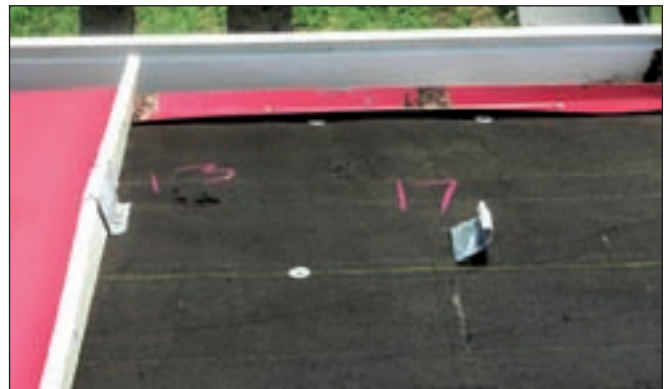
Figure 4. These eave clips were too far from the panel ends. The clip at the left was 13" from the edge of the deck. The other clip was 17" from the edge. It would have been prudent to install double clips along the eave.

- Where the basic (design) wind speed is 110 mph or greater, it is recommended that two clips be used along the eaves, ridges, and hips. Place the first eave clip within 2 to 3" of the eave, and place the second clip approximately 3 to 4" from the first clip. Figures 1 and 4 illustrate ramifications of clips being too far from the eave.

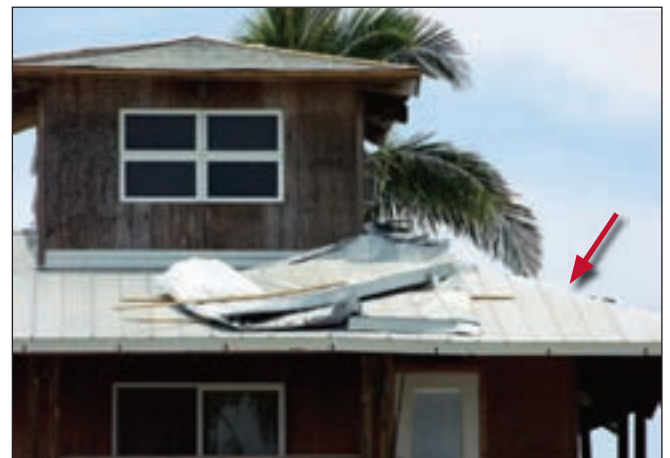
Figure 5. The panels blew off the upper roof and landed on the lower roof of this house. The upper asphalt shingle roof shown had been re-covered with 5V-Crimp panels that were screwed to nailers. The failure was caused by inadequate attachment of the nailers (which had widely-spaced nails) to the sheathing. Note that the hip flashing on the lower roof blew off.

- When clip or panel fasteners are attached to nailers (Figures 5, 6, and 7), detail the connection of the nailer to the nailer support (including the detail of where nailers are spliced over a support).

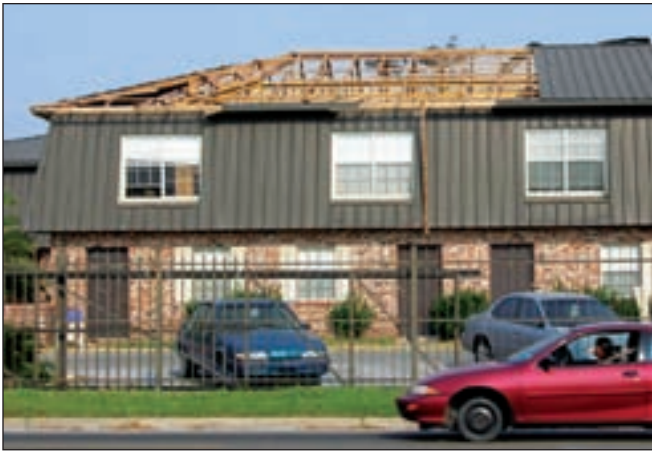
Figure 6. Blow-off of nailers caused these panels to progressively fail. The nailers were installed directly over the trusses. In an assembly such as this where there is no decking, there is no opportunity to incorporate an underlayment. With loss of the panels, rainwater was free to enter the building.
