Mitigation Assessment Team Report

Hurricane Ike in Texas and Louisiana

Building Performance Observations, Recommendations, and Technical Guidance

FEMA P-757 / April 2009

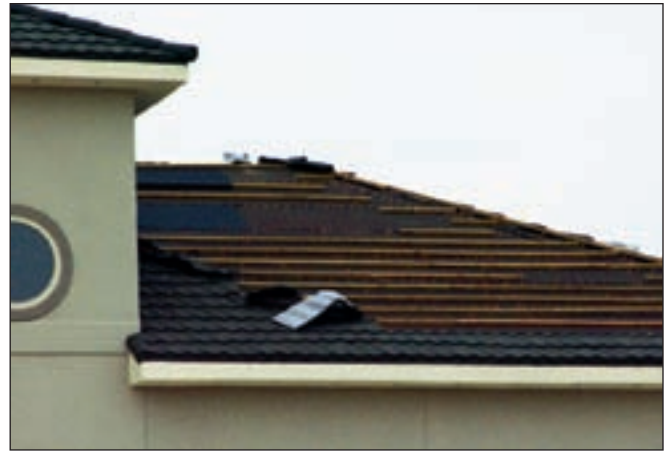
Figure 7. This residence had metal shingles that simulated the appearance of tile. The shingles typically blew off the battens, but some of the battens were also blown away.

- When clip or panel fasteners are attached to nailers (Figures 5, 6, and 7), detail the connection of the nailer to the nailer support (including the detail of where nailers are spliced over a support).

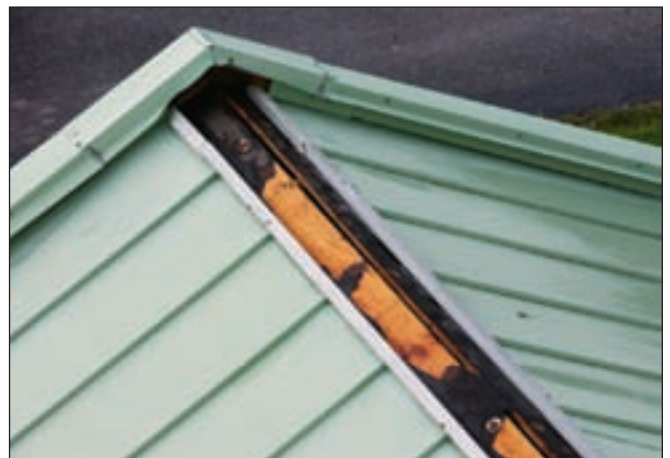
Figure 9. The ridge flashing fasteners were placed too far apart. A significant amount of water leakage can occur when ridge flashings are blown away.

- For concealed clips over a solid substrate, it is recommended that chalk lines be specified so that the clips are correctly spaced.
- Hip, ridge, and rake flashings: Because exposed fasteners are more reliable than cleat attachment, it is recommended that hip, ridge, and rake flashings be attached with exposed fasteners. Two rows of fasteners are recommended on either side of the hip/ridge line. Close spacing of fasteners is recommended (e.g., spacing in the range of 3 to 6" on center, commensurate with the design wind loads), as shown in Figure 8 in order to avoid flashing blow-off as shown in Figure 9.

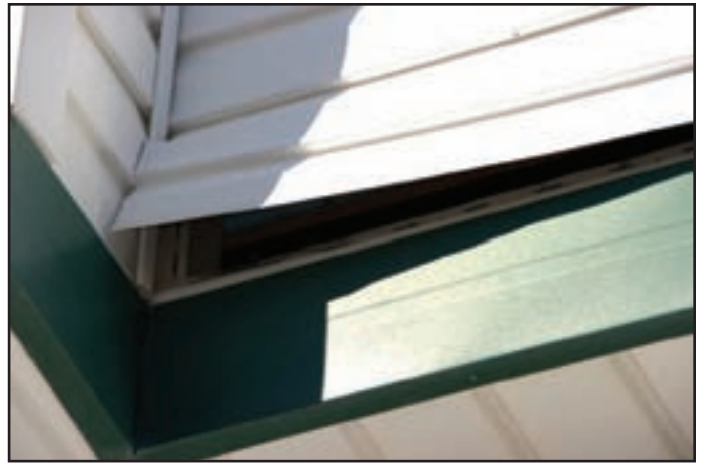
Figure 4. Utility trim was substituted for the starter strip and the bottom lock was cut off the siding. Siding was able to pull loose under wind pressure.

- Use the manufacturer-specified starter strip to lock in the first course; do not substitute other accessories such as a J-channel or utility trim (Figure 4) unless specified by the manufacturer. If the manufacturer specifies a particular strip for high-wind applications, use it. Make sure that the starter strip is designed to positively lock the panel, rather than just hooking over a bulge in the strip; field test the interlock before proceeding with the installation.

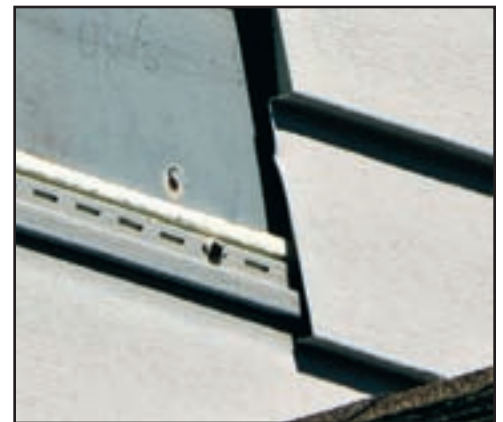
Figure 5. The siding panel was not properly locked into the panel below.

- Make sure that every course of siding is positively locked into the previous course (Figure 5). Push the panel up into the lock from the bottom before nailing rather than pulling from the top. Do not attempt to align siding courses with adjacent walls by installing some courses loosely.

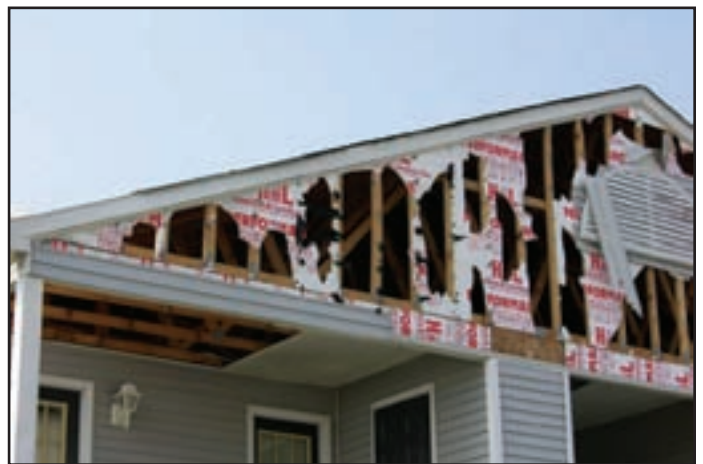
Figure 7. The vinyl siding at this gable was installed over plastic foam insulation. Without wood sheathing, the wind pressures on the vinyl are increased. Also, if the siding blows away, the foam insulation is very vulnerable to blow-off. With loss of the foam insulation, wind-driven rain can freely enter the attic, saturate the ceiling insulation, and cause collapse of the ceiling.

- At gable end walls, it is recommended that vinyl siding be installed over wood sheathing rather than over plastic foam sheathing, as was done at the house shown in Figure 7.

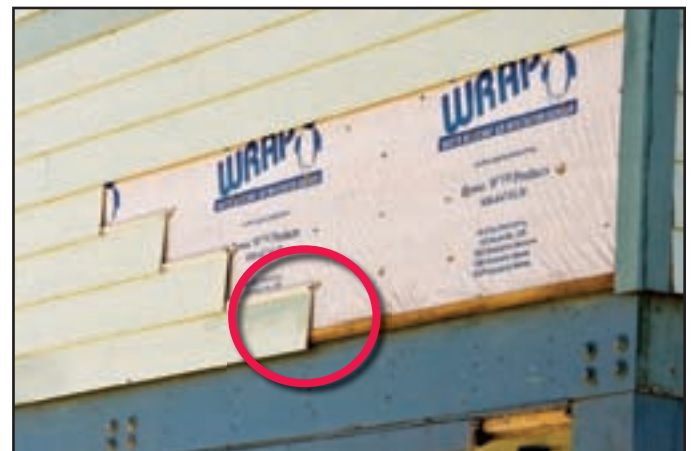
Figure 12. Blind nailed siding installed with exposed gap at bottom (red circle) is vulnerable to failure.

- Do not leave the underside of the first course exposed or extending beyond the underlying material (Figure 12). Consider the use of a trim board to close off the underside of the first course.
