# 11 Designing the Building Envelope

This chapter provides guidance on the design of the building envelope in the coastal environment.<sup>1</sup> The building envelope comprises exterior doors, windows, skylights, exterior wall coverings, soffits, roof systems, and attic vents. In buildings elevated on open foundations, the floor is also considered a part of the envelope.

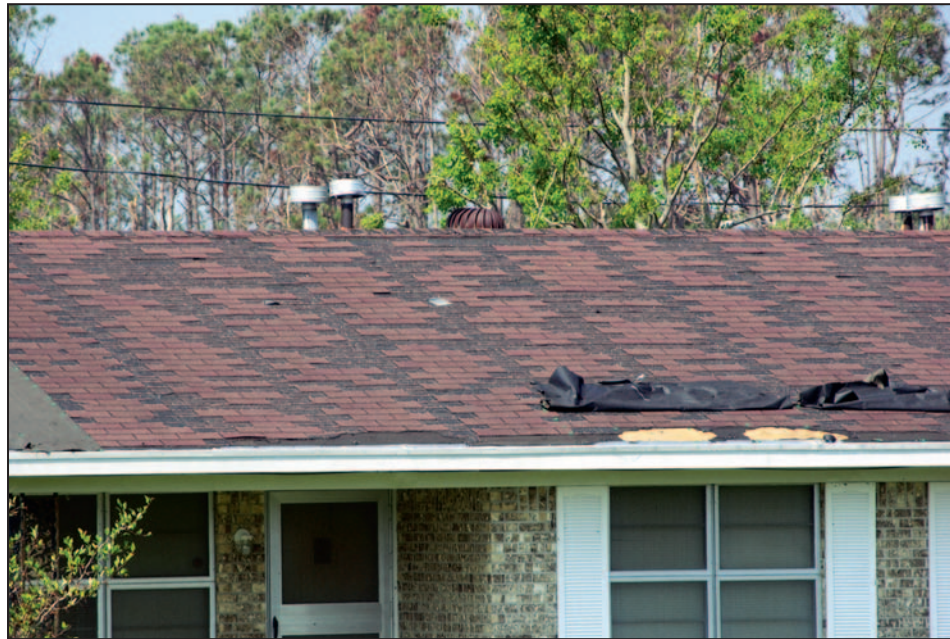
Shingle damage is also sometimes caused by installing shingles via the raking method. With this method, shingles are installed from eave to ridge in bands about 6 feet wide. Where the bands join one another, at every other course, a shingle from the previous row needs to be lifted up to install the end nail of the new band shingle. Sometimes installers do not install the end nail, and when that happens, the shingles are vulnerable to unzipping at the band lines, as shown in Figure 11-38. Raking is not recommended by the National Roofing Contractors Association or the Asphalt Roofing Manufacturers Association.

**Figure 11-38.**  
Shingles that unzipped at the band lines because the raking method was used to install them. Estimated wind speed: 135 mph. Hurricane Katrina (Mississippi, 2005)

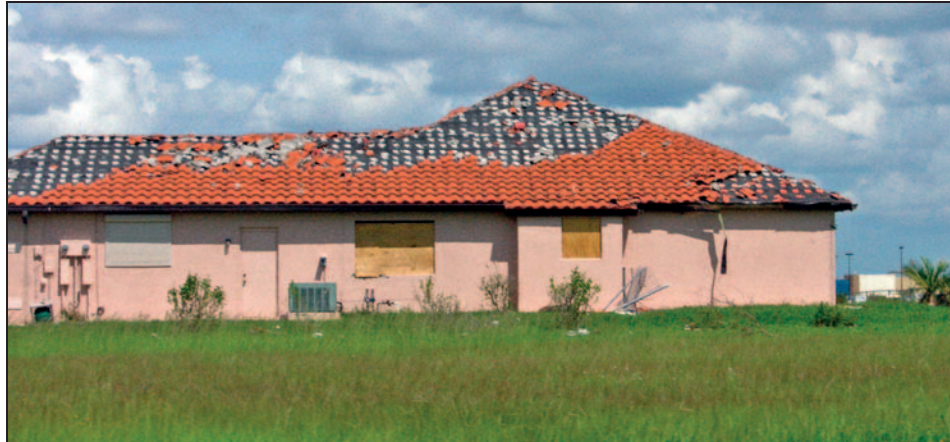
Figure 11-43 shows a house with adhesive-set tile. There were significant installation problems with the foam paddies, including insufficient contact area between the patty and the tile. As can be seen in Figure 11-43, most of the foam failed to make contact with the tile. Some of the foam also debonded from the mineral surface cap sheet underlayment (see Figure 11-44).

Figure 11-43.  
Blown-off adhesive-set tile. Note the very small contact area of the foam at the tile heads (left side of the tiles) and very small contact at the nose (circles). Estimated wind speed: 140 to 160 mph. Hurricane Charley (Florida, 2004)

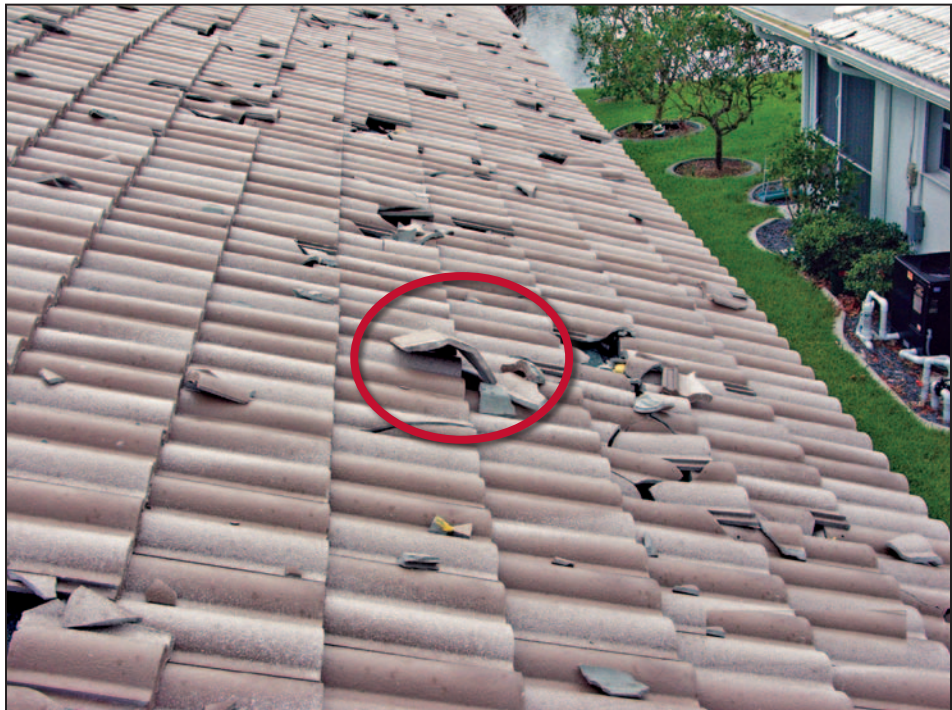
Because of the brittle nature of tile, tile is often damaged by wind-borne debris, including tile from nearby buildings or tile from the same building (see Figure 11-47).

Figure 11-47.  
Damage to field tiles  
caused by tiles from  
another area of the  
roof, including a hip  
tile (circle). Estimated  
wind speed: 140 to 160  
mph. Hurricane Charley  
(Florida, 2004)

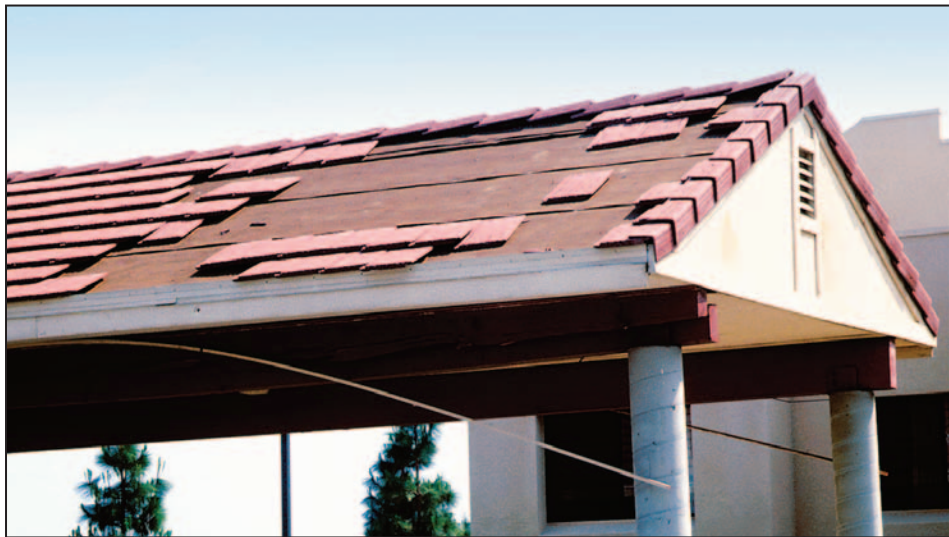
- Tiles nailed only at the head may or may not perform well. If they are attached with a smooth-shank nail into a thin plywood or OSB sheathing, pullout can occur. Figure 11-50 shows tiles that were nailed to thin wood sheathing. During the earthquake, the nose of the tiles bounced and pulled out the nails. Specifying ring-shank or screw-shank nails or screws is recommended, but even with these types of fasteners, the nose of the tile can bounce, causing enlargement of the nail hole by repeated pounding. To overcome this problem, wind clips near the nose of the tile or a bead of adhesive between the tiles at the headlap should be specified.

Figure 11-50.  
Tiles that were nailed  
to thin wood sheathing.  
Northridge Earthquake  
(California, 1994)

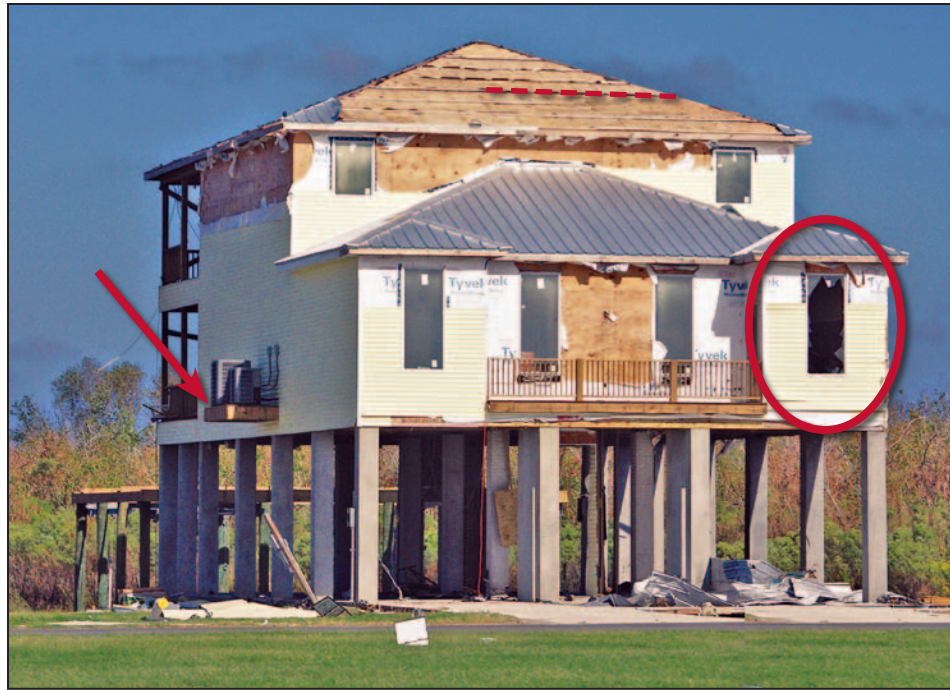
Figure 11-52 illustrates the importance of load path. The metal roof panels were screwed to wood nailers that were attached to the roof deck. The panels were well attached to the nailers. However, one of the nailers was inadequately attached. This nailer lifted and caused a progressive lifting and peeling of the metal panels. Note the cantilevered condenser platform (arrow), a good practice, and the broken window (circle).

Figure 11-52.  
Blow-off of one of the nailers (dashed line on roof) caused panels to progressively fail; cantilevered condenser platform (arrow); broken window (circle). Estimated wind speed: 130 mph. Hurricane Katrina (Louisiana, 2005)

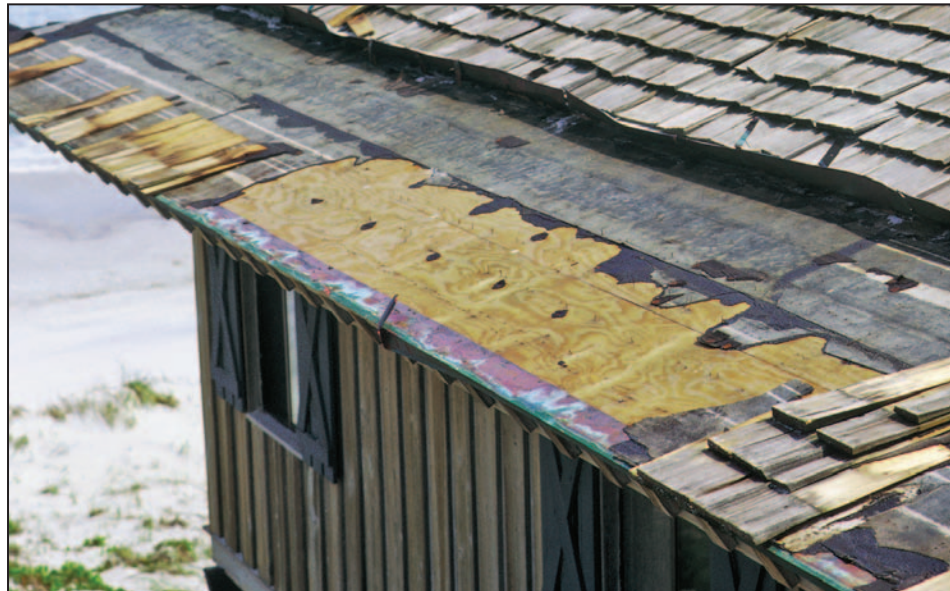
For enhanced durability, preservative-treated wood is recommended for shingle or shake roofs on coastal buildings. Stainless steel fasteners are recommended for roofs within 3,000 feet of an ocean shoreline (including sounds and back bays). See Figure 11-54 for an example of shingle loss due to corrosion of the nails.

**Figure 11-54.**  
Loss of wood shingles  
due to fastener corrosion.  
Hurricane Bertha (North  
Carolina, 1996)
