TORNADO OUTBREAK *of* **2011**

IN ALABAMA, GEORGIA, MISSISSIPPI,
TENNESSEE, AND MISSOURI

8 Observations on Infrastructure Performance

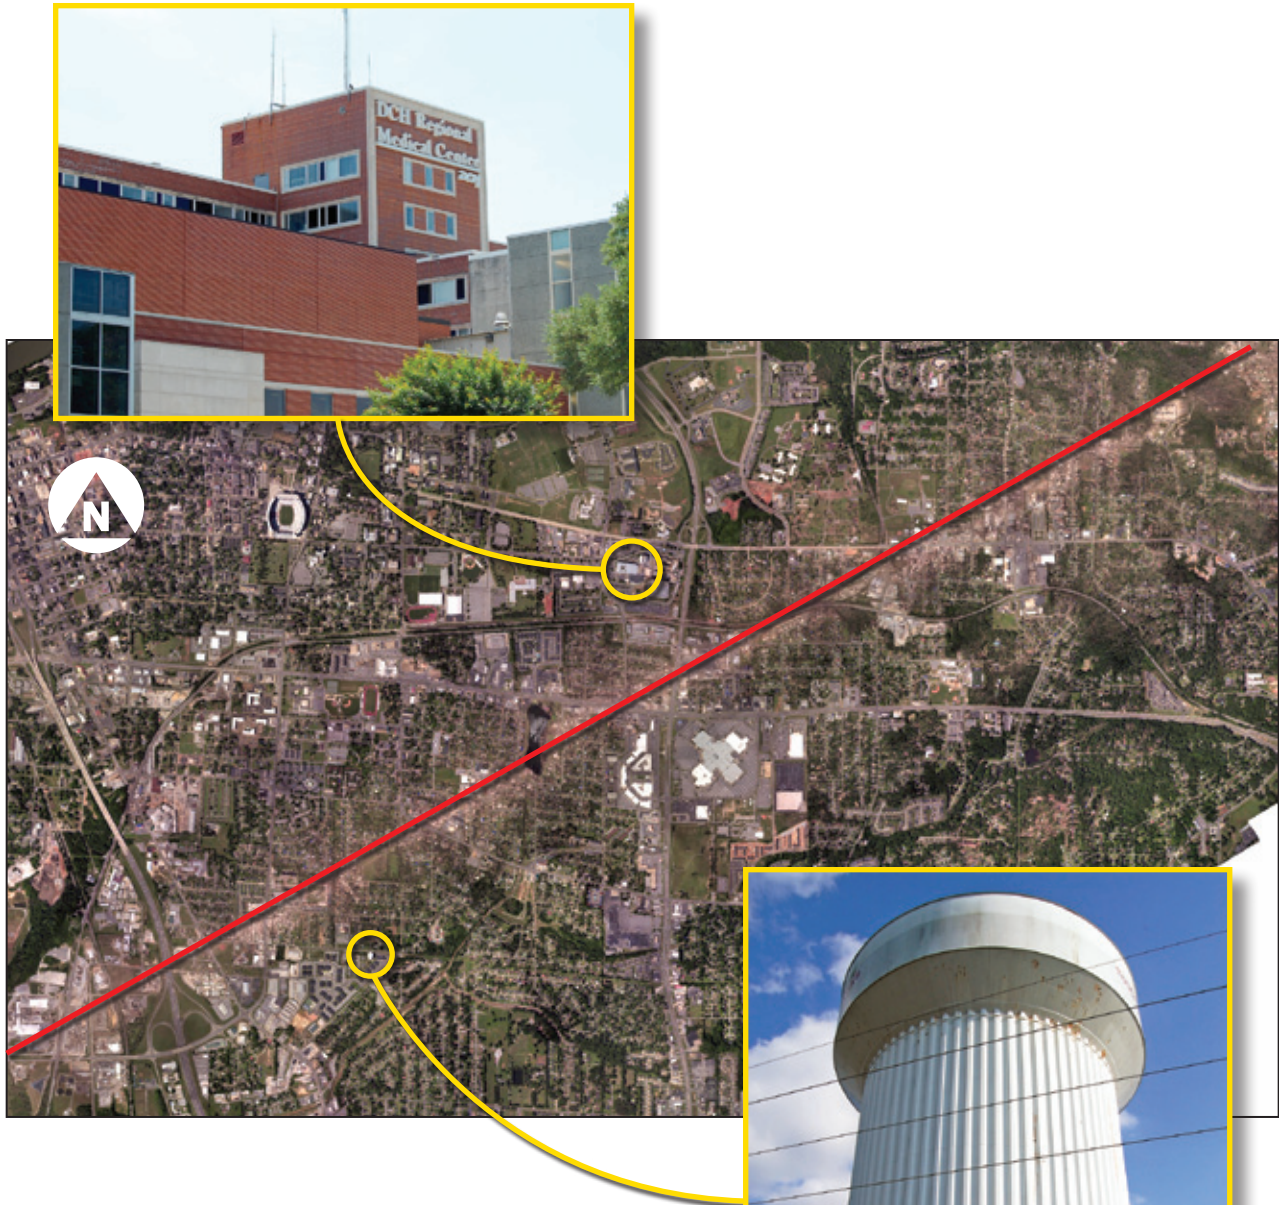
Location of Facility in Tornado Path: Figure 8-3 shows an aerial view of the tornado damage swath. NWS rated the center of the tornado circulation as EF4 in the vicinity of one of the Tuscaloosa Water Works storage towers and the DCH Regional Medical Center, a local hospital served by the Tuscaloosa Water Works that suffered reduced water pressure after the tornado.

Figure 8-3:
Aerial view showing the approximate centerline of the damage swath (red line)¹ in relationship to the Tuscaloosa Water Works storage tower (yellow circle, top inset) and the DCH Regional Medical Center (yellow circle, bottom inset)

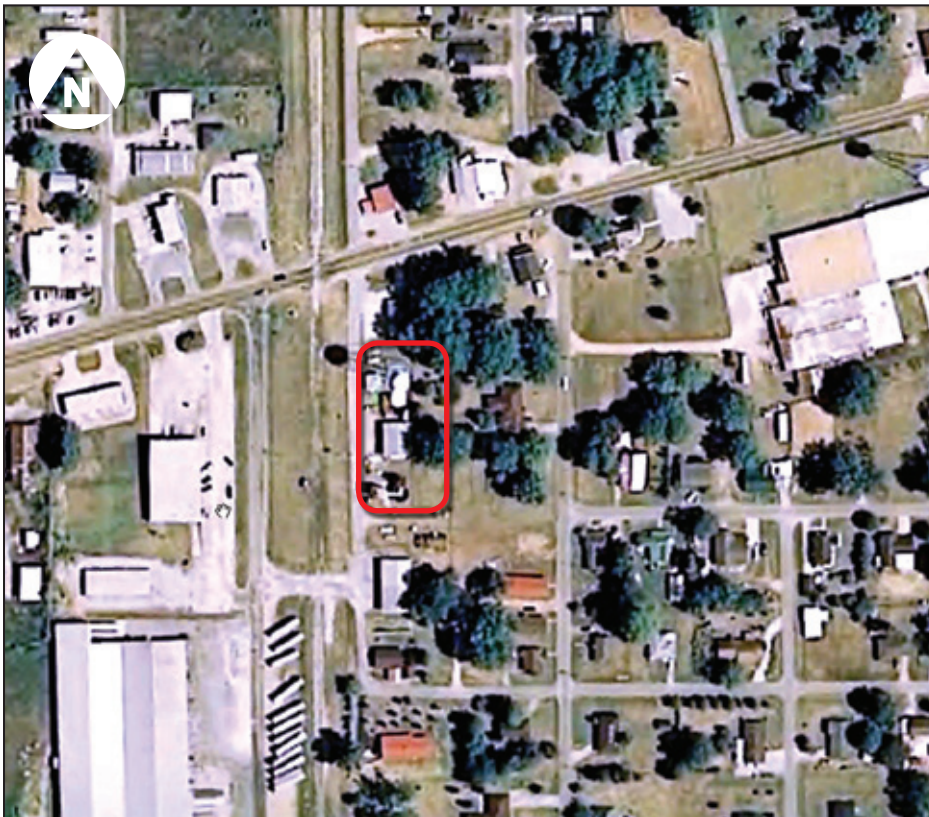
Facility Description: The Smithville Water Treatment and Distribution System Plant is shown in Figure 8-6. The water for the urban system is drawn from two wells, treated, stored in an underground clear well, and then pumped into a large storage tank (Figure 8-7). From the storage tank, treated water is gravity-fed to customers. Treatment consists of aeration, sand filtration, chlorination, and pH control. Since the well water is high in dissolved iron, it is also treated for iron removal. The wells, treatment plant, lift pumps, and storage tower are all on Earl Frye Street in Smithville.

Figure 8-6: Smithville Water Treatment Plant and storage tower (red box) aerial photograph pre-dates the tornado (Smithville, MS)

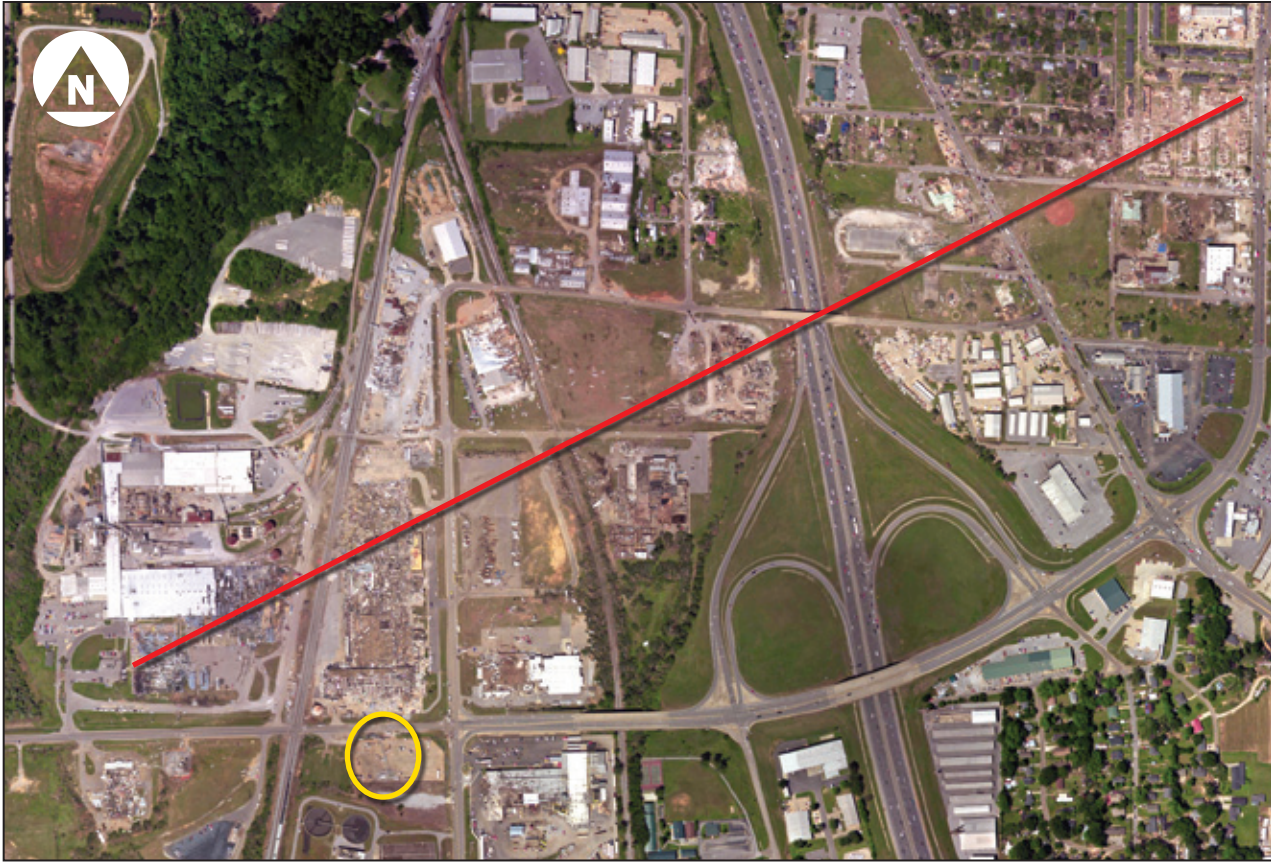
Location of Facility in Tornado Path: The location of the EMS communications tower is shown in Figure 8-1. Figure 8-14 shows an aerial view of the centerline of the tornado damage swath near the EMS communications tower. The EMS communications tower was within 1,000 feet of the center of the tornado damage swath.

Figure 8-14: Aerial view of the approximate centerline of the tornado damage swath (red line) in the vicinity of the latticed 250-foot EMS communications tower (yellow circle) (Tuscaloosa, AL)

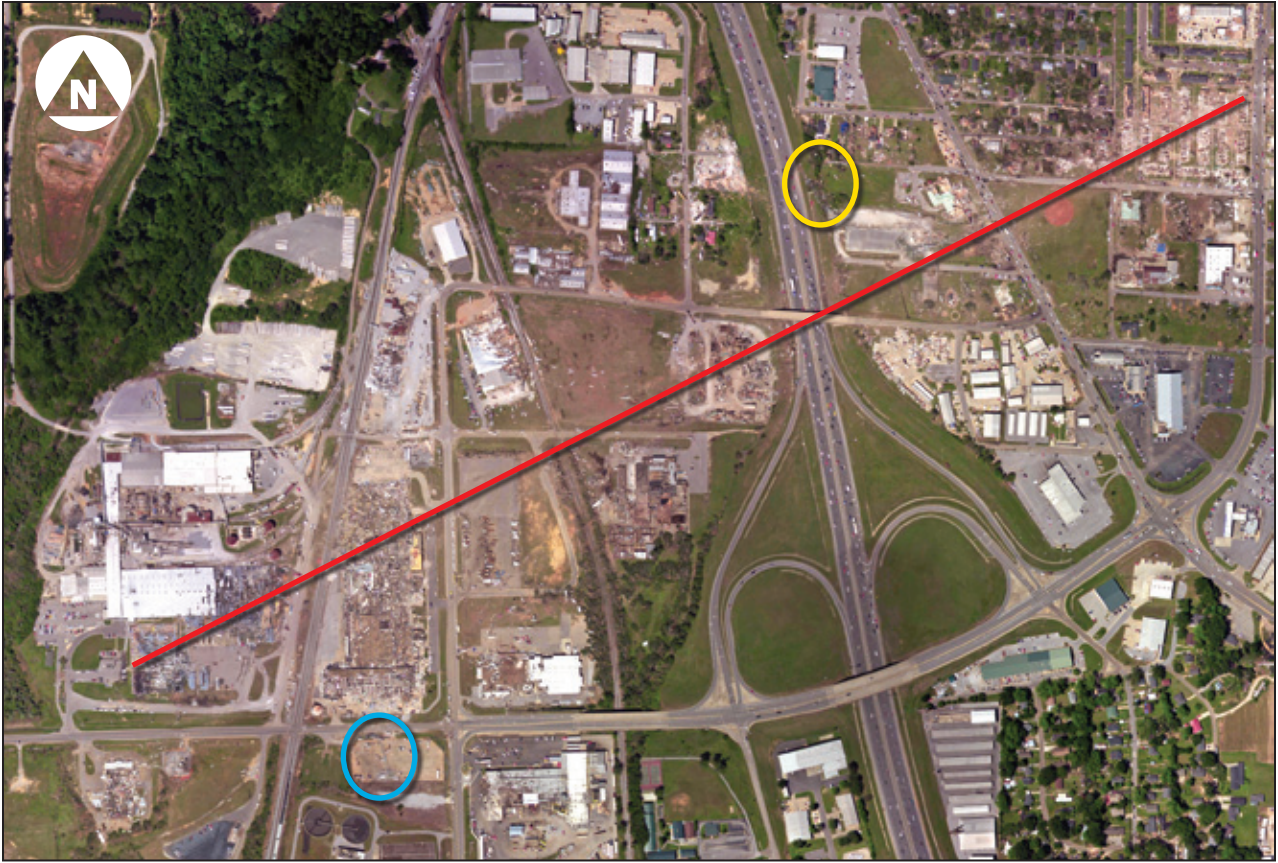
Location of Facility in Tornado Path: The location of the latticed 300-foot cellular tower is shown in Figure 8-1. Figure 8-18 shows an aerial view of the centerline of the tornado damage swath in the vicinity of the 300-foot latticed cellular tower; also shown is the location of the EMS communications tower 0.6 mile to the southwest (described in Section 8.3.1.1). The 300-foot cellular tower was approximately 500 feet north of the center of the tornado damage swath.

Figure 8-18: Aerial view of the approximate centerline of the tornado damage swath (red line) in the vicinity of the 300-foot latticed cellular tower (yellow oval). Also shown is the 250-foot EMS tower described in Section 8.3.1.1 (blue oval) (Tuscaloosa, AL).

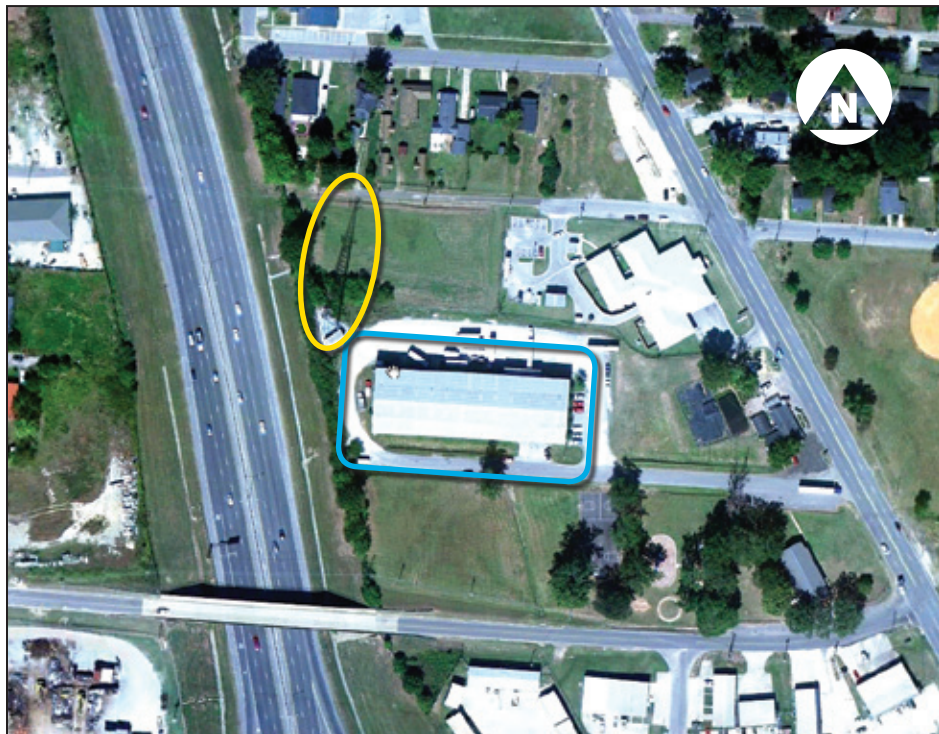
No wind-displaced building materials were seen physically adhered to the fallen latticed tower. However, a large metal building southeast of the tower had been destroyed (Figures 8-21 and 8-22), and large sections of metal panels were scattered throughout the area. The MAT also observed a trailer frame leaning against the fence surrounding the cell tower base (Figure 8-23). These observations suggest that the storm created large amounts of wind-borne debris and wind-displaced sheathing in the vicinity of the tower and wind-displaced material likely struck the tower.

Figure 8-21:
Photograph of the 300-foot cellular tower (yellow oval) and the metal building to the southeast (blue box) before the April 27, 2011 tornado (Tuscaloosa, AL)

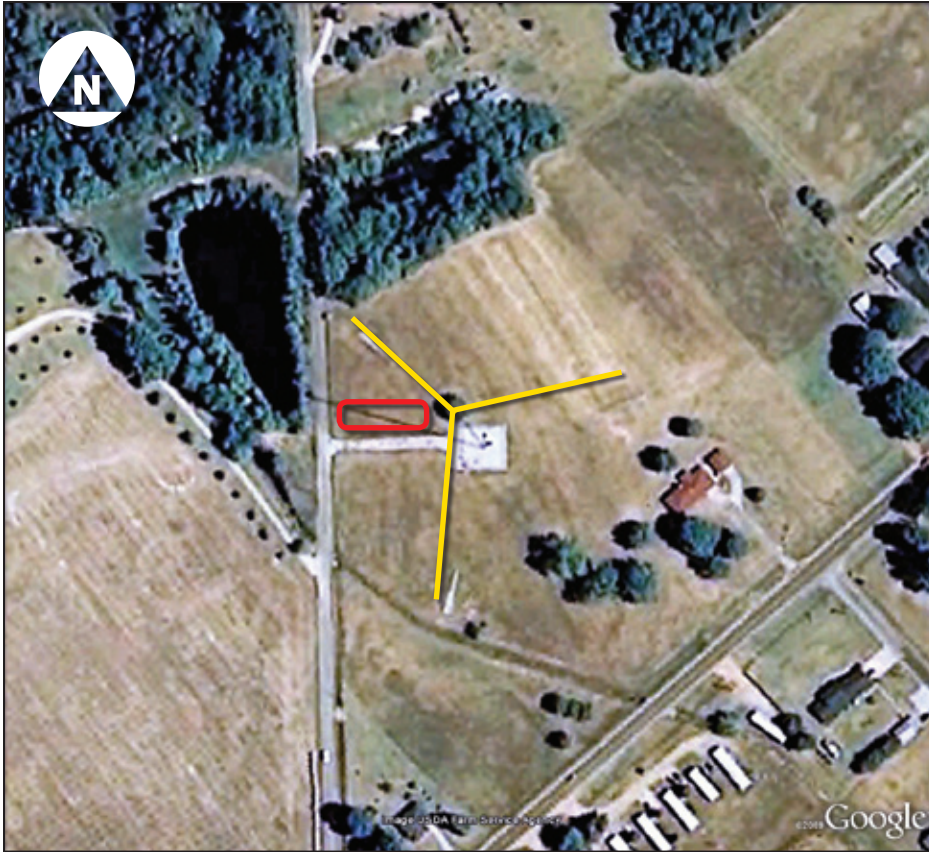
Facility Description: The guyed tower was laterally supported by three sets of earth anchors. The guys and anchors were oriented approximately at 60 degrees (east-northeast), 180 degrees (south) and 300 degrees (west-northwest), as shown in Figure 8-27.

Figure 8-27:
Aerial photograph showing the 300-foot-tall guyed cellular tower after the tornado; the yellow lines show the location of the original guys, and the red box shows the position of the tower remnants observed by the MAT (Smithville, MS)
SOURCE: © GOOGLE EARTH
