TORNADO OUTBREAK *of* **2011**

IN ALABAMA, GEORGIA, MISSISSIPPI,
TENNESSEE, AND MISSOURI

6 Observations on Critical Facility Performance: Schools

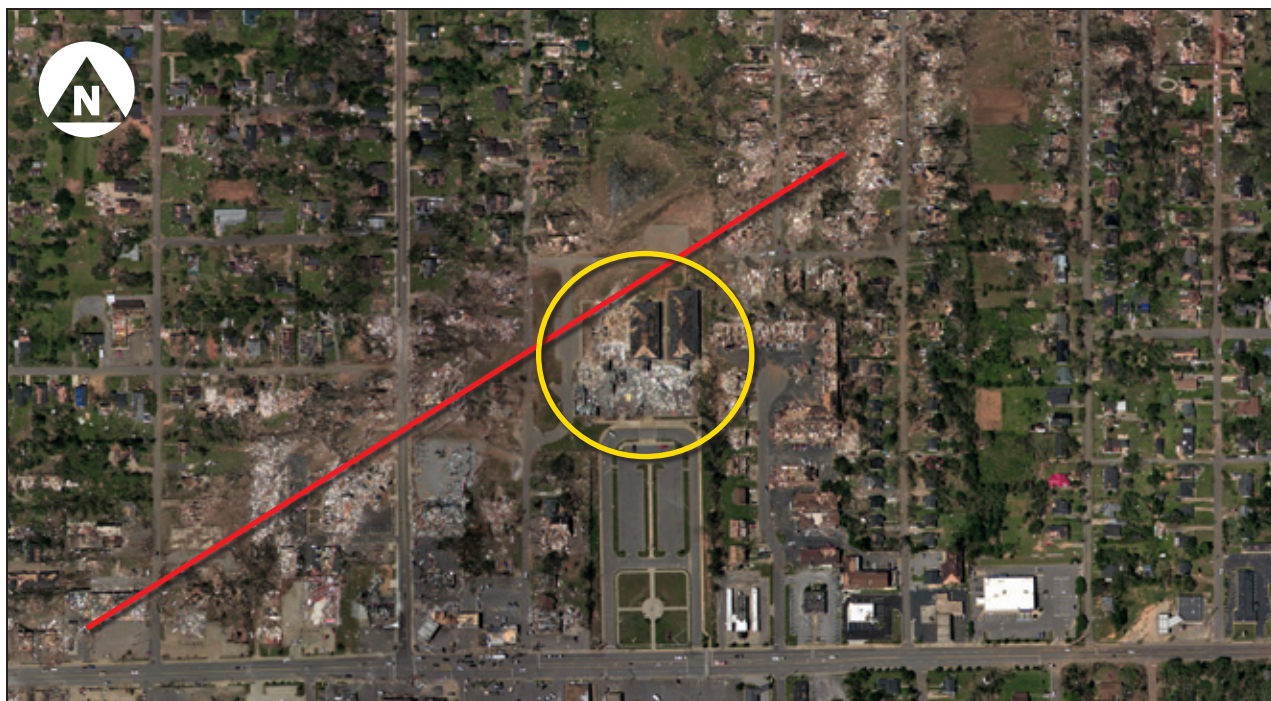
Figure 6-3: Aerial view of tornado track in vicinity of Alberta Elementary School (yellow circle). The center of the damage swath is approximated by the red line¹ (Tuscaloosa, AL).

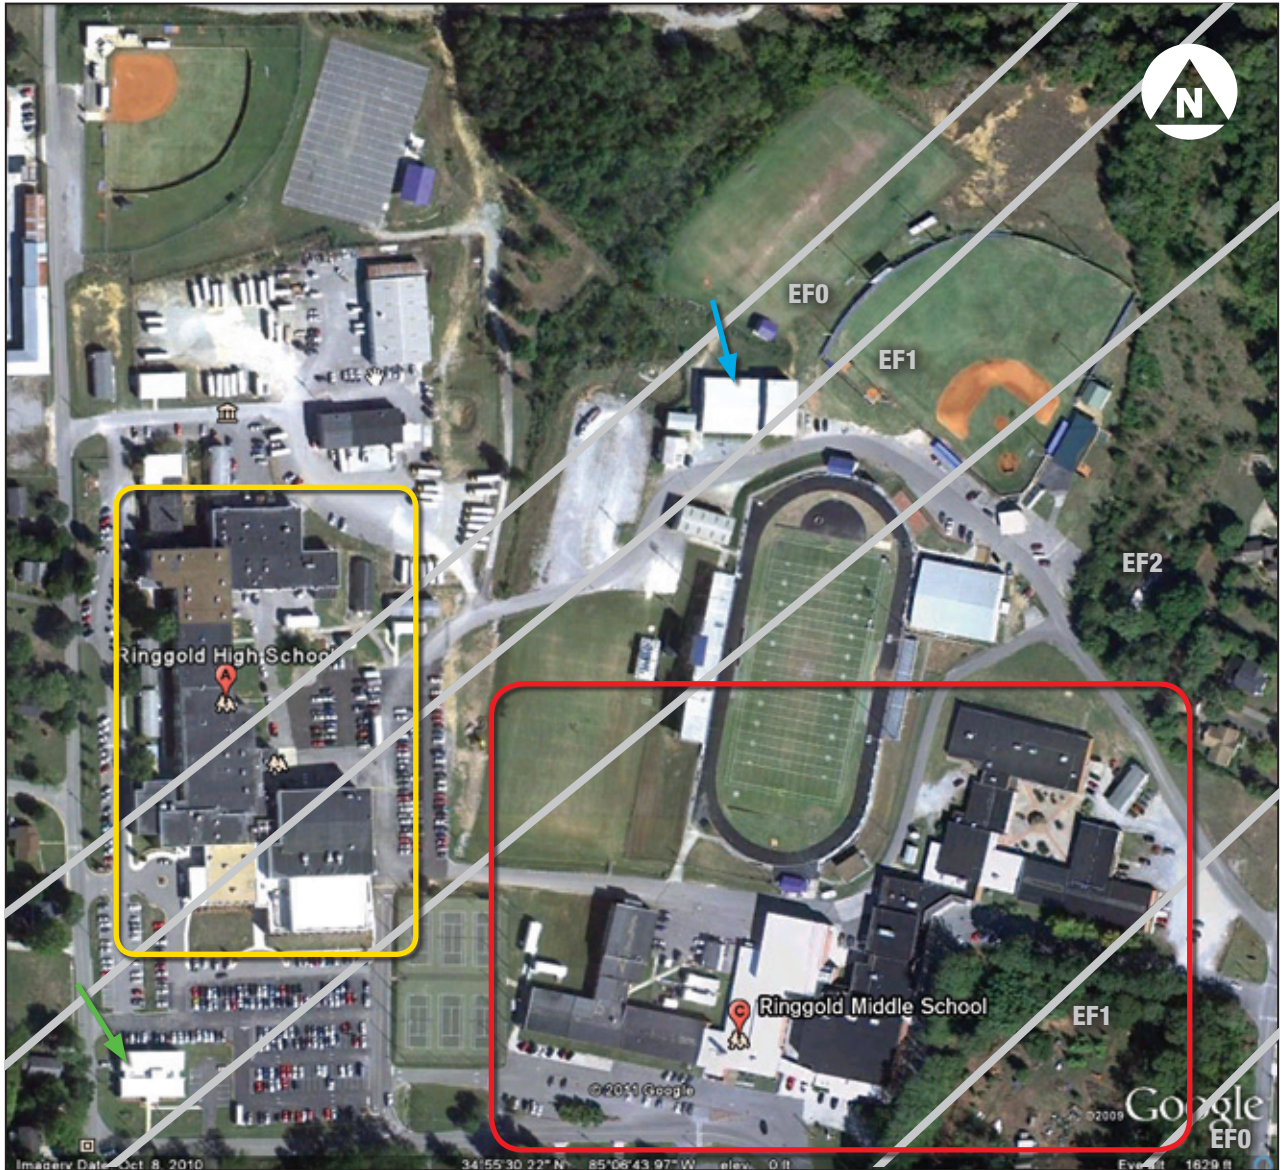
Figure 6-23:⁹ View of the Ringgold High School (yellow box) and Ringgold Middle School (red box) prior to the April 2011 tornado. The art center and cheerleading/wrestling facility are shown by the green and blue arrows. NWS EF contour ratings are also shown (Ringgold, GA).

As shown in Figure 6-23, the NWS derived the rating as EF1 at the southern end of the high school, which correlates with the MAT EF1 rating for this building.

As shown in Figure 6-23, the NWS derived the rating as EF2 at the middle school, which is different from the MAT EF1 rating for this school.

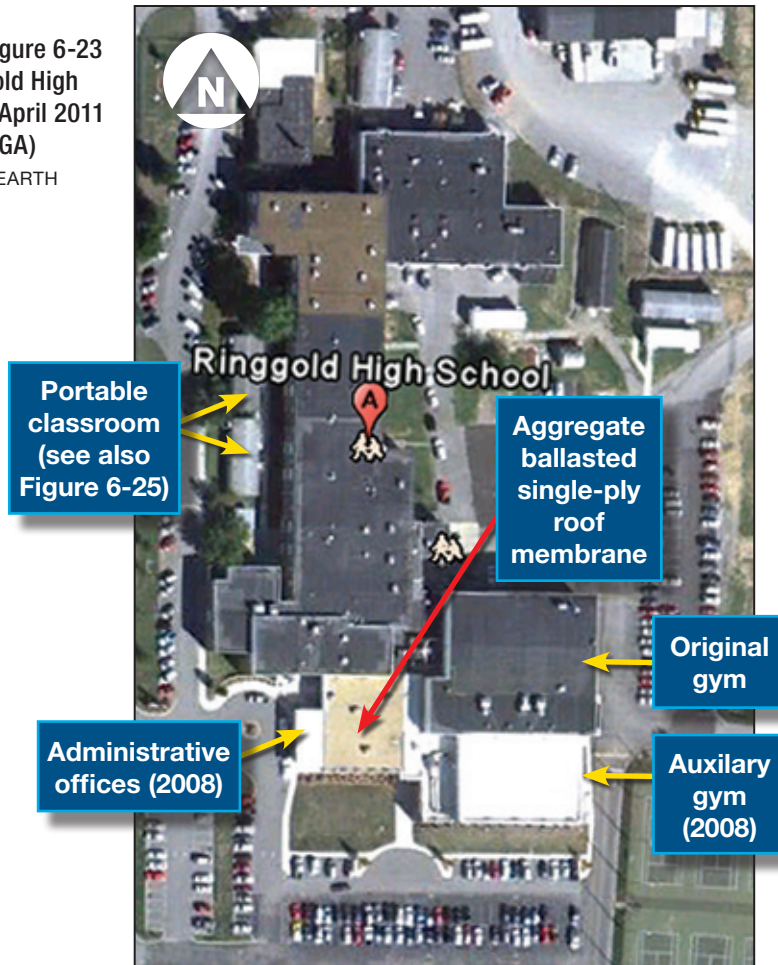
Figure 6-24:
Close-up view of Figure 6-23
showing the Ringgold High
School prior to the April 2011
tornado (Ringgold, GA)

A lower roof adjacent to the 2008 auxiliary gymnasium (see Figures 6-24 and 6-26 for location) had an aggregate ballasted EPDM roof system (Figure 6-30). The winds were such that most of the aggregate on this roof was not scoured. However, the windows shown in the Figure 6-30 inset were likely broken by the roof aggregate. An adjacent roof had a fully adhered single-ply membrane over polyisocyanurate insulation over steel deck. This roof membrane blew away (oval area at Figure 6-30).

In addition to the above damage, the 2008 art center (shown in Figures 6-23 and 6-31) and the cheerleading/wrestling facility (shown in Figures 6-24 and 6-32) were damaged.

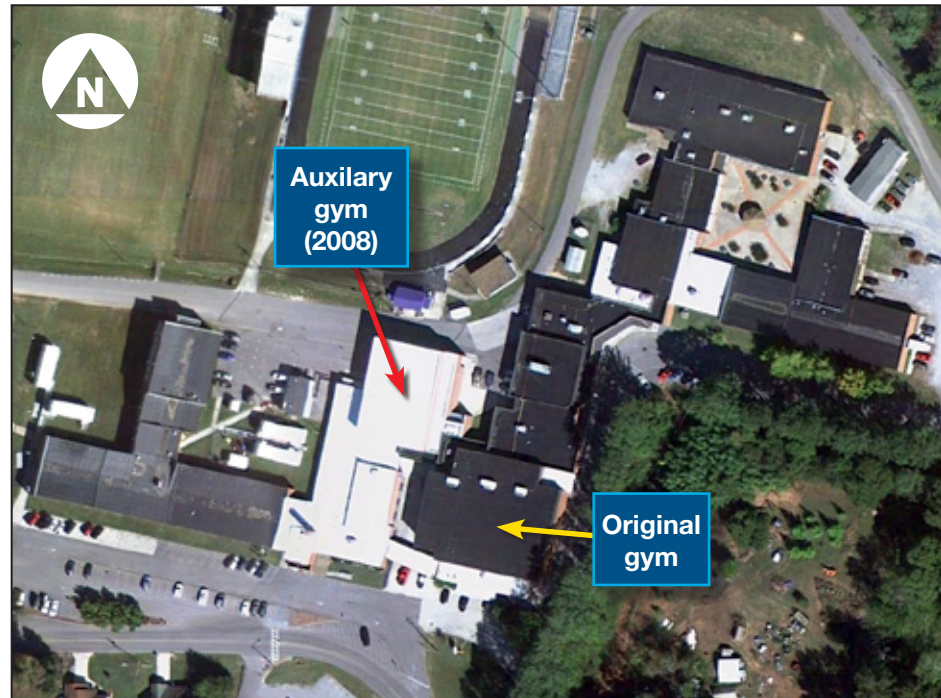
Figure 6-33:
View of the Ringgold Middle School prior to the April 2011 tornado (Ringgold, GA)

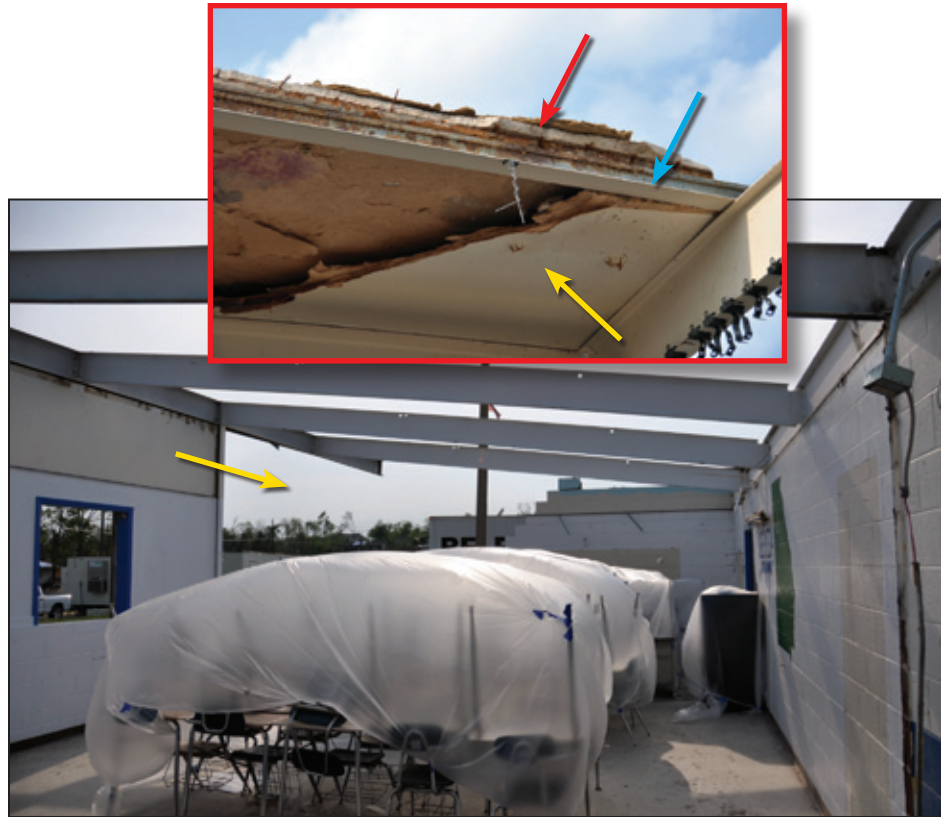
The cementitious wood-fiber deck panels blew off the original gymnasium along one perimeter, resulting in standing water on the gymnasium floor (Figure 6-37). Cementitious wood-fiber panels also blew off over some of the classrooms and overhang shown in Figure 6-38. Figure 6-38 also shows a wall that blew in (the damaged wall is shown in the blue oval of Figure 6-34). The wall was EIFS over metal studs. The stud track was attached to a concrete sill with powder-driven fasteners spaced at $23\frac{1}{2}$ inches and $26\frac{1}{2}$ inches. The fasteners only had about $\frac{3}{8}$ inch of embedment. The two windows adjacent to the wall opening and the window at the right of Figure 6-38 were broken, as were several other windows at this wing.

Figure 6-37: Deck panels blew off the original gymnasium. The inset shows the resulting standing water on the wood floor (Ringgold, GA).

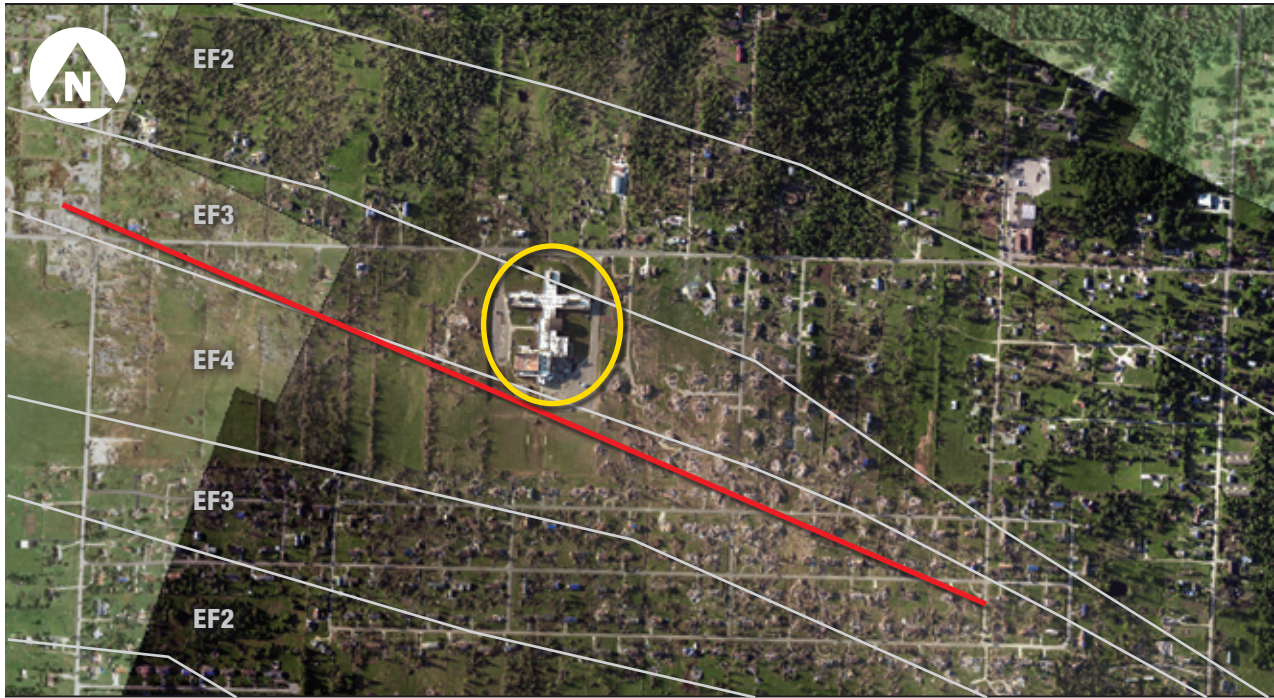
Figure 6-39: Aerial view of the tornado track in the vicinity of the Joplin East Middle School (yellow circle). The center of the damage swath is approximated by the red line. NWS EF contour ratings are also shown (Joplin, MO).

As shown in Figure 6-39, the NWS derived the rating as EF3 at the middle school, which is different from the MAT EF2 rating for this school.

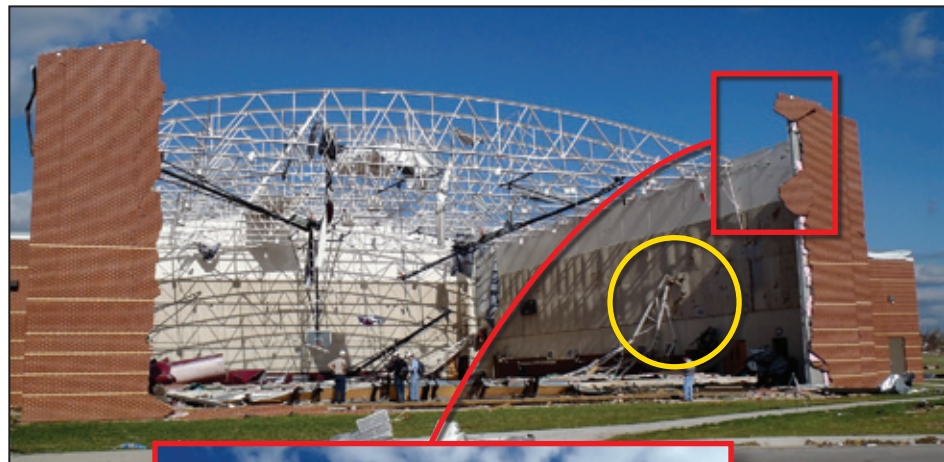
Figure 6-44:
View of the end of the collapsed truss (yellow circle) shown in Figure 6-43 (Joplin, MO)

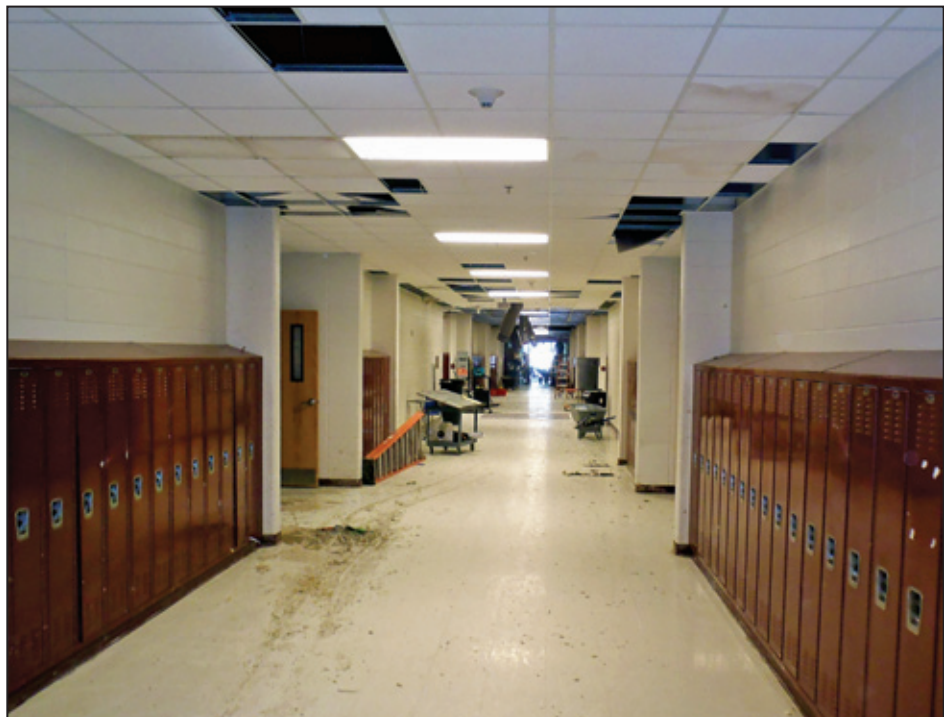
The remainder of the middle school received damage from wind-borne debris, including glazing damage, as well as water damage due to damaged roof covering, decking, and rooftop equipment (Figures 6-40 and 6-47). The rain intrusion caused damage to the HVAC equipment, ceiling boards, floor coverings, and furnishings.

Figure 6-47:
View of rain infiltration
damage in a school corridor
(Joplin, MO)

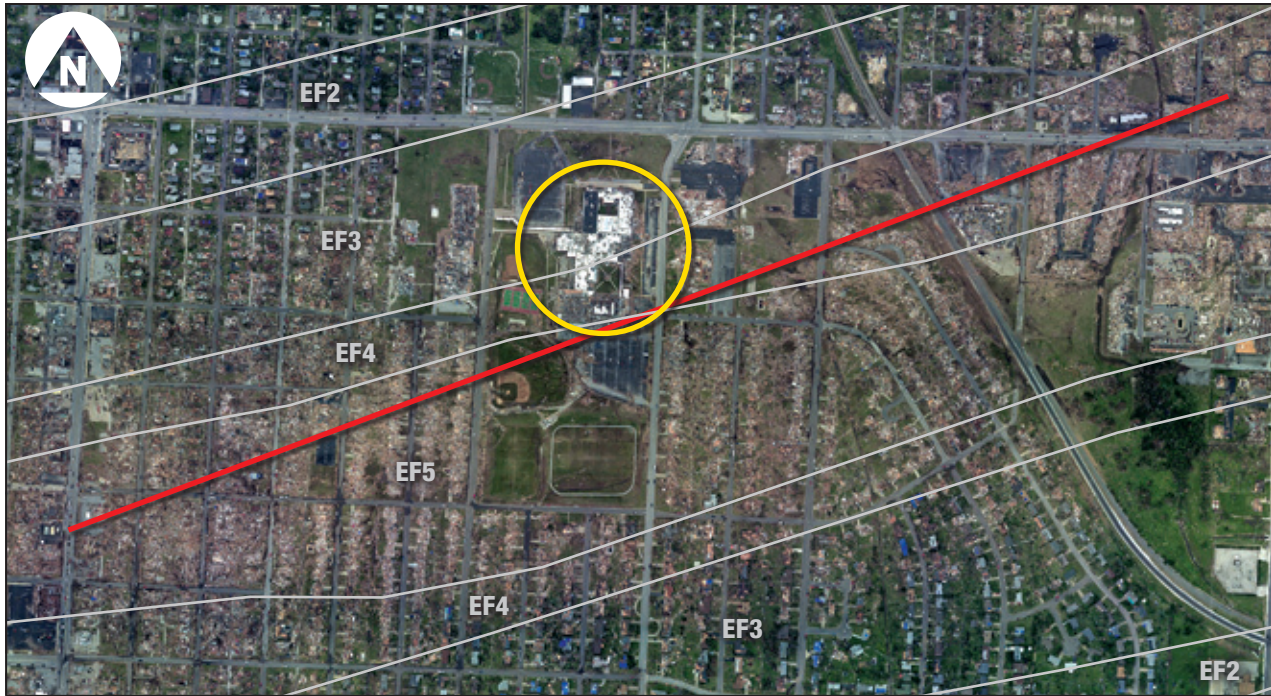
Figure 6-48: Aerial view of the track in the vicinity of the Joplin High School (yellow circle). The center of the damage swath is approximated by the red line. NWS EF contour ratings are also shown (Joplin, MO).

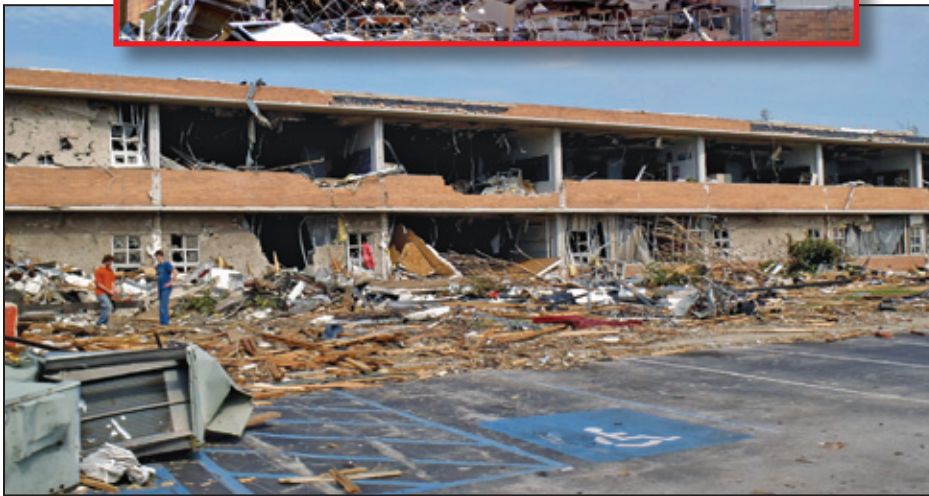
Figure 6-52:
Collapse of the exterior brick
veneer/reinforced CMU wall
and roof assembly into the
corridor at the north end of
the north classroom wing
(Joplin, MO)

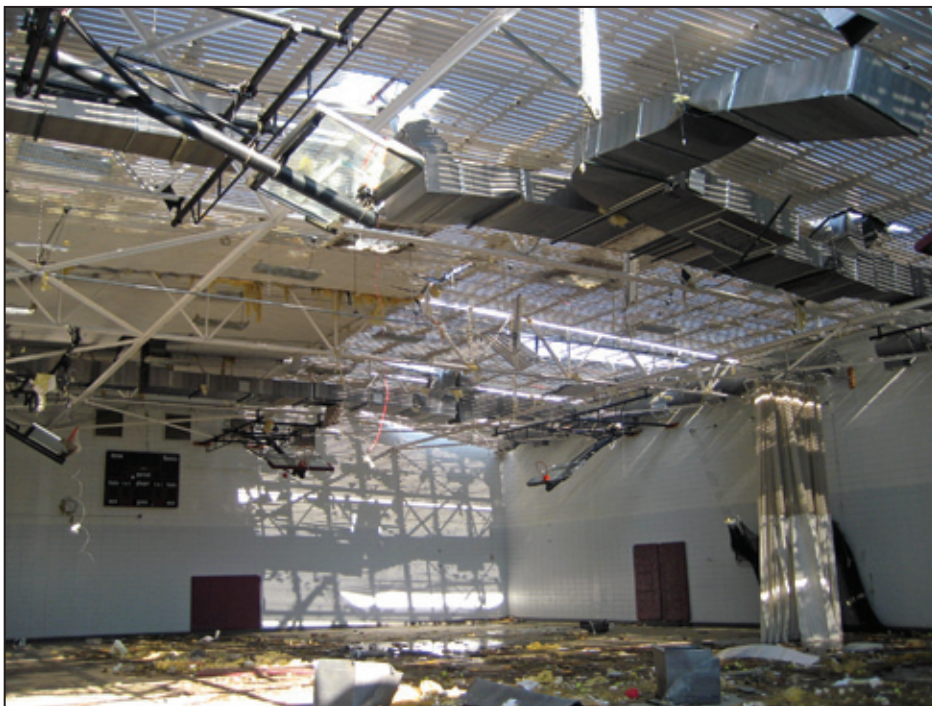
Figure 6-55:
Interior view of the second gymnasium (Joplin, MO)
