Building Envelope Performance

5.1 Doors

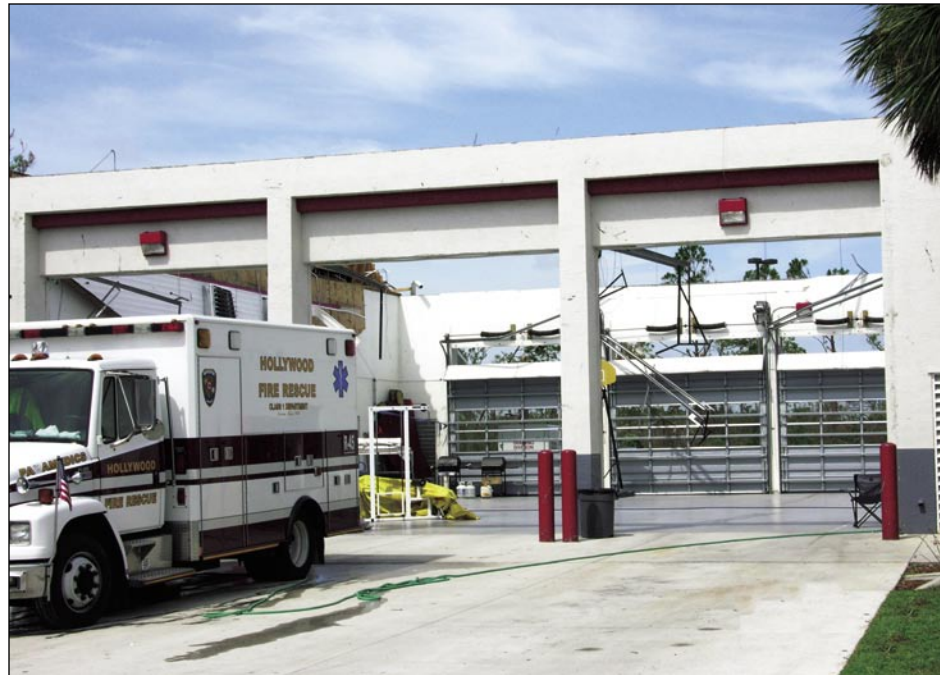
Surprisingly, sectional doors on two newer fire stations also failed. At the Aqui Esta Fire Station (east of Punta Gorda Isles), five of the six doors were not damaged, but the sixth door pulled out of the track. This station was first occupied in 2000. At a fire station in Deep Creek (Figure 5-10), all three windward doors were blown in. The tracks were attached with ¼-inch lag screws at 24 inches on center. The leeward doors were not damaged, but the roof structure blew off the apparatus bay.

Figure 5-10. At two of the windward doors, the doors were pushed out of the tracks; at the third door, one of the tracks was pushed from the wall (Deep Creek).

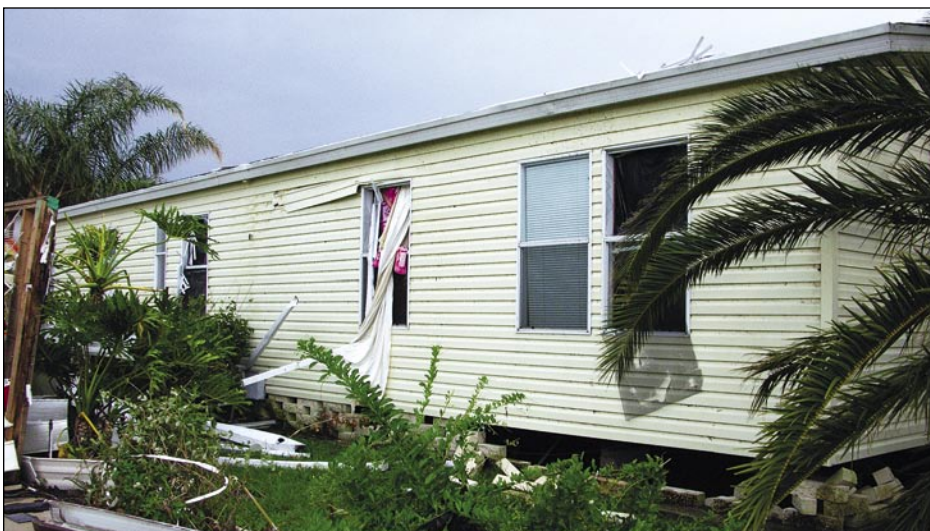
Figure 5-11. Most of the windows on this side of a manufactured home were broken by windborne debris (east of Port Charlotte).

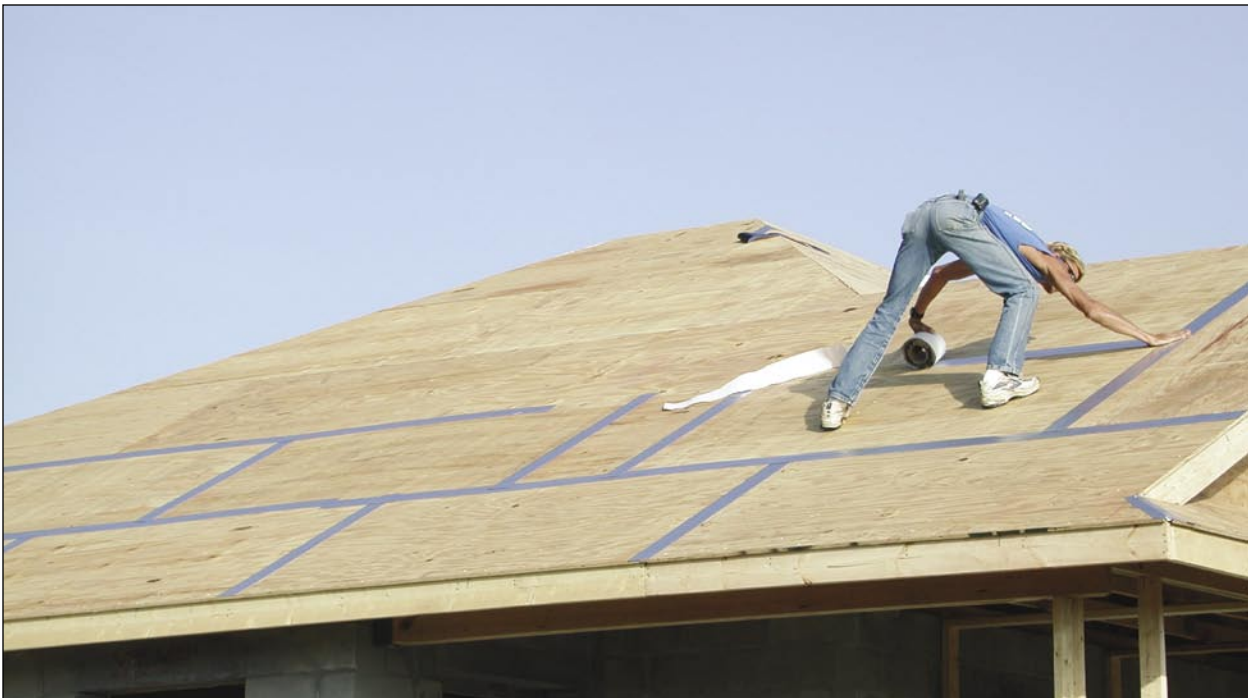
For steep-sloped roofs, a secondary water penetration barrier that minimizes the water infiltration through the sheathing, if the roof cover fails, offers important backup protection for shingle, tile, and metal panel installations. Figure 5-23 illustrates the installation of self-adhering modified bitumen tape at sheathing joints. The tape is installed at the joints to allow water to shed off the sheathing if the primary roof covering (e.g., shingles) and underlayment are blown off.

Figure 5-23. Installation of self-adhering modified bitumen tape at sheathing joints, as part of an enhanced underlayment system on a Fortified...for safer living™ house under construction (IBHS)

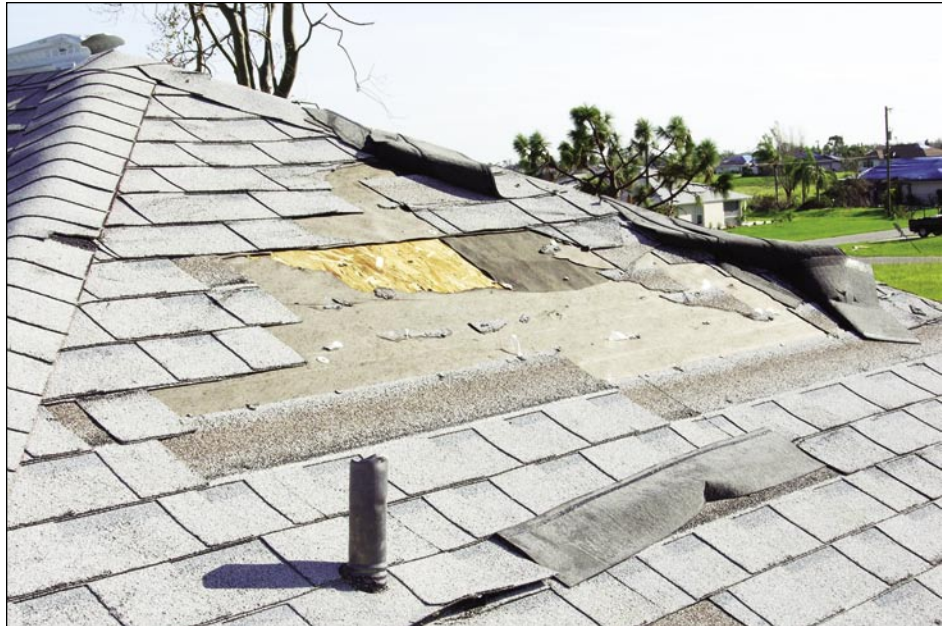
Many shingle roofs in the Port Charlotte and Punta Gorda area were undamaged, while others lost a few hip and/or ridge shingles or a few tabs. Other roofs, including roofs far inland, lost many shingles, as shown in Figures 5-24 and 5-25. The shingles shown in Figure 5-24 were attached with 6 nails per shingle, but the nails were attached about 1½ inches above the nail line. In addition, the shingles were poorly bonded. Though continuous, the self-seal strip was narrow (approximately ½ inch). When shingles were pulled apart during the investigation, many granules from the underlying shingle were pulled up, thus indicating that the granules were not well embedded. The starter course was incorrectly applied, and the nails at the hip shingles were incorrectly located. Note the area where the deck is exposed. Water can flow between the deck and underlayment and leak into the building at the sheathing joints.

Figure 5-24. Asphalt shingle roof installed on a new residence about 2 months before the hurricane hit; shingles were blown off several areas (Deep Creek).

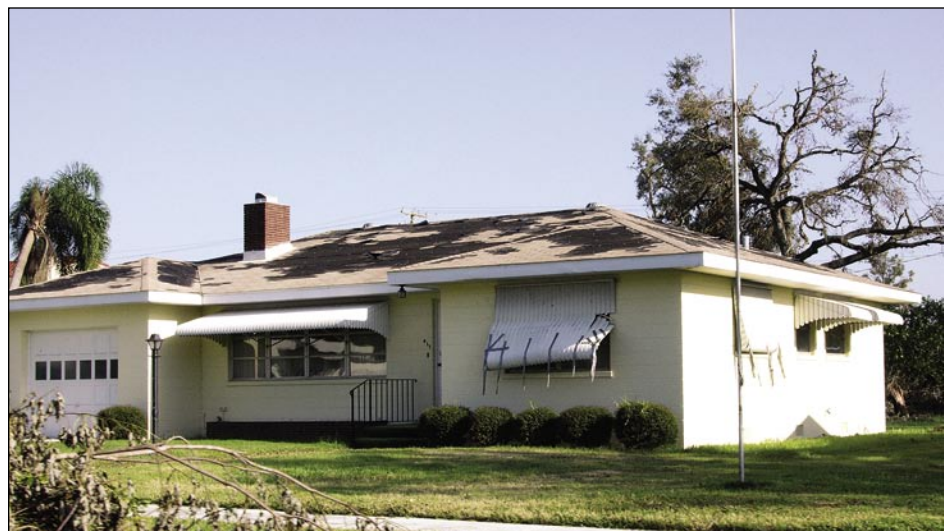
Figure 5-25. Residence with a significant number of asphalt shingles lost. The metal window shutters shown were not designed for windborne debris (Fort Meade).

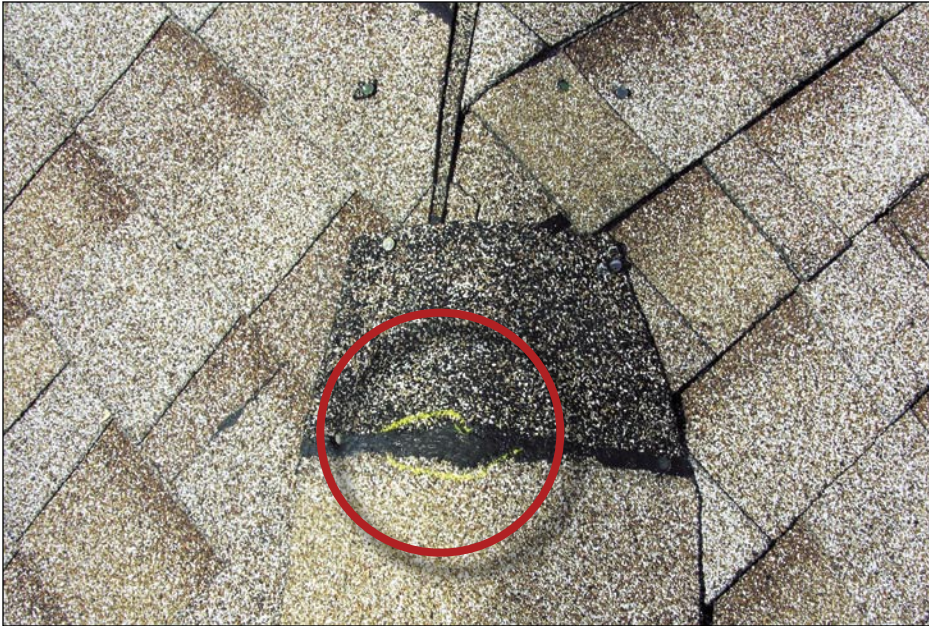
Figure 5-26. Only the portion of the self-seal adhesive that is indicated in yellow had bonded (within the red circle). No bonding occurred on the right side of the hip line (Deep Creek).

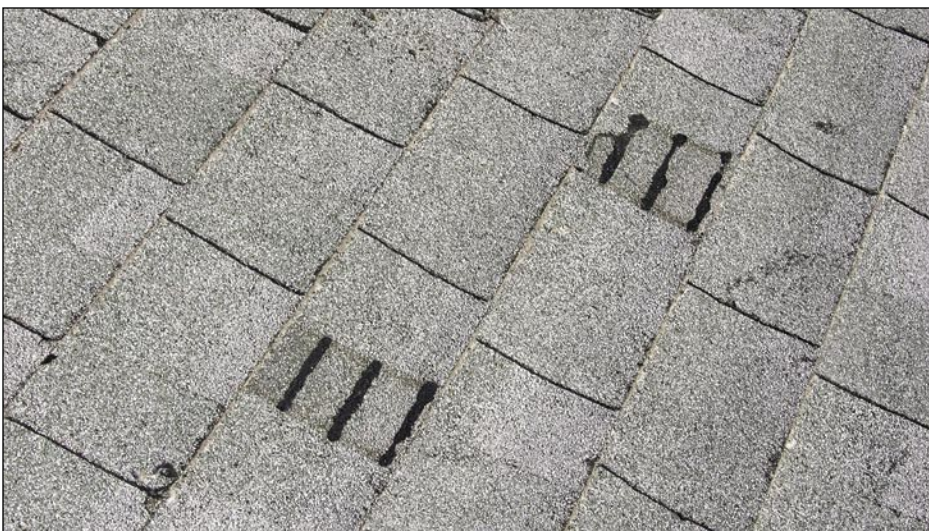
On a few roofs with architectural shingles, instances of blow-off of laminated tabs were observed (Figure 5-27). This type of failure was due to an inadequate amount and/or strength of adhesive used in the manufacturing of the shingles.

Figure 5-27. Two laminated tabs blown off (Deep Creek)

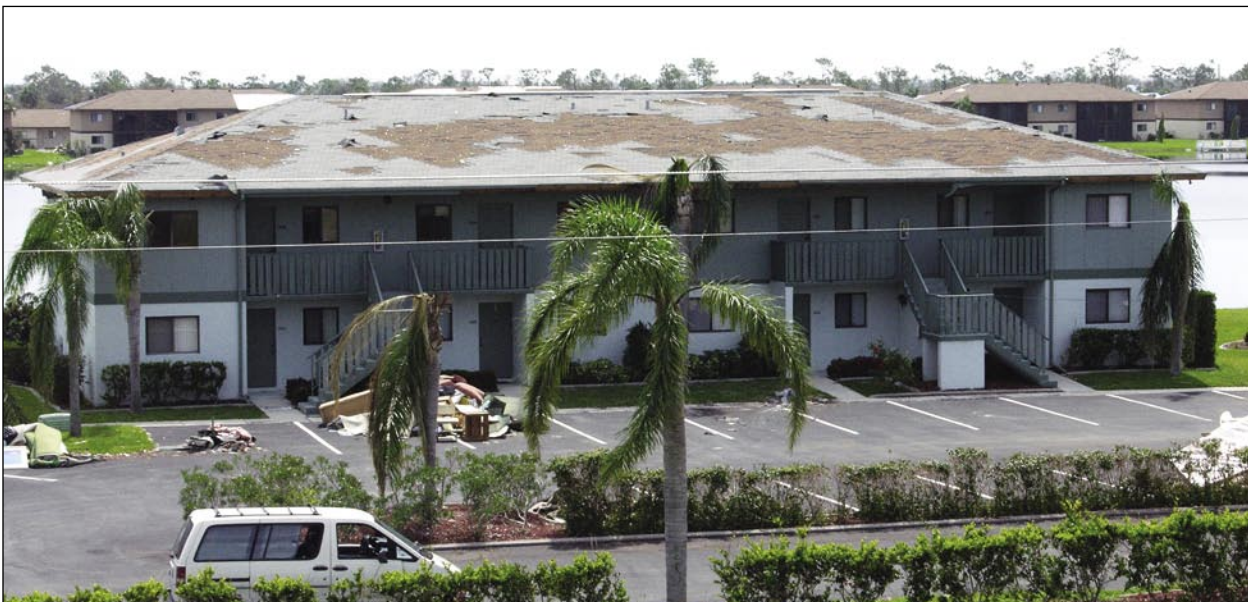
On many residences that had been re-covered (i.e., new shingles had been installed on top of old shingles), large numbers of the re-cover shingles were blown away and the underlying older shingles remained in place. Some of these blow-offs may have been due to use of nails that were too short, although on the building shown in Figure 5-28, the nails had adequate sheathing penetration, but the newer shingles were poorly bonded (likely due to substrate irregularities). When re-covering versus tearing off the old shingles down to the sheathing, more substrate irregularity occurs, which can interfere with bonding of the self-seal adhesive of the new shingles. Most of the re-cover blow-offs were likely due to bonding problems associated with substrate irregularities.

Figure 5-28. Re-covered apartment building (the newer shingles are grey and the older shingles are brown) (Deep Creek).

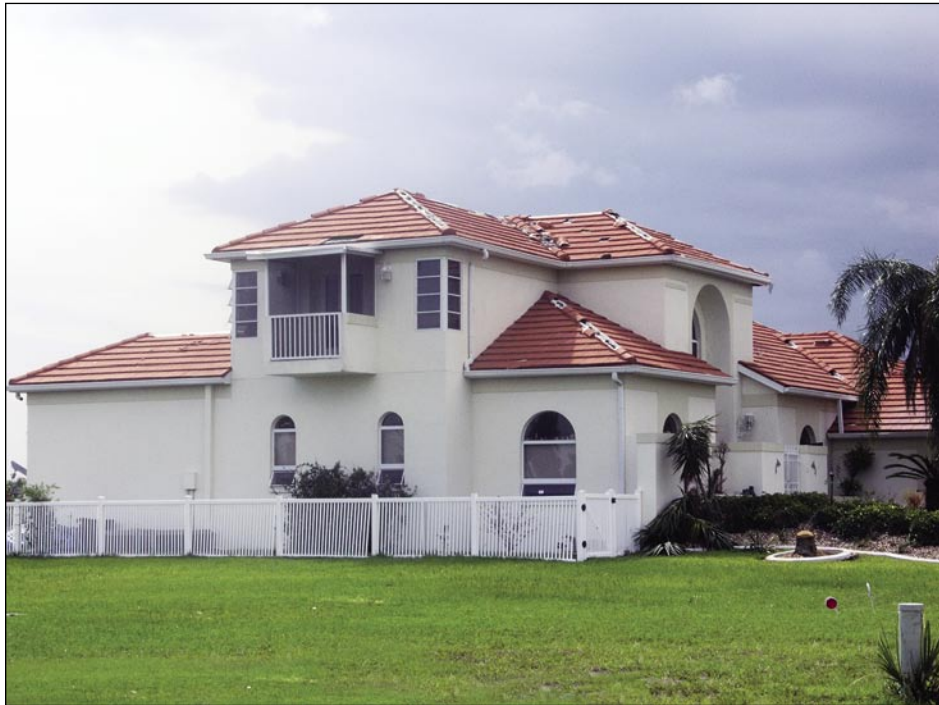
Figure 5-32.
Most of the mortar-set
hip and ridge tiles blew
off this house (Port
Charlotte).

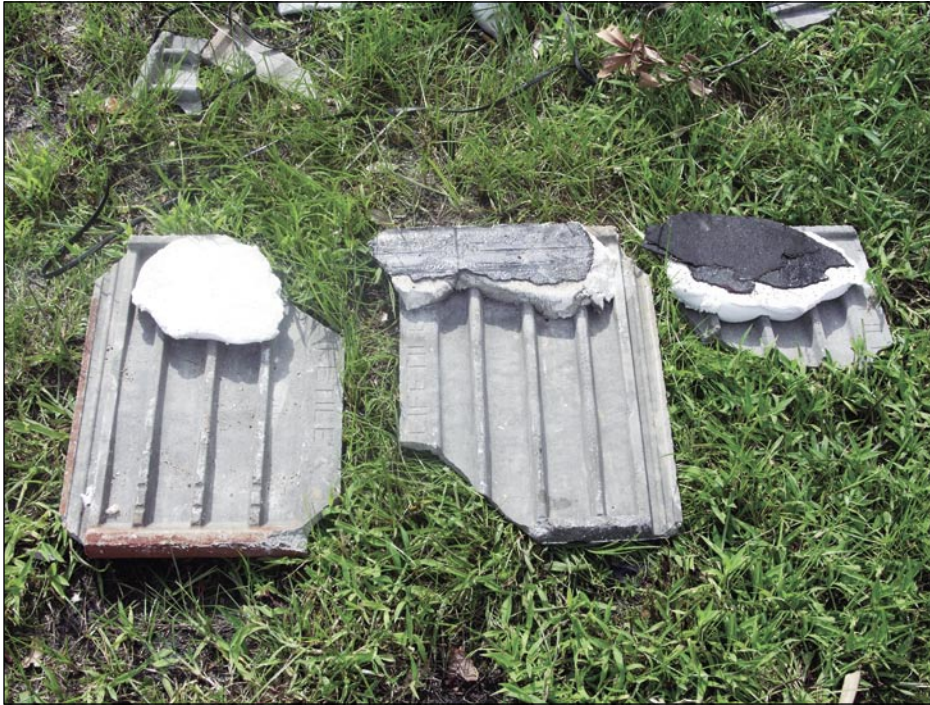
Figure 5-33.
Tile debris from the roof
shown in Figure 5-32
(Port Charlotte)

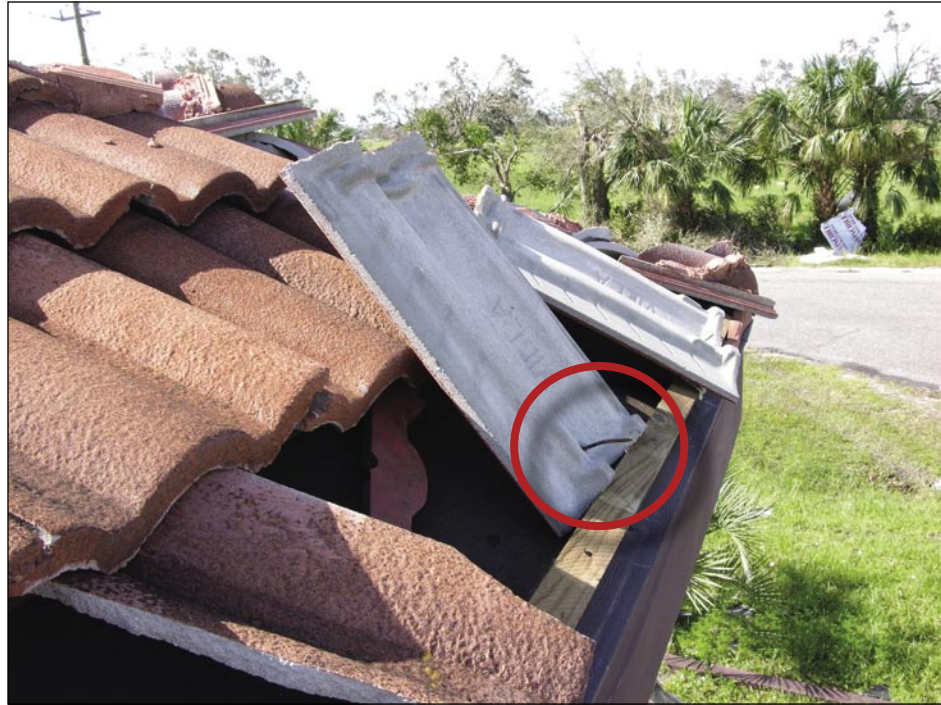
Figure 5-34.
Each tile on this building
was attached to battens
with a single 3¹/₈-inch
long smooth shank nail
(Arcadia)

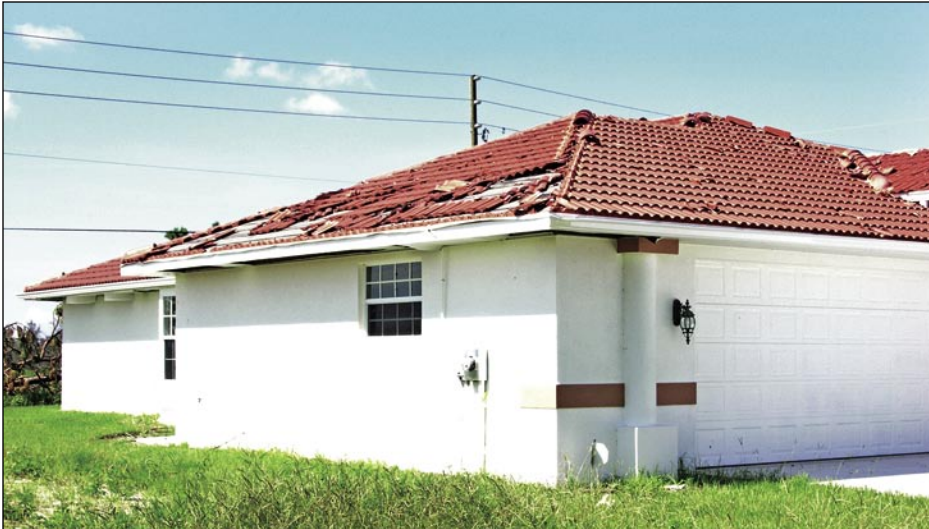
At a residence near the one shown in Figure 5-35, missiles (likely tiles from its roof) broke a few field tiles. The field tiles were attached with one screw per tile directly to the deck.

Figure 5-35. Windborne debris (likely tiles from this roof) broke several of the field tiles (Deep Creek).

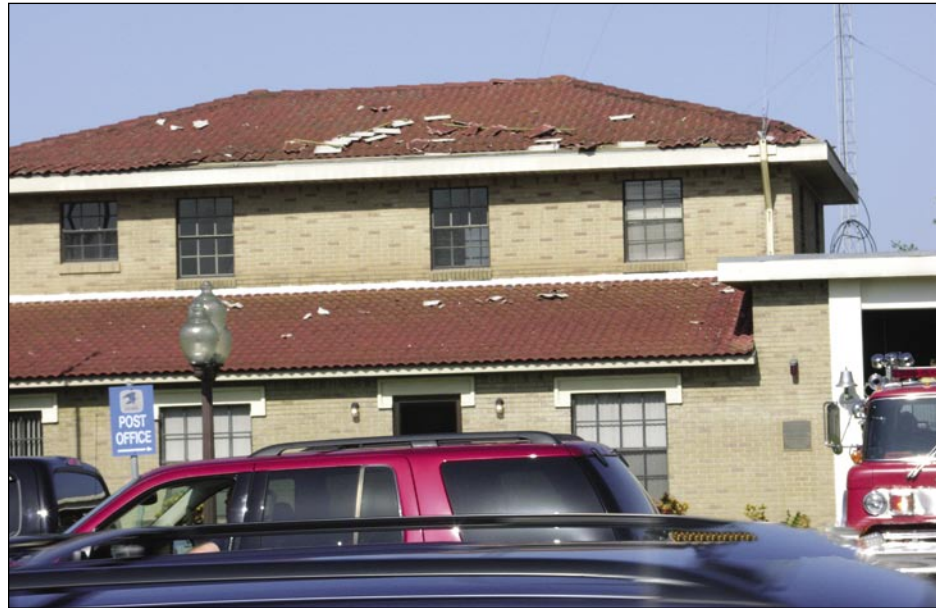
Figure 5-37 shows several areas where batten-attached tiles on a fire station were damaged. The tile debris on the lower roof is from the upper roof. The tiles were installed when the building was re-roofed in the mid- to late-1980s. According to the 2001 FBC (Table 1507.4.7), the attachment method observed on this roof is suitable for buildings with a mean roof height up to 40 feet in areas with a basic wind speed of 100 mph. The building (which has a mean roof height of less than 30 feet) is located in an area that is now mapped with a basic wind speed somewhat less than 110 mph; therefore, the installed attachment at

this pre-2001 FBC building does not meet the current code. The estimated speed at this Exposure B location was in the range of 95 to 110 mph. The tiles did not perform as predicted by the code (i.e., the tiles should have been good for 100 mph at a roof height up to 40 feet).

Figure 5-37.
Fire station with at least three battens blown off. Some tiles remained attached (Fort Meade).

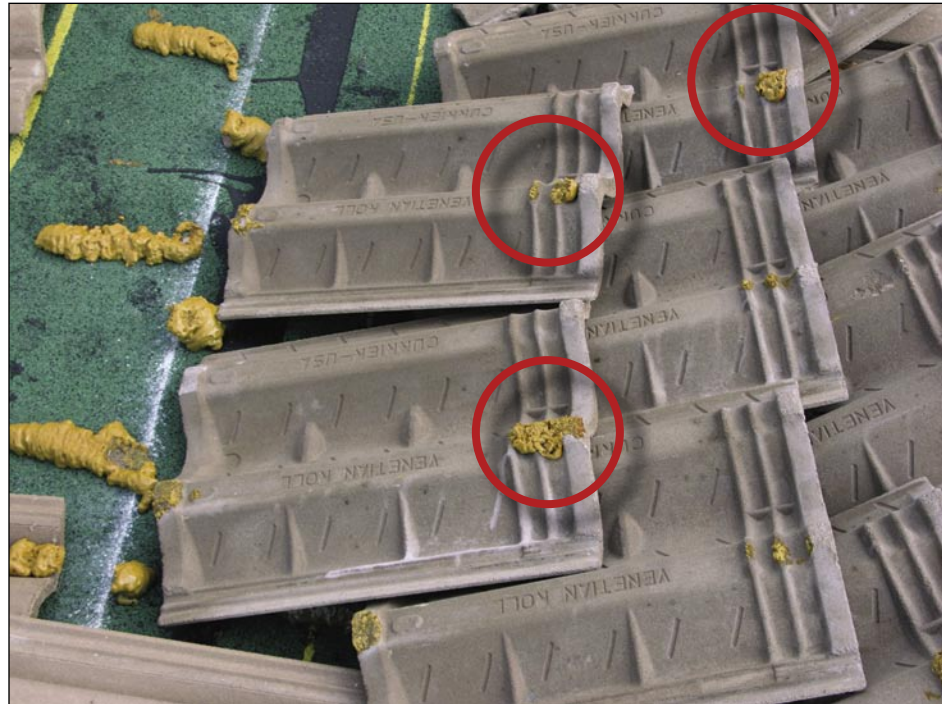
Figure 5-39.

In Figure 5-39, to meet the small paddy placement criteria, the paddy should have been 3 inch by 3 inch minimum, with approximately 8 to 9 square inches of foam contact with the tile near the head. As shown in the photo, clearly there was very insufficient contact area. The paddies were rectangular rather than square; perhaps a medium paddy placement was intended. To meet the medium paddy placement criteria, the paddy should have been 2 inch by 7 inch minimum, with approximately 12 to 14 square inches of foam contact area. The small round paddies shown in Figure 5-39 were placed after the down-slope tiles were set. Foam from these paddies occurred between the tile end laps. These round paddies are not shown in the foam manufacturer's installation instructions. Although failed tiles typically debonded from the paddies, in at least one location, the paddy debonded from the cap sheet underlayment.

Note the very small contact area of foam at the tile heads (left side of the tiles) and very small contact area at the tails. The long narrow paddies were intended to be underneath the pan portion of the tile (Punta Gorda Isles).

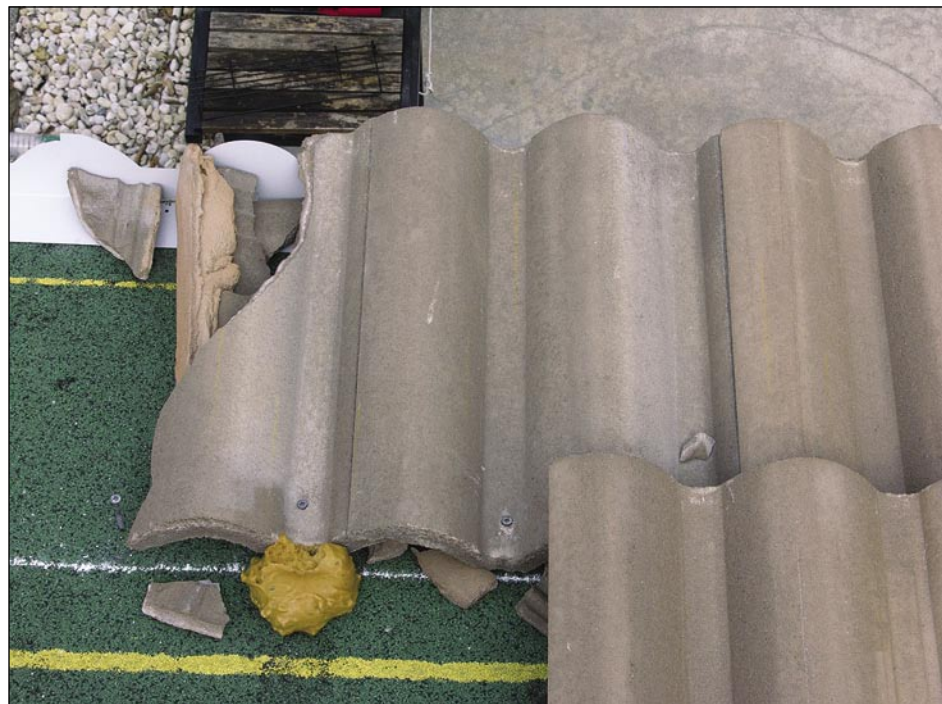
Figure 5-40.

Figure 5-40 is a close-up of the eave area of the roof shown in Figure 5-38. The manufacturer's installation instructions do not require screws, but they do require foam paddies.

View of the eave. The first row of tiles was attached with two screws per tile; foam was not used to adhere this row (Punta Gorda Isles).

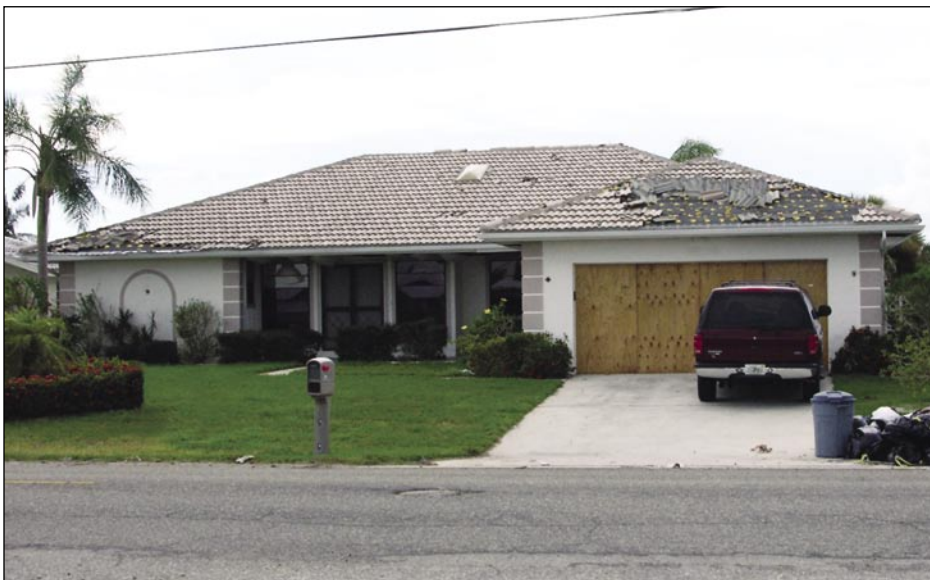
The residence shown in Figures 5-41 and 5-42 was located in an area identified in the code with a basic wind speed of approximately 125 mph. Assuming the intent was to provide a small paddy placement, according to the foam manufacturer's literature, this attachment would have been suitable for a basic wind speed of 135 mph in Exposure B (assuming proper application). The estimated speed at this Exposure B location was in the range of 125 to 140 mph. Therefore, had the foam paddies been properly sized, located, and installed according to the manufacturer's literature, the tiles should not have blown off.

Figure 5-41. In addition to field tile blow-off, most of the hip tiles and several ridge tiles were also blown off this house (Punta Gorda Isles).

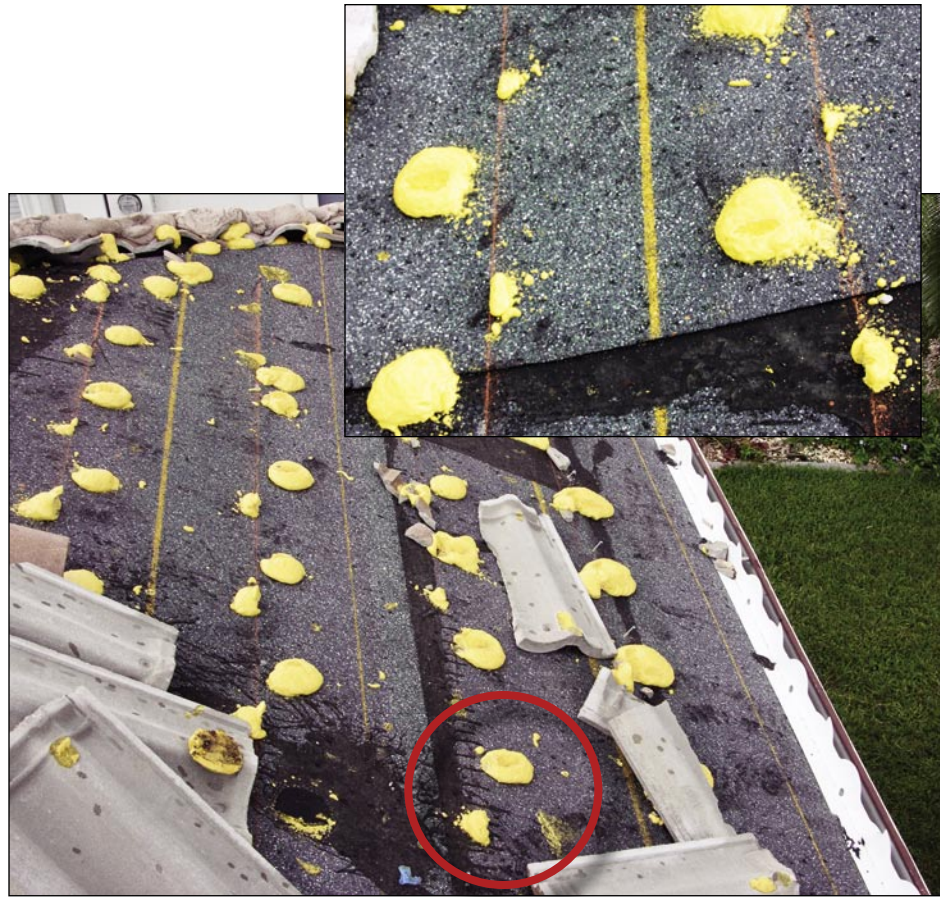
Figure 5-42.

To meet the small paddy placement criteria, the paddy should have been 3 inch by 3 inch minimum, with approximately 8 to 9 square inches of foam contact with the tile near the head. The paddies were typically about the correct size, but they did not achieve the required contact area (see inset in Figure 5-42). The paddies were also typically located too close to the upslope end of the tile. In Figure 5-42, the first row of tiles at the eave was attached with one nail and a foam paddy. Most of the nails remained in the deck. The foam manufacturer's instructions do not require nails at the eave. (The dark spots on the tile are rain drops.) An attic vent also rolled back and allowed water to enter the building.

The paddy on the tile at the lower left debonded from the asphalt bleed-out near a cap sheet lap. Only the center portion of the paddies made contact with the tiles, as shown in the inset (Punta Gorda Isles).

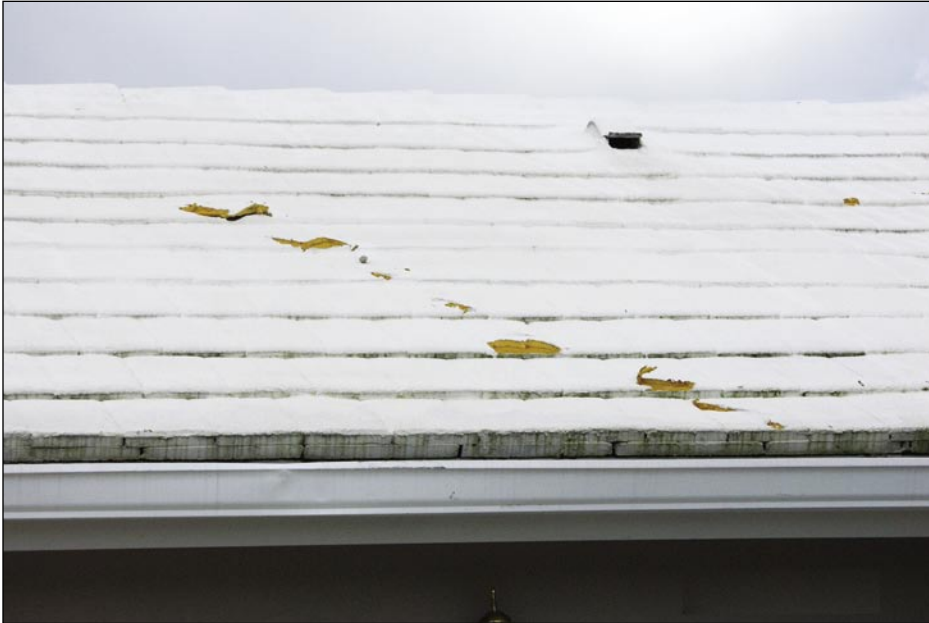
A few tile roofs that had been covered with sprayed polyurethane foam (SPF) were investigated by the MAT. Figure 5-46 shows one of these roofs. A missile had impacted the foam and gouged it in several locations, but no tile debris was blown off. The SPF appeared to provide some protection for the tiles. However, SPF applications may not

Figure 5-46. This residence had a tile roof that had been covered with SPF. A missile gouged the foam, but no tile debris was blown off (Punta Gorda Isles).

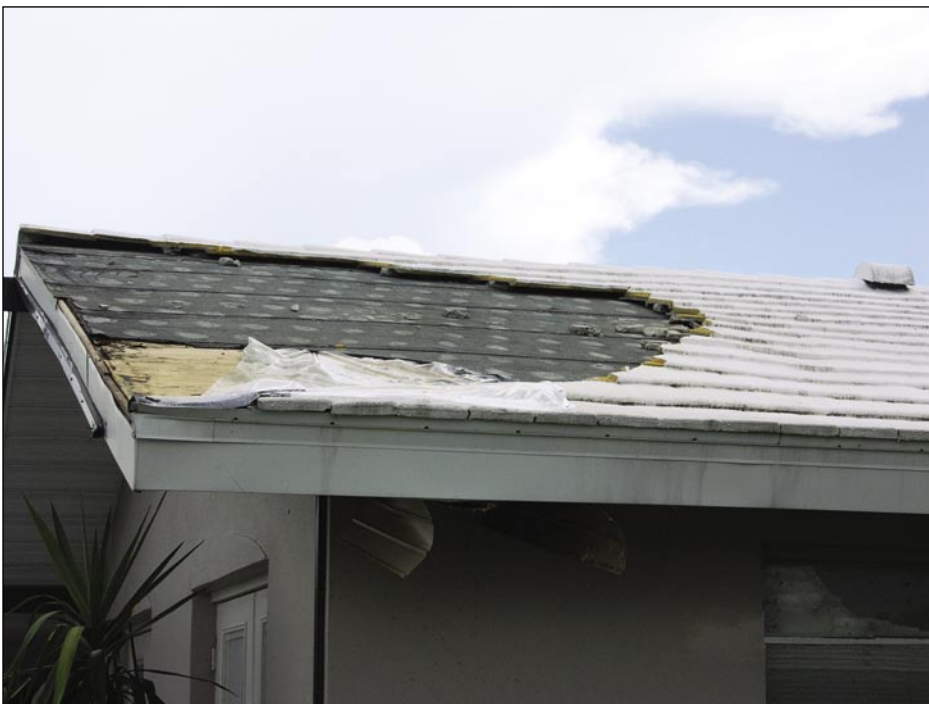
improve the uplift resistance. Figure 5-47 shows a roof that lost SPF covered tiles. In this instance, the SPF bonded tiles together and, as a result, large sections of tiles were lifted off the roof. Although the larger fragments should not fly as far as smaller fragments, because they are more massive, they could be more damaging (depending upon their velocity) if they were to become windborne.

Figure 5-47. The other side of the roof shown in Figure 5-46 with a portion of the underlayment and several tiles blown off (Punta Gorda Isles)

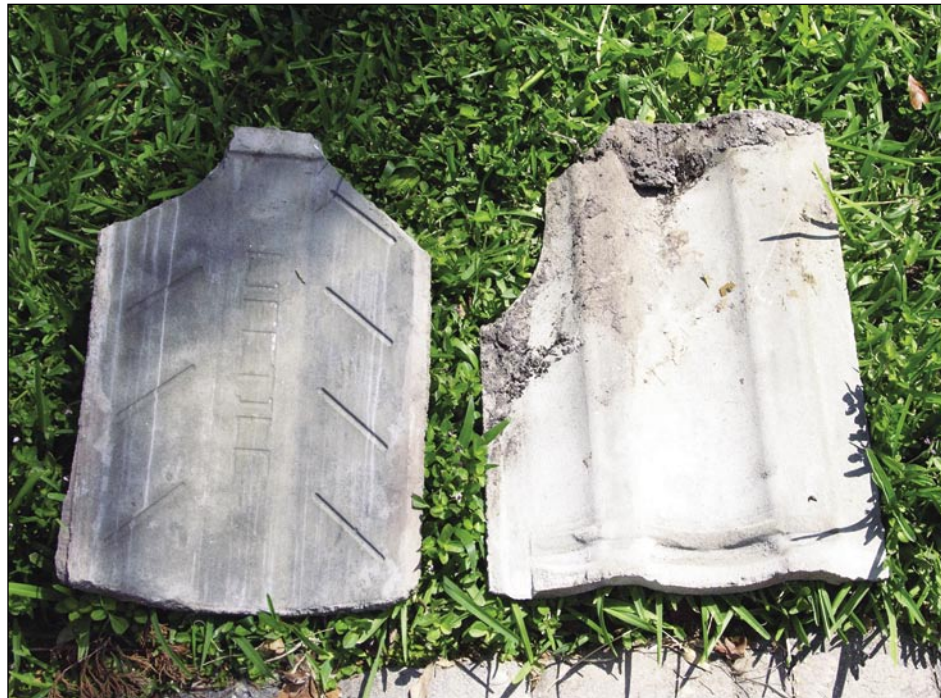
There were many reports of tiles or tile fragments hitting occupied buildings and flying through windows (shown previously in Figures 3-31 and 3-32). The owner of one residence reported that six of their windows were broken by tiles from a neighbor's house (Figure 5-48). The homeowner's metal roof was not damaged, but wind-driven rain forced through the broken windows caused extensive interior wind and water damage.

Figure 5-48.
Tiles that flew through windows of an occupied residence (Deep Creek)

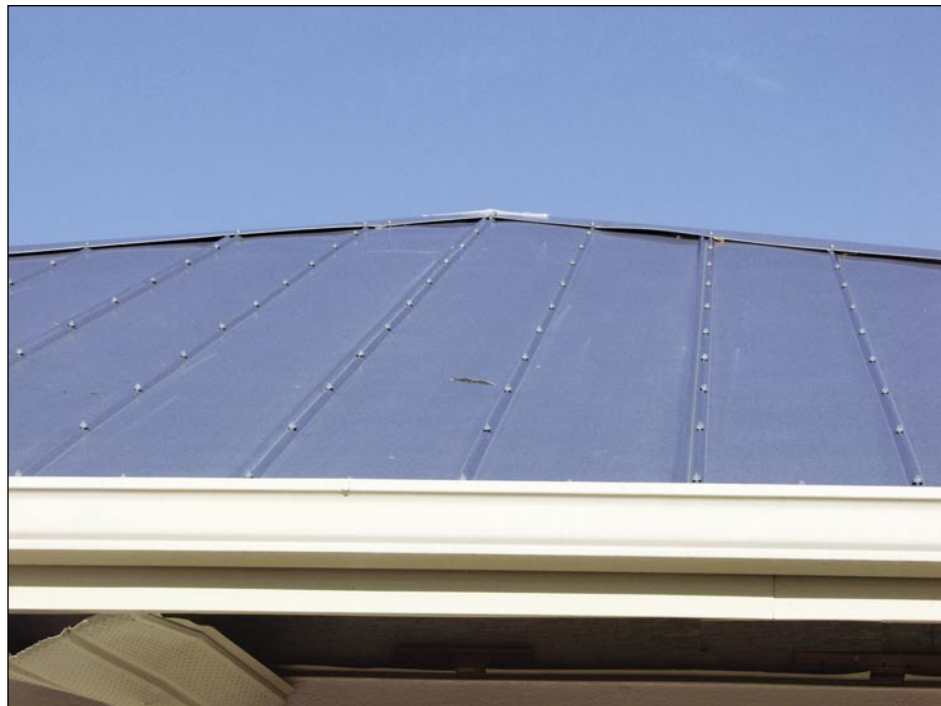
Another key element of good performance is the spacing of fasteners along the eave and at hip and ridge flashings. Only a single fastener occurred at the eave between the rib fasteners shown in Figure 5-50; considering the basic wind speed of 125 mph 3-second peak gust in this location, use of two fasteners between the ribs would have been prudent. Note that the hip flashing is bowed; two fasteners between the ribs would have also been prudent at the flashings. Close spacing at the flashings and eave is important to keep the flashings and panel ends from billowing during high winds. Although the roof in Figure 5-50 did not fail, the flashing and eave fasteners were too far apart.

Figure 5-50. The number of fasteners was not increased at the corner, perimeter, hip, or ridge areas (close-up of the residence shown in Figure 5-5). Also note that several of the soffit panels were blown away (Deep Creek).

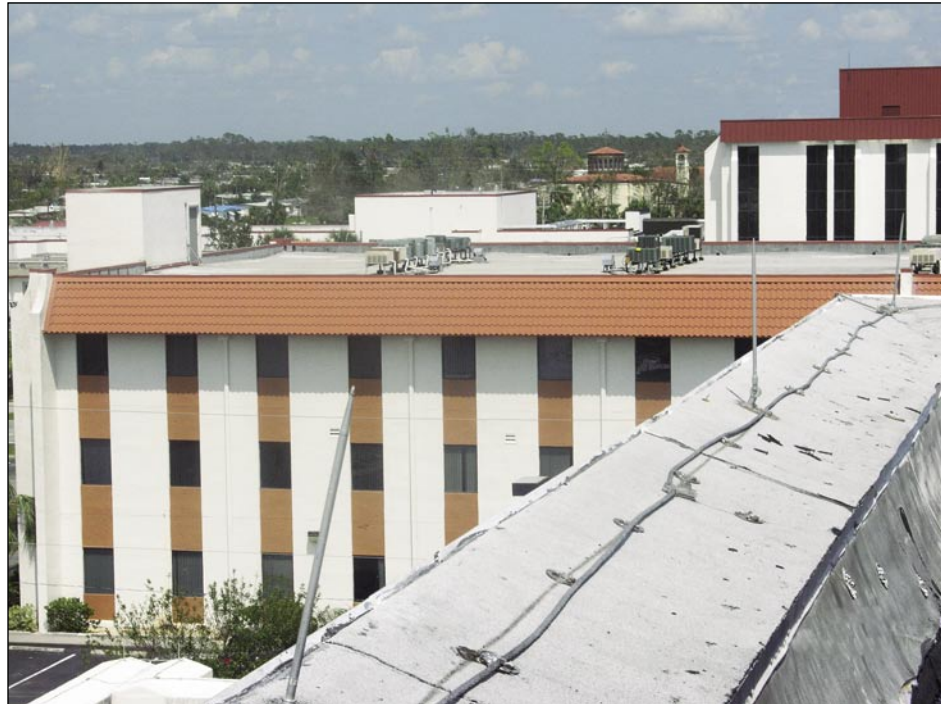
Figure 5-60. This view of the back side of the upper roof of a hospital (see Figure 6-8) shows that the missing gutter and asphalt plank walkway pad were blown away (Arcadia).

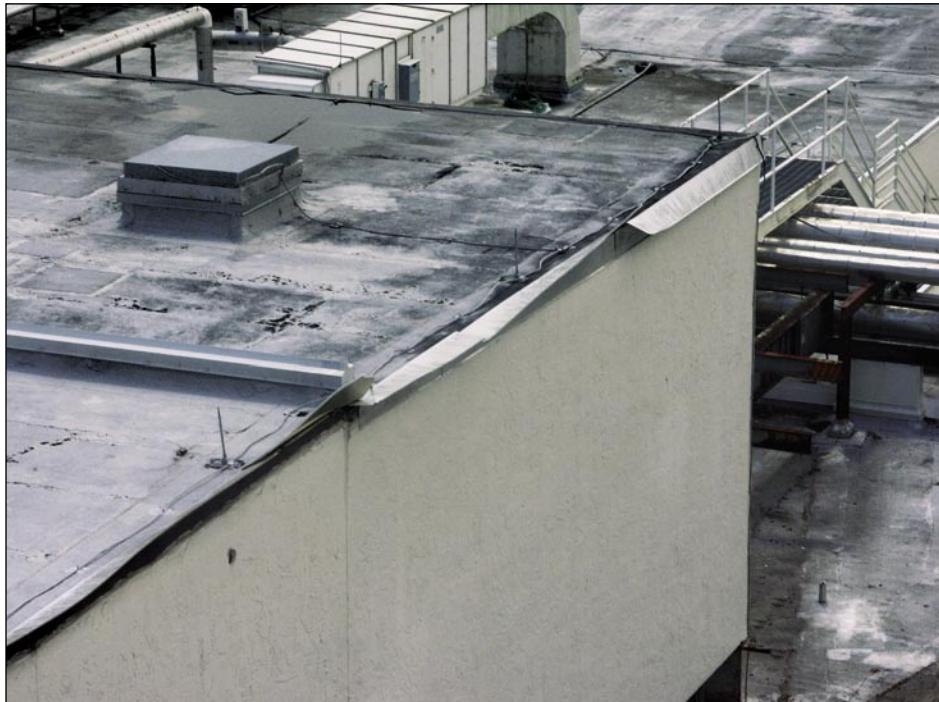
An edge flashing failure also occurred at a middle school in Cape Coral, first occupied in 1998 (Figure 5-63). This metal edge flashing had also been improperly installed underneath the membrane. The flashing should have been installed over the modified bitumen cap sheet and then stripped in to clamp the edge of the membrane. Wind lifted the gutter and metal edge flashing and peeled the modified bitumen membrane. The gutter was not designed for uplift resistance. A portion of a middle school in Port Charlotte also had a mineral surface BUR cap sheet roof, and the metal edge flashing had also been improperly installed underneath the membrane. However, none of the edge flashings lifted. Except for some missile damage, the BUR on this roof performed very well.

Figure 5-63. The edge flashing had a 2-inch vertical flange that extended into the gutter. The flashing was not cleated (Cape Coral).

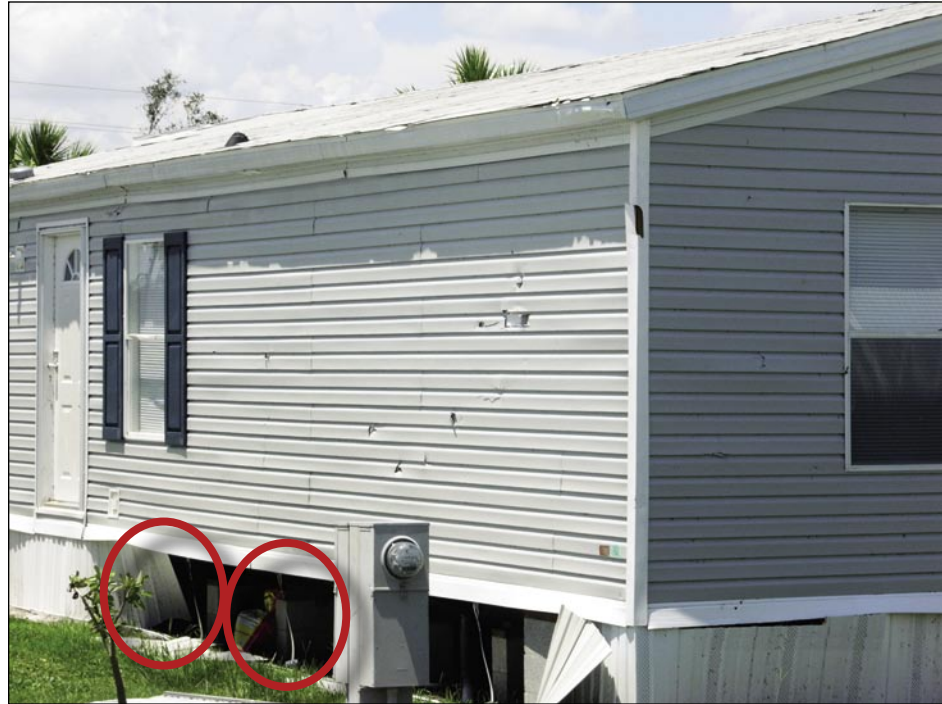
Vinyl siding is quite susceptible to windborne debris damage as shown by Figure 5-66. Because the vinyl siding cannot resist debris impact, resistance to debris impact is provided by the wall sheathing (if any) between the siding and the wall studs. On some of the residences, plastic foam sheathing was used instead of wood sheathing between the vinyl and the studs. The walls of these buildings offered very little resistance to windborne debris penetration, as they were composed only of vinyl siding, underlayment, foam sheathing, fiberglass batt insulation in the wall cavity, and gypsum board on the interior side of the studs. Residents who rode out the hurricane in their homes were quite susceptible to injury from windborne debris penetrating the light exterior walls.

Figure 5-66. The vinyl siding on this manufactured house was ruptured in several locations by windborne debris (most of which were likely building envelope components from other nearby manufactured houses). Note the missing skirt and loose foundation anchor straps (Zolfo Springs).

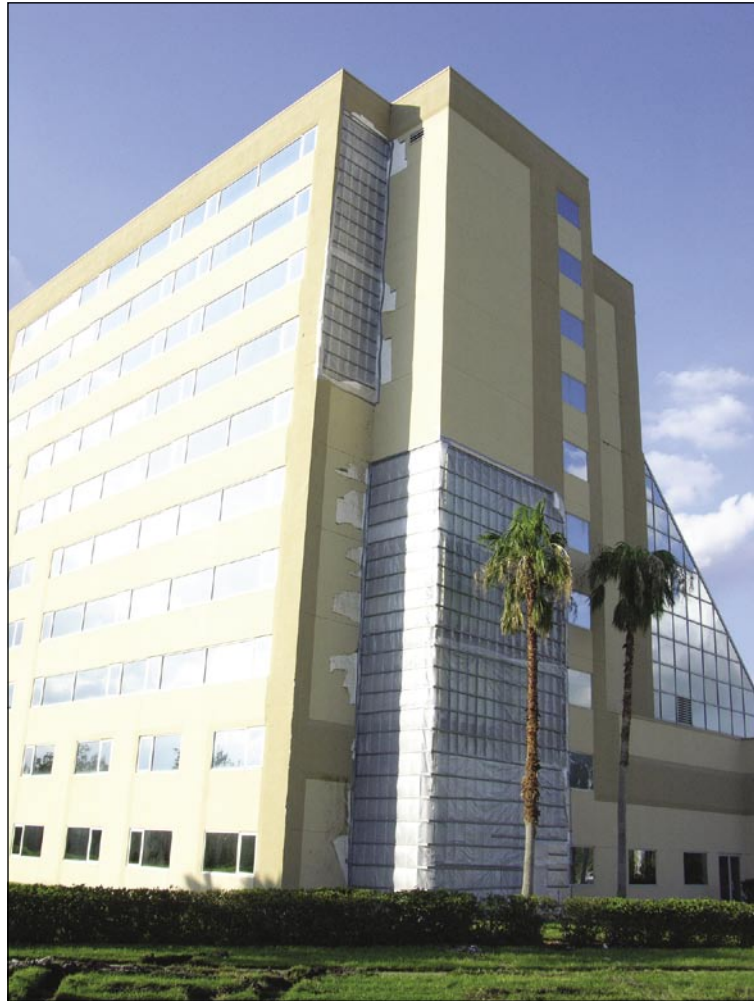
Figure 5-68.

Exterior non-load bearing walls generally performed well, but there were notable exceptions. Figure 3-25 showed a collapsed unreinforced masonry wall. Figures 3-33 and 5-68 show extensive EIFS failure on a hotel near the Orlando airport. Other EIFS damage was shown in Figure 3-26. Further discussion and analysis of EIFS failures is given in FEMA 489, *Hurricane Ivan in Florida and Alabama*, where this type of damage was prevalent.

This hotel experienced significant EIFS failure on several sides (Orlando). EIFS debris broke several windows (Figure 3-33).

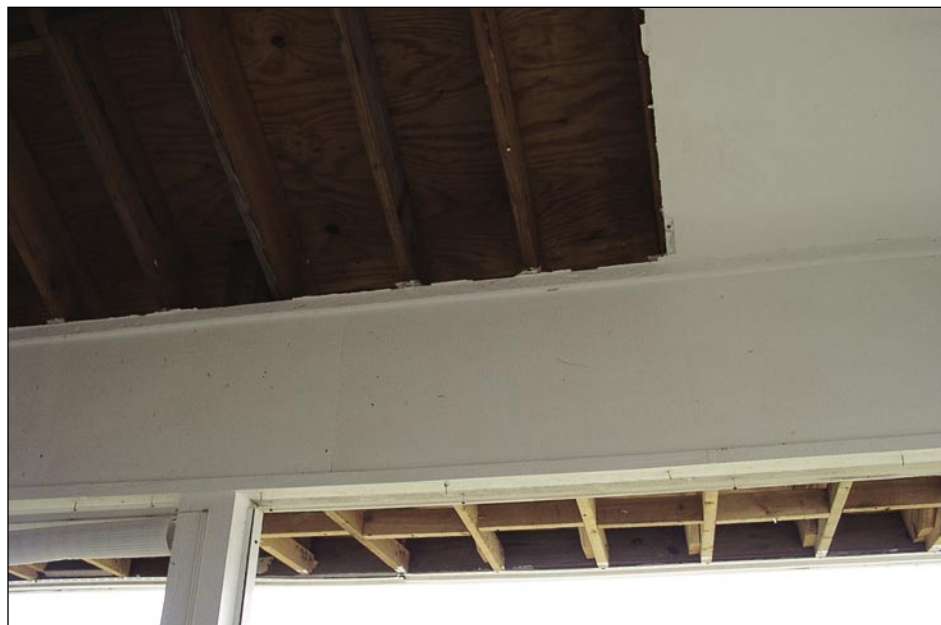
Figure 5-69.

Many buildings lost some or all portions of their soffits (shown previously in Figure 3-21). The damaged soffits were typically vinyl or aluminum. Some of the soffits failed by suction (i.e., downward pressure), while others failed by positive pressure (i.e., they were pushed upward). In many instances where soffits were lost on residences, water was driven into the attics and ultimately into living spaces. The wind also displaced attic insulation and blew it out of attics (much of the insulation was blow-in insulation, rather than insulation batts). Figure 5-69 shows ceiling damage adjacent to soffit loss at a residence on North Captiva Island.

An exterior eave with soffit failure, which resulted in water intrusion (North Captiva Island)

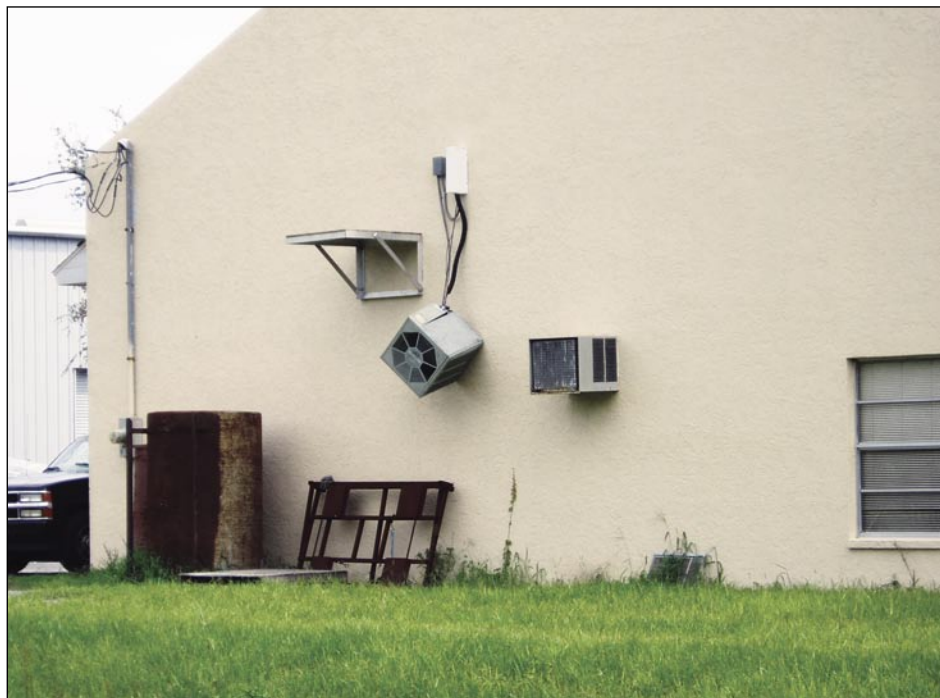
Condenser problems like those discussed in Section 5.5.1 were also observed at commercial and critical/essential facilities (Figures 5-74 and 5-75). A complete lack of anchor systems or inadequate or deteriorating fasteners resulted in the loss of many compressors. Installation methods observed were not standardized. In Figure 5-75, although the condenser did not move off its rail, it would have been prudent to use two side-by-side screws, with more edge distance between the screw and strap end.

Figure 5-74.
Condenser unit
displaced from the
elevated platform (Port
Charlotte)

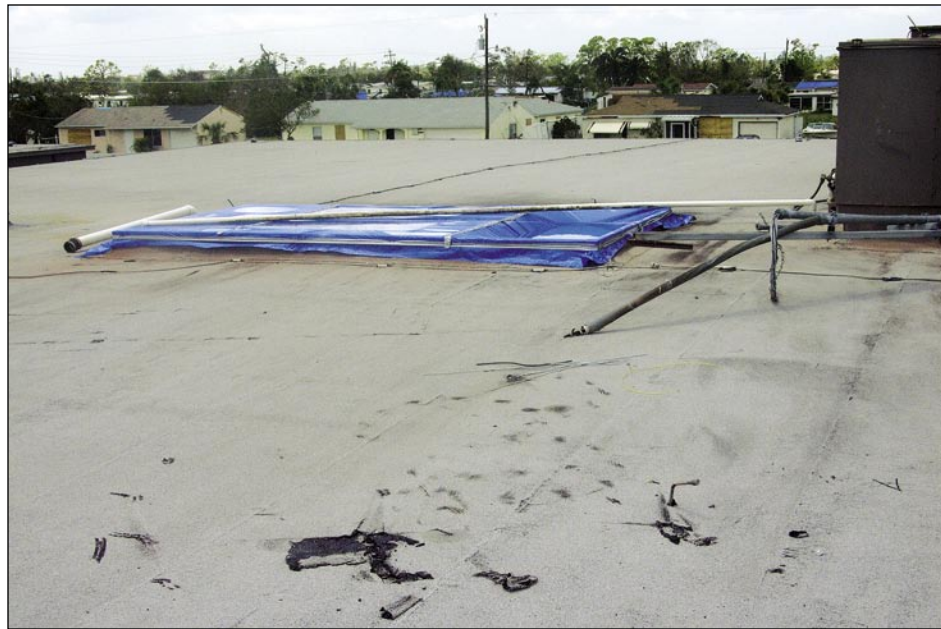
Loss of HVAC units was also observed as shown in Figure 5-77. A number of these large units were blown off their supports. Additional damage to equipment included loss of access panels on package units, debris impact damage to relief air hoods, and damaged rooftop ductwork. Figure 5-78 shows a unit that was marginally anchored.

A large HVAC unit blew off this curb. Note the loose LPS conductors (this side of the curb). This school had significant damage to several pieces of rooftop equipment (Port Charlotte).
