Building Envelope Performance

5.1 Doors

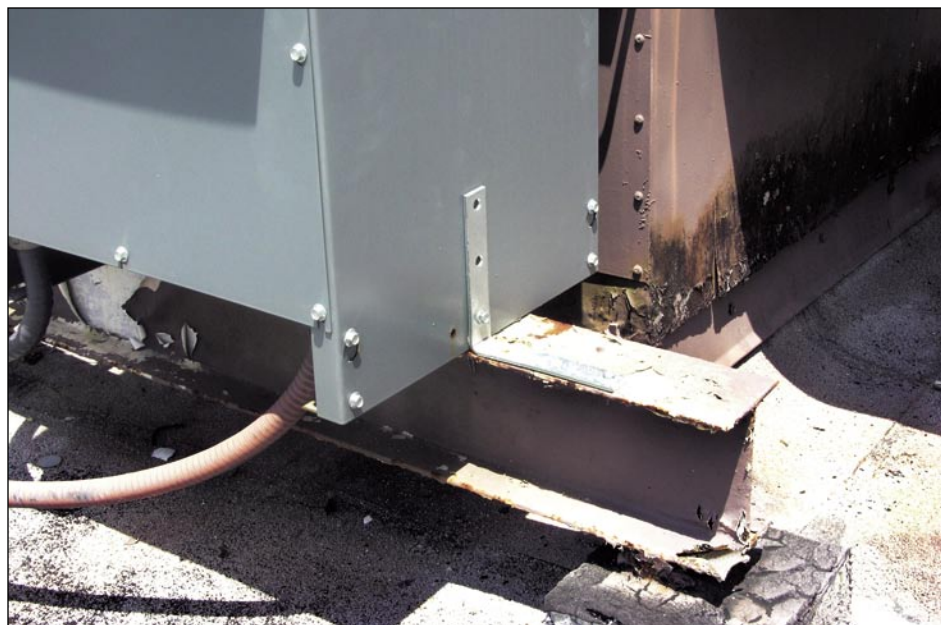
Figure 5-78.

Loss of HVAC units was also observed as shown in Figure 5-77. A number of these large units were blown off their supports. Additional damage to equipment included loss of access panels on package units, debris impact damage to relief air hoods, and damaged rooftop ductwork. Figure 5-78 shows a unit that was marginally anchored.

A thick angle bracket was used to anchor this unit. Although two screws attached the angle to the support beam, only one screw was used at the unit (Port Charlotte).

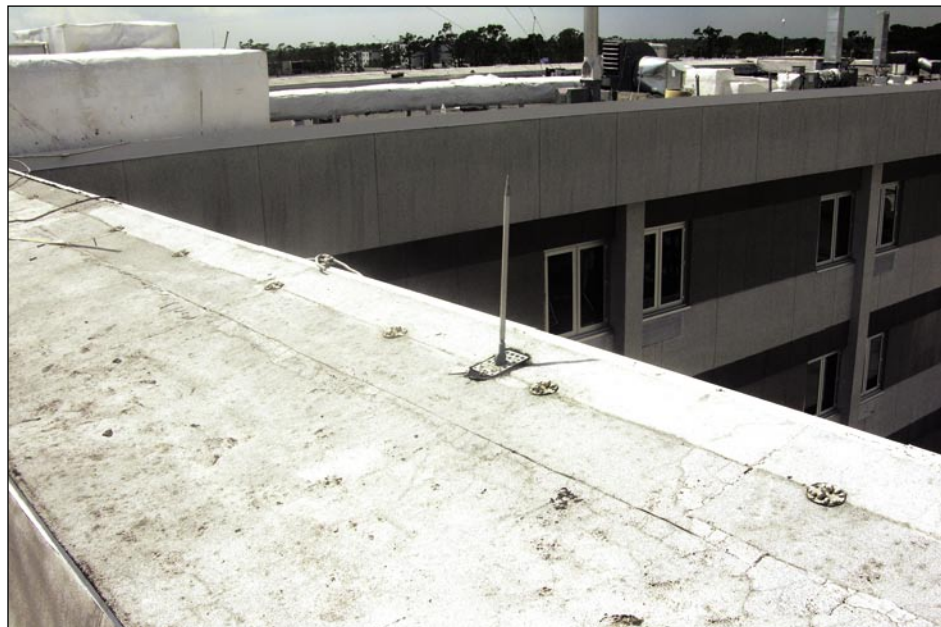
Figure 5-81.
The LPS conductor on this hospital blew away, but the air terminal was still attached. A lightning strike to this air terminal would not be safely dissipated (Port Charlotte).

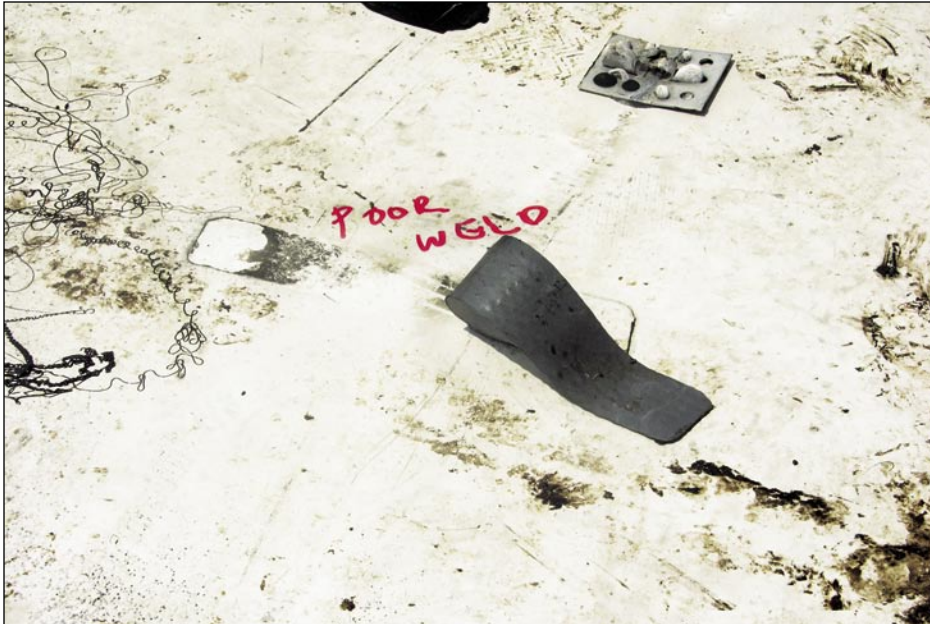
LPS failures were typically the result of poorly anchored systems. Connectors often fail by opening up and releasing the conductor cable or they debond from the roof (Figure 5-82). In other cases, the air terminal base plates debond from the roof (Figure 5-83). In Figure 5-84, a prong-type conductor splice connector (approved for roof heights up to 75 feet) failed. Bolted-type connectors are prudent in hurricane-prone regions because they are less likely to pull apart and cause damage to the roof (Figure 5-85).

Figure 5-82.
The LPS conductor pulled away from the conductor connector at the top of the photo. The conductor was also attached to the membrane with poorly welded strips of PVC (Port Charlotte).

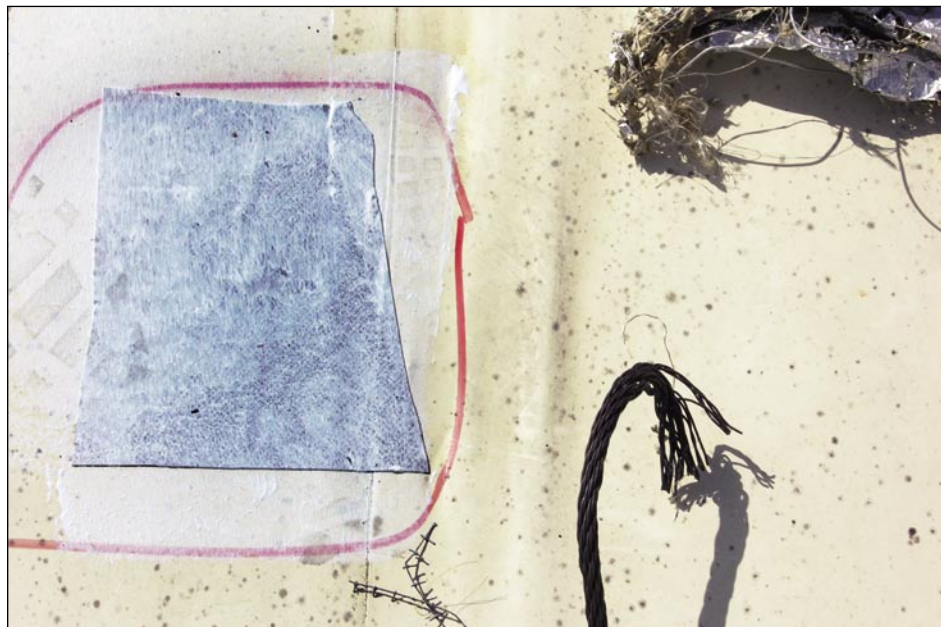
Figure 5-85.
When LPS conductors detach, the conductor ends can whip around and puncture and tear the roof membrane. The patch near this frayed conductor is likely a repair of damage caused by a whipped conductor (Punta Gorda).
