Structural Systems Performance

4.1 Wood-Frame Buildings

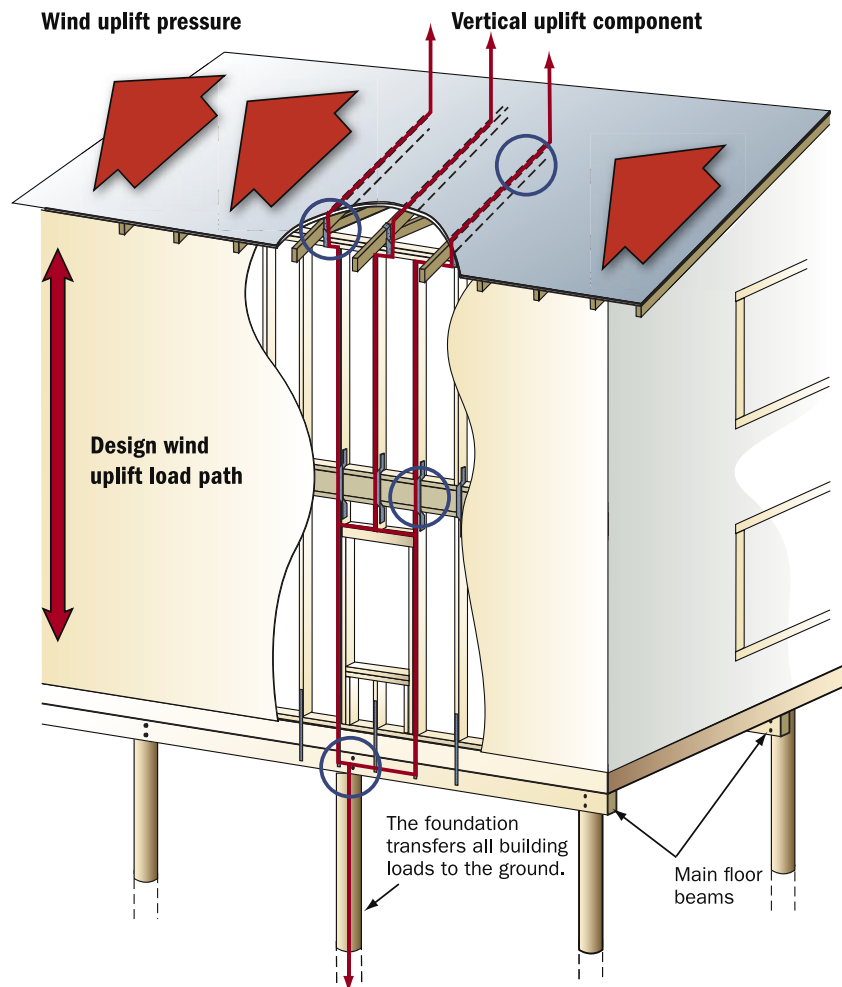
Figure 4-4. Load path of a two-story building with a primary wood-framing system: walls, roof diaphragm, and floor diaphragm

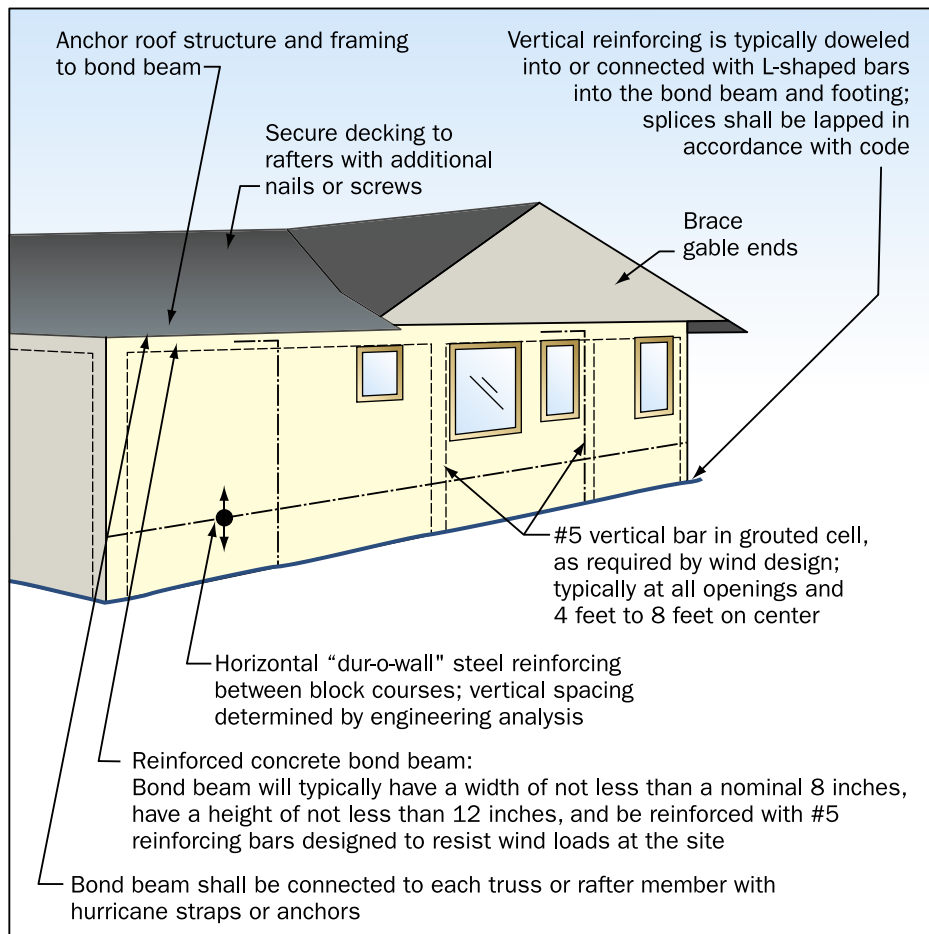
Concrete and reinforced masonry buildings provide a high degree of structural strength, rigidity, and security, and typically provide a long building life span. These buildings have sound structural wall systems due to inherent safety factors and redundancy built into the design and construction. Figure 4-12 illustrates an adequately designed reinforced masonry wall system.

Figure 4-12.
Adequately designed
reinforced masonry wall
system
