# *Basic Assessment and Characterization of Damage*

*The MAT's observations of the type and extent of damage caused by Hurricane Charley's high winds and flooding are broadly presented in this chapter and discussed in detail in Chapters 4, 5, and 6.*

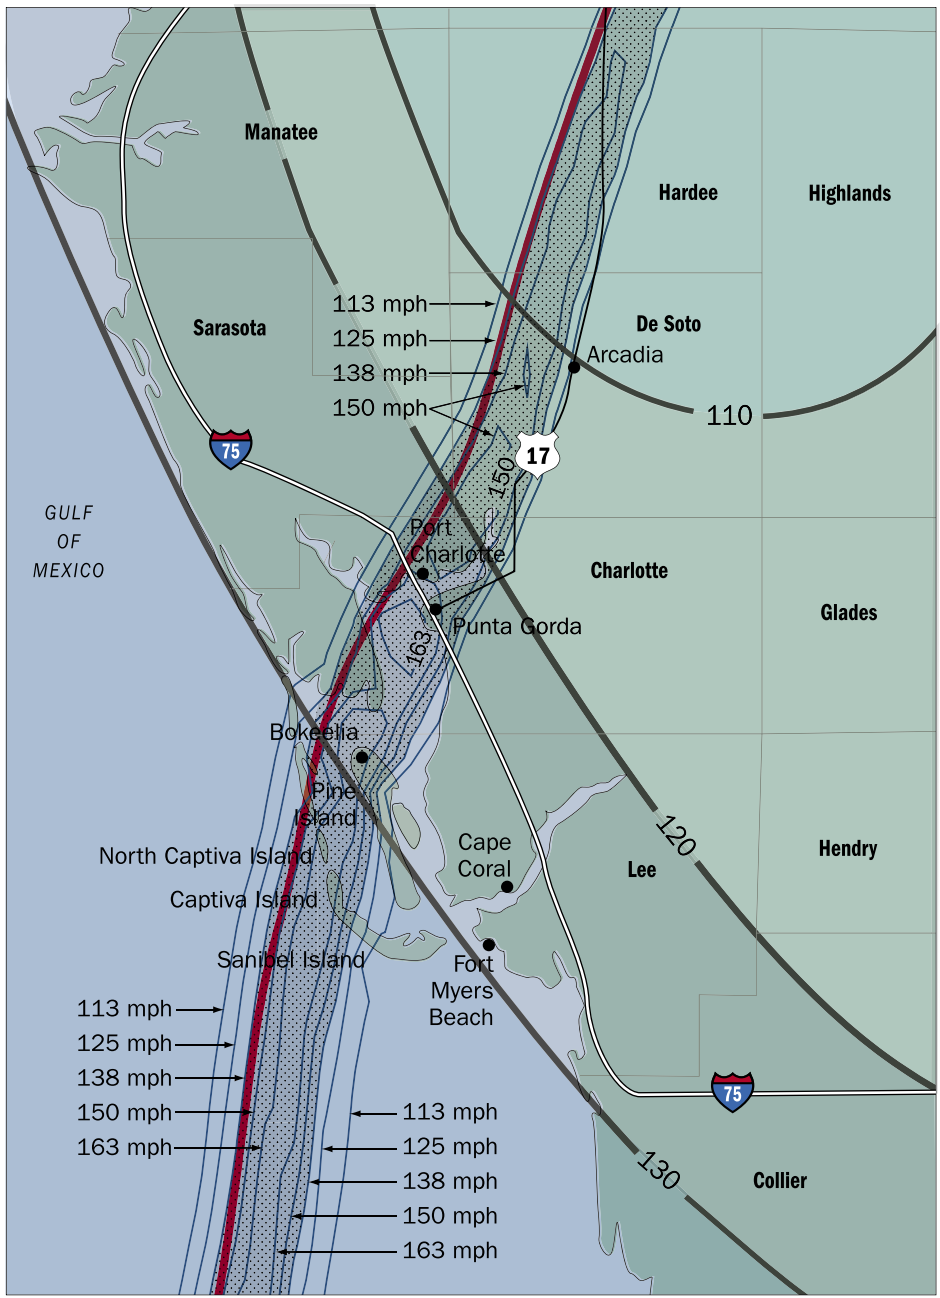
Figure 3-1. Overlay of estimated Hurricane Charley wind field from H-wind (adjusted to 3-second peak gust) on wind contours from the 2001 FBC wind speed map

the 2001 FBC, Figure 3-1 will assist in relating damage from the wind event to the expected performance of both new and old buildings.

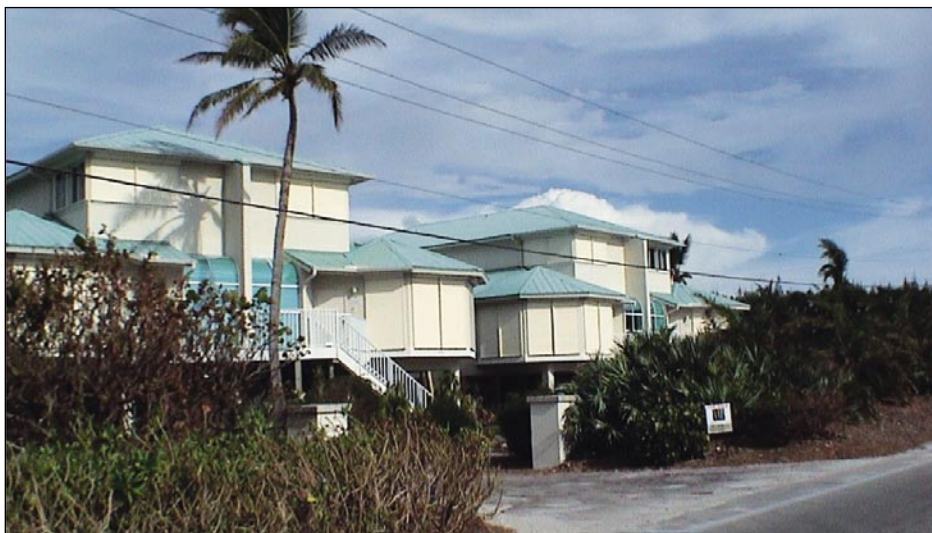
Unfortunately, damage from windborne debris will remain an issue during hurricanes even if all glazings are protected. Significant amounts of debris were generated in the areas that experienced winds less than 100 mph when poorly constructed or non-engineered enclosures, pool screens, carports, and attached structures could not withstand the hurricane winds. Adequately protecting buildings from windborne debris, as required by code, is a sound building practice. Use of the 120-mph wind contour line to require glazing protection on buildings was supported by the extensive damage to glazing systems along the eye's path. However, as discussed in Section 5.2, glazing damage was documented in areas that experienced speeds well below 120 mph. An example of shutters performing as designed is shown in Figure 3-30.

**Figure 3-30.**  
Newer house with  
storm shutters  
(Sanibel Island)

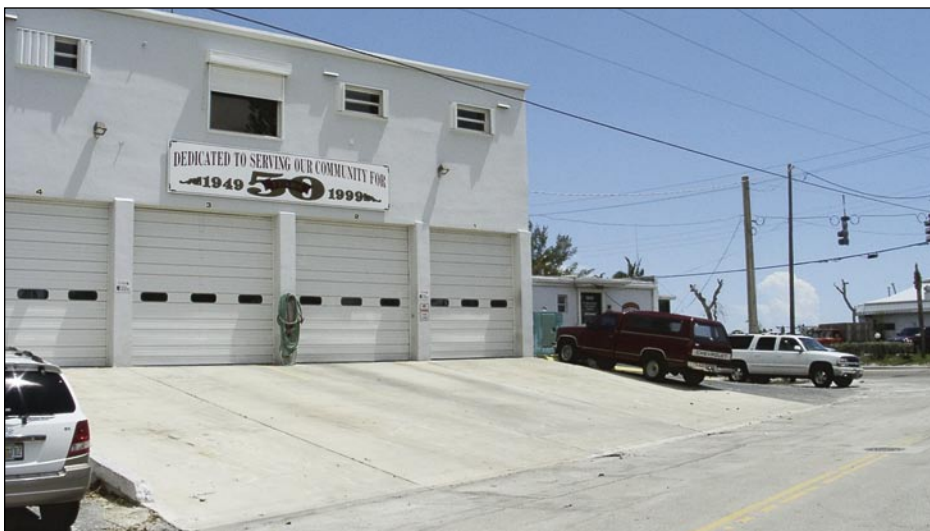
Figure 3-54.  
Fire station elevated on fill prevented any storm surge damage (Fort Myers Beach)

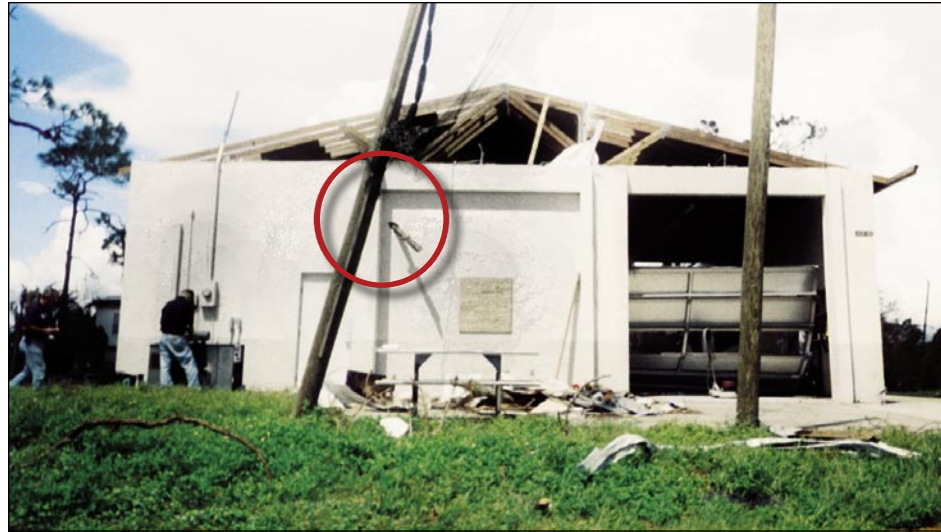
Most of the buildings being used for police and fire stations were older buildings that had not been enhanced or mitigated to resist wind and windborne debris to the level at which new essential facilities are required to be designed. Roof coverings, sectional doors, and roof structural systems were the most commonly damaged components of fire and police stations and hospitals. In one instance, the MAT observed cementitious wood-fiber decking that was not adequately secured to resist uplift had lifted off the supporting roof structure (Figure 3-56). On gable end and hip roofs, metal and asphalt shingle roof coverings were damaged; gable end wall collapses were also observed (Figure 3-57).

Figure 3-57. Gable end wall collapse and rolling and sectional door failure at fire station (Aqui Esta, east of Punta Gorda Isles). A close-up of the missile in the circle is shown in Figure 3-35.

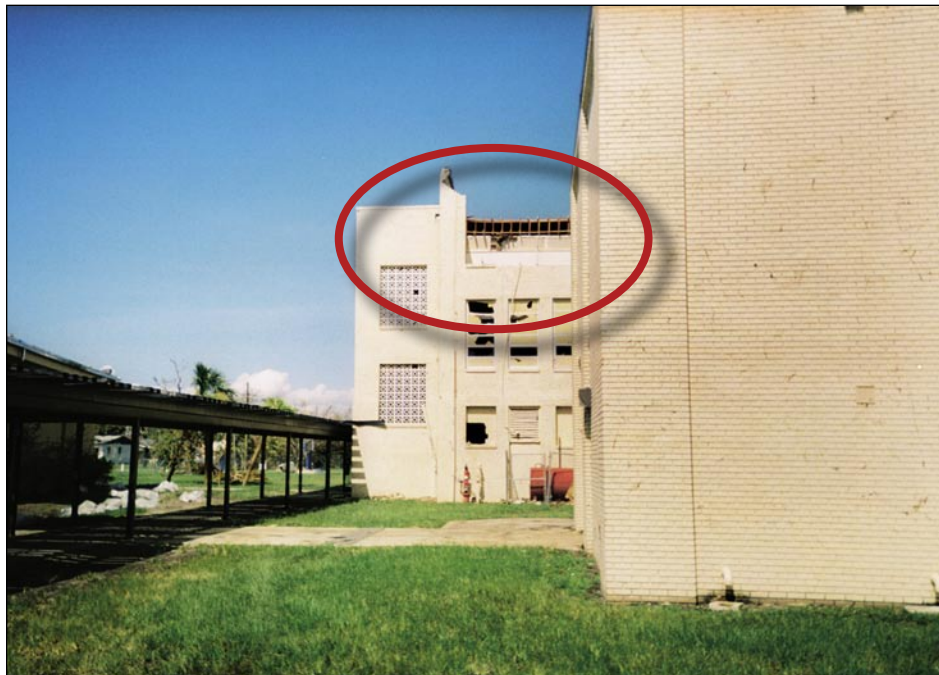
As with other critical facilities, roof coverings were the most commonly damaged components of schools (Figure 3-59). Other damage to schools included loss of soffits and large overhangs that were not adequately attached to the structure, leading to the collapse of URM parapets and walls in older schools (Figure 3-60). Glazing damage was common; windows were broken from aggregate surface roofs and other windborne debris. In the higher wind areas, typically, portable classroom units were damaged or destroyed.

**Figure 3-60.**  
Example of URM parapet  
wall collapse and broken  
windows at an older  
school (Punta Gorda)
