# *Performance of Critical and Essential Facilities*

## 6.1 Emergency Operations Centers

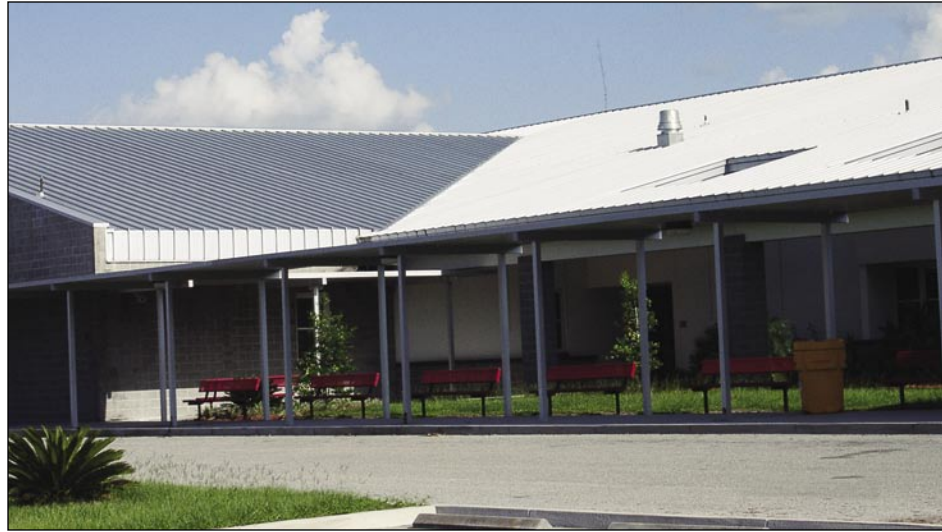
**Figure 6-19.**  
Middle school with  
minimal roof covering  
damage (Arcadia)

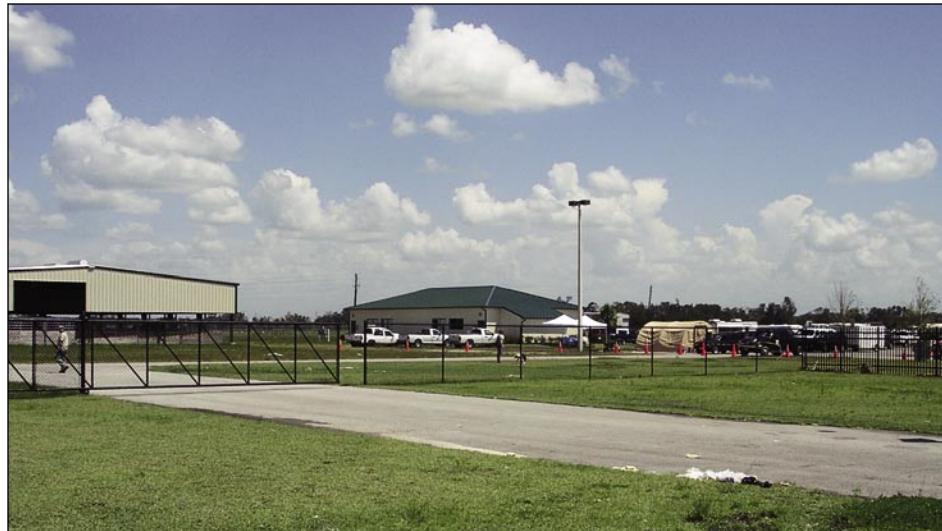
According to the on-site representative meeting with the MAT, after the partial collapse, shelter staff and inhabitants were moved to a nearby high school while the eye of the storm passed by and only one injury was reported. The MAT's observations of the high school, the middle school, and pre-engineered metal buildings in the vicinity of the Turner Agri-Civic Center (Figures 6-19 and 6-20, respectively) showed minimal damage and no structural failures. Estimated 3-second peak wind gust speeds for the area are between 110 and 120 mph for Exposure B terrain and between 125 and 140 mph for Exposure C terrain. The large open field upwind of the Turner Agri-Civic Center likely created Exposure C wind conditions for the building. Other organizations with greater access to the site and design and construction documents are investigating more deeply into the failure of this facility.

**Figure 6-20.**  
Pre-engineered metal  
buildings with minimal  
damage located near the  
Turner Agri-Civic Center  
(Arcadia)

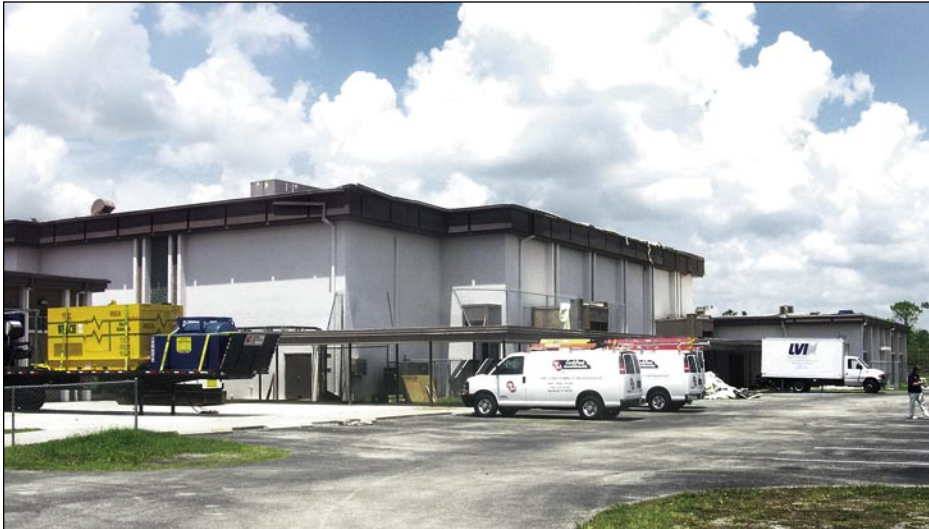
Constructed in 1971, this school is one of two on the state shelter list for Charlotte County. The building is generally constructed of reinforced masonry walls (8-inch CMU) supporting metal roof joists (Figure 6-21). The walls are reportedly reinforced using two #5 reinforcing rods (vertical) in adjacent cells at 10 feet on center maximum spacing; there is also a bond beam at the top of the wall. The roof deck is metal with lightweight insulating concrete. The school is located in a Category 3 storm surge zone, making it vulnerable to storms with high surge levels. The school was used as a shelter during the storm for an unknown number of occupants. The building was evaluated for use as a school shelter and has an American Red Cross (ARC) 4496 compliant shelter capacity of 1,000 persons; another 500-person capacity was proposed, but was found to not be ARC 4496 compliant.

Figure 6-21.  
Exterior view of Port  
Charlotte Middle School  
showing both gymnasium  
area (tall section) and  
typical classroom (lower  
section, rear of photo)

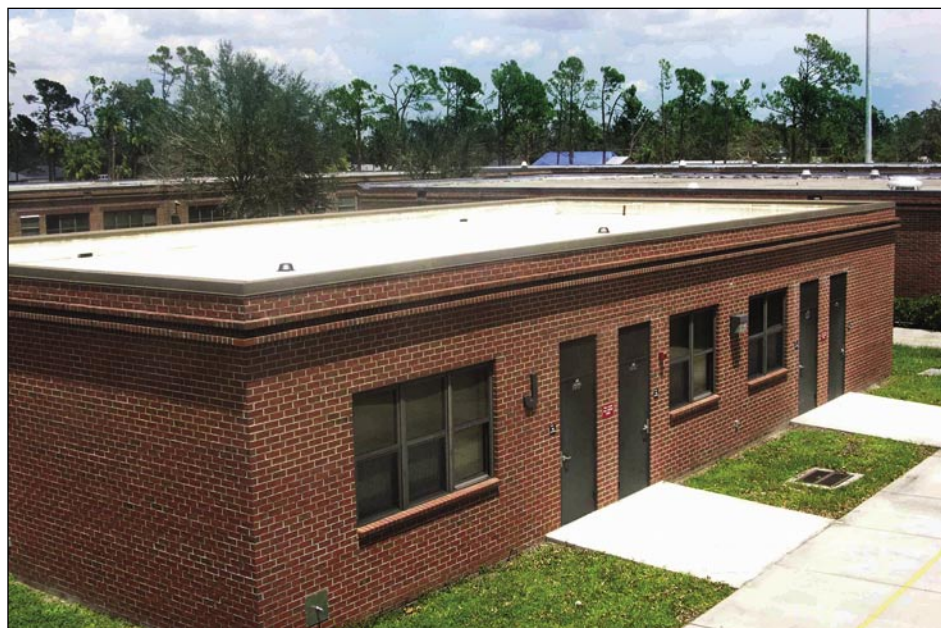
Figure 6-23.  
Exterior view of Liberty  
Elementary (Port  
Charlotte)

During the MAT assessment, no structural damage was observed and minimal damage was observed on the designated shelter areas of the facility. There was no apparent structural damage to the shelter area and structural damage appeared to be limited to a failed canopy at a side entrance of the school. During the storm, electrical power to the school was lost. The school is not equipped with an emergency generator, so the day after the storm, the shelter staff and occupants were moved to another school that had power.

No significant roof covering or rooftop equipment damage was observed and there were no reported roof leaks in the shelter area; however, there were significant debris issues. The loss of metal panels over walkways between buildings and loss of aggregate surfacing from the BUR increased the debris hazard at this site and added to the debris field.
