# Mitigation Assessment Team Report on **Hurricane Ike**

## Mitigation Assessment Team Report **Hurricane Ike in Texas and Louisiana**

Building Performance Observations, Recommendations,  
and Technical Guidance

FEMA P-757 / April 2009 / NHC 2009 Release

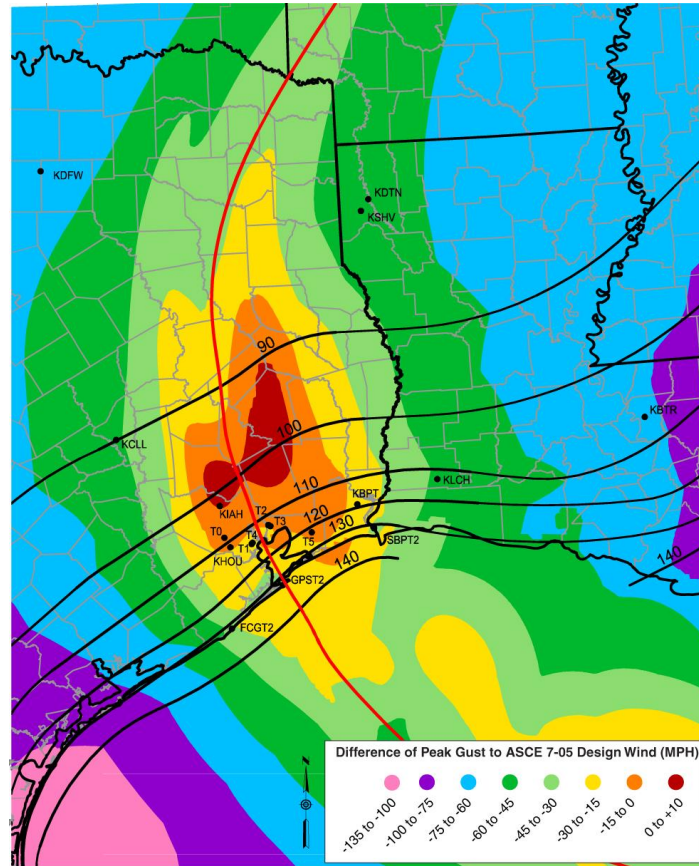
- Ike's winds were less than IRC/ASCE 7 design levels.
- Expectations were that minimal damage to both structural elements and components would be seen.
- MAT observed good structural performance, but poor cladding performance.

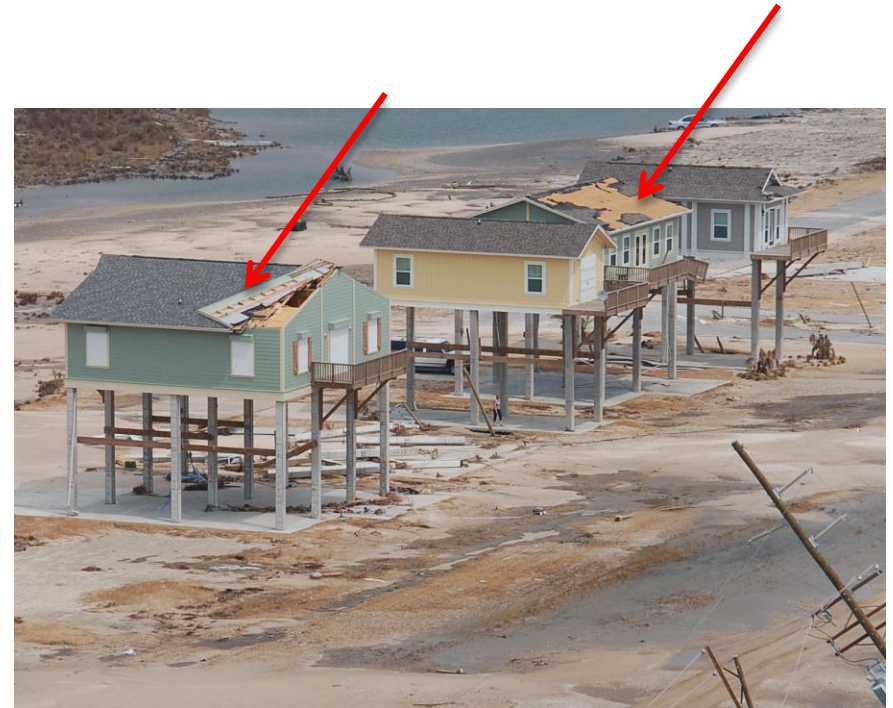
- Shingle loss varied from a few shingles to whole roofs
- TDI currently allows Class F shingles (ASTM D 3161 rated at 110 mph) for all wind zones – 110, 120, & 130 mph.

- TDI should only allow ASTM D 7158 rated shingles:
  - Class D – 90 mph rating
  - Class G – 120 mph rating
  - Class H – 150 mph rating
- Manufacturers should provide Class labeling on the backside of shingles

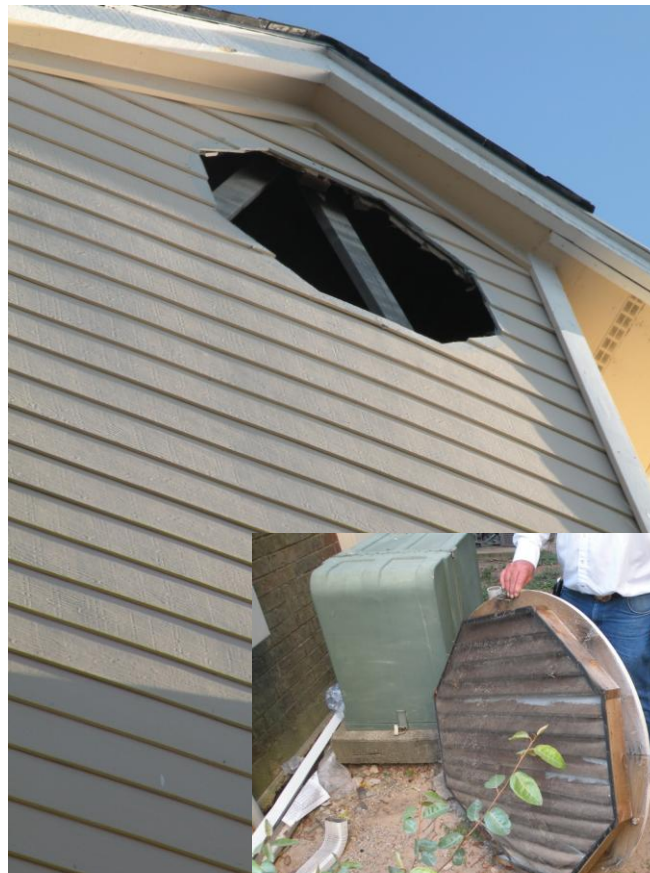
- Observed failures included:
  - Continuous roof ridge vents.
  - Gable end vents.

- Recommendations:
  - Continuous roof ridge vents frequently allows the infiltration of water into the attic and should not be allowed by TDI
  - Gable end vents should be properly connected to the structure and shuttered.

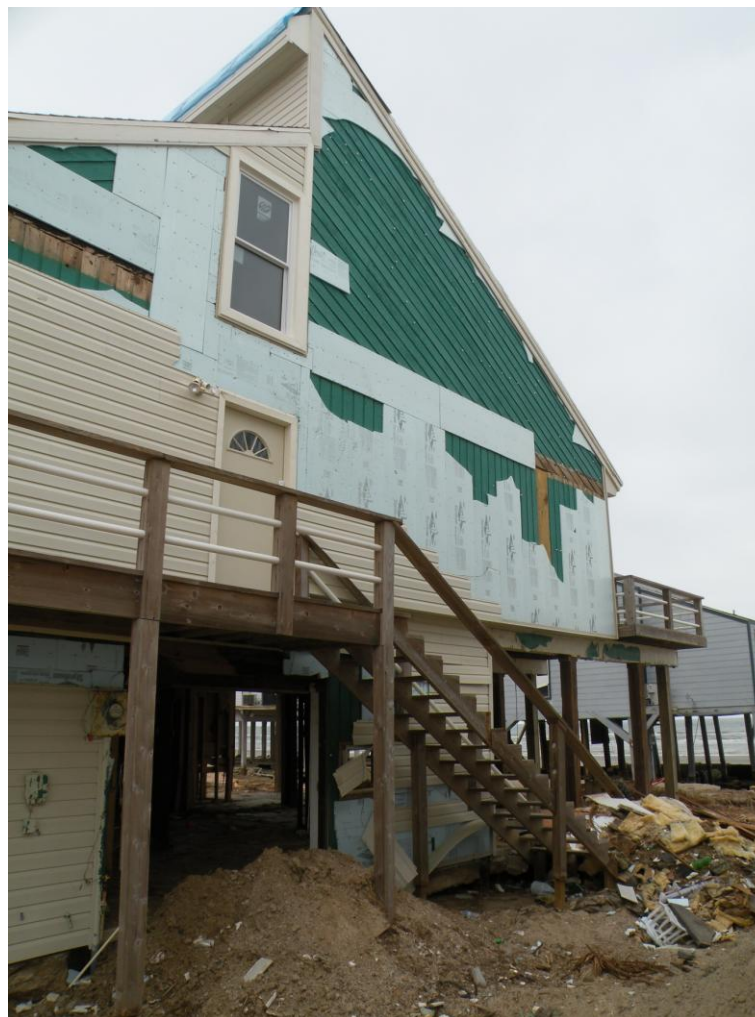
# Vinyl Siding

- Vinyl siding and fiber cement cladding were the predominant cladding observed. Failures were the result of:
  - Materials were not high wind zone rated.
  - Installations were poor or non-compliant with high wind zone recommendations.
- Recommendations:
  - Code authorities and TDI and their inspection programs should ensure that products and installations meet manufacturers' high wind zone guidelines.

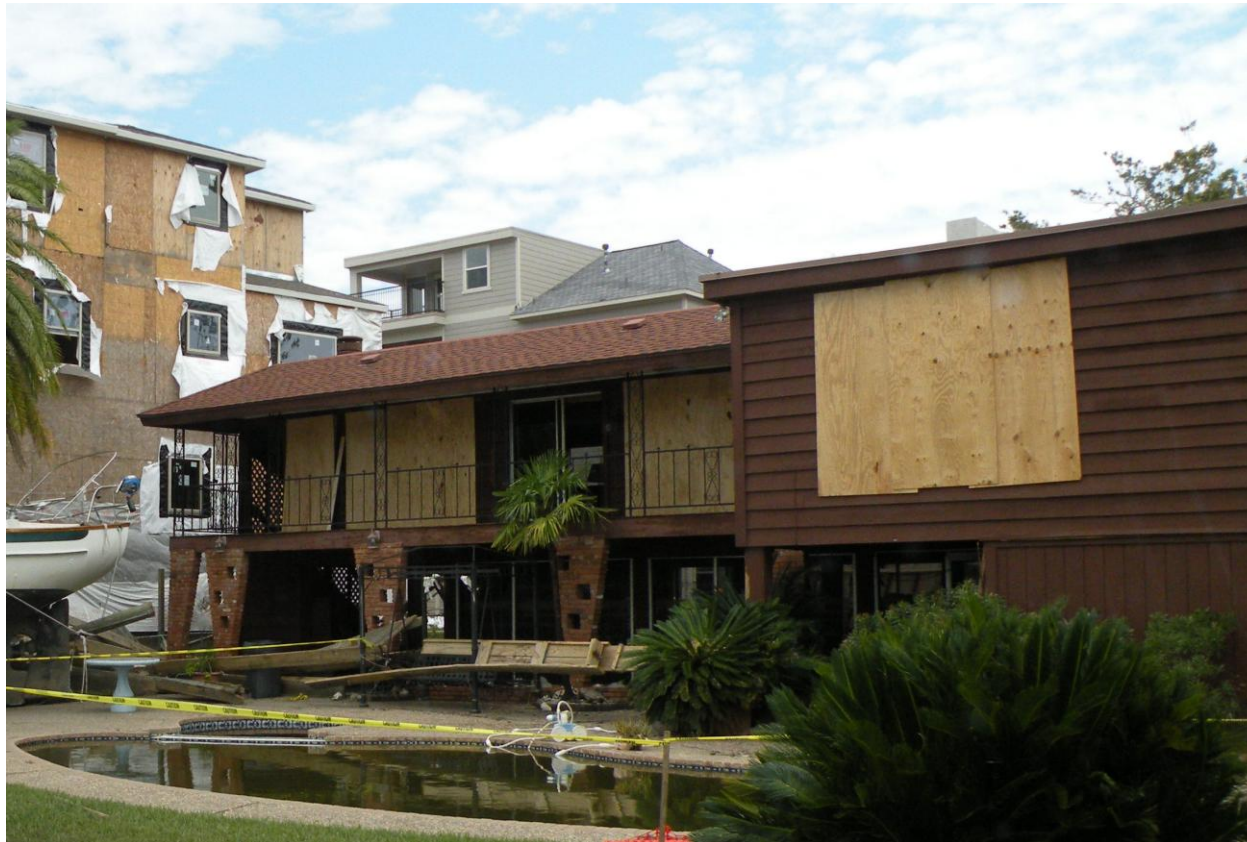
# Windborne Debris Protection

- Shutter performance varied from:
  - Excellent
  - Only installed on the windward face
  - Not attached to the building structure
  - Non-existent

- ASCE 7-05/2003 IRC require opening protection within 1 mile of the coastal mean high water line where wind speeds are 110 mph or greater.
- TDI requires opening protection only in the Seaward (130 mph) and Inland I (120 mph) zones.
- It is recommended that TDI include the 1 mile portion of the Inland II wind zone (110 mph) in its windborne debris protection requirement.

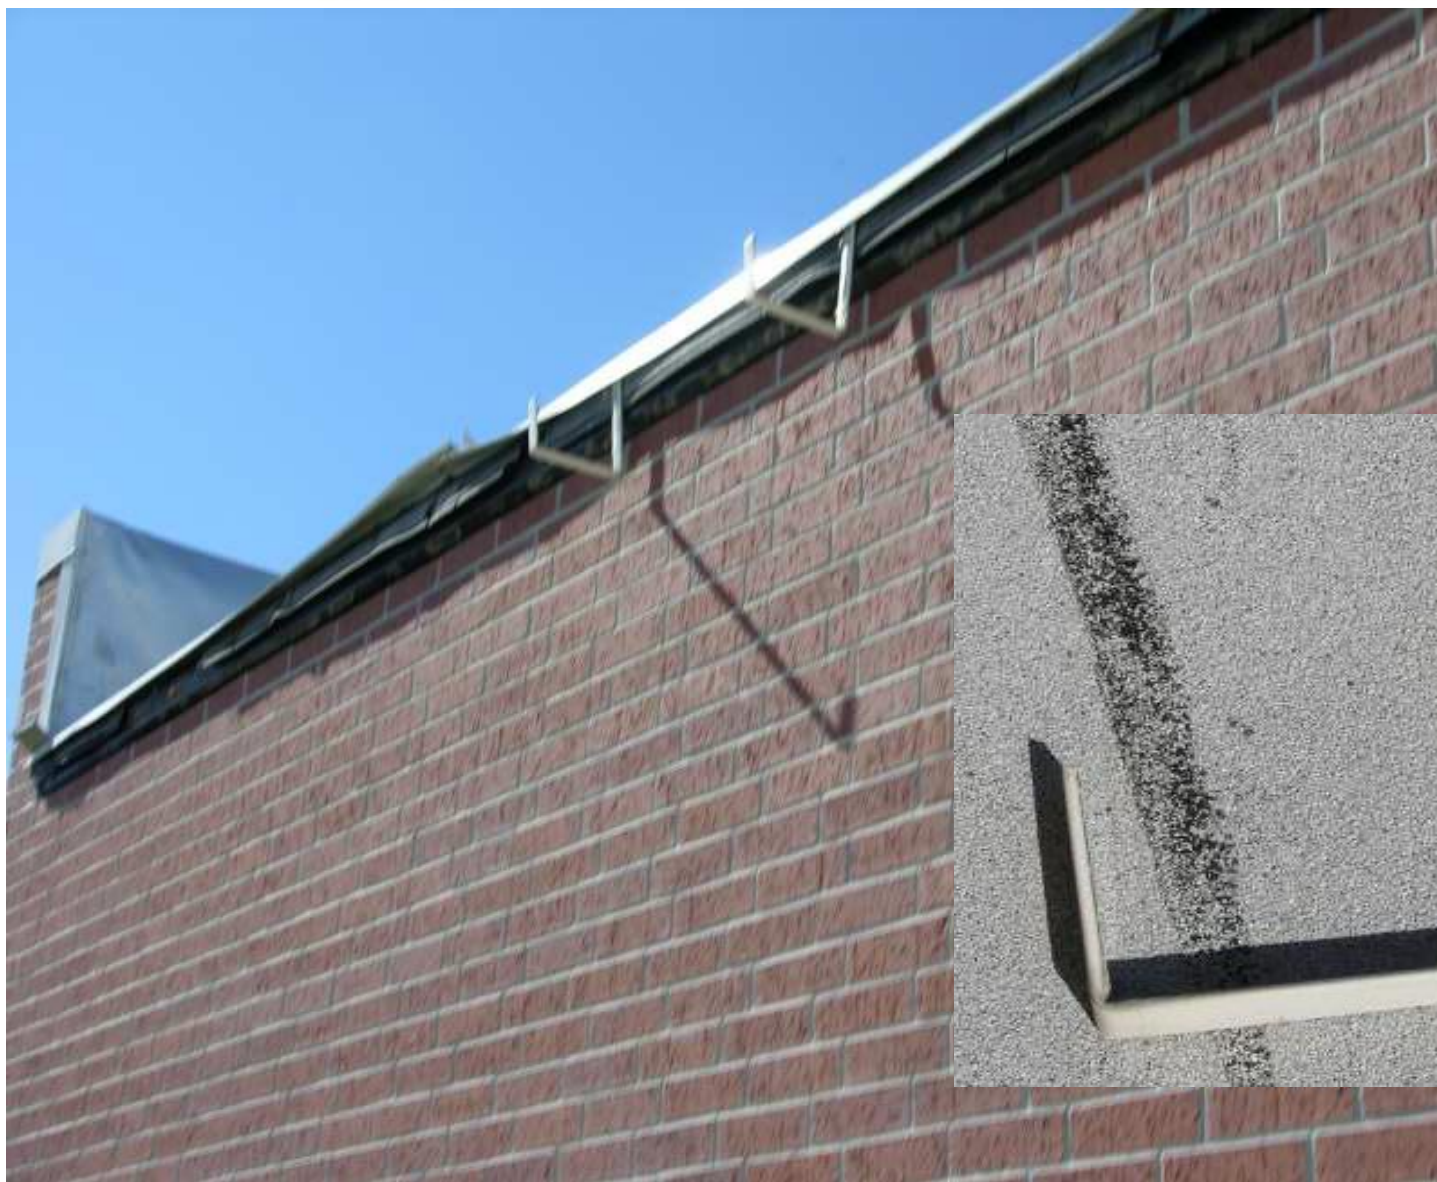
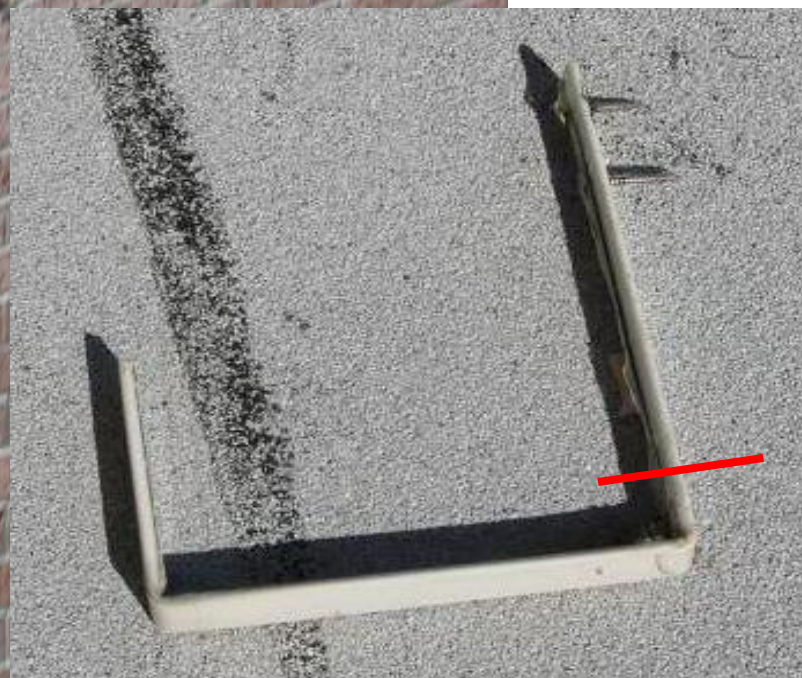
- Observation: Most critical facilities had wind vulnerabilities -- some were significant

- Existing facilities: perform comprehensive vulnerability assessment of wind-force resisting system and building envelope
- Mitigation: Consider Guidance in FEMA 543 and 577. If recommendations not implemented, base decision on deliberation and consideration of residual risks
- Mitigation projects: 2-stage peer review

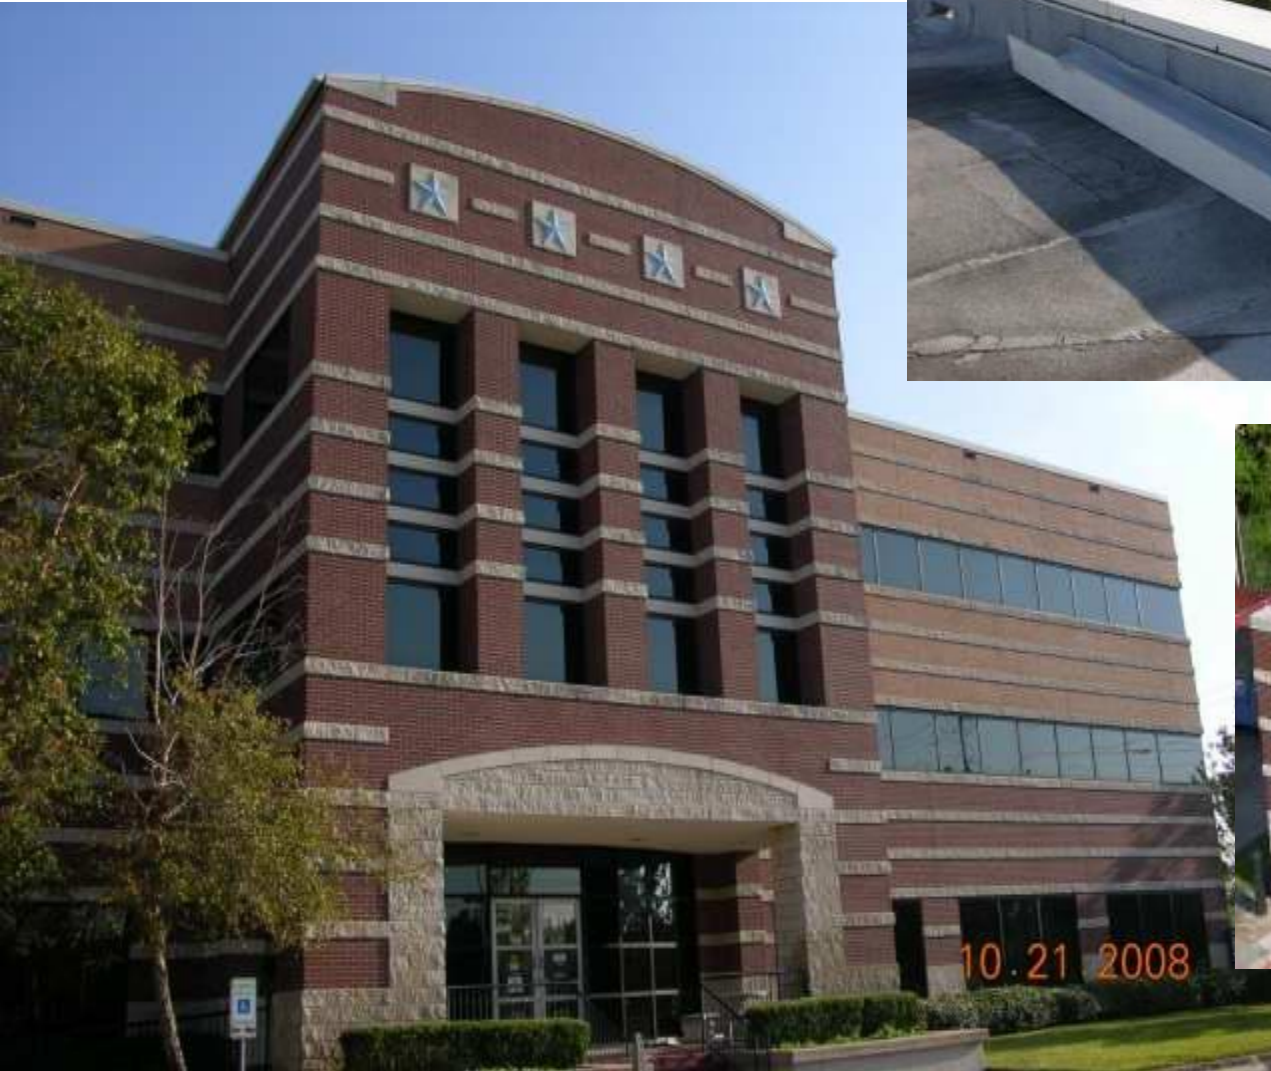
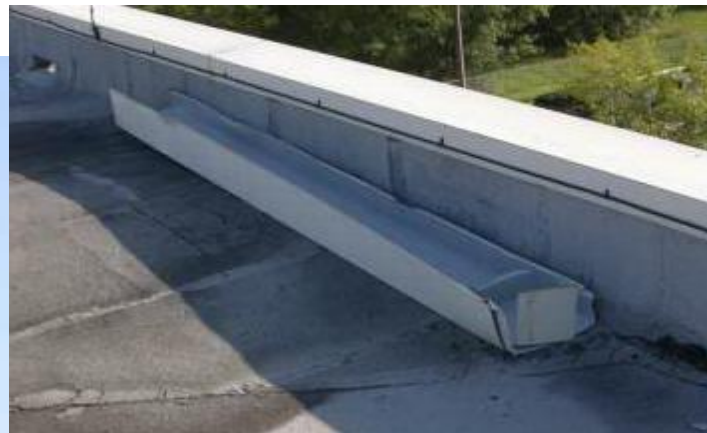
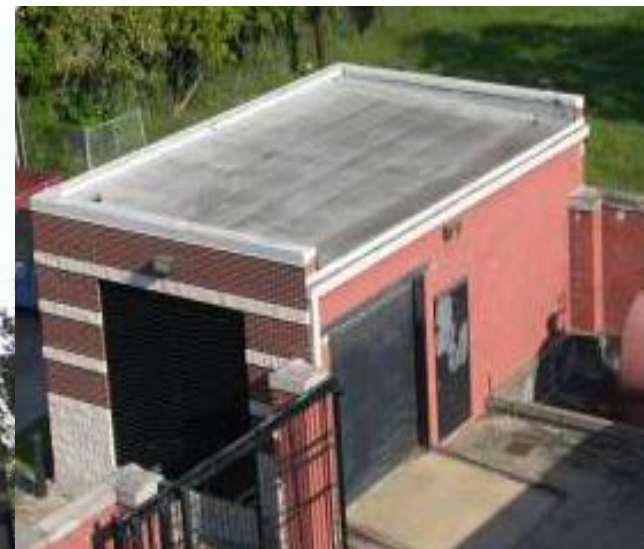
- Observation: Mitigated projects not sufficiently robust and/or not sufficiently comprehensive
