Investigation of November 10, 1986 Blowout and Fire OCS Lease 0244 West Cameron Block 71

Gulf of Mexico
off the Louisiana Coast

J. L. Guidry
P. McDonald
S. J. Patkowski
C. J. Schoennagel
B. R. Stewart

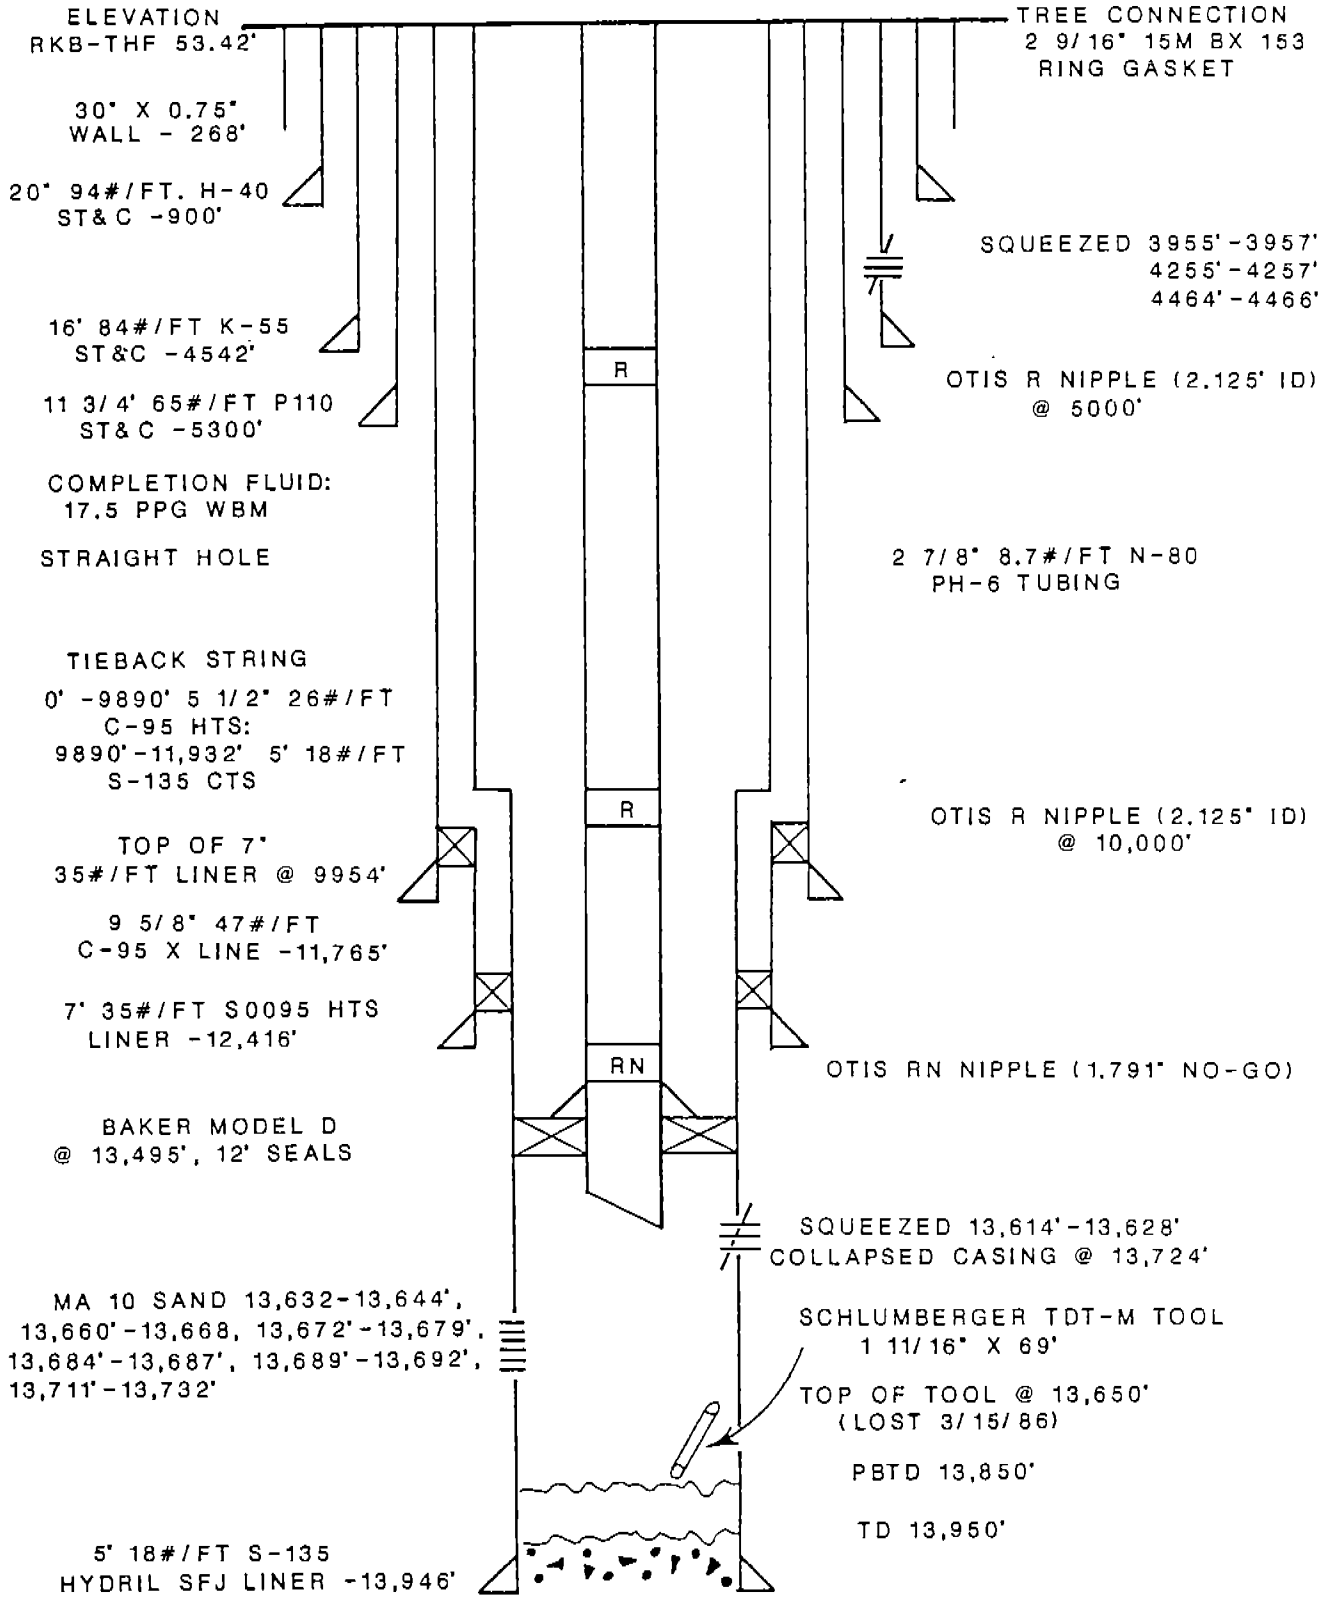
SCHMATIC OF WELL NO. 12

Efforts to kill the well by bullheading 15 ppg mud downhole failed. Circulation through the supposed leak could not be established. The casing pressure was bled down to 0 psi.

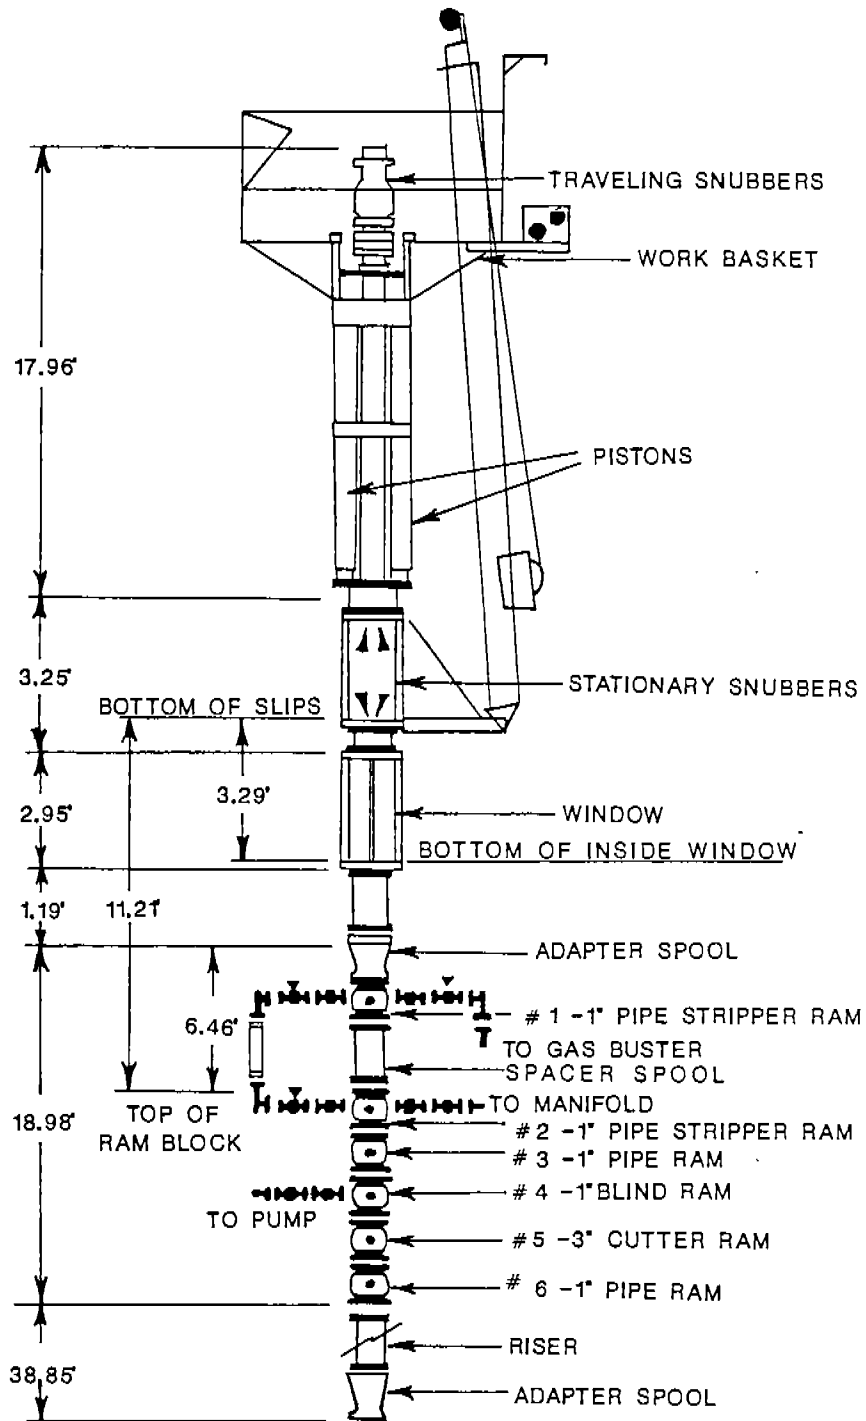
SCHEMATIC OF THE SNUBBING UNIT AND BOP STACK

The snubbing unit sustained fire damage to equipment located in the vicinity of the window. The six joints of 1-inch pipe, stripping rubber, and inserts of the Nos. 1 and 2 Stripper Rams were destroyed. Little damage occurred to the workbasket or the equipment located below the window.

The probable cause of the incident was the running of the tool joint between the Nos. 4 and 5 joints of 1-inch pipe into the closed Stripper No. 2, causing the pipe to buckle and fail. In turn, the well pressure acted on the pipe, the pipe seal was broken, and well control was lost.
