OCS REPORT
MMS 86-0006

**Investigation of January 6, 1984, Flash Fire
Ship Shoal Block 269
Gulf of Mexico,
Off The Louisiana Coast**

February 1986

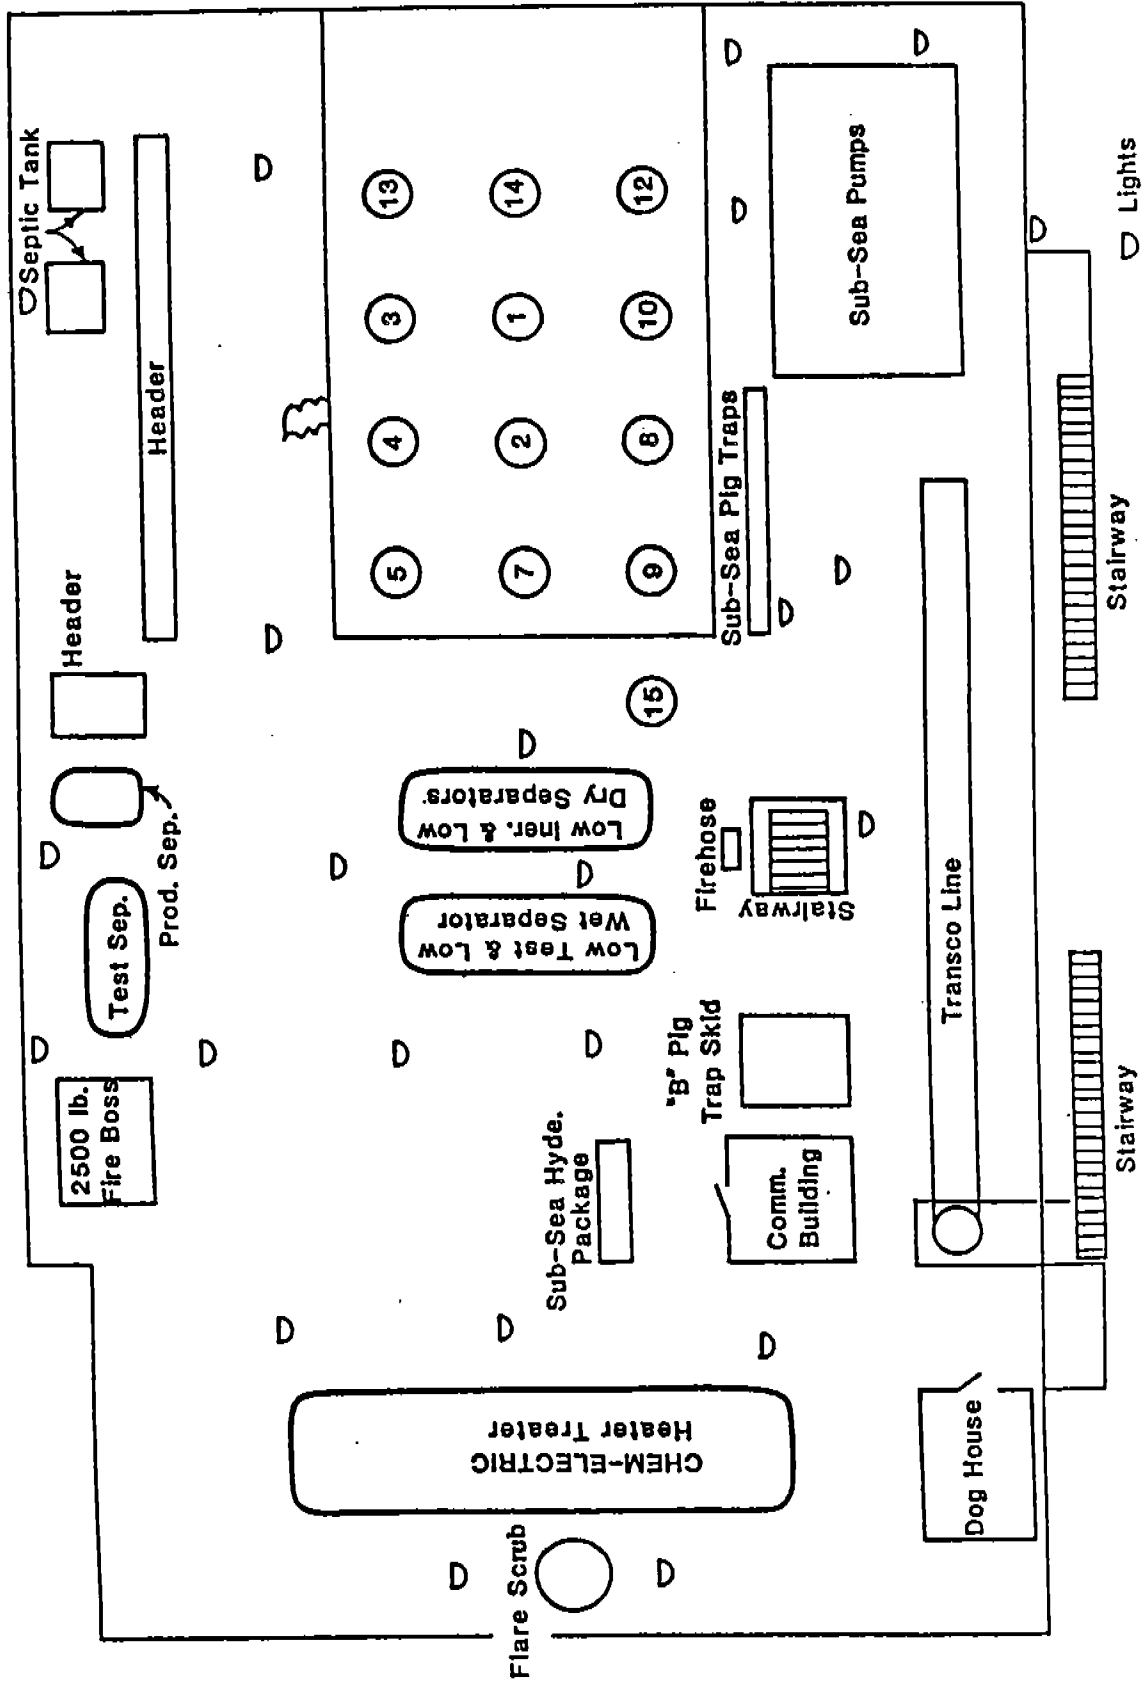
MIDDLE DECK, PLATFORM "A" ATTACHMENT NO.8

The chem-electric unit, located on the middle deck of Platform A, developed problems about 4:55 p.m. on the afternoon of January 6, 1984. A safety device on the chem-electric activated the alarm panel, and Mr. Roger Hebert, safety technician, responded and began to take the unit out of service. He determined that the burst plate had leaked. Although no pollution was seen coming from the chem-electric, it is believed that the problem with the chem-electric and the following bypass procedures were the original contributors to operative actions taken that resulted in the pollution which caused the accident.

from the chem-electric could also be routed to all three locations at the same time by opening the valves 2, 4, 5, and 6 on the water outlet. Assuming that the water from the chem-electric was routed to all three locations, then it is conceivable that the fluid from the skimmer tank could gravity feed to the sump on the auxiliary platform and through the overboard line to the Gulf. Installation of a check valve in the skimmer tank inlet line during the design stage would have eliminated a hydrostatic liquid flow to a lower level discharge point.

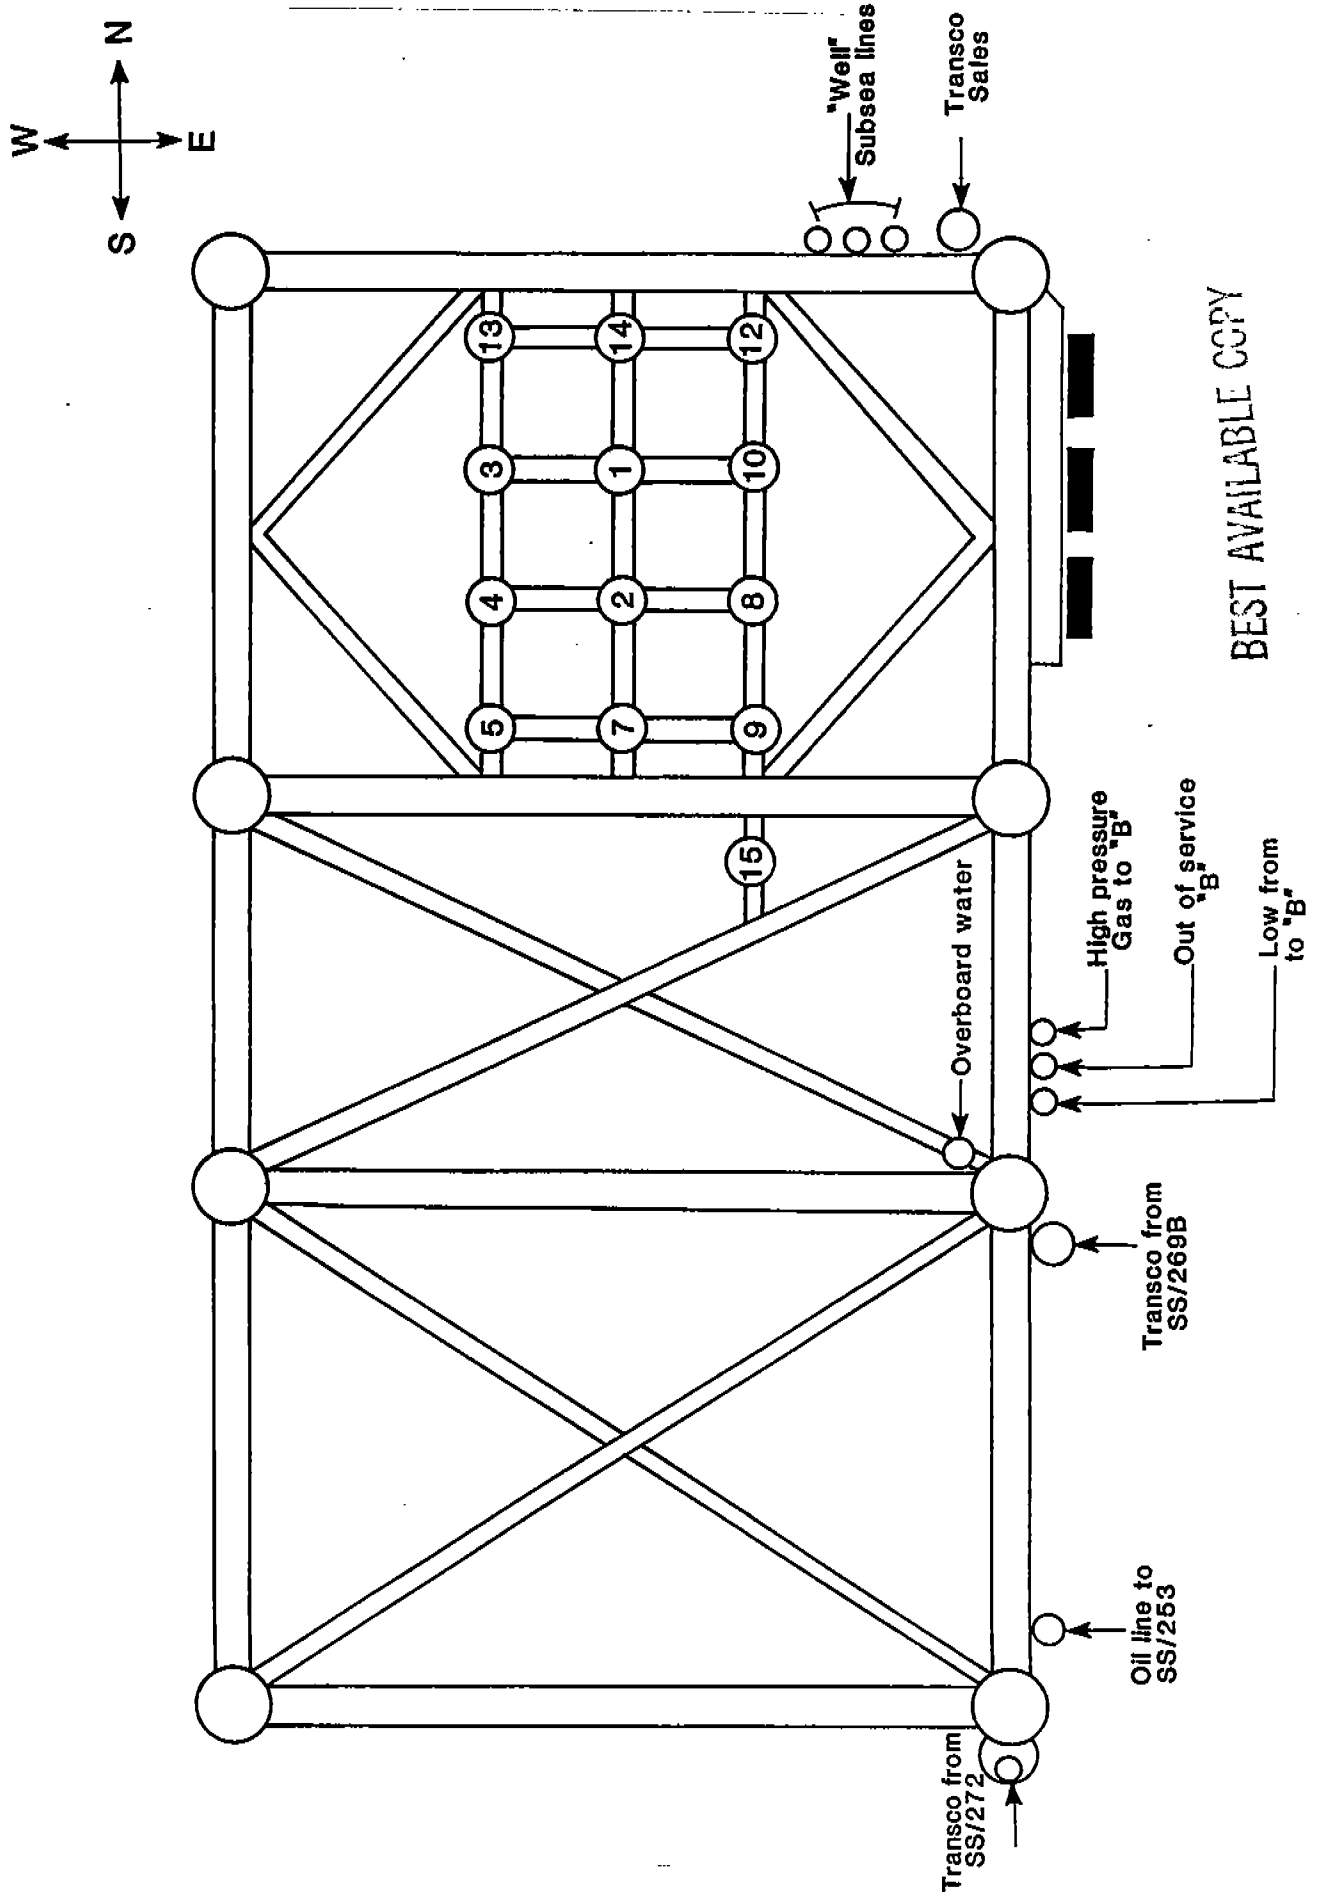
BOAT LANDING - JACKET

1. Liquid hydrocarbons hydrostatically discharged from the skimmer tank to the sump and drip pans on the auxiliary platform presumably were the material cause/fuel for the fire.
2. Ignition was caused by a piece of extremely hot metal, being trimmed by the welder on the handrails of the living quarters on the top deck, dropping in the water where hydrocarbons were present.
