**Investigation of Electrocution on Drilling Rig  
Ship Shoal Block 170, Well No. 1  
OCS-G 33644  
26 January 2013**

**Gulf of Mexico  
Off the State of Louisiana**

**U.S. Department of the Interior  
Bureau of Safety and Environmental Enforcement**

**September, 2014**

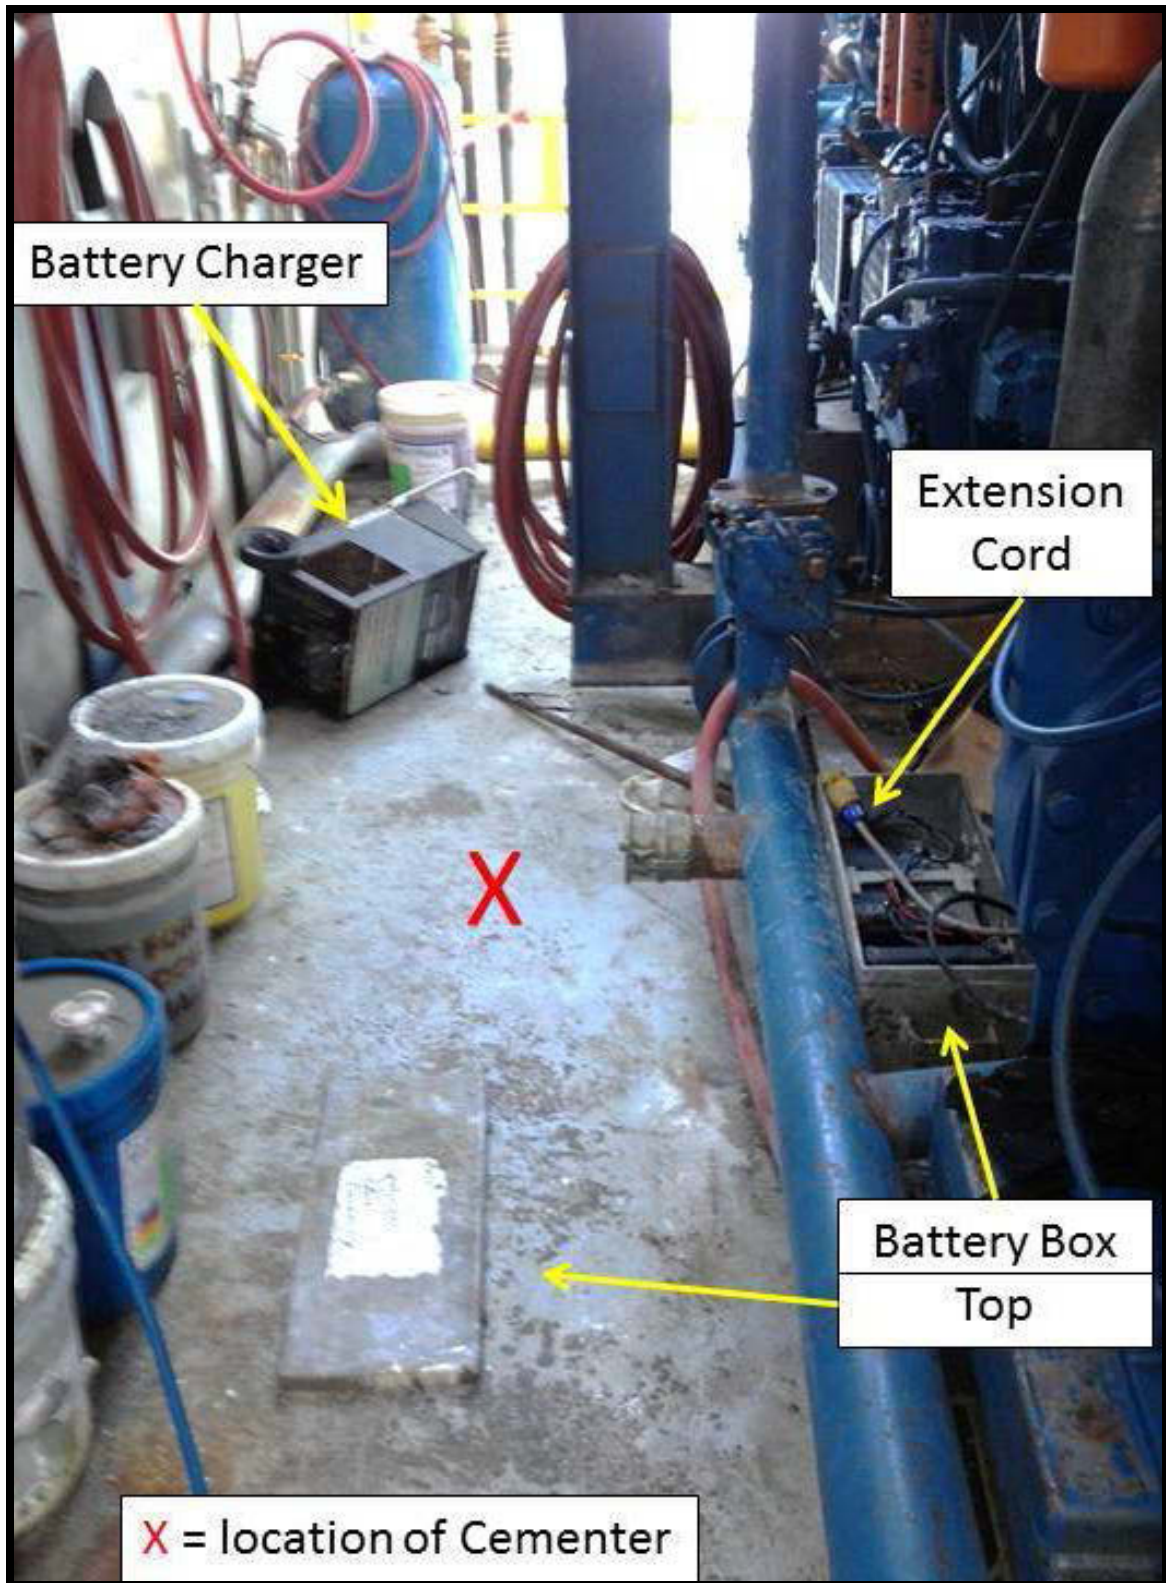
Figure 8: Geography of the scene of the Incident (1)

The work area where the Cementer was found is shown in *figures 8 and 9*. The photographs were taken the day after the Incident. The Rig deck in the proximity of the Incident location was described in statements as being "damp." Examinations of other photographs taken immediately after the Incident indicates possible residual salt water or other liquid residue on the deck in the proximity of the Battery Box area (*see figure 10, p. 25*).

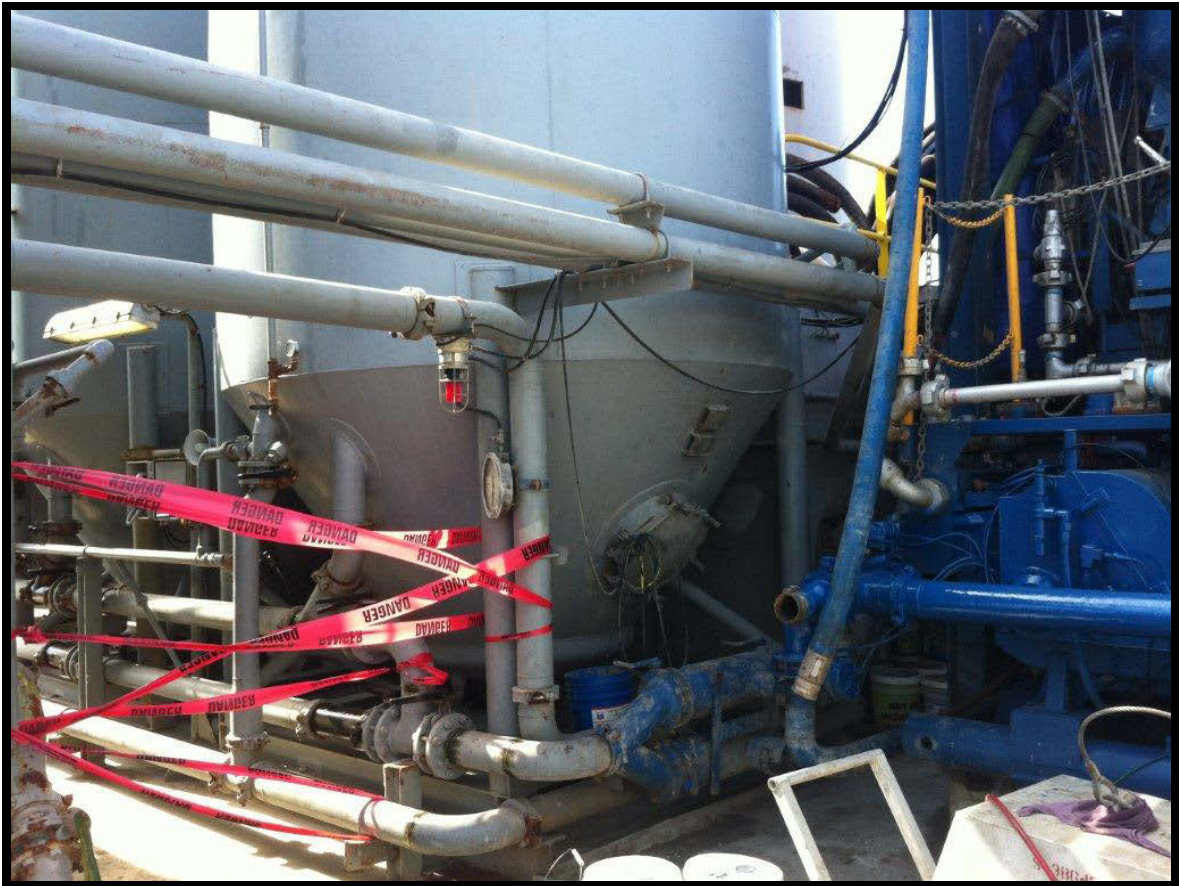
***Figure 11: Scene of Incident at time of arrival of BSEE Inspectors.***

*1/26/2013 1800-2000 hrs:* The I3P Rep taped off the area where the Incident occurred including the area that had been used in the attempt to revive the Cementer. The I3P Rep then took written statements from the crew.

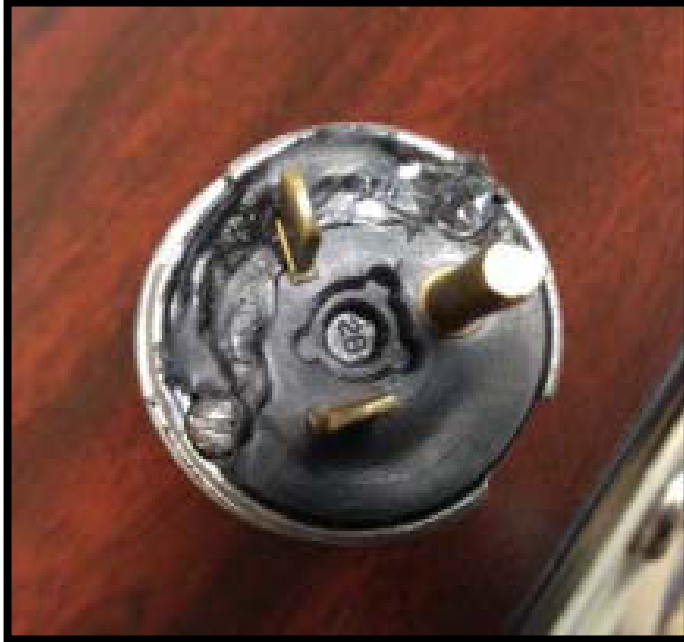
*Figure 14: Male plug, replacement extension cord*

1/31: The IP3#2 contracted by the Operator conducted a survey of the area and found that the new extension cord from the new battery box was not properly secured, nor was it industrial quality (*see figure 13 for his report*). He also found that the plug male end looked as if it were burned or melted,

but was definitely damaged (see figure 14). During this inspection, the location of the replacement battery box was found to be too close to a fuel tank. The replacement Baker Hughes personnel were told of the identified safety problems and another new extension cord was prepared onshore and sent to the Rig for use on the Unit.

From later statements made by I3P and other personnel, the third attempt to make an acceptable extension cord to supply power to the Cementing Unit screens also resulted in production of a defective extension cord. The fourth cord made up by Baker Hughes apparently worked properly. No information was received about the ultimate relocation site of the battery box or the routing of the extension cord from the Appleton outlet to that new battery box.

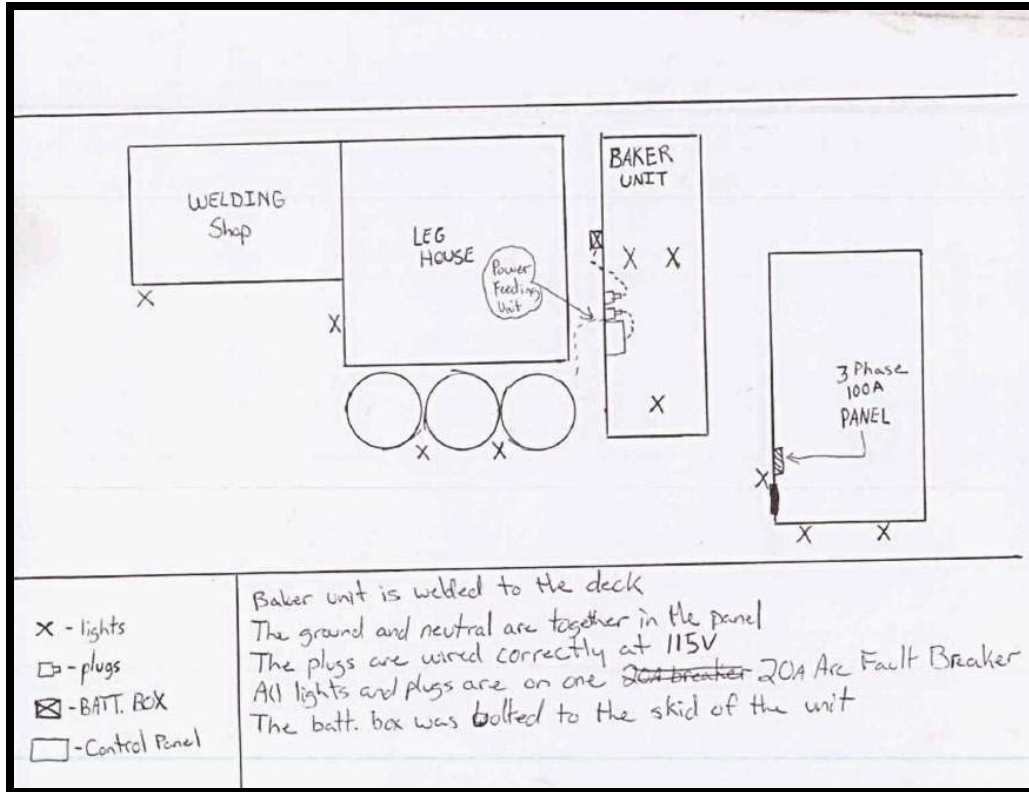
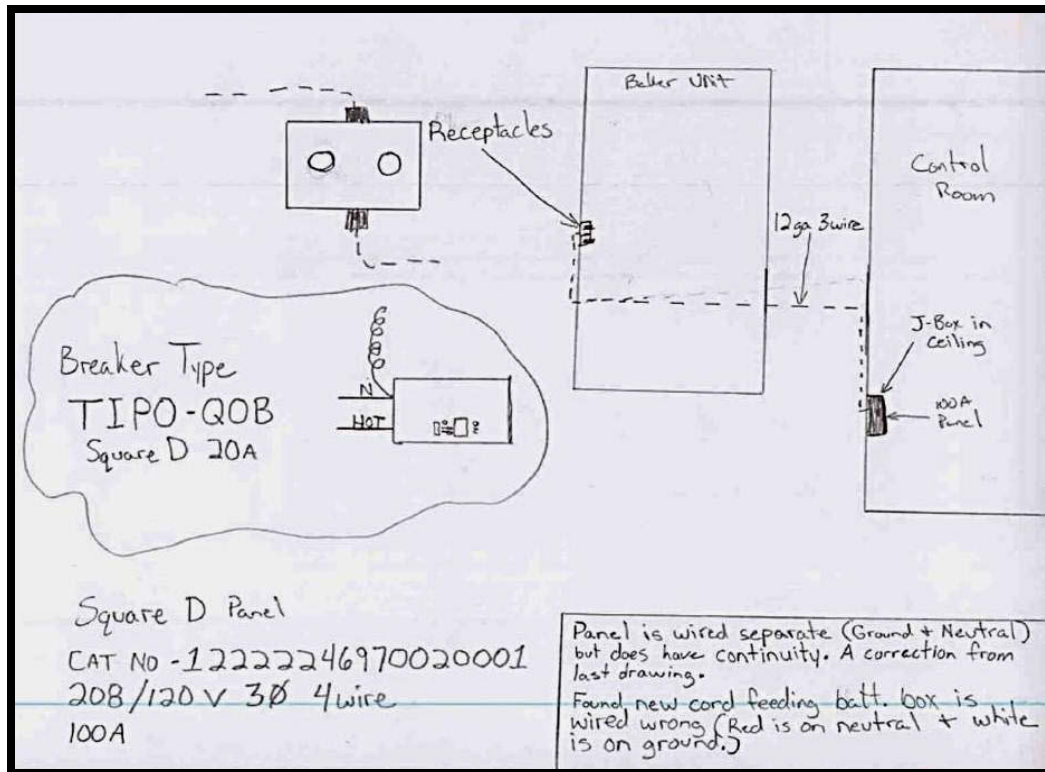
Figure 15: Wiring diagrams from Rig Electrician

From statements, diagrams, interviews with Rig and Baker Hughes personnel, electric power was supplied to the Cementing Skid by connecting the Rig's 115 Volt AC system (115VAC) to the dual Appleton Outlet Box mounted near the ceiling of the control room. The Rig Electrician stated he installed the power cable to the inlet of that Outlet Box. The Outlet Box itself and all electric wiring downstream of it on the Skid were the property and responsibility of Baker Hughes and were installed and maintained by Baker Hughes personnel. The Rig Electrician stated that Rig Company rules prevented him from working on other company's equipment. He stated there was no ground fault circuit interrupter (GFCI) on the power line supplied to the Skid; however, the circuit did run through the breaker panel. He indicated a GFCI is not necessarily a part of such a system.

The Rig Electrician supplied two diagrams showing the wiring from the Rig's power supply to the Skid's Appleton Outlet box. He also provided information on the circuits and breakers. His drawings are shown in *figure 15*.

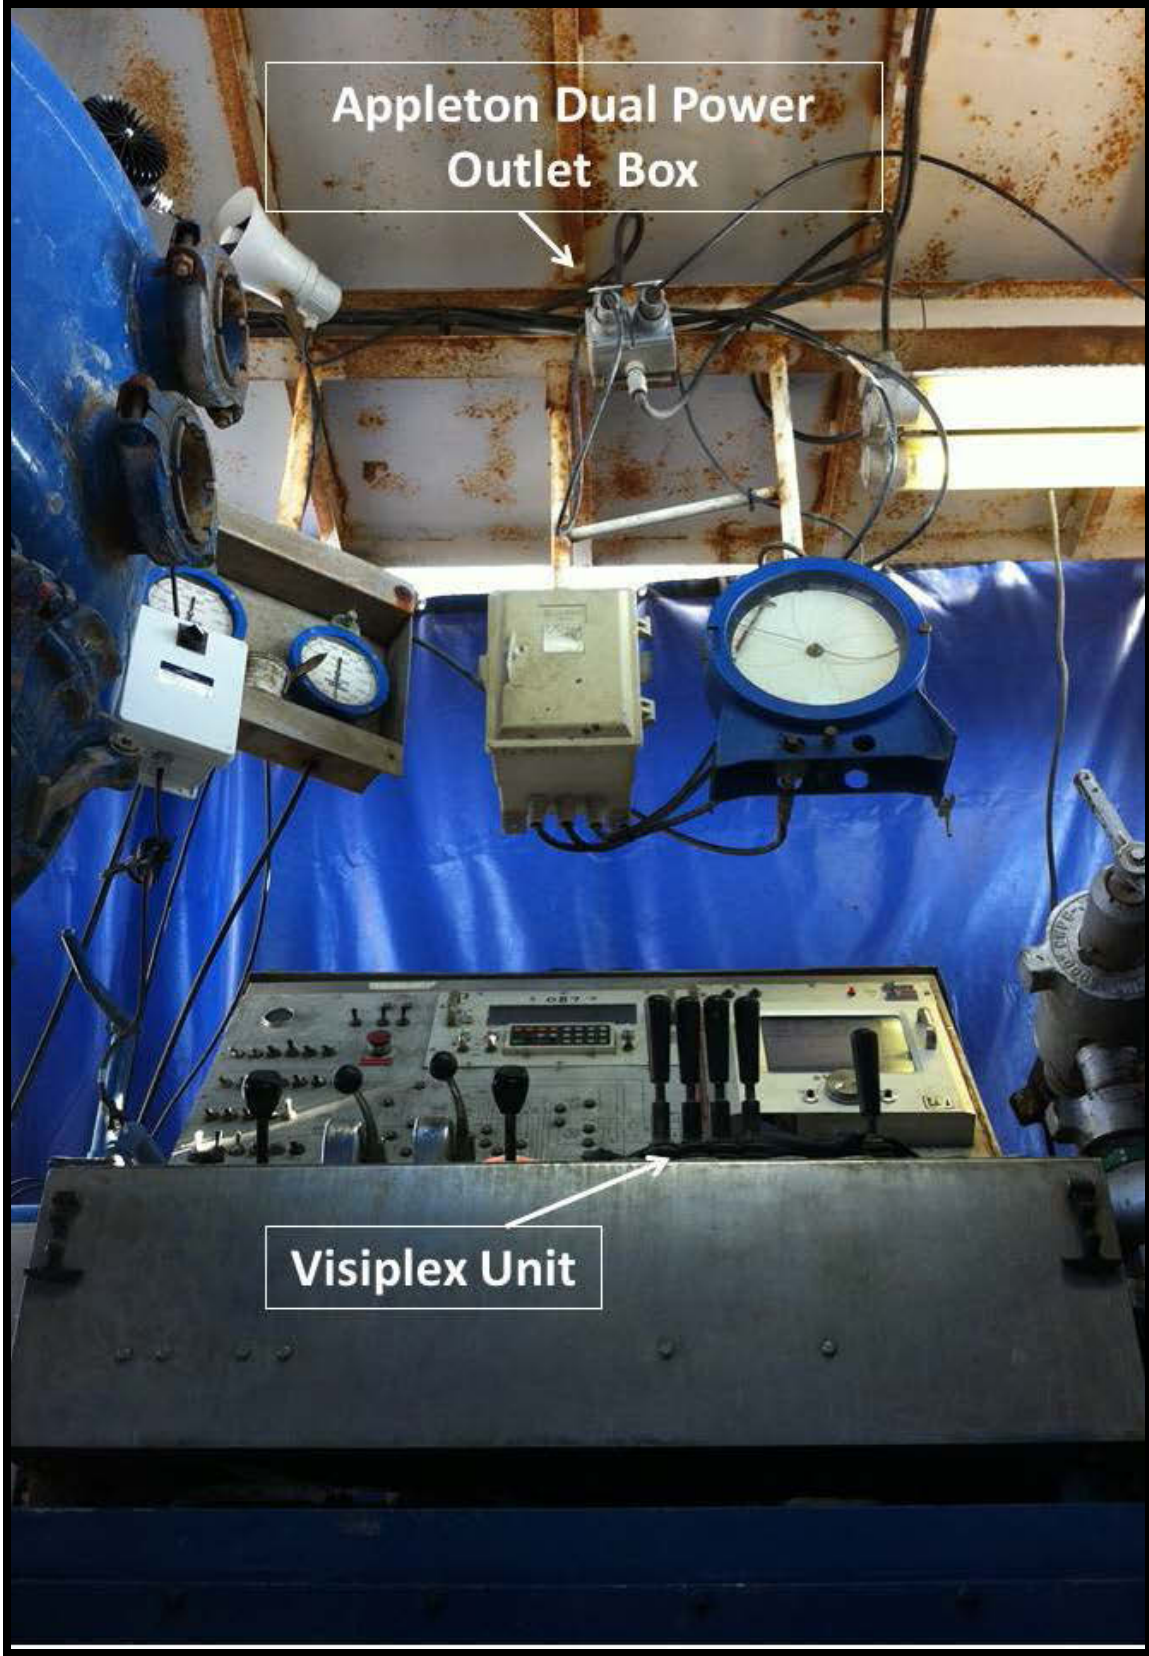
*Figure 17: Appleton dual power outlet box in “control room” of Skid (after replacement)*

115VAC power from the Rig generator was fed to an explosion proof, Appleton dual Outlet box located above the “control room” of the Skid (*see figure 16*). The “control room” was in fact only a tin-roofed area, open to the elements on the sides but partially protected by a tin roof and a tarp (*see figure 17*). The Outlet was a dual to accommodate the design of the Cementing Unit electrics to provide separate primary and backup power sources feeding the instrumentation. The Outlet and all downstream wiring, electrical fixtures, instrumentation, etc., were installed and maintained by Baker Hughes. Despite being outside, the Outlet had no integral ground fault circuit interrupter (GFCI).

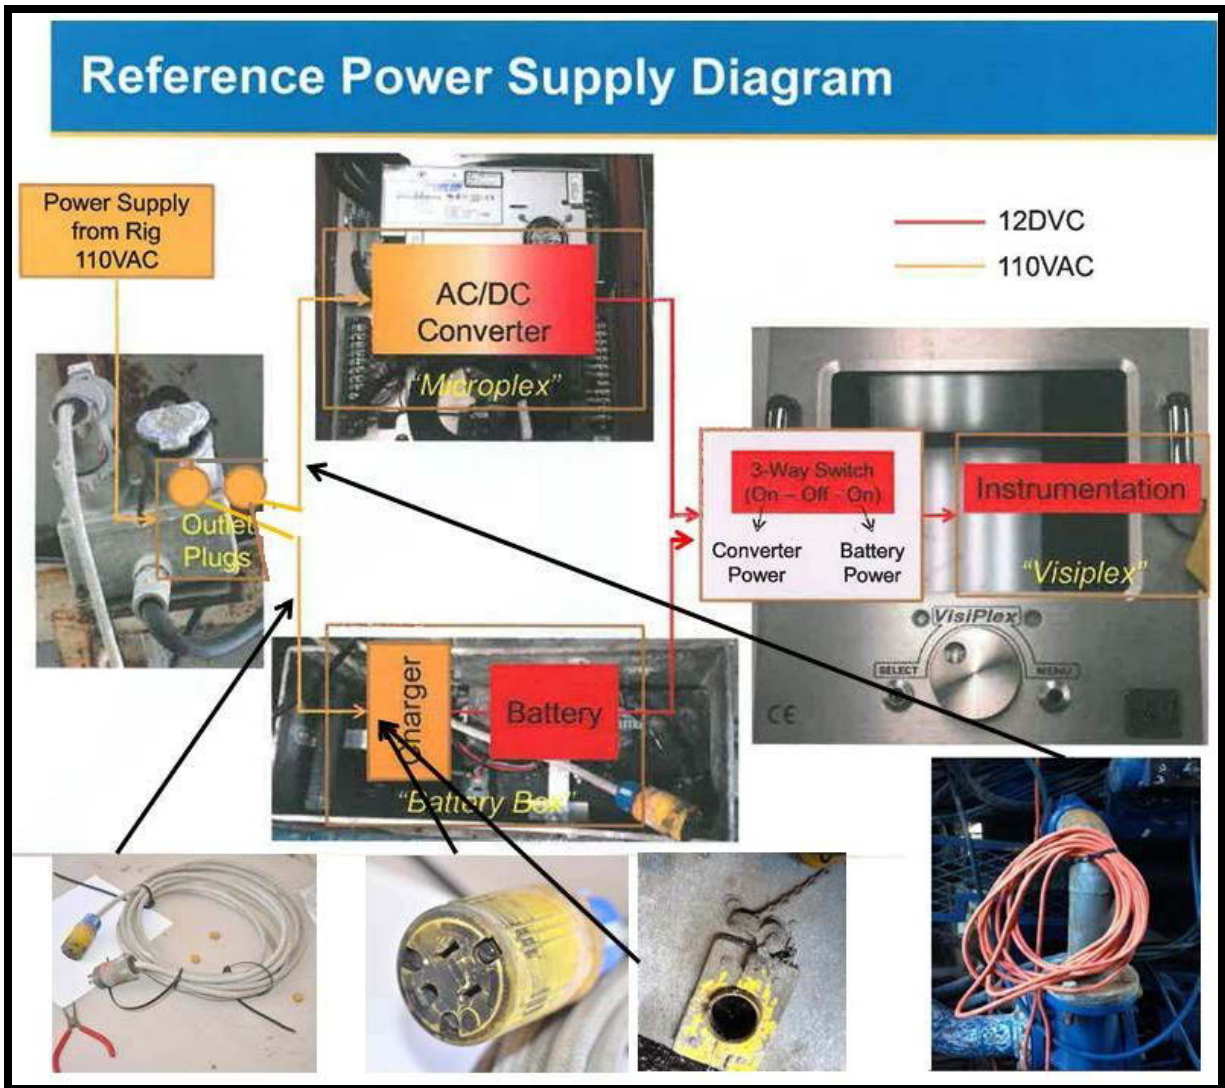
**Figure 18: Power supply diagram** (after diagram provided by Baker Hughes)

To power the Visiplex, two different methods, a primary and a backup, were designed and provided on the Skid. The elements of these two circuits are shown in *figure 18*. As the system was designed, the primary method of getting the 12VDC current to the Visiplex was to use an extension cord running from one of the dual Appleton Outlet plugs to an AC/DC converter. A pronged power connection cord then took power from an outlet jack of the AC/DC converter to the inlet jack of the Visiplex.

The battery was wired to another outlet plug in the wall of the Battery Box (Cannon socket and plug), which accommodated another connection cord. That cord was (a) plugged into that outlet of the Battery Box, and then (b) plugged into a special connection on the rear of the Visiplex.

In summary, the Visiplex was intended to be powered by the AC/DC converter as primary source, switching to the back-up power provided by the Battery Box circuit if Rig power failed or spiked. The two Cementing Unit circuits, primary and backup, are represented in *figure 18*.

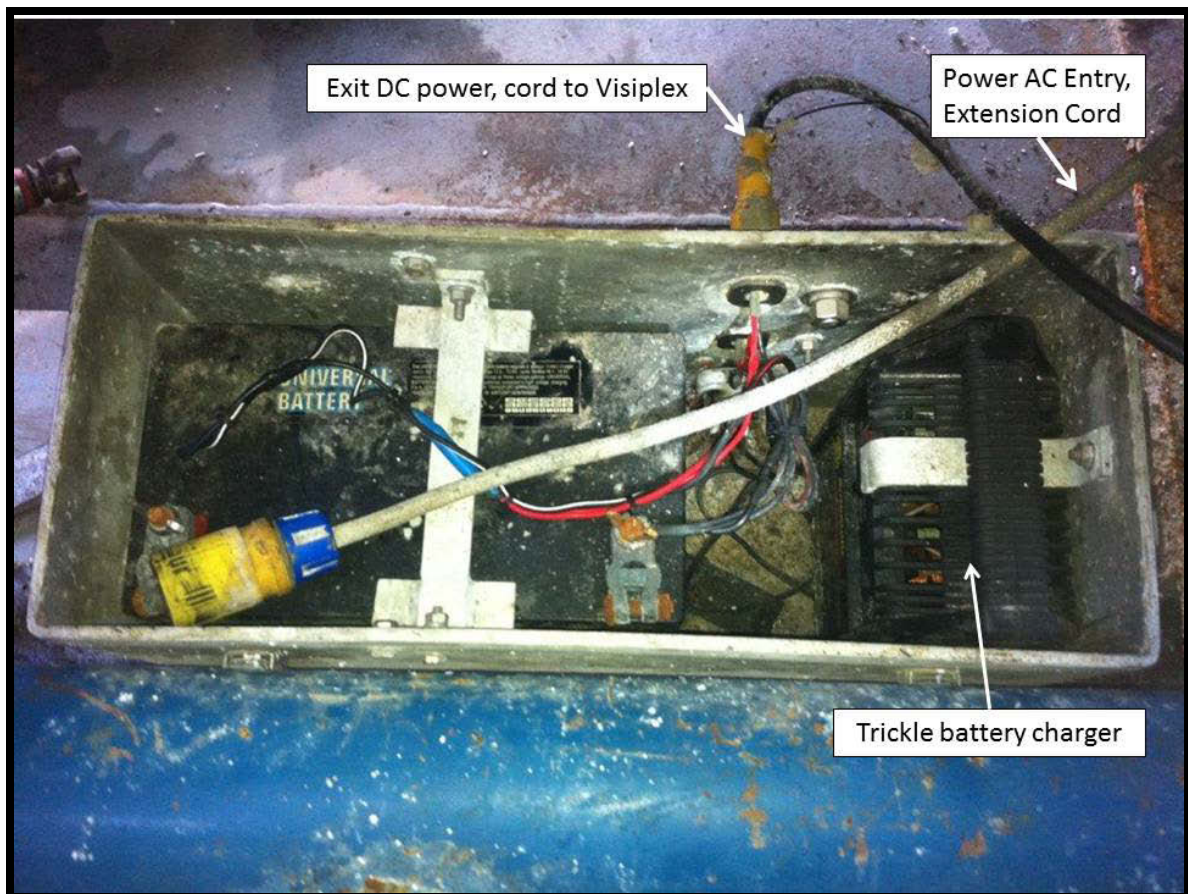
**Figure 26: Battery Box on location, one day after Incident**

The inlet receptacle on the Battery Box was fitted with a porcelain or Bakelite insulator around the embedded male plug where the line passed through the aluminum wall. Two wires then carried power to the trickle charger within the box which was then connected to the 12VDC battery (*see figures 26, 27*). A third wire, a ground for the male plug to the case of the Battery Box, was not present. Such a ground wire was installed and present on the replacement battery box (*see figure 28*). From the 12VDC battery, power was wired to a three prong DC power outlet in the Battery Box wall which was the connection for the cord carrying DC power to the Visiplex.

The SME Group Report indicated the trickle battery charger installed in the metal case of the Battery Box is considered “double insulated” due to the plastic case of the trickle charger, and therefore does not require a ground wire on the trickle charger. However, the replacement battery box was grounded to the case of the box itself by a connection from the male inlet plug. A coating of burned insulation covered the inlet insulator inside the Battery Box (*see figures 29, 30*).

From discussions with SMEs, it is possible that a ground wire originally existed inside the Battery Box but was shorted and burned earlier resulting in the ash residue inside the Battery Box. However, in such a case the trickle charger would continue to operate normally because of the double insulation. A residual metal tab connection for a ground wire from the male inlet plug was not observed during inspection of the Battery Box by the SME Group.

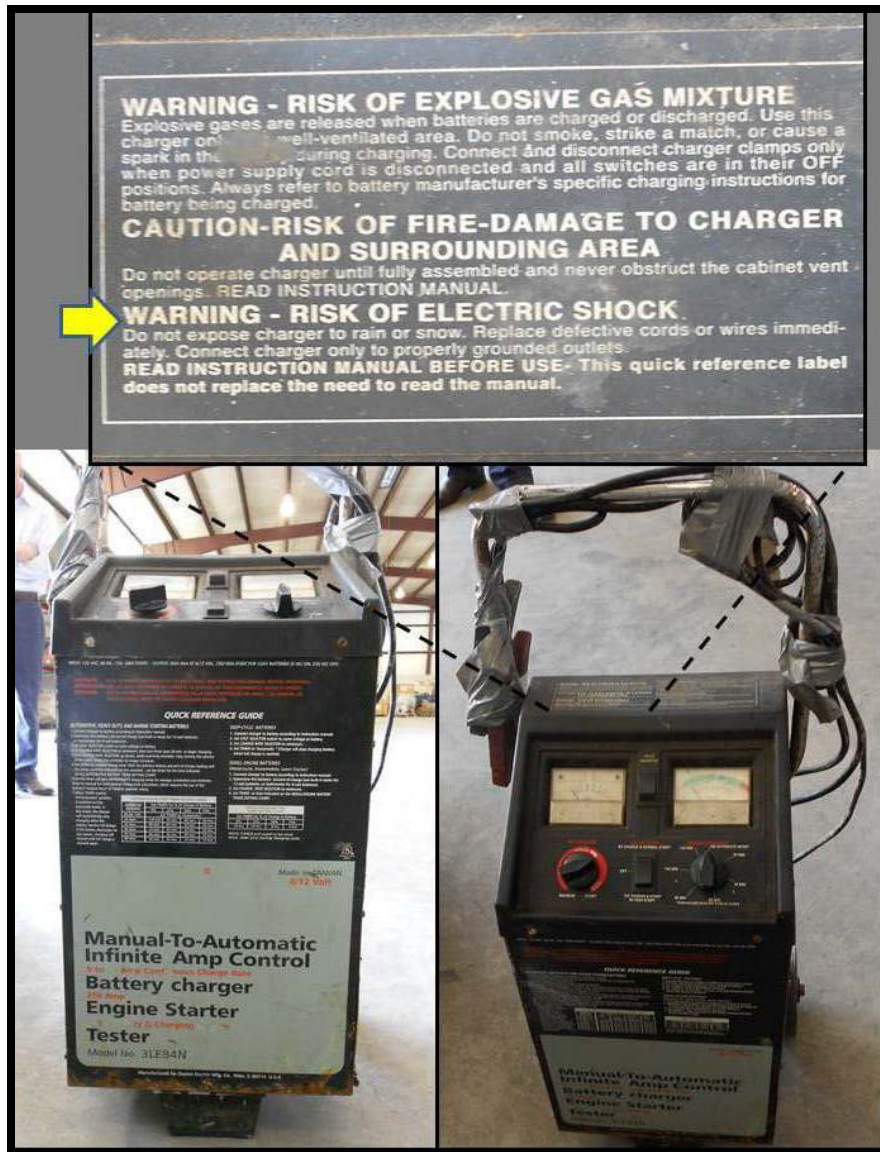
Figure 31: Rig Battery Charger and warning label (1)

The Rig Battery Charger was a Dayton Electric Manufacturing Co. Model 3LE84N. Dayton is a product name for a line of electrical equipment manufactured by Grainger Industrial Supply. This model battery charger has been replaced in the Grainger/Dayton sales product lines by other products and is no longer being produced. However, there are a great many units of this model battery charger still in service, and the replacement products apparently have similar wiring and capabilities as do many competitor's products. The Battery Charger is described in the literature as being intended for heavy duty use in service stations, maintenance shops, farms and fleets. It meets UL listed standards. Its AC cord is a conductor heavy duty that is 6-ft. long.

Typical of these types of wheeled heavy duty battery chargers, danger warning labels and instructions for proper use adorn the case. Posted in two locations, on the top and the back of the Battery Charger, are specific warnings against the danger of electric shock if using a non-grounded outlet or extension cord (see figures 31, 32). Other warnings include recommendation to avoid contact with rain, or water and instructions to replace defective wiring or cords immediately. Also on the case are warnings to read the instruction manual.

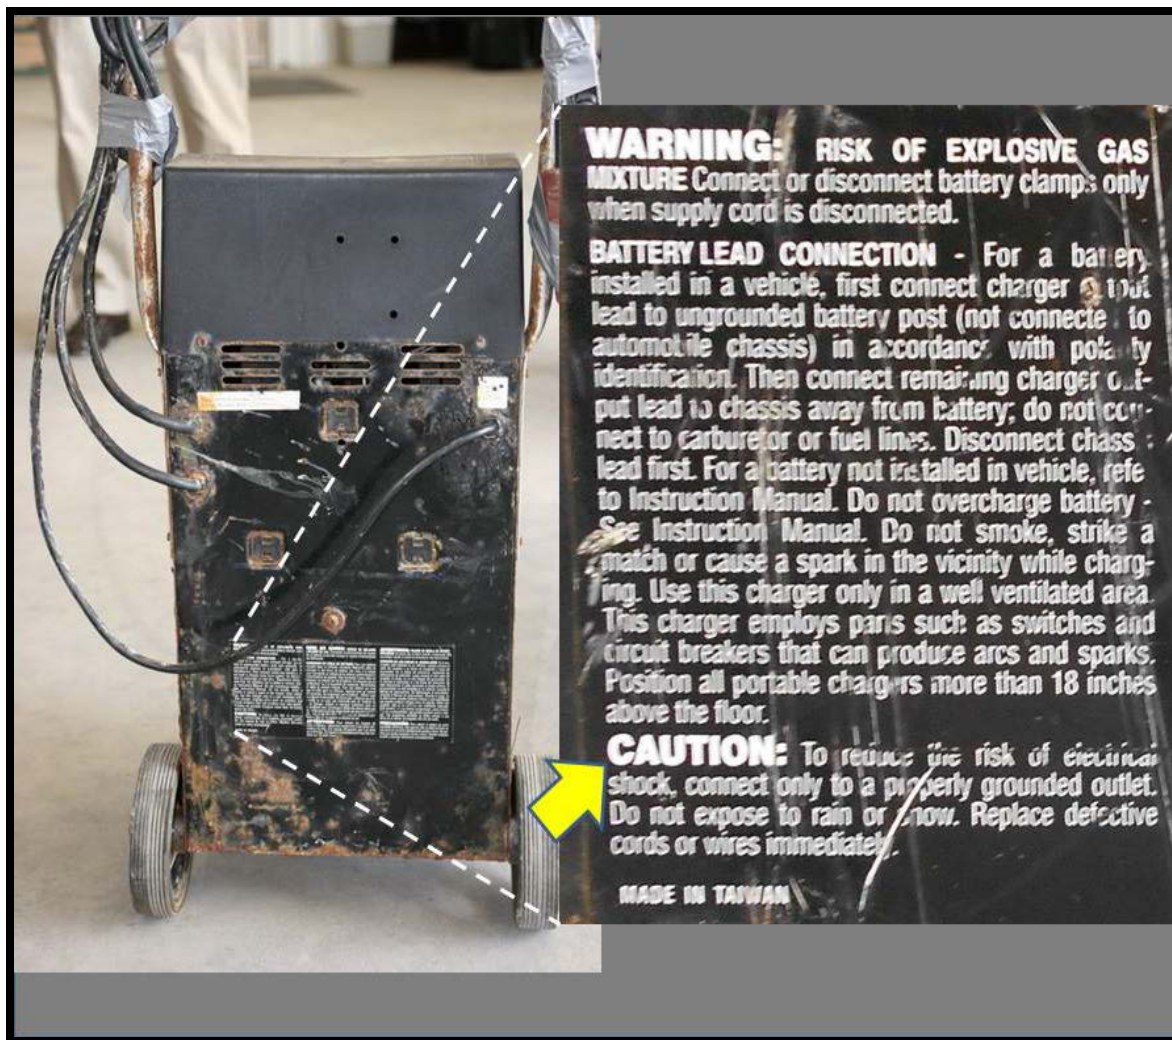
Figure 32: Rig Battery Charger and warning label (2)

The Battery Charger showed evidence of corrosion and weathering from exposure to the elements despite the warning labels to avoid contact with water (see figure 33). However, examination of the external and internal components of the Battery Charger by the SME Group did not discover any obvious malfunctions that would have contributed to the Incident (see figure 34 for wiring schematic of Battery Charger).

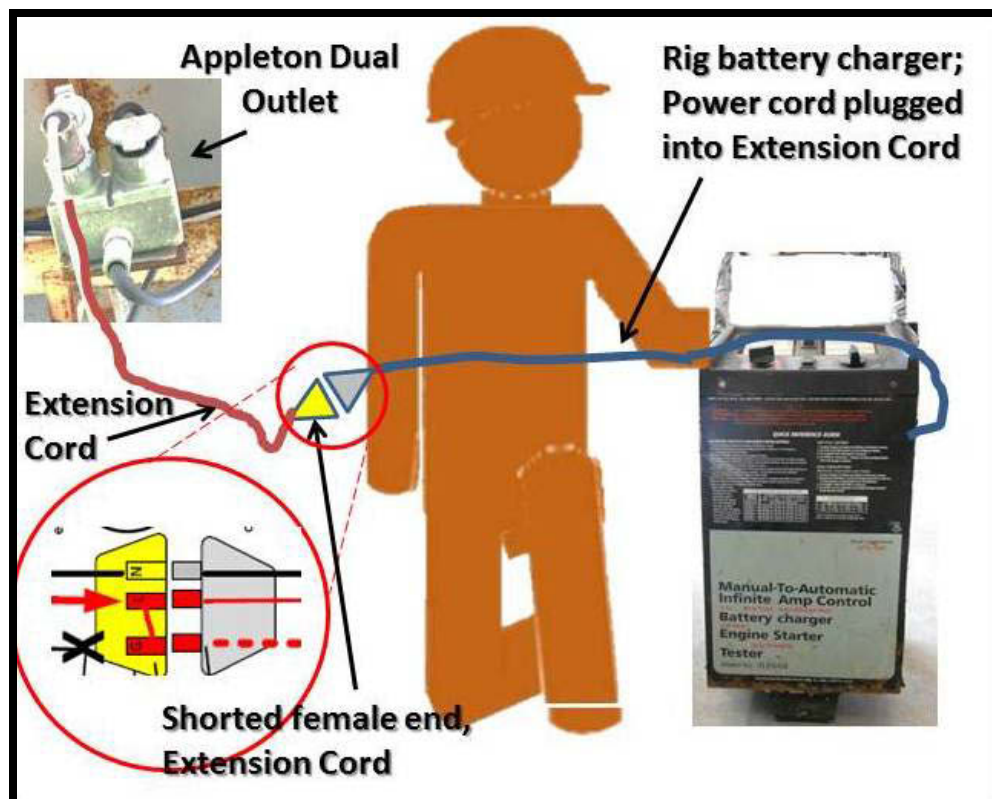
*Figure 35 – Position of electronics and Cementer when the Incident occurred.*

When the incident occurred, the elements were positioned approximately as shown in *figure 35*.

The Extension Cord was plugged into the Appleton power outlet. The power cord for the Rig Battery Charger was plugged into the Extension Cord. The Cementing Hand was kneeling on the deck having completed plugging the Rig Battery Charger power cord into the female end of the Extension Cord. The burned connection and short in the female end of the Extension Cord was causing the ground wire of the Rig Battery Charger power cord to be energized.

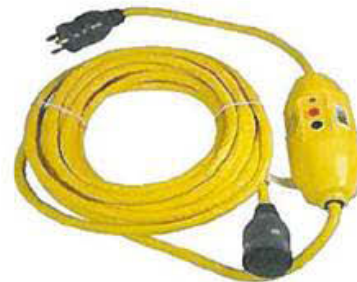
Examples of GFCI Protected Extension Cord and Receptacle Outlet

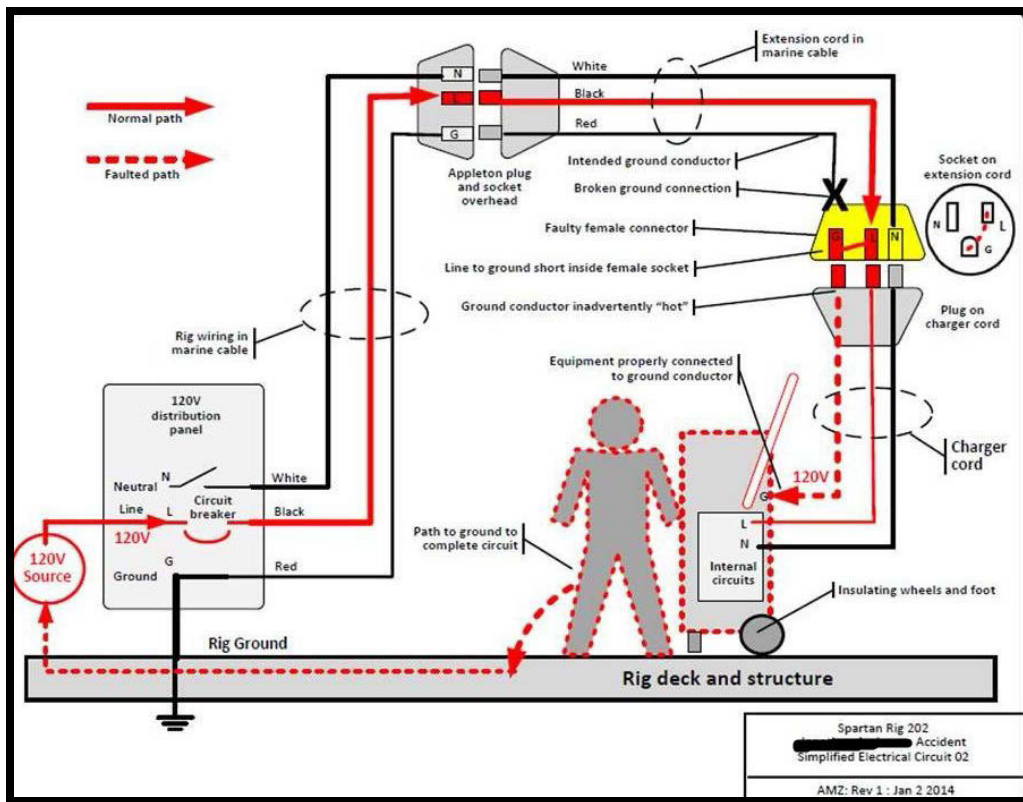
Figure 43: SME Group Report, Attachment 3

7. *The fault current originated in the female socket of the extension cord. (conclusion)*
