**Investigation of Fatal Accident  
South Pelto Block 15, Well No. 4  
OCS-G 09652  
26 January 2005**

**Gulf of Mexico  
Off the Louisiana Coast**

**U.S. Department of the Interior  
Minerals Management Service  
Gulf of Mexico OCS Regional Office**

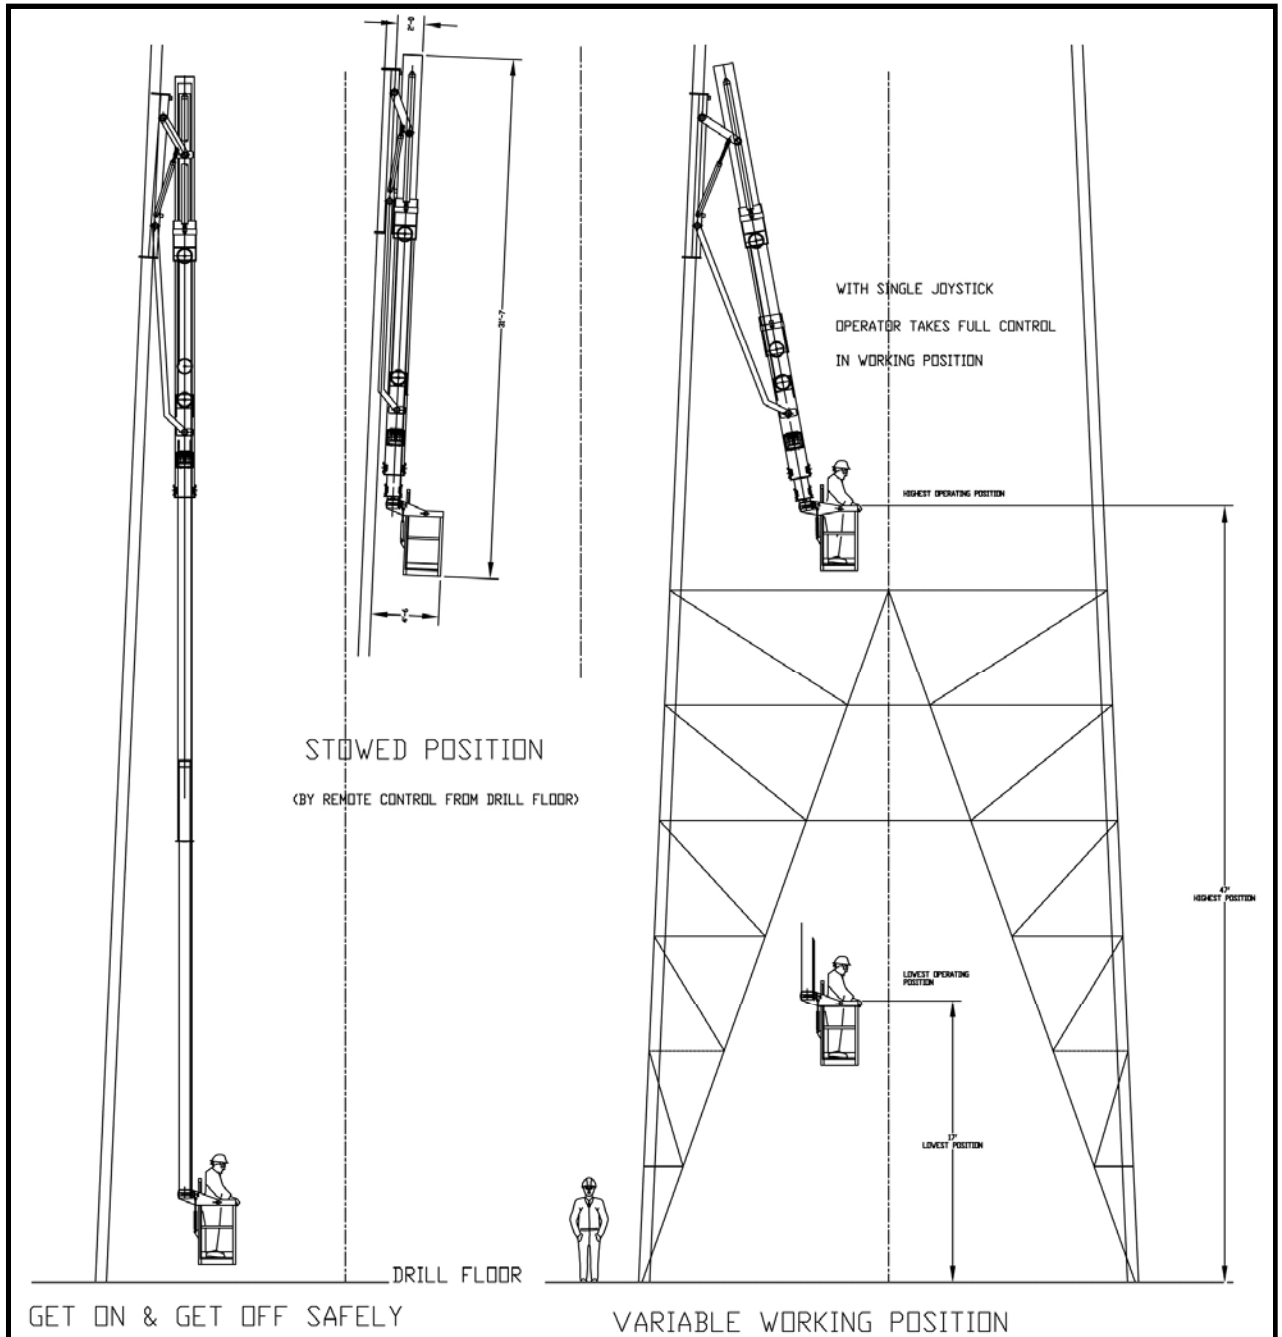
## Design Diagram, Veristic Hydraulic Stabbing Board

5. It is possible that design of the hydraulic system contained an element, the limit control circuits, that could have contributed to the control response delay under certain conditions.
