**Investigation of Loss of Well Control and Fire  
South Timbalier Area Block 220, Well No. A-3  
OCS-G 24980  
23 July 2013**

**Gulf of Mexico  
Off the Louisiana Coast**

David Trocquet – Chair  
Jack Williams  
Marty Rinaudo  
James Richard  
Charles Arnold  
Michael Idziorek  
Michael Pittman  
Matthew Capon - USCG

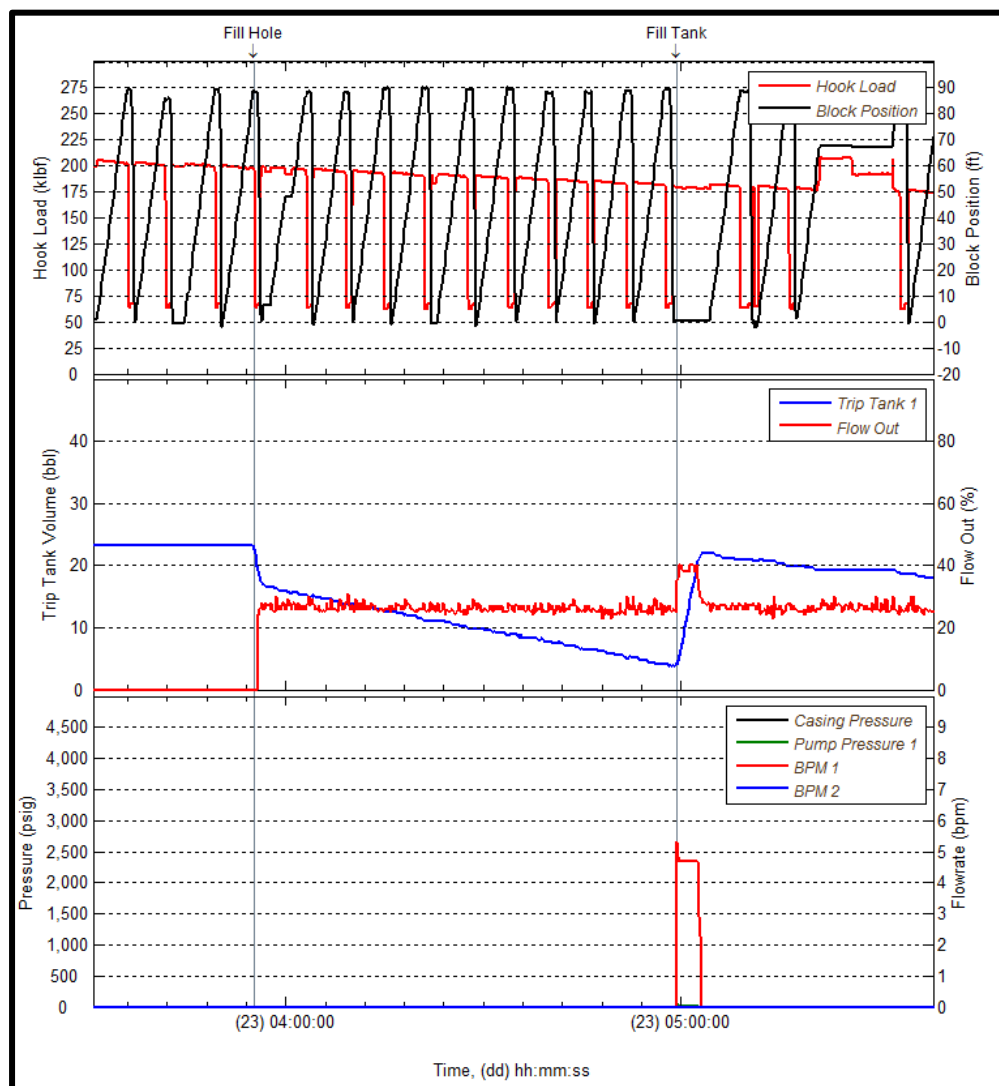
**Figure 13:** Summary plot of digital trip records for stands 2 thru 18 (from SME Committee Report)

Figure 13 (above) shows the recorded digital data when pulling the first 17 stands. Tripping started at 0331 hrs. At 0357 hrs, after pulling 4 stands, the hole was filled with 6.0 bbl of 15.1 ppg completion brine. The displacement of 4 stands of 5-in drillpipe was calculated by the SME Committee to be 2.9 bbl. This indicated 3.1 bbl of seepage loss had occurred over 46 minutes since the hole was last filled, indicating a seepage loss rate of 4 bph. From this time until the annular BOP was closed at approximately 0841 hrs, the circulating pump of the trip tank was left on and the Well was kept full.

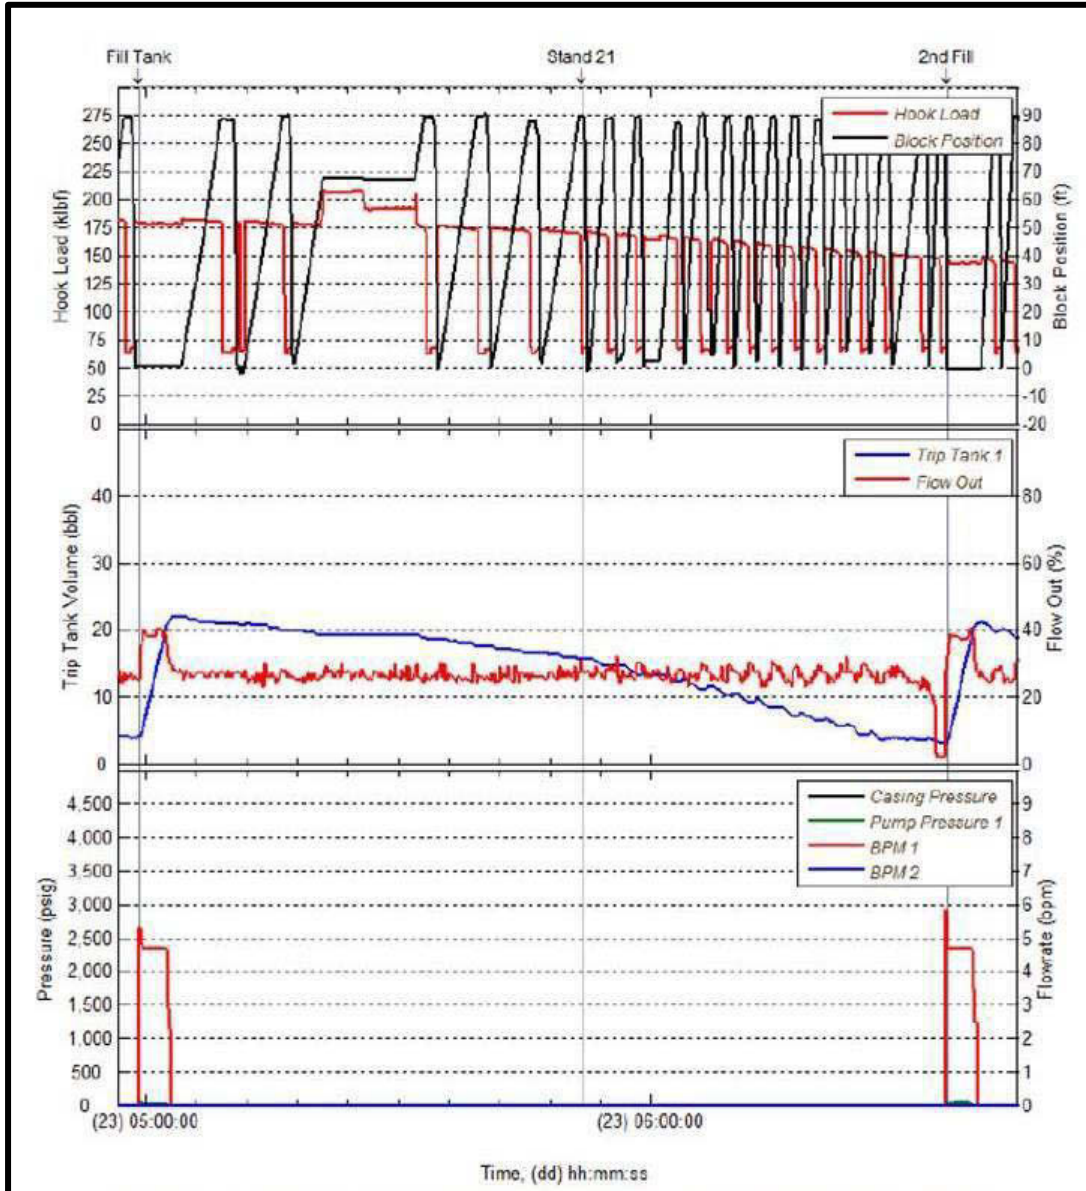
Figure 14: Summary plots of digital trip records for second trip tank fill-up (from SME Committee Report)

Figure 14 (above) shows a summary of the recorded digital data between the first trip tank fill-up and the second trip tank fill-up (stands 16 thru 35). The trip tank was re-filled for the first time during the trip at 0459 hrs after pulling stand 15. The tank volume had decreased 19.5 bbl from an initial reading of 23.2 bbl to 3.7 bbl for 14 stands, which had a total displacement of 10 bbl. The SME Committee calculated from this data an apparent seepage loss of 9.5 bbl over the first 52 minutes of the trip, approximately a 10 bph seepage loss rate. It was noted by the SME Committee team that no swabbing tendency was observed in the trip tank volume though some sticking seemed to be associated with stand 18.

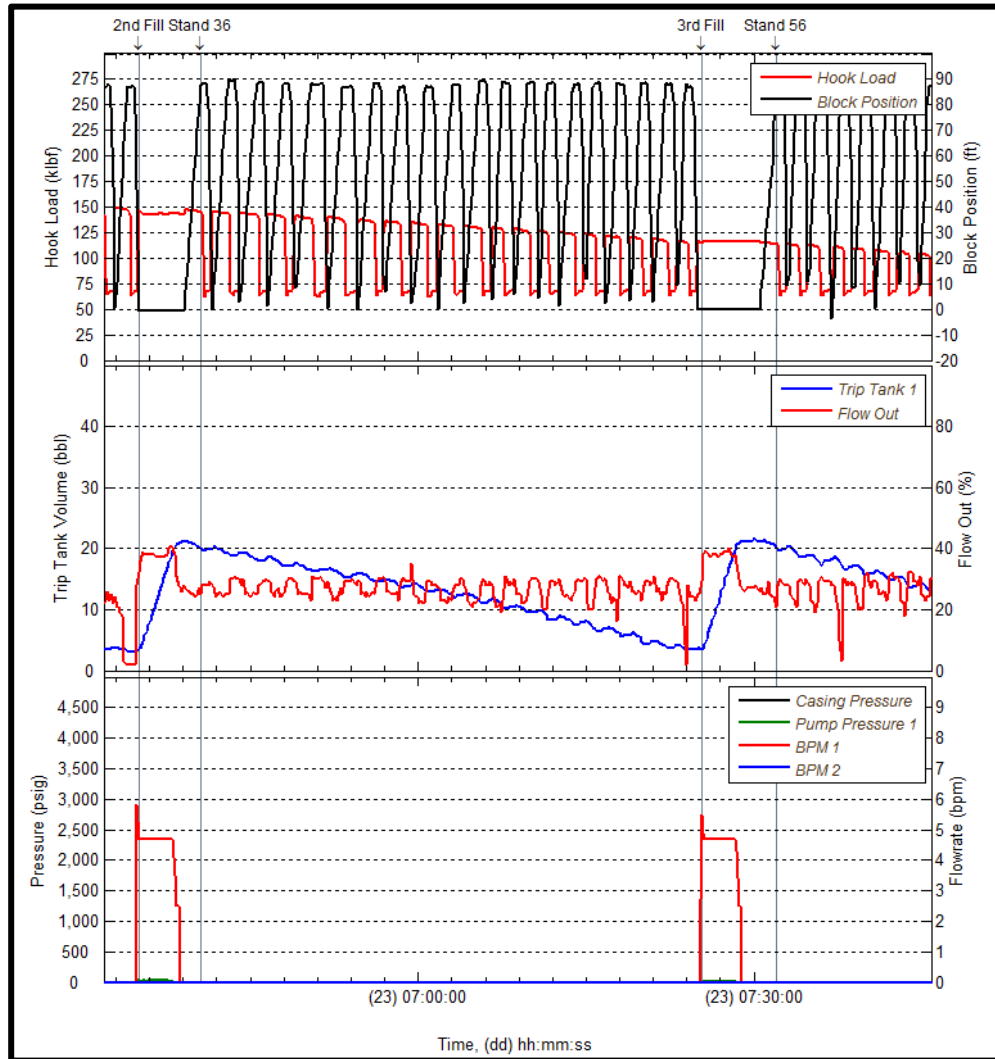
**Figure 15:** Summary plots of digital trip records for third trip tank fill-up (from SME Committee Report)

Figure 15 (above) shows a summary of the recorded digital data between the second trip tank fill-up, and the third trip tank fill-up (stands 36 thru 55).

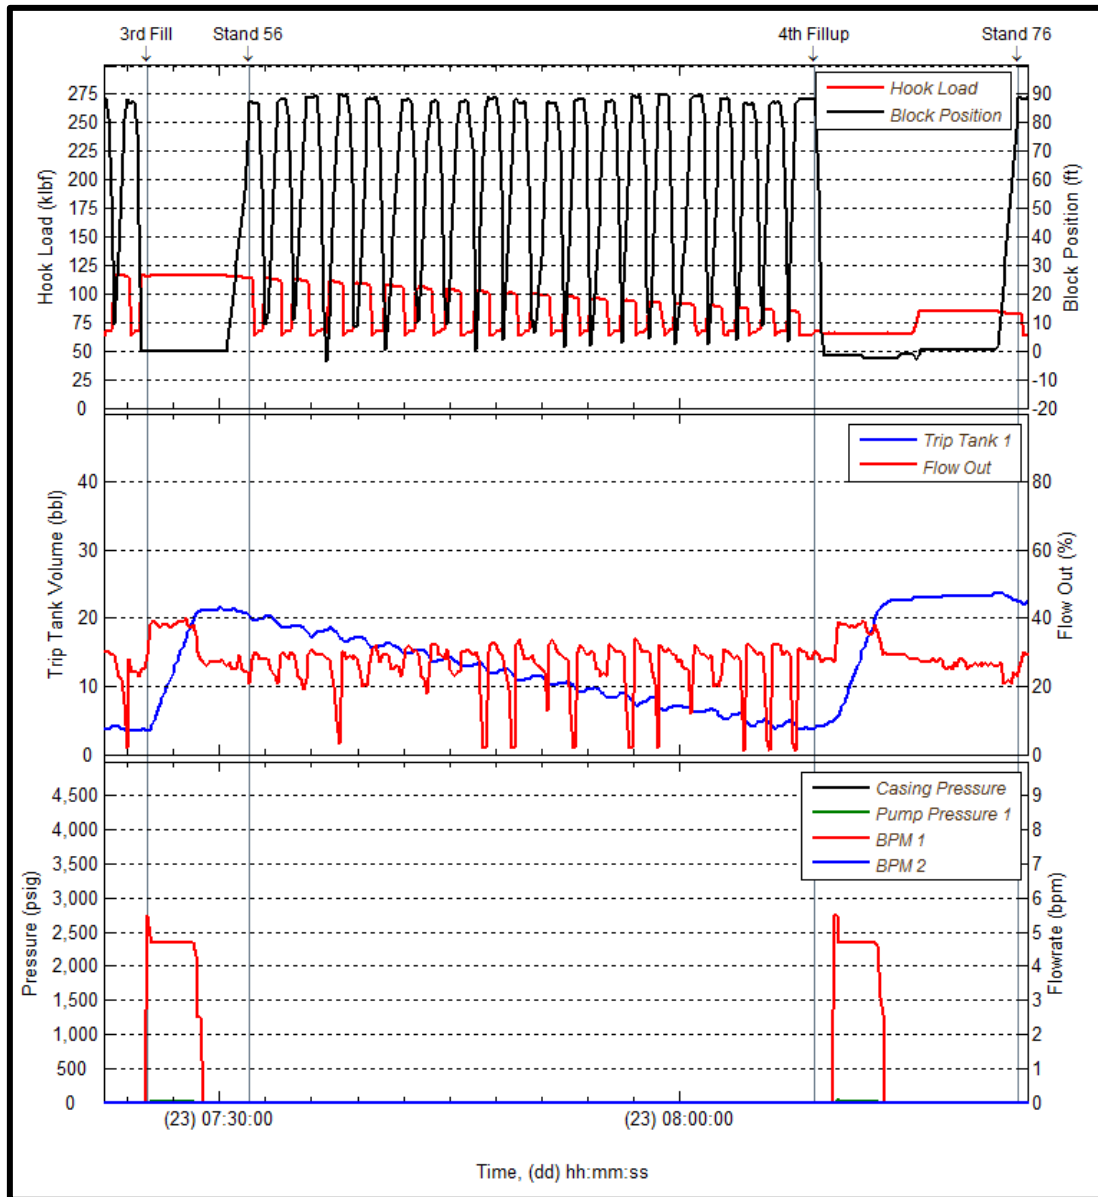
**Figure 16:** Summary plots of digital trip records for stands 56-75 and fourth trip tank fill-up (from SME Committee Report)

0729 hrs - The trip tank had been filled for the fourth time and was reading 21.2 bbl. After pulling stand 75 of 5-in drillpipe by 0809 hrs the trip tank volume had decreased by 17.5 bbl and was reading 3.7 bbl. The volume of workstring removed from the well was 14.3 bbl for 20 stands of 5-in drillpipe. An average seepage loss of 3.2 bbl during this 39.9 minute or 4.8 bph loss rate was calculated (see figure 16, below).

The SME Committee Report noted that at this time the flow-out indicator dropped to near zero when pulling each stand. They concluded this indicated the circulating pump was having difficulty filling the

trip tank, keeping up with the increased pulling speed of the pipe. From the SME Committee Report, “...for example, Stand 75, which was the last stand of 5” pipe, was pulled in 30 seconds for an average pulling speed of 180 fpm. This was removing steel from the well at 1.4 bpm. If the fluid level in the work string could not fall as fast as the pipe was pulled, the work string temporarily behaved more like a closed end pipe in which the volume of steel and fluid being pulled from the well reached values as high as 4.4 bpm. The swing in the fluid level in the trip tank for Stand 75 was about 1.3 barrels per stand. However, the records clearly show that the hole was continuously filled after each stand.”

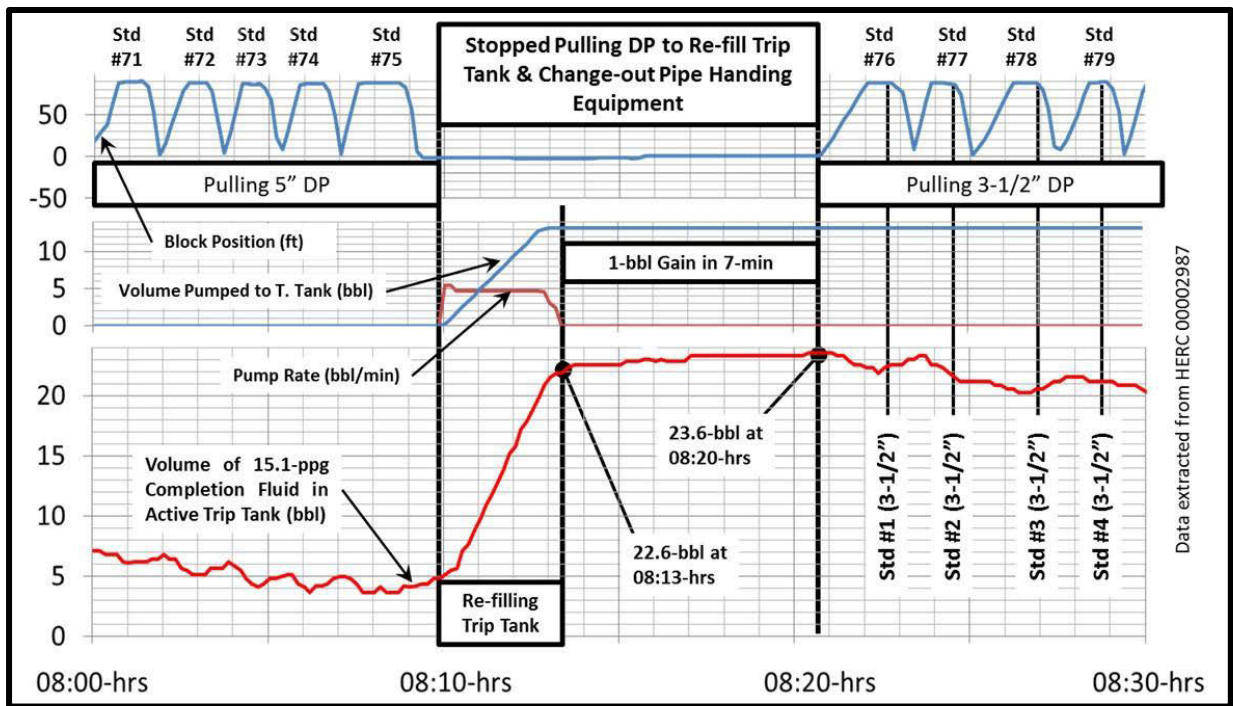
**Figure 17:** Digital plot: first indication that Well could be flowing (from SME Committee Report)

Figure 17 (above) graphically shows the time period when tripping operations were stopped to change the pipe handling equipment. About 12 minutes elapsed between racking the last stand of 5-in pipe and latching to pull the first stand of 3 ½-in pipe. From the SME Committee Report: “While the pipe was stationary, the trip tank volume increased from 22.6 bbl at 08:13 to 23.6 bbl at 08:20. Either this was not noticed or it was not thought to be significant, because the trip tank pump was never turned off to check visually for flow. Had the trip tank gain been investigated further and acted upon at this time, securing

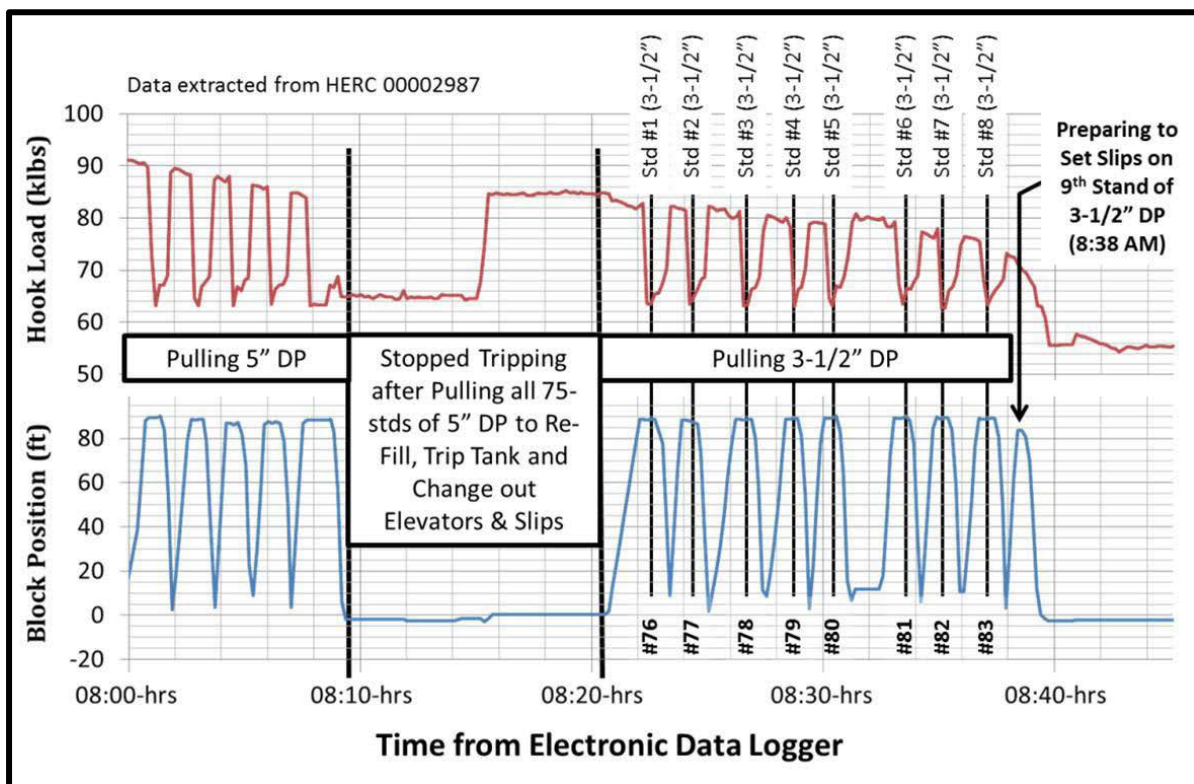
**Figure 19:** Hook load and block position history just prior to the attempted shut-in (from SME Committee Report)

Based on the 23 July 2013 electronic data log, the 9th stand of 3½-in drillpipe was in position to set the slips at about 0838 hrs. Hook load and block position data just prior to the rig crew taking steps to control the Well at that time is shown in figure 19.

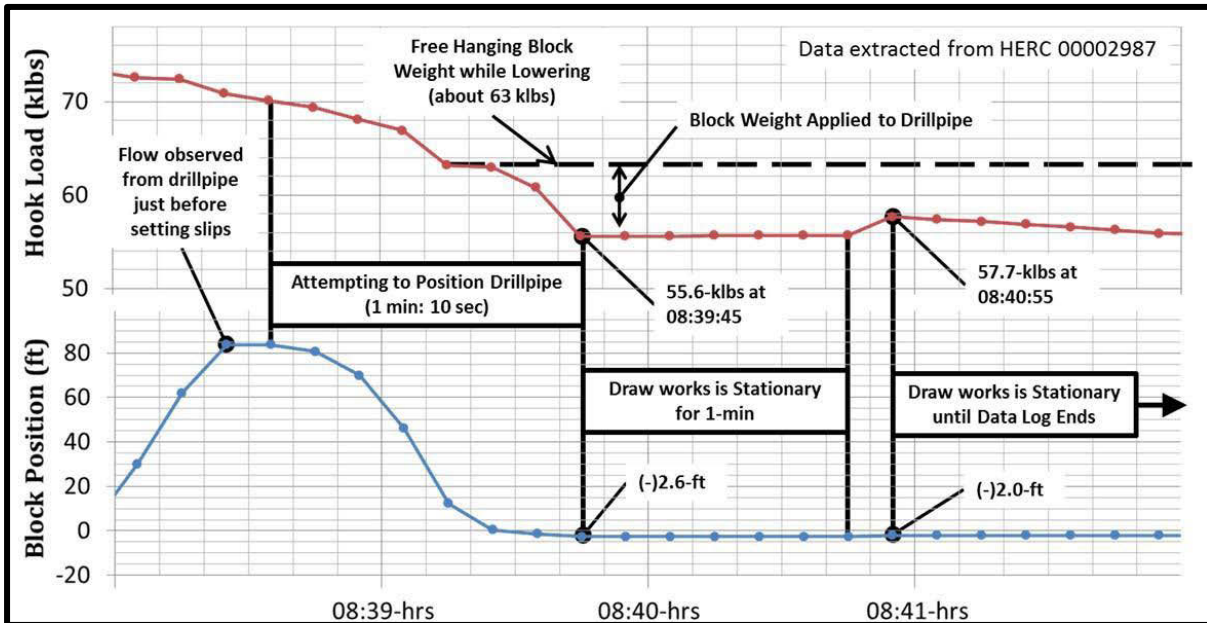
**Figure 24:** Initial kick response to install a drillstring safety valve (from SME Committee Report)

*Figure 24* is from the SME Committee Report. It depicts hook load and block position on an expanded time scale during the critical period when control of the wild well may still have been possible. The SME Committee Report states the following:

*“...hook load falls about seven thousand pounds below the normal hanging weight of the traveling block / top drive and that the block position goes slightly below zero to -2.6 ft. According to multiple witness accounts the drillstring safety valve could not be installed because the 3-1/2” drillpipe had shifted up relative to the elevators and 3-1/2” drillpipe box connection was up inside the top drive bell guide. Approximately 1,140 feet of drillpipe and was still in the well. The estimated total weight of the remaining work string was about 19,000 pounds in air or 14,600 pounds when submerged in 15.1 ppg completion fluid...”*

*“...there is an indication in the data log [see figure 24] that there was an attempt to reposition the block ending by 08:40:55. It is likely that this was an attempt to make space for the drillstring safety valve. The driller’s account indicates that the drillpipe followed the top drive up during this attempt and that the drillpipe box connection remained inaccessible.*

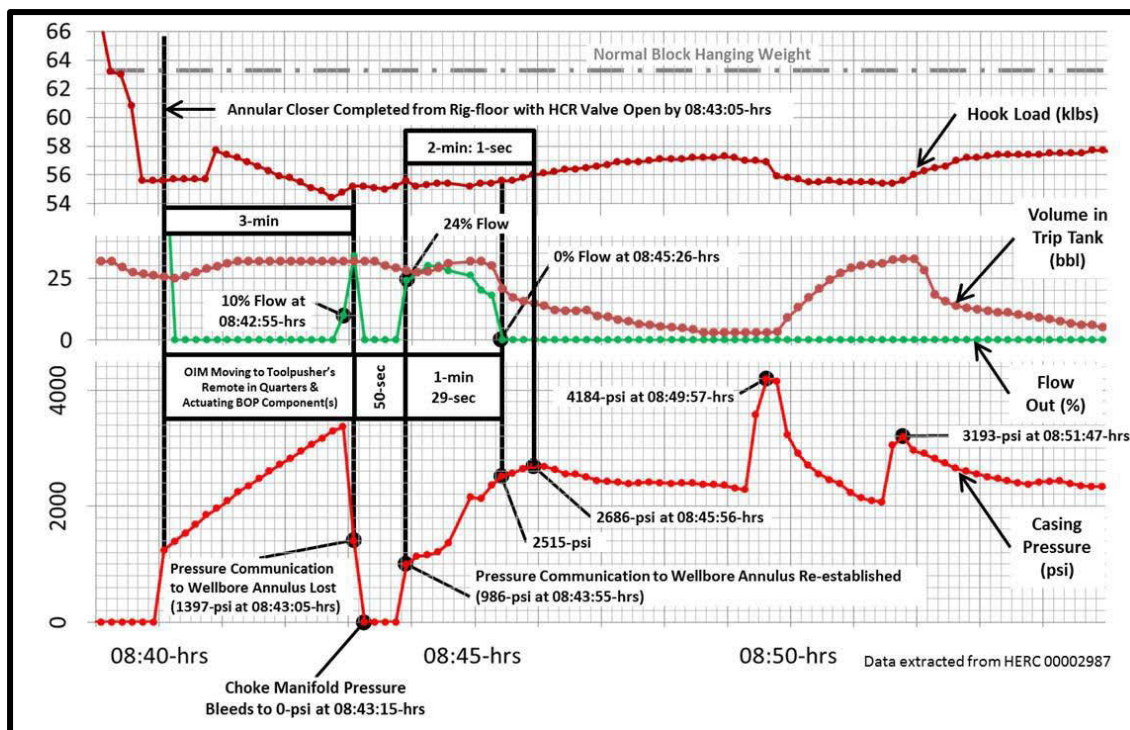
**Figure 25:** Data recorded after kick was detected: 0836 hrs to 0855 hrs (from SME Committee Report)

*“Once it became imprudent to continue efforts to install a drillstring safety valve, the only remaining barrier to a blowout through the inside of the drillpipe available was closing the blind shear rams. The data log indicates that the blind shear rams were not actuated for another three minutes at 08:43:55 [see figure 25].*

Figure 25 shows electronic data presentation created by the SME Committee for their report. It covers the period from the initial observation on the rig floor of the loss of control, through the abandonment of the Rig. This data was recorded over a 20 minute period beginning just before the indications of impending loss of well control became evident and were acted upon.

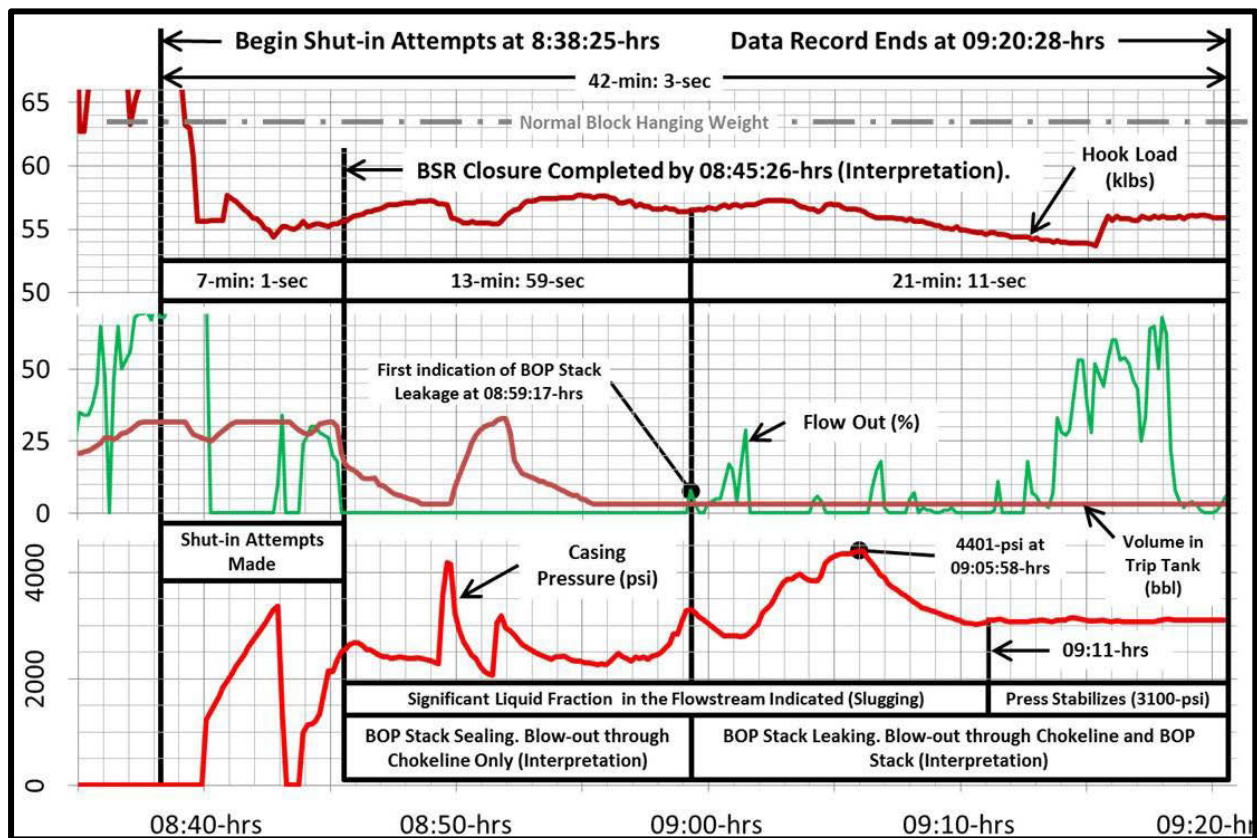
**Figure 26:** Data recorded during and after attempted shut-in (from SME Committee Report)

*“The upper pipe rams could have also been closed immediately prior to this action in an attempt to prevent upward pipe movement. It is unlikely that the upper pipe rams would have stopped upward pipe movement because a tool joint was spaced-out above the upper pipe rams. The block position sensor showed only 0.6 ft of movement, (figure [26]), so the amount the driller picked up would have to be on the order of inches and not feet.”*

0900 hrs – From SME Committee Report, first indication from the flow-out sensor of leakage through the BOP stack was recorded.

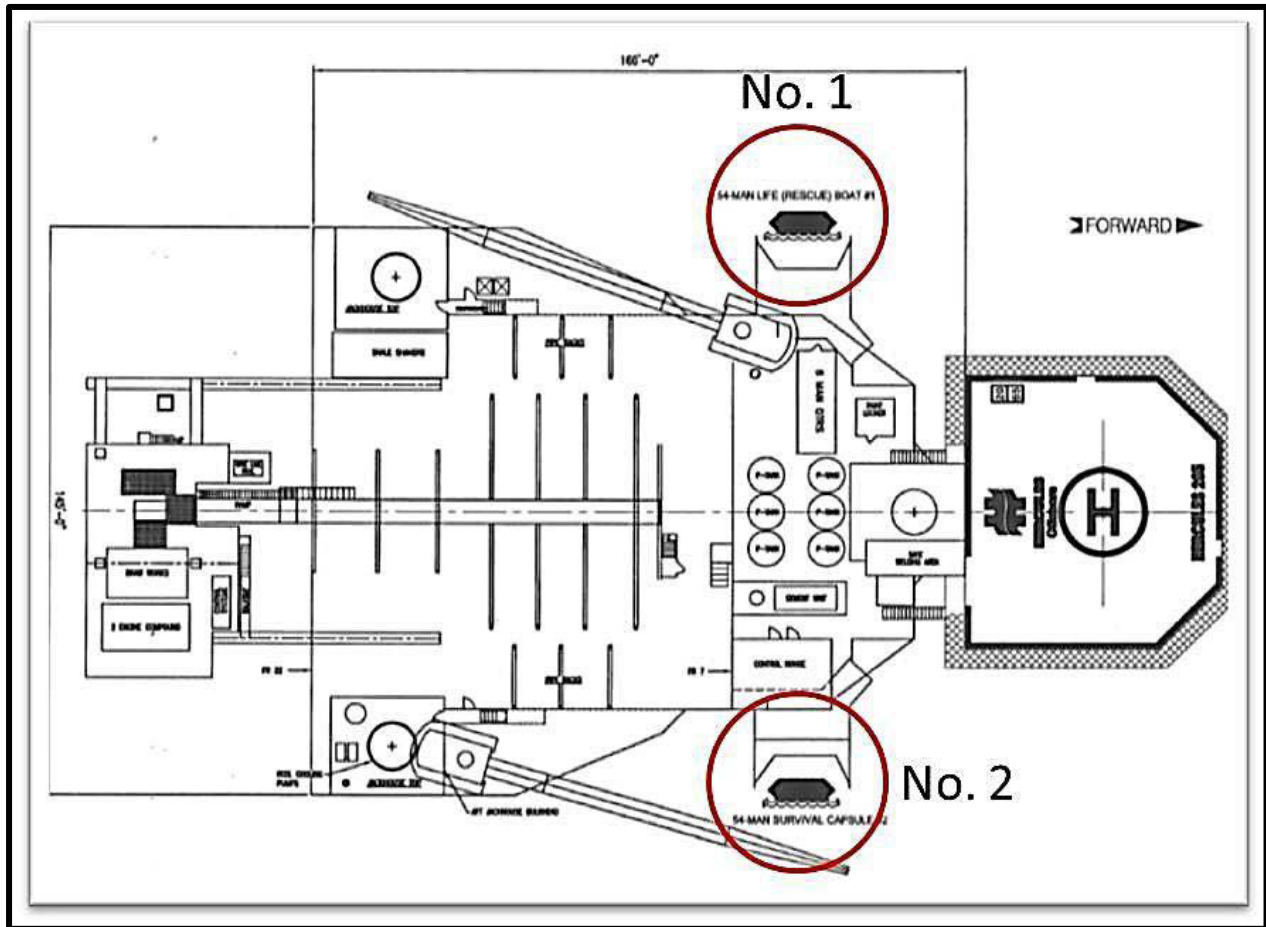
**Figure 27:** Hercules 265 survival capsule arrangement

**23 July 2013:** At approximately 0848 hrs, the OIM ordered the evacuation of the Rig. Announcements were made throughout the Rig on the vessel’s public address system. Crew members were directed to report to their primary life-capsule stations. The Rig was outfitted with two life-capsule stations: #1 life-capsule station was located on the port side; #2 life-capsule station was located on the starboard side (see figure 27). The total personnel capacity of each life-capsule was 54 persons each.

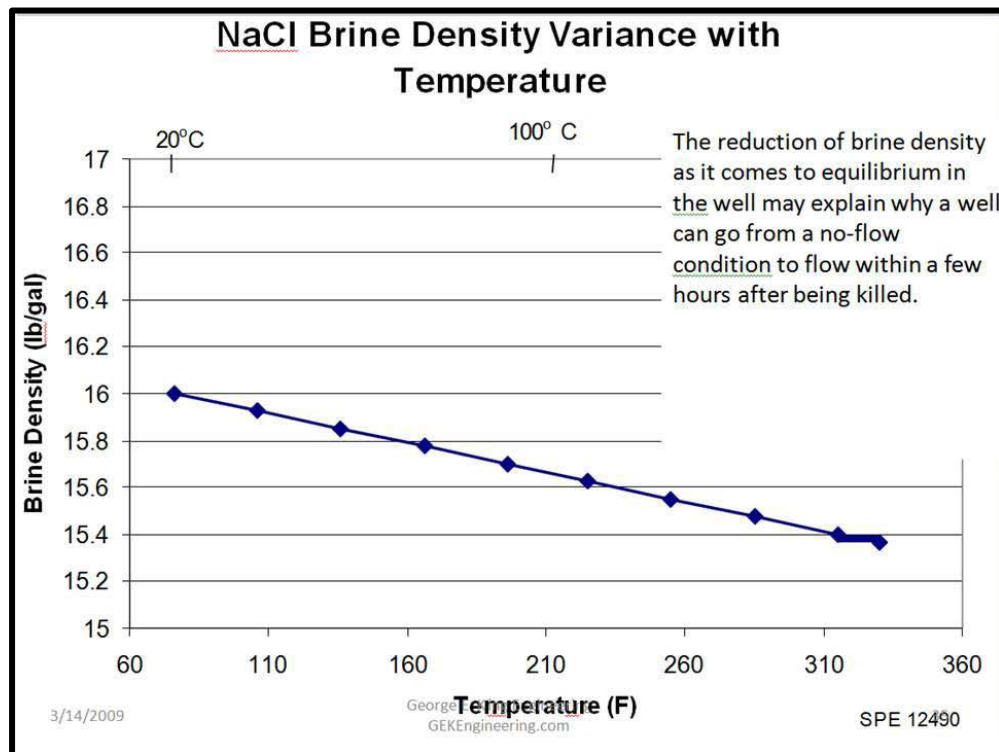
*Figure 38: NaCl brine density variance with temperature*

As can be seen, a note on the second slide included here (*figure 38*) reads, *“The reduction in brine density as it comes to equilibrium in the well may explain why a well can go from a no-flow condition to flow within a few hours after being killed.”*

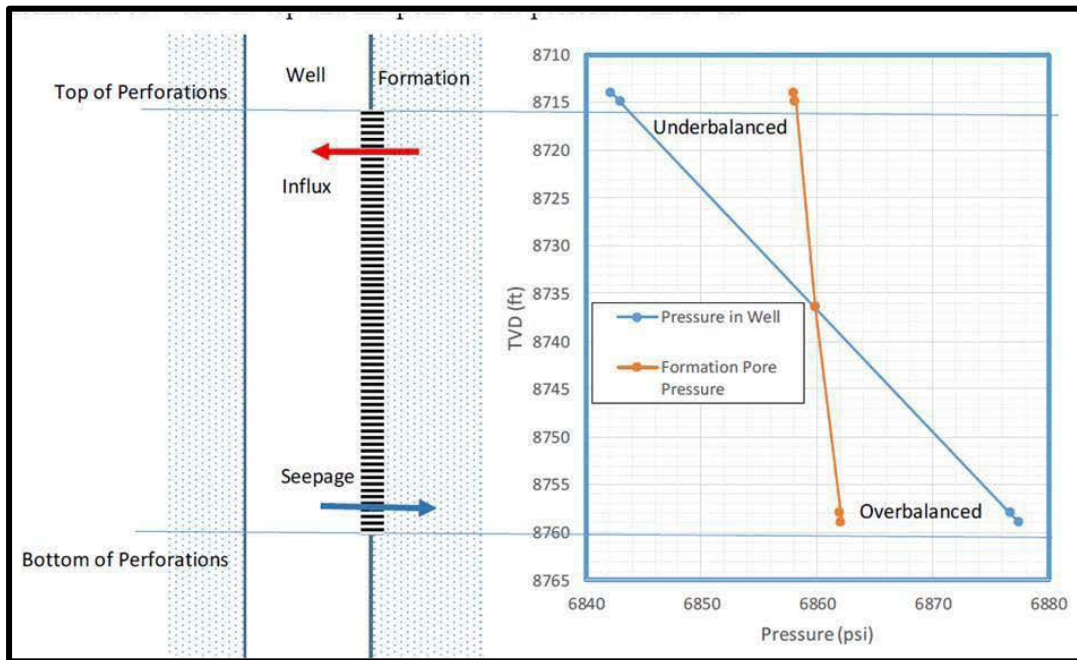
**Figure 39:** Pressure conditions for balance at perforation midpoint (from SME Committee Report)

*“The blue line [in figure 39] was originally shifted about 90 psi to the right for a full column of 15.3 ppg brine. After opening the bypass around the packer at 00:17 prior to starting out of the well, it is likely that not all of the 3.6 bbl of gas trapped below the packer had been swept down into the formation during the short periods of a high flow rate. If one barrel of gas remained and was released when the bypass was opened, it is estimated that the upward migrating dispersed gas would be capable of reducing the bottom-*

hole pressure by about 68 psi. This would have shifted the blue curve back to the left so that the overbalance at the midpoint of the perforations would then be  $90 - 68 = 22$  psi.”

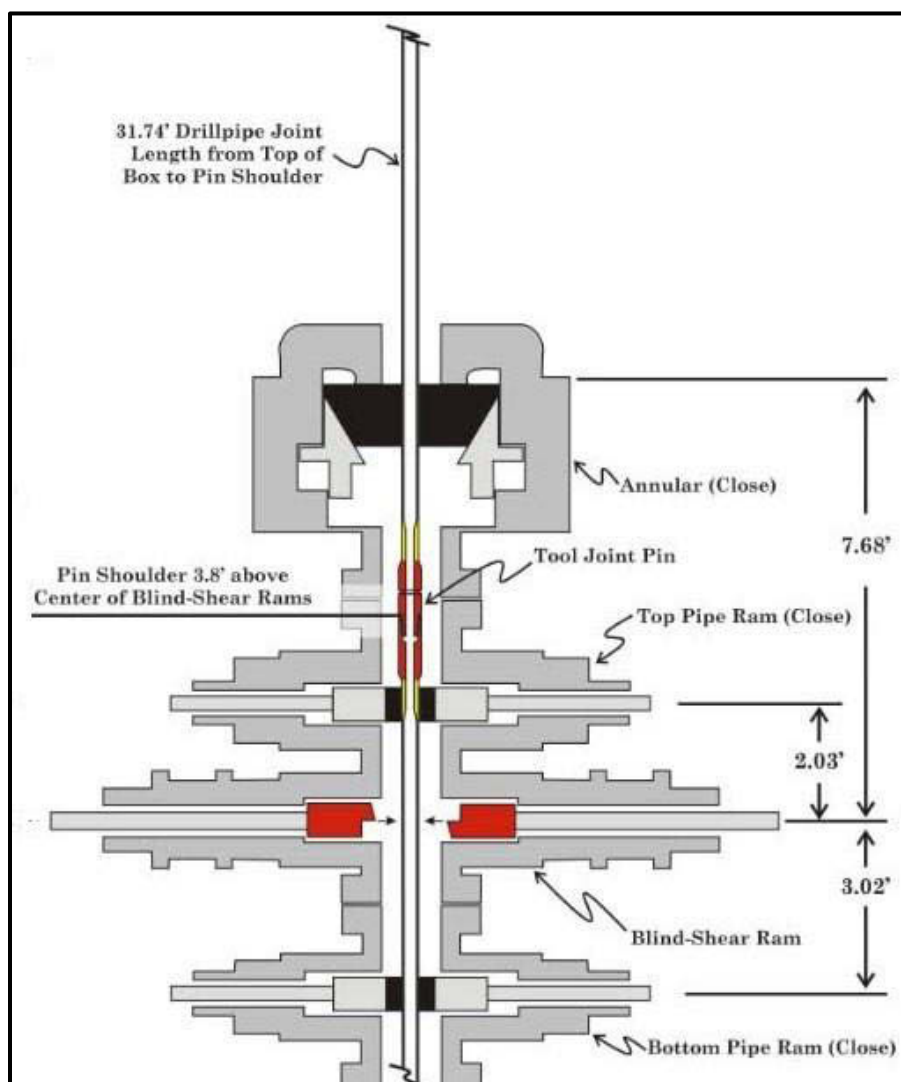
**Figure 40:** Simplified schematic of the BOP stack and drill pipe configuration (from SME Committee Report)

The surface BOP stack on the Hercules 265 jack-up rig was a Cameron Type U 13 5/8-in rated for 10,000 psi working pressure. The annular preventer had a working pressure rating of 5,000 psi. The SME Committee conducted extensive forensic analysis on the BOP after the Incident and their report is technically detailed and specific. The Panel regards their report as currently definitive in its examination of the operations and functions of the Rig's BOP elements during the Incident.

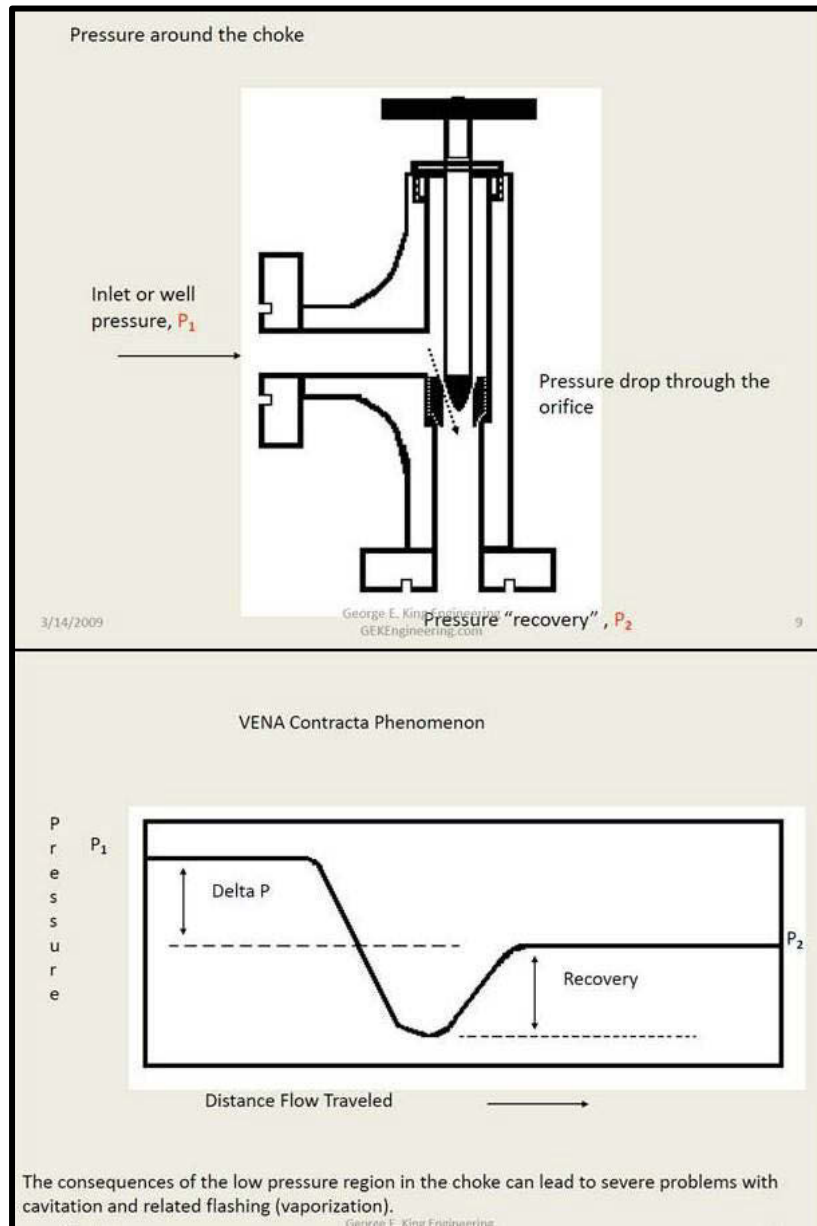
**Figure 41:** Pressure drop during flow through a choke

Figures 41, 42, 43 (below) are slides taken from the King Engineering review of choke basics. The paper noted the larger the difference between the inlet and outlet pressures, the higher the potential for damage to the internals of the choke. From the King Engineering review, when delta P ratio,  $[(P_1 - P_2) / P_1]$  rises above 0.6, damage is likely to occur. The review notes that when a choke provides a pressure drop, energy from the drop is lost by: increased velocity; vaporization of light hydrocarbons to gas; vaporization of water; cavitation; and/or heat production associated with liquid friction.

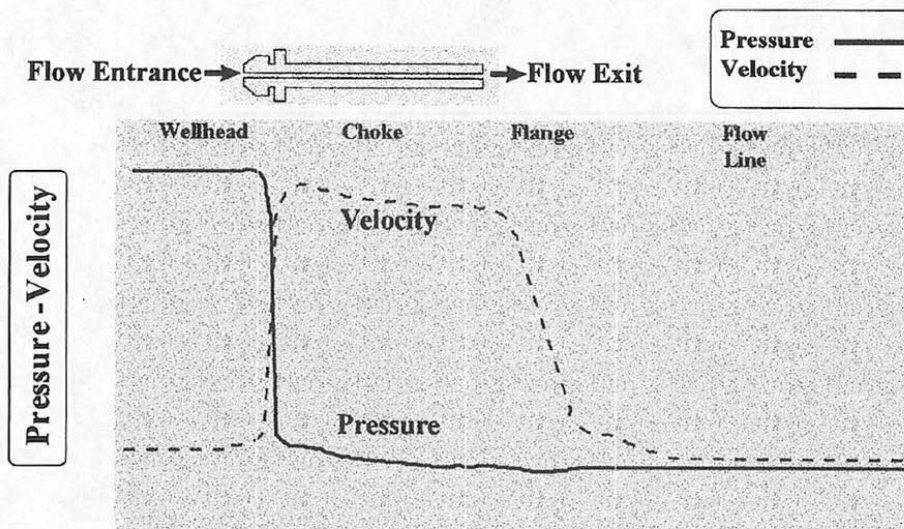
The velocity profile and pressure drop across a choke with a large pressure drop – opportunity for erosion is very high.

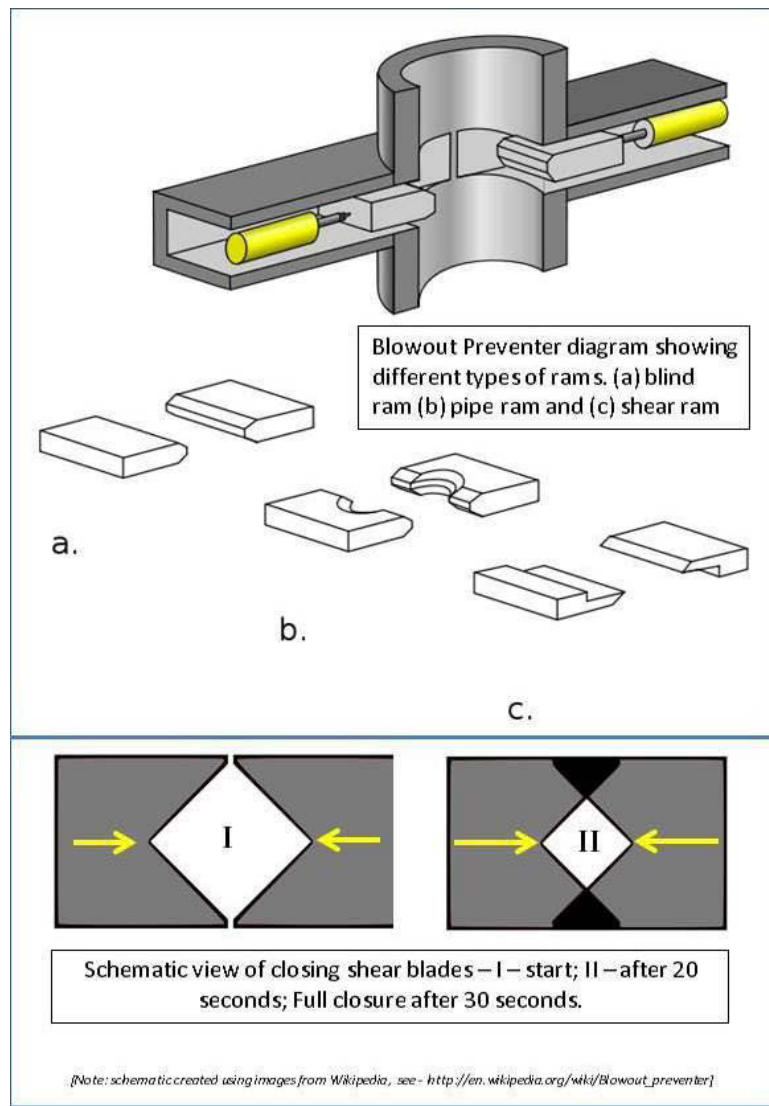
**Figure 48:** Why blind shear rams create production choke conditions

The problems of controlling high pressure production and the damage and erosion that occurs in production systems bears a superficial similarity to the erosional problems encountered when a BOP ram slowly closes on a high pressure flow. The SME Committee noted the sand-cut damage to the BOP in their Report and discussed the significance of the damage:

*“...Further, it is believed that this high pressure in the well and a loss of hydraulic closing pressure would have allowed the blind shear rams to begin to leak continuously at a high pressure if they had successfully sealed. Gas moving through a small opening at sonic velocity and carrying sand is known to cause very high erosion rates that can cut through steel in a short period of time...” (emphasis added).*

The similarity of the orifice created by the slowly closing blind shear rams to the orifice of a choke is illustrated in *figure 48*. The delta P of the flow conditions of the Well when the attempt was made to control it by activating the blind shear rams can be calculated as follows:  $\Delta P = (P_1 - P_2) / P_1$ , or  $(3,000 \text{ psi} - 14.7 \text{ psi}) / 3,000 \text{ psi} = \text{approximately } 1.0$  which is the maximum attainable in this calculation. The calculated delta P for the surface flowing condition of the Well was much higher than the 0.6 that would theoretically begin to create severe damage if applied to production equipment, regardless of the additional erosional effects of sand entrained within the produced fluid.

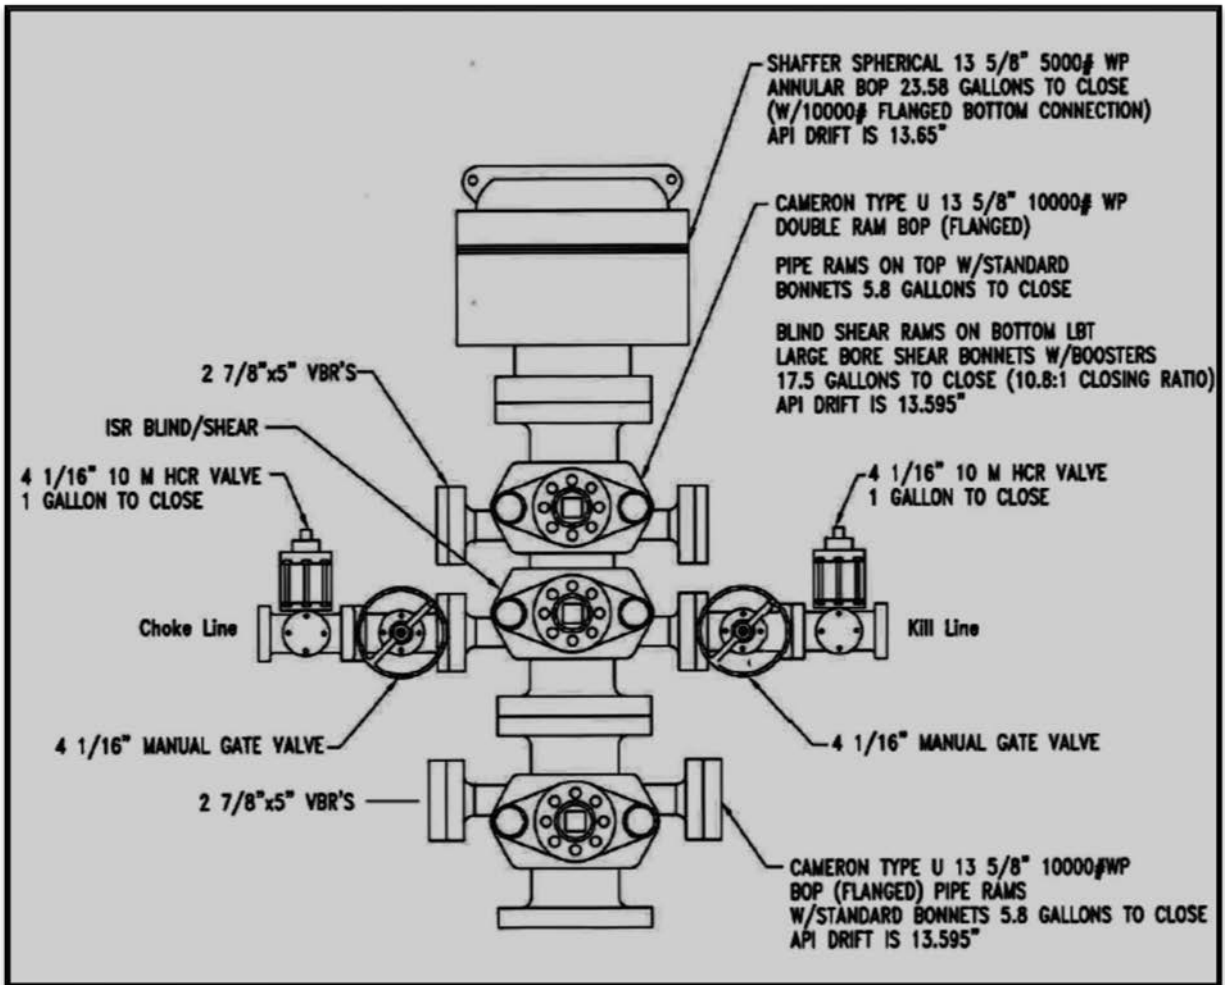
*Figure 49: Schematic of Hercules 265 BOP stack*

Cameron manufactured the BOP stack used during well-related activities by the Hercules 265 in compliance with API specifications. The subject stack was designed and tested in accordance with API Specification 16A. BSEE's information management system confirmed the BOP stack for the Hercules 265 had an API RP 53 Certification on 5 April 2013.
