Bureau of
Safety and
Environmental
Enforcement

QC-FIT EVALUATION OF SHEAVE FAILURES

QC-FIT Report # 2016-05
November, 2016

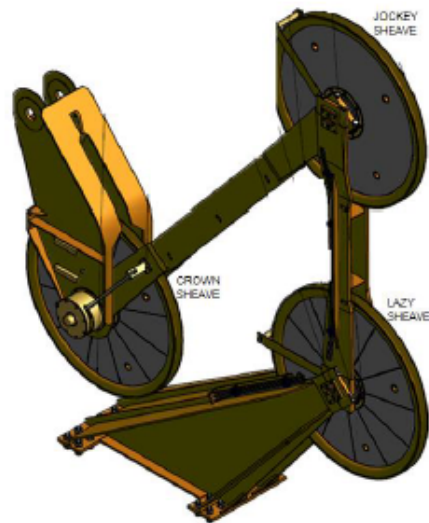
- Issue:** Hub weld cracking incidents have been reported for the CMC's 78" fastline jockey sheave (the middle of the three sheaves in the fastline linkage arm assembly). These cracks propagate from weld defects near the root of the weld between the web plates and the hub.

Illustrations: Above: Example of crack at hub of old fastline sheave. Right: Cross-section of typical sheave. The red arrows are pointing at the welds that supplier defines as "critical".

- Solution:** NOV recommends that the present fastline jockey sheave be replaced with a single-web sheave. Until replacement is performed, the critical welds of the sheaves in the fastline linkage arm assembly should be visually inspected for cracks on a weekly basis. The Critical Welds are shown in the Maintenance Instructions and in the figure below. Additionally, users should ensure that appropriate fastline stabilizers are installed, as these significantly lower the dynamic high-frequency side loading on the sheaves.
