Appendices

What Was EPA Doing When the Blowout Began?

Claims of Digging High

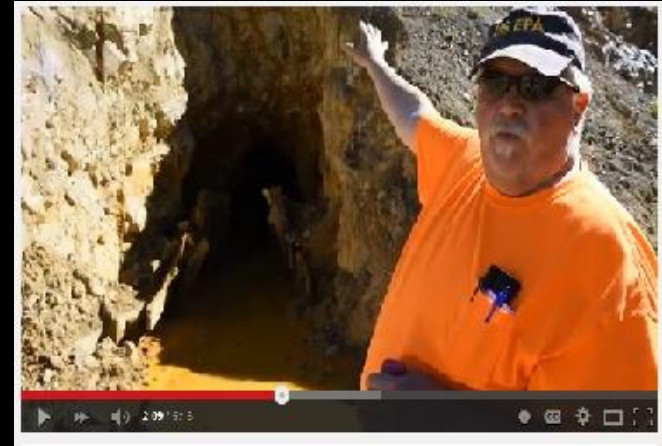
DOI Technical Evaluation: “The plan consisted of excavating the rock crown over the adit but leave the fill below the adit roof in place. A steel pipe would be inserted through the fill and into the mine pool . . . and the water in the mine would be pumped down. . . .” It was asserted that the EPA crew believed the water inside the adit was below the crown of the adit . DRMS again discussed the plan to reopen the adit with the EPA OSC and all were in agreement to proceed. The two DRMS specialists left the site, and “*the contractor began excavating. . .*”³ The ACOE peer reviewer more directly refers to EPA actions as “start[ing] to dig out the plug. . . .”⁴

EPA Addendum: “The team had *just finished locating the bedrock*, and were clearing away some additional rubble in front of the adit face, when they spotted a water spout. . . .”⁵

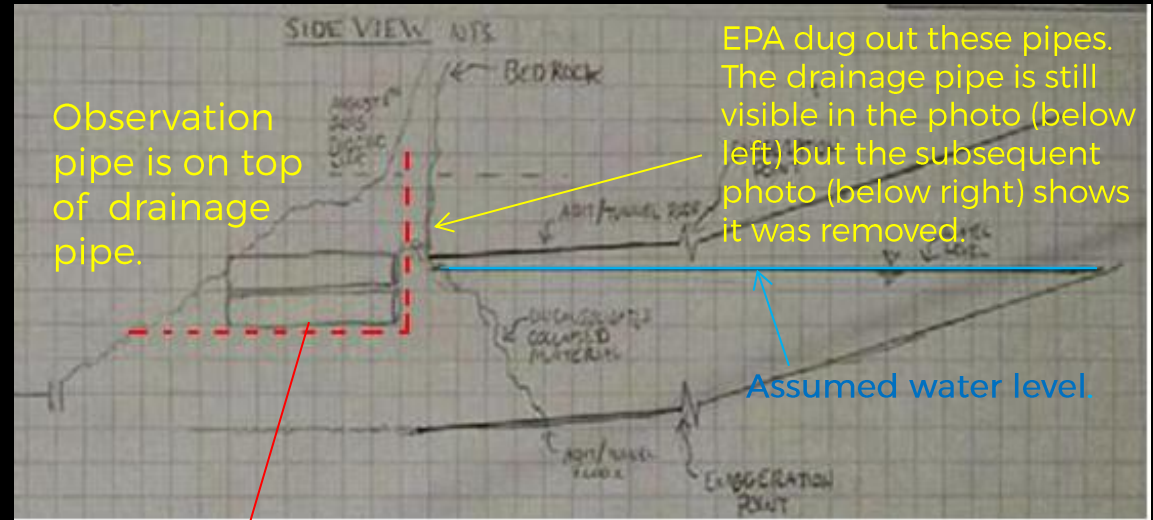
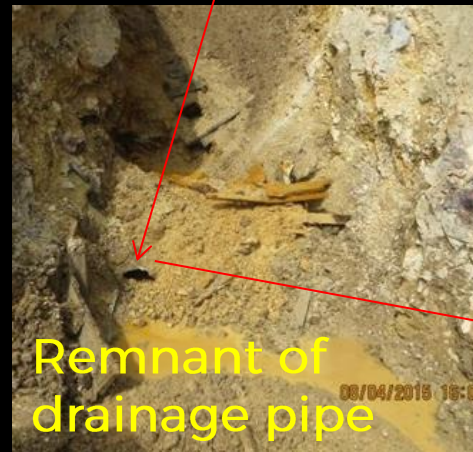
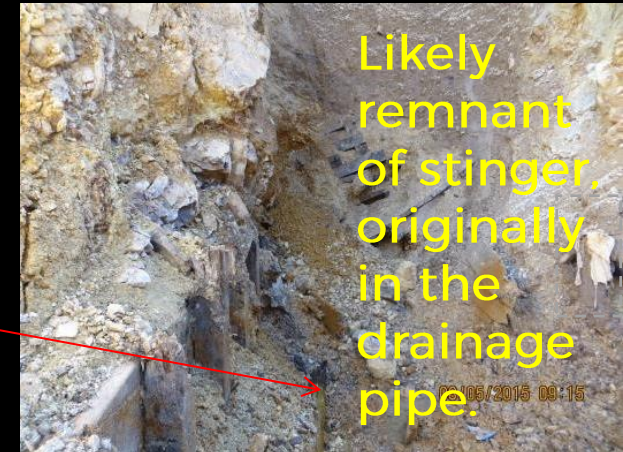
EPA's Attachment D indicates that EPA knowingly excavated close to the plug, and, in doing so, was at an elevation below the water level that they reportedly assumed in the drawing.¹ The pipes (and dashed red lines) were actually lower relative to the floor as shown in figures A 17, 18, and 19. This means that EPA actually was digging even lower than their assumed water level.

DOI's *Technical Evaluation* includes a photo showing a partially *backfilled* excavation (See, A 4) and its caption misleadingly states, "[t]his indicates that the bottom of the excavation was about 10 feet above the level of the floor of the adit; this corroborates reports that they were *digging high*, trying to stay above the assumed water level in the adit. . . ."² DOI failed to mention that this statement relates to the elevation after EPA backfilled and relies on the idea the drainage pipe was substantially above the floor.

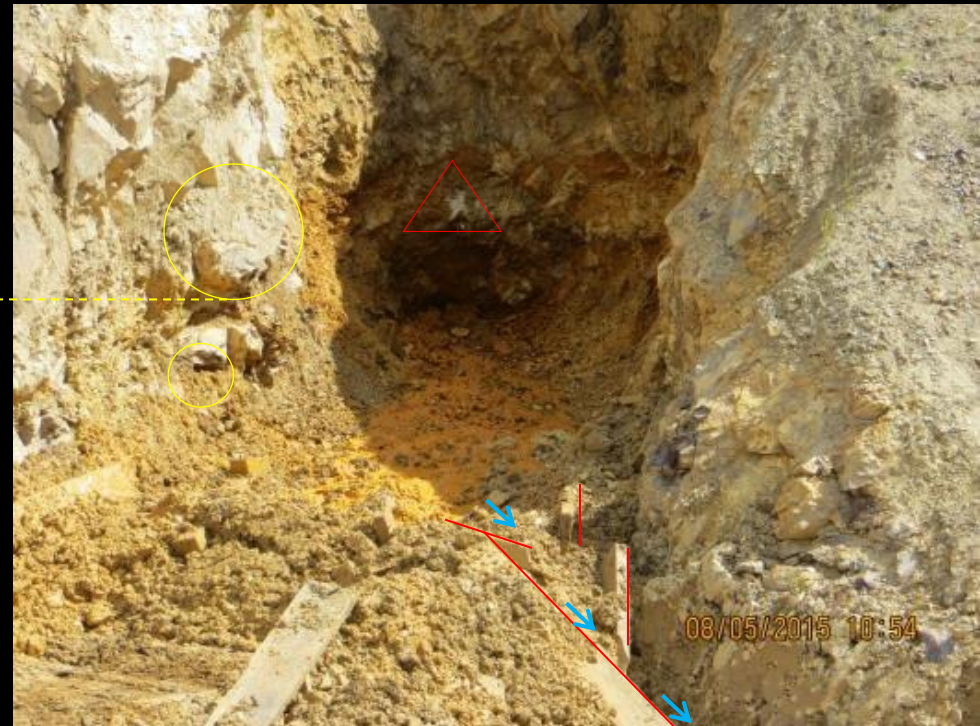
Above: 10:51 AM, August 5.¹

Below: 10:54 AM, August 5. The spurt turned into a wave of orange water. In the lower right, planks are set to direct water toward a channel.²

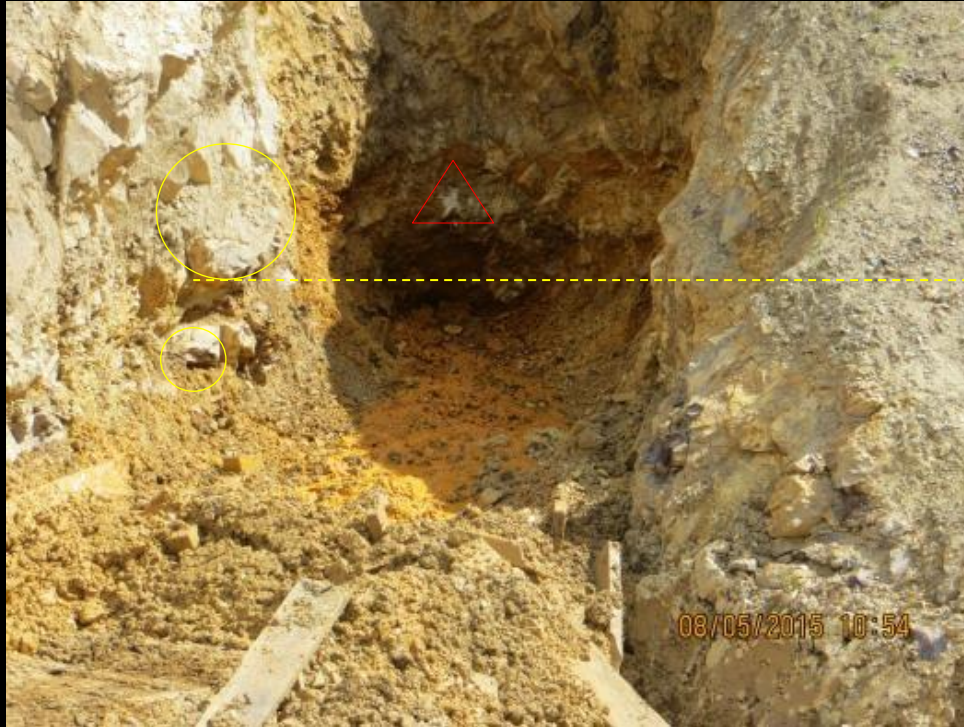
Above: 10:54 AM, August 5.¹

Below: Still from video filmed concurrently on August 5.²

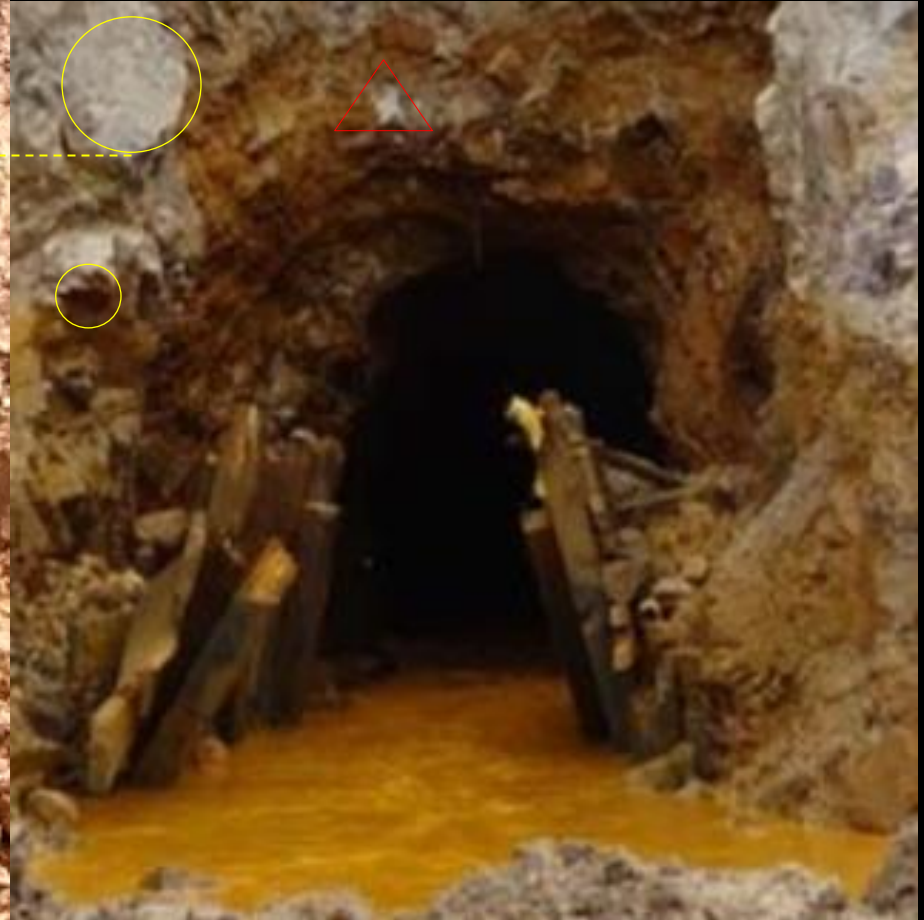
Below: After peak of blow out, August 5.²

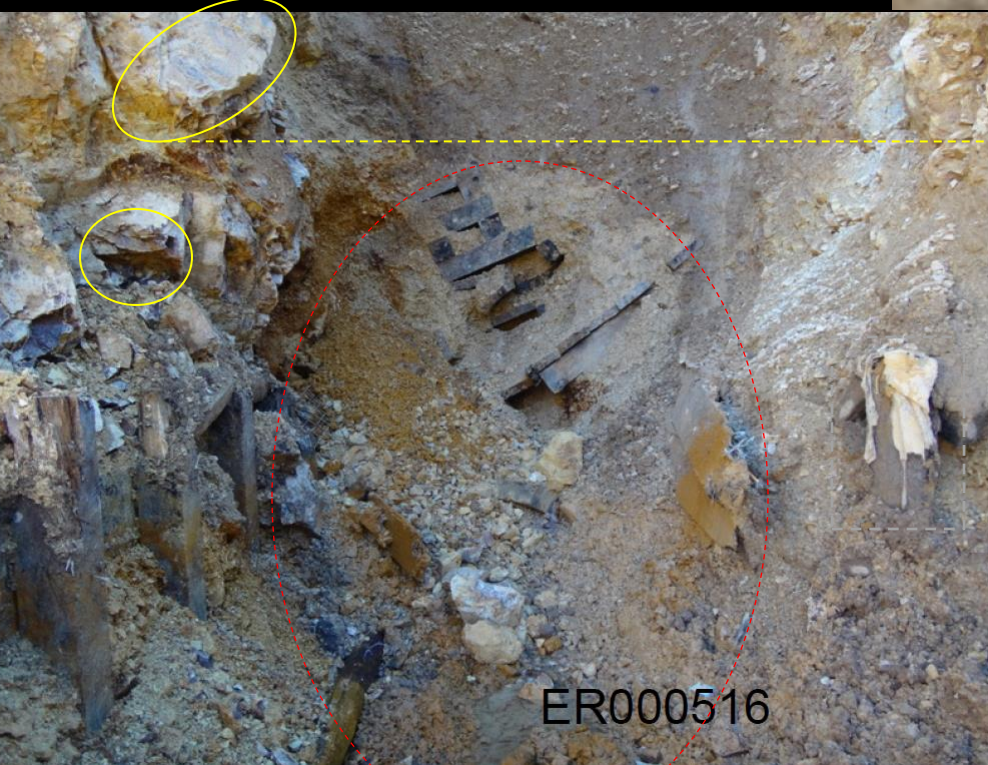
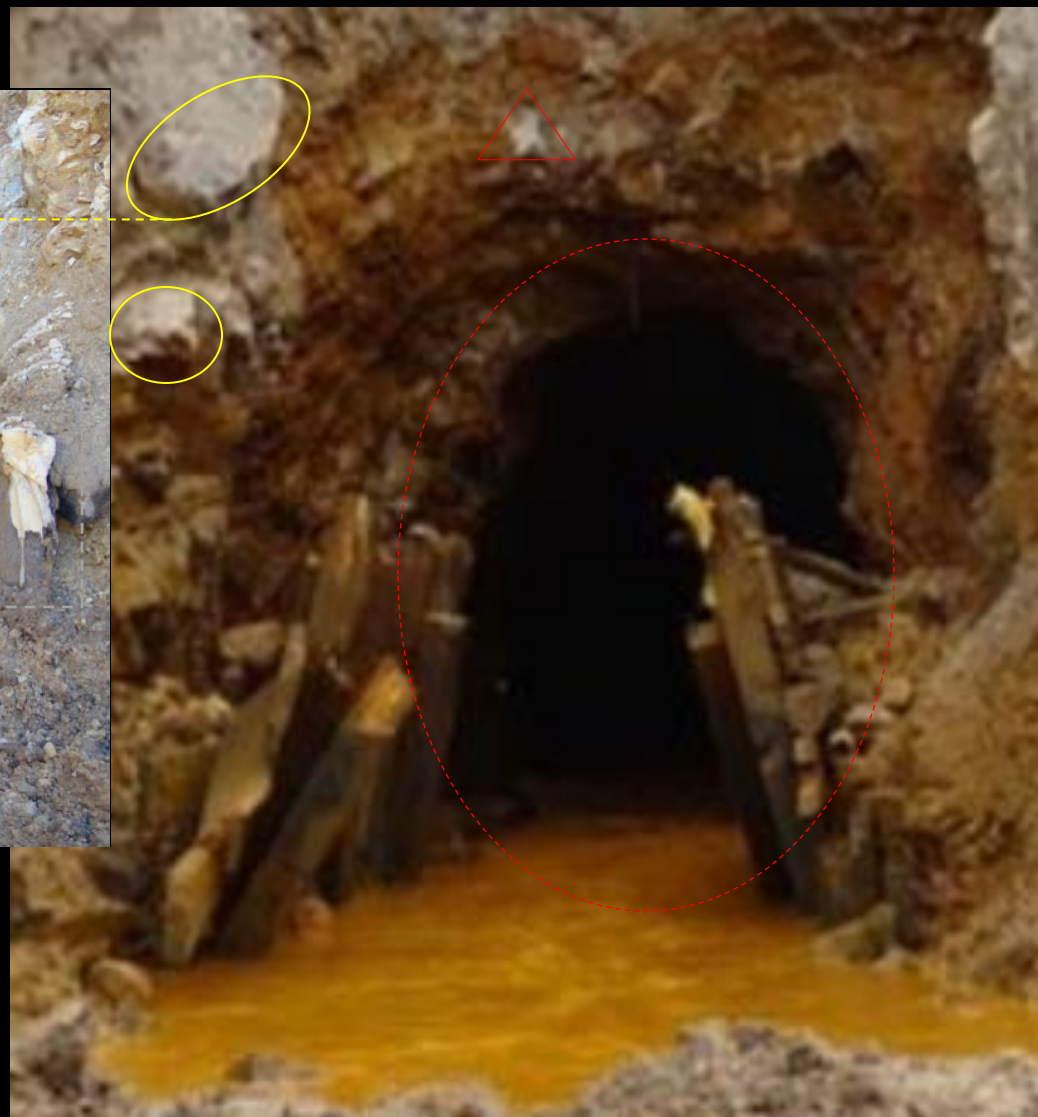
Below: Believed to be taken around 9:15 AM, August 5.¹

Below: After peak of blow out, August 5.²

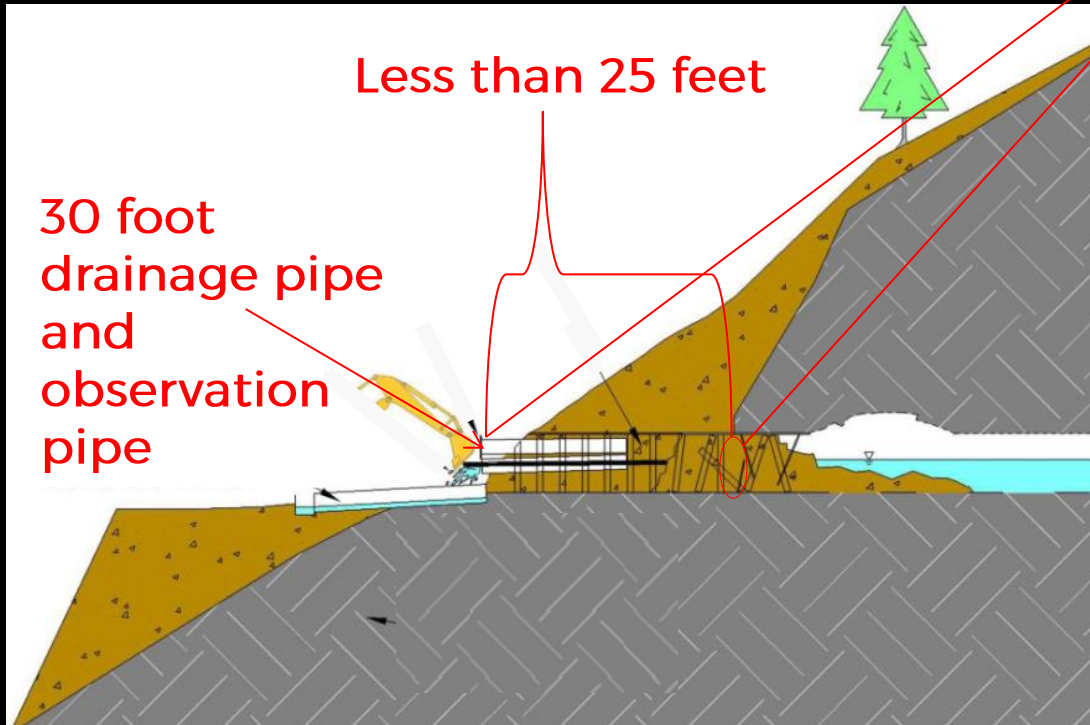
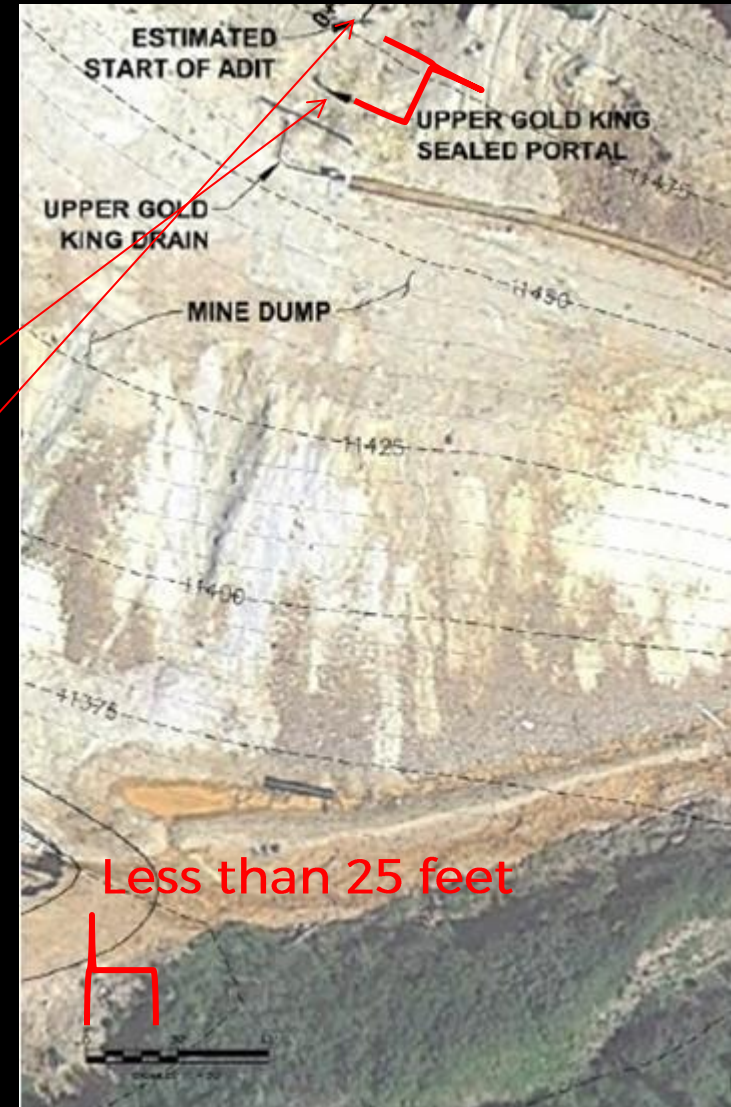
DRMS installed pipes in the portal structure in 2009 (bottom left).¹ The pipes began at the “sealed portal” that is annotated on the EPA topographical image (right).² The image also annotates the “estimated start of adit.” The distance between these two points appears to be less than 25 feet. Contrary to the *Technical Evaluation’s* depiction, this distance could not accommodate a collapse that extended significantly beyond the adit opening, a stinger that reportedly ran 12 to 16 feet (from the collapse to the drainage pipe), and 30 feet of a drainage pipe.

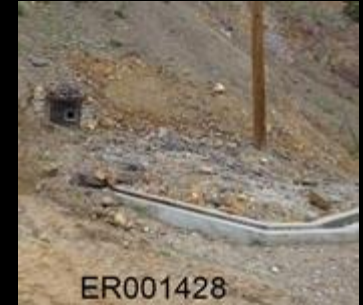
Concrete channel directed water off of the waste rock dump. The channel turned to the right. (See photos at right).

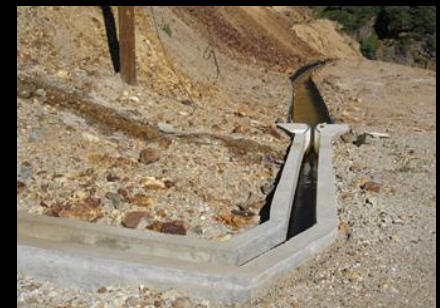
Waste rock dump.

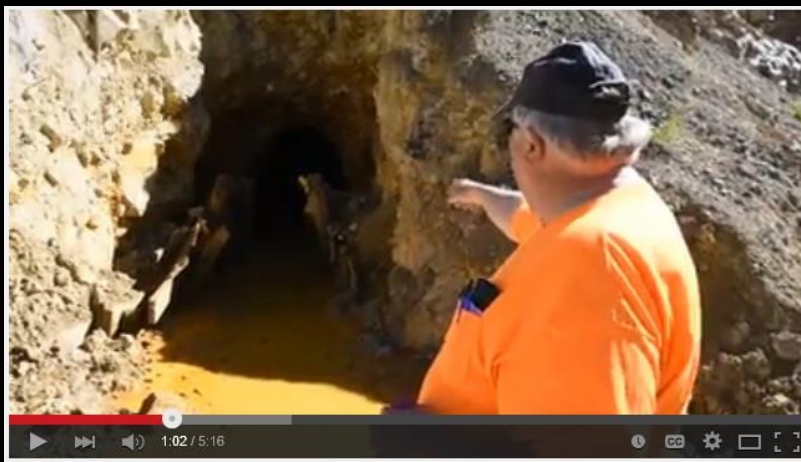
EPA OSC : Explaining the events of August 5 on an EPA video: “It was draining like, 200 gallons a minute or so, underneath. Nothing was coming out anywhere high (*gestures to top of existing adit*).”¹

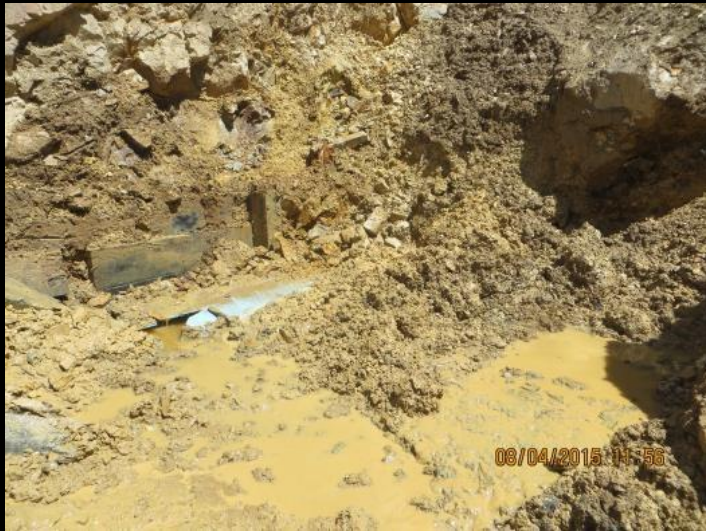
11:56 AM¹

Although there is a large time gap in the photographs taken late in the excavation stage on August 4, the contractor responsible for photographic documentation reported “excavation was proceeding slowly” in the middle of the time gap.⁴
