Investigation of November 20, 2014, Explosion and Fatality Lease OCS-00842, West Delta Block 105 Platform E

Gulf of Mexico Region, New Orleans District
Off Louisiana Coast

October 26, 2016

U.S. Department of the Interior
Bureau of Safety and Environmental Enforcement

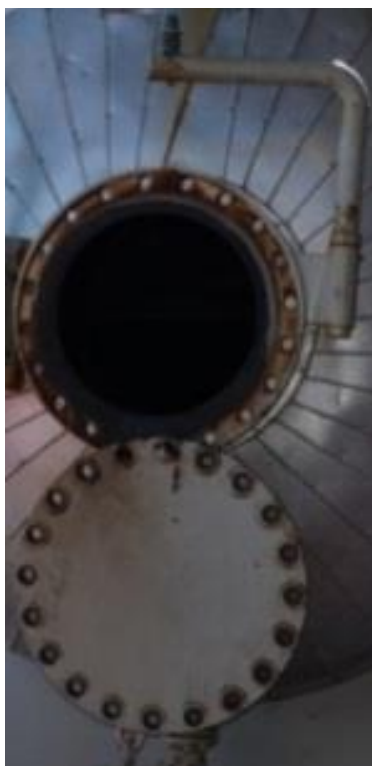
Figure 9 - Open Manway (November 21, 2014)

The Turnkey crew then slowly unbolted the hatch using the impact wrench until there were four bolts remaining. The hatch was connected to a davit arm that was intended to support the hatch when removed. However, the eye bolt was broken so they decided to cut it with a hand saw and instead of removing the hatch entirely, they left one bolt and allowed the hatch cover to swing below the manway opening (Figure 9).

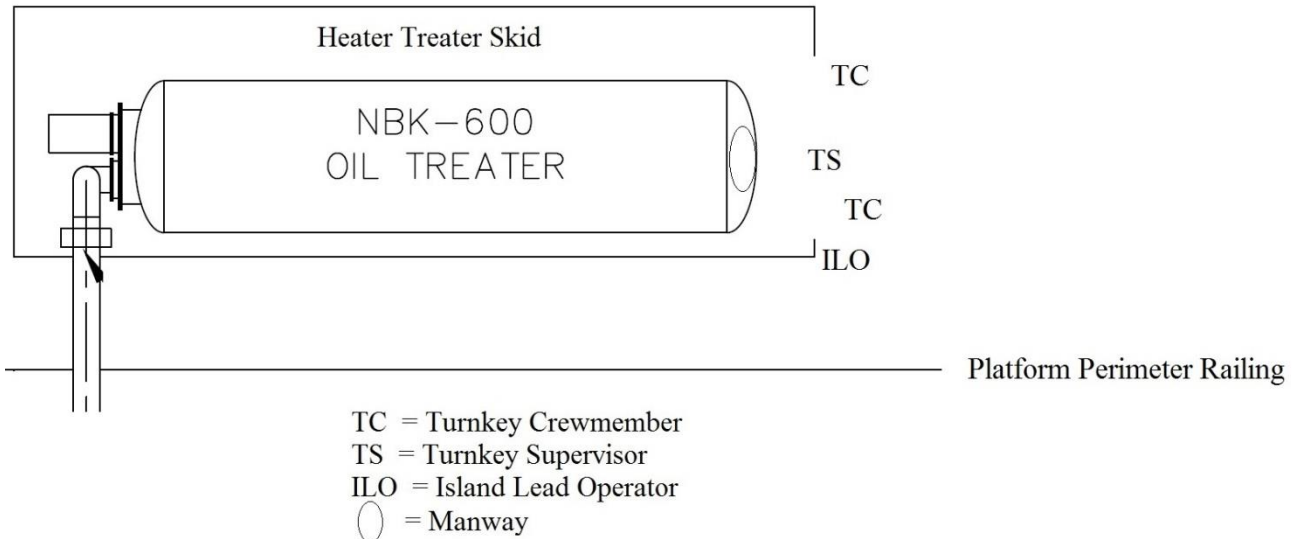
Figure 10 - BSEE Representation of Approximate Locations of Individuals at the Time of the Incident Based on Witness Descriptions – Edited from Lower Deck Plan, Top View

As the Turnkey Supervisor was believed to have been spraying salt water on the lip of the manway hatch, an explosion occurred inside the heater treater. Force from the explosion exited out of the open manway where the Turnkey and Island personnel were standing (Figure 10). The explosion caused a loud noise that was heard throughout the platform, including the galley and living quarters where most other platform personnel were located at the time.

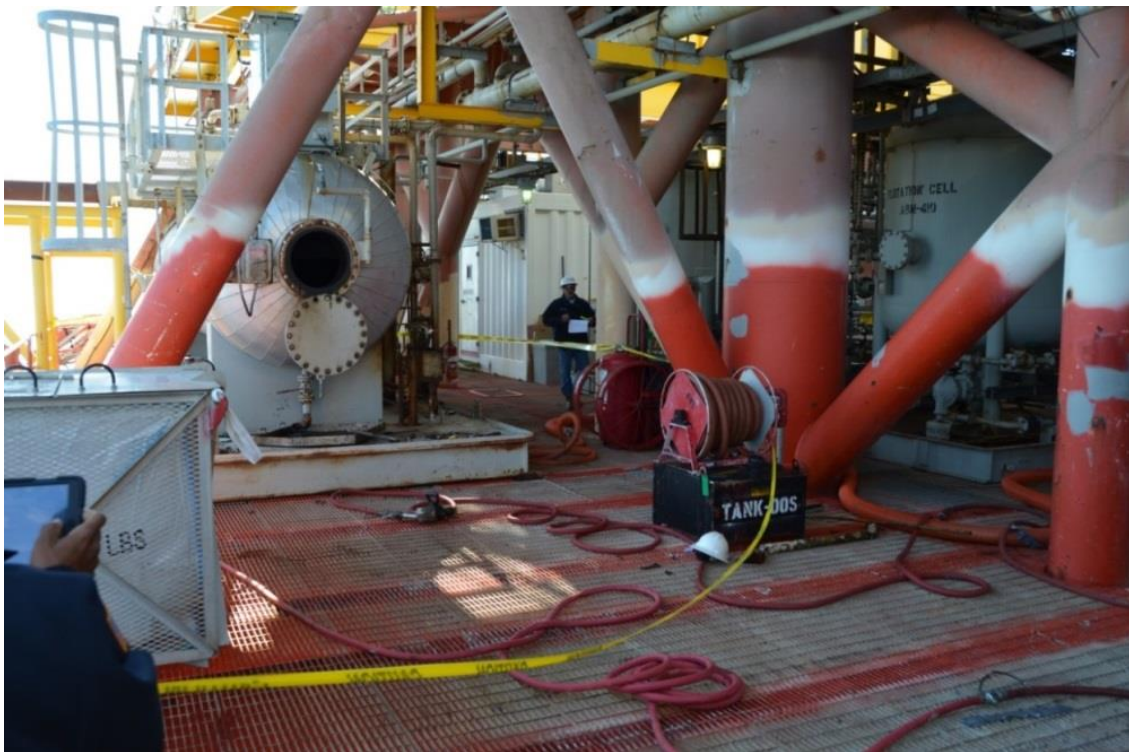
Figure 11 - Production Deck and Heater Treater (November 21, 2014)

BSEE Investigators arrived at the WD 105 E platform on the morning of November 21, 2014, to conduct their initial onsite investigation. They documented Fieldwood and Turnkey equipment, the MCC building, dry oil tank area and incident scene, which was considered the area immediately surrounding the WD 105 E heater treater and was cordoned off by Fieldwood personnel the previous evening with yellow tape (Figure 11).

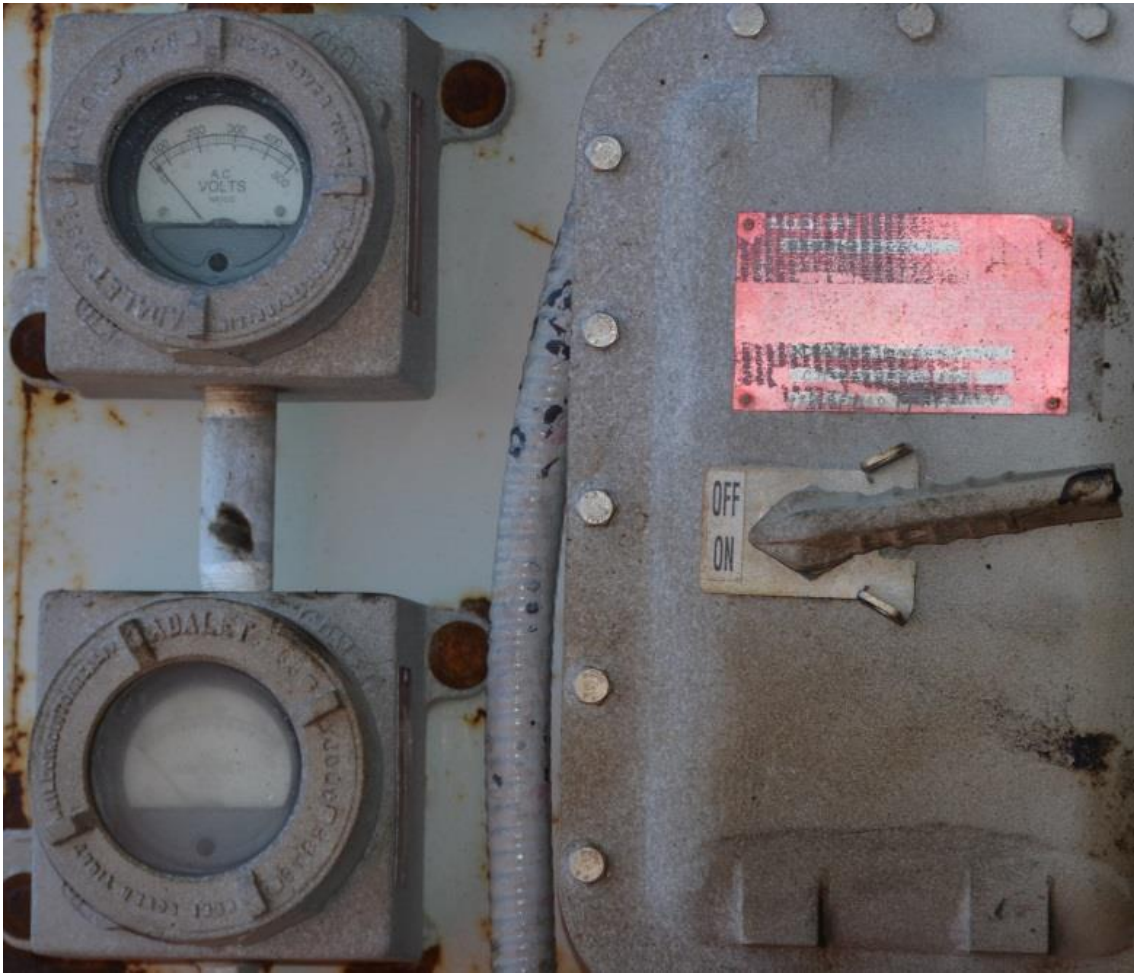
Figure 15 - Disconnect Switch, Volt and Amp Meters After Turning the Heater breaker Off (November 21, 2014)

The BSEE Investigators also took photos during the initial onsite investigation on November 21, 2014. In particular, a close-up view of a photo taken of the volt and amp meters located on the heater treater adjacent to the disconnect switch and manway before the heater treater breaker was turned 'Off' (Figure 14), appeared to show the volt and amp meter readings¹¹ greater than the readings observed on those meters after the heater treater breaker had been turned 'Off' (Figure 15). This indicated that electricity appeared to have been present up to that point in the electrical circuit prior to turning off the heater treater breaker on November 21, 2014.

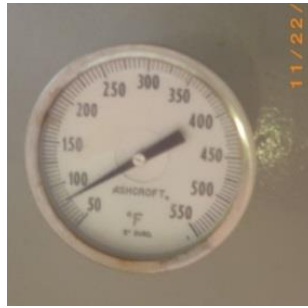
Figure 17 - Temperature Gauge on Transformer (November 22, 2014)

Additionally, hours after the heater breaker was turned 'Off' on the afternoon of November 21, 2014, BSEE Investigators observed the temperature gauge on the transformer at slightly over 100 degrees Fahrenheit (Figure 16), which was higher than the outside temperature,¹² and of the same gauge taken the following day (Figure 17).

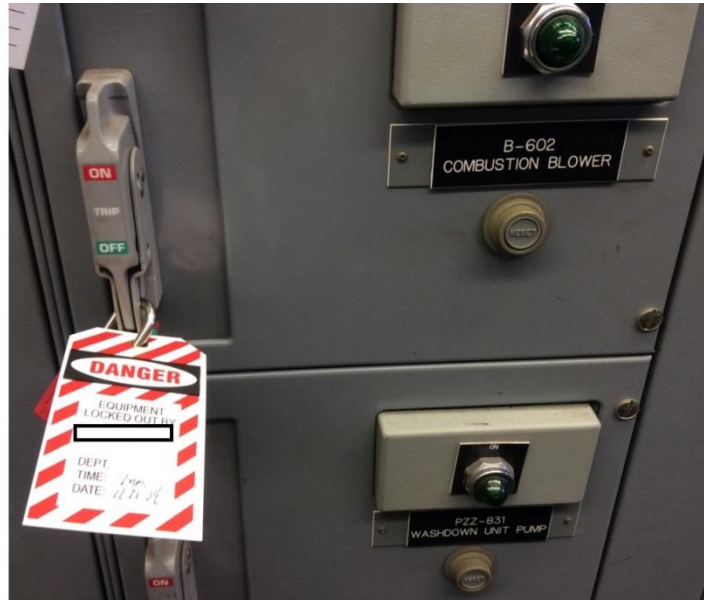
Figure 21 - Blower Motor on November 21, 2014 (Name Redacted by BSEE)

The Island Acting PIC also performed energy isolation for the heater treater blower motor breaker (Figure 21), which was isolated correctly. This breaker was also in the MCC building, but with a

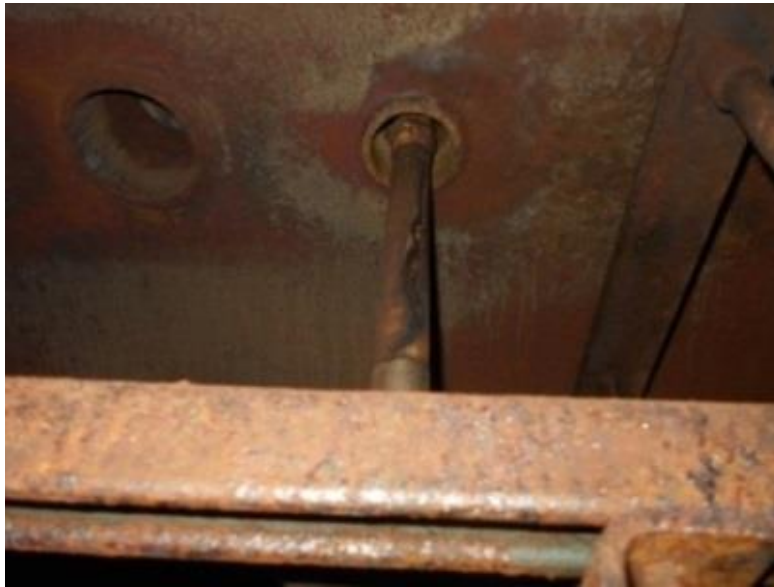
Figure 25 - Internal View of High Voltage Entrance Bushing (April 25, 2015)

Upon a post-incident evaluation of the grid in April 2015, a third-party technician identified normal signs of arcing on four of the Teflon insulators, and tracking (a failure mechanism for insulation breakdown) on the entrance bushing and two of the Teflon insulators (Figures 25, 26 and 27). He indicated that the metal grids and hardware were found to be in good condition.

A similar condition to that observed on the entrance bushing and insulated hangers after this incident may have also been observed previously on this platform, as both of the Fieldwood WD 105 E PICs recalled maintenance on the heater treater grid in years prior. They indicated observing similar conditions to some of the electrical components of the heater treater as was observed in April 2015 (see Figures 25 to 27); such as that the entrance bushing was bad. One PIC explained that the insulation was coated with chemicals, paraffin or something else; and electricity jumped over the insulator from the connection point on the top to the insulator and eventually cut a path to travel through. He said they also changed the fitting on the penetration to the vessel, some insulators and hangers. Both PICs explained that something had previously caused the grid to stop working prior to that maintenance, but they did not know what and they did not draw any conclusions regarding the operations of the heater treater in those previous circumstances compared to 2014.

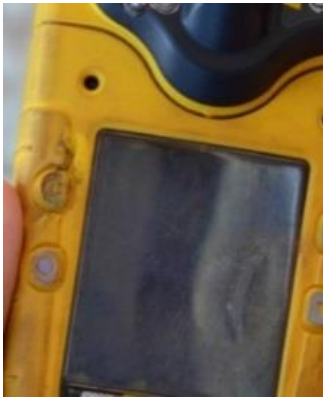
Figure 31 - Gas Detector Front (November 21, 2014)

On November 21, 2014, BSEE Investigators discovered a gas detector unit at the incident scene. The unit had been separated from its battery, both of which were located on the heater treater skid, but with the gas detector unit to one side of the hatch and the battery to the other (Figure 30). The BSEE investigators collected the two items and retained them for investigative purposes. Also included in the gas detector unit was a media card, on which data usage would be maintained. The gas detector was leased to Turnkey, with the last reliable calibration date of October 31, 2014.

The BSEE Panel attempted to retrieve data from the media card through Department of the Interior resources, as well as through the gas detector manufacturer. However, both attempts to recover data were unsuccessful. The manufacturer believed the reason for the inability to read the data was because of extensive damage to the main unit (Figure 31), as well as physical damage to the card believed to be from an impression in the metal socket of the gas detector unit (Figure 32).

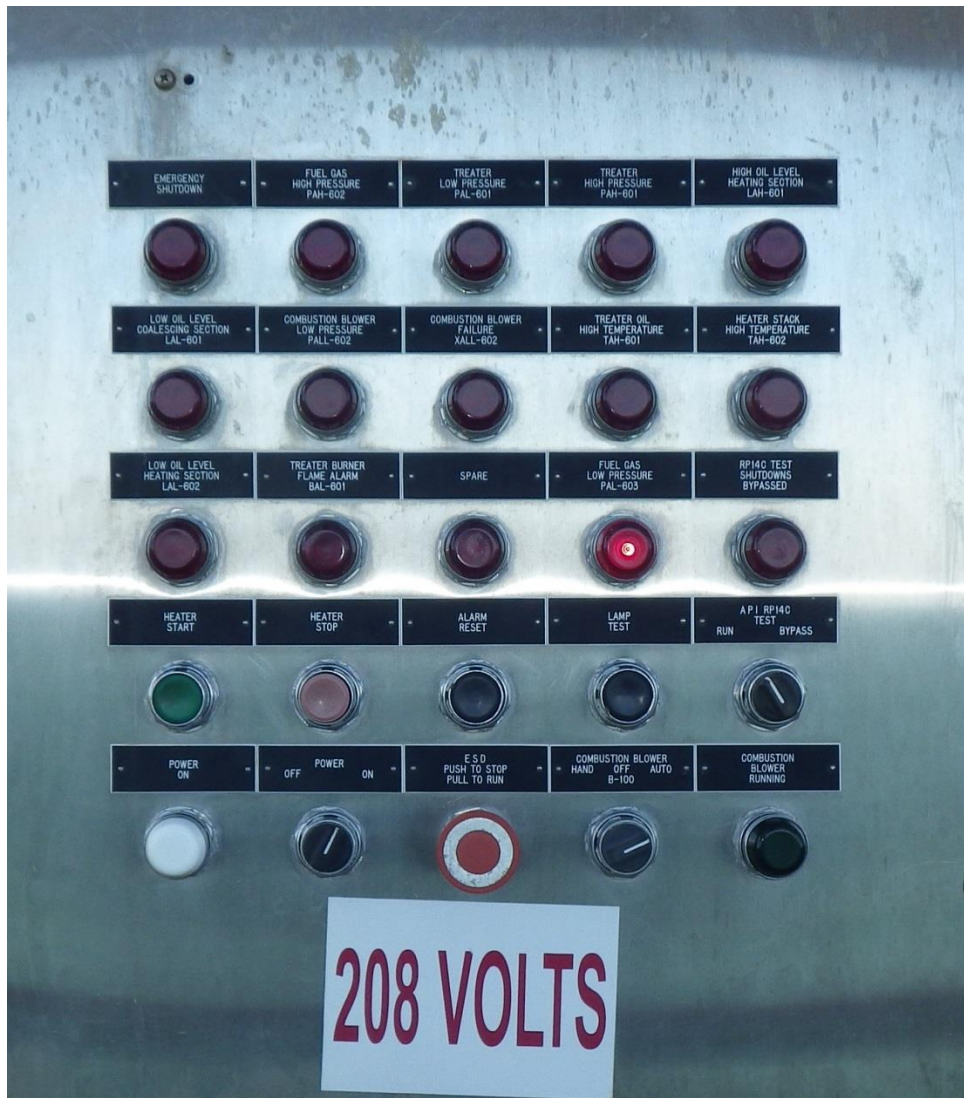
Figure 33 - Annunciator Panel (November 21, 2014)

³⁸ During their onsite investigation on November 21, 2014, BSEE Investigators observed that the annunciator lamp for Low Oil Level Coalescing Section [LSL]-601 on the heater treater control panel was not lit (Figure 33). It remains uncertain exactly why this lamp was unlit. The only lamp observed as lit was for Fuel Gas Low Pressure PAL-603.

The WD 105 E heater treater control system had an annunciator panel located adjacent to the burner section of the vessel that provided visual alarm annunciation via lamps, safety shutdown and control of the heater treater; as well as the PLC. Upon inspection of the panel on November 21, 2014, BSEE Investigators observed one alarm lamp as lit, for: Fuel Gas Low Pressure PAL-603 (Figure 33), before instructing Fieldwood to turn the panel 'Off' for safety reasons.
