M/V CONNECTED
Coral Reef Restoration Monitoring Report
Monitoring Events 2004-2005
Florida Keys National Marine Sanctuary
Monroe County, Florida

December 2006

Joe Schittone
Erik C. Franklin
J. Harold Hudson
Jeff Anderson

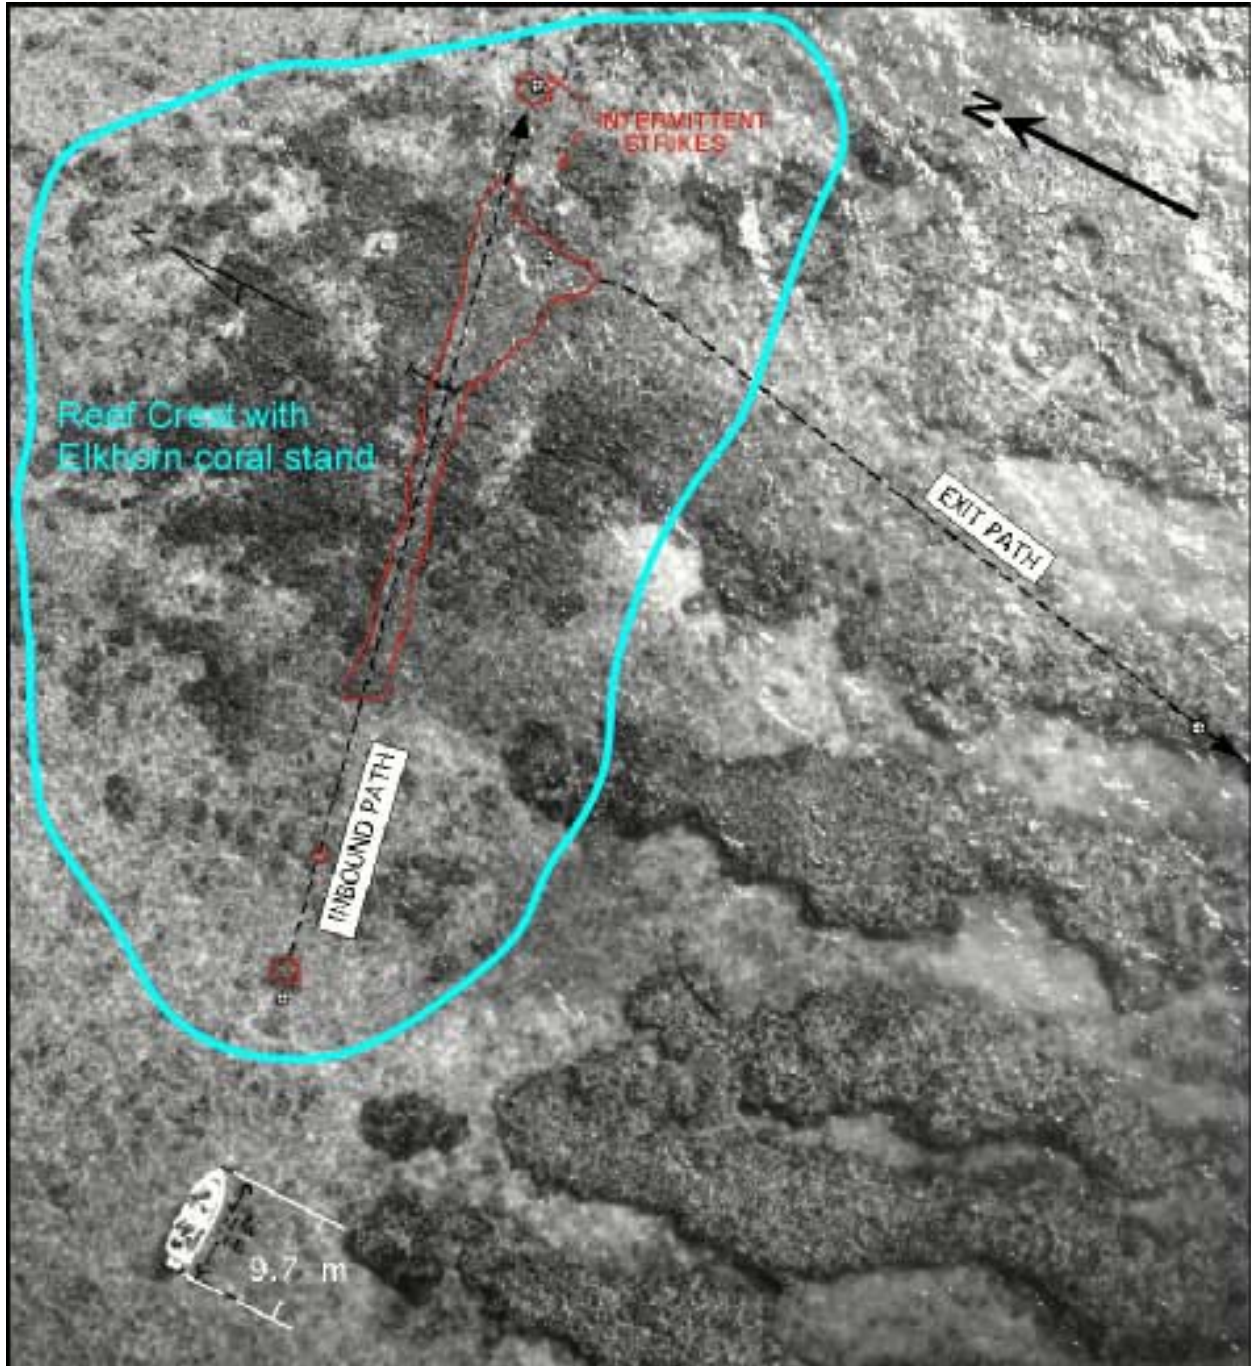
The most prominent feature of the injury site consisted of a wide grounding track plowed through an elkhorn coral stand (Figure 2). The width of the injury swath varied between 3-7 m along the inbound path and widened at the final resting place to 9 m (Figure 3). The latitude and longitude of the beginning of the inbound track were recorded as 24° 28.811' N and 81° 43.105' W and the end of the inbound track as 24° 28.822' N and 81° 43.091' W (datum GRS80). During removal, the vessel was pivoted and extracted to the south (Figure 3). The area of damaged reef framework and live coral colonies from the inbound path and resting place was 189.58 m². In addition, small intermittent areas of injury were documented in front of the

Figure 3. The M/V *Connected* grounding site at Western Sambo Reef with the area damaged from the vessel's inbound path and final resting place outlined in red. The aerial photograph was taken on April 5, 2001.

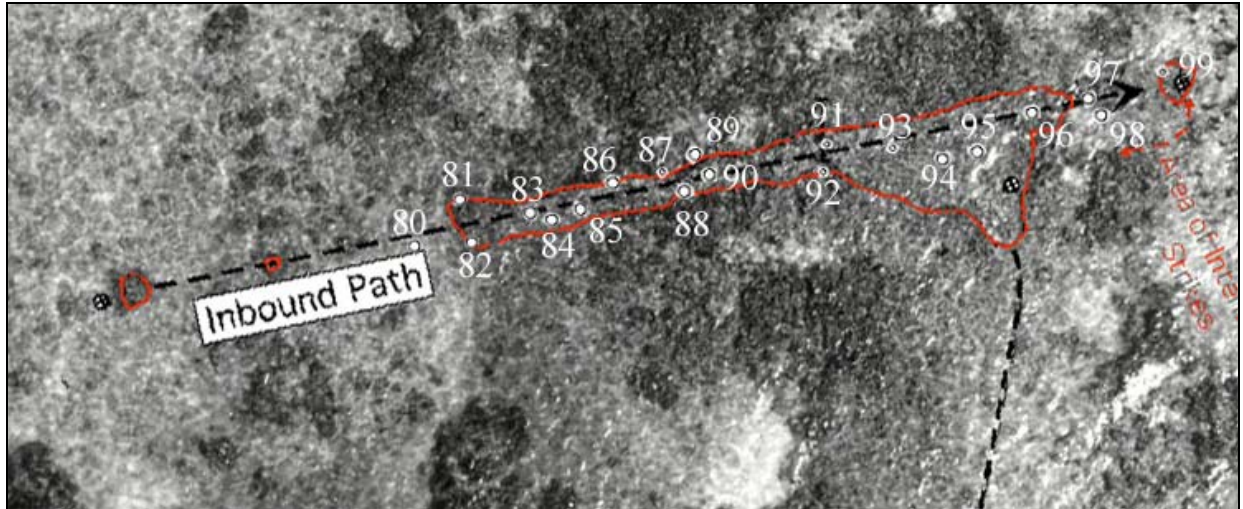
Figure 4. Diagram of reef crown restoration modules (white circles) installed at the *Connected* grounding site (inset from Figure 3). Large circles are “king crowns” and small circles are “queen crowns.”
