Leadville Mine Drainage Tunnel Risk Assessment

Leadville Mine and Drainage Tunnel Project, Colorado
Great Plains Region

The Bureau of Reclamation has completed a study to evaluate the stability and assess the risk associated with the Leadville Mine Drainage Tunnel (LMDT) in Leadville, Colorado. The risk assessment consists of the following four sections:

Existing Condition of the Leadville Mine Drainage Tunnel

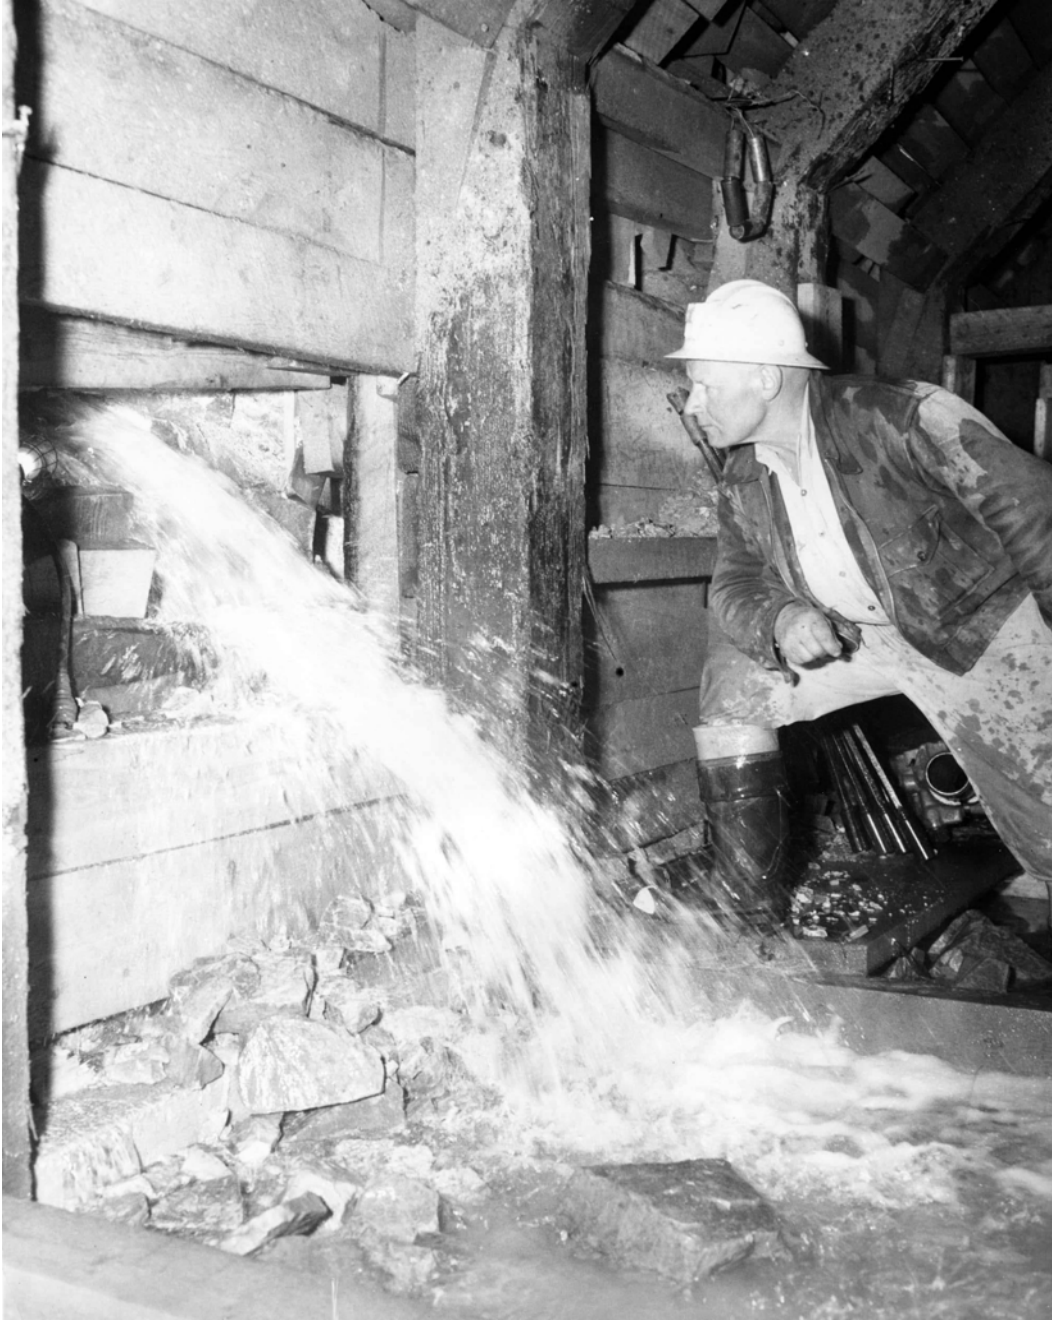
A heavy waterflow cut in a limestone fissure in the Leadville limestone at Station 95+65 increased the rate of drainage from the Robert Emmet and other shafts rapidly, see Figure 12. By October 1951 the water level in the Robert Emmet Shaft was only a few feet above the tunnel floor, as determined by pilot holes drilled before actual connection. The flow entering the LMDT from the Robert Emmet Shaft since the connection remained nearly constant at about 400 gpm.

Figure 12. Photograph showing the inflow to the LMDT through a drillhole connected to the Robert Emmet shaft, taken from (Salsbury, 1956). This is prior to driving the Robert Emmet lateral.

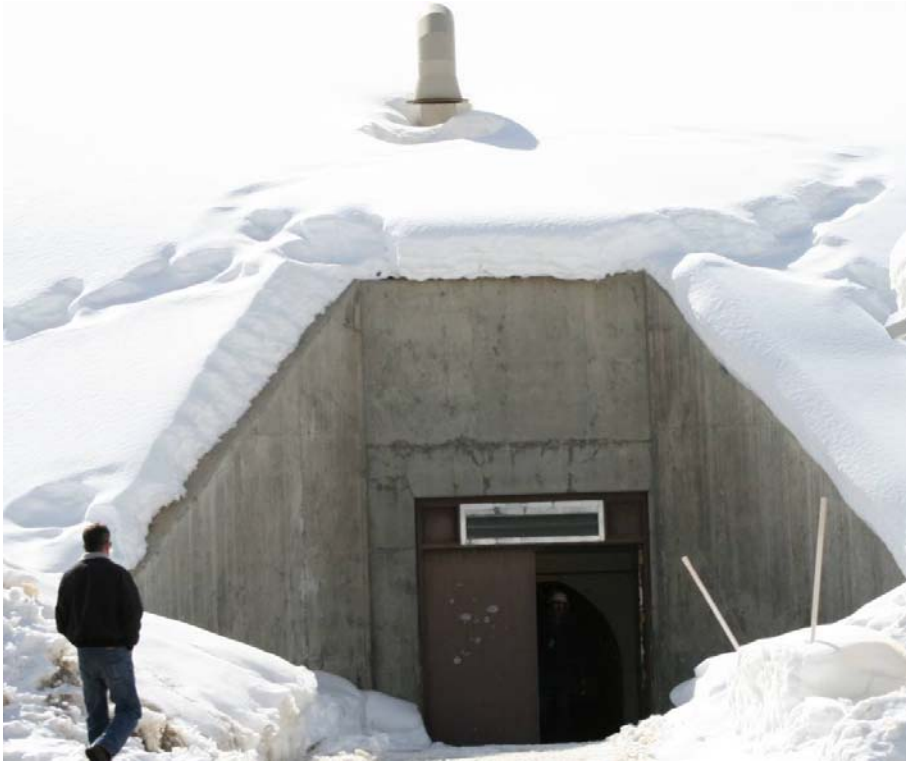
On March 25, 2008, an inspection of the LMDT was made by Reclamation geotechnical engineers Michael Gobla and Jack Touseull, and civil engineer Kevin Atwater for the purposes of evaluating the structural integrity of the portal, tunnel liner, and timber lattice bulkhead. The inspection included the portal structure, drainage ditch, reinforced concrete liner, weep holes, and the timber lattice bulkhead. The concrete is sound and relatively fracture free. One lift line located about 3 feet above the door opening was damp as evidenced in the accompanying photograph in Figure 17. A few short hairline cracks were noted in the portal structure. The portal structure is in overall excellent condition.

Figure 17. Photograph of the LMDT portal structure taken on March 25, 2008.

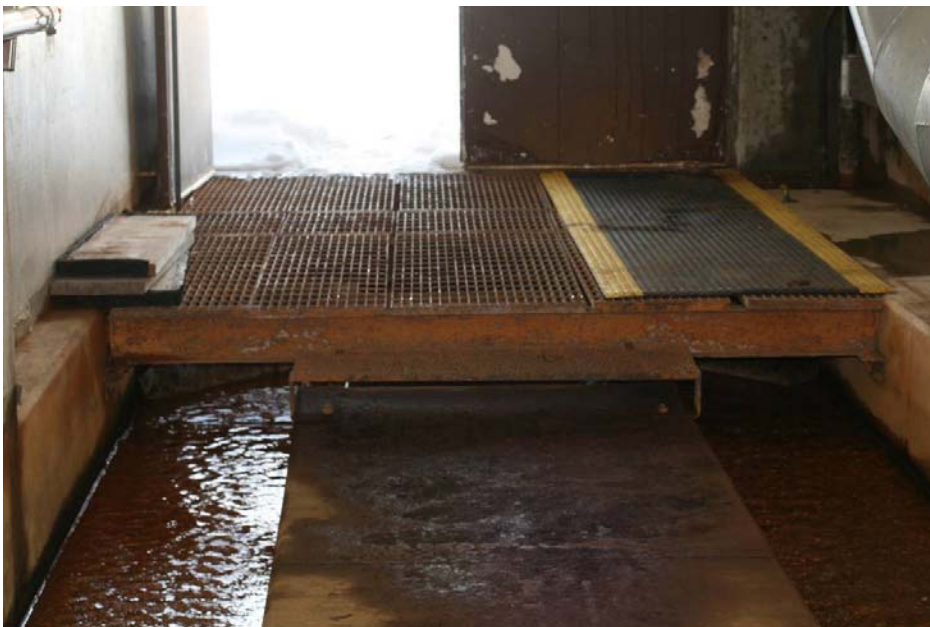
Entrance to the portal is controlled by a steel door which is normally kept closed and locked. Just inside the LMDT portal is a floor grating with removable panels to allow access to the sump at the end of the two drainage ditches; a concrete walkway divides the ditches, see Figure 18. Beyond the grating, electrical equipment is located on the right side (looking downtunnel) for operation of the lights and ventilation system. The overhead lights, ventilation fan, and ventilation pipeline are shown in Figure 19. All of the equipment was in operating condition at the time of the inspection.

Figure 18. Photograph taken on March 25, 2008 looking at the downstream end of the LMDT showing the concrete center walkway with drainage ditches on either side and steel floor grating.

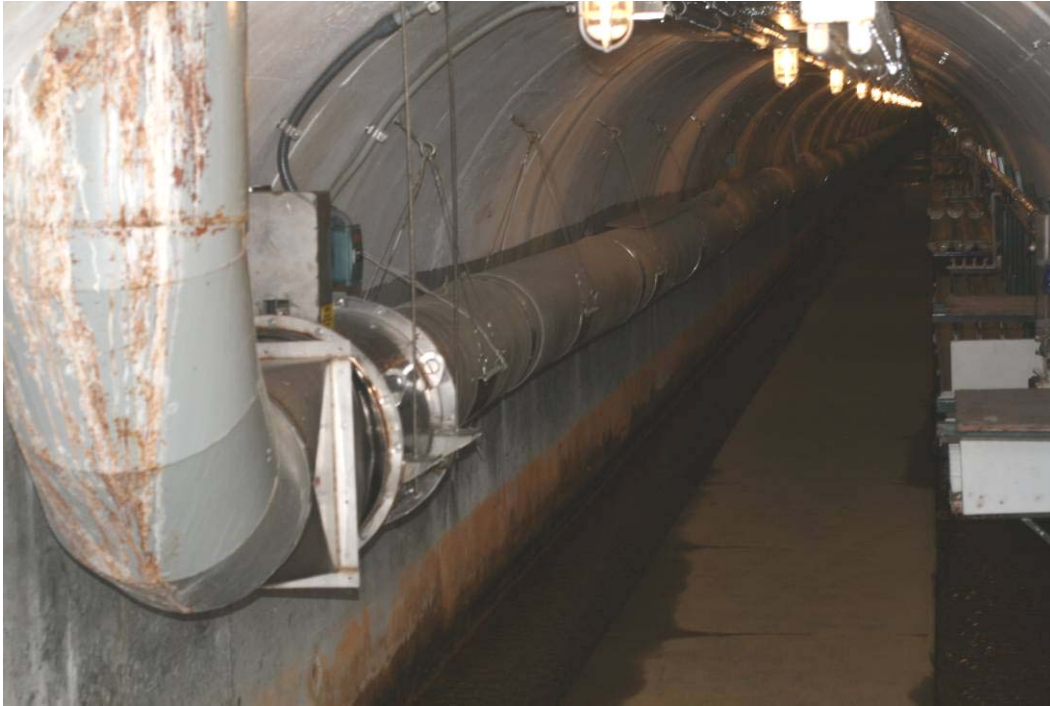
Figure 19. Photograph taken on March 25, 2008 looking upstream from the Portal area in the LMDT showing the ventilation fan, motor controls, and vent pipe at left, and the electric lights at the upper right.

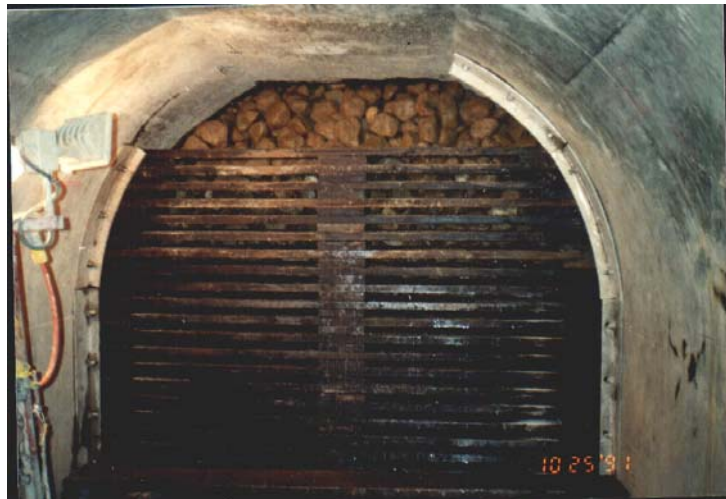
During the 1990-1992 modifications, gravel-fill was placed between the existing bulkhead at 4+66 and a new wood-lattice timber bulkhead constructed at Station 4+60 to 4+61. The gravel backfill was 1.5 to 2.5 inches in diameter; however, this was problematic in that the flow moved the gravel and caused plugging off of the flow through the new timber lattice. A vertical zone of 3-inch to 12-inch cobbles was instead placed immediately behind the new timber bulkhead at 4+61 which eliminated the plugging of the lattice. The new timber lattice, made of 2 x 12 inch creosote-treated Douglas Fir, is held together with stainless steel screws. A stainless steel L-shaped support was placed immediately in front of the timber lattice structure to lock it in place. The stainless steel support is anchored to the concrete liner using $\frac{3}{4}$ -inch-diameter stainless steel bolts. Details of the bulkhead construction are shown on drawing 1335-D-123 Typical Tunnel Section, Cutoff Wall, and Timber Bulkhead. Inspection of this bulkhead on March 25, 2008 found it to be in excellent condition.

In a Memorandum (Armer, 2001), the stability of the bulkhead at Station 4+60 was evaluated. It was reported that with flow 2.5 feet above the floor (current condition), the bulkhead had a factor of safety of 3.3. If water flow were to rise to the full height of the LMDT, the factor of safety would be greater than 1.0 for the bulkhead assembly.

Figure 26. Construction photograph showing the cobbles behind the timber-lattice bulkhead at Station 4+60 of the LMDT.

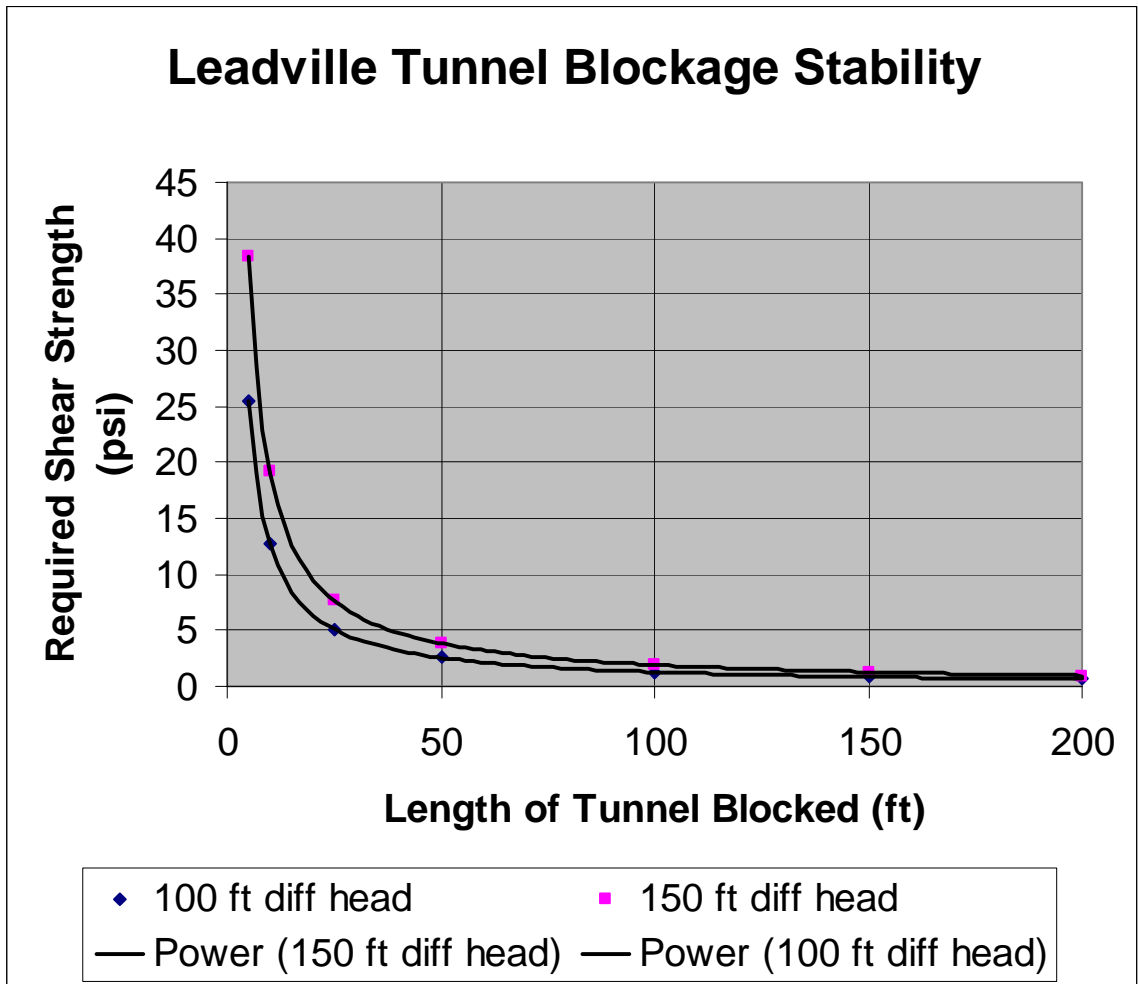
The results of the calculation are shown graphically in Figure 3 where the data are plotted as required shear resistance vs. length on the y and x axis respectively. Two plots, the upper representing the differential head of 150 feet, and a lower representing the differential head of 100 feet are shown. Both are asymptotic. The curves are down trending with a decrease in required shearing resistance as the length of the blockage (and total frictional contact area) increases. As expected, more shearing resistance is required to hold the larger differential head of 150 feet. Further, the shearing resistance required is seen to decrease as the length of the blockage increases.

For a length of blockage of less than thirty feet, the amount of shear strength required to maintain the blockage in place rapidly increases. At blockages greater than about 50 feet in length, the required shear strength is small and does not change significantly with increasing blockage length. The calculation is a simplification of the actual situation, but is useful in showing the approximate range of frictional shear strength needed for various lengths of blockage to resist the driving force caused by the differential head.

Figure 3. Required shear strength versus length of tunnel blocked from collapse in LMDT.

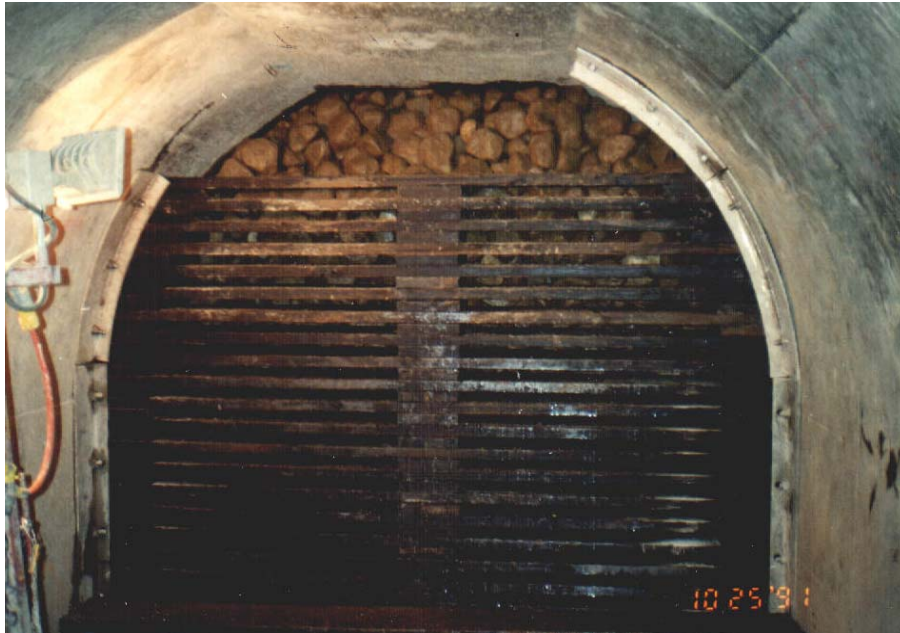
At the downstream end, from Station 4+60 to 4+61 is the Timber Lattice Bulkhead as shown in Figure 4. The timbers are held in place by an L-shaped bracket made of stainless steel which is anchored to the Concrete Tunnel Lining. From Station 4+61 to Station 4+66 there is 5-feet of cobble and gravel fill held in by the Timber Lattice Bulkheads. The fill immediately against the bulkhead on the downstream side is comprised of cobble-size rock as seen in Figure 5.

Figure 5. Photograph taken on October 25, 1991 of the Timber-Lattice Bulkhead as construction was nearing completion showing the layer of cobbles at Station 4+62 of the LMDT.

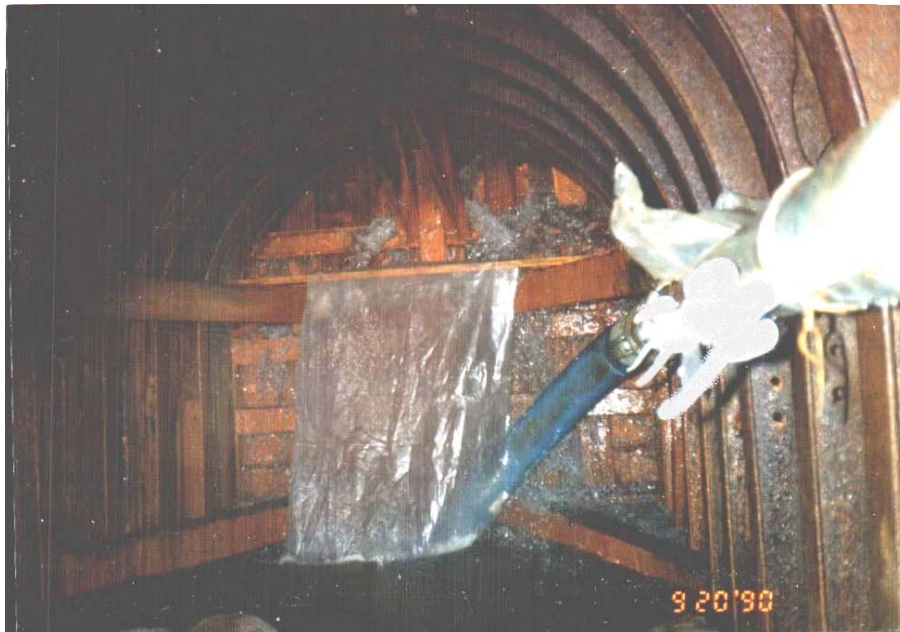
Figure 6. Photograph taken on August 20, 1990 showing the porous bulkhead located at Station 4+66.

At Station 4+66 a porous timber bulkhead was previously constructed in 1980 when the LMDT was excavated back to approximately Station 5+00 (Figure 6), new steel supports were placed, and gravel backfill was installed to bear against the sand-filled collapse zone. The tunnel along this porous plug section was originally excavated to approximately 11 feet wide and 12 feet high (Gobla and Vandenberg, 2008). Various tunnel supports and spacing were used. Both wood and steel sets were used with the only common denominator being the use of wood for blocking and lagging and the use of spiling through bad ground. The exact configuration and location of all the various support members are not documented. Spacing varied and various support members or configurations were changed over the years as maintenance and stability issues occurred.

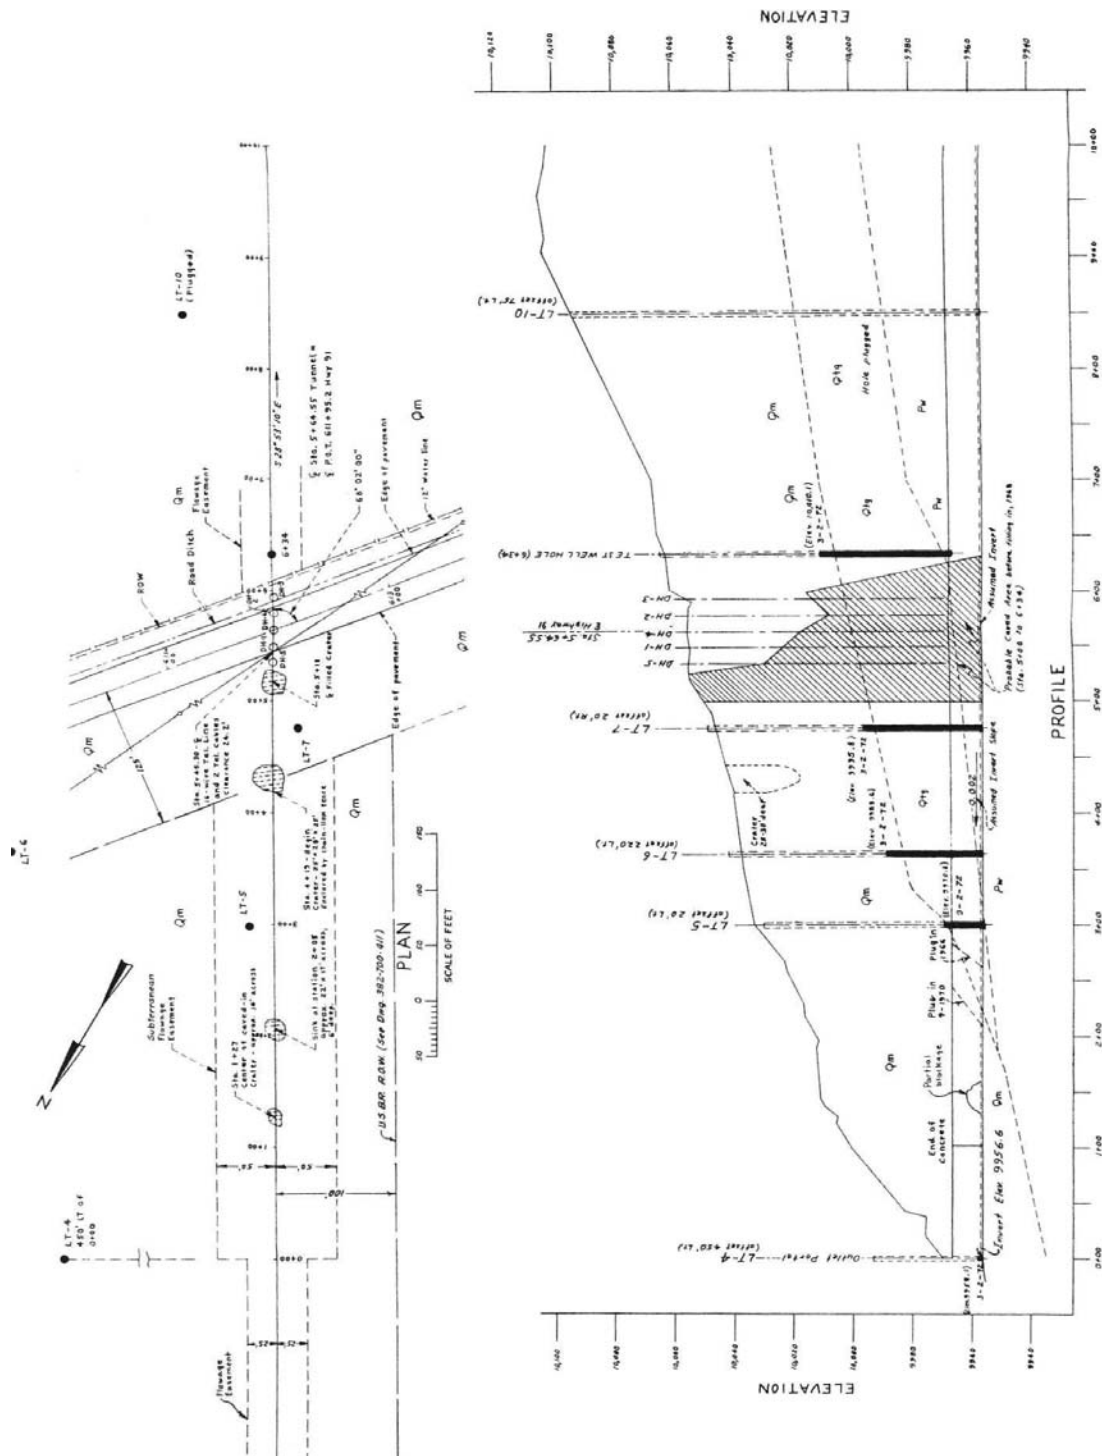
The tunnel at Station 4+62 has a bedrock bottom and 4-foot-high bedrock side walls, above which the rest of the wall and crown are composed of unconsolidated terrace gravel materials. The bedrock surface slopes up station and by Station 6+35 the entire tunnel is completely in bedrock (Reclamation, 1989). The change from a tunnel roof in terrace gravels to a rock roof is probably the reason why the 1968 surface subsidence and the area of tunnel collapse did not extend further southeast. The thickness of the overlying overburden above the blockage area averages about 100 feet. Most of the blockage in the tunnel is from the 1968 ground subsidence that occurred some where between Station 5+00 and drill hole #2, at about Station 5+75, and extended all the way to the surface (Figure 7).

The interpretation of the length of the collapsed zone was based upon the data from five drill holes and downstream observations in the tunnel. Figure 7 shows the collapse going all the way to Station 6+32. However, no other documentation supports that this was the actual case; no back filling that was done through drill holes other than drill holes 2 and 3, at about Station 5+92, see Table 3. It is possible that this 40 foot area from Station 5+92 to Station 6+32 may have collapsed since then, but it is not known for certain. There is no direct evidence that material is plugging the tunnel any further up station than 5+92.

Figure 7. Plan and section showing condition of the LMDT in 1972 including the location of sinkholes, 1968 injection drill holes, and monitoring wells installed in 1968, taken from (Reclamation, 1976).

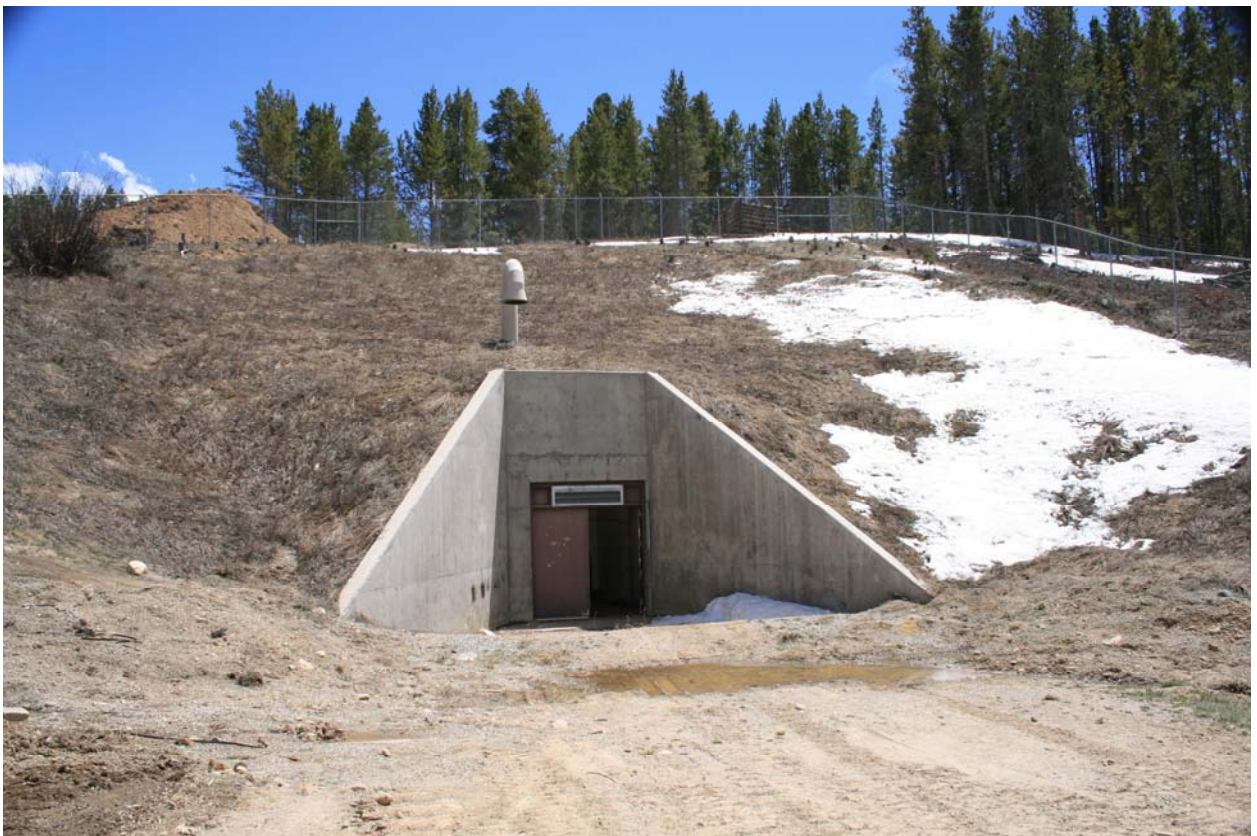
It should be noted that the tunnel from Stations 0+54 to 4+61 was supported with steel sets, lined with reinforced concrete and the inside diameter reduced in size to an 8 feet wide by 8.5 feet high, semi-circular arch. Furthermore, the portal area has a massive concrete structure, (Figure 8) and the space behind the concrete tunnel lining was pressure grouted. Therefore, the entire structure together with the bulkhead and reduced cross sectional area would provide additional restraint to the material plugging the larger diameter tunnel from being ejected.

Figure 8. Photograph taken May 21, 2008 showing the reinforced concrete LMDT Portal with 1-ft. thick wing walls.

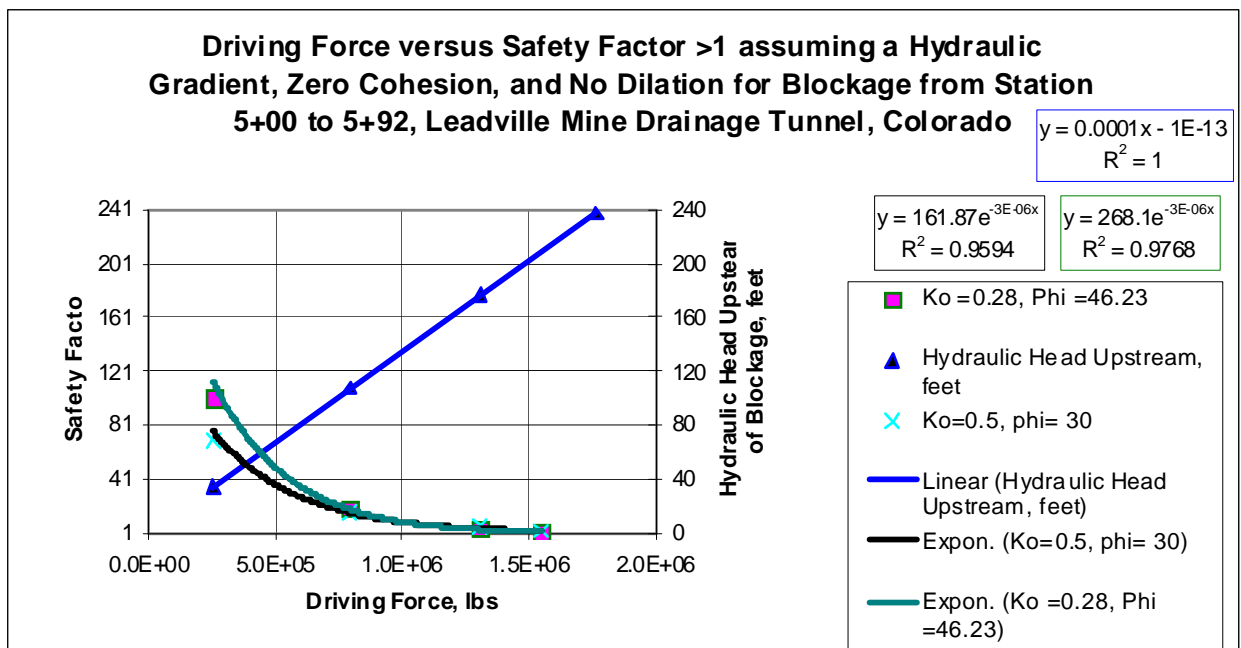
The Excel spread sheets in Appendixes B & C summarize the type of calculations that were made. The results are summarized in figures 9 and 10. Figure 9 shows the calculation for the plug considering an instantaneous loading condition. In other words, it assumes that the upper blockage near the Pendery Fault has failed

As would be expected, the lower the friction angle, the lower the safety factors for a given hydraulic head. As the hydraulic head increases, the safety factor decreases for each value of friction. However, for each pair of curves, with a different friction angle, the two curves when plotted against safety factor are non linear and with increasing hydraulic head converge. At a factor of safety of 1, indicating the driving and resisting forces are equal, the hydraulic head is nearly 220 feet. This is more than 100 feet higher than any groundwater levels ever measured in this part of the LMDT. The calculations show that this pressure pulse can be withstood and the plug will not “blowout.”

Figure 9. Driving force versus differential head and safety factor for an instantaneous increase of head at the upstream end (Station 5+92) of the plug in the LMDT. The additional resistance from the manmade bulkheads and porous cobble and gravel fills located from Station 4+61 to Station 5+00 are not included in the calculation.

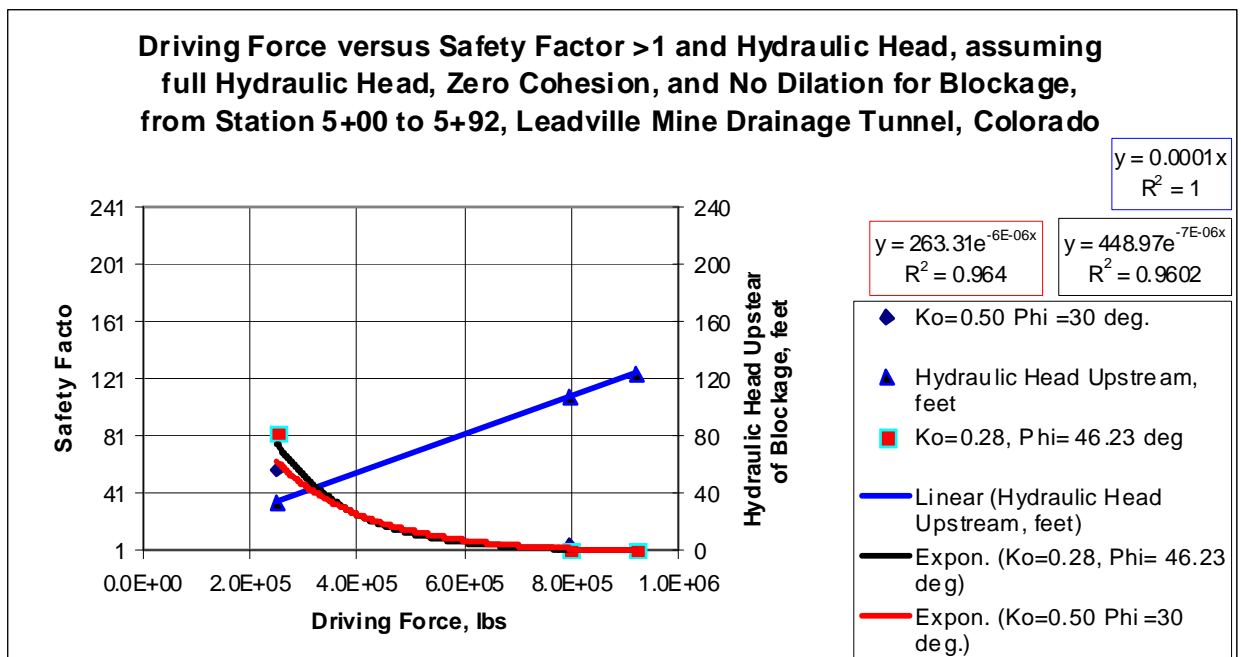
The results shown in Figure 10 for the full hydraulic head across the length of the plug indicate that the conservative factor of safety remains above 1.0 for differential heads up to about 125 feet.

Figure 10. Driving force versus safety factor for a diffusion of head along the plug from the upstream end at Station 5+92 to just above the porous fill at Station 5+00. Again the additional resistance provided by the manmade bulkheads and porous cobble and gravel fills located from Station 4+61 to Station 5+00 are not included in the calculation.

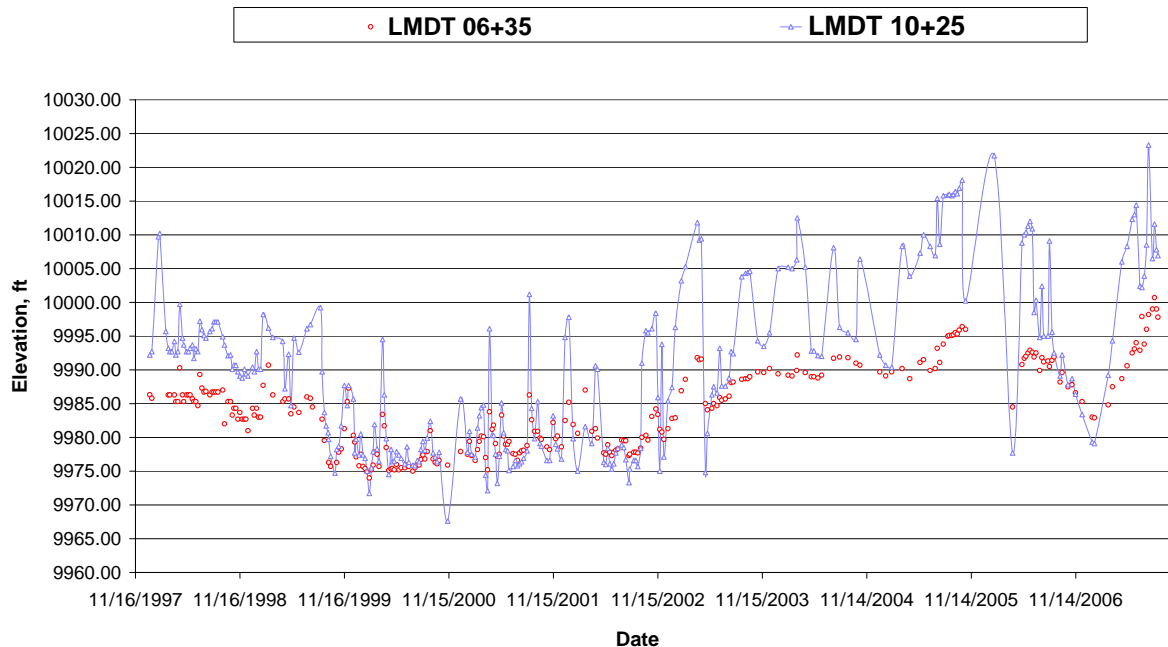
One final observation was made for the water elevation data for drill holes at Stations 6+34 and 10+25. There appears to be a difference in head between these

two wells, see Figure 11. This would suggest that a small tunnel collapse or blockage may have formed some place between the two wells. Reviewing the history of the tunnel, in 1979 a well was drilled into the tunnel at Station 6+65, but while waiting for delivery of well screen, a sinkhole appeared next to the drill rig and the hole was lost. If there is a blockage in this area, then the risk to the tunnel blockage downstream of Station 6+34 may be reduced even further since the pressure gradient down the tunnel would experience another damping effect from this blockage. This also points out an important fact that given the history of the LMDT, new collapses may form and old ones may grow. As a result, there will be even more barriers to not only impede flow down the LMDT but to create additional hydraulic barriers, which will create additional stepped pressure drops along the drainage path.

Figure 11. Water levels measured in wells at Stations 6+35 and 10+25.

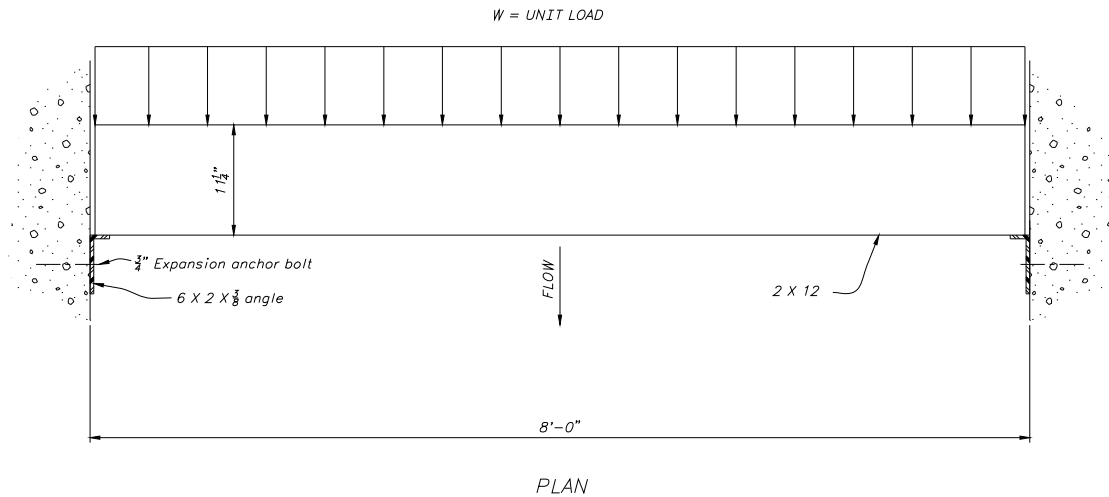
- Timber beam (see Figure 12) was assumed simply supported and uniformly loaded.

Figure 12. Plan view of timber beam.

- Length of beam for moment and bearing = 7.9 ft.
- Effective length (length – 2 x depth of beam) of beam for shear = 6.0 ft.
- The timber was assumed to be Douglas Fir Larch, select structural grade as shown on drawing no. 1335-D-123. Properties for the timber are from Timber Construction Manual, American Institute of Timber Construction, 2nd ed., 1974. Timber properties follow:
 - Allowable bending stress (repetitive member use) = 2050 lb/in²
 - Allowable horizontal shear stress = 95 lb/in²
 - Allowable compression perpendicular to grain = 385 lb/in²
 - Duration factor (assume 50 years) = 0.96

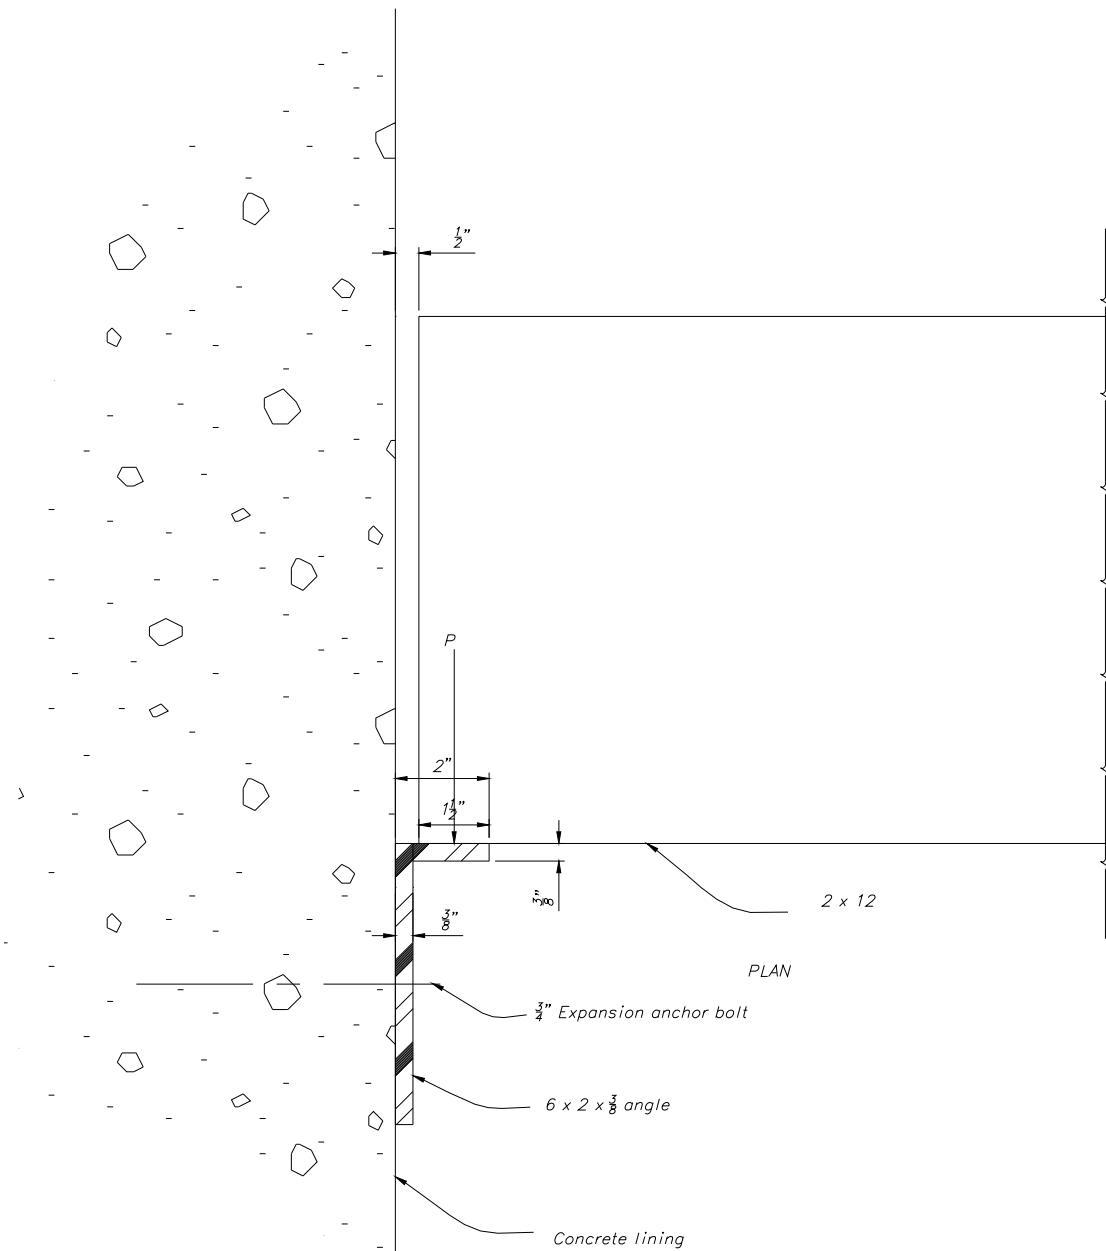
The analysis of the 6 x 2 x $\frac{3}{8}$ angle (see Figure 2) was based on the following properties

- Yield strength (F_y) assumed to be 39,000 lb/in² (type 304L)
- Assumed allowable shear stress = 0.4 x F_y
- Assumed allowable bending stress = 0.66 x F_y

Figure 13. View of angle bracket and anchor bolt.

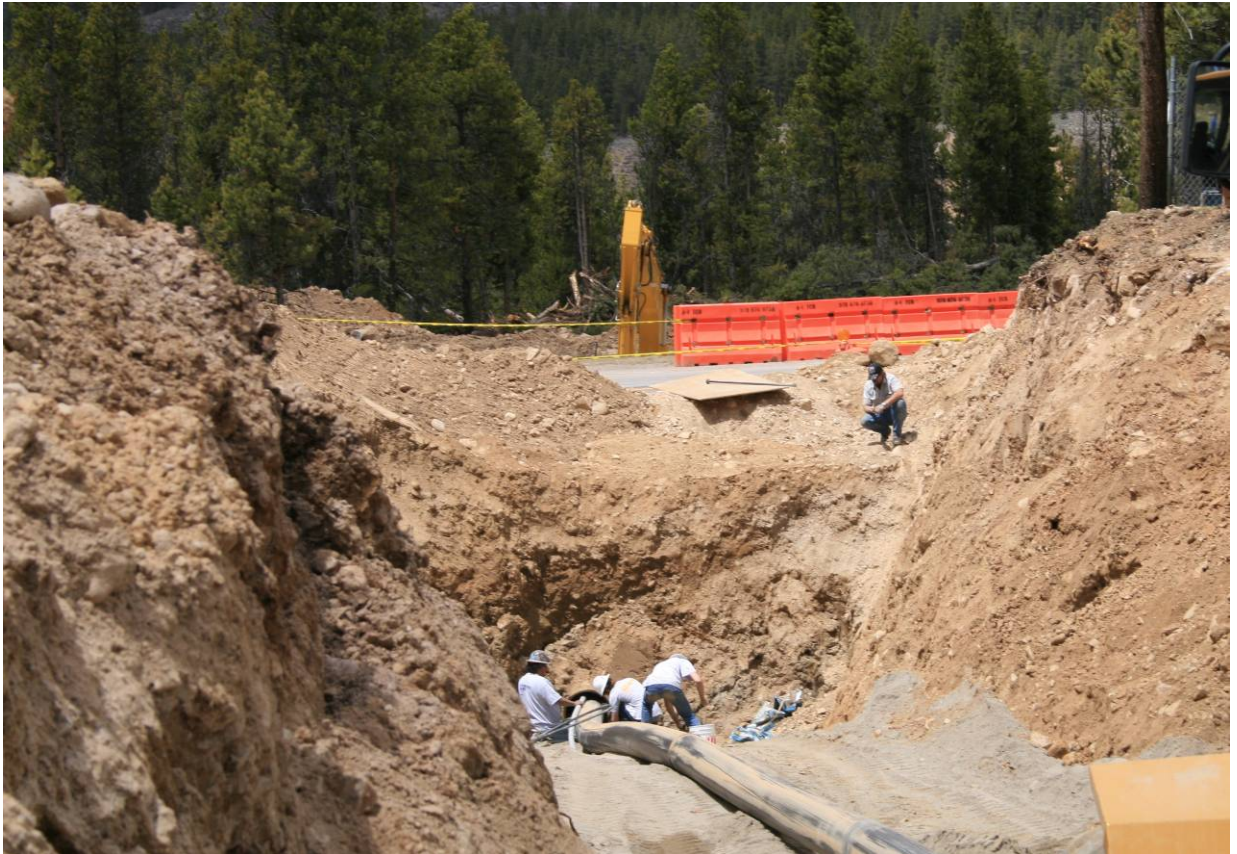
The assessment of these properties was accomplished from review of available project data, discussions with project personnel, site visits and published data. Recent excavation for a pipeline installation indicated that the Glacial Moraine is able to stand at steep angles in excavations and in dumped fill embankments, see

Figure 14. This indicates that the material has cohesion and the actual shear strength of this material is likely closer to the maximum value for the range of strengths assumed in the analysis.

Figure 14. Excavation in May, 2008 into the Glacial Moraine at Leadville for installation of a pipeline under Highway 91 along the alignment of the LMDT. Note the steep slopes of the excavation and spoil banks indicating high shear strength of the soil.

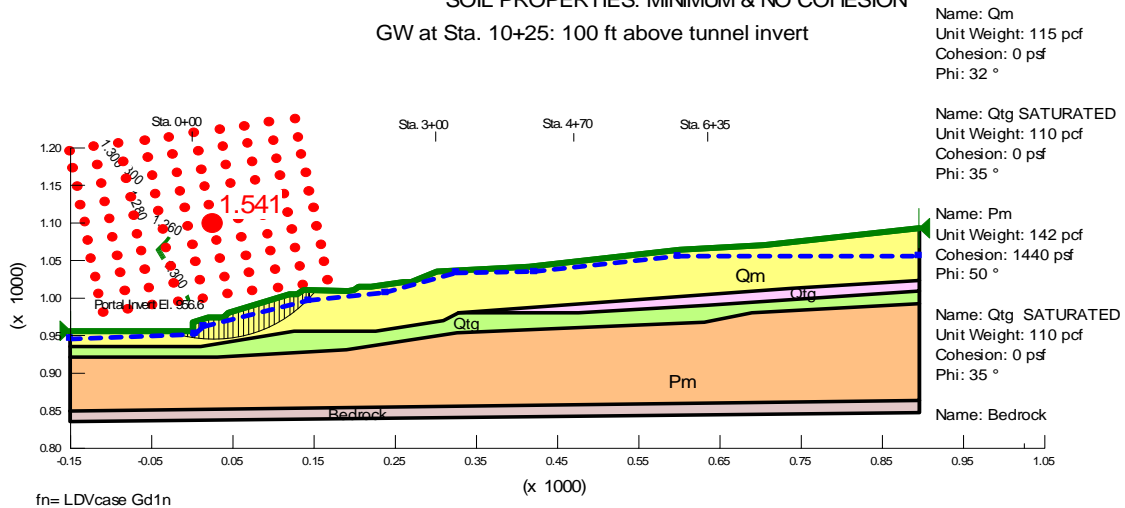
APPENDIX D - FIGURE 14 LEADVILLE DRAINAGE TUNNEL

STUDY 2008 - SEISMIC COEFFICIENT: 0.000g
SOIL PROPERTIES: MINIMUM & NO COHESION
GW at Sta. 10+25: 100 ft above tunnel invert

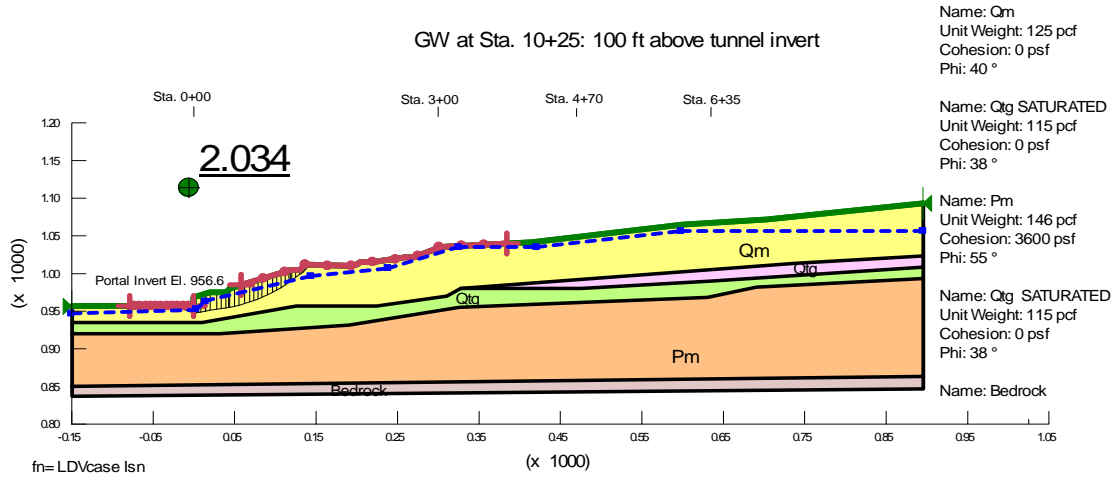
APPENDIX D - FIGURE 15 LEADVILLE DRAINAGE TUNNEL

STUDY 2008 - SEISMIC COEFFICIENT: 0.00g
SOIL PROPERTIES: AVERAGE & NO COHESION

GW at Sta. 10+25: 100 ft above tunnel invert

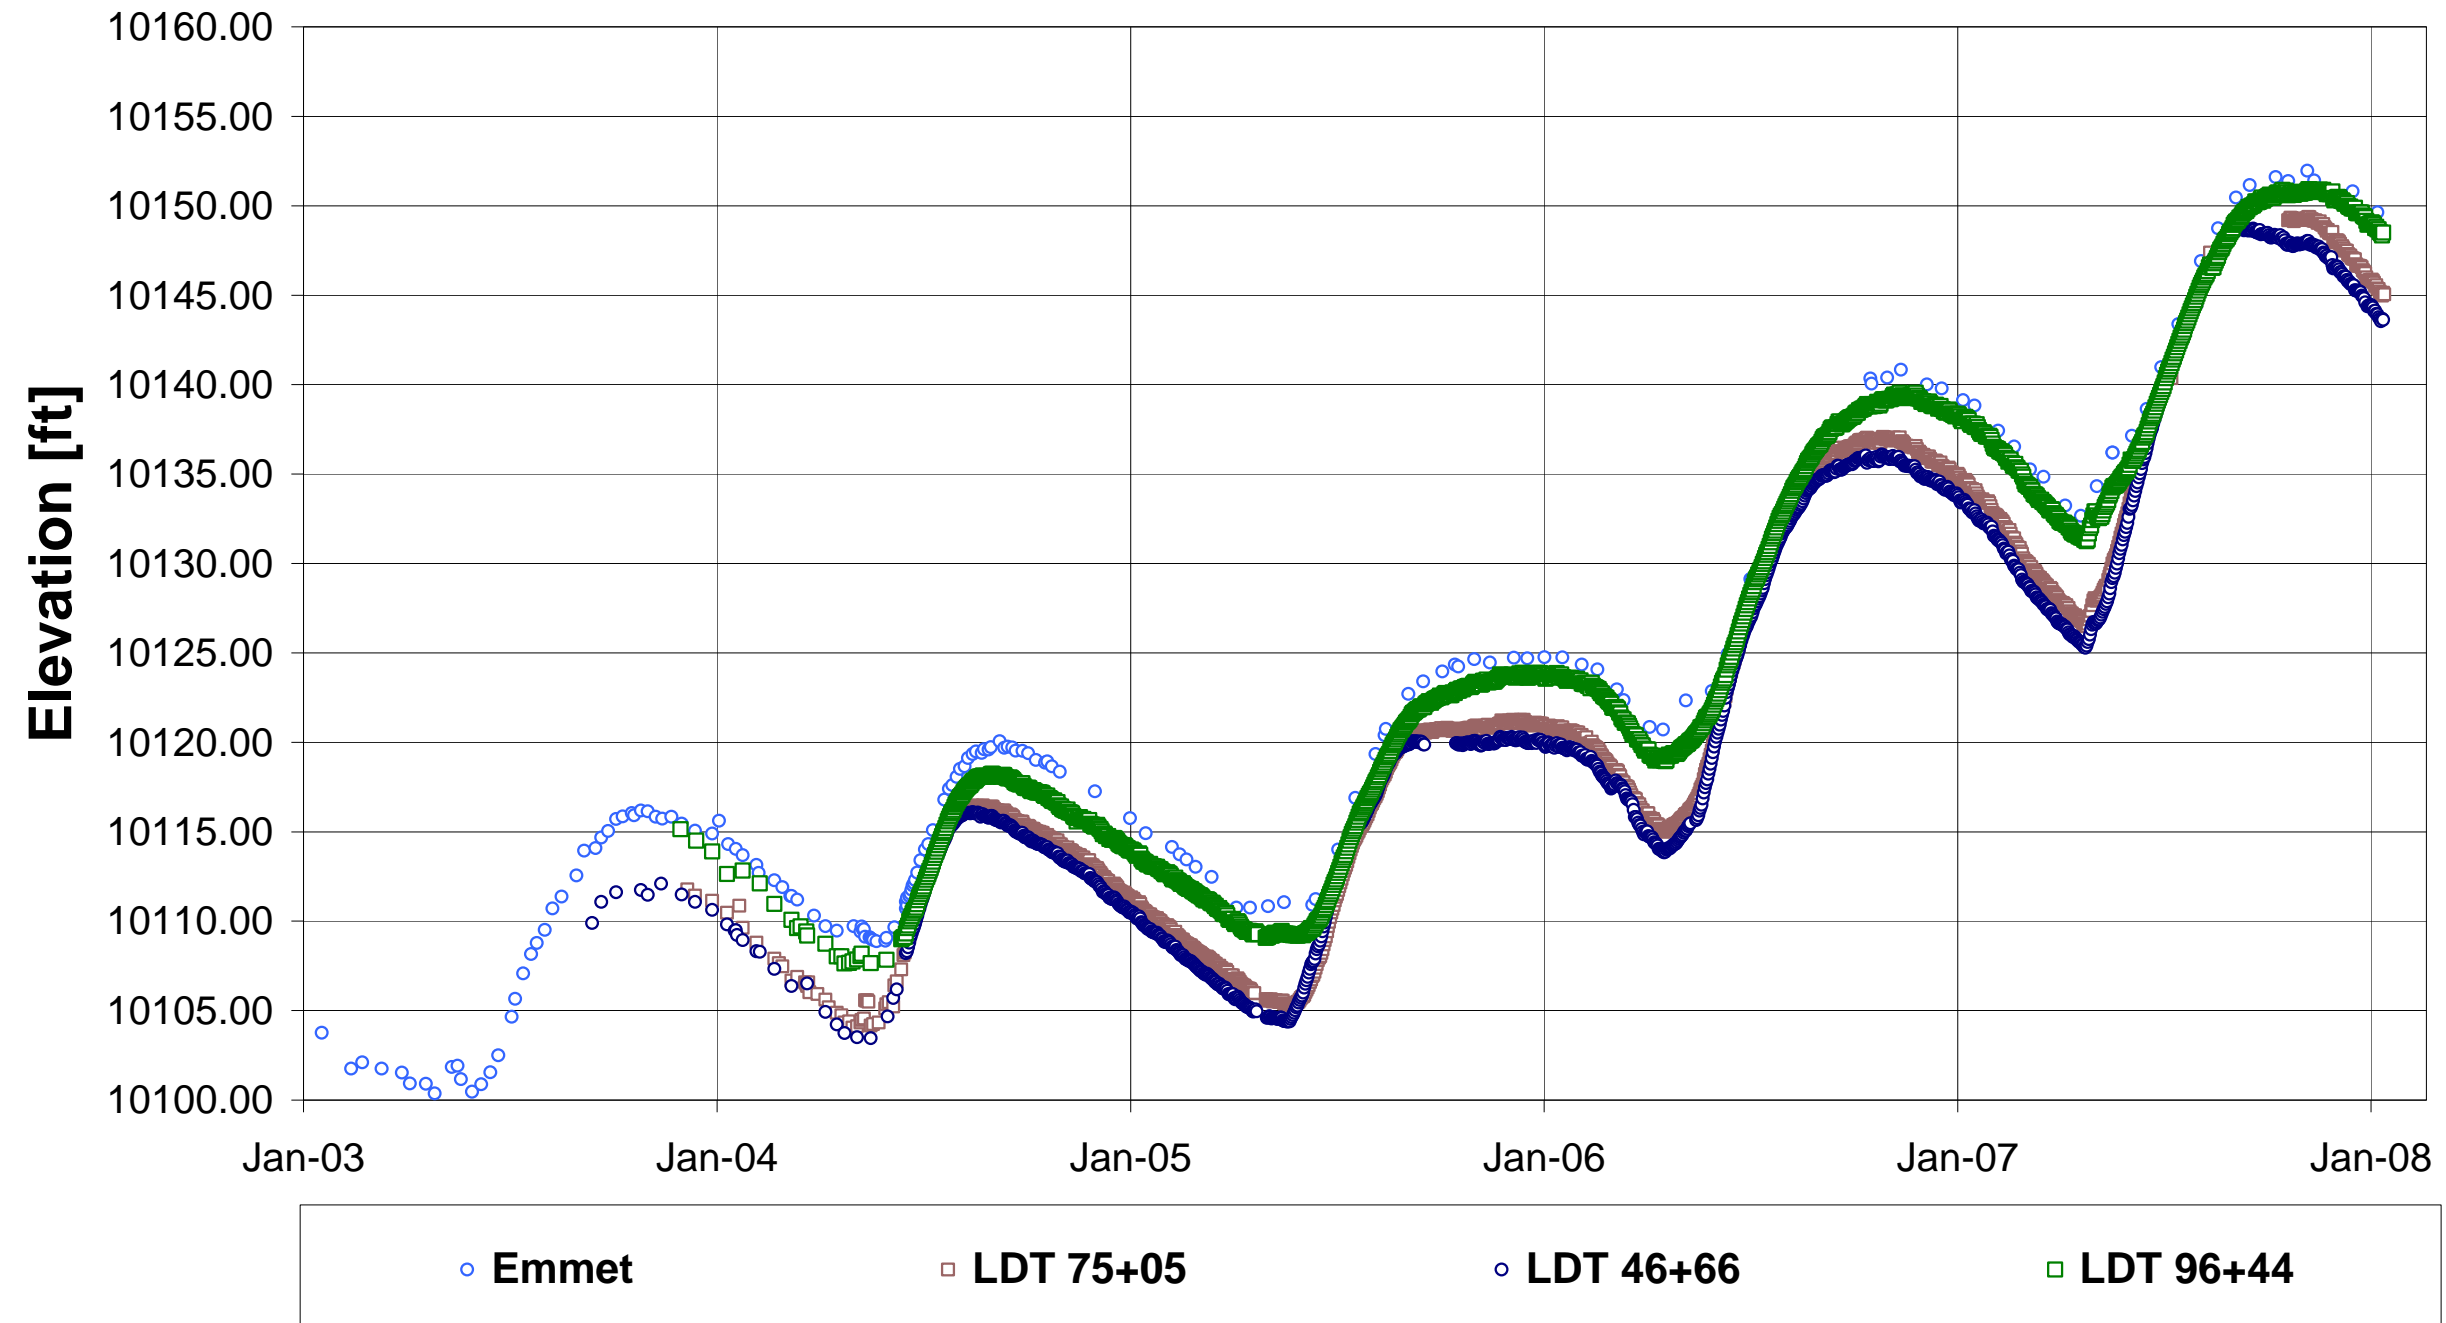
Figure 3. Water Levels in the Upstream Tunnel

The water treatment plant has operated successfully since its construction, providing clean discharge to the river. However, since about 2003, there has been a gradual rise in the water level near the old mine workings (referred to as the “Mine Pool”), as illustrated in Figure 3. Based on monitoring wells, this higher water level is transmitted down the tunnel at least as far as Station 46+66 (monitoring well LDT 46+66), below which the water level drops (monitoring well LDT 36+77). The water level along the tunnel is also shown in Figure 1. Concerns have been raised that if the difference in water level is due to a blockage caused by tunnel collapse, rupture of the blockage under a continued increase in the Mine Pool level could lead to adverse consequences near the tunnel portal. These concerns prompted this PFMEA study.

- There could be interconnection between the Mine Pool and the tunnel as evidenced by the water levels in the Robert Emmet Shaft closely following the tunnel monitoring wells (Figure 3).
