Leadville Mine Drainage Tunnel Risk Assessment

Leadville Mine and Drainage Tunnel Project, Colorado
Great Plains Region

The Bureau of Reclamation has completed a study to evaluate the stability and assess the risk associated with the Leadville Mine Drainage Tunnel (LMDT) in Leadville, Colorado. The risk assessment consists of the following four sections:

Existing Condition of the Leadville Mine Drainage Tunnel

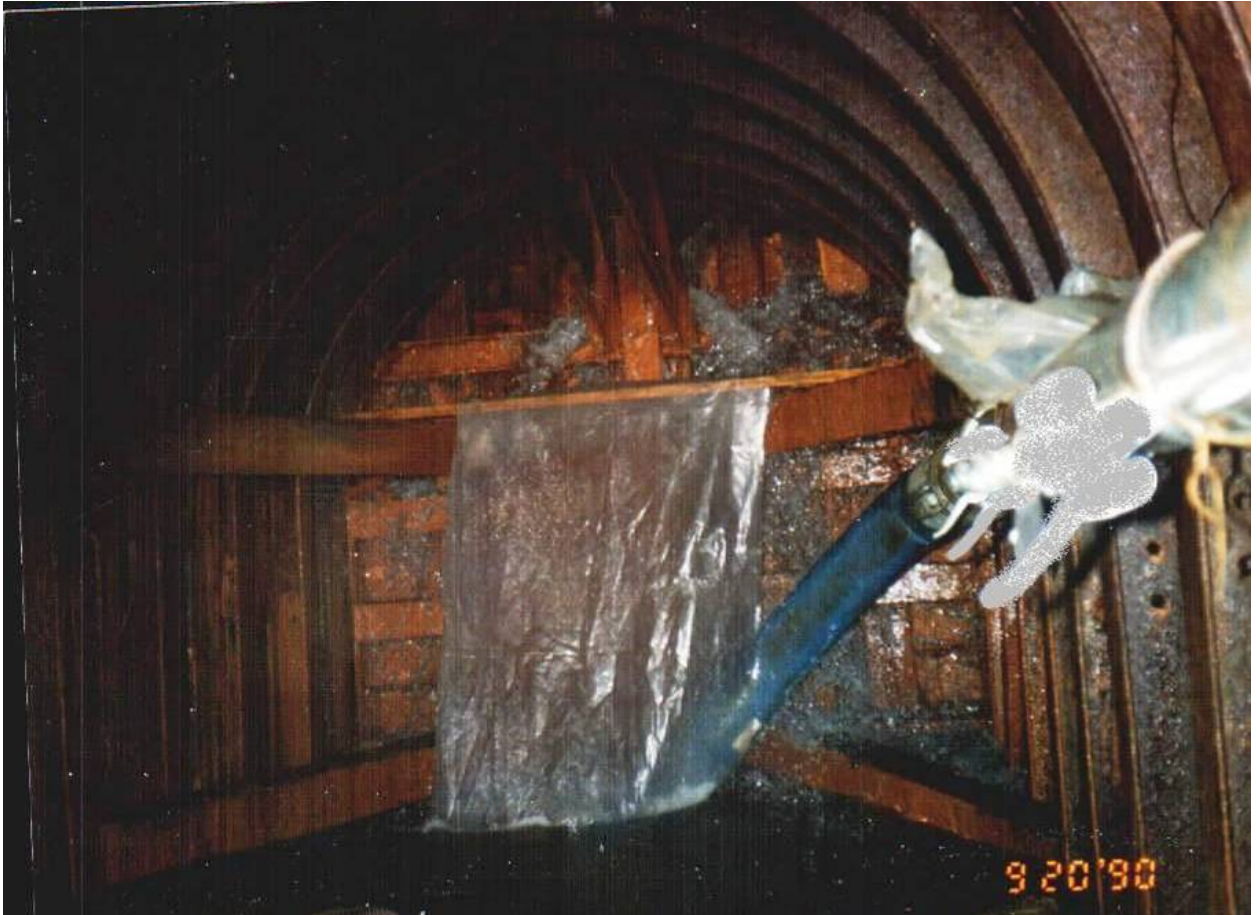
Figure 6. Bulkhead at Station 4+66 (date noted on photo)

- Photos indicate the first timber bulkhead near Station 4+66, which is no longer visible in the tunnel, was braced against steel sets placed downstream of the bulkhead, with gravel fill placed upstream (and subsequently also downstream) of the bulkhead. This bulkhead appears to be quite robust, as shown in Figure 6.

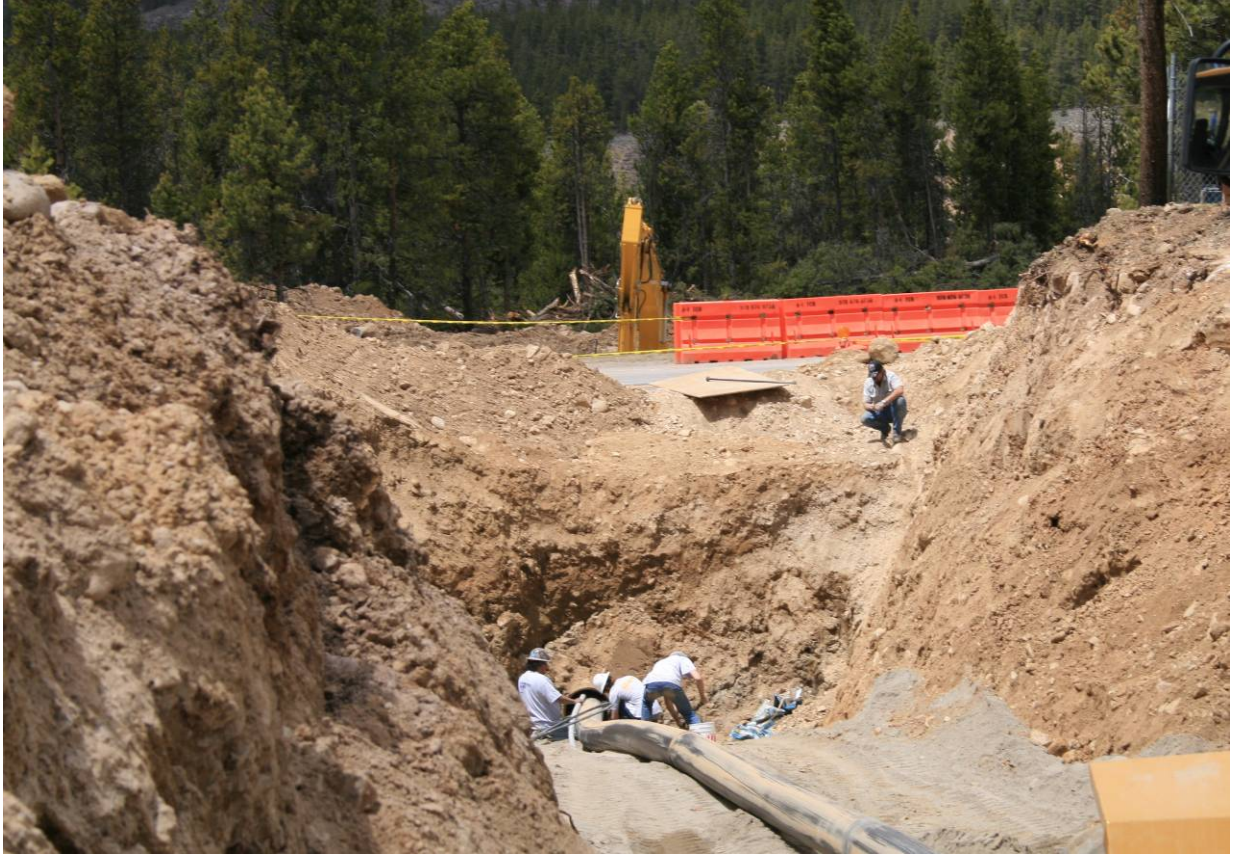
Figure 8. Excavation into the Glacial Moraine at Leadville for installation of a pipeline under Highway 91 along the alignment of the LMDT (late spring 2008)

- Excavation for a pipeline in the spring of 2008 resulted in nearly vertical unsupported slopes up to about 25 feet high in the glacial moraine material, indicating high strength with a component of cohesion, as shown in Figure 8. It would be very difficult to collect and test samples of this material, but this excavation reveals a lot about its strength.
