Macondo

T H E G U L F O I L D I S A S T E R

Chief Counsel's Report | 2011

National Commission on the BP Deepwater Horizon Oil Spill and Offshore Drilling

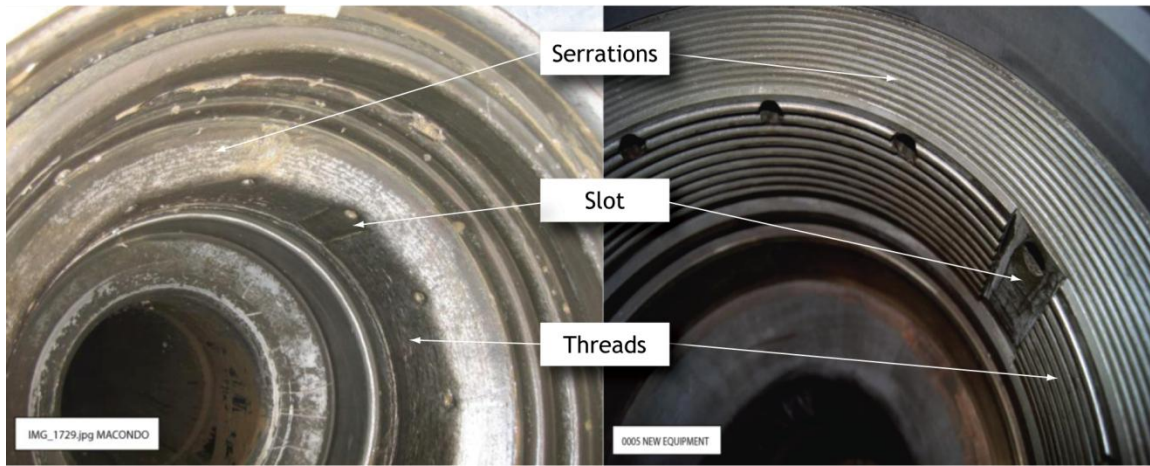
Figure 4.1.8. Erosion of the inside of the casing hanger.

Post-blowout inspection of the production casing hanger and seal assembly retrieved from the Macondo well shows severe erosion on the inside of the casing hanger (shown in the left-side photo in Figure 4.1.8). Serrations near the top of the casing hanger—normally 1/8-inch deep—are almost completely abraded away.⁶⁸ Threads that normally run around the inside of the casing hanger are flattened.⁶⁹ The slot that normally interrupts the threads—1/4-inch deep when new—appears as an almost nonexistent indentation.⁷⁰ These observations all suggest that hydrocarbons came up through the production casing.

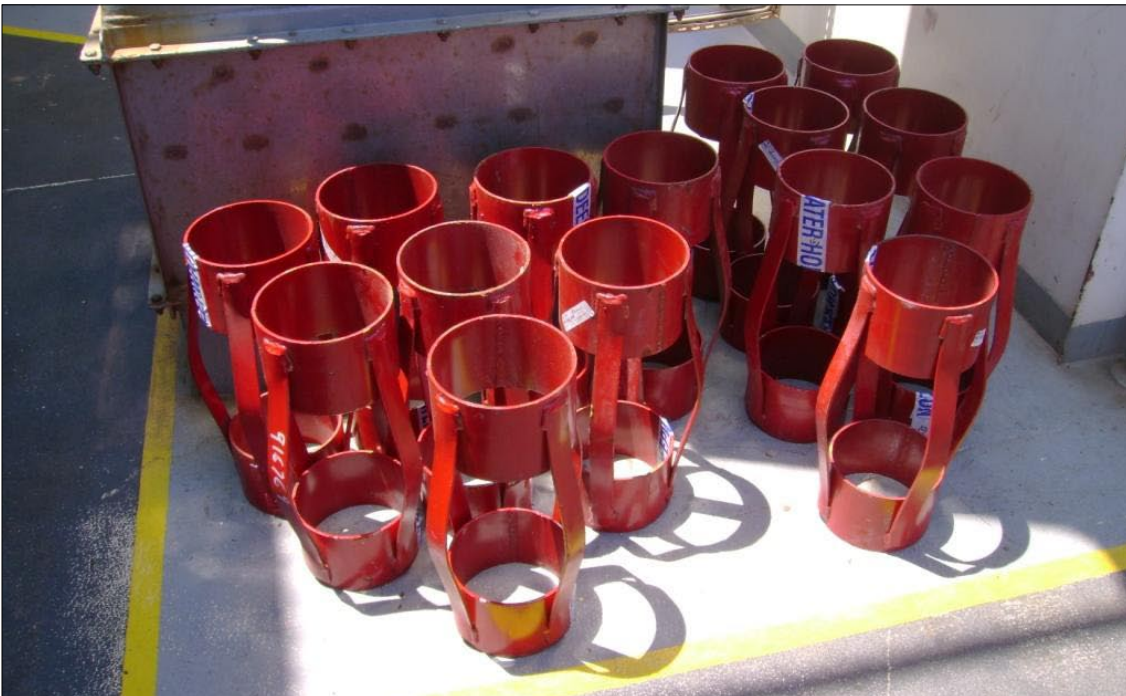
Figure 4.3.15. Centralizers delivered to the *Deepwater Horizon* on April 16, 2010.

Sometime after 5 a.m. on April 16, a helicopter arrived at the *Deepwater Horizon*, carrying the 15 additional centralizers and Weatherford service technician Daniel Oldfather.¹⁰⁸ The helicopter did not, however, carry the stop collars and accessories that would be needed to secure the centralizers on the casing. Those had been shipped by boat and were scheduled to arrive by 4 p.m. (before the casing would be run).¹⁰⁹ Oldfather explained this to the rig crew when he landed.¹¹⁰

Morel was still visiting the rig at the time the helicopter landed. He examined the centralizers when they arrived. Like the other BP engineers, he had expected that the centralizers would have integrated stop collars. He now recognized that this was not the case.¹¹¹ Morel called Guide and told him that these were not the “one-piece” centralizers that he was expecting. Guide agreed they were not what he had planned on using either.¹¹² Morel took digital pictures of the centralizers and emailed them to Guide, telling him that “the centralizers do not have the stop [collars] on them.”¹¹³ However, Morel also told Guide that the centralizers could still be used because the boat carrying the collars would arrive in “plenty of time before needing them.”¹¹⁴

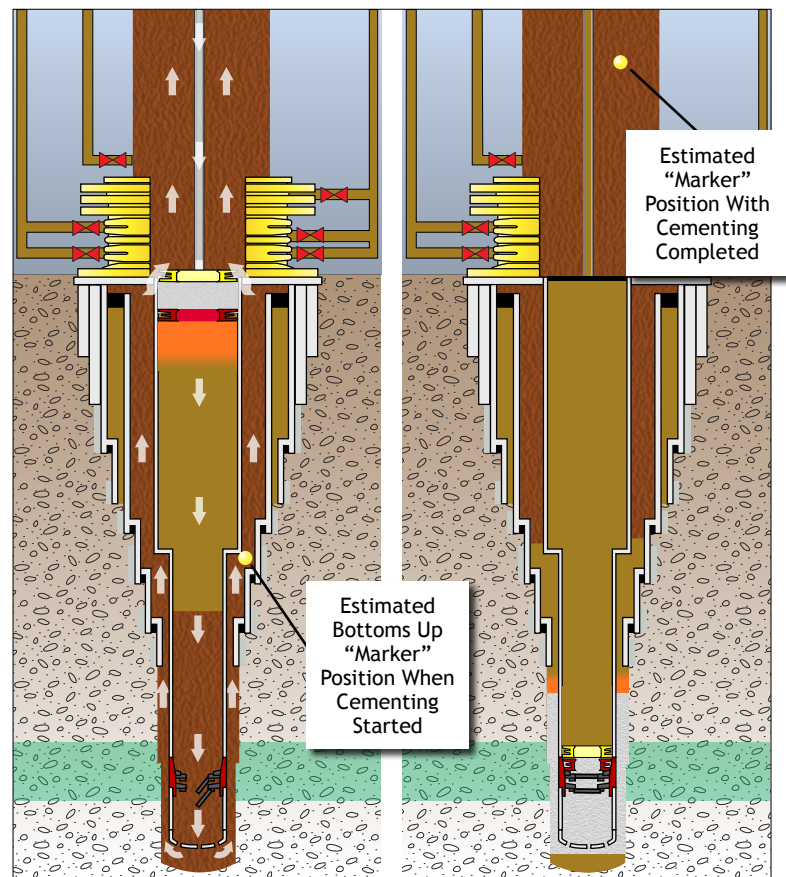
Figure 4.3.18. BP's pre-cementing mud circulation.

At approximately 4:18 p.m. on April 19, the rig crew re-established mud circulation after running the long string.¹⁹⁹ The rig crew then circulated a total of approximately 350 barrels of mud at rates up to 4 bpm before beginning the cementing process.²⁰⁰ This figure exceeds the 261 bbl called for in the April 18 Halliburton cement job procedure²⁰¹ but is significantly lower than the 2,760 bbl required for a full bottoms up.²⁰²

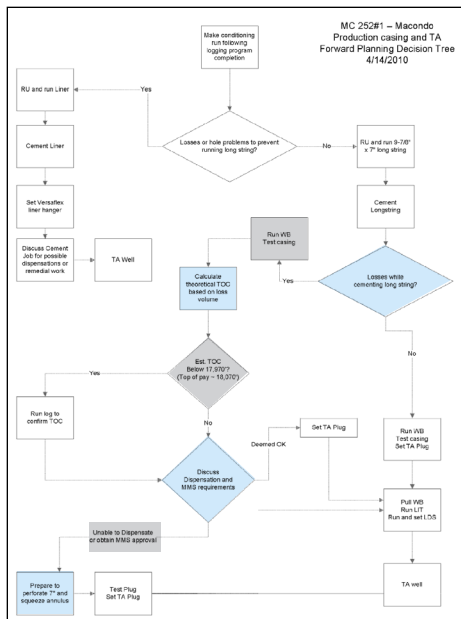
Figure 4.3.19. Decision tree.

reported losses while pumping the cement job, the decision tree stated that BP engineers would “Calculate theoretical [top of cement] based on loss volume.” If that calculation estimated that TOC was *below* 17,970 feet that would mean that there was less than 100 feet of cement above the top of the pay zone—400 feet less than MMS requires.²⁴⁷ In that situation, the decision tree required a “log to confirm” the TOC.

If the theoretical calculation predicted that TOC was *above* 17,970 feet, the decision tree stated that the Macondo team would discuss MMS requirements and consider seeking a dispensation. If unable to get dispensation or “obtain MMS approval,” then BP would “perforate” the casing and “squeeze” the annulus to remediate the cement job. An operator would not normally run a cement evaluation log and plan to remediate cement before temporary abandonment operations; the Macondo team’s explicit discussion of these contingencies illustrates how concerned they were about the possibility of cement losses.²⁴⁸

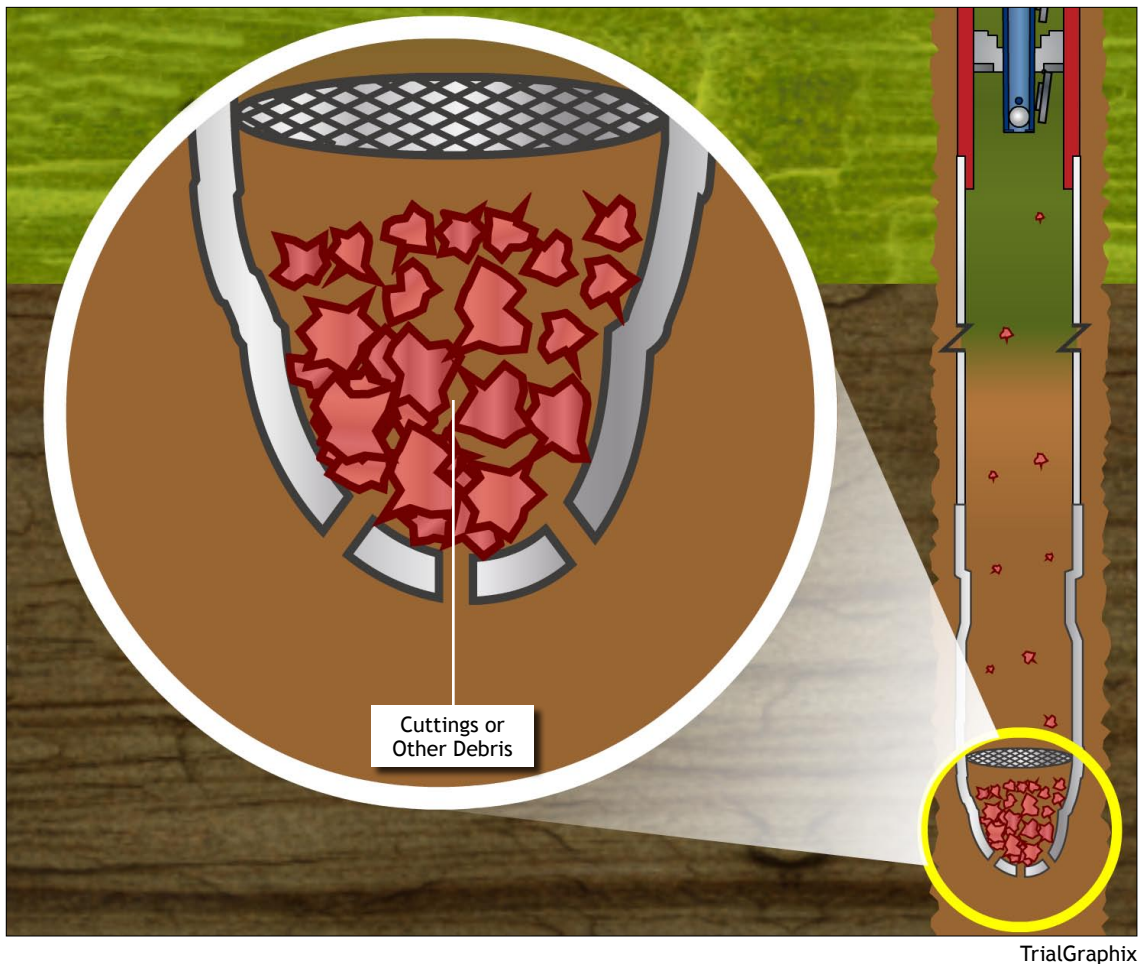
Figure 4.3.20. Clogged reamer shoe.

bottom of the reamer shoe.³⁰⁵ Debris and/or cuttings may have plugged these holes during the course of casing installation as shown in Figure 4.3.20. This could explain why the rig crew was unable initially to establish mud circulation after landing the production casing. It could also explain why the pressure dropped suddenly from 3,142 psi—that pressure may have been sufficient to clear a clog in the reamer shoe to allow mud to flow again.

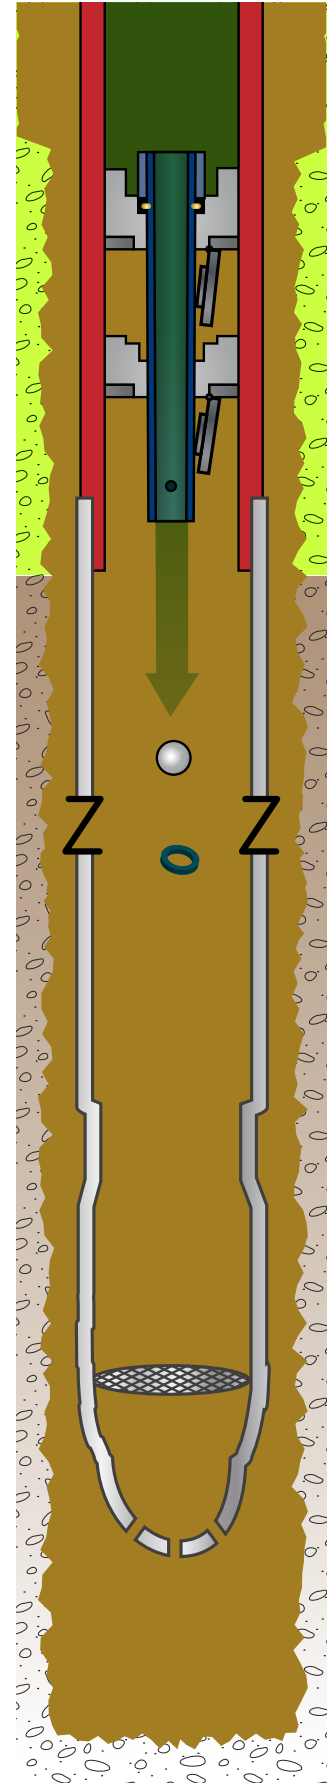
Figure 4.3.21. Ball forced through tube.

A second possibility, shown in Figure 4.3.21, is that the sudden pressure drop may have been caused when pump pressure forced the ball inside the auto-fill tube through the end of the auto-fill tube. The collar that would normally have retained the ball within the auto-fill tube was held in place with brass pins. It is possible those pins and the collar failed, allowing the ball to pass through.³⁰⁹ This would have left the auto-fill tube in place between the float valves and created a path for flow in either direction.

If the ports in the bottom of the auto-fill tube were clogged, the rig pumps may have placed enough force on the collar to shear the brass pins instead of the pins holding the auto-fill tube in place. Clawson informed Morel on April 19 that it would only take 1,300 psi of pressure to force the ball through the collar without converting the float valves.³¹⁰ It is not apparent whether Morel considered or informed others of this possibility.³¹¹

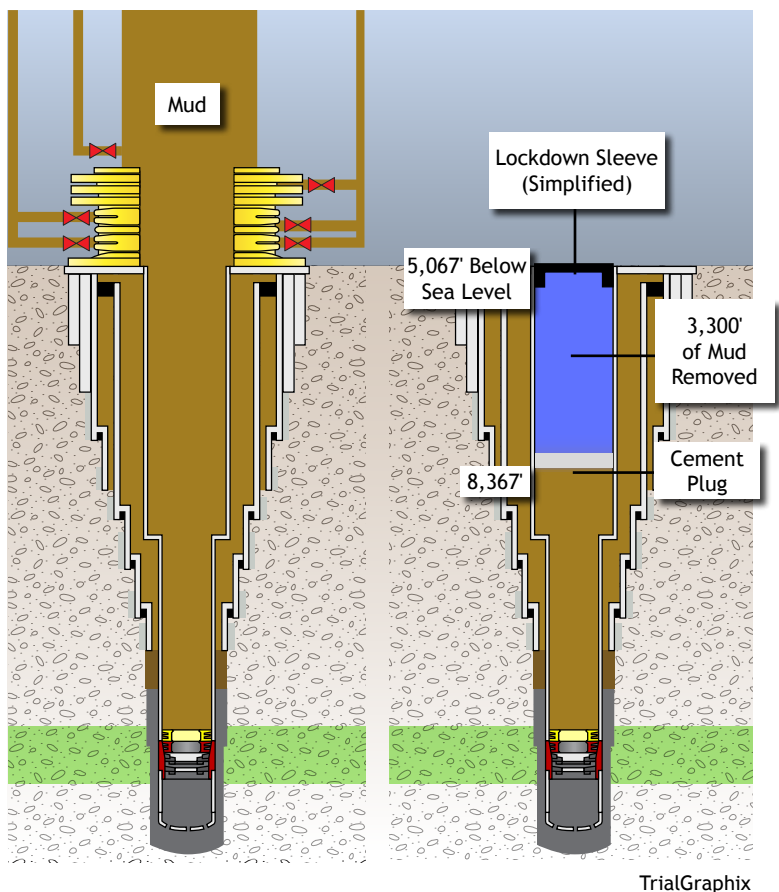
Figure 4.5.1. Planned configuration after temporary abandonment.

After finishing cementing the production casing (left), the rig crew began temporary abandonment procedures that would have allowed the *Deepwater Horizon* to remove its riser and BOP from the well and move on to another job (right). The blowout occurred before the rig crew set the cement plug and lockdown sleeve.

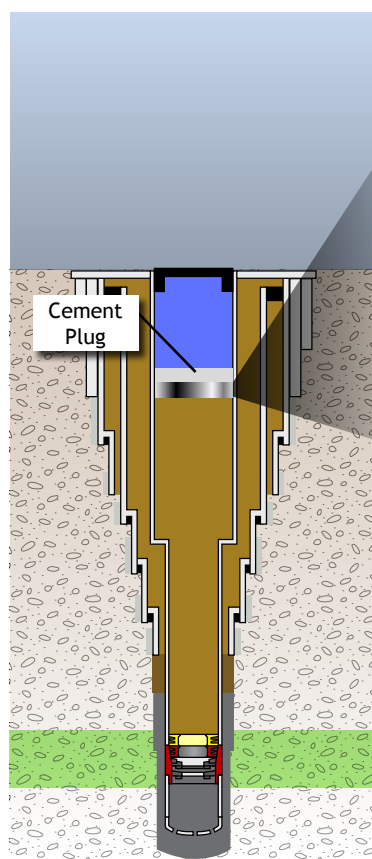
Figure 4.5.5. Bridge plug.

BP could have used a mechanical plug in lieu of or in addition to a cement plug.

seawater.¹⁰⁵ Setting a cement plug in mud can present a risk of contamination and certain other chemical complexities.¹⁰⁶ But contamination issues can exist with cement plugs set in seawater as well,¹⁰⁷ and the complexities can be managed with proper cement slurry design and the use of spacer.¹⁰⁸ In order to help ensure that cement plugs set in drilling mud are secure, engineers also use **mechanical retainers** or **bridge plugs**—metal and rubber devices that fit into the casing and hold the cement,¹⁰⁹ as shown in Figure 4.5.5. The mechanical plug then serves as an additional barrier, apart from the cement it helps to set.¹¹⁰

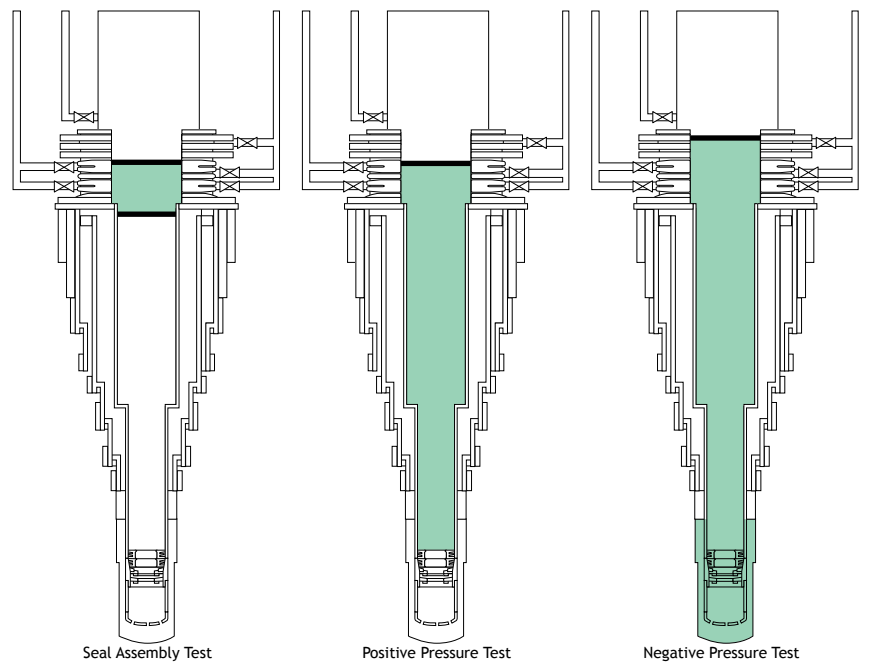
Figure 4.6.1. Well integrity tests.

The rig crew conducted three pressure tests as part of the temporary abandonment procedure to verify the integrity of the well. From left to right: the seal assembly test, the positive pressure test, and the negative pressure test. Test regions are shown in green.

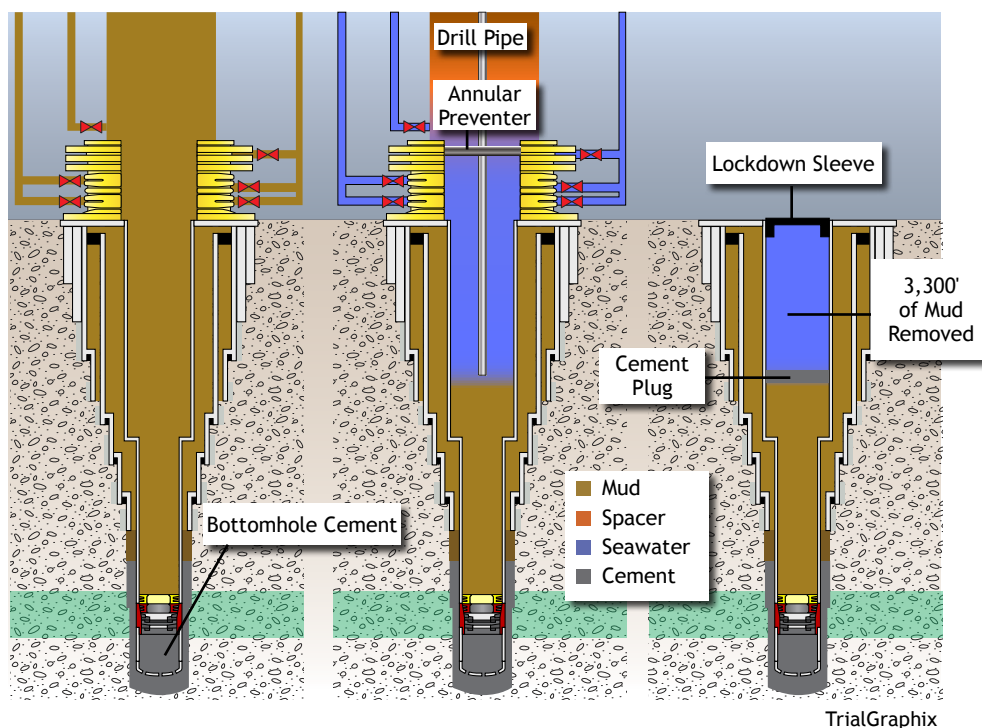
Figure 4.6.5. End of cement to temporary abandonment.

After the final casing string was cemented, heavy drilling mud filled the riser and the well (left). After the temporary abandonment planned for Macondo, the riser and its drilling mud would be removed. The drilling mud in the final casing string would be replaced with lighter seawater to a depth of over 8,000 feet below sea level (right). The removal of the hydrostatic pressure this drilling mud applied to the bottom of the well would increase the stress on the casing, seals, and cement. The negative pressure test simulated the conditions of temporary abandonment to confirm the integrity of the well in a controlled environment (middle).

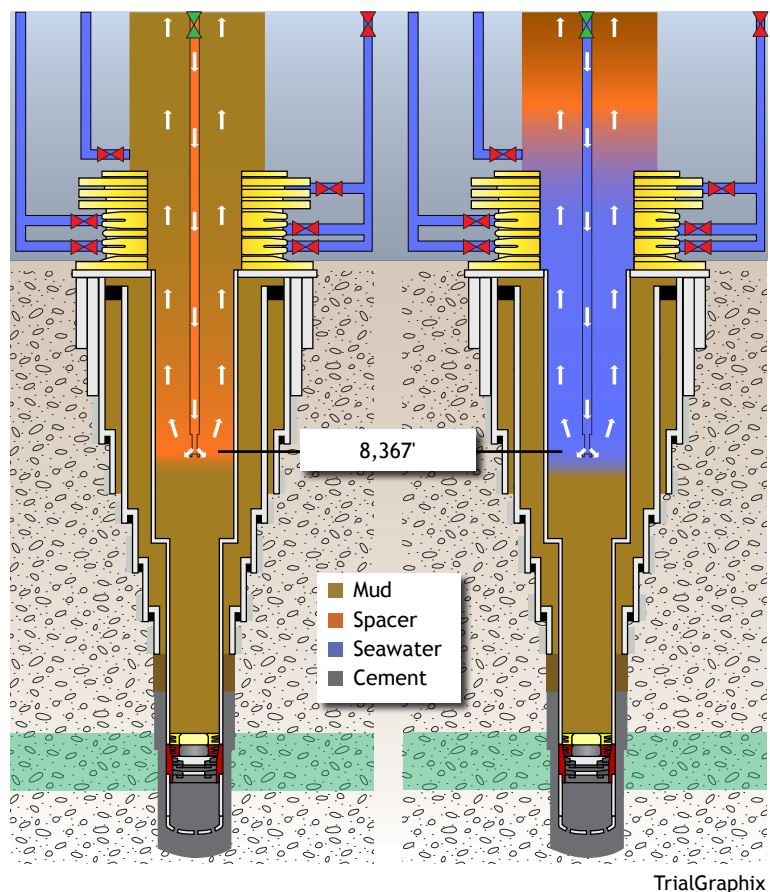
Figure 4.6.6. Preparations for the negative pressure test.

To prepare for the negative pressure test, the rig crew needed to displace the mud in the drill pipe and casing string from a depth of 8,367 feet to above the BOP. The crew did so by pumping spacer fluid (left) and then seawater (right) down the drill pipe until the mud was above the BOP.

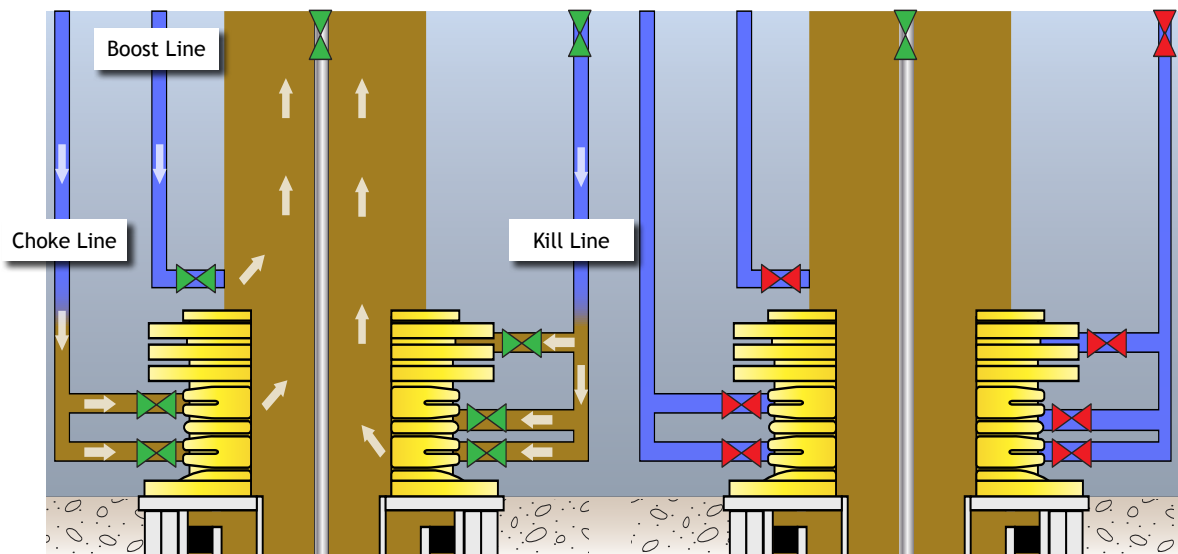
Figure 4.6.9. Negative pressure test progress, 3 p.m. on April 20, 2010.

To begin preparations for the negative pressure test, the rig crew displaced the boost, choke, and kill lines with seawater. Seawater was pumped into the lines on the rig, forcing mud into and up the riser (left). After the lines were displaced, the crew closed the valves connecting them to the riser and BOP (right).

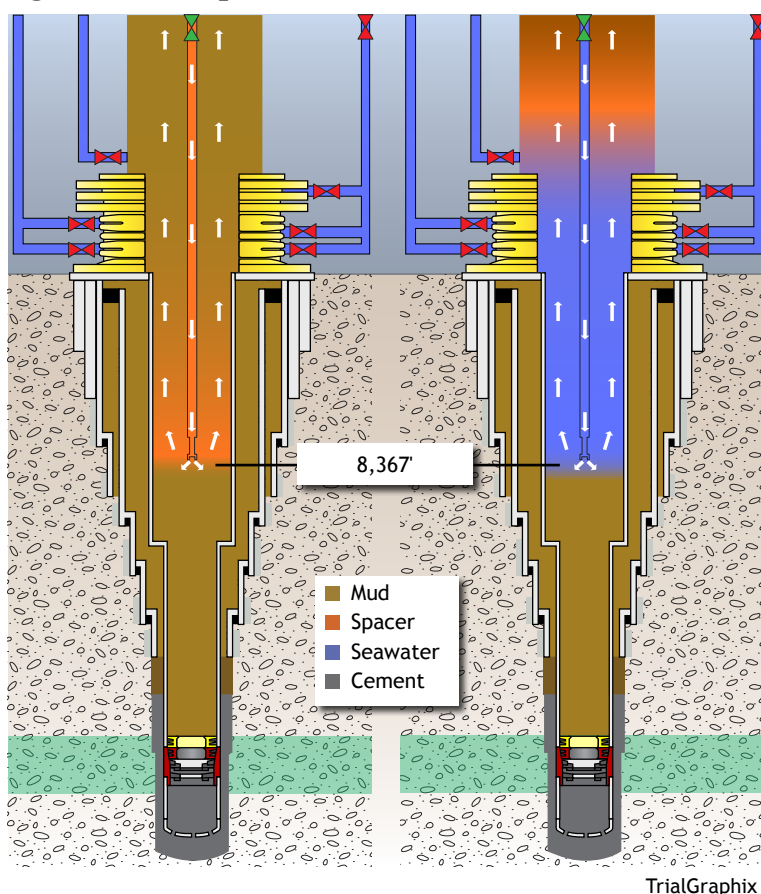
Figure 4.6.10. 4 p.m.

The crew displaced the mud in the drill pipe and in the casing from 8,367 feet to above the BOP. The crew first pumped a spacer fluid down the drill pipe, which forced the mud out and up the casing and the riser (left). Following the spacer, the crew pumped seawater into the drill pipe. This forced the spacer and the mud up the casing. The crew’s intent was to pump enough seawater to displace the spacer and mud above the BOP (right).

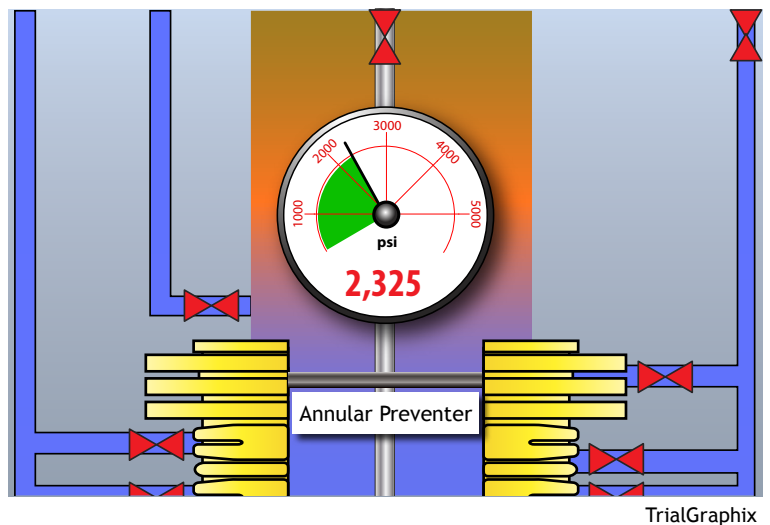
Figure 4.6.11. 4:53 p.m.

After pumping 352 barrels of seawater behind the spacer, the crew closed the upper annular preventer, believing that they had displaced all of the spacer above the BOP.²⁵ BP's post-incident report calculates that the crew was correct, albeit by a slim margin of just 12 feet.²⁶ But that calculation is optimistic. It assumes that none of the heavy spacer fell back down through the much lighter seawater that was pushing it upward through the wellbore. Given the substantial density differential between the spacer and seawater and the substantial amount of time it took to displace 454 barrels of spacer, it is likely that at least some of the spacer fell backward through, or mixed with, the seawater on its way up the casing into the riser. Even putting aside that complication, Transocean and at least one independent expert have calculated that the tail end of the spacer did not end up above the BOP.²⁷

The crew closed the annular preventer around the drill pipe. The drill pipe pressure was approximately 700 psi higher than should have been expected, a sign that some spacer may have remained beneath the BOP.

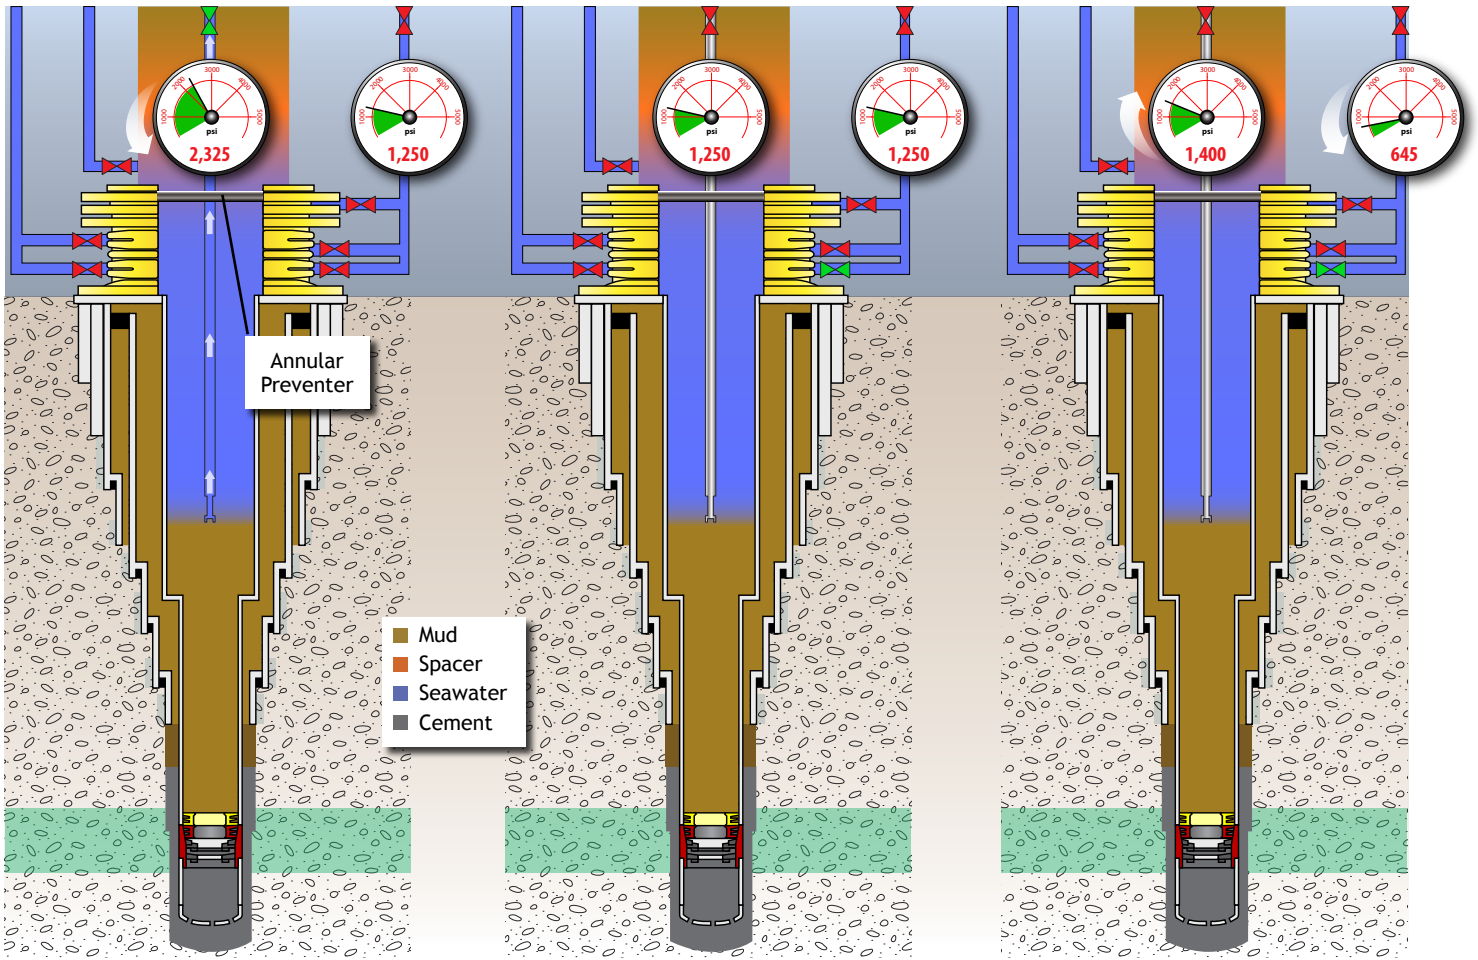
Figure 4.6.12. 4:55 p.m.

After the annular preventer was closed (left) the crew bled down the pressure in the drill pipe to equalize its pressure with the pressure in the kill line. Because both the drill pipe and the kill line go to the same vessel, when the valve connecting the kill line to the BOP is opened, the pressures should remain equal (middle). Instead, when the valve was opened, the pressures diverged (right).

The rig crew next bled the drill pipe to 1,250 psi, in an effort to equalize pressure on the drill pipe with pressure on the kill line (which was 1,250 psi at the time, as shown in Figure 4.6.12).³⁰ Once the crew had bled the drill pipe pressure down to 1,250 psi, it opened a valve on the kill line at the BOP so that both the drill pipe and kill line were open to the well. At this point, the drill pipe and kill line should have behaved like two straws in the same glass of water: The pressure in both should have been a steady 1,250 psi. Instead, when rig personnel opened the valve, the drill pipe pressure jumped, and the kill line pressure dropped.³¹

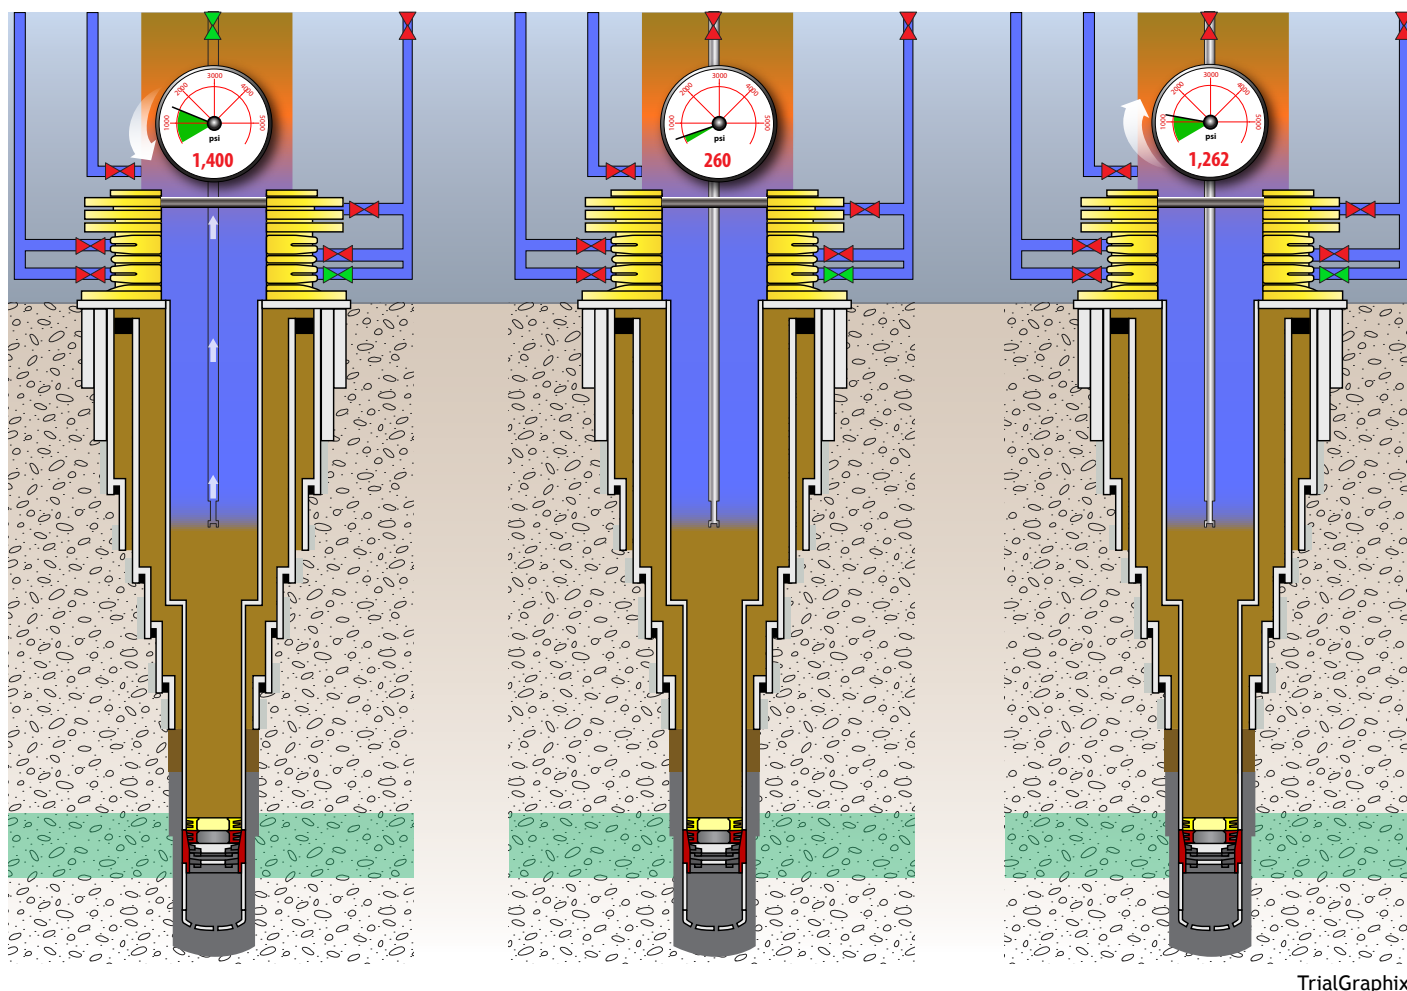
Figure 4.6.13. 4:58 p.m.

The crew began the negative pressure test by attempting to bleed the drill pipe pressure to 0 psi (left). However, the crew was unable to reduce pressure to below 260 psi (middle). This bleed returned an unknown amount of water to the rig. The crew shut in the drill pipe, and the pressure built up to 1,262 psi (right). In a successful negative pressure test, pressure does not build up.

The uncertainty over how much fluid flowed from the well during the bleed-off suggests that the well site leaders and crew failed to monitor the bleed-off volumes with requisite rigor. It does not appear that anyone had calculated ahead of time how many barrels should have flowed from the

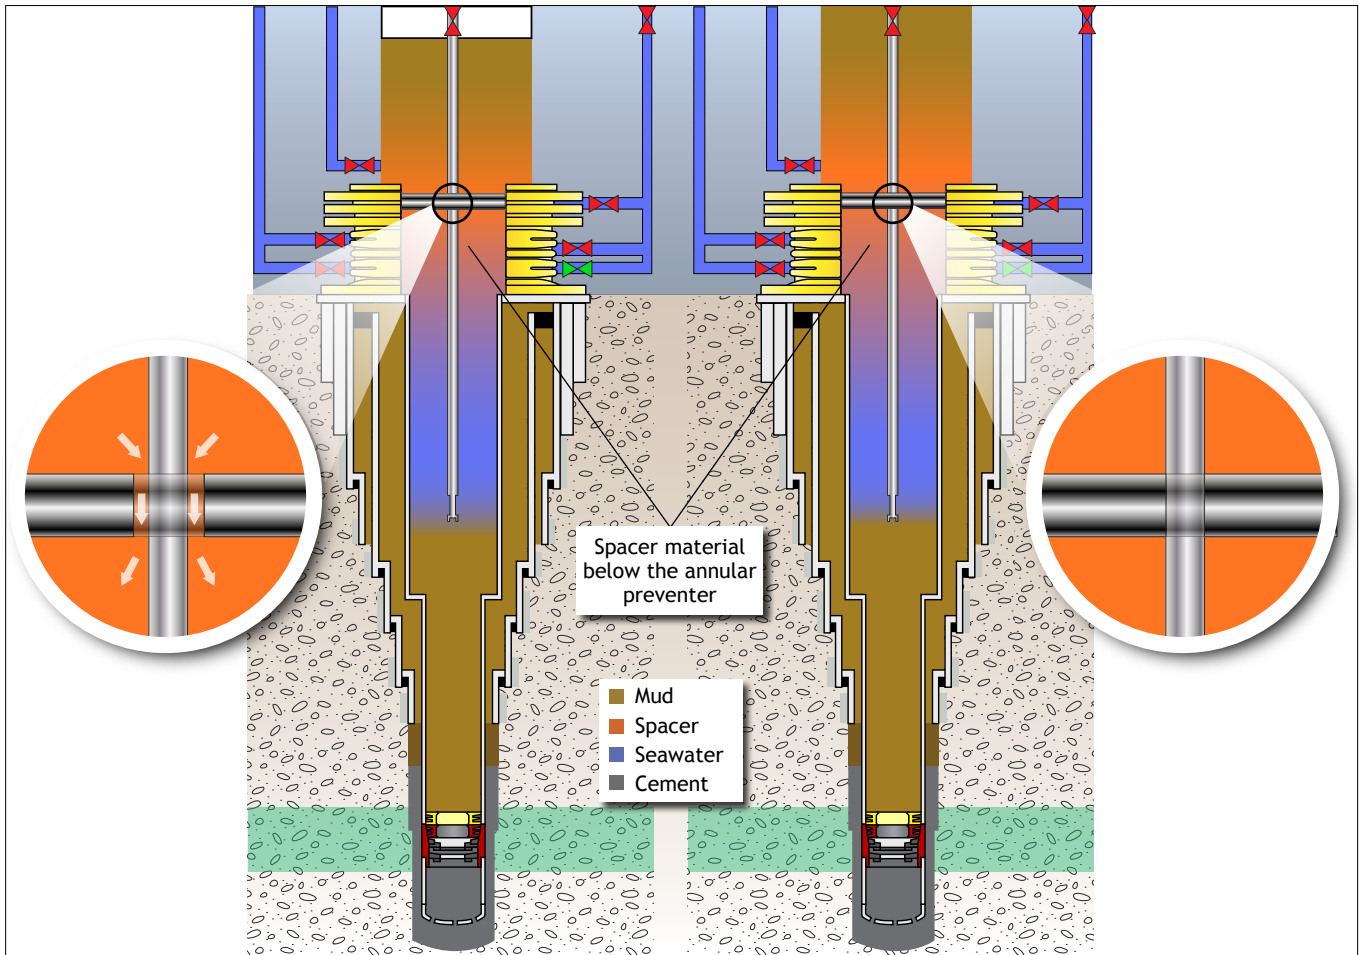
Figure 4.6.14. 5:10 p.m.

The rig crew noticed that the fluid level in the riser was falling. Because the annular preventer was not sufficiently tight around the drill pipe, spacer fell beneath the BOP (left). In response, the rig crew tightened the seal of the annular preventer and refilled the riser (right), but did not circulate the spacer back above the BOP.

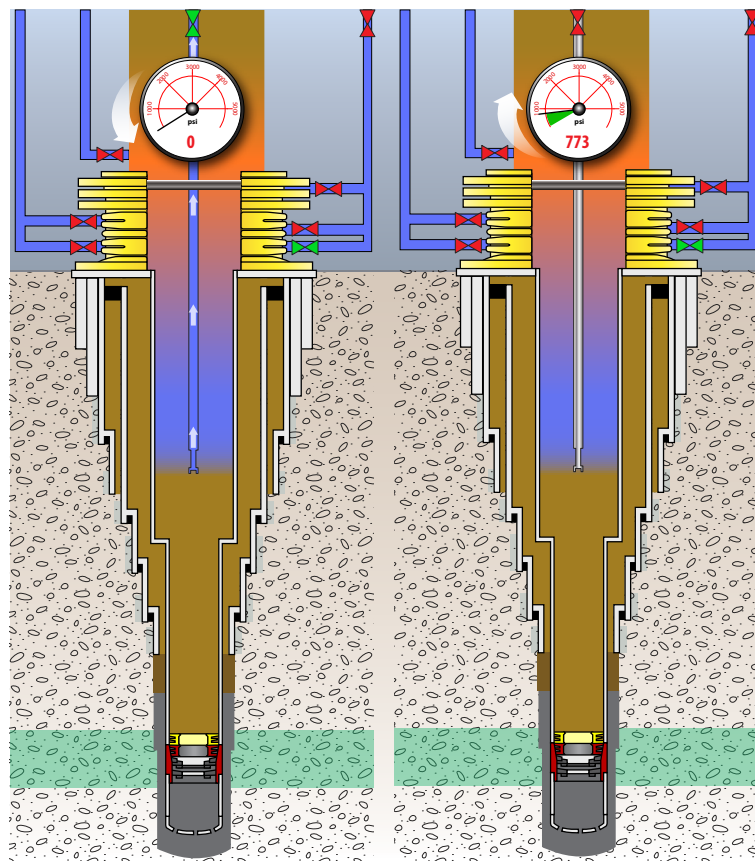
Figure 4.6.15. 5:26 p.m.

The rig crew attempted again, this time successfully, to bleed the drill pipe pressure down to 0 psi. Fifteen barrels of seawater were returned during this bleed (left). The drill pipe was shut in, but the drill pipe pressure rose to 773 psi. Fifteen barrels is a higher return than should have been expected, and the drill pipe pressure should not have built back up.

The rig crew bled drill pipe pressure down for a third time, this time through the kill line. Witnesses reported that three to 15 barrels were returned as the drill pipe reached 0 psi (left). When the drill pipe was shut, the drill pipe pressure rose to 1,400 psi. According to BP witnesses, the Transocean rig crew attributed this rise to a “bladder effect.” A 15-barrel return would have been excessive, and the rise of drill pipe pressure to 1,400 psi was a clear sign that the negative pressure test had failed (right).

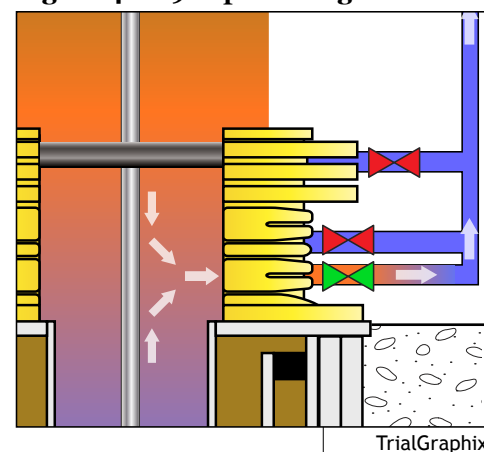
Figure 4.6.19. Spacer migration.

The second negative pressure test showed again that the well lacked integrity. The 1,400 psi reading from the drill pipe indicated that hydrocarbons were leaking into the well. The fact that the kill line pressure was 0 psi at this time suggests that something may have been blocking fluids from flowing through the kill line and transmitting pressure to the gauges on the rig. One possibility, alluded to earlier, is that the spacer below the BOP had migrated into the 3¹/₁₆-inch

Leftover lost circulation material used as spacer for the negative pressure test could have migrated into the kill line during bleeds.

diameter kill line and clogged it.⁹⁰ It is also possible that rig crews accidentally closed a valve that should have been open. The kill line could also have been clogged by undisplaced mud in the kill line or by gas hydrates that solidified during the test (the same type of hydrates that complicated containment operations).⁹¹ The exact reason may never be known.

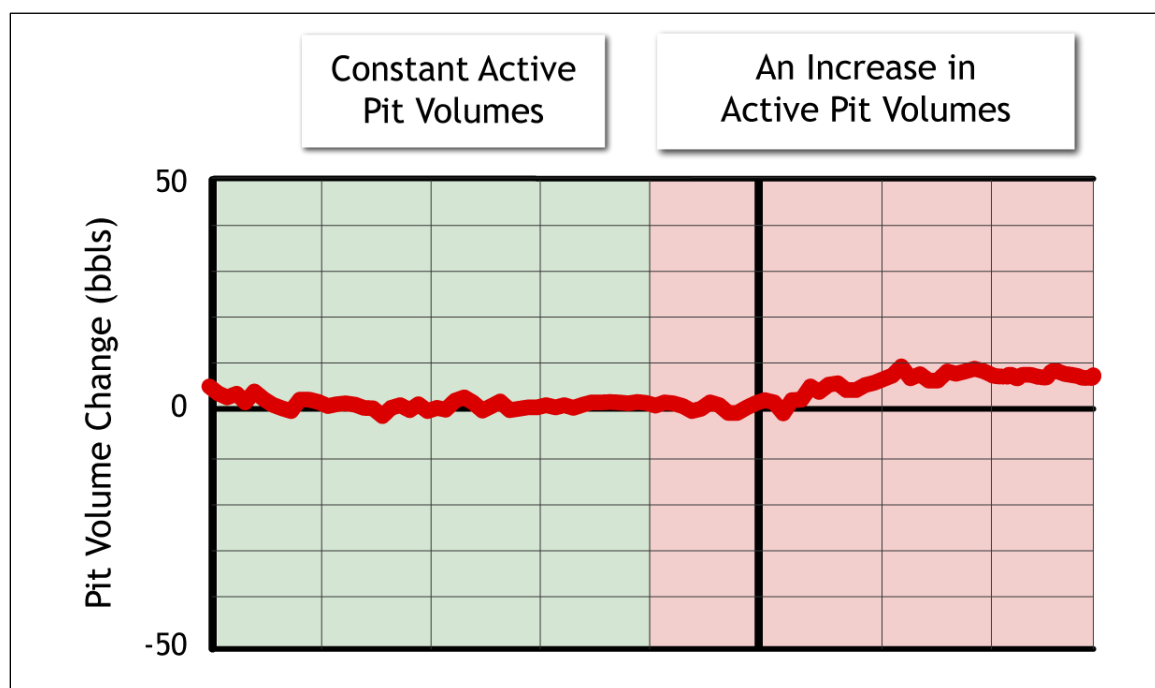
Figure 4.7.1. Active pit volume in a closed-loop system.

In a closed-loop system, active pit volume will remain constant so long as the well is stable. An increase in active pit volume strongly indicates that a kick is under way.

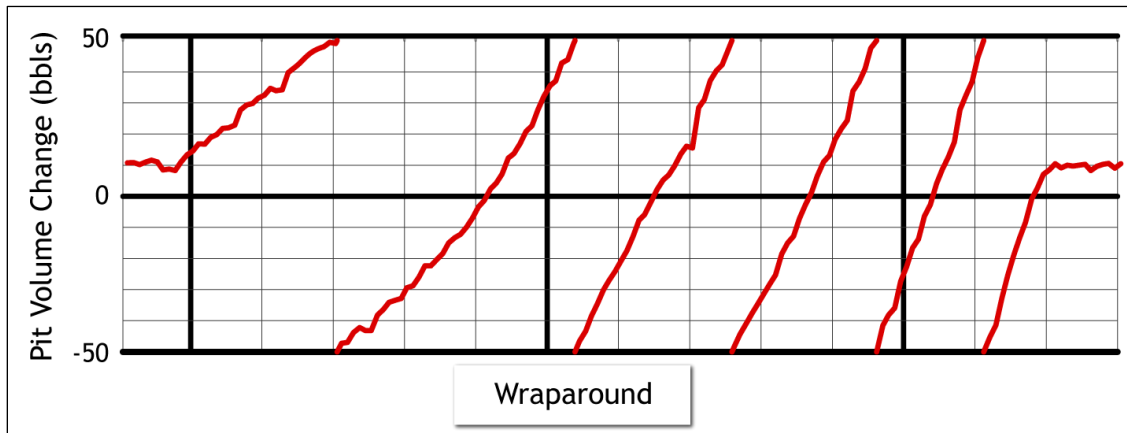
Figure 4.7.2. Active pit volume in a non-closed-loop system.

In a non-closed-loop system, active pit volume will increase continuously regardless of the well's stability.

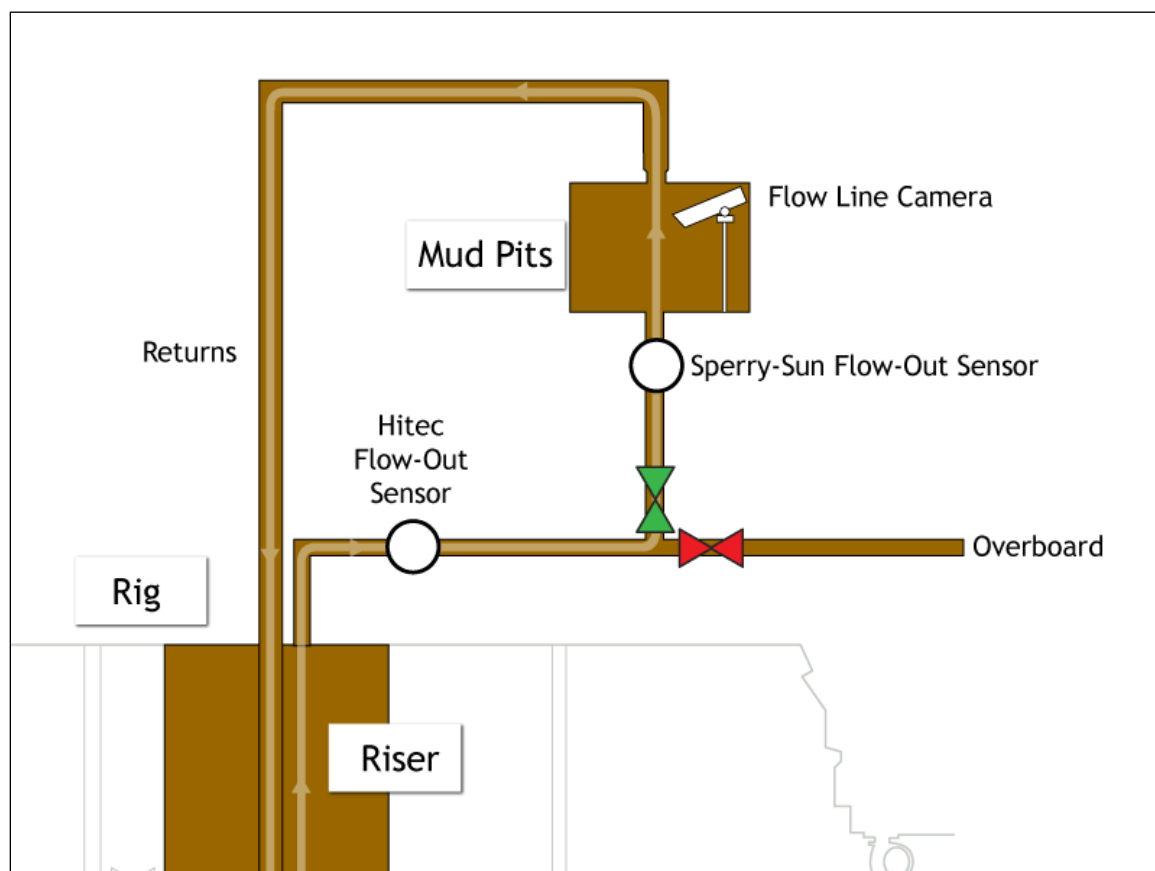
Figure 4.7.5. Flow-out sensors and flow line camera.

In addition to the data display systems, the rig also had video cameras that monitored key areas and components, including the rig floor and the flow line. The flow line camera (also illustrated in Figure 4.7.5) simply pointed at the flow line. Like the Sperry-Sun flow-out sensor, this camera was located after the fork; rig personnel could use it to observe flow returning to the pits but not flow that had been routed overboard.⁴⁷ When returns were sent overboard, rig personnel could still visually inspect for flow but could not do so using the video camera. They had to physically look behind the gumbo box (which was located before the fork).⁴⁸

The Sperry-Sun flow-out sensor and the rig's flow line camera could not register returns going overboard. The Hitec flow-out sensor could, but data from the Hitec flow-out sensor sank with the rig.

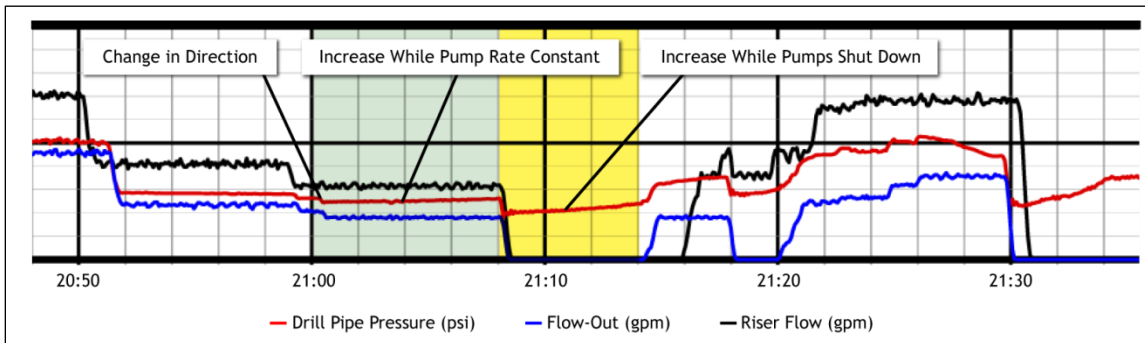
Figure 4.7.10. Drill pipe pressure anomalies from 9:01 to 9:14 p.m.

During the course of these activities, drill pipe pressure gradually increased. From 9:08 to 9:14 p.m., while the pumps were shut down, drill pipe pressure increased by approximately 250 psi (see Figure 4.7.10). This was a significant anomaly.¹⁵² By 9:14 p.m., the increase would have been noticeable and a cause for concern.¹⁵³ The driller apparently missed this increase, perhaps because “having looked and seen 60 seconds of constant pressure...he may have then turned to do the next step in the process which was line up another mud pump to pump down the kill lines.”¹⁵⁴ It is unclear why the assistant driller and the mudlogger also missed the increase.¹⁵⁵

At 9:01 p.m., drill pipe pressure changed direction. By 9:08 p.m., with the pump rates constant, drill pipe pressure had increased by approximately 100 psi. From 9:08 to 9:14 p.m., while the pumps were shut down, drill pipe pressure increased by approximately 250 psi. Each of these changes in drill pipe pressure was an anomaly that should have prompted rig personnel to stop and investigate, but the signs apparently went unnoticed.

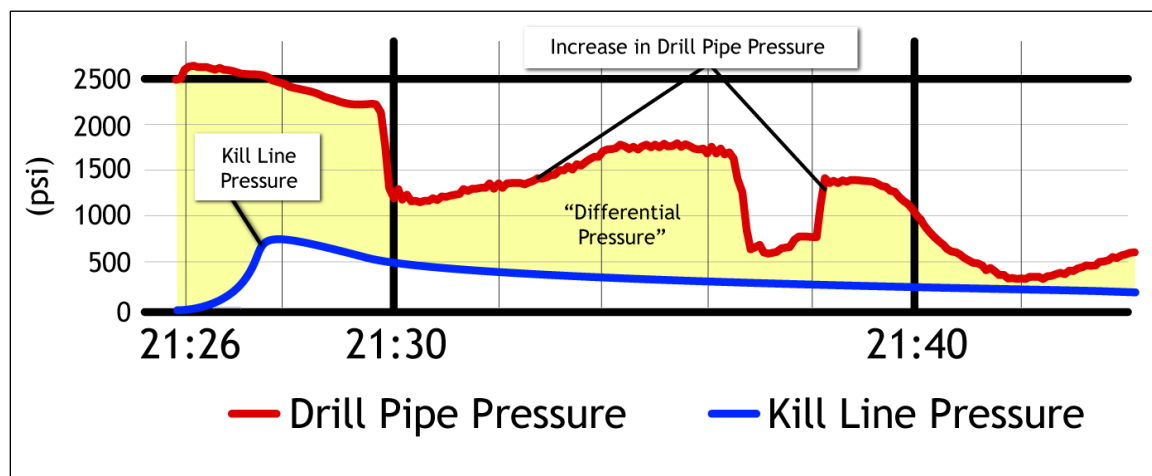
Figure 4.7.11. Drill pipe pressure and kill line pressure anomalies from 9:27 to 9:40 p.m.

From 9:30 to 9:35 p.m., drill pipe pressure increased by approximately 550 psi (see Figure 4.7.11). This was another significant anomaly: With the pumps shut off, there should have been no movement in the well.¹⁷² (The increase might have reflected mud continuing to travel up the wellbore with oil and gas below.)¹⁷³ Revette and Anderson were intently watching the screens, but they did not shut in the well. Instead, Revette ordered Transocean floorhand Caleb Holloway to bleed off the drill pipe pressure¹⁷⁴—apparently to eliminate the differential pressure. At 9:36 p.m., Holloway cranked open a valve on the stand pipe manifold to bleed down the pressure.¹⁷⁵ But it was taking longer than usual to bleed off.¹⁷⁶ Revette told Holloway, “Okay, close it back.”¹⁷⁷

At 9:27 p.m., kill line pressure reached approximately 800 psi. From 9:30 to 9:35 p.m., while the pumps were shut down, drill pipe pressure increased by approximately 550 psi. After the crew attempted to bleed it down, drill pipe pressure again shot up, at 9:38 p.m., by approximately 600 psi. Each of these anomalies was a sign that fluids were moving in the well. Despite observing those signs, the crew did not yet shut in the well.
