Purpose: RCRA Compliance Evaluation Inspection

Facility: Clean Harbors Buttonwillow, LLC.

EPA ID Number: CAD 980 675 276

Dates of Investigation: October 18 through 22, 2010

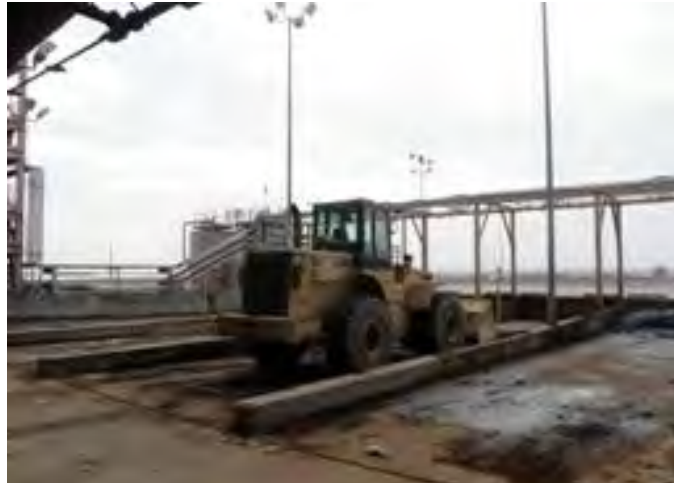
Olympus Stylus 8000, Photo #5; View of the bulk unloading bays at the STU, facing southeast.

The bulk waste unloading bays at the STU were inspected during the CEI. The floors and walls of the four bays are structurally sound, with no obvious cracks or other physical defects. No evidence of waste migration from the bays was noted.

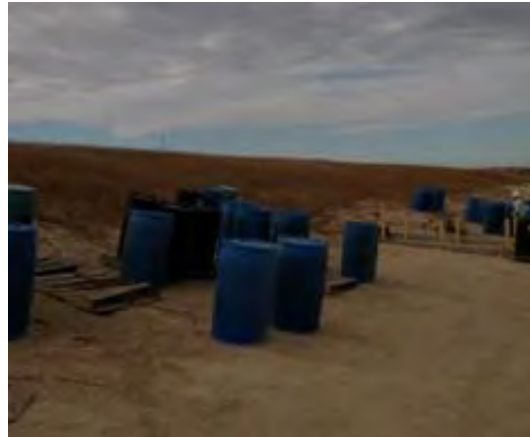
Olympus Stylus 8000, Photo #82; View of the leachate collection system and less-than-90-day storage area at WMU 33 Cell #3B.

The inspectors observed 13, full, 55-gallon containers of F039 leachate in the storage area associated with WMU 33, Cell #3, shown below in Olympus Stylus 8000, Photo #82.

Olympus Stylus 8000, Photo #82; View of the leachate collection system and the less-than-90-day storage area at WMU 33, Cell #3.

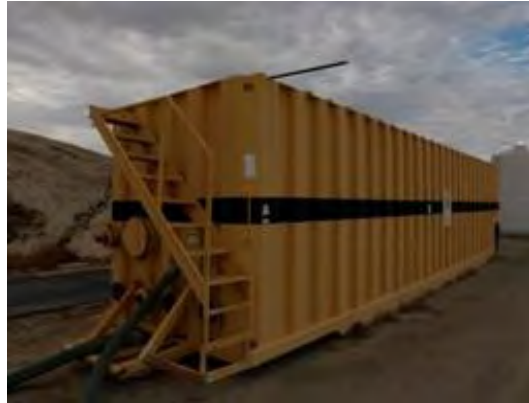
Olympus stylus 8000, Photo #96; leachate collection frac tank (Tank 80) at WMU 35 Cell #1.

Olympus Stylus 8000, Photo #96; View of the leachate collection frac tank (Tank 80) at WMU 35, Cell #1.

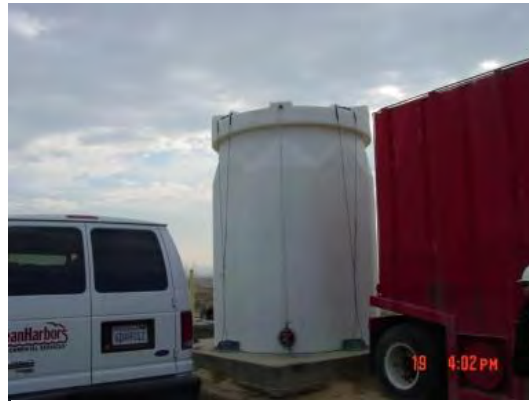
Sony DSC-S75, Photo #11; View of a 5,000-gallon, white plastic, leachate collection tank at WMU 35 Cell #3, facing west.

Sony DSC-S75, Photo #11; View of a 5,000-gallon, plastic, leachate collection tank at WMU 35, Cell #3, facing west.

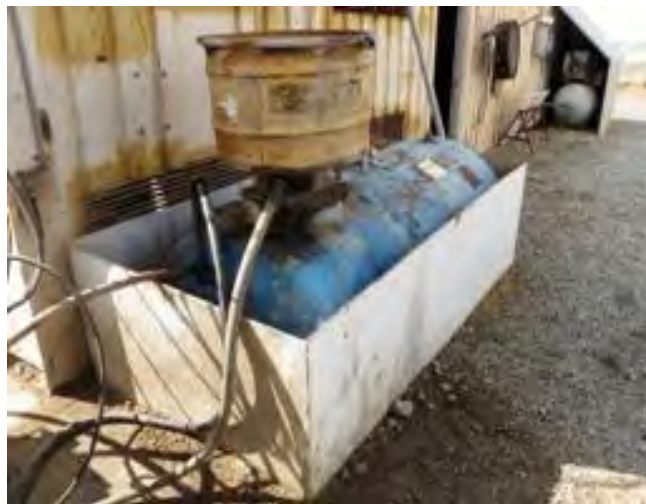
Vehicle maintenance is performed at the Shop Building west of the STU area. Used oil generated from maintenance activities is stored in an approximately 500-gallon aboveground used oil tank, presented in the photo to the right. The used oil is picked up and transported to other Clean Harbors facilities for disposal. Used oil is regulated as a hazardous waste in California. The inspectors did not verify if the tank was in compliance with the tank requirements during this inspection.

Olympus Stylus 8000, Photo # 50; View of the used oil storage tank at the maintenance building.

The Used Oil Storage Tank Area is located west of the Heavy Equipment Storage Area and the Maintenance Area. The used oil AST is located within secondary containment, the base of which was covered in liquid (refer to Olympus Stylus 8000, Photo #50 below). At the time of the CEI, the accumulation start date noted on the used oil storage tank label indicated that the 90 day accumulation date would be reached on July 22, 2010 (refer to Olympus Stylus 8000, Photo #51 below). Staining was identified in the area surrounding the used oil storage tank.

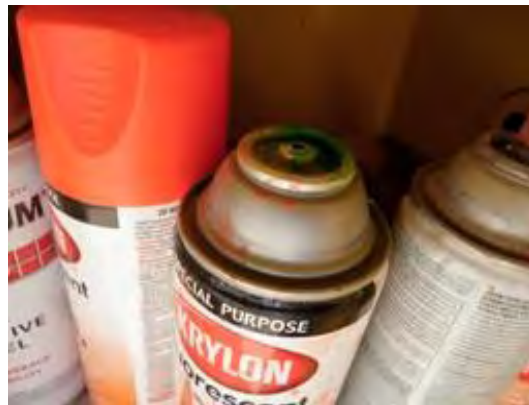
The Drum Unloading Area is located directly north of and adjacent to the Drum Unloading Bay. The Drum Unloading Area is constructed of concrete, and an overhead roof is present. During the CEI, inspectors identified a flammable materials storage cabinet with various aerosol canisters. Inspectors further noted that a nozzle on one of the aerosol cans was broken.

Olympus Stylus 8000, Photo #48; View of a flammable storage cabinet at the STU, holding aerosol products.

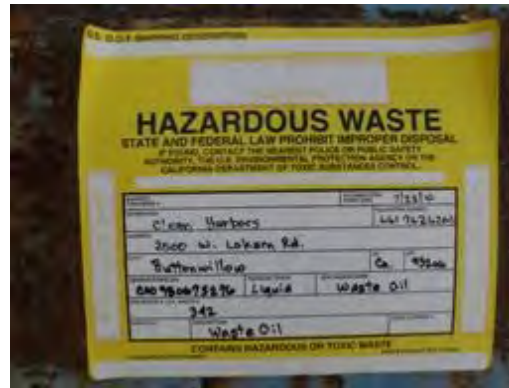
Olympus Stylus 8000, Photo #51; View of the label on the waste oil storage tank at the maintenance building. Accumulation start date is 7/22/10.

Clean Harbors shipped the used oil offsite on October 22, 2010. A copy of the manifest for the used oil shipment is included as Attachment #4.

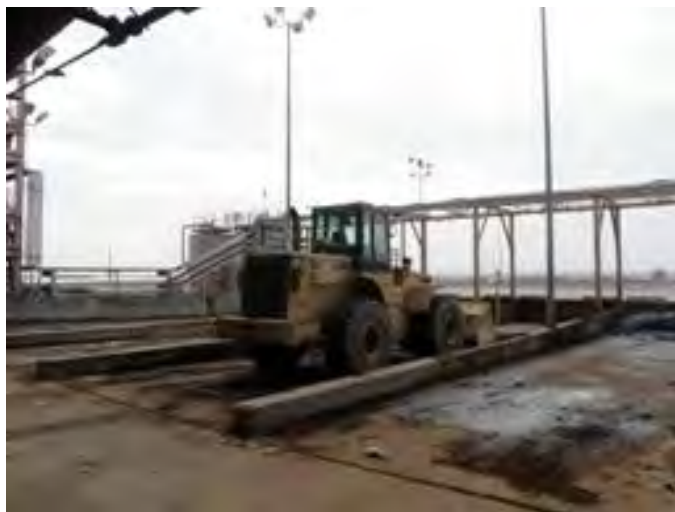
Olympus Stylus 8000, Photo #5; View of the bulk unloading bays at the STU, facing southeast.

At the time of the inspection the westernmost bay contained approximately two (2) cubic yards (yds³) of gray soil, the bay directly to the east was empty, the next bay to the east contained a small amount of brownish/gray soil, and the easternmost bay nearest the Main STU Structure was empty.

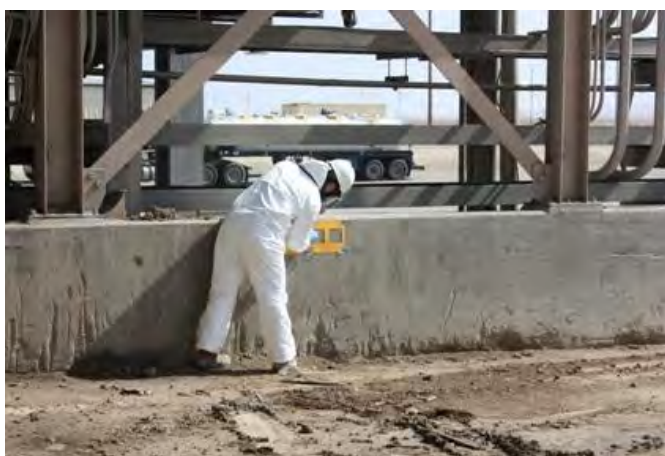
Figure 1 Canon EOS Rebel XSi, Photo #20; PCB wipe sampling at location CH-1935-WP-04, facing east-southeast

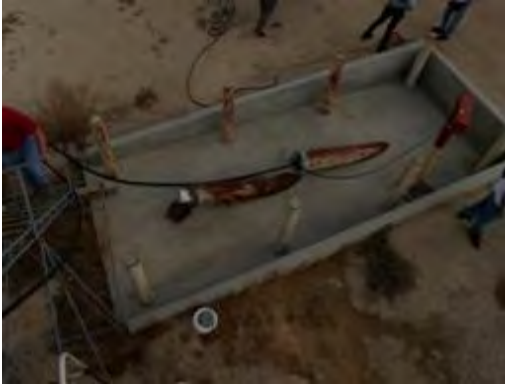
Olympus Stylus 8000, Photo #76; View of the leachate collection system at WMU 28 from the top of the leachate collection frac tank (Frac Tank 3).

At the time of the CEI, the frac tank was structurally sound, labeled as hazardous waste and dated 9/14/2010. The inspectors observed that the ports on top of the frac tank were not closed. Photos of these open ports can be viewed below.

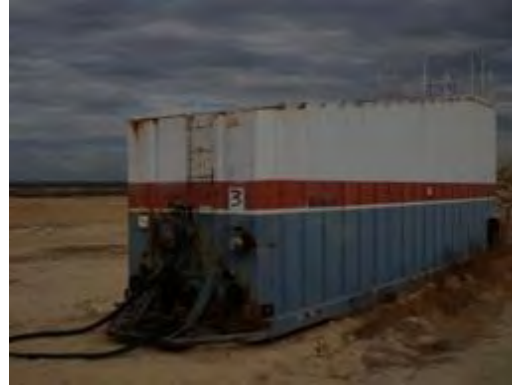
Olympus Stylus 8000, Photo #73; View of the leachate collection frac tank (Frac Tank 3) at WMU 28.

22 CCR §66260.10 [40 CFR §260.10] defines treatment as any method or process that changes the physical or chemical character of a hazardous waste to make it less hazardous, safer to manage, reduced in volume, etc. The open ports on the WMU frac tank would allow rainwater to enter the container and dilute the F039 hazardous waste. The open ports would also allow evaporation of the F039 hazardous waste (reduction in volume). Clean Harbors' RCRA permit does not authorize evaporation or dilution as hazardous waste treatment methods.

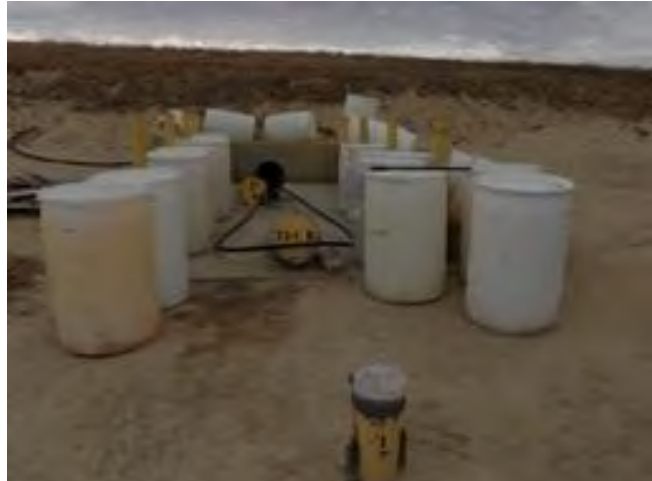
Olympus Stylus 8000, Photo #91; View of the leachate collection system at WMU 33 Cell #1. There are four full and one partially-full 55-gallon containers of F039 leachate in the less-than-90-day storage area.

The inspectors observed five, 55-gallon containers (four full, one partially filled) of F039 leachate in the storage area associated with WMU 33, Cell #1, shown to the right. The hazardous waste containers were labeled as hazardous waste, closed, and dated (dates ranging from 10/8/2010 through 10/18/2010).

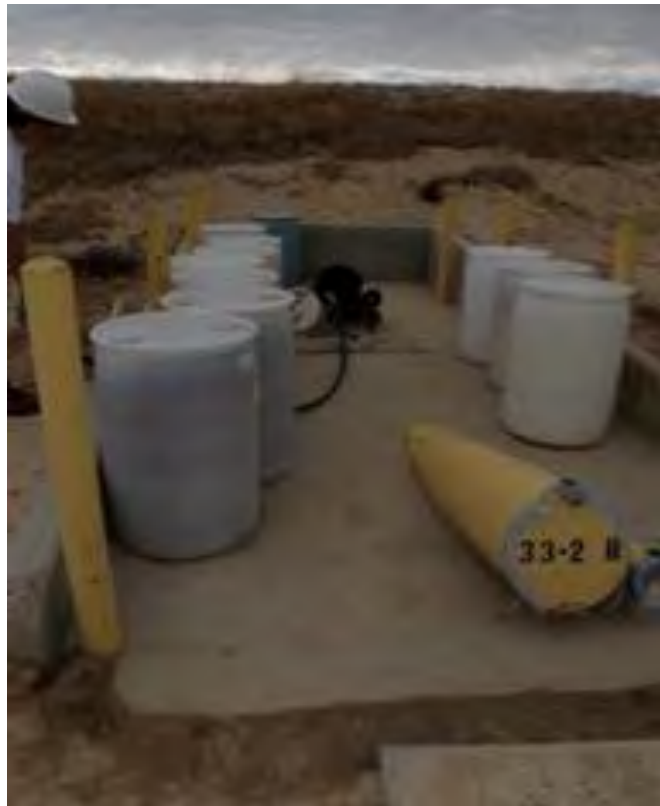
Olympus Stylus 8000, Photo #90; View of the leachate collection system at WMU 33, Cell #2. One, full 55-gallon container of F039 leachate, dated 10/13/10 to the left.

At WMU 33, Cell #2, the inspectors observed several empty containers and one, full, 55-gallon container of F039 hazardous waste leachate, as shown to the right. The container was labeled as hazardous waste, closed, and dated 10/13/2010.

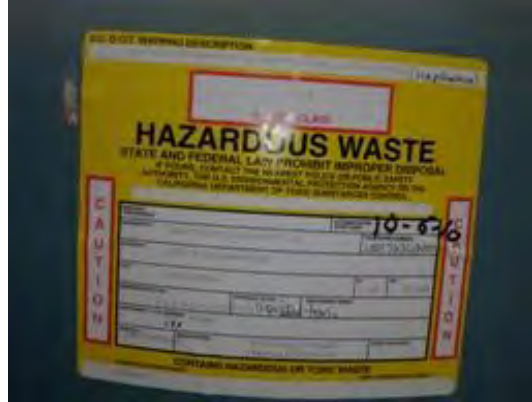
Olympus Stylus 8000, Photo #83; View of the label on a 55-gallon container of F039 leachate (naphthalene) from WMU 33, Cell #3, stored in the less-than-90-day storage area.

The hazardous waste storage containers were labeled as hazardous waste, closed, and dated (dates ranging from 9/22/2010 through 10/19/2010). Two of the hazardous waste labels indicated the leachate management method as incineration (for naphthalene contamination); an example of the hazardous waste label is presented in Olympus Stylus 8000, Photo #83 above.

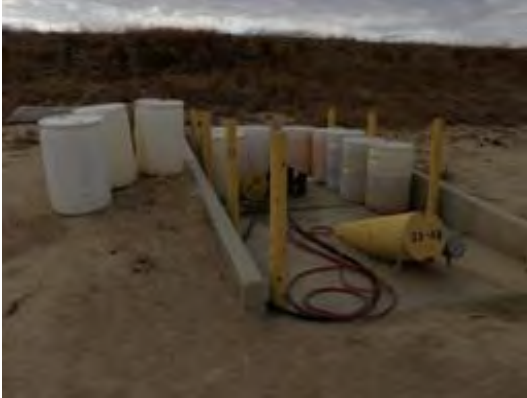
At WMU 33, Cell #4, the inspectors observed several empty containers and three, full, 55-gallon hazardous waste containers holding F039 leachate, shown in Olympus Stylus 8000, Photo #87.

Olympus Stylus 8000, Photo #87; View of the leachate collection system and less-than-90-day storage area at WMU 33, Cell #4.

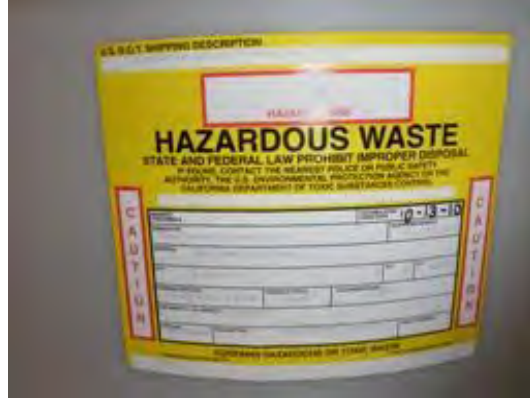
Olympus Stylus 8000, Photo #86; View of the label on a 55-gallon container of F039 leachate from WMU 33, Cell #4, stored in the adjacent less-than-90-day storage area.

The hazardous waste storage containers were labeled as hazardous waste, closed, and dated (dates ranging from 10/8/2010 through 10/19/2010); an example label is shown above in Olympus Photo #86.

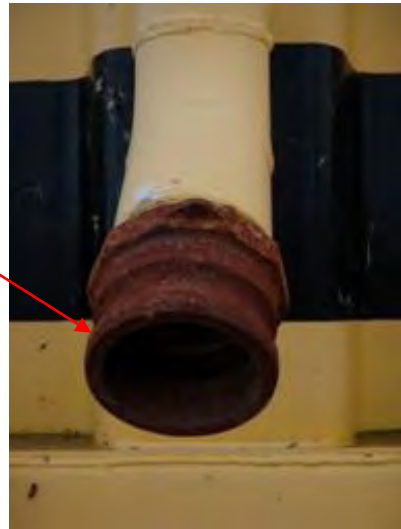
At WMU 35, Cell #1, the inspectors observed that the primary and secondary LCRSs discharge to a 20,000-gallon frac tank (known as Tank 80). The frac tank was structurally sound, labeled as hazardous waste, and dated 9/14/2010. However, the inspectors observed that the ports on top of the frac tank were open, as well as the pumping port on the side of the tank, as shown in the following four photos.

Olympus Stylus 8000, Photo #99; View of the open pumping port at the rear of the leachate collection frac tank (Tank 80) at WMU 35, Cell #1.

22 CCR §66260.10 [40 CFR §260.10] defines treatment as any method or process that changes the physical or chemical character of a hazardous waste to make it less hazardous, safer to manage, reduced in volume, etc. The open ports on the WMU frac

tank would allow rainwater to enter the container and dilute the F039 hazardous waste. The open ports would also allow evaporation of the F039 hazardous waste (reduction in volume). Clean Harbors' RCRA permit does not authorize evaporation or dilution as hazardous waste treatment methods.

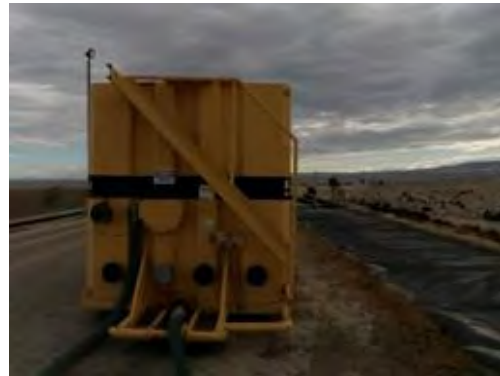
At WMU 35, Cell #2, the inspectors observed that the primary and secondary LCRSs discharge to a 20,000-gallon frac tank (known as Tank 70), shown in the photo to the right.

The frac tank was structurally sound, labeled as hazardous waste, and dated 9/14/2010. As with the frac tank at Cell #1, the leachate frac tank at WMU 35, Cell #2 is not closed (no photo taken during the CEI).

22 CCR §66260.10 [40 CFR §260.10] defines treatment as any method or process that changes the physical or chemical character of a hazardous waste to make it less hazardous, safer to manage, reduced in volume, etc. The open ports on the WMU frac tank would allow rainwater to enter the container and dilute the F039 hazardous waste. The open ports would also allow evaporation of the F039 hazardous waste (reduction in volume). Clean Harbors' RCRA permit does not authorize evaporation or dilution as hazardous waste treatment methods.

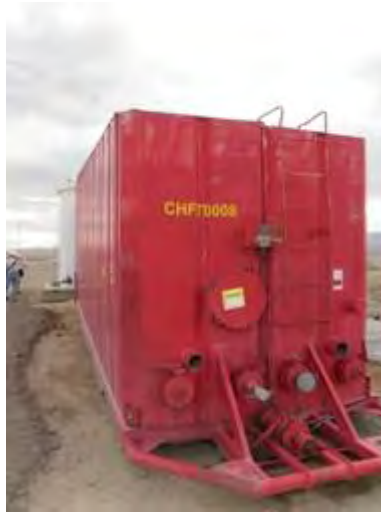
The frac tank was structurally sound, labeled as hazardous waste, and dated 9/4/2010. However, the labels were extremely faded and the accumulation start dates were only barely legible; the following two photos show examples of the labels.

Olympus Stylus 8000, Photo #105; View of the red, leachate collection frac tank at WMU 35, Cell #3.

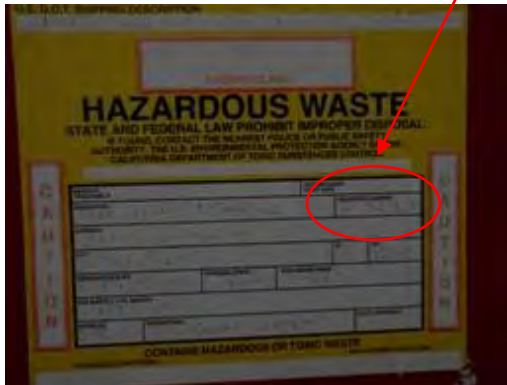
Dates not clearly visible

Olympus Stylus 8000, Photo #104; Label on the red, leachate collection frac tank at WMU 35, Cell #3. Note that the accumulation start date is not clearly visible.

22 CCR §66262.34(a)(2) [40 CFR §262.34(a)(2)] requires the date of accumulation to be clearly marked and visible on each hazardous waste storage container.

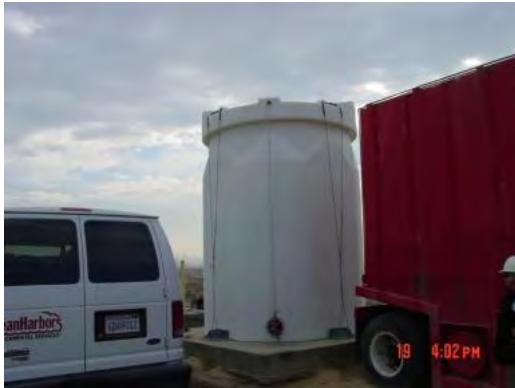
The plastic tank is double-walled, structurally sound, labeled as hazardous waste, and dated 9/1/2010, shown above. However, the tank is not equipped with a leak detection system.

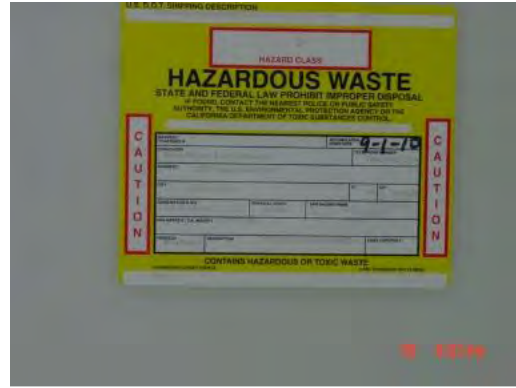
Sony DSC-S75, Photo #9; View of a 5,000-gallon, plastic, leachate collection tank at WMU 35, Cell #3; close-up of the hazardous waste label on the east side of the tank, facing west.

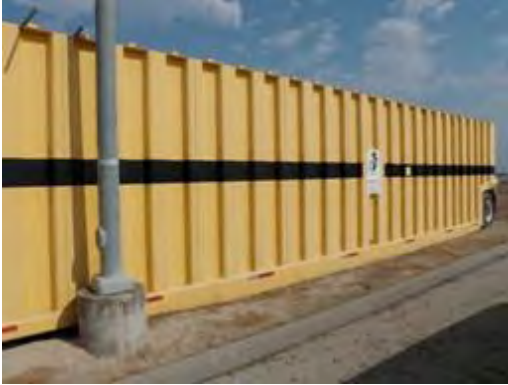
Olympus Stylus 8000, Photo #55; View of the leachate collection frac tank at WMU 34, facing northeast.

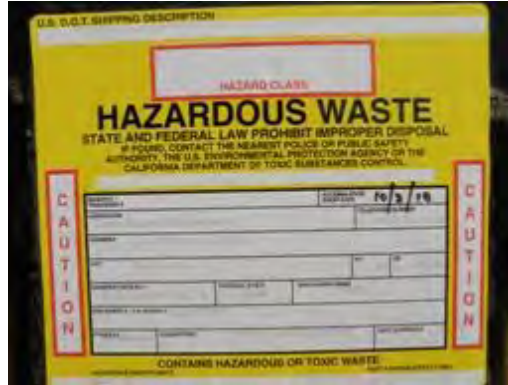
Olympus Stylus 8000, Photo #54; View of the label on the leachate collection frac tank at WMU 34. Accumulation start date is 10/2/10.

At the time of the CEI, the frac tank was structurally sound, labeled as hazardous waste and dated 10/2/2010, as shown in Olympus Stylus 8000 Photo #54.

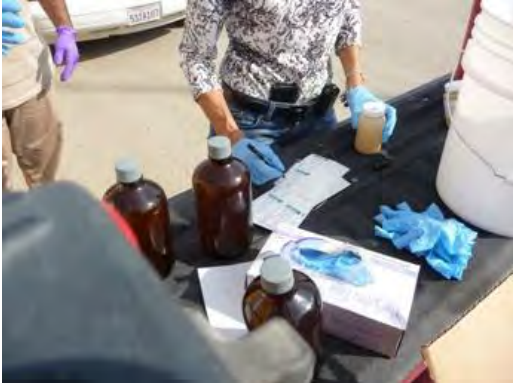
Sample processing (i.e., placement into containers, labeling) occurred on the tailgate of a Clean Harbors truck, shown below. After the samples were collected, the inspectors noted some leachate spillage on the ground beneath the tailgate, shown below.

Panasonic Lumix DMC-TZ5, Photo #35; WMU 34 leachate sampling –transferring samples into containers and labeling.

22 CCR §66264.15(b)(4) [40 CFR §264.15(b)(4)] require daily inspections of areas subject to spills. Based on the drippage observed during Clean Harbors' leachate sampling, the leachate risers, pump hoses, and sample collection/ processing areas qualify as areas subject to spills.

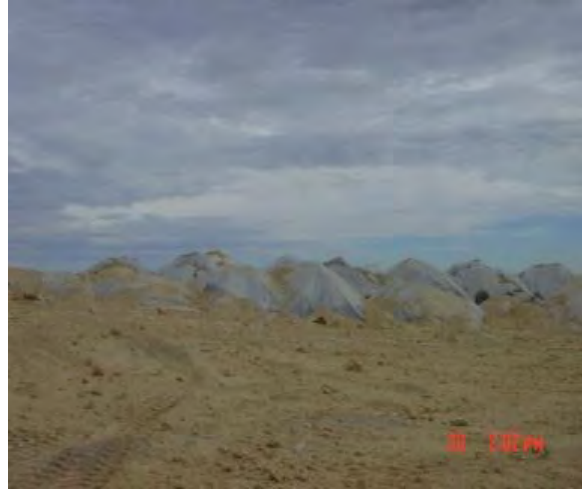
Sony Digital DSC-S75, Photo #13; View of the treated waste staging piles atop WMU 34 (under plastic tarping). View is from the southwest corner of WMU 34 facing east.

The inspectors noted 10 treated waste piles on the North side of WMU 34 that have been staged for longer than one year at the time of the CEI. From the batch numbers, the treatment dates for the batches in storage for longer than one year are 10/30/2008, 11/3/2008, 03/20/2009, 3/24/2009 (2 piles), 5/20/2009, 6/2/2009, 6/6/2009, and 10/9/2009 (2 piles).

Additionally, the inspectors noted that two of these piles (specifically batch identification numbers 090606-003 and 081103-004) were wastes that were already previously processed and did not meet universal treatment standards.

When asked by the inspectors during the inspection, Mr. Almberg stated that he knew of no reason for not re-treating these 10 waste piles after the initial post-treatment results showed that they failed to meet treatment standards. 22 CCR §66268.50(b) [40 CFR §268.50(b)] allows a TSD facility to store restricted hazardous waste for up to one year, provided that the storage is necessary to facilitate proper recovery, treatment, or disposal.

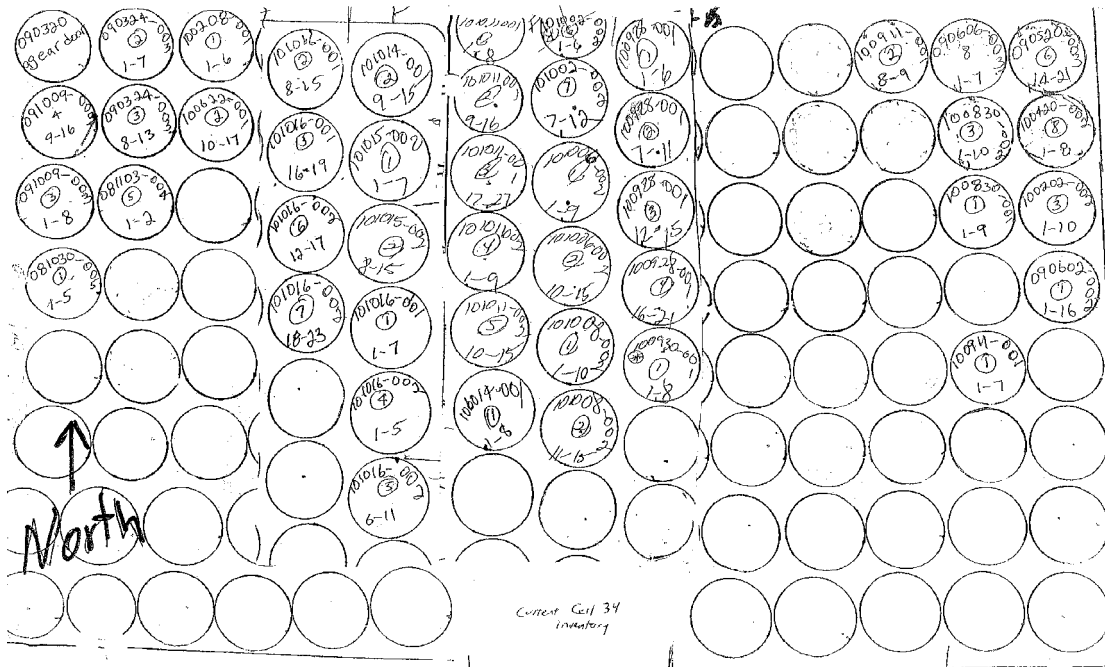
Current map/inventory of the North side of WMU 34 obtained during the CEI showing temporary staging area for treated waste piles.

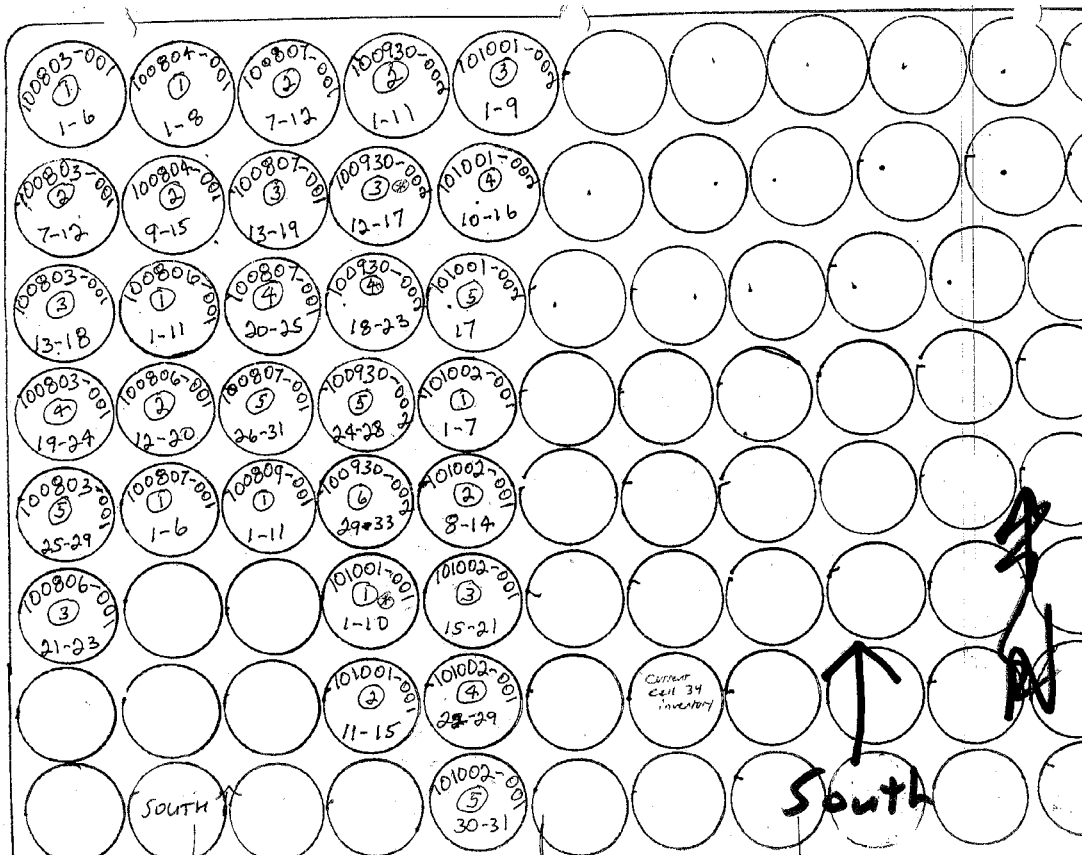
Current map/inventory of the South side of WMU 34 obtained during the CEI showing temporary staging area for treated waste piles
