Watershed Rehabilitation Program Watershed Protection and Flood Control Act of 1954

Watershed Rehabilitation Projects Completed in Wisconsin as of August 2006

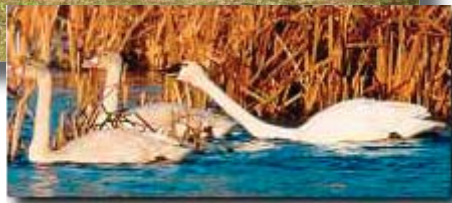
Removal of sediment from Alma Mill Creek structure No. 3.

Considerable sedimentation occurred behind these dams over the years, reducing the ability of the structures to provide storage for floodwater. Separation at joints in the main pipe carrying water through the structure was likely to cause failure of one of the dams if left unchecked. Rehabilitation included repair of the pipe and removal of sediment, restoring floodwater and sediment storage capacity to the dams. Removal of sediment allows more space for trapping of sediment. Sedimentation has an adverse effect on sago pondweed, a favorite food source of tundra swans.
