JOSEPH BARKER, JR. HOUSE
FEATURES OF SIGNIFICANCE WITH PRESERVATION RECOMMENDATIONS

SUBMITTED BY
THE CENTER OF EXPERTISE FOR THE PRESERVATION OF HISTORIC STRUCTURES AND BUILDINGS
U.S. ARMY CORPS OF ENGINEERS, SEATTLE DISTRICT
FOR THE
U.S. ARMY CORPS OF ENGINEERS, HUNTINGTON DISTRICT

16 JULY 2014

FEATURES OF SIGNIFICANCE WITH PRESERVATION RECOMMENDATIONS

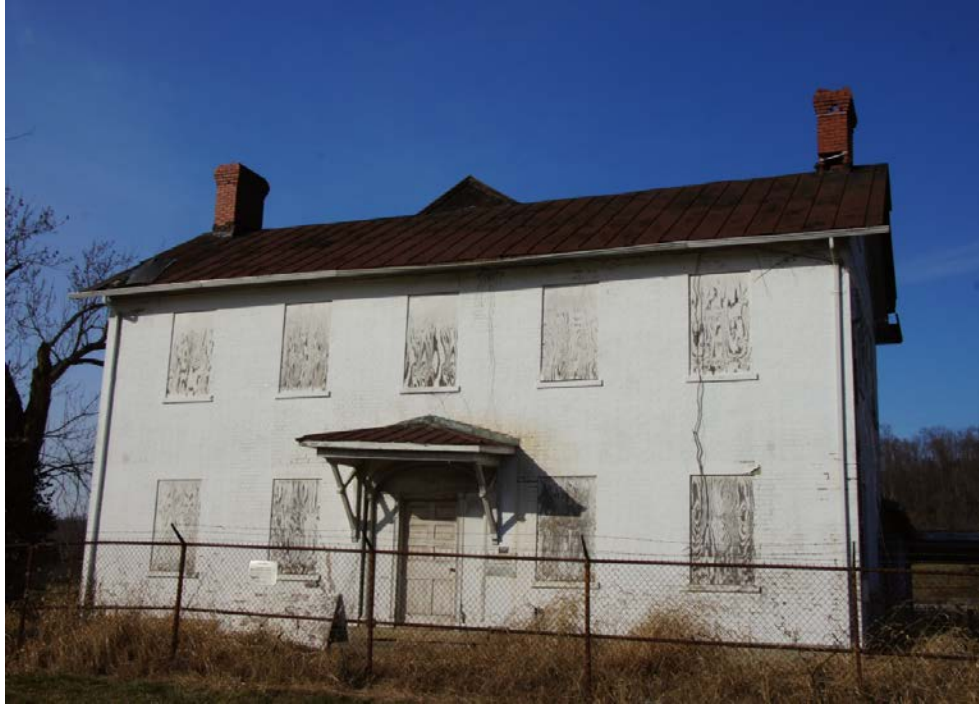
Photo 1.

View is of the river facing elevation of the brick house, looking northwest. The gable peak of the frame section is visible along the roofline, and is off-set from center.

Recommendation: The Federal style surround – including classical pilasters, elliptical fanlight, and side lights – is among the most significant features on the house. Because the wood components have experienced deferred maintenance, some damage is evident from exposure and water. There is some severe loss of material and dry rot that should be immediately addressed through protective painting and possible consolidation.

Recommendation: The corbel cap of the east chimney should be repaired, and mortar joints replaced where missing (using a mortar composition, pigment, and application identical to the original). Chimneys should also be covered to prevent water access into the interior of the house.

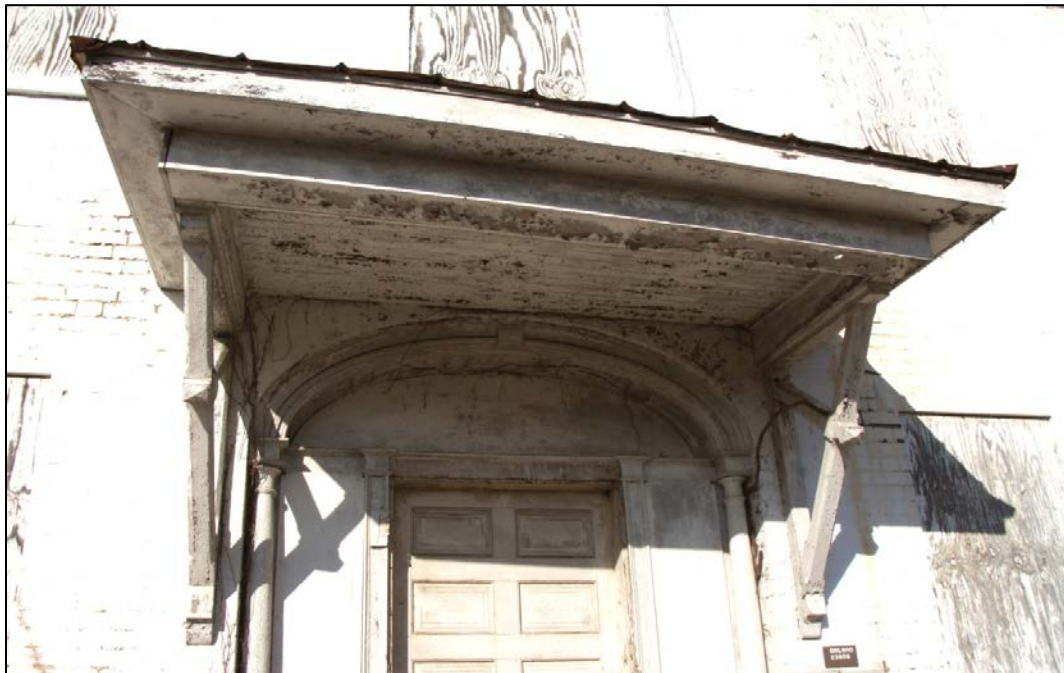
Photo 4.

A close-in view of the entrance hood reveals its awkward relationship to the elliptical arch and fanlight, as well as the contrast of Neo-classical and Eastlake styles.

Recommendation: The six-panel door is original and features original door knobs, key hole, hinges, and should be regularly monitored for damage or vandalism. No immediate treatments are required.

Recommendation: The Eastlake style hood over the door is a late nineteenth century addition, but has achieved some significance in its own right. It has served to protect the entrance, and should be inspected for damage to the standing seam metal. Soldering repairs should be made if needed.

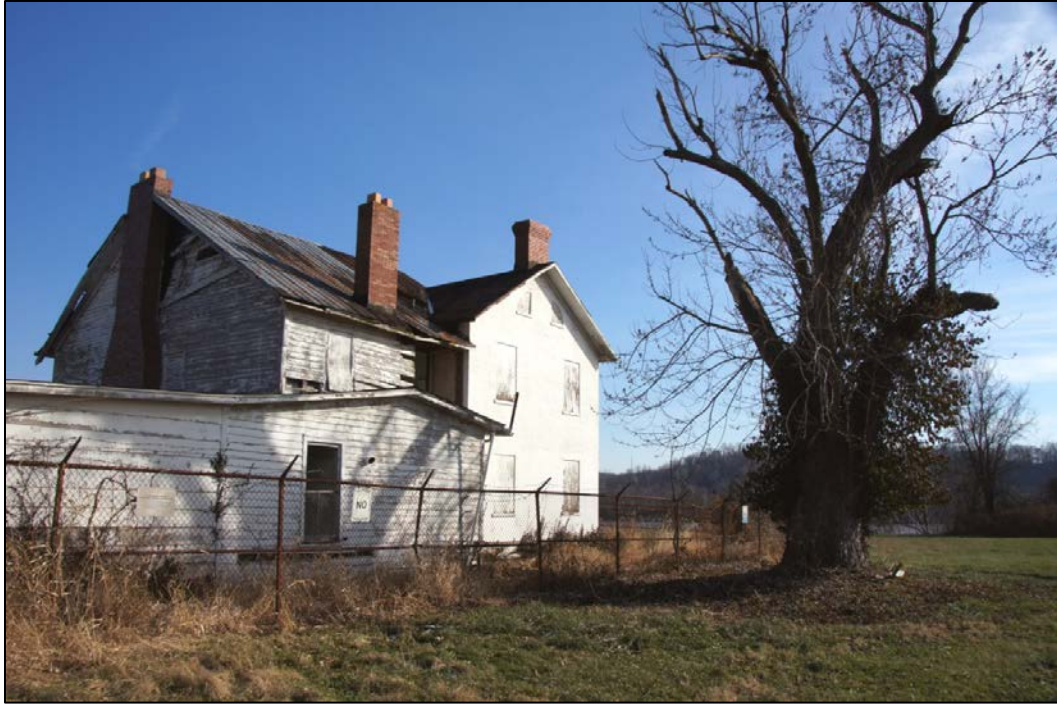
Photo 8.

View from the rear of the property showing twentieth century additions: the two-story frame section is the oldest addition; and later one-story additions dating to the early and mid twentieth century are located in the foreground.

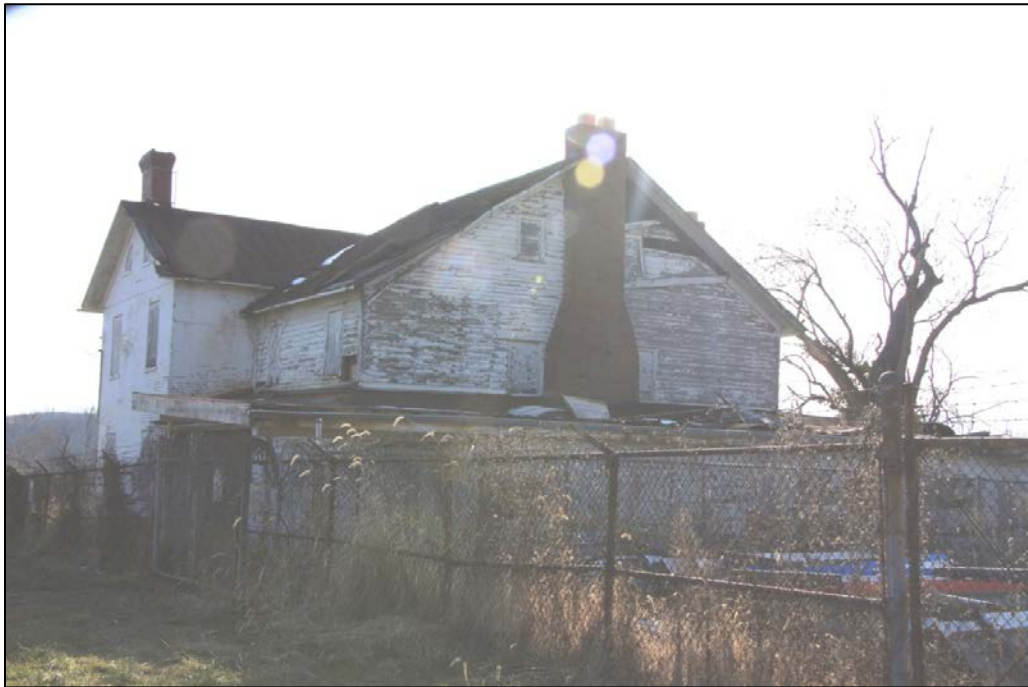
Photo 9.

View of the frame section of the house, looking southwest. Note the tapering chimney on the exterior.

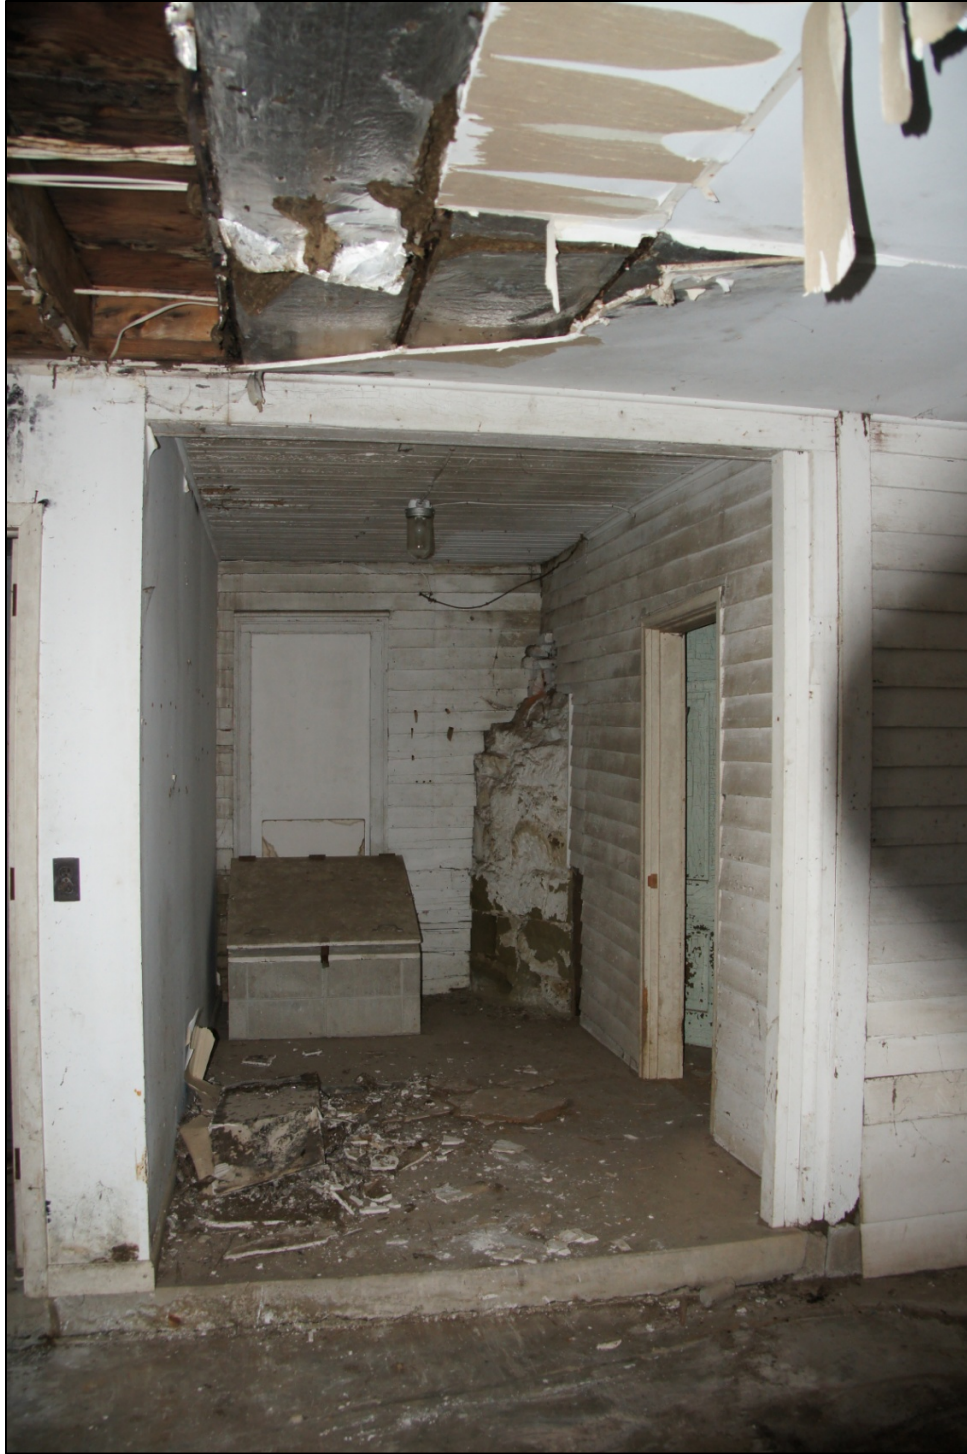
Photo 10.

View from the non-significant, twentieth century garage addition (Room 10), looking toward the north/rear exterior wall of frame house. Room 9 is through the door on the right.

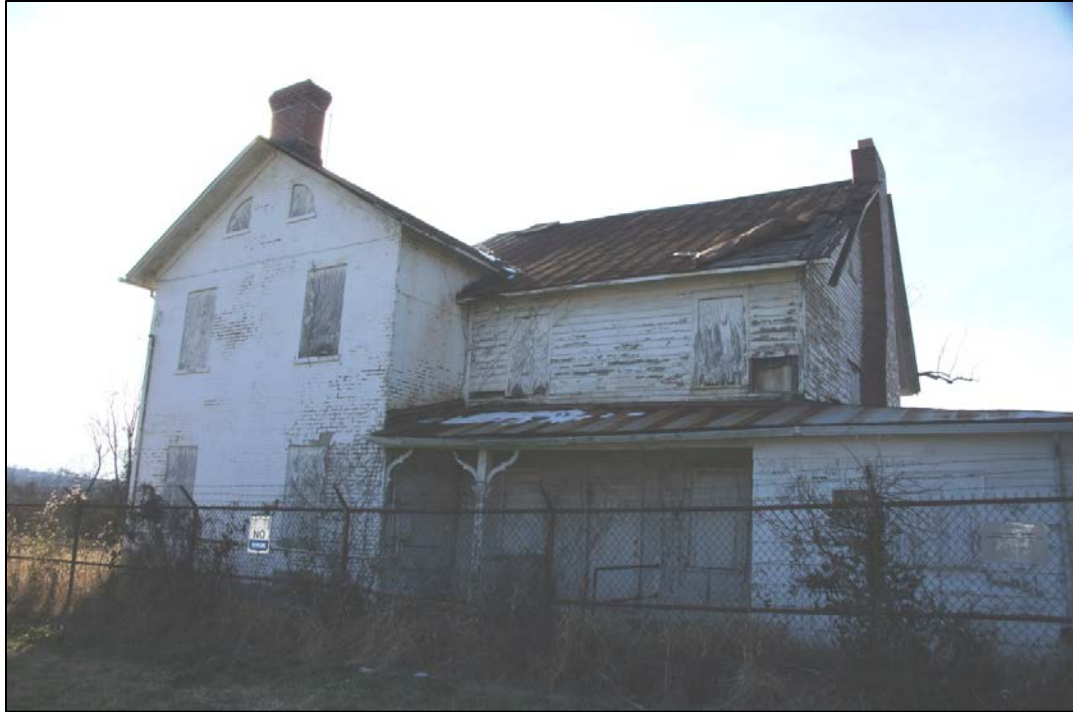
Photo 11.

East elevation, showing frame house at right, and brick section at left.

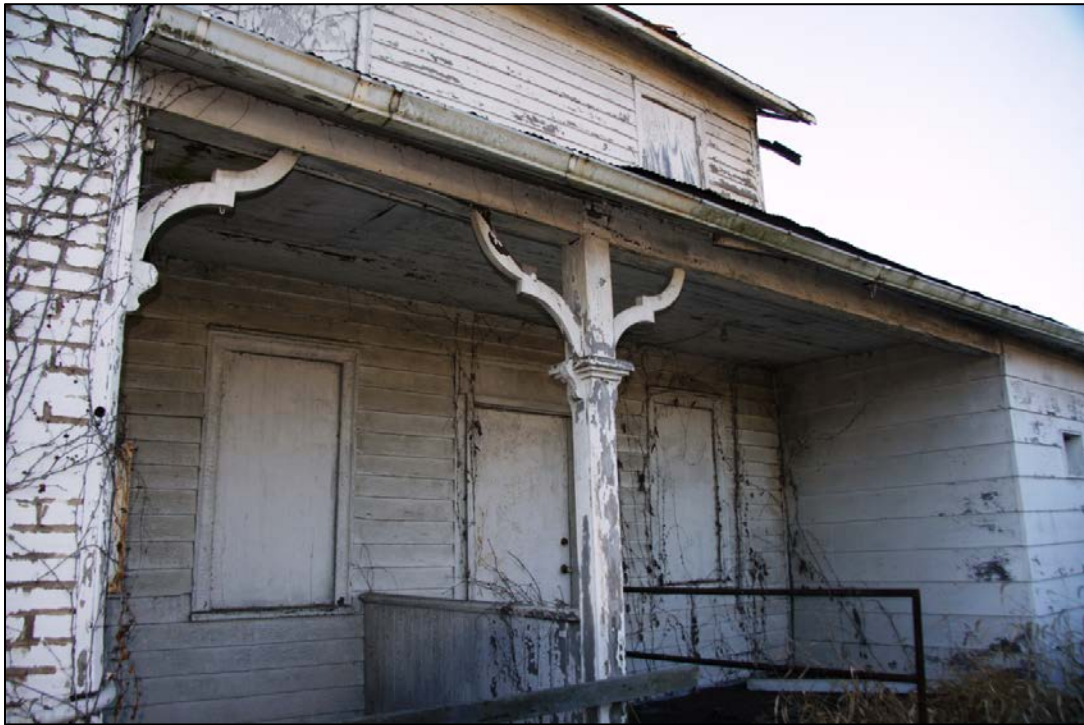
Photo 12.

East elevation of the frame section. Square porch columns with decorative millwork brackets suggest a late nineteenth century period of alteration.

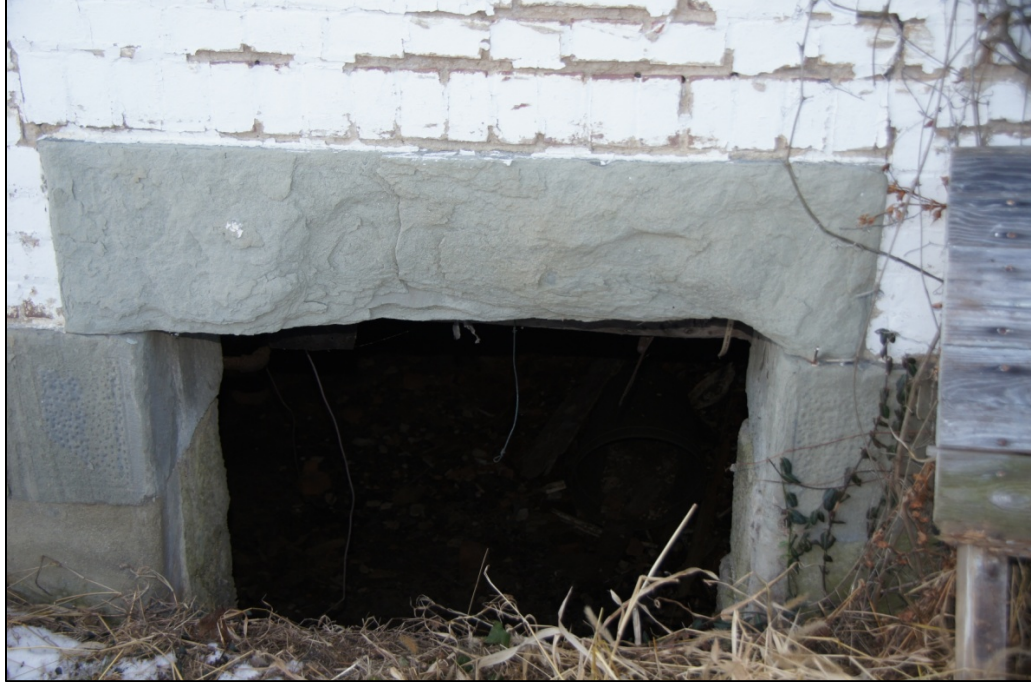
Photo 17.
East foundation elevation showing former coal chute.

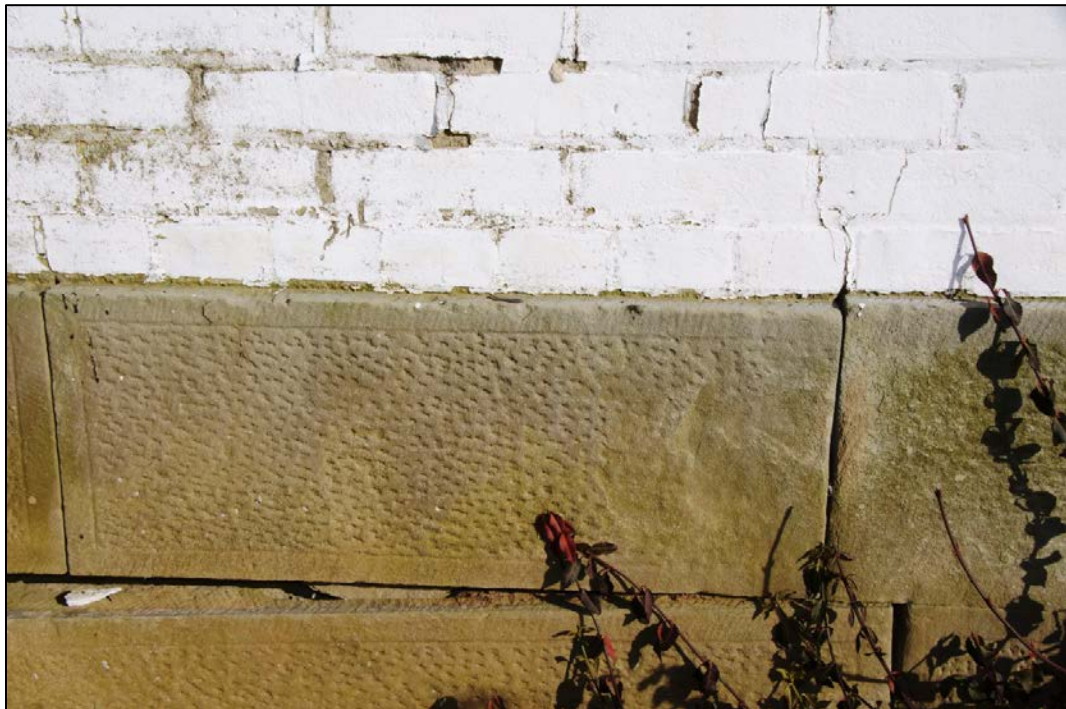
Photo 18.
Original foundation, west elevation. Sandstone cap blocks exhibit bush hammered finish with chiseled margins.

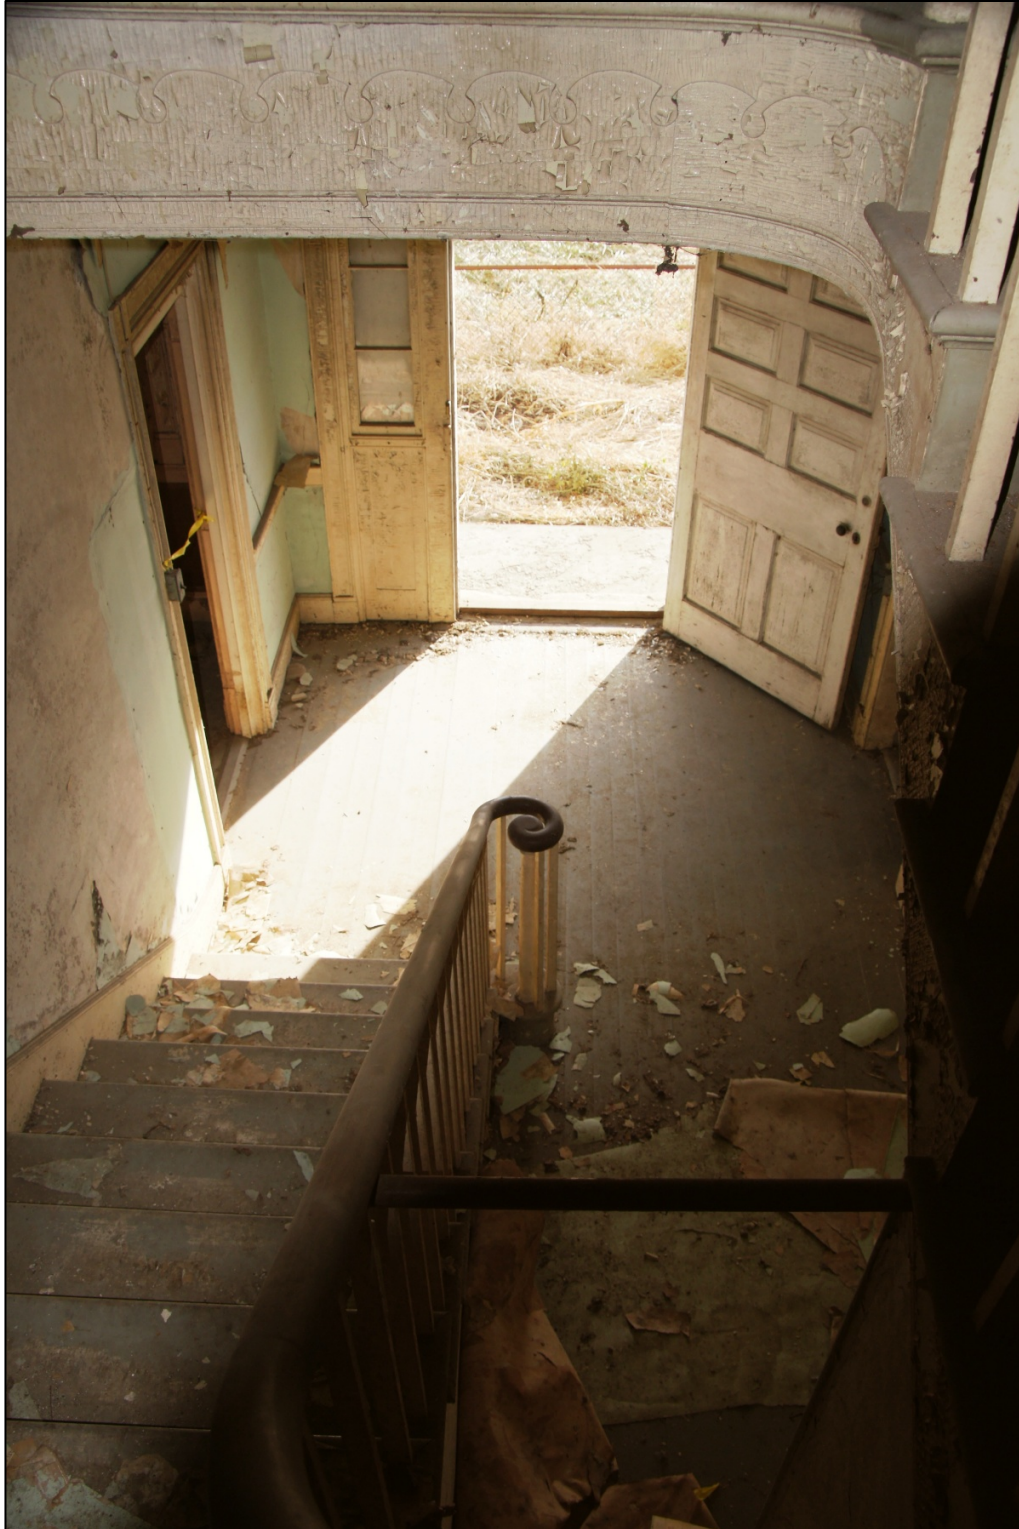
Photo 21.

Room 4 – View of front entrance and foyer looking south from stair turn.

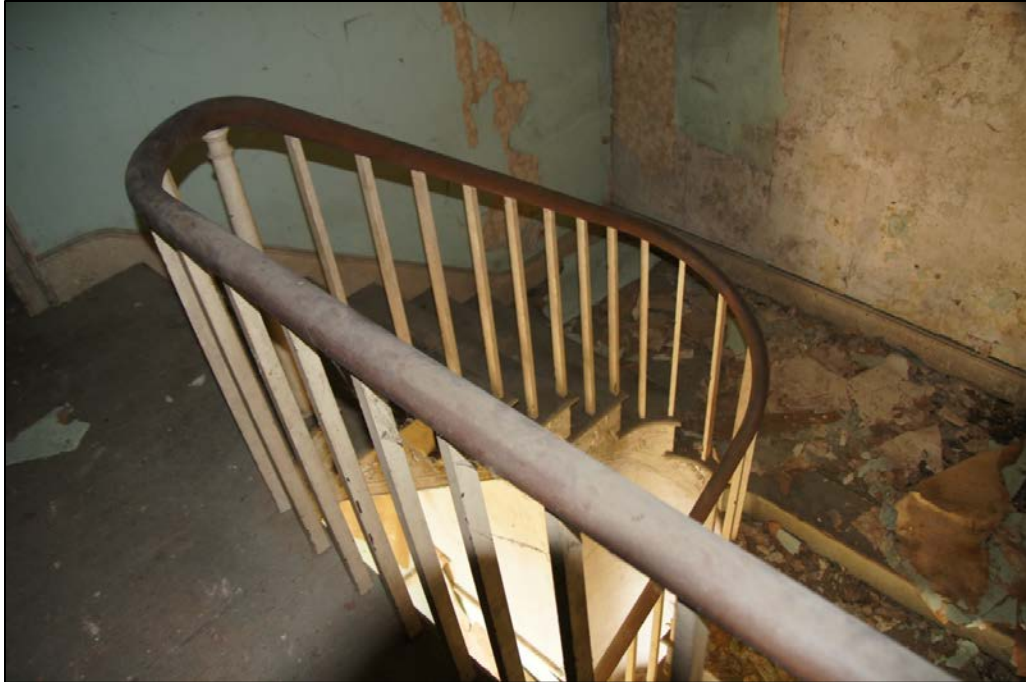
Photo 23.

Room 4 – Staircase from second floor landing looking downward to midpoint landing. The original dark stained railing with the characteristic Federal “mahogany” appearance is intact.

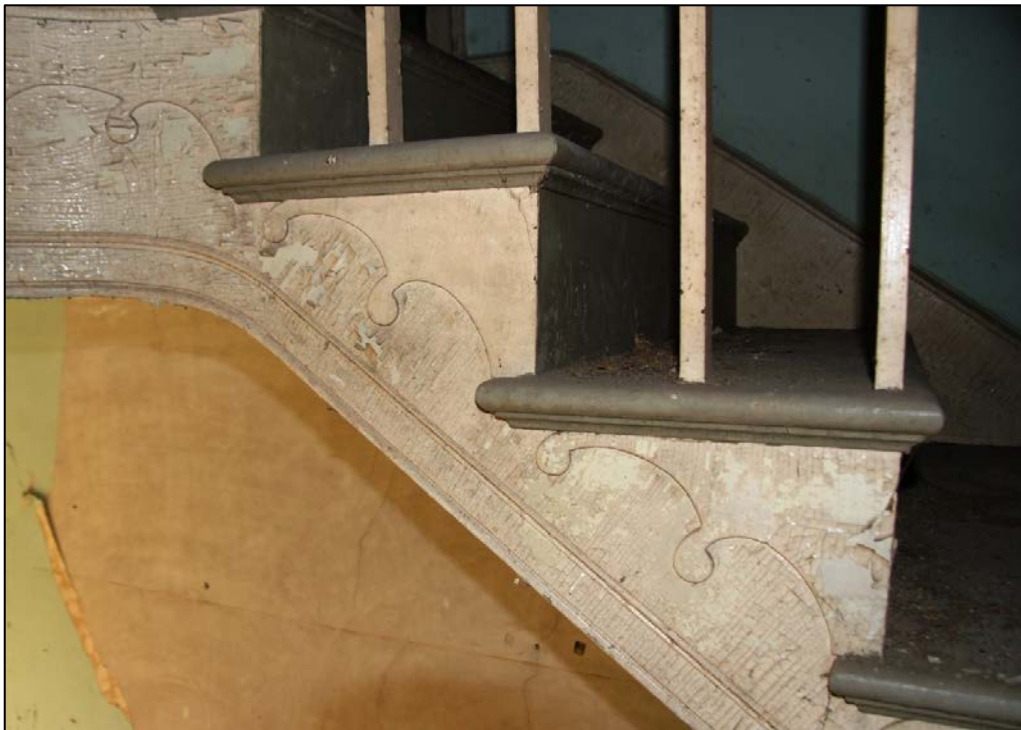
Photo 24.

Room 4 – Original scrolled stair ends and crown molding tread details.

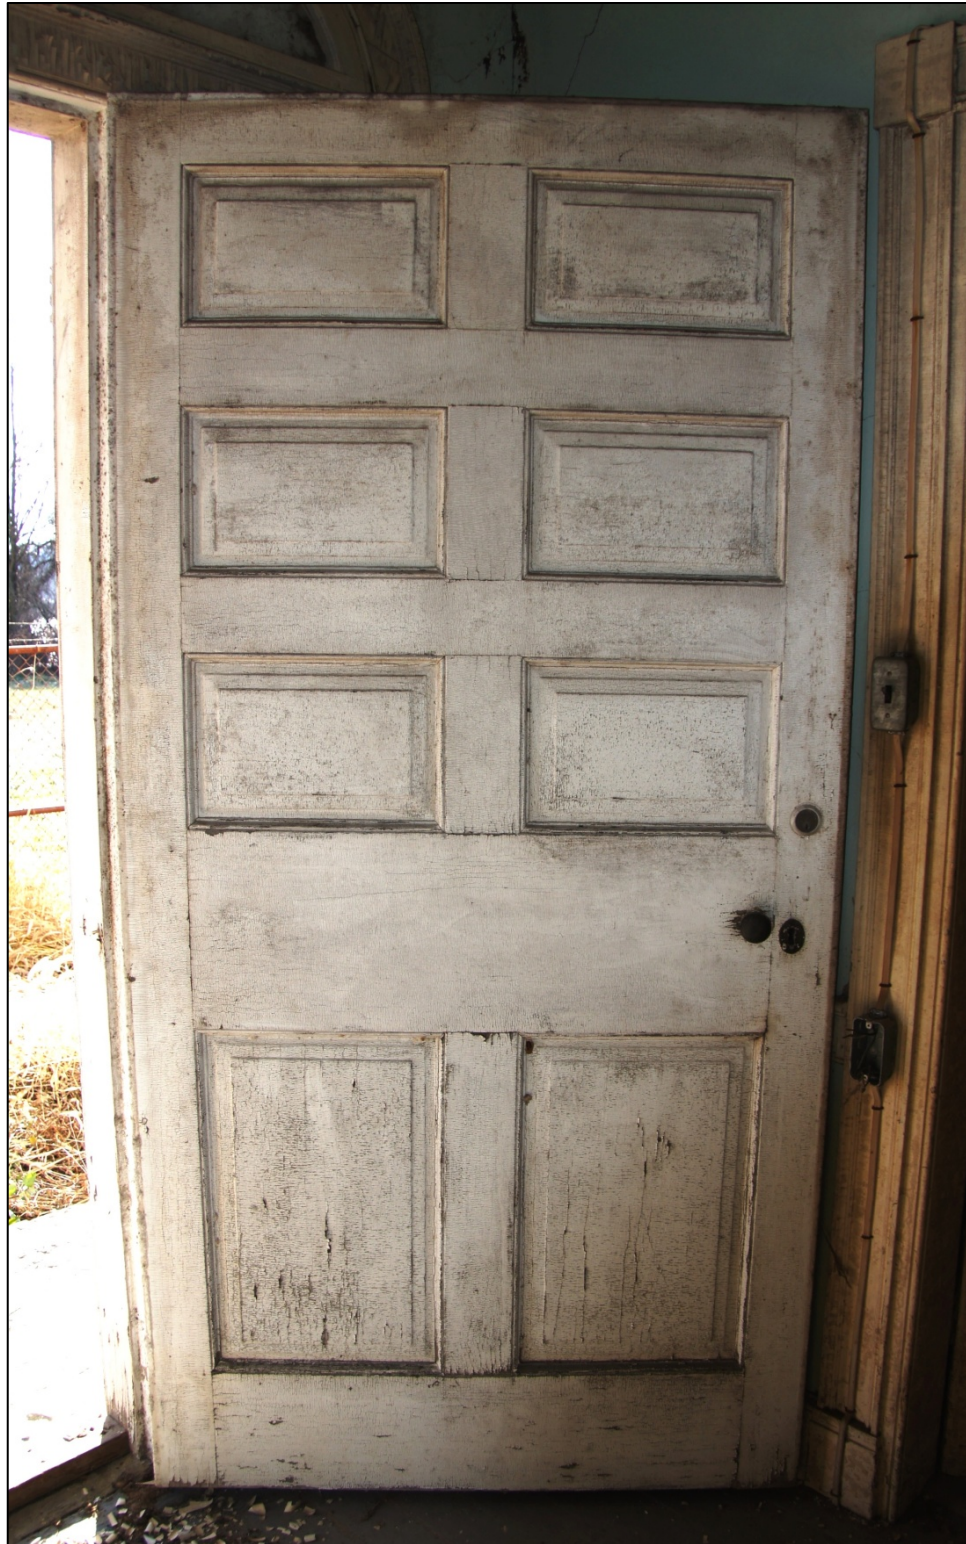
Photo 25.

Room 4 – Exterior side of front entrance door. The eight-paneled door is typical of early Federal style domestic architecture and features original hardware and key hole.

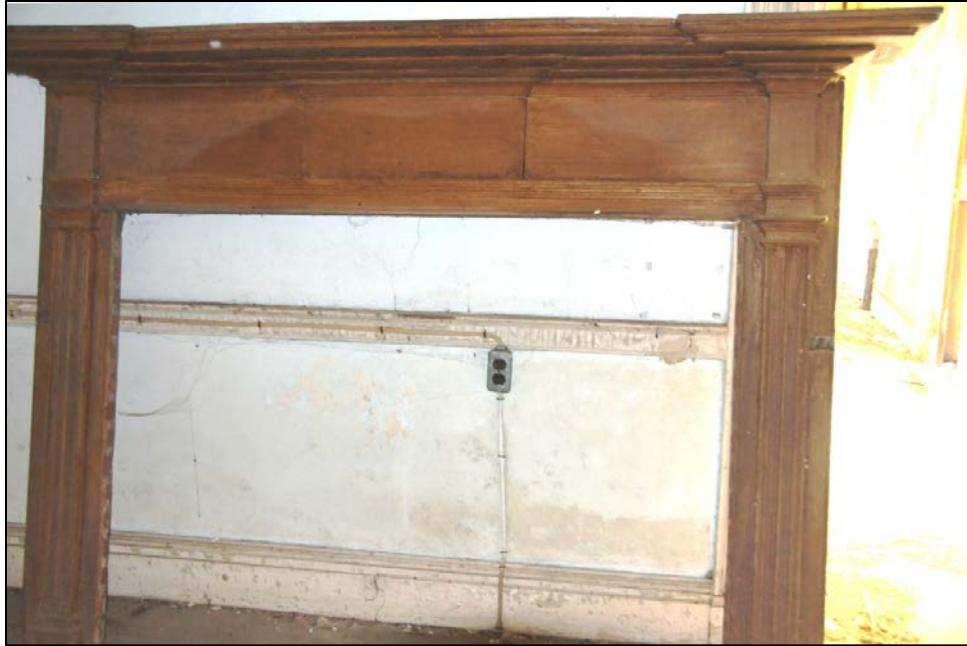
Photo 28.

Room 5 – A Neo-classical surround that rests against the wall fits the dimensions of the hearth found in Room 8 of the frame building. Its stylistic consistency with mantels in the brick house suggest that the hearth represents a separate kitchen building that was constructed along with the brick house. As the years progressed, the kitchen building may have been expanded and eventually united with the brick house.

Recommendation: The large Federal style fireplace surround leaning against the wall likely belonged to the hearth in the frame house. This is feature dates to the original construction period of the brick house and should be retained.

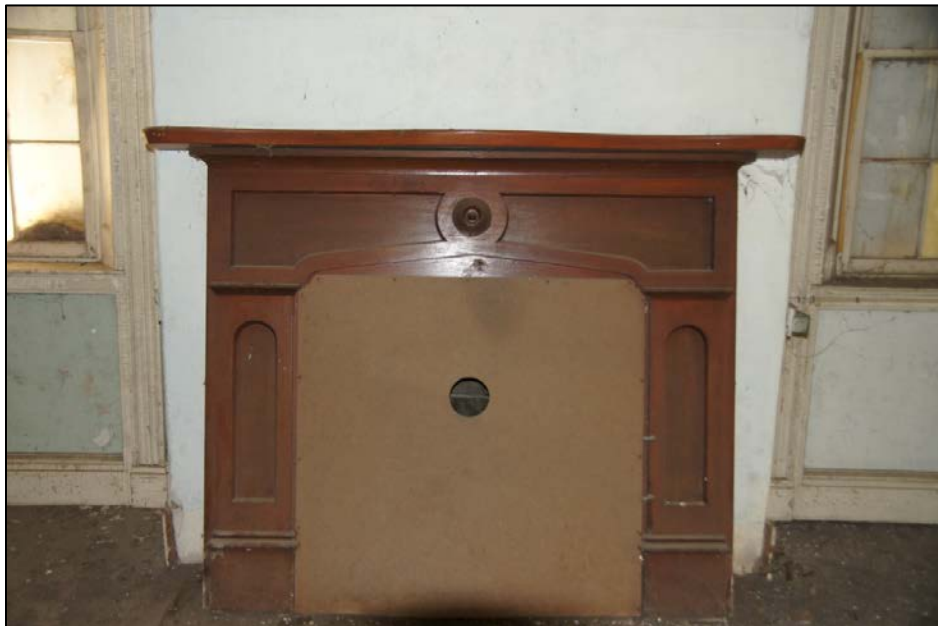
Photo 29.

Room 5 – An Eastlake style surround of later vintage (1880s) rests against the opening where the original fireplace surround has been removed.

Recommendation: The original [west] fireplace surround is missing. The hearth presently has an Eastlake-style surround that is not fully engaged. The Eastlake feature likely represents a late nineteenth century period of remodeling, and is contemporary with the front door hood. Though not associated with the original construction period, it should be retained as part of the historical evolution of the brick house.

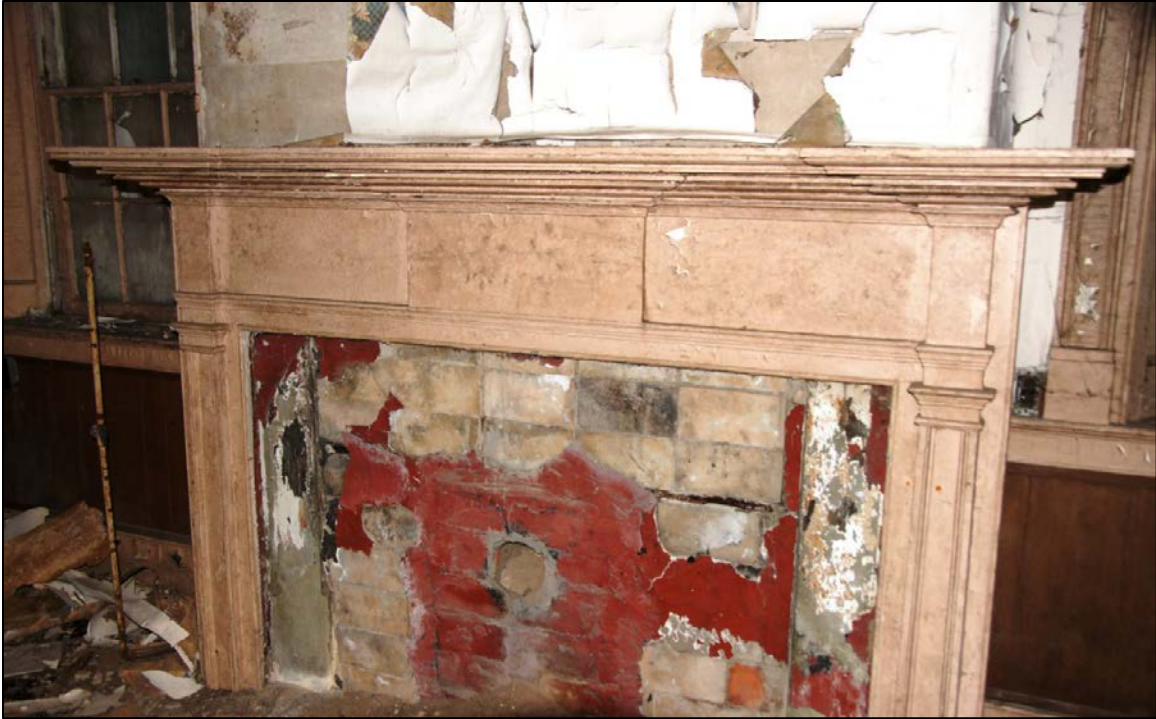
Photo 30.

Room 3 – Original fireplace surround on the east wall features Neo-classical pilasters, moldings, and central panel depicted in a number of period builder’s guides. The hearth has been filled in to accommodate a later piped stove. This room also features original stripped/unpainted beadboard wainscoting.

Recommendation: The east fireplace surround and coal grate are original, and represent the type of surround that is missing from Room 5. It should be cleaned of flaking paint, dirt, and periodically inspected for condition.

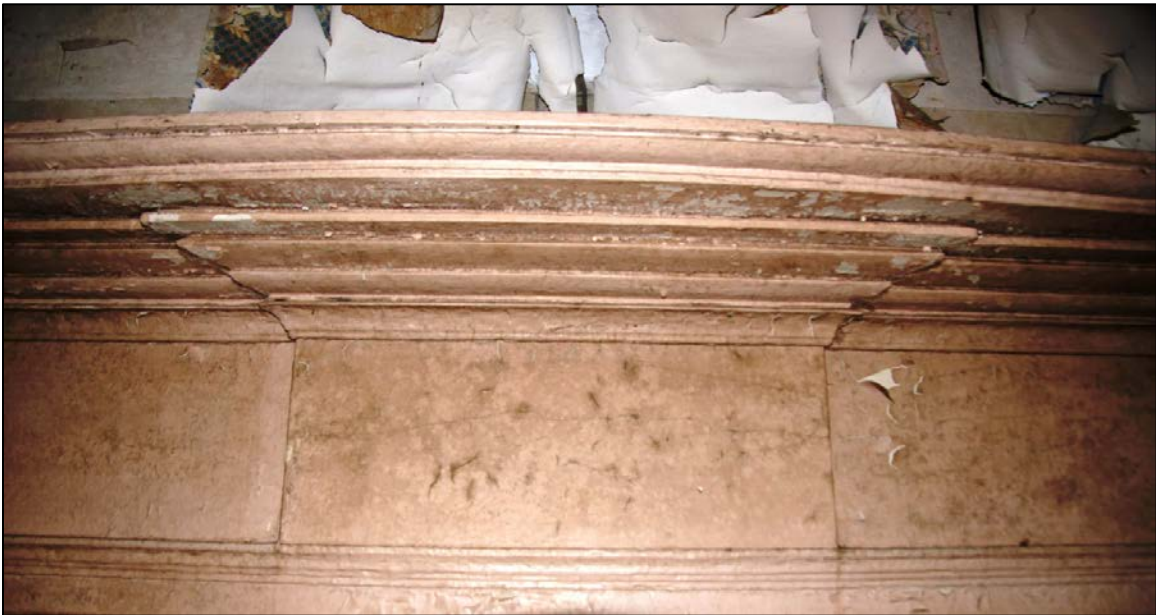
Photo 31.

Room 3 – Detail of Neo-classical fireplace surround with unembellished central panel.

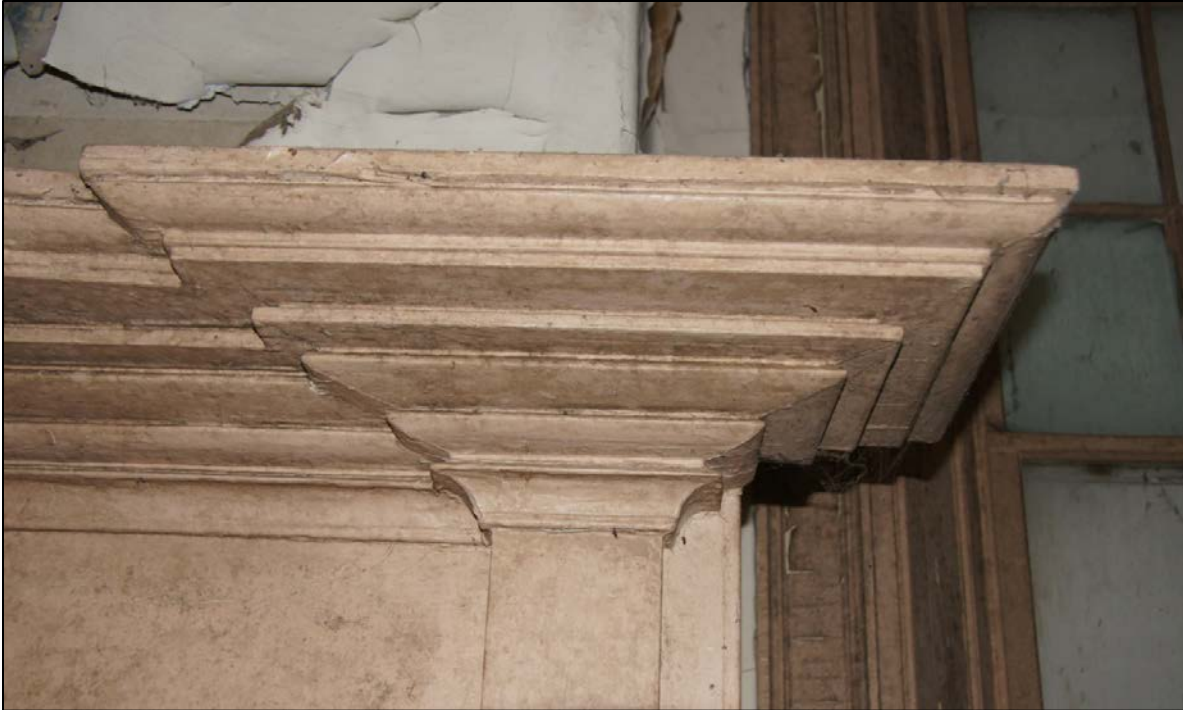
Photo 32.

Room 3 – Original mantel pilasters terminate in delicately layered moldings.

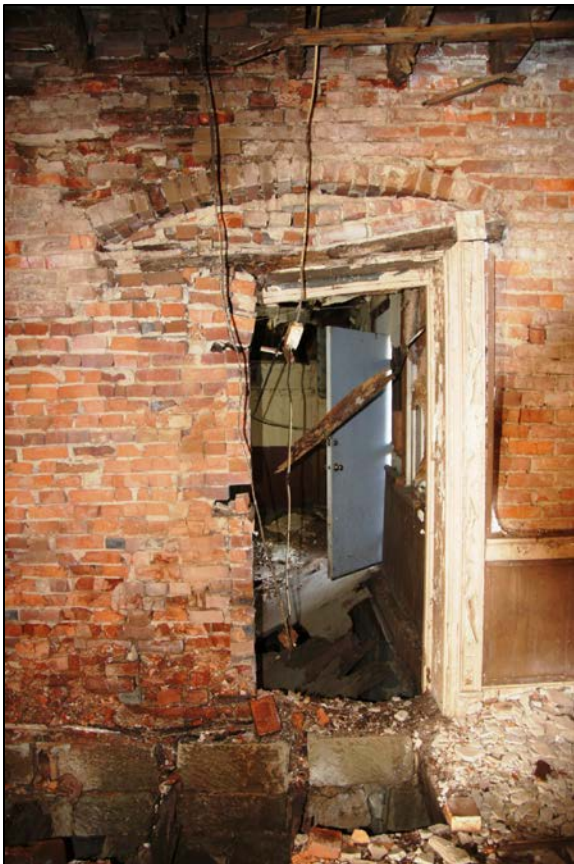
Photo 33. Room 3 – Juncture of brick house and frame section, showing partially in-filled door opening with relieving arch, rear/north wall.

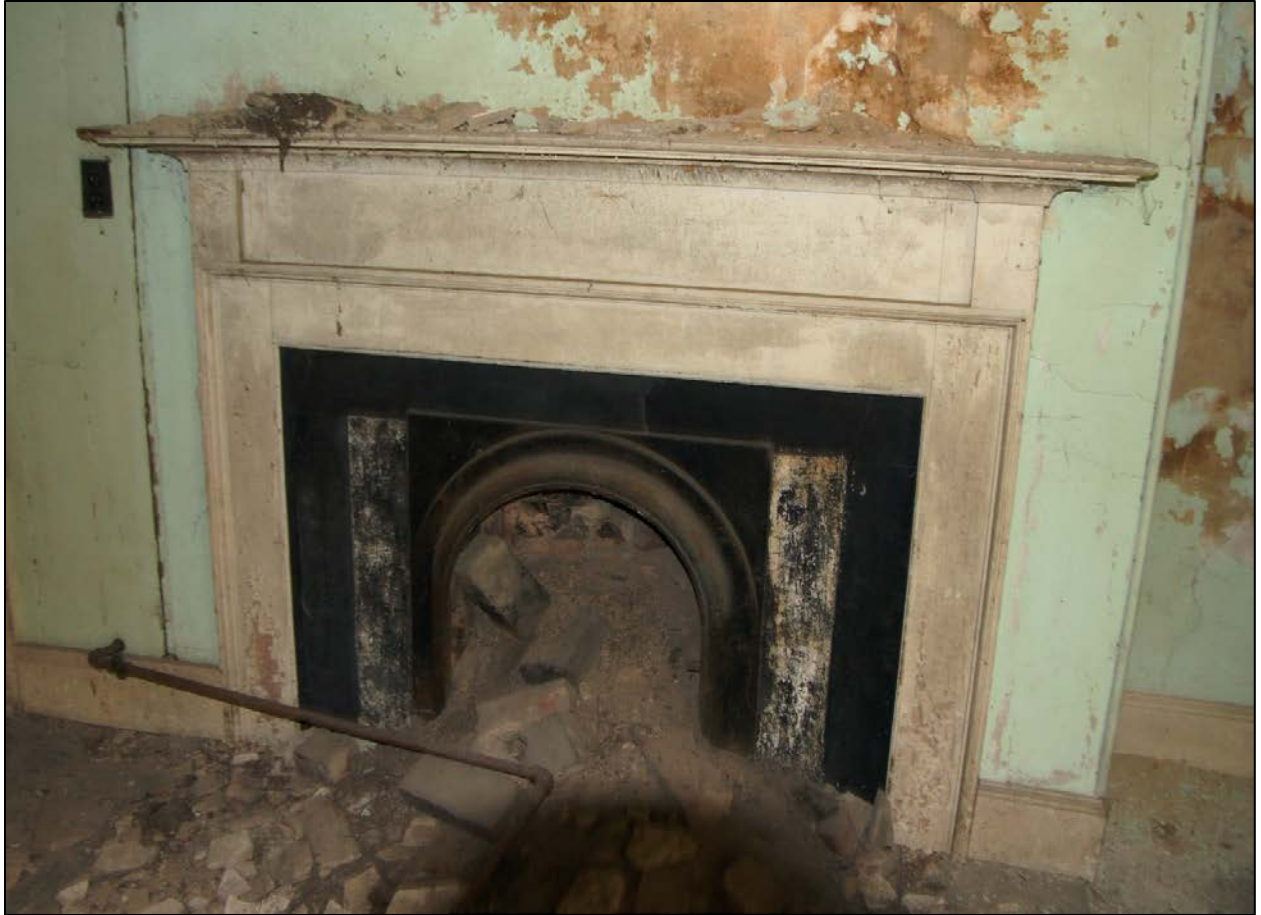
Photo 35.

Room 11 – Original fireplace surround and arched metal insert. Lacking pilasters and layered moldings, the second floor surrounds are simpler versions of the more detailed first floor surrounds.

Recommendation Plaster surfaces are original, though repainting has occurred and colors are likely not original. Cosmetic damage is the most prevalent, with black mold present on many surfaces, and some painted surfaces have disengaged and are hanging loose. A lack of ventilation and moisture from leaking roof and chimney are likely causes. Given the general soundness of all plaster, it can be inferred that original lath and plaster keys are of high quality and in a good state of preservation as little to no cracking or failure is evident aside from a section of the rear/north wall in Room 11 that has lost plaster due to roof damage and water penetration. All interior spaces should be periodically aired and dried. Some drying benefit can be realized when exterior plywood window coverings are removed for inspection and repair.

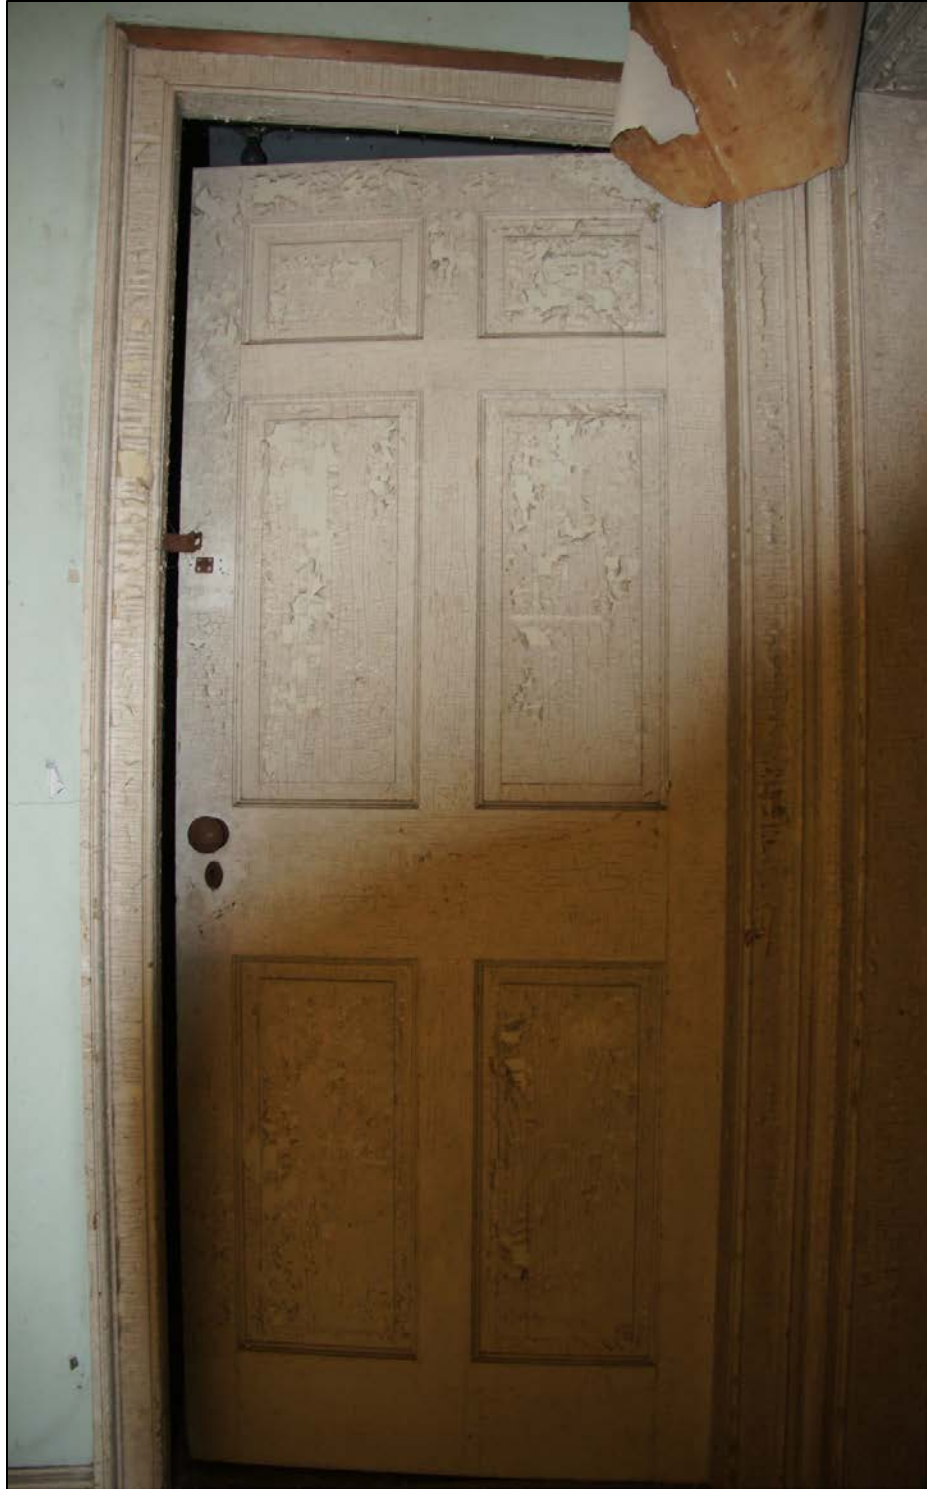
Photo 36.

Room 11 – Original six paneled door to Room 11 at the top of the stair landing at second floor. Metal knob and keyhole cover, and door framing are all original.

Recommendation: Original six-panel wood door displays all original framing, trim, knobs, hinges, and hardware. Cleaning and scraping of loose paint and dirt is recommended.

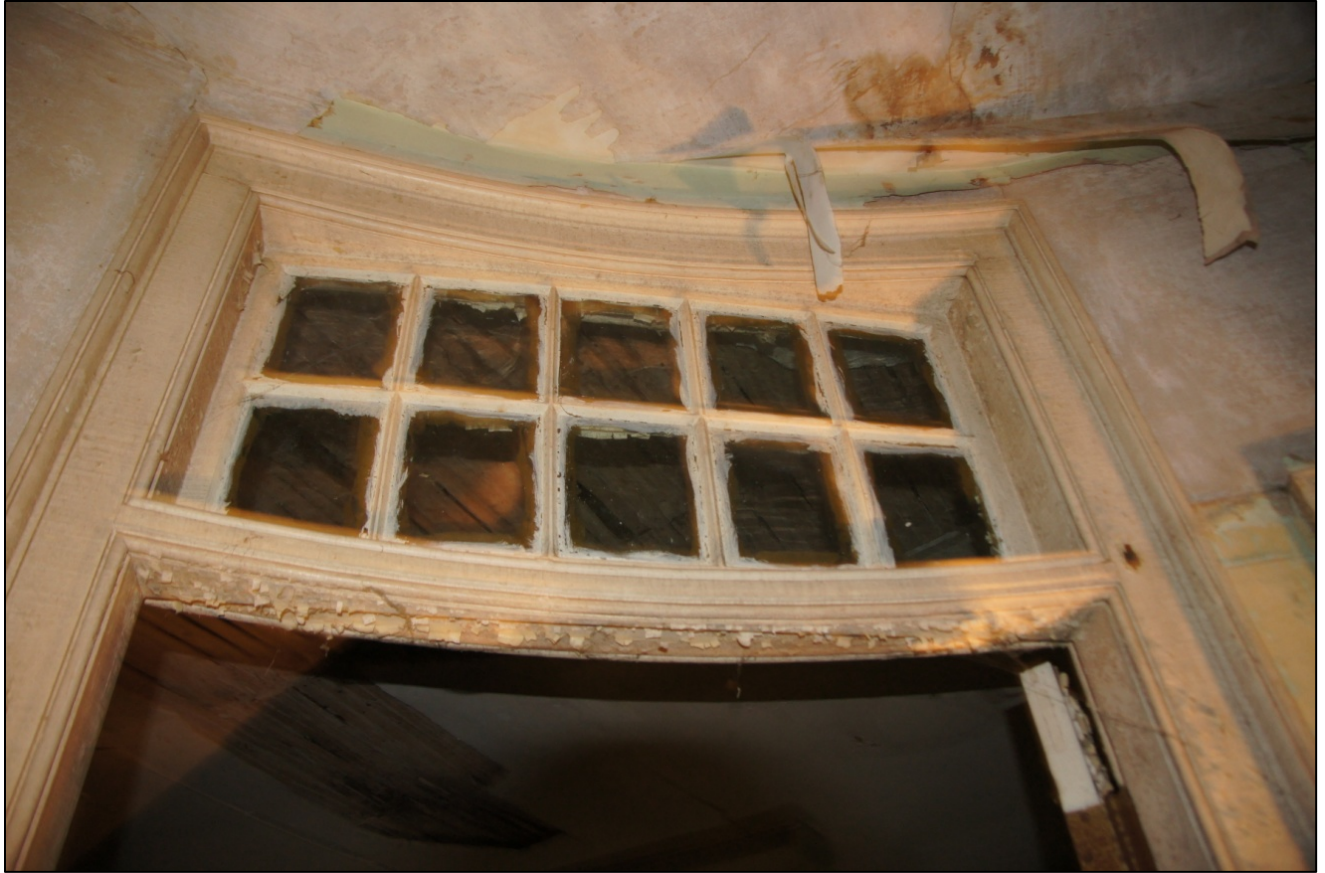
Photo 37.

Room 12 – Original door and transom framing in hallway entering Room 14. Note that the original fixed multi-light transom was not designed with a curve, but set into the framing.

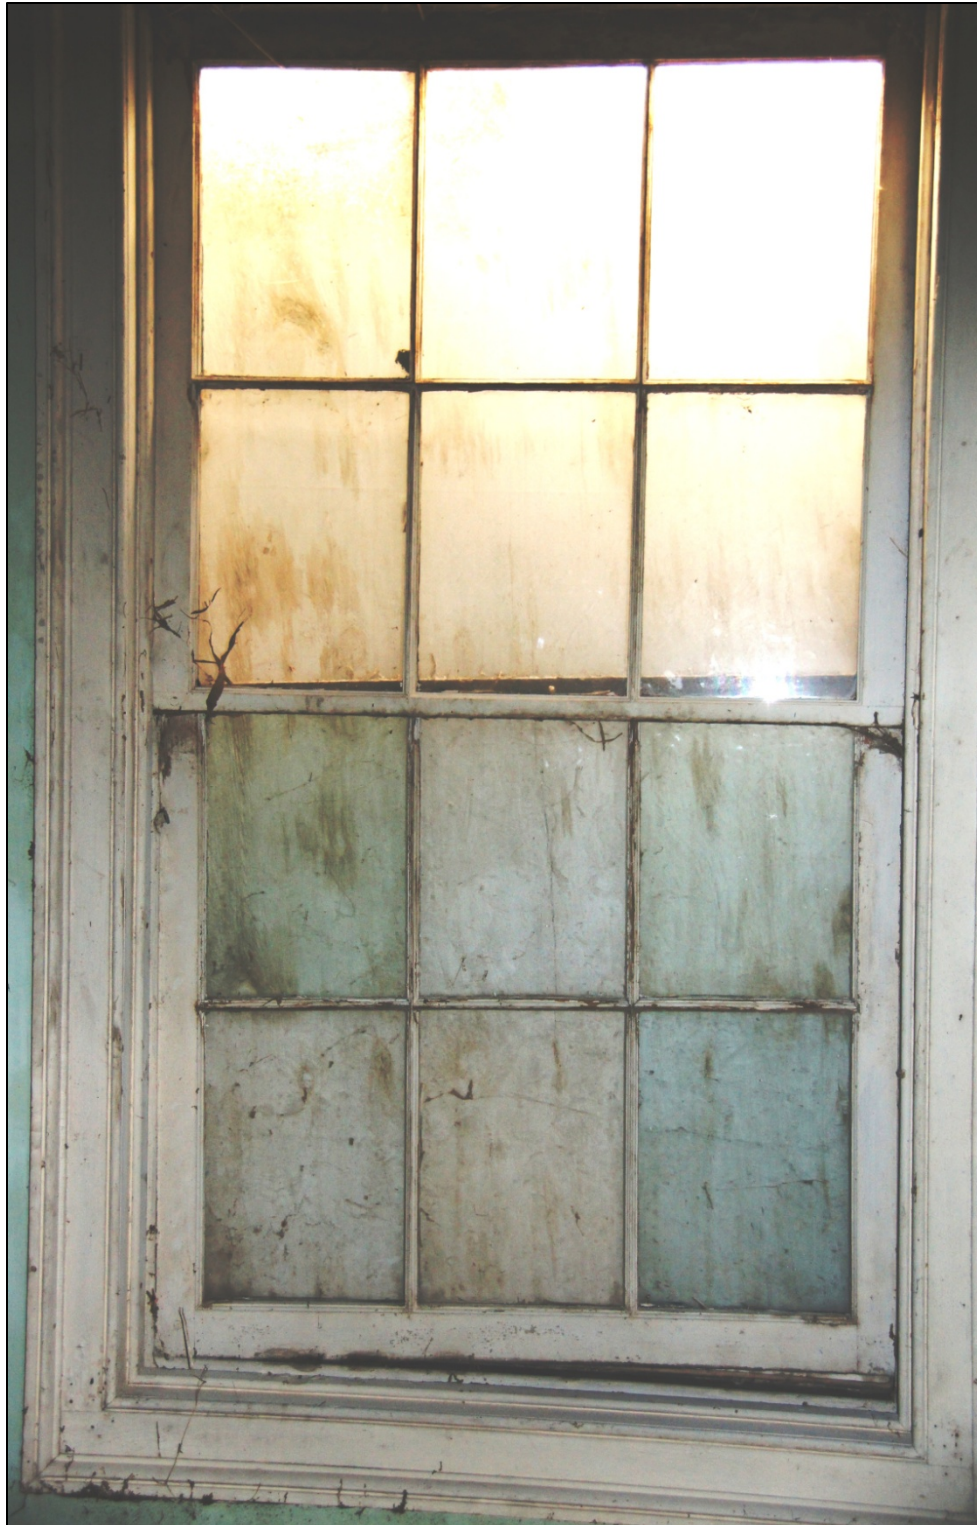
Photo 38.

Room 13 – Original window sash and framing. The window's flush setting with the wall plane and overall simplification, as compared to other second floor windows may indicate this small room was originally intended as a closet or storage.
