JOSEPH BARKER, JR. HOUSE
FEATURES OF SIGNIFICANCE WITH PRESERVATION RECOMMENDATIONS

SUBMITTED BY
THE CENTER OF EXPERTISE FOR THE PRESERVATION OF HISTORIC STRUCTURES AND BUILDINGS
U.S. ARMY CORPS OF ENGINEERS, SEATTLE DISTRICT
FOR THE
U.S. ARMY CORPS OF ENGINEERS, HUNTINGTON DISTRICT

16 JULY 2014

FEATURES OF SIGNIFICANCE WITH PRESERVATION RECOMMENDATIONS

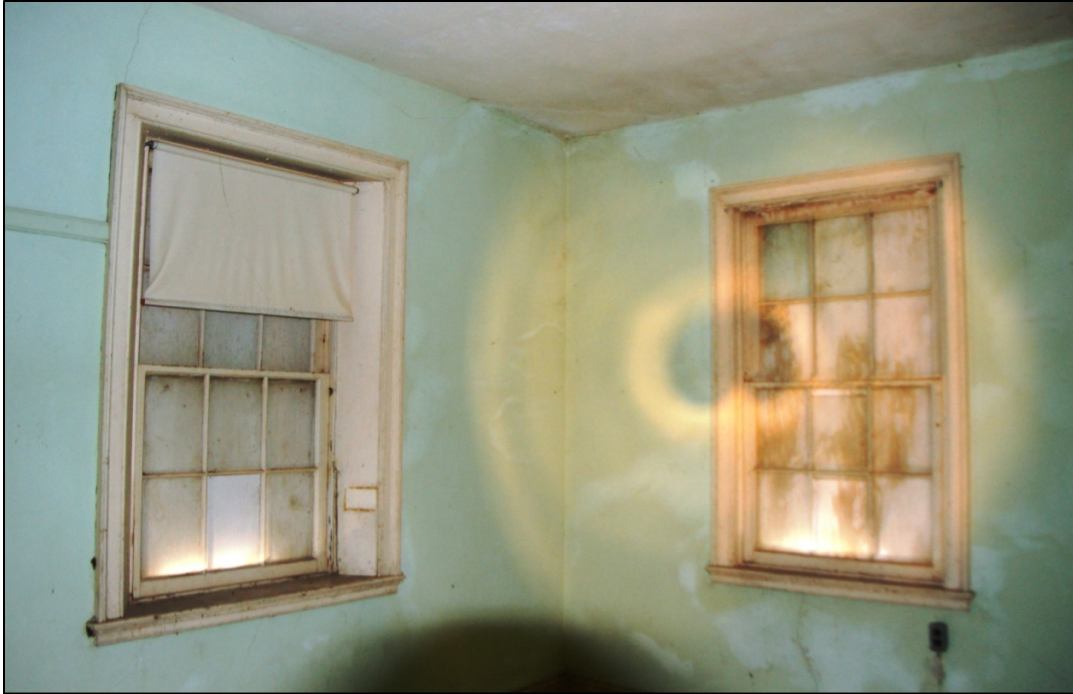
Photo 39.

Room 14 – Southwest corner, showing simpler window framing than the first floor. All wood window sashes, frames, sills, and trim are original.

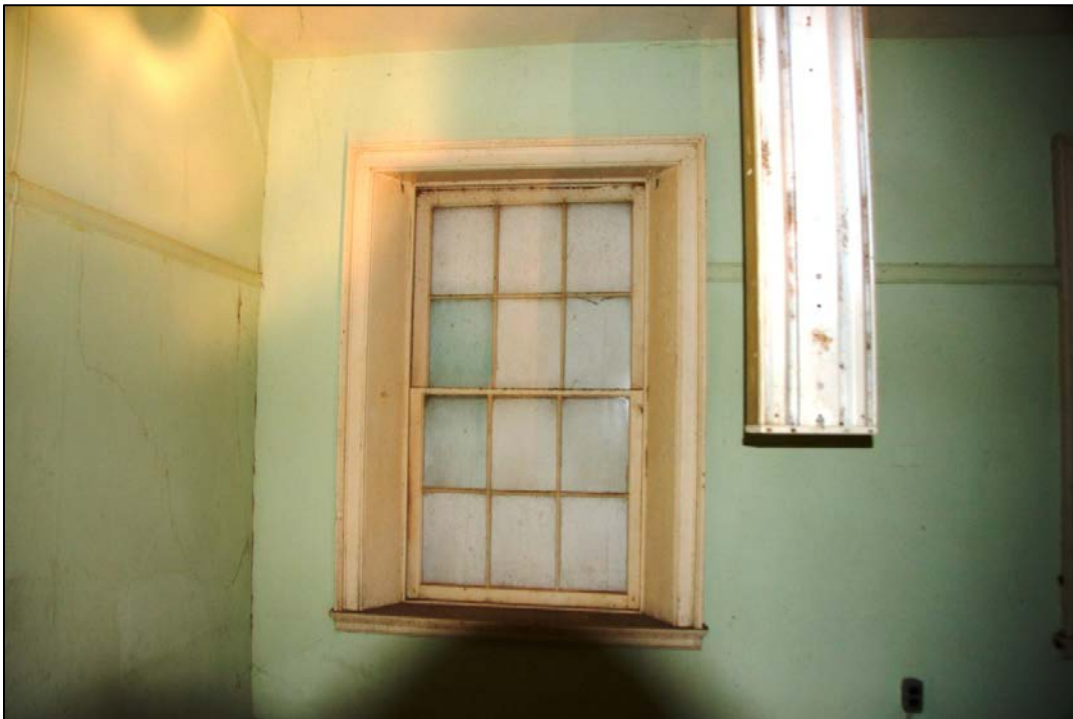
Photo 40.

Room 14 – Southeast corner. Recessed window boxing, framing, and six-over-six window sash is original.

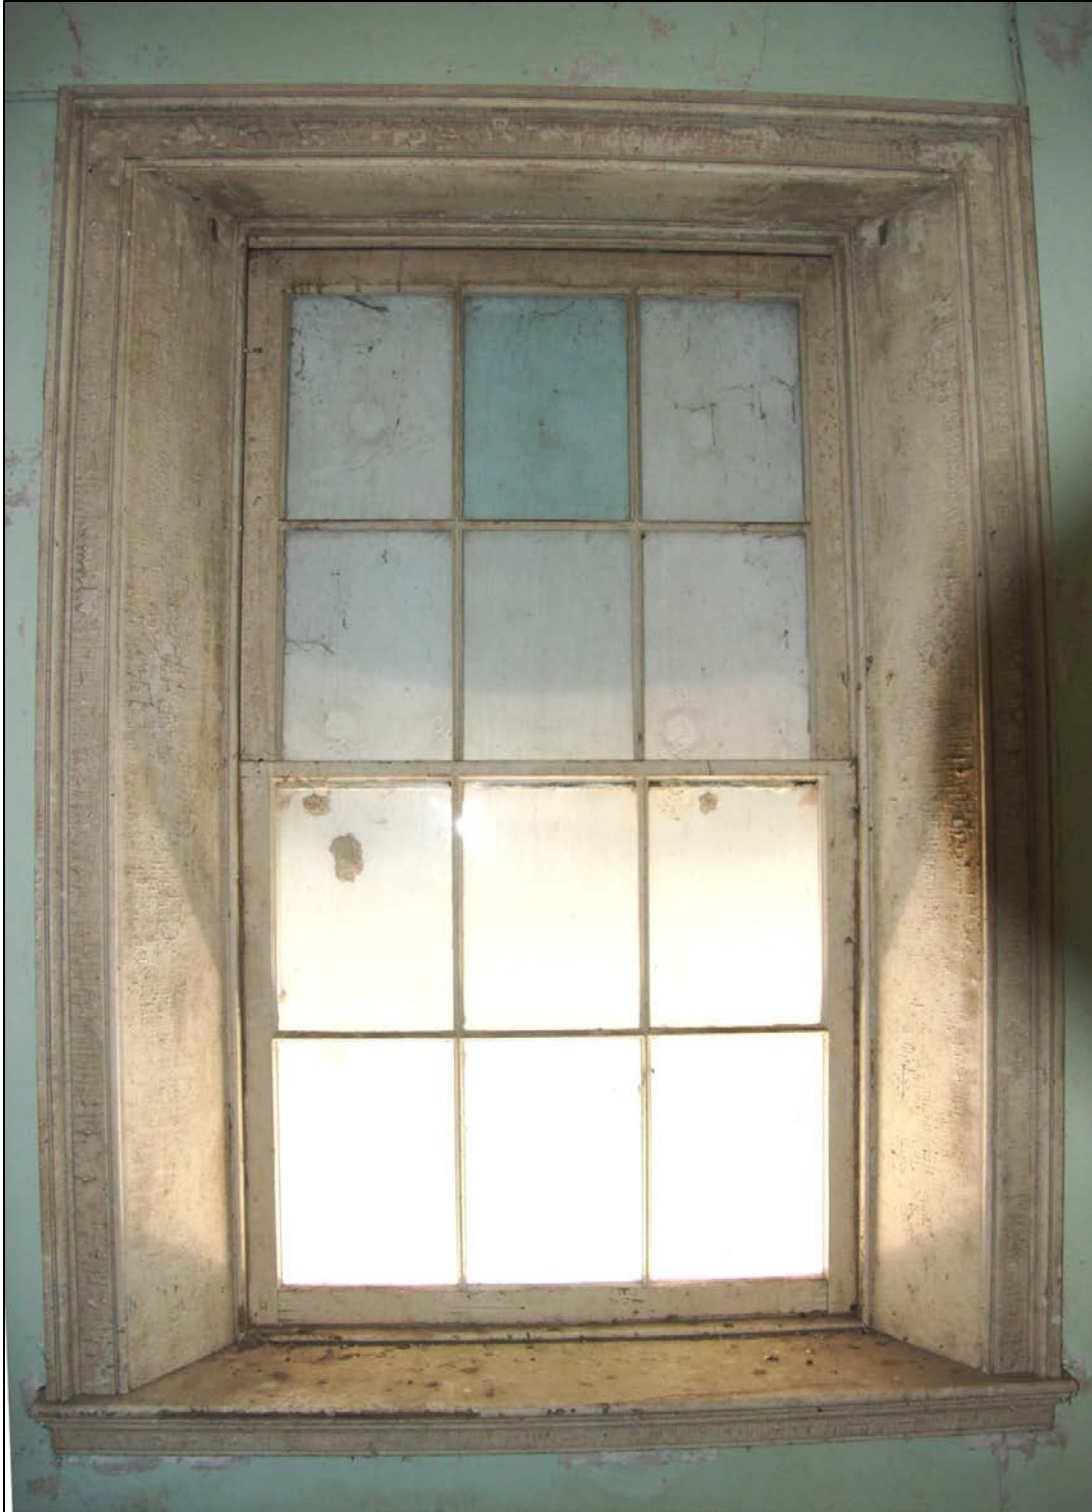
Photo 41.

Room 15. Original west window sash with recessed framing. This unit is representative of the design and condition of all second story windows in the brick section of the house.

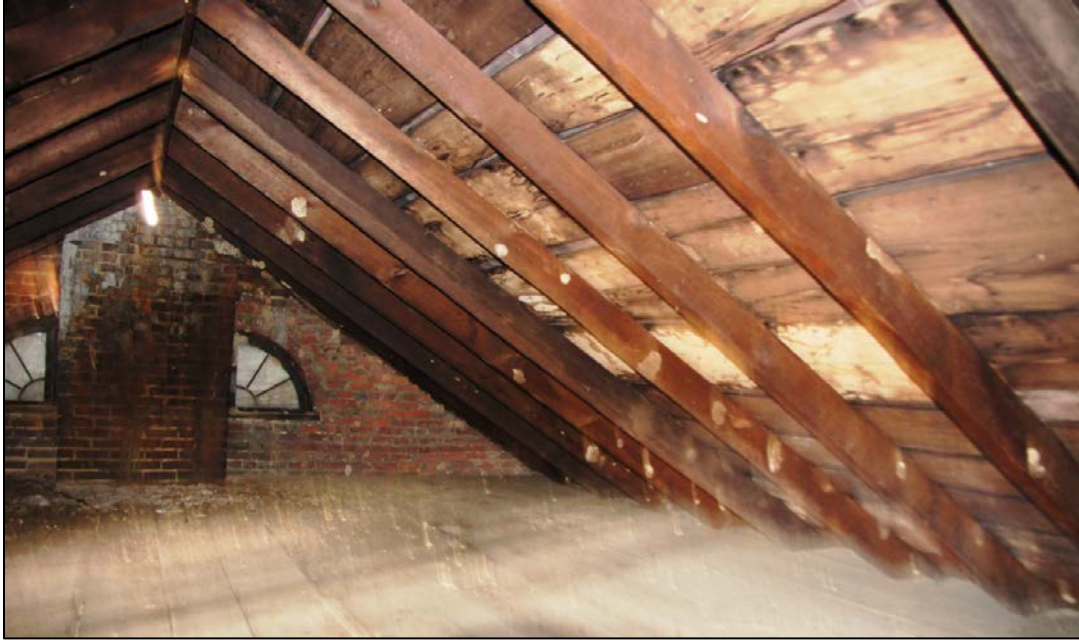
Photo 42.

Attic story of the brick house, showing ceiling construction of rafters and decking. The workmanship of the gable lacks the refinement of the lower two stories, suggesting much of the present roof is not original and was repaired or rebuilt at some time. This is also supported by the poor quality of construction in the joinery of the rafters at the peak and in the awkward termination of the brick end walls.

Recommendation: The present attic construction does not appear to be fully original to the first construction period, but was likely repaired or reconstructed during a later historic period (1825-1900). Immediate attention should be given to repair any damaged roof deck boards or to solder/seal metal roofing to prevent water passage.

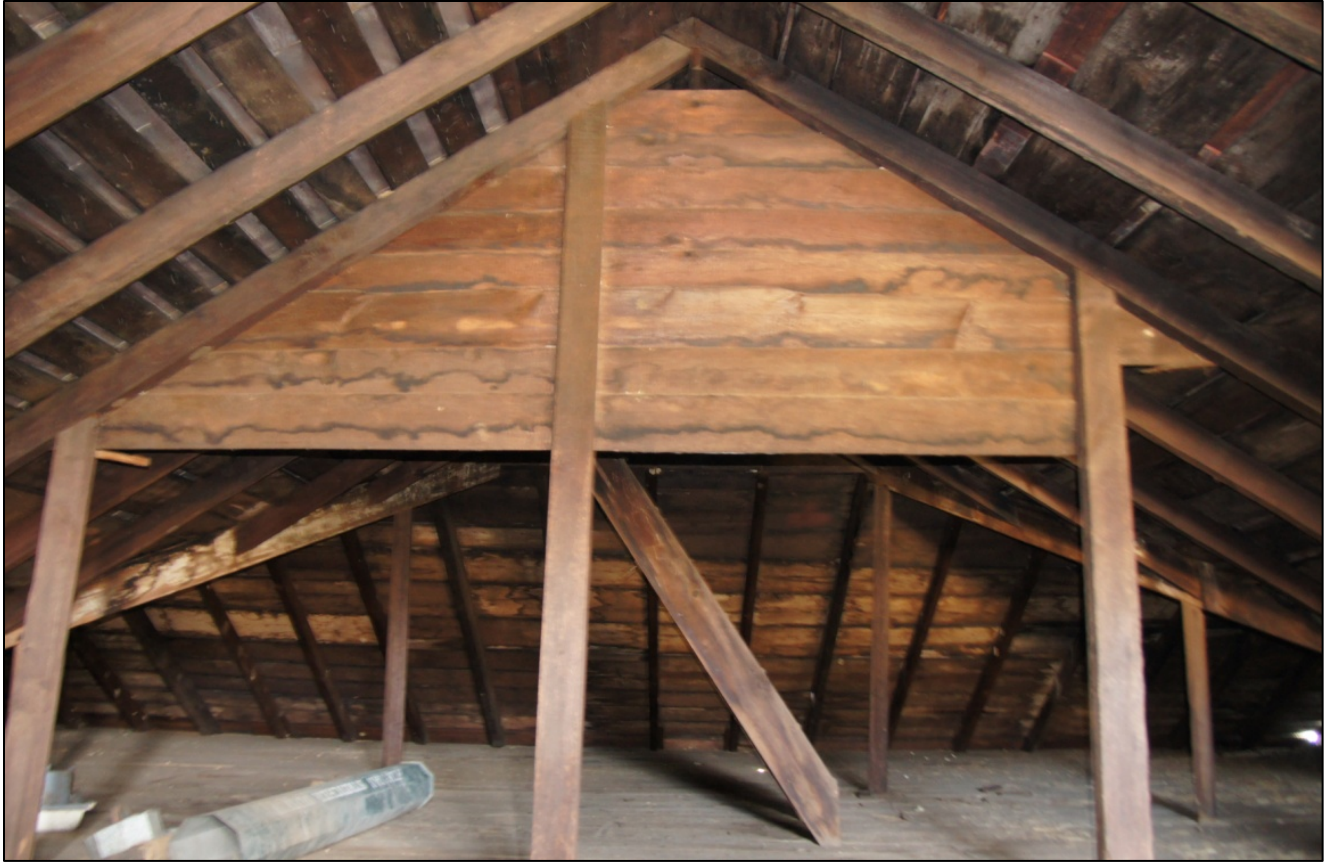
Photo 44.

Attic – Looking south from the second floor/attic of the frame house into the attic of the brick house. The partial wall of boards marks the meeting of the two sections.

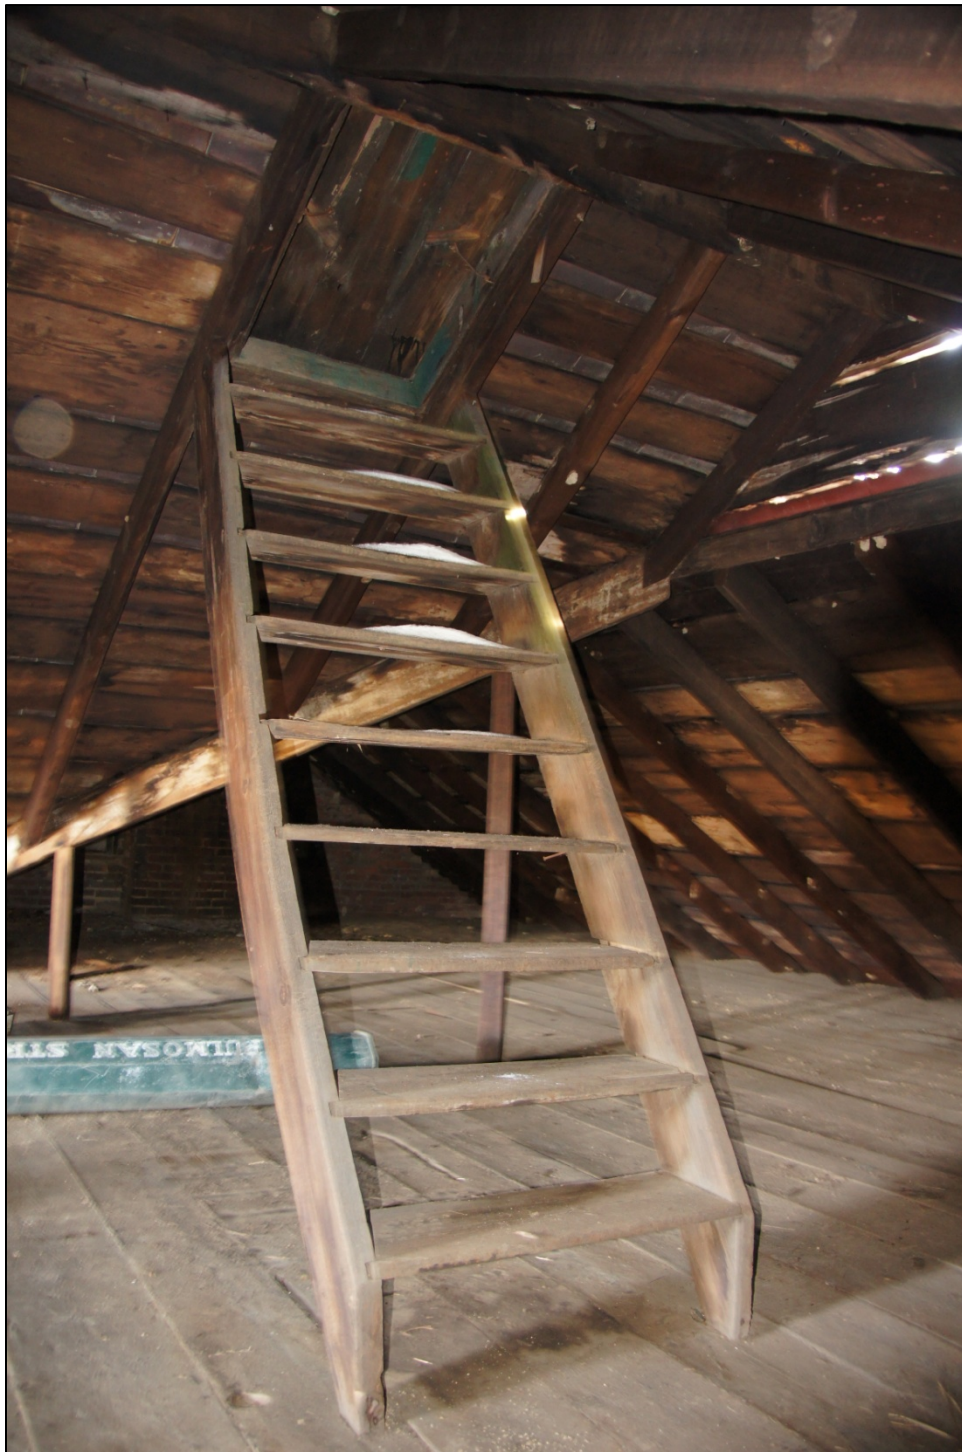
Photo 45.

Attic floor of brick house with ladder to roofline hatch. This section of roof is the point where the gable of the frame house extends slightly beyond the roofline of the brick house.

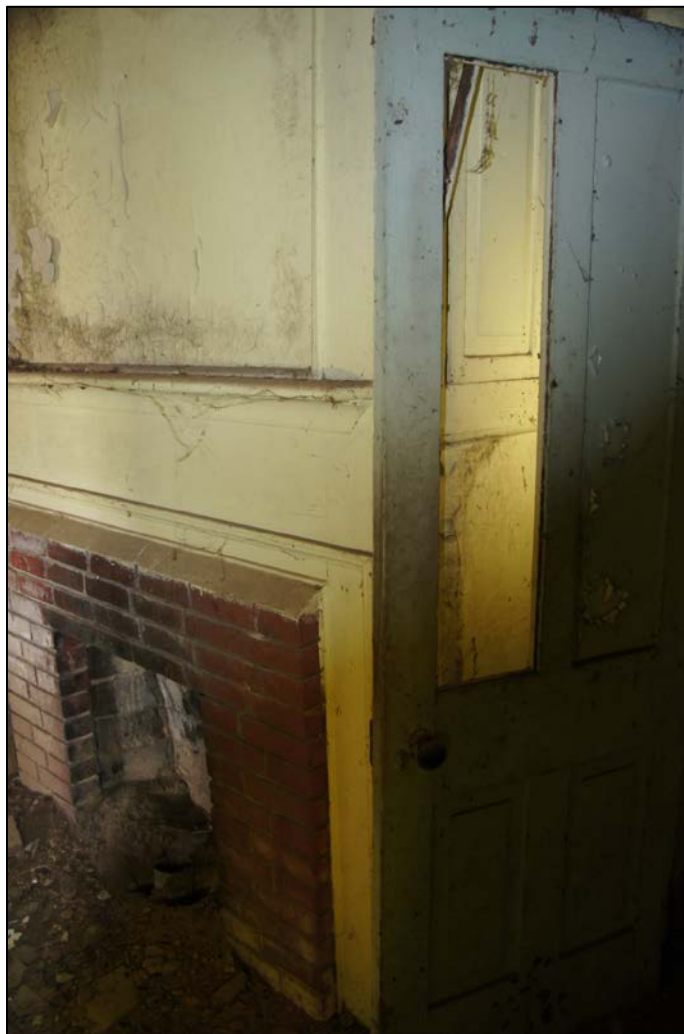
Photo 46.

Room 6 – View of fireplace and surround. The feature is identical to the fireplace surround located directly above on the second floor. A four paneled wood door to Room 7 is at right.

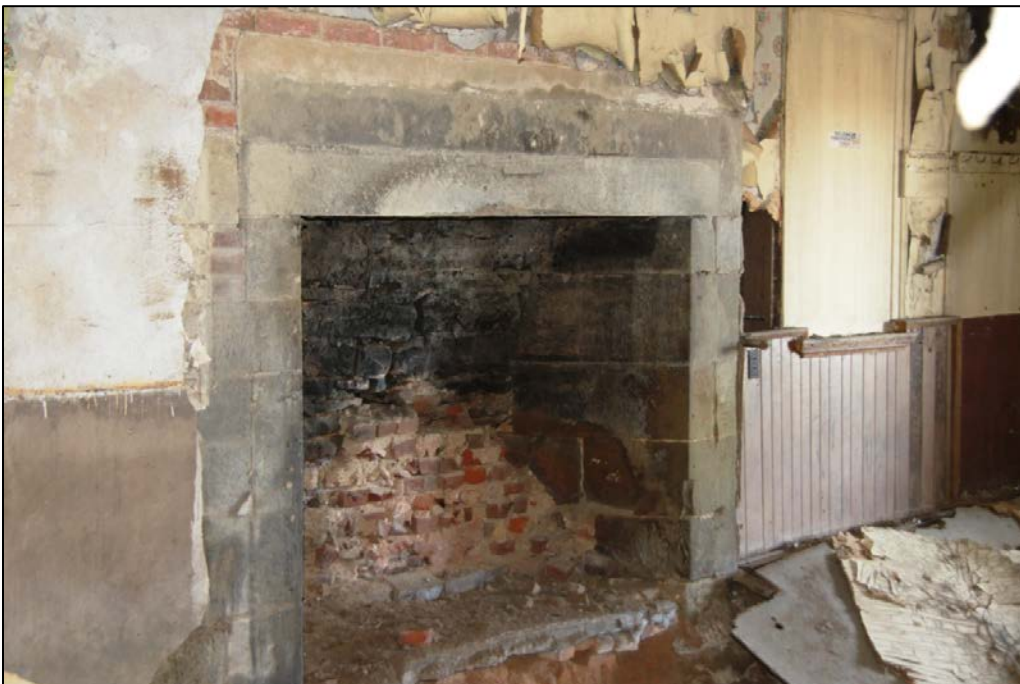
Photo 48.

Room 8 – Detail of hearth in Figure 47, with dressed sandstone and brick materials exposed, looking northeast. The hearth was probably originally framed by the unattached mantel surround found in Room 5.

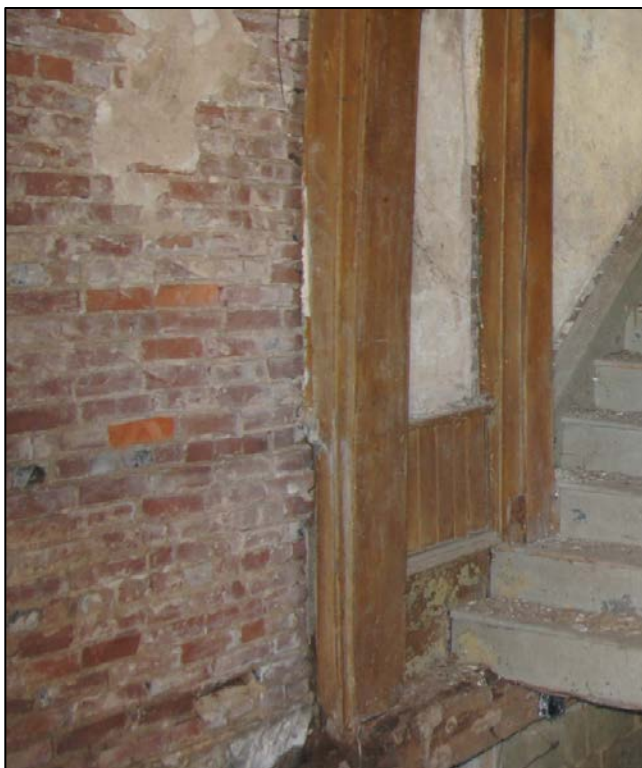
Photo 49. Room 8 – Detail, rear wall of the brick house, first floor, looking southwest. The mortar joints of this wall are struck and appear similar in profile, materials, and execution as joints on other exterior elevations of the house.

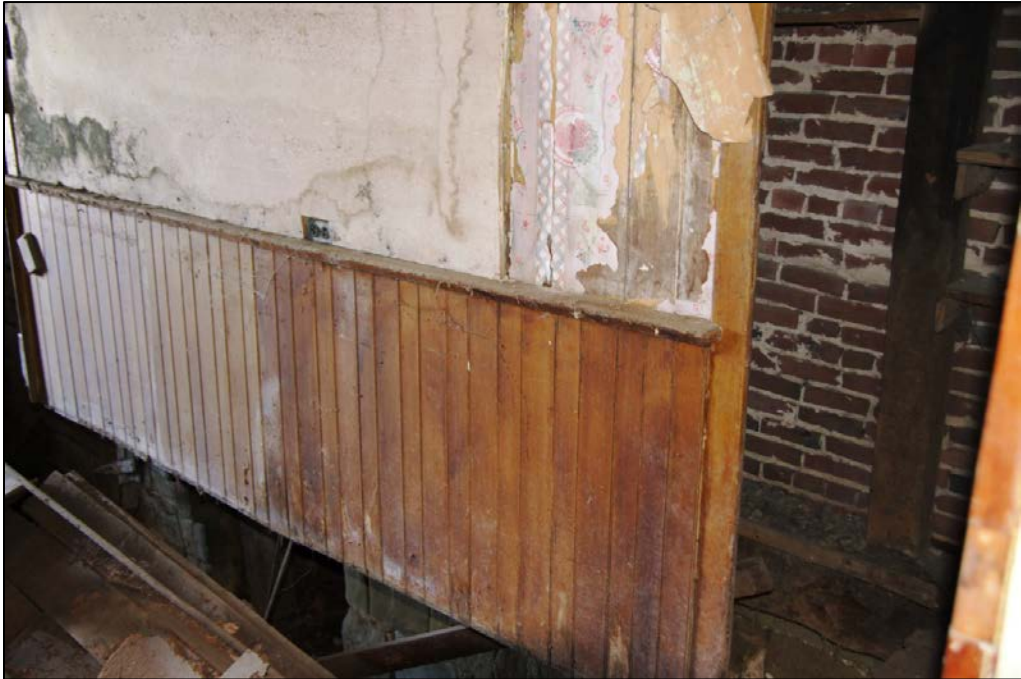
Photo 51.

Room 8 – First floor, frame house showing beadboard wainscoting composed of alternating wide and narrow boards and chair rail.

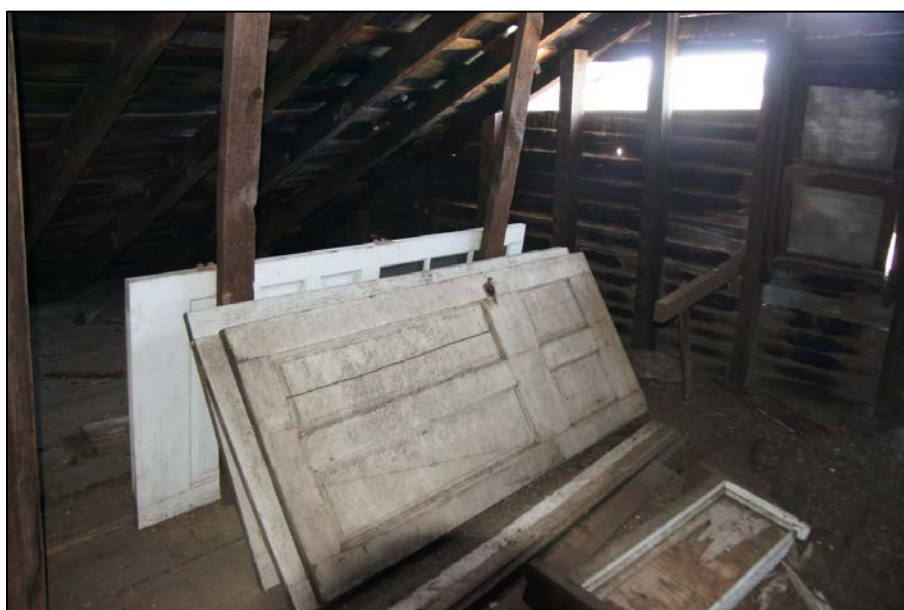
Photo 53.

Room 17 – Frame house, attic story, showing salvaged doors.

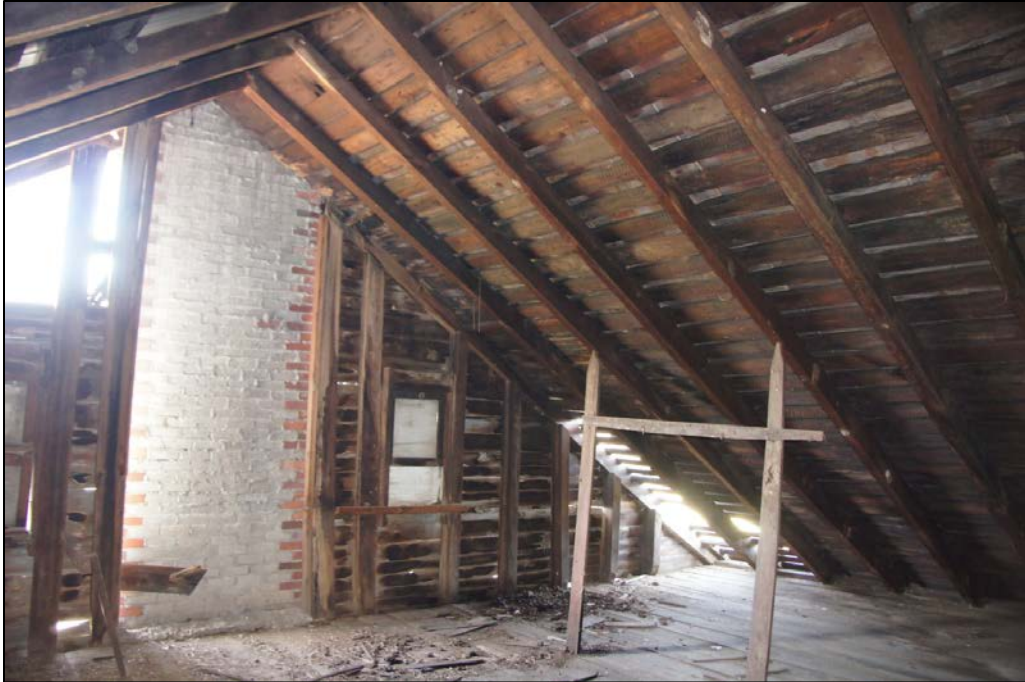
Photo 54.

Room 17 – Attic story of frame house, showing gable rafters and plank decking.

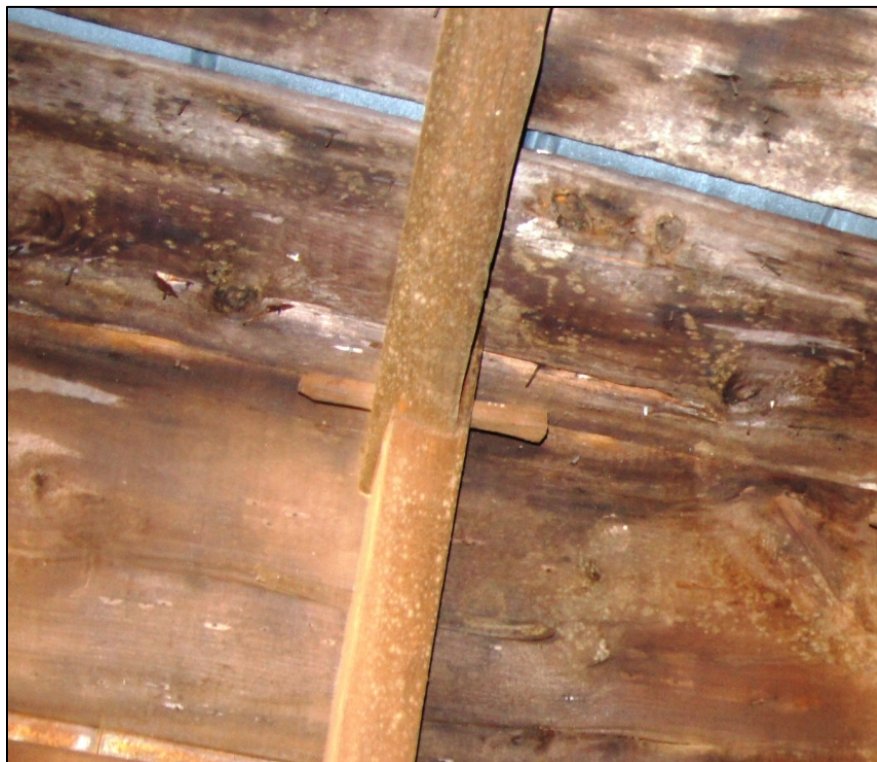
Photo 55.

Room 17 – The rafters in the frame house are joined by pegs.
