**US Army Corps  
of Engineers** ®  
Kansas City District

# **Evaluation of Reported Notch Problem Locations Below Rulo, Nebraska**

**April 2013**

## **FINAL REPORT**

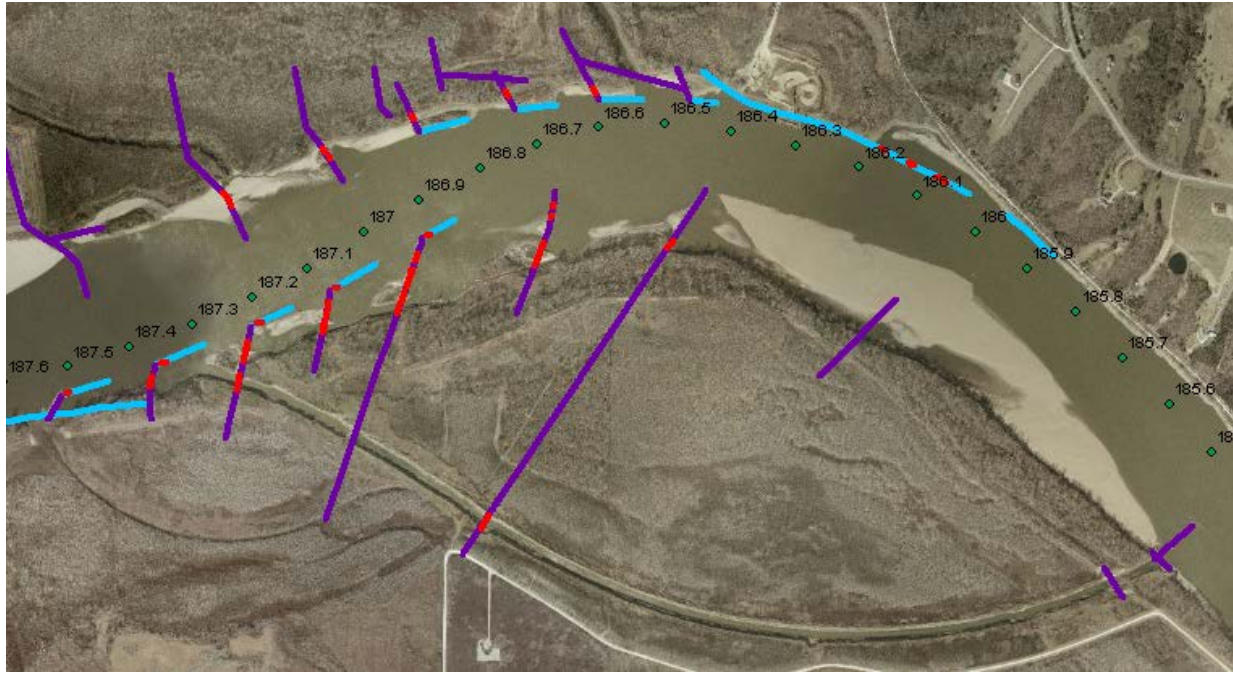
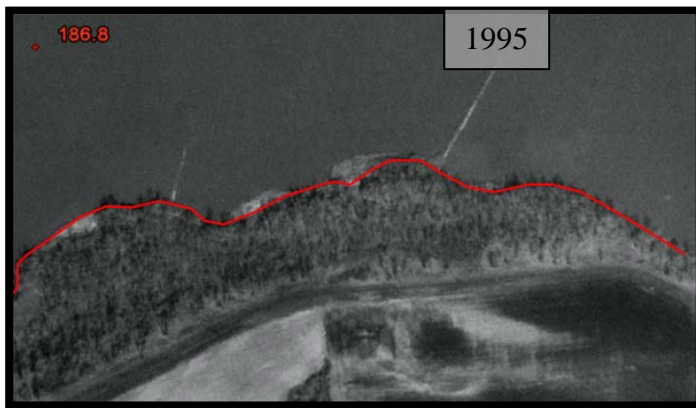
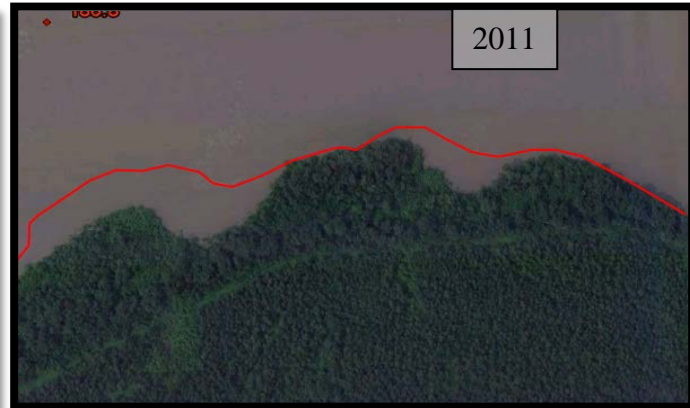
**Figure 1-9: Bank Erosion on Federal Land for Increased Aquatic Habitat**

Larger notches, along public property and designed to erode the bank, direct water at the base of the bank, eroding away the bank which leads to increased acreage of open river and increased area of aquatic habitat. These notches are moved toward the bank in an iterative process as the bank slowly erodes away. An example of this erosion on federal land at Overton Bottoms North near River Mile 186 can be seen in Figure 1-9 below.

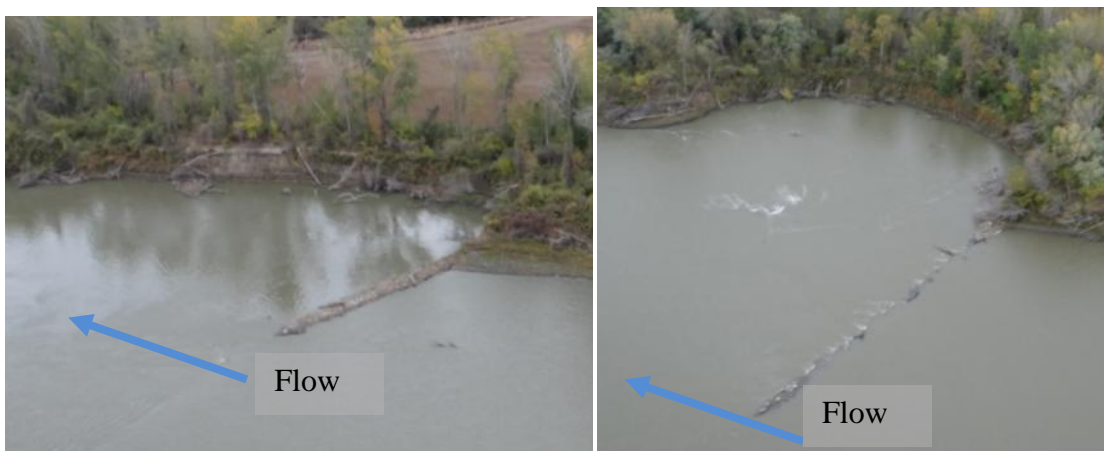
**Figure 1-10: Two examples of erosion around structures with no notches.**

The banks above revetments and upstream and downstream of the dikes are not armored with rock and are subjected to the erosive action of the river's flow under the right conditions. Two examples of erosion behind dikes with no notches are shown in Figure 1-10.

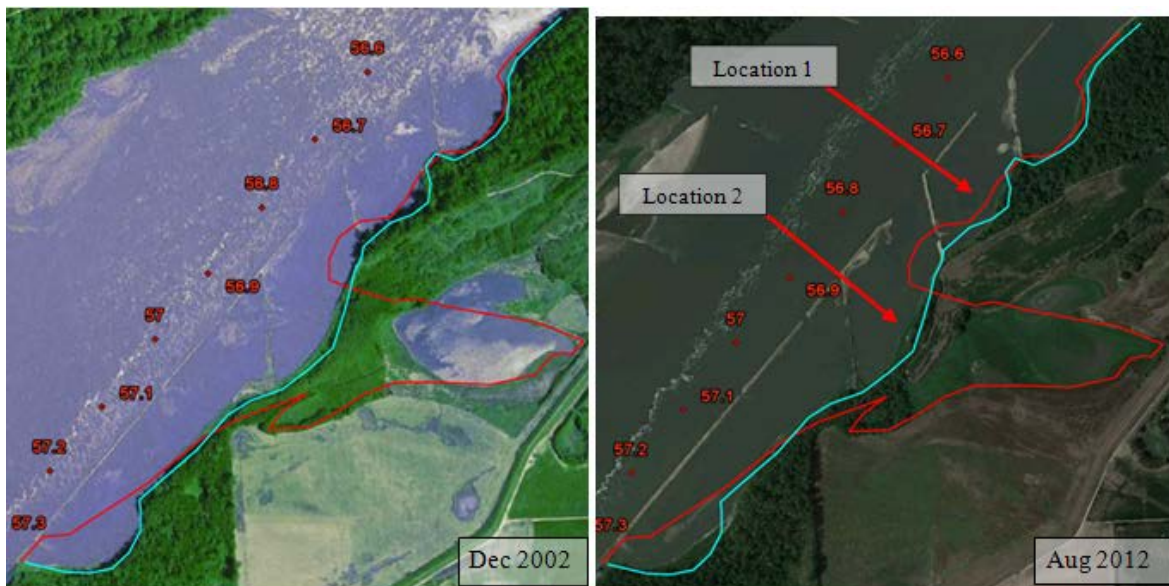
**Figure 2-2(e): Aerial Photo Comparison of Locations 1 and 2 over 10 years**

The most recent aerial photo available after the 1995 flood event was taken in 2002. Aerial photos from 2002 and 2012 were compared. The 2002 photo predates the notch in D059.25 but is after the notches in R61.5 were constructed. The red line represents the bank line in 1995 as shown in figure 2-2(d) above and the blue line indicates the bank line in 2002. These photos are shown in Figure 2-2(e) below.

The large scour hole from the 1993 flood has almost completely filled in. Between 1995 and 2002, one bank location experienced erosion but it is upstream of all three notches and therefore not caused by the notches. This area appears to have partially filled in between 2002 and 2012. The notches do not appear to be causing bank erosion.

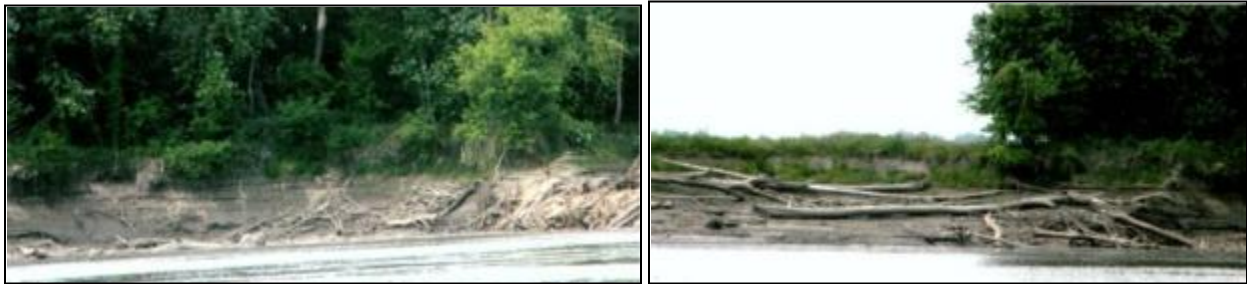
**Figure 2-3(a): Submitted Photos for Location 3**

Mr. Kuenzel stated, “Boles bottom at MM 59 shows heavy bank erosion some rock was added in last years but more is needed right bank.” His photos taken at Location 3 can be seen below in Figure 2-3(a).

Aerial photos between 1995 and 2012 were compared. The photos in Figure 2-3(c) indicate the bank has eroded near the root of D062.2.

The bank near the root of the dike shows some erosion in the 2002 photo. By 2009, the bank had moved 120 feet from the bank location of April 1995. The bank location does not appear to have moved since 2009 when the dike was repaired. Over the period of 17 years shown in the aerial photos, the bank line moved as indicated by the red shaded area in Figure 2-3(c).

There is erosion at this location near the root of the dike structure. The dike contains a notch that is 20 feet wide with a bottom elevation one foot below the top of the adjacent dike height, and is at least 250 feet from the bankline. Since the notch is only 20 feet wide and 1 foot deep, located out on the dike and slightly downstream of most of the erosion, and has been in place since 1985, it is unlikely the cause of the erosion that has occurred near the root of the dike. The dike repair completed in 2009 should help prevent further erosion.

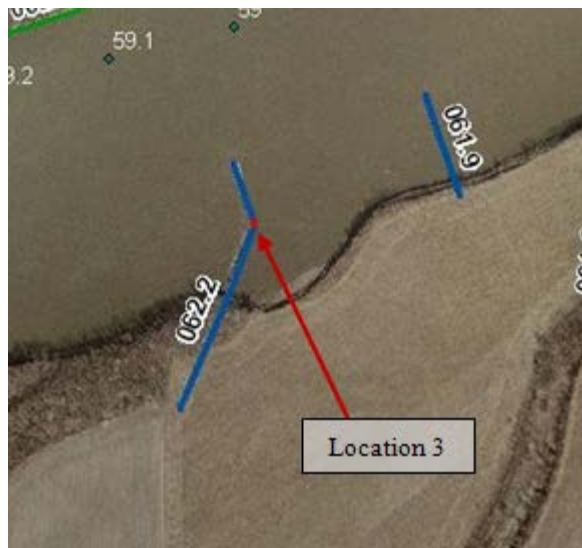
**Figure 2-3(b): Overview of Location 3**

Location 3 is located downstream of structure D062.2 near the Labadie Power Plant intake. A notch was constructed at this location in 1985 and the structure repaired in 2009 with nearly 1,000 tons of rock. Notch details can be seen in Table 2.2.

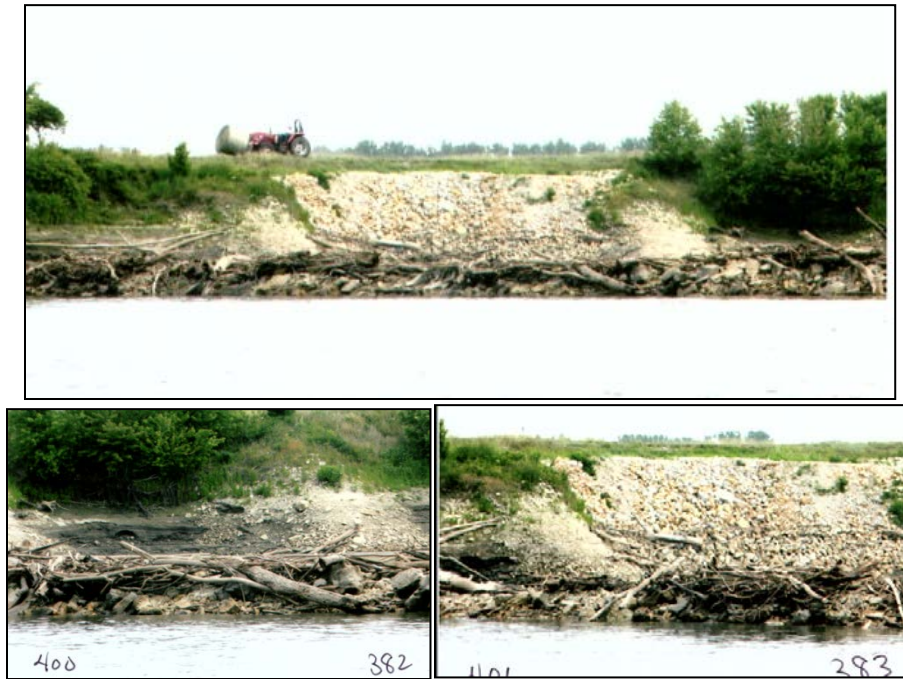
**Figure 2-4(a): Submitted Photos for Location 4**

For Location 4, Mr. Kuenzel stated, “Augusta bottom 200 yards below MM 62 left bank showing hard points that have been put in along with additional rock laid against the toe of the levee. Notice the farmer moving hay bales on the top of the levee the bank of the river is less than 50 feet. There is no excuse for this.” His submitted photos of Location 4 can be seen in Figure 2-4(a).

Since the notch is a small/medium notch, located 400 feet away from the bank, and not aligned so as to direct water toward the bank, it is unlikely the notch is the cause of the bank erosion that occurred near the root of the dike. Hard points were added in 2002 and the bank line has not changed since that time.

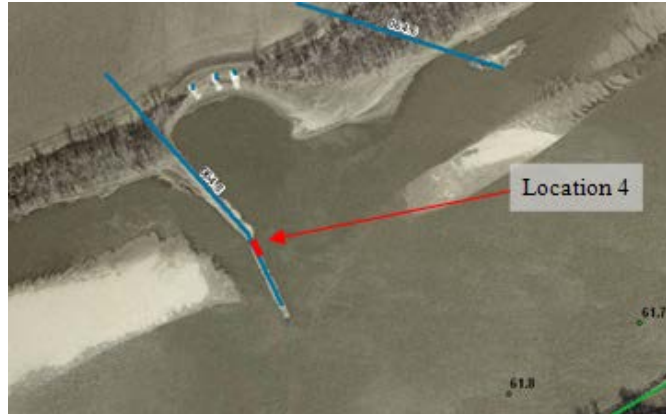
**Figure 2-4(b): Overview of Location 4**

Aerial photos were compared over the past 17 years. The photos in Figure 2-4(c) indicate the bank eroded between 1995 and 2002 near the root of D064.8.

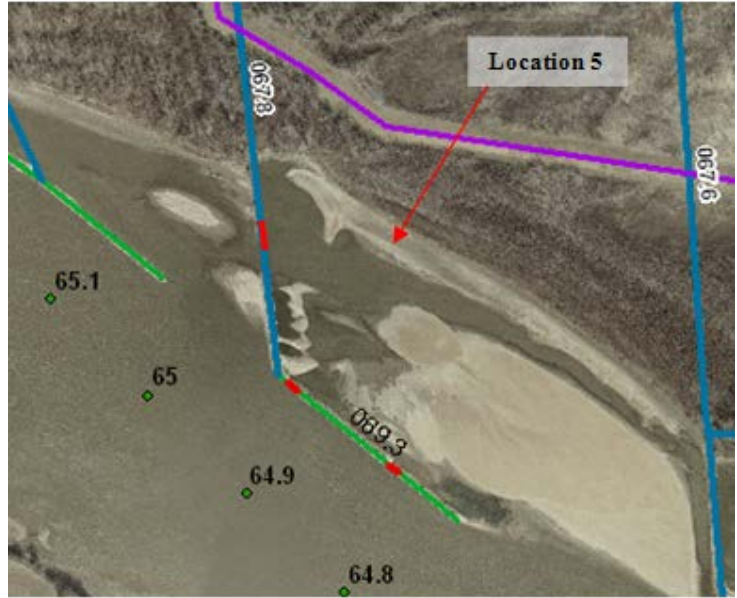
**Figure 2-5(b): Overview of Location 5**

Location 5 is located near two notches in revetment R069.3 and one notch in dike D067.8. Details can be seen in Table 2.4. In 2002 the revetment was repaired with almost 3,500 tons of stone fill to the design elevation of +5 CRP.

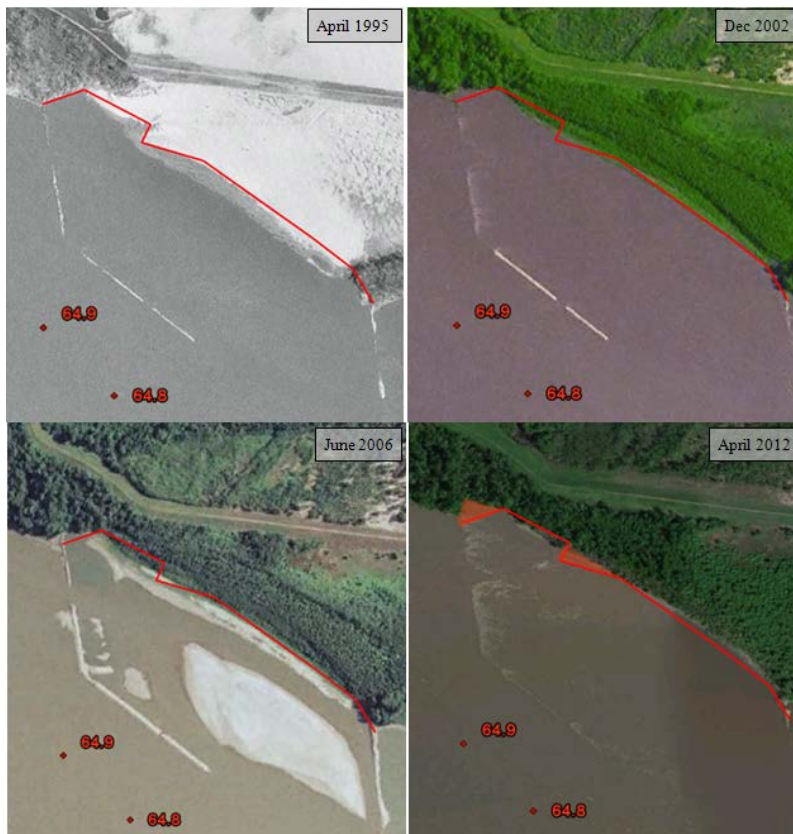
**Figure 2-5(c): Aerial Photo Comparison of Location 5 over 17 years**

Aerial photos between 1995 and 2012 are shown in Figure 2-5(c) and indicate very little change in the bank line. This location experienced significant scour from the 1993 flood. Bank movement that has occurred since 1995 is represented by the red shaded area in the 2012 photo.

The notches in the revetment are small and between 750 – 800 feet from the bank. The notch in the dike is medium size and almost 400 feet from the bank. Most of the bank erosion is near the root of the dike which is upstream of all three notches and not affected by flow through the notches. Therefore, it is unlikely the notches are the cause of the bank erosion. The dike structure, D067.8, is currently on the deficiency list as being 3 feet low and will be repaired at the next opportunity. The erosion could be caused due to the deficient elevation of the dike structure next to bank.

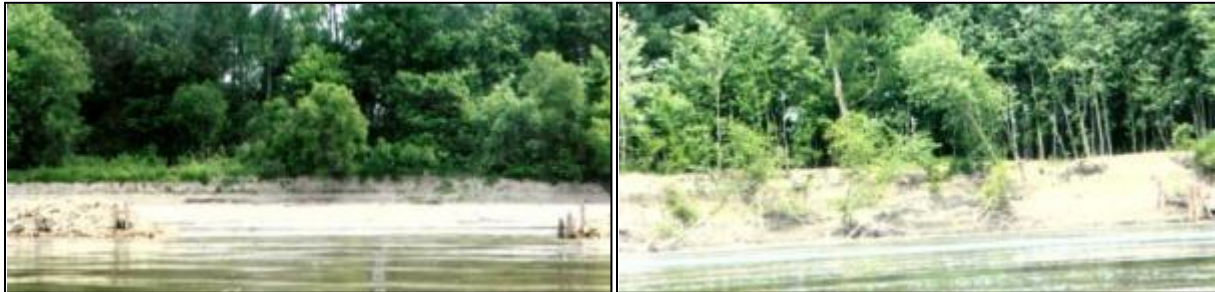
**Figure 2-7(a): Submitted Photos for Location 6**

Mr. Kuenzel stated, “Pictures... show revetment being cut this is at MM 70.7 left bank. There is no excuse for this at all.” He also notes an issue on the other side of the river and stated, “MM 70.7 right bank this is less than 100 feet from the toe of St Johns Island levee.” His submitted photos are shown in Figure 2-7(a).

The left bank line and the right bank line areas for Location 6 and Location 7 have shown no movement since 1995, therefore, the notches have not caused any bank erosion.

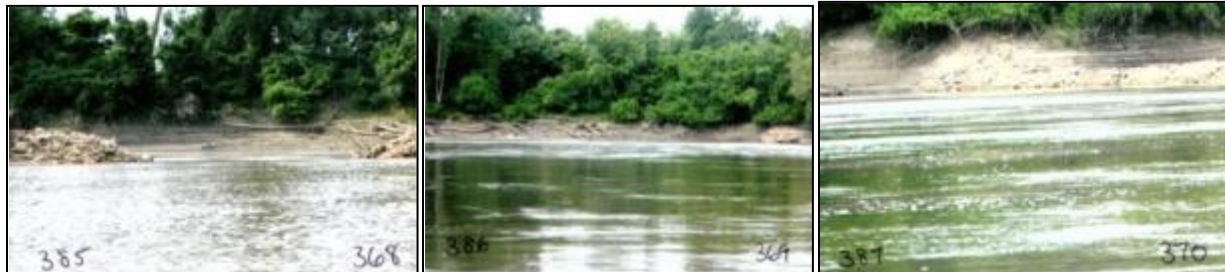
**Figure 2-7(b): Submitted Photos for Location 7**

For location 7, Mr. Kuenzel stated, “Pictures... show heavy bank erosion from dike being notched at mm 71.5 right bank.” These photos are shown in Figure 2-7(b).

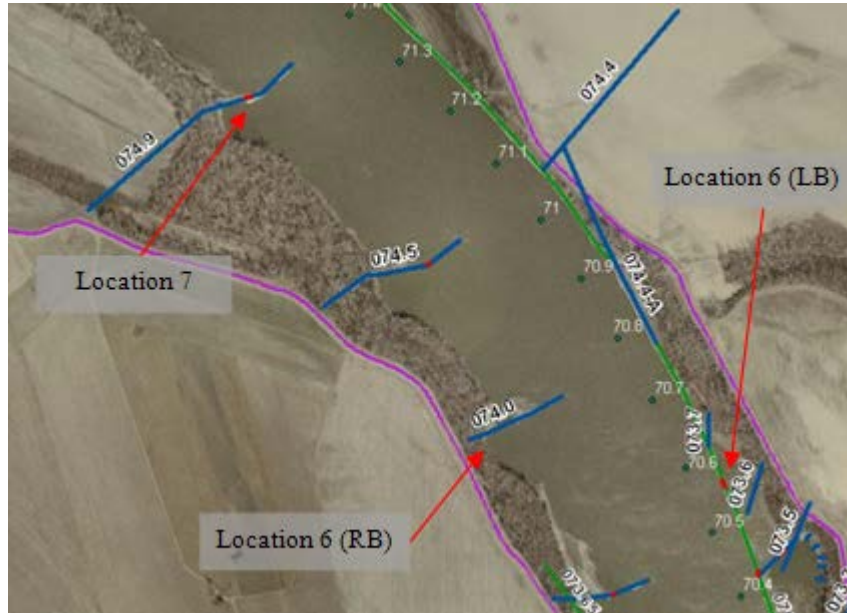
**Figure 2-7(c): Overview of Locations 6 and 7**

Location 6 is near structure R078.1 on the left bank (contains a notch created in 2006) and near D074.0 on the right bank (does not contain a notch). D074.0 was repaired in 1990 and again in 2000 with a total of 9,178 tons of stone fill. The notch in D074.9 at Location 7 was constructed in 2005. Notch details are shown in Table 2.5.

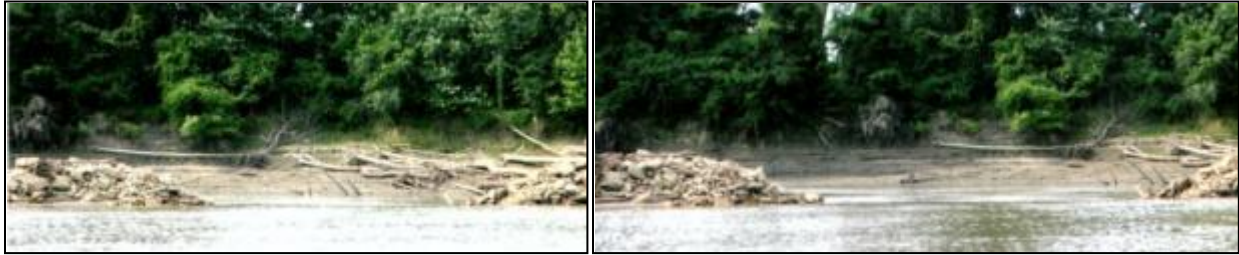
**Figure 2-8(a): Submitted Photos for Location 8**

At Location 8, Mr. Kuenzel stated, “Pictures...shows dike notch at right bank MM 72 cut is very bad into bar ground that we farm.” His submitted photos of the location are shown in Figure 2-8(a).

The bank line shows no movement over the 17 year period in the photos. Therefore, the notches have not caused bank erosion.

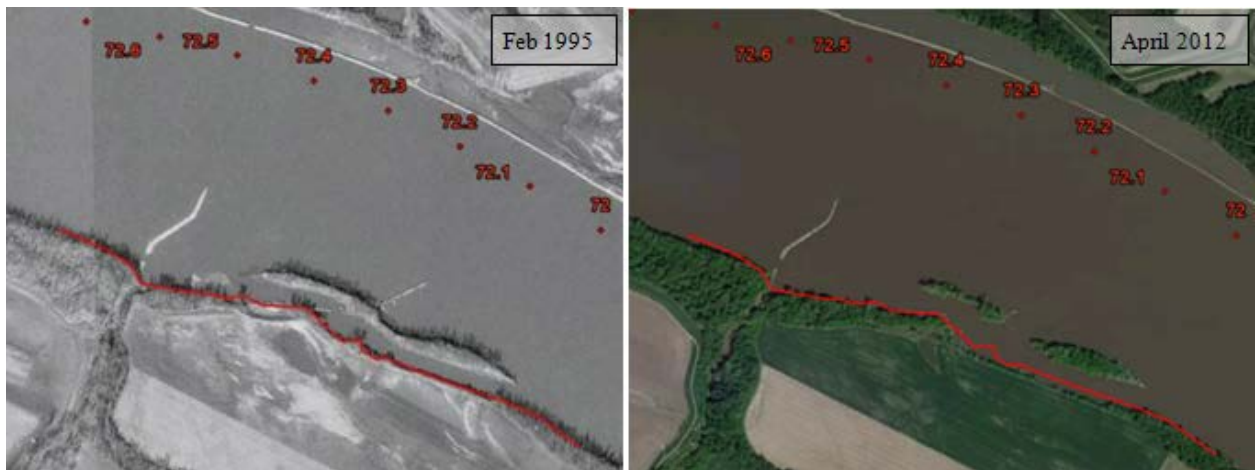
**Figure 2-8(c): Aerial Photo Comparison of Location 8 from 1995 to 2012**

Aerial photos from 1995 to 2012 were compared and are shown in Figure 2-8(c). The red line indicates the bank line location from 1995.

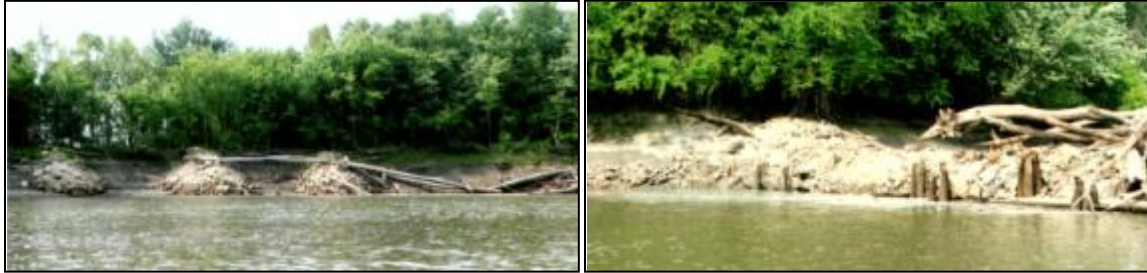
**Figure 2-9(a): Submitted Photos for Location 9**

At Location 9, Mr. Kuenzel stated, “Dike at MM 73 right bank notice how the dike has been notched.” In addition, “Pictures... show hard points put in at MM 73 right bank this would not be like this had the dike not been notched.” His submitted photos of Location 9 can be seen in Figure 2-9(a).

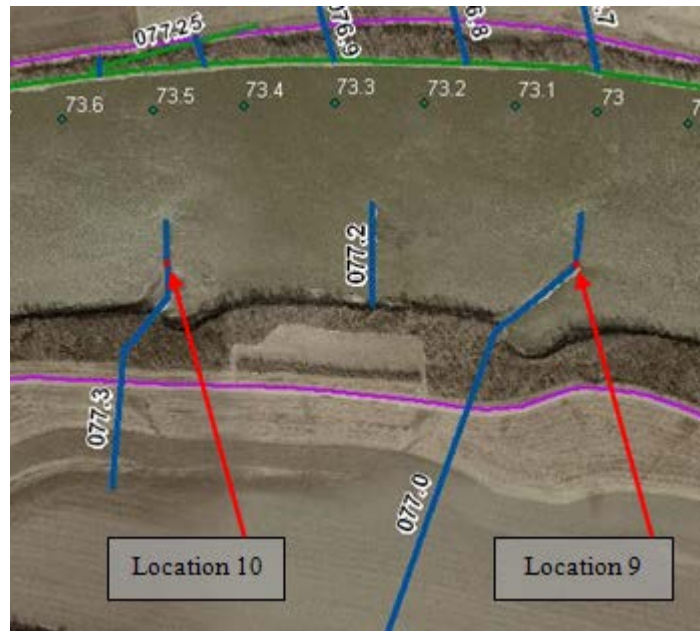
**Figure 2-9(c): Overview of Locations 9 and 10**

Erosion over the 17 year period is apparent near the root of each dike at both locations. Since the notches are small (20 ft wide), located 300 to 400 ft away from the bank, and the erosion is near the root of the structures, it is unlikely the notches are the cause of the bank erosion. The worst erosion occurred at Location 9 which was repaired in 2009. The repair should help prevent additional erosion.

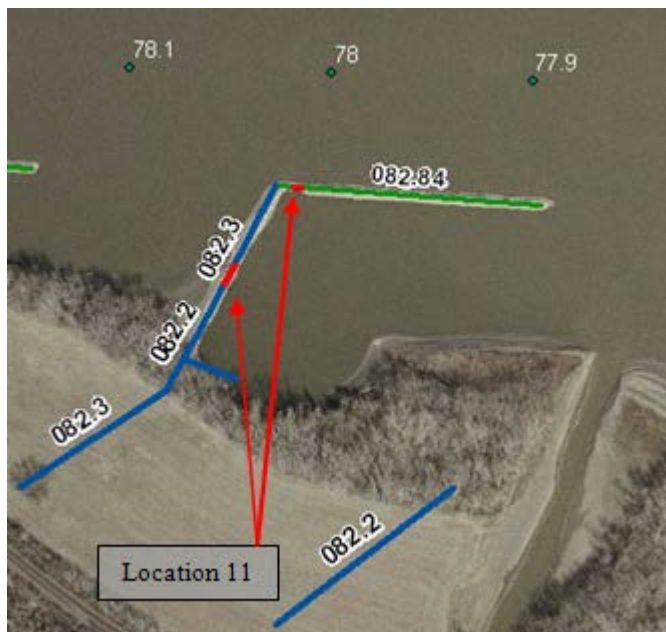
**Figure 2-10(b): Overview of Location 11**

There is one notch in D082.3 which was constructed in 1979 and one notch in R082.84 at the end of D082.3 that was created 1978. In 2002, 2,922 tons of rock was added to R082.84 to raise the deficient areas to an elevation of +5 CRP. Additional notch details can be seen in Table 2.8.

The bank has moved less than 50 feet at its greatest point over the 16 year period and the bank is over 650 feet from the railroad tracks at this location. The notch in the dike is a medium notch and located approximately 250' from the bank. The notch in the revetment small and located over 600 feet from the bank. Both notches were constructed in the late 1970's. Due to the size and locations of the notches, they are unlikely the cause of the bank erosion. The bank will be monitored for additional bank movement and the notch filled or moved riverward if determined to be the cause of erosion.

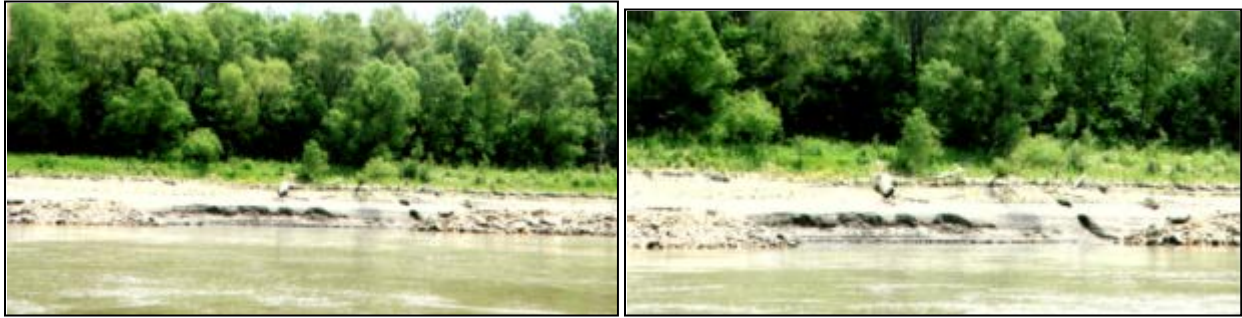
**Figure 2-12(a): Submitted Photos for Location 12**

Mr. Kuenzel stated, “Pictures... are of a notched revetment at MM 83.8 left bank. this was only done so it would cut the bank out to make a major erosion problem.” His submitted photos can be seen in Figure 2-12(a).

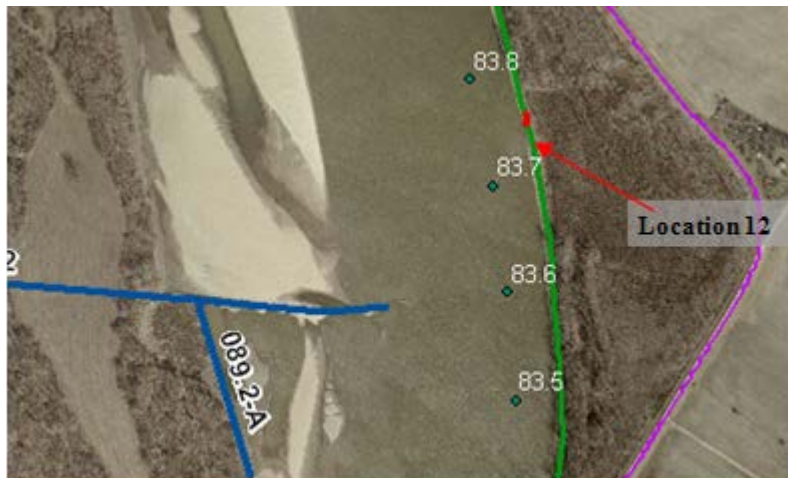
**Figure 2-12(b): Overview of Location 12**

The scour hole from the 1993 or 1995 flood has almost completely filled in. It does not appear that the notch has caused any erosion. The notch was created to connect the aquatic area landward of the revetment to the river. Since the notch was placed for aquatic connectivity and not bank erosion, only one 50 foot wide notch was placed in the location

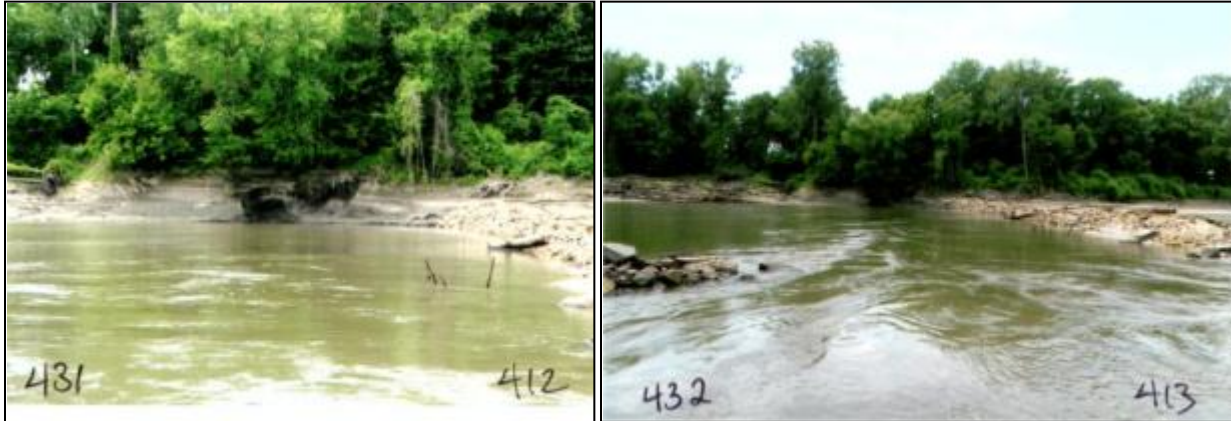
**Figure 2-13(a): Submitted Photos for Location 13**

At Location 13, Mr. Kuenzel stated, “Heavy bank erosion at MM 88.9 right bank most of this due to a dike notch.” His submitted pictures can be seen in Figure 2-13(a).

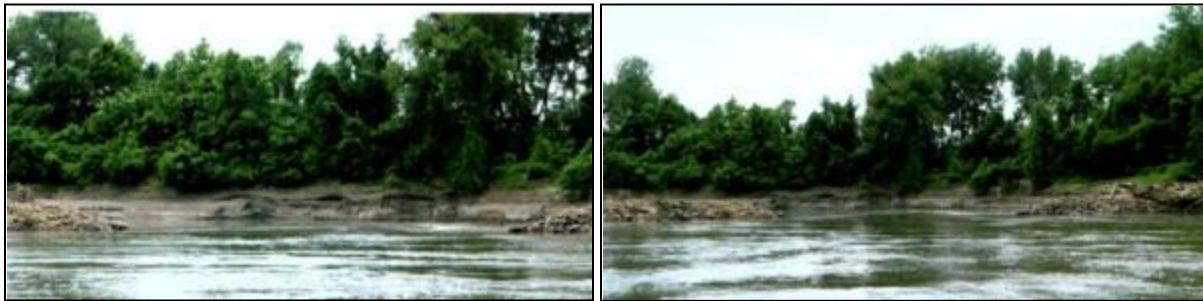
**Figure 2-13(b): Submitted Photos for Location 14**

At Location 14, Mr. Kuenzel stated, “MM 89 right bank heavy bank erosion due to dike notching this also within 100 ft of the toe of the berger levee. I have lost about 3-5 acres of land due to this.” His submitted photos for this location are in Figure 2-13(b).

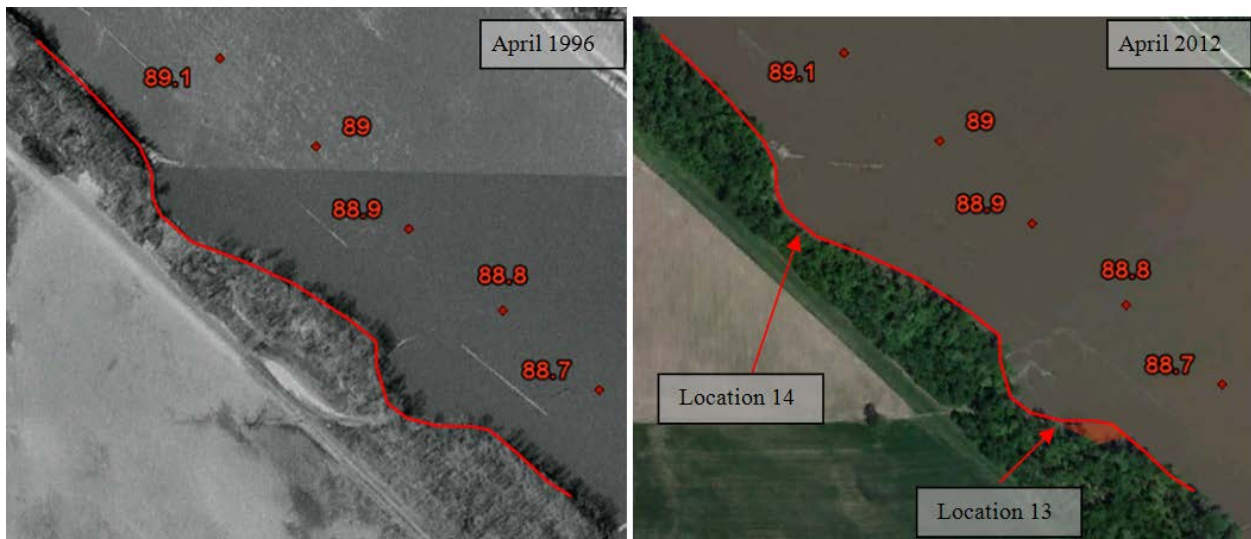
**Figure 2-13(d): Aerial Photo Comparison of Locations 13 and 14 from 1996 to 2012**

Photos from 1996 to 2012 were analyzed to determine movement of the bank line near the area of concern. The red line indicates the bank location from April 1996. These photos are shown in Figure 2-13(d).

Location 13, with one notch at the juncture of the dike and revetment shows bank erosion as indicated by the red shaded area in the 2012 photo above. Location 14, with a notch at the juncture of the dike and revetment and a notch in the dike, shows no bank erosion. It is unlikely the notch at location 13 caused the erosion noted in the photo since it is small and located 230 feet from the bank. Structure D094.3 is on the structure deficiency list and will be repaired as soon as possible. The notch in D094.9 has widened slightly over time and will be evaluated and repaired if necessary. Overall, the notches do not appear to be the cause of bank erosion.

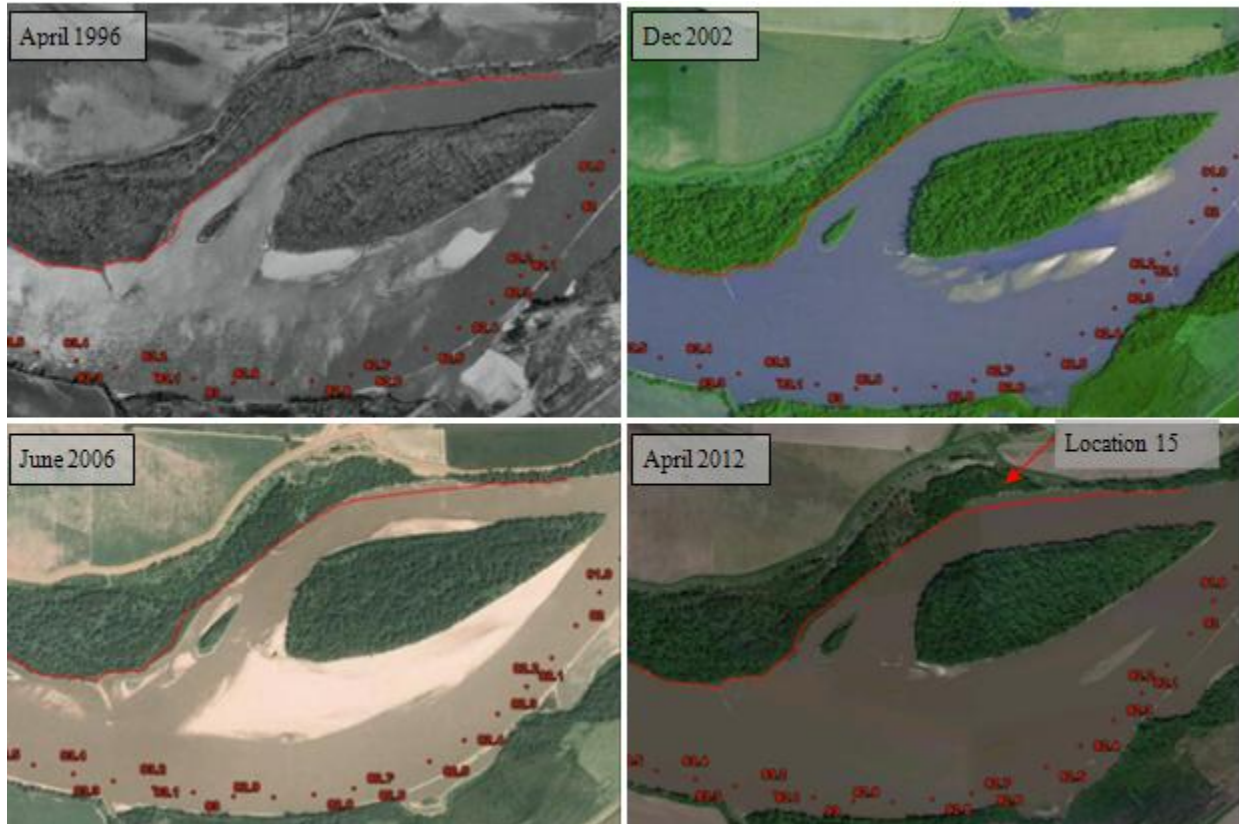
**Figure 2-14(c): Aerial Photo Comparison near Location 15 from 1996 to 2012**

The red arrow in the April 2012 photo above indicates the bank line that experienced the most erosion during this timeframe. A closer look at this area between June 2009 (addition of the last set of hard points) and April 2012 is shown in Figure 2-14(d).

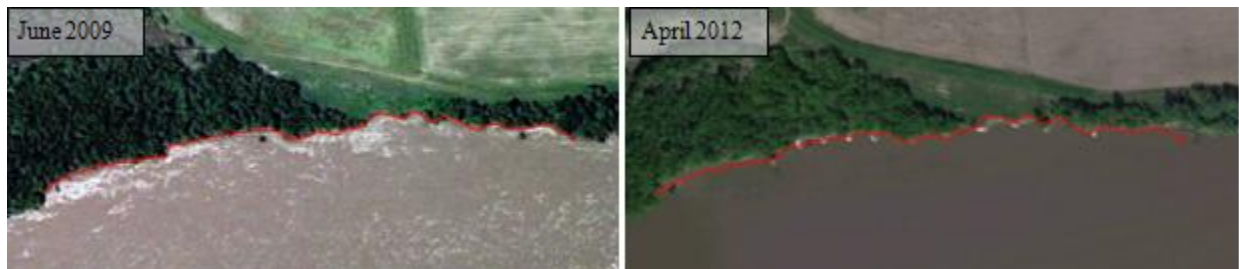
**Figure 2-14(d): Aerial Photo Comparison near Hard Points from 2009 to 2012**

This natural chute has deepened and eroded the landside bank as indicated in the photos above. Hard points were added in 1999, 2004 and 2009 to prevent meander of the chute and appear to be working as designed. Closing off the chute with a rock structure will not improve the situation over what currently exists as other natural chutes on the lower river are completely closed off and have experienced erosion and meander even more significant. An example of this is shown in Figure 2-15, which shows the meander of the natural Bryan Island Chute at river mile 23 near St. Charles, Missouri .

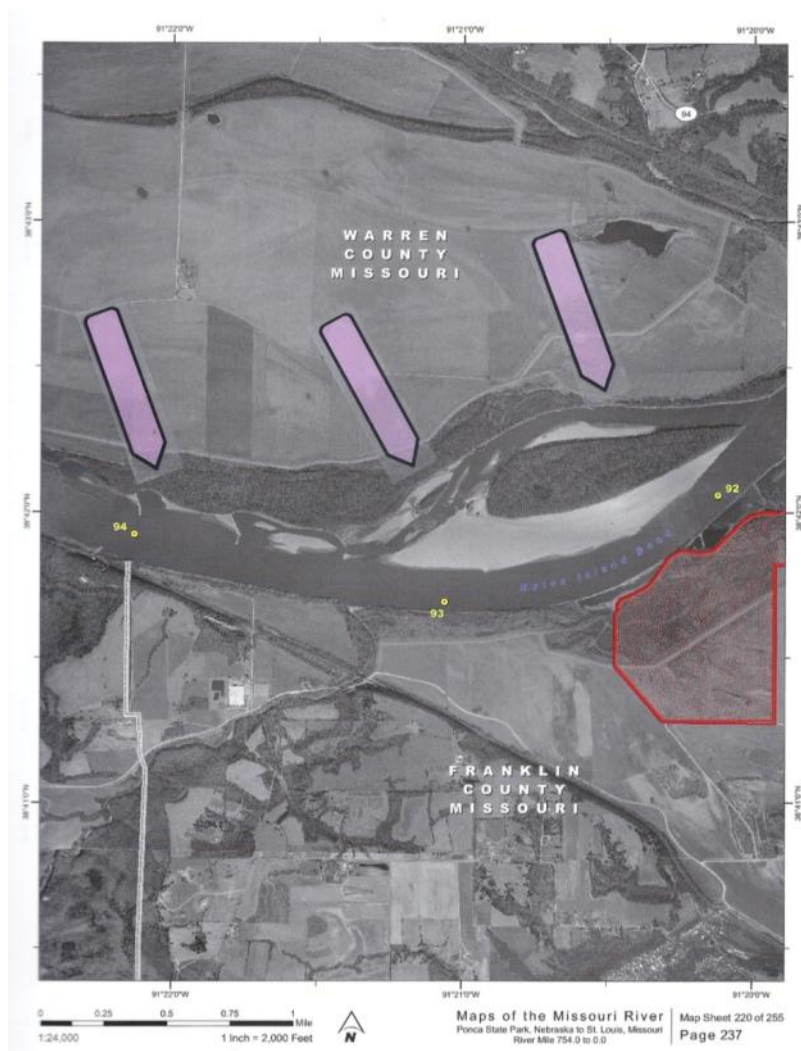
**Figure 2-16(a): Submitted Photo by Dale Gloe**

Dale Gloe submitted concerns about erosion around river mile 93. He believes the area needs immediate attention by building dikes to a higher level and directing water toward the main channel to at least slow the erosion and land loss along the north bank of the river and chute. He believes further erosion will jeopardize the Tri-County Levee. He indicated three areas of concern as shown below in Figure 2-16(a).

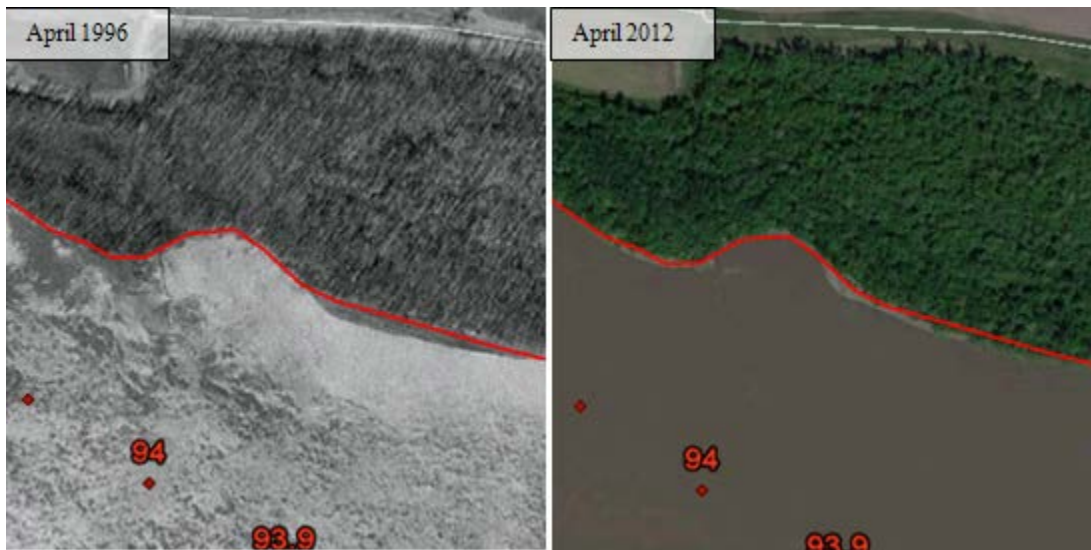
**Figure 2-16(c): Aerial Photo Comparison for Location 3 Near River Mile 94**

This location showed no bank movement over the 16 year period and therefore the notch has not caused any bank erosion.

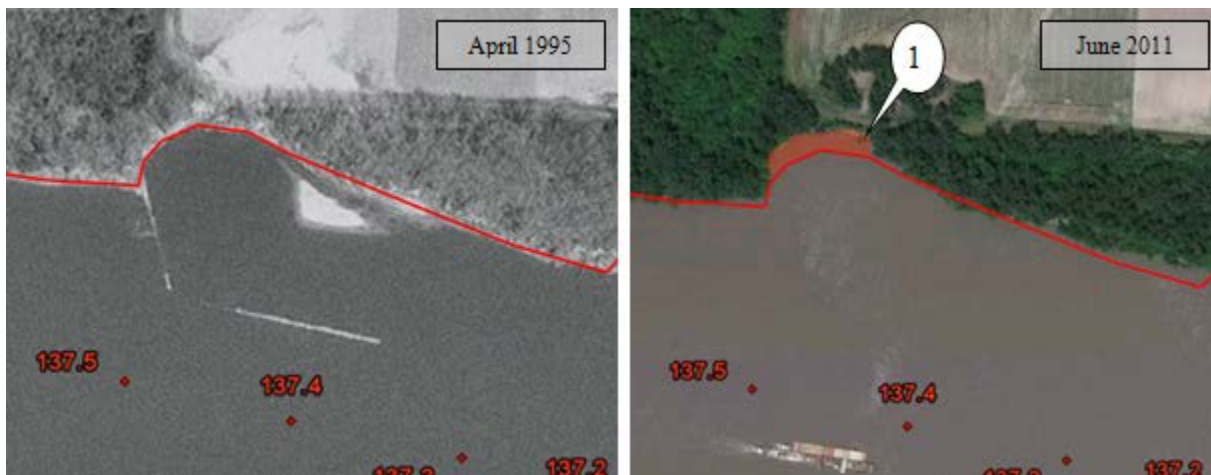
**Figure 2-17(c): Aerial Photo Comparison at Location 1 from 1995 to 2011**

At Location 1, there is one notch in R145.95. Details can be seen in Table 2.14. Bank line movement was determined by comparing aerial photos from 1995 to 2011. These photos are shown in Figure 2-17(c). The red line indicates the bank line location in 1995. The bank moved landward in the 16 years as indicated by the red shaded area in the June 2011 photo.

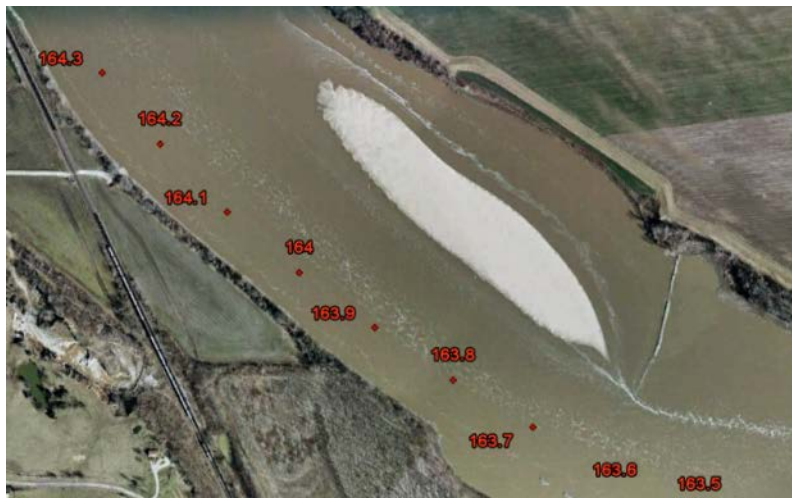
**Figure 2-19(e): Flow Conditions Upstream of Structure D171.5 in 2006**

The repair work in 2001 reduced the flow landward of the sandbar, however, as apparent in the 2006 photo shown in Figure 2-19(e) below, there is still significant flow in this area. This flow is likely the cause of the erosion since 2003 as the 2006 photo shows the flow going around the riverward end of the dike.

Corps staff met on-site with representatives of the Levee District in 2001 to examine the area. The repairs of 2001 were accomplished shortly after that meeting. This area has shown significant erosion between 1995 and 2003 and the erosion has continued since 2003, but at a slower rate. The erosion appears to be caused by flow between the sandbar and the bank as seen in Figure 2-19(e). It is evident that even at river levels below the top of the dike, a portion of the river's flow is diverting behind the sand bar next to the bank. The dike is effective at channeling the flow back out into the river. The dike repair completed in 2001 has likely slowed the erosion rate. Due to the size and location of the notch and the obvious flow around the sandbar, the flow around the sandbar is the cause of the erosion and not the notch. The area will continue to be monitored and additional action taken if the integrity of the dike is threatened.

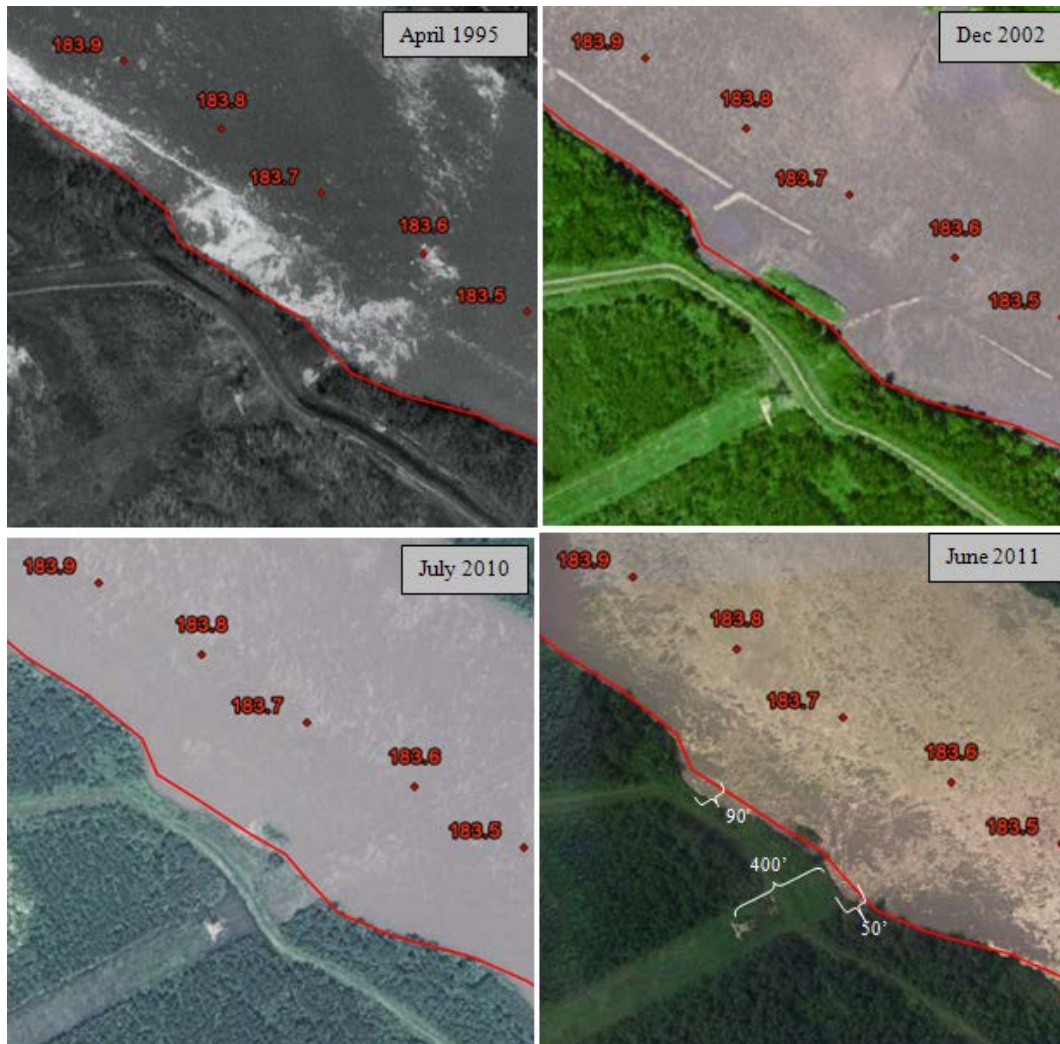
**Figure 2-20(b): Aerial Photo Comparison at Area of Concern from 1995 to 2011**

Aerial photos from 1995 and 2011 are shown in Figure 2-20(b). The red line indicates the bank line location from April 1995. In places, the bank has eroded approximately 90 feet in 16 years. The transmission tower is still over 400 feet from the bank line.

The bank has eroded up to 90 feet since the last two notches were constructed in 2002 and 2003. As the bank erodes, the distance between the bank and the notch increases, resulting in reduced effects on the bank from the notch. The erosion from the notch will stop once it is over 100 feet from the bank, leaving over 300 feet between the transmission tower and the bank line. In addition, the buried portion of structure D191.2 is upstream of the transmission tower (see Figure 2-20(a)) and will protect the bank around the tower. This area is actively monitored and the notches will be reduced in size or filled completely if the erosion continues to the point of endangering the tower.

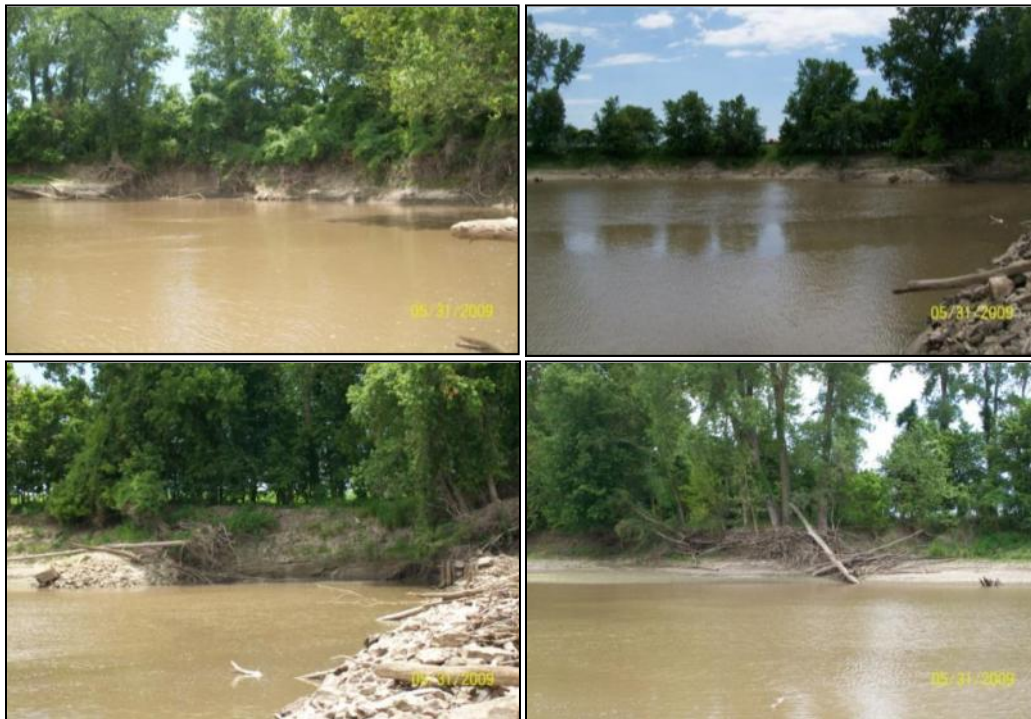
**Figure 2-21(a): Submitted Photos of Area of Concern**

Doris Linneman stated, “The experiment of the notching of dikes should end. The dikes should be filled back to the original height. Equal money should be available for repairs as needed to dikes and bank stabilization instead of spending all the funds for birds, fish, etc.” She also believes the bank erosion is caused by notched dikes and abnormal high river flow over the last 15 years. Her area of concern is near river mile 205, on the right descending bank. Her submitted photos are shown below in Figure 2-21(a).

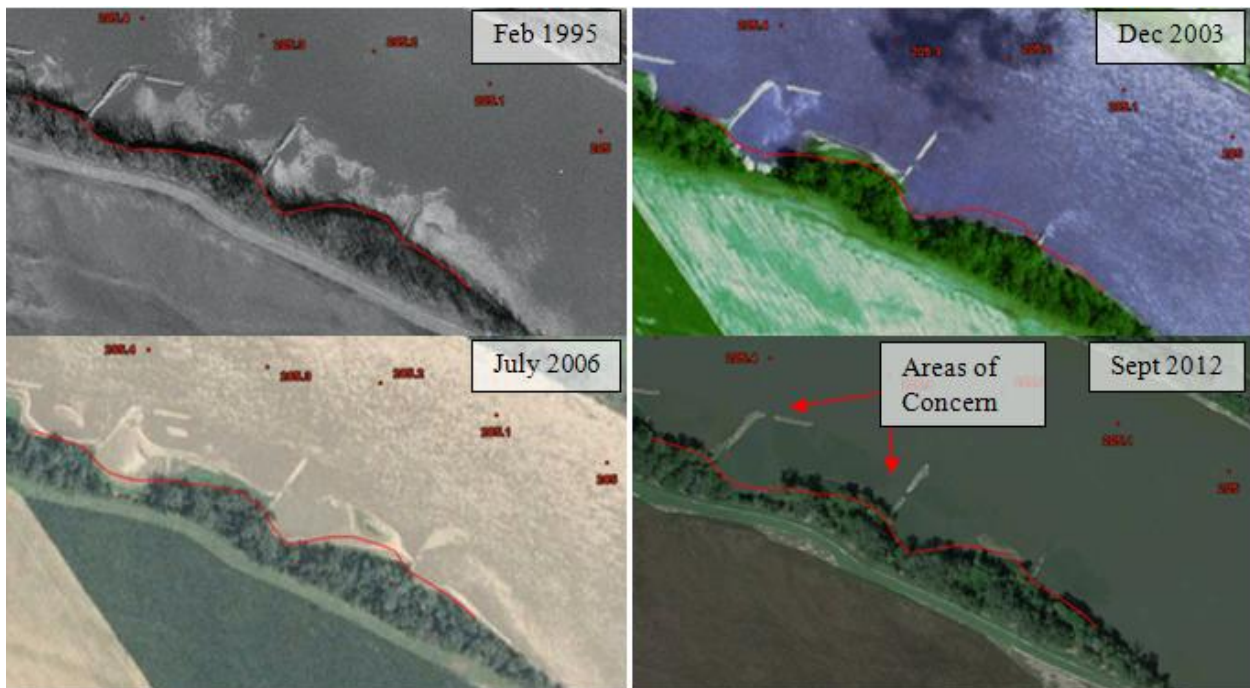
**Figure 2-21(c): Aerial Photo Comparison Near Area of Concern from 1995 to 2011**

Aerial photography from February 1995 to September 2012 was compared to determine bank movement. The bank line eroded approximately 30 feet near the root of D214.55 and slightly eroded downstream of D214.45. Hard points were added near the root of D214.55 in 1997 and appear to have prevented any additional erosion. The aerial photos are shown in Figure 2-21(c).

Corps representatives met with the Linneman family in 1997, 2000, and 2005. As a result of those meetings hardpoints were constructed, one rootless dike was tied into the bank, a revetment was repaired, and a flanked dike was repaired by trucking rock into the area. The area was inspected during the summer of 2012 and the elevations of the structures are consistent with design elevations. The erosion occurred between 1995 and 2003. The 2012 photo shows that the bank line has almost returned to the 1995 location. It is unlikely the notches caused the erosion due to the small size of the notches and distance between the notches and the erosion.
