**US Army Corps  
of Engineers** ®  
Kansas City District

# **Evaluation of Reported Notch Problem Locations Below Rulo, Nebraska**

**April 2013**

## **FINAL REPORT**

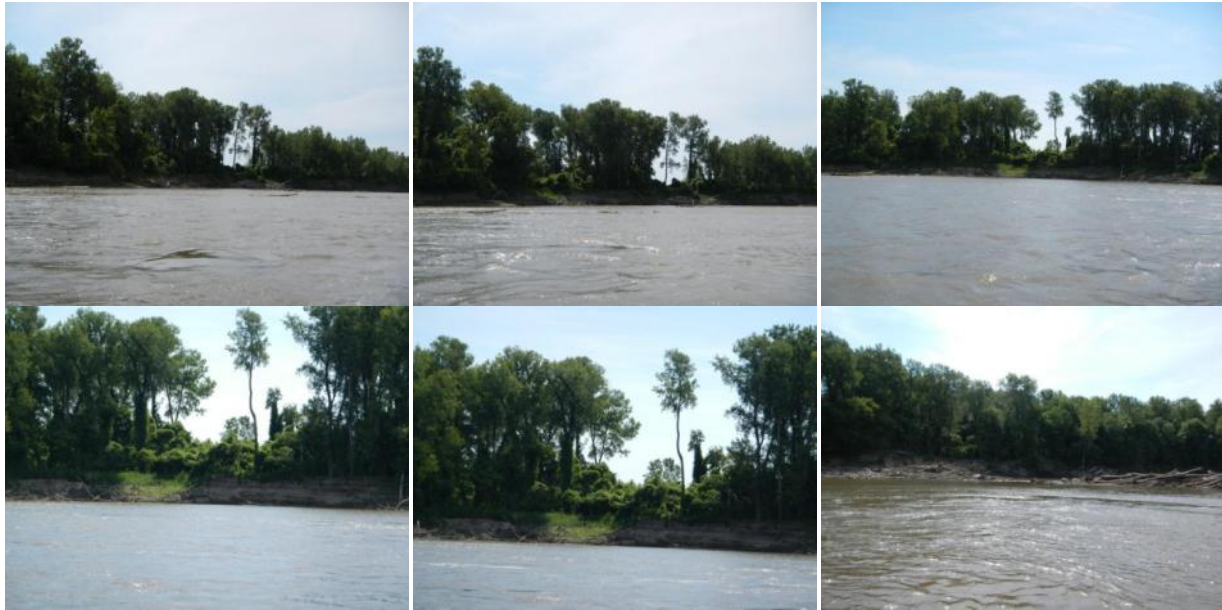
Figure 2-22(a): Submitted Photos for River Mile 232.3

Carol Stundebeck and Jeffrey Gebhardt have concerns at river mile 232 about erosion occurring near the root of two dikes. Photos submitted by Ms. Stundebeck are shown below in Figure 2-22(a).

There has been considerable erosion at this location, especially around and downstream of structure D244.09. Most of the erosion appears to have occurred between 2002 and 2012. Due to the small size of the notches and their distance from the bank, it is unlikely the notches were the cause of the bank erosion. It appears from the 2012 photo that the root of D244.09 is in need of repair and has been added to the deficient structure list.

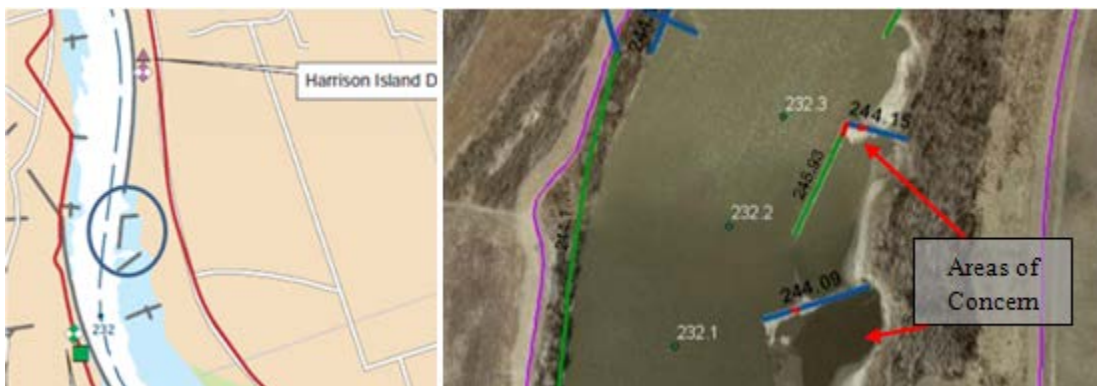
Figure 2-22(b): Overview of Area of Concern

The picture on the left in Figure 2-22(b) was submitted by Ms. Stundenbeck. The picture on the right in Figure 2-22(b) shows the structure details.

There are three notches at this location. One notch is located in structure D244.15, one notch is located at the end of D244.15 in structure R245.93, and one notch is located on structure D244.09. Notch details are shown in Table 2.21.

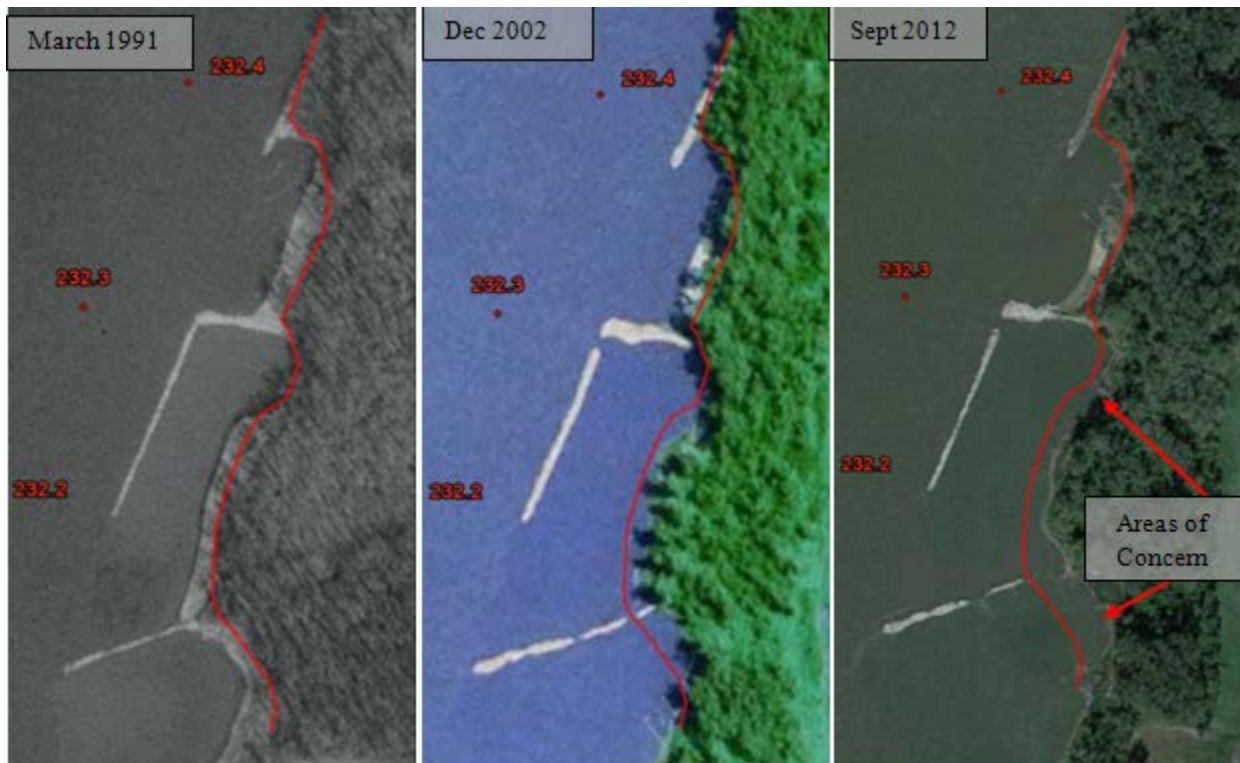
Figure 2-22(c): Aerial Photo Comparison of Area of Concern from 1991 to 2012

Aerial photos were analyzed to compare bank line movement from March 1991 to September 2012. These images are shown below in Figure 2-22(c).

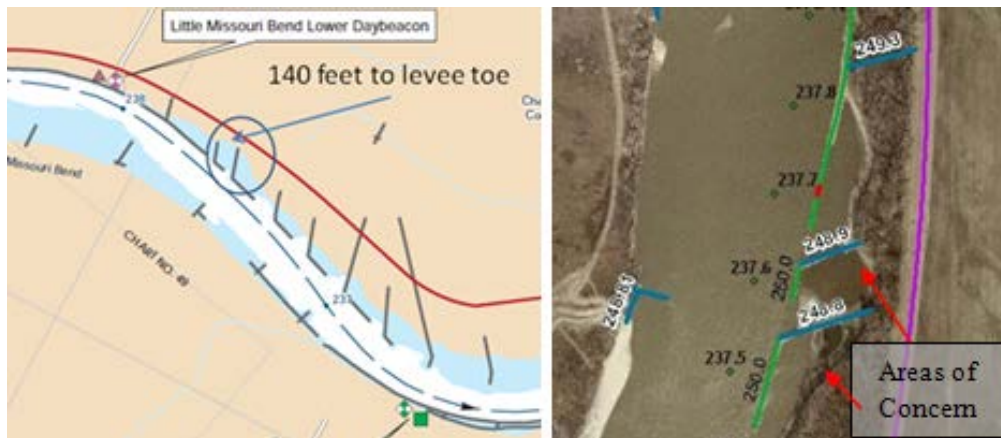
Figure 2-23(a): Overview of Area of Concern

Jeffrey Gebhardt and Carol Studenbeck have a concern with erosion occurring between river mile 237 and river mile 238. Mr. Gebhardt believes it is relatively close to the Lower Chariton River Levee and may result in severe damage to the levee in a few years.

The picture on the left in Figure 2-23(a) was submitted by Ms. Studenbeck. The structures are D248.8, D248.9 and R250.0 as shown in the picture on the right. None of these structures contain a notch.

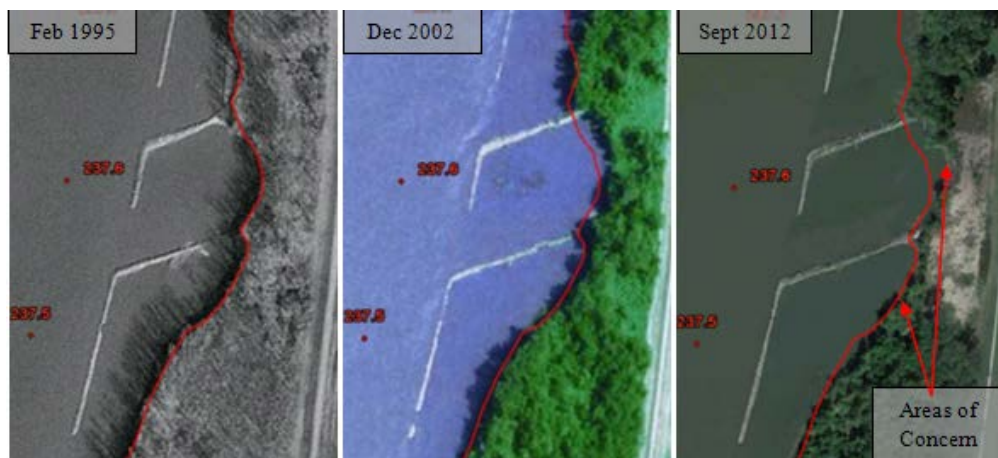
Figure 2-23(b): Aerial Photo Comparison for Area of Concern from 1994 to 2012

Aerial photos were compared from February 1995 to September 2012 to determine bank movement. The photos are shown in Figure 2-23(b).

Representatives from the Corps have met numerous times on-site with Levee District representatives over the past 15 years. Hardpoints (not visible in the photos) were constructed in 2002 as a result of one of those meetings. There are no notches in the location identified and therefore notches are not the cause of the bank erosion. The last on-site inspection showed the hardpoints are in need of repair and will be repaired when the next river contract is in the area. The area will continue to be inspected at least twice a year until the repair is completed.

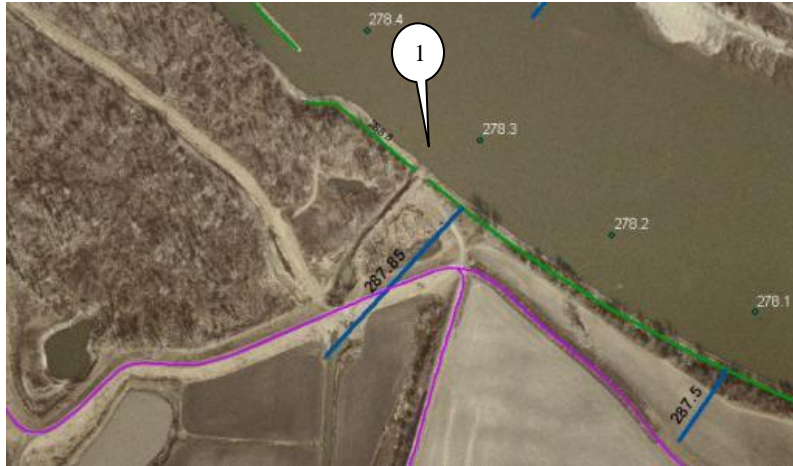
**Figure 2-25: Overview of Location 1**

As shown in Figure 2-25, there are no notches at structure D287.85. The structure has not been modified since 1956.

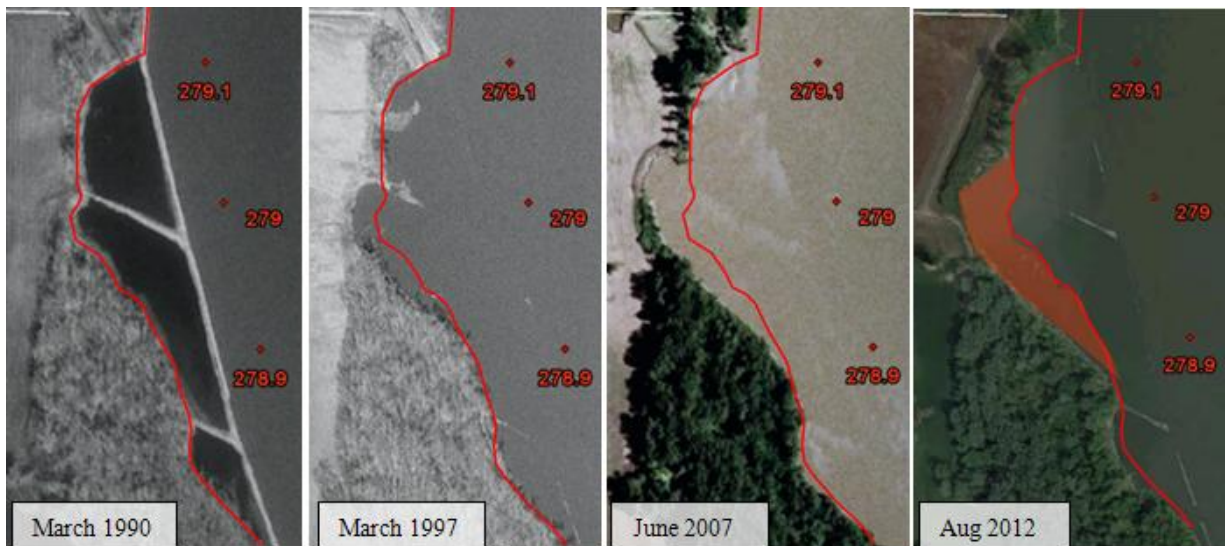
**Figure 2-26(b): Aerial Photo Comparison at Location 2 from 1990 to 2012**

Aerial photos from 1990 to 2012 were reviewed and shown in Figure 2-26(b). There was significant bank movement between March 1990, March 1997 and June 2007. The red shaded area indicates the bank erosion that has occurred since 1990.

This area has shown significant erosion and the eroding bank is close to a levee. The levee was moved closer to the erosion location sometime between 2007 and 2009 (Figure 2-26(c)). A recent on-site inspection showed that the middle dike is no longer tied into the bank. This ‘flanked’ dike is likely the cause of the bank erosion as it allows water to flow between the dike and the bank during high flows resulting in bank erosion. The revetment and the middle dike are on the structure deficiency list and will be repaired as soon as possible.

| <b>Location</b> | <b>Recommendation</b> |
|---|---|
| 2 | This area will be monitored. In addition, the structure is noted on the deficiency list as needed additional rock due to the revetment being 4' low in some areas |

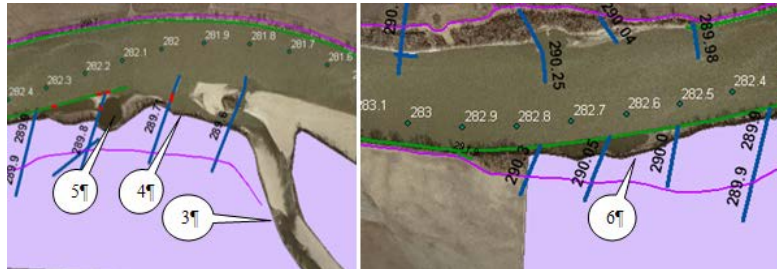
**Figure 2-27: Overview of Locations 3 - 6**

There are notches at two of the four locations. However, the locations are on public land owned by the Corps of Engineers. Public land is indicated by the pink shaded area in Figure 2-27.

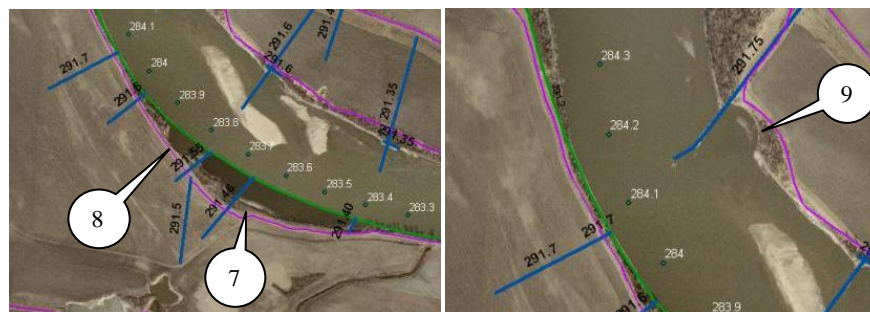
**Figure 2-28: Overview of Locations 7 - 9**

There are no notches in the structures around Location 7, 8, and 9, as shown in Figure 2-28. The revetment at this location was repaired in 2001 and D291.40 was constructed in 2006. The revetment is in need of additional repair and is currently on the structure deficiency list and will be repaired at the next opportunity.

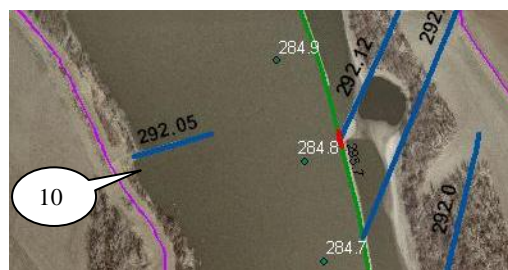
**Figure 2-29: Overview of Location 10**

There is no notch at Location 10 as shown in Figure 2-29.

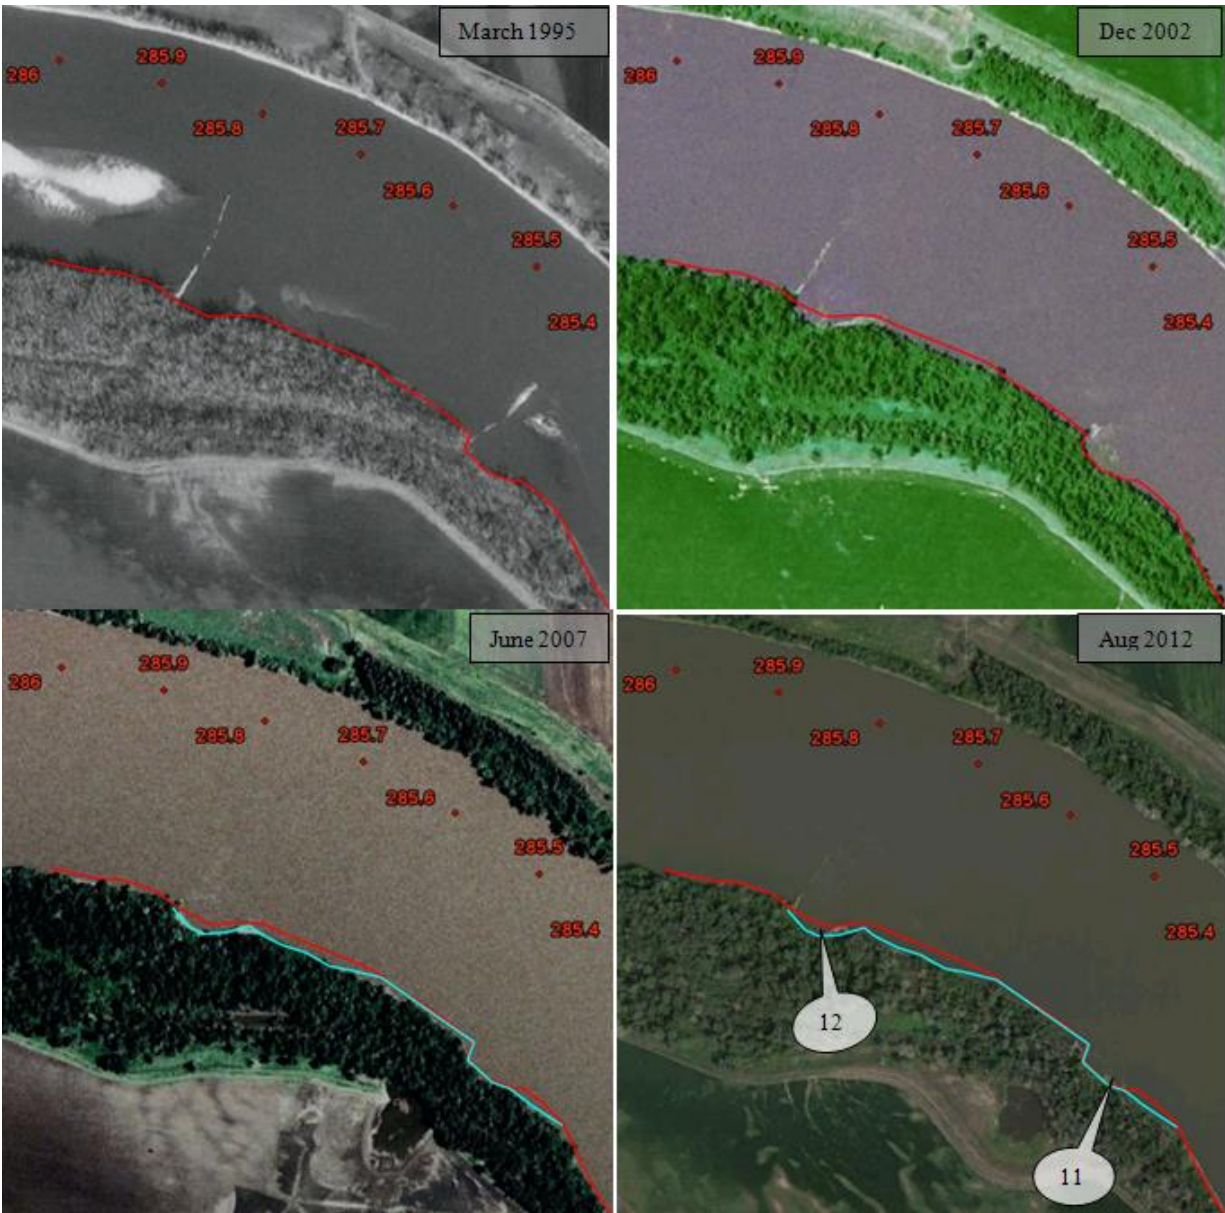
**Figure 2-30(b): Aerial Photo Comparison at Locations 11 and 12 from 1995 to 2012**

Aerial photos from March 1995 and August 2012 were compared and shown in Figure 2-30(b). The red line indicates the 1995 bank line location and the blue line indicates the bank line location in 2003 prior to the construction of the last two notches.

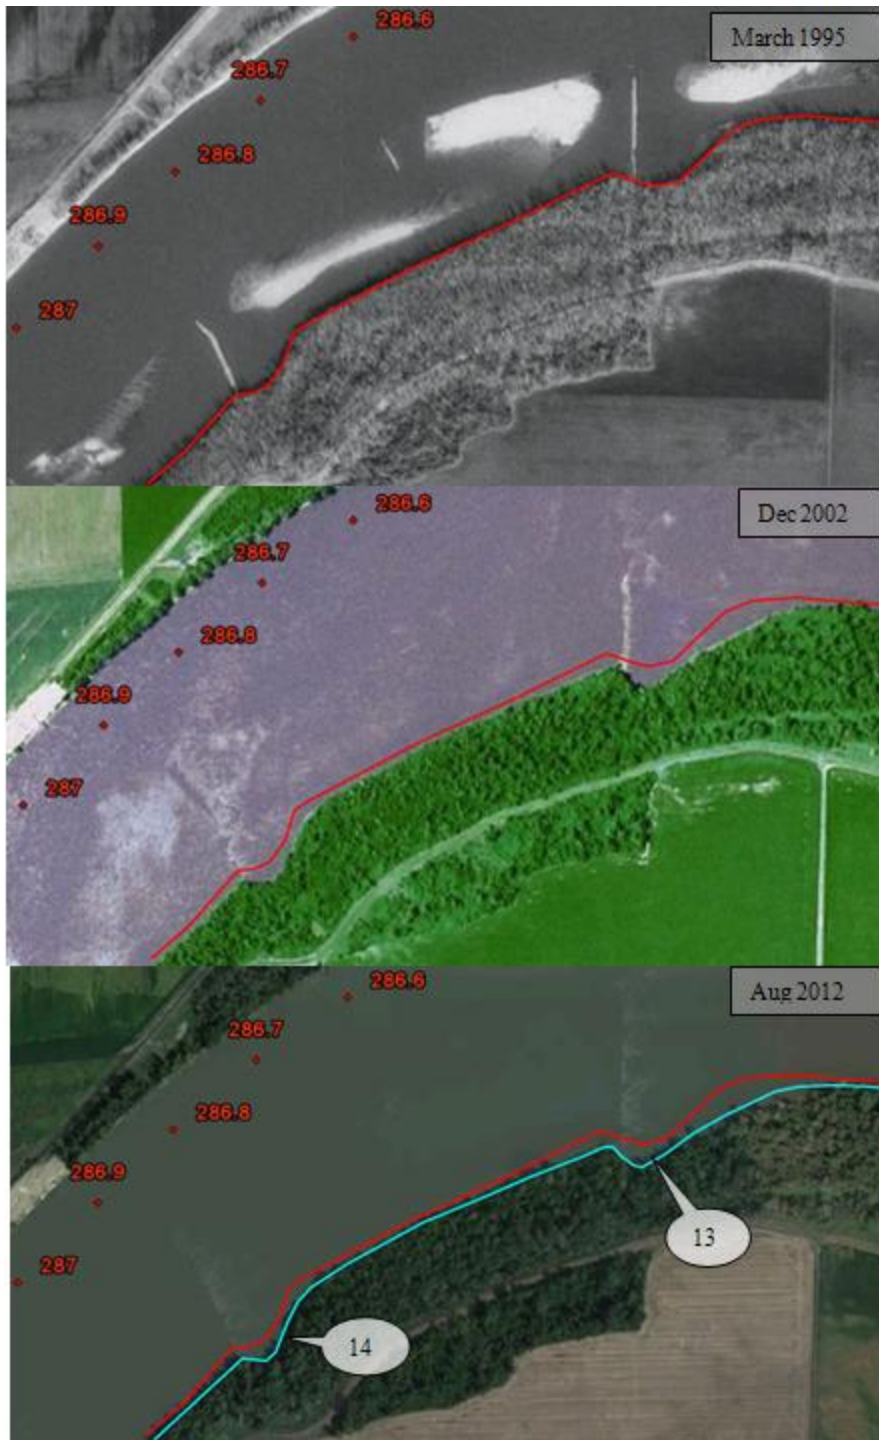
**Figure 2-31(b): Aerial Photo Comparison at Locations 13 and 14 from 1995 to 2012**

Aerial photos from March 1995 to August 2012 were compared as shown in Figure 2-31(b). The red line indicates the bank line location in 1995 and the blue line indicates the bank line location in 2002.

The aerial photos indicate the bank erosion occurred prior to the creation of the 2004 notches and shows no movement since that time. It is unlikely the pre-2004 notches caused the bank erosion between 1995 and 2002 due to the small size of the notches and distance from the bank line.

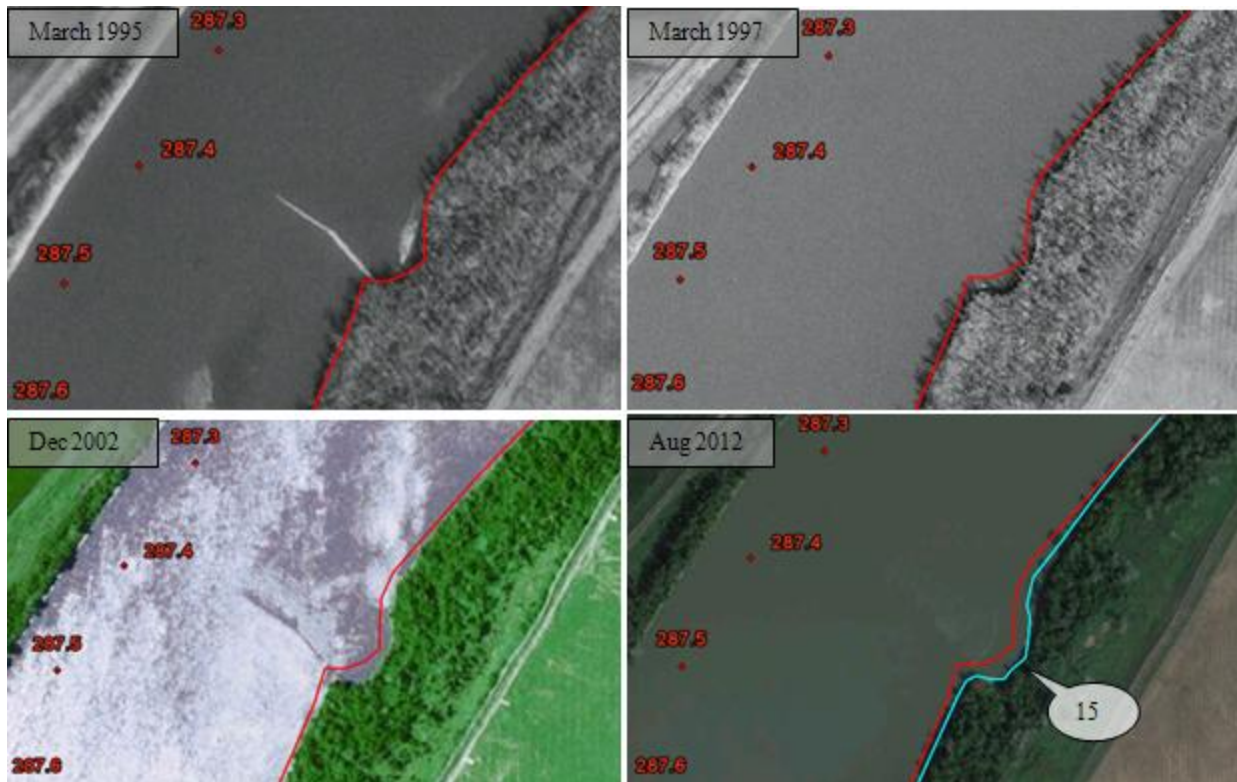
**Figure 2-32(b): Aerial Photo Progression near Location 15 from 1995 to 2012**

Aerial photos from March 1995 and August 2012 were compared. The red line indicates the bank line location in 1995 and the blue line indicates the bank line location in 2002. The photos are shown in Figure 2-32(b).

Bank movement began as early as 1997 and continued until 2002, as indicated by the aerial photos. It is unlikely the 1983 notch is the cause of the bank erosion due to the small size of the notch and the distance from the bank. The bank shows no erosion over the last 10 years, therefore, the 2004 notch has not caused any bank erosion.

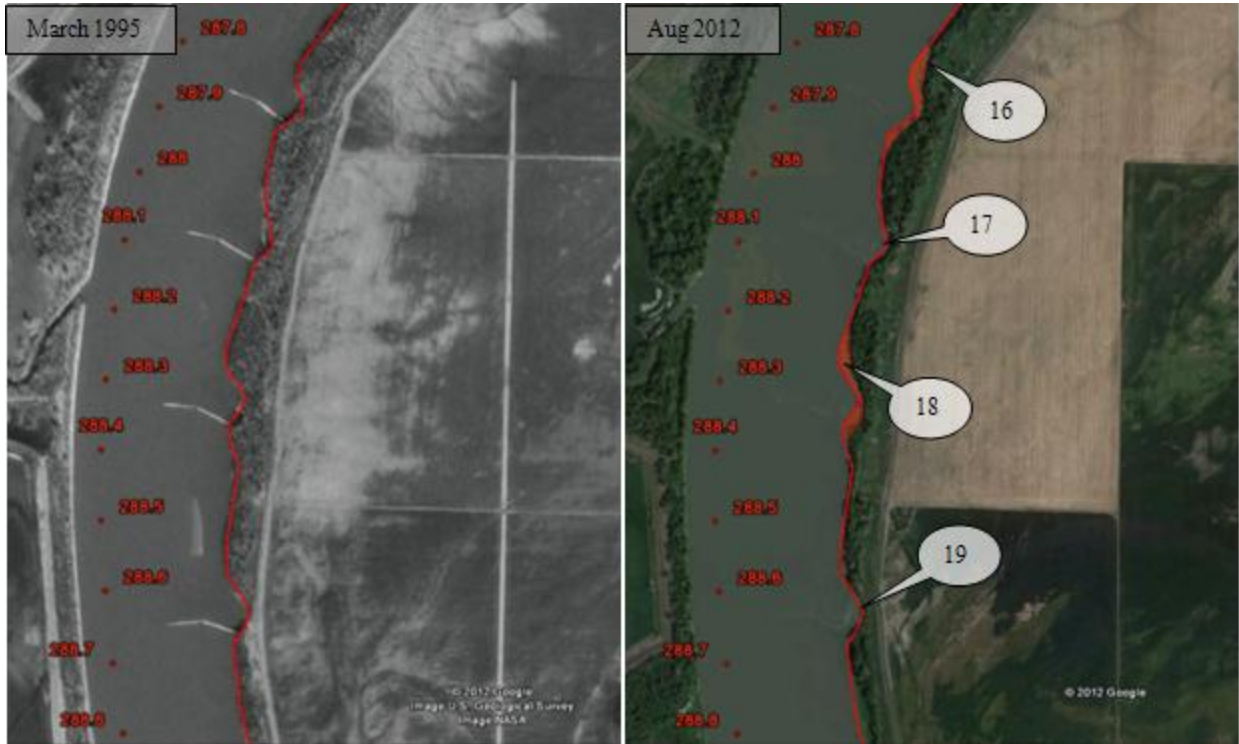
**Figure 2-33(b): Aerial Photo Comparison at Locations 16 – 19 from 1995 to 2012**

Aerial photos from March 1995 and August 2012 were compared to determine bank line movement. The bank movement can be seen by the red shaded areas in Figure 2-33(b).

There has been bank movement at Location 16 and 18. Locations 16 and 17 have more recent constructed notches closer to the bank than Locations 18 and 19. The notches at Location 18 are small and located far from the bank and unlikely the cause of the bank erosion. Since Location 16 and 17 have similar notches constructed at the same time, but only Location 16 shows bank erosion, the notch at Location 16 is unlikely the cause of the bank erosion.

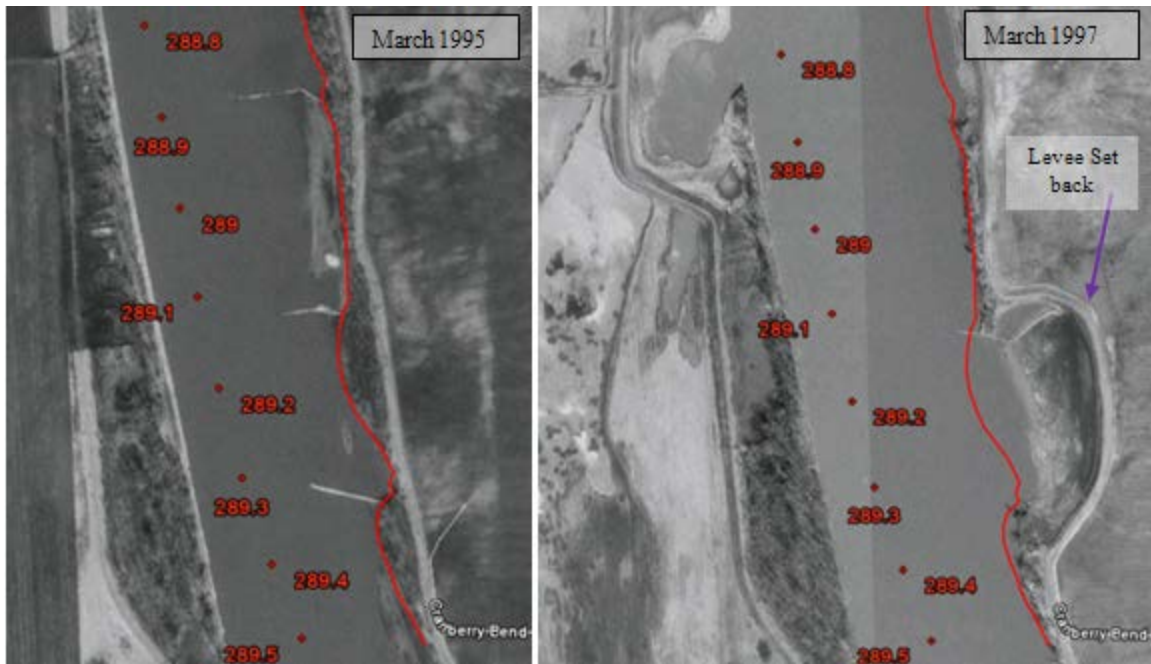
**Figure 2-34(b): Aerial Photo Comparison for Location 20-22 from March 1995 to March 1997**

Aerial photos were reviewed to determine bank line movement near Locations 20, 21 and 22. The red line indicates the bank line location in March 1995. Between March 1995 and March 1997, a scour hole formed near river mile 289.2 and the levee was set back. The scour hole is seen in Figure 2-34(b).

Most of the bank erosion at these locations is due to the two scour holes that formed during flood events. There is erosion downstream of structure D295.0 that occurred between 1995 and 1997 that does not appear to be directly related to scour hole formation. However, the notch in structure D295.0 has been in place since 1977, is only 1 foot below the top of the adjacent structure, and is a considerable distance from the bank. It is unlikely the erosion was caused by the notch.

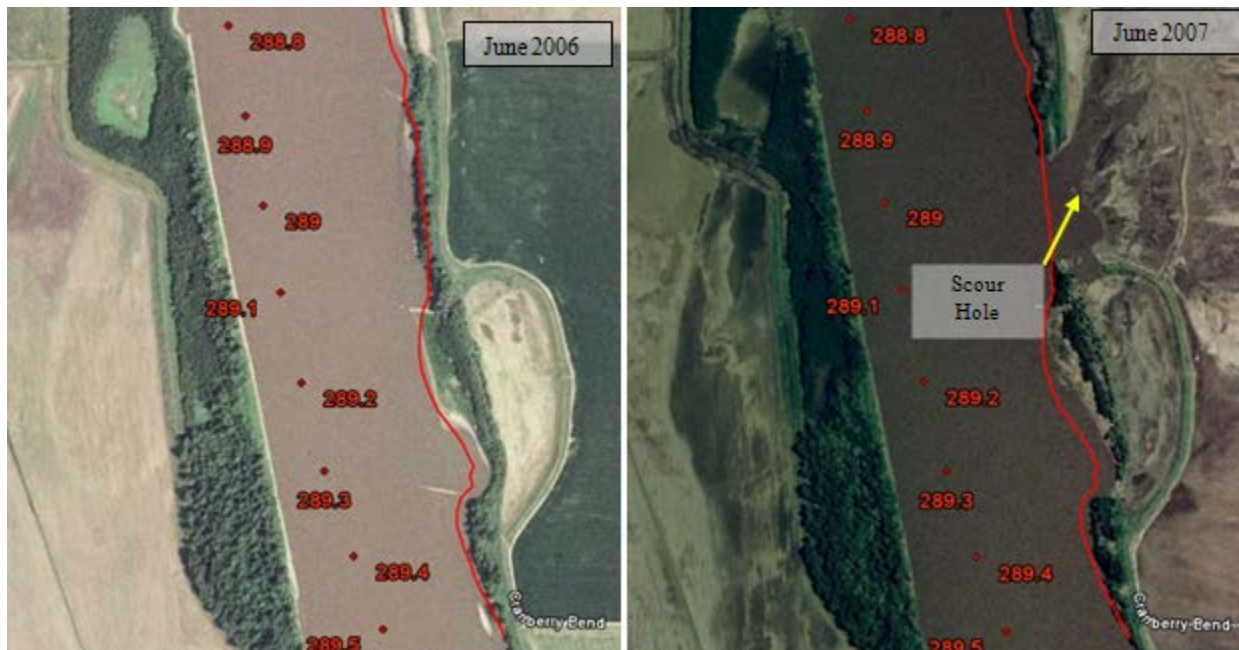
**Figure 2-34(c): Aerial Photo Comparison for Location 20-22 from June 2006 and June 2007**

The next set of photos (Figure 2-34(c)) are from June 2006 and June 2007. The red line indicates the bank line location from March 1995. The June 2007 photo indicates another scour hole formed immediately upstream of the previous scour hole. The newer scour hole can be seen in Figure 2-34(c).

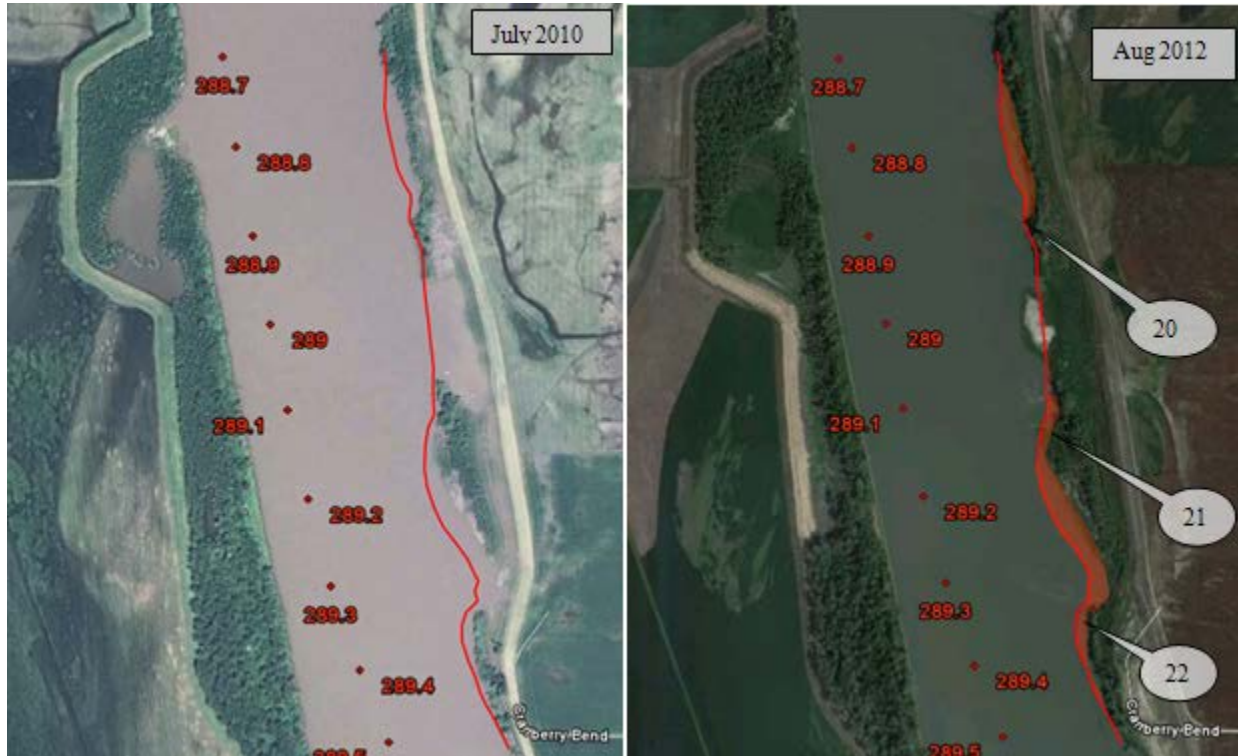
**Figure 2-34(d): Aerial Photo Comparison for Location 20-22 from July 2010 and Aug 2012**

The last set of photos (Figure 2-34(d)) are from July 2010 and August 2012. The levee had been set back to its original location (from March 1995 photo) by July 2010. High water is apparent in the June 2010 photo. The August 2012 photo shows the scour holes have mostly filled in.

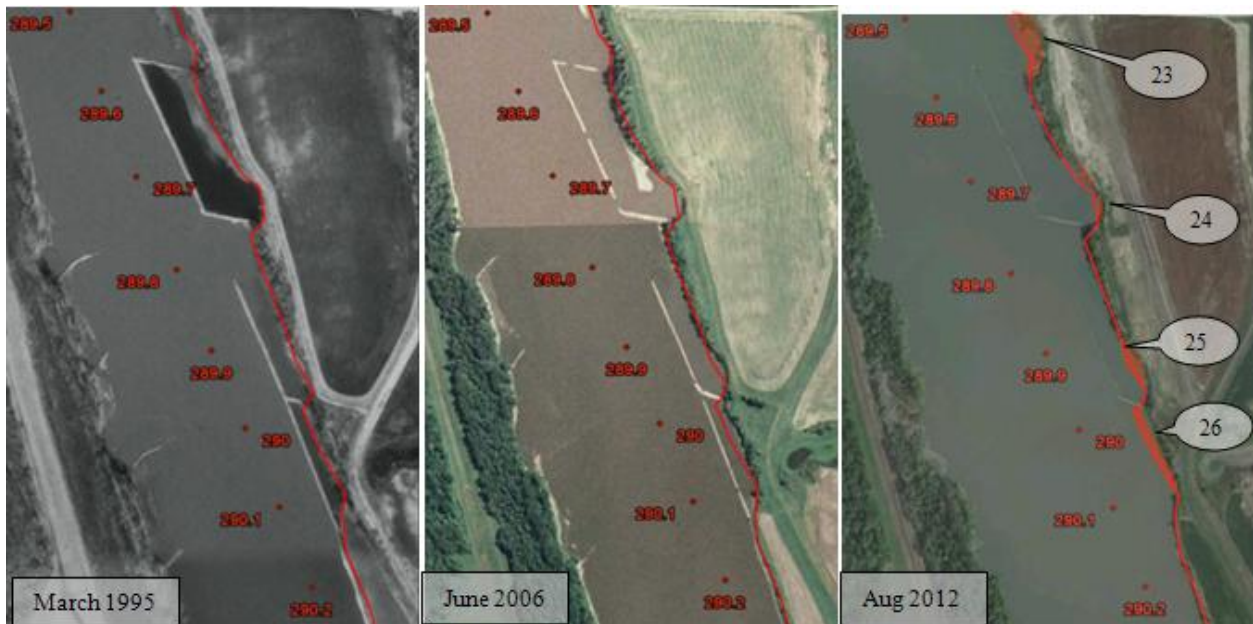
**Figure 2-35(b): Aerial Photo Comparison at Locations 23 – 25 from 1995 to 2012**

Aerial photos from March 1995, June 2006, and August 2012 were compared as seen in Figure 2-35(b). Bank movement over the 17 years is indicated by the red shaded areas.

This area has been a concern for at least the last 10 years. The notches are all small and located away from the bank. Corps staff have meet on-site with Levee District representatives at least three times to inspect the area. During those inspections all structures were determined to be up to design elevation and notches were not identified as the cause of the erosion. Based on the notch and erosion locations shown above, the bank erosion does not appear to be caused by the notches. The area will continue to be monitored

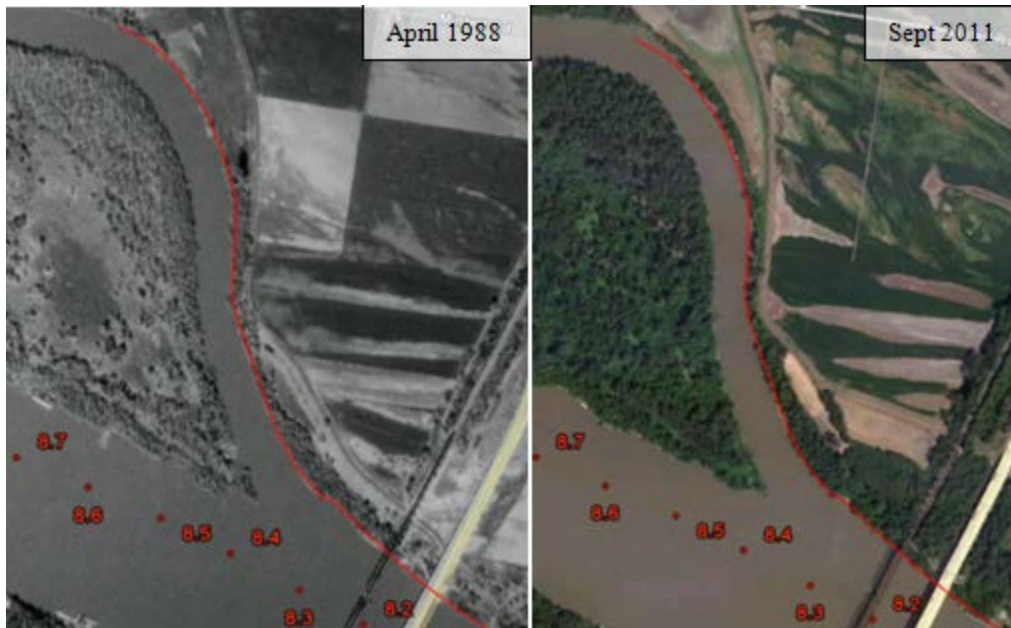
**Figure 3-1(b): Aerial Photo Comparison from 1988 to 2011**

Aerial photos from April 1988 and September 2011 were compared as shown in Figure 3-1(b). These photos indicate minimal bank movement.

This location, in a natural chute, does not contain any notches and shows minimal bank movement since 1988. Corps staff has met on-site with representatives of the Levee District numerous times over the last 5 years. As a result of those meetings, existing hard points were repaired and new hard points constructed downstream of the existing ones. No further repairs are scheduled at this time.

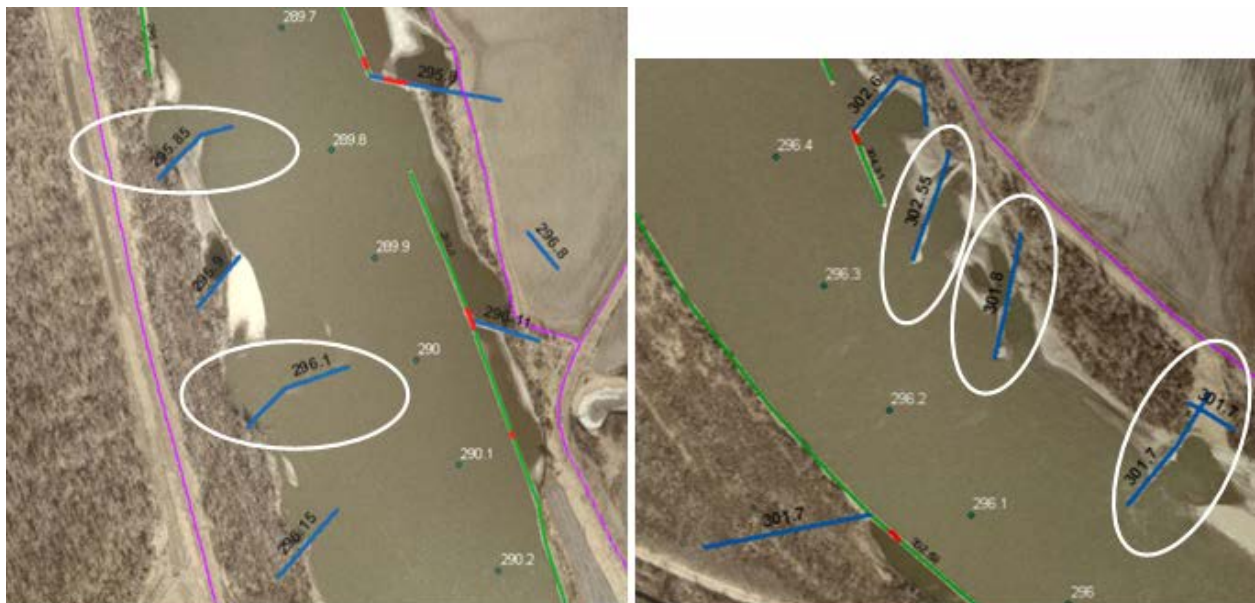
Figure 3-2: Structure Names and Locations near River Mile 290 and River Mile 296

There are no notches at any of these locations. Structure locations are circled and can be seen in Figure 3-2.

Corps staff meet on-site with Mr. Casner in 1998 to inspect the dikes at river mile 296. The dikes at this location were repaired soon after that meeting. There are no notches at either of these two locations and recent inspections show that all structures are up to design elevation.

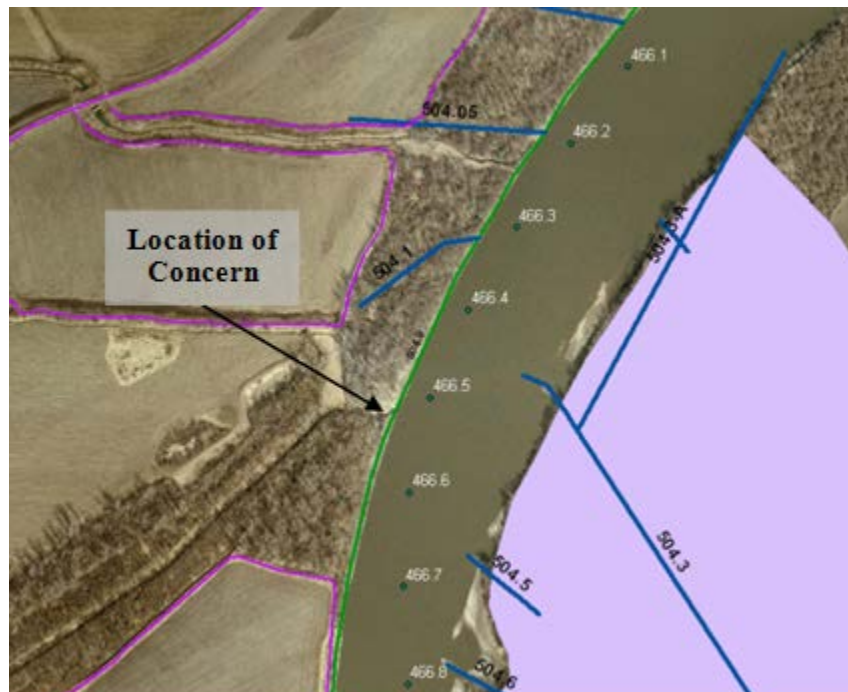
Figure 3-3: Overview of Area of Concern

David Banks stated “The area parallel to the river and just downstream of Forbes Creek needs stabilization. It was rocked several years ago and needs rock added to stabilize the bank or they may lose the riverfront property.” This area is shown in Figure 3-3.

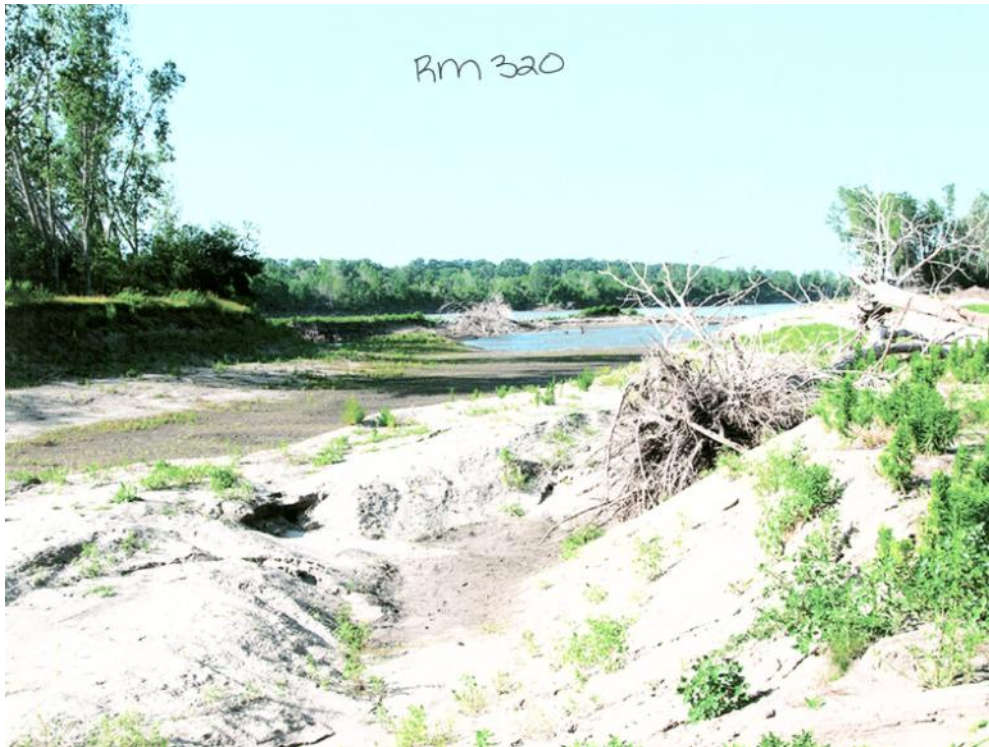
**Figure 4-1(a): Photo Submitted by Larry Hicks near River Mile 320**

The photo submitted for river mile 320 is shown in Figure 4-1(a).

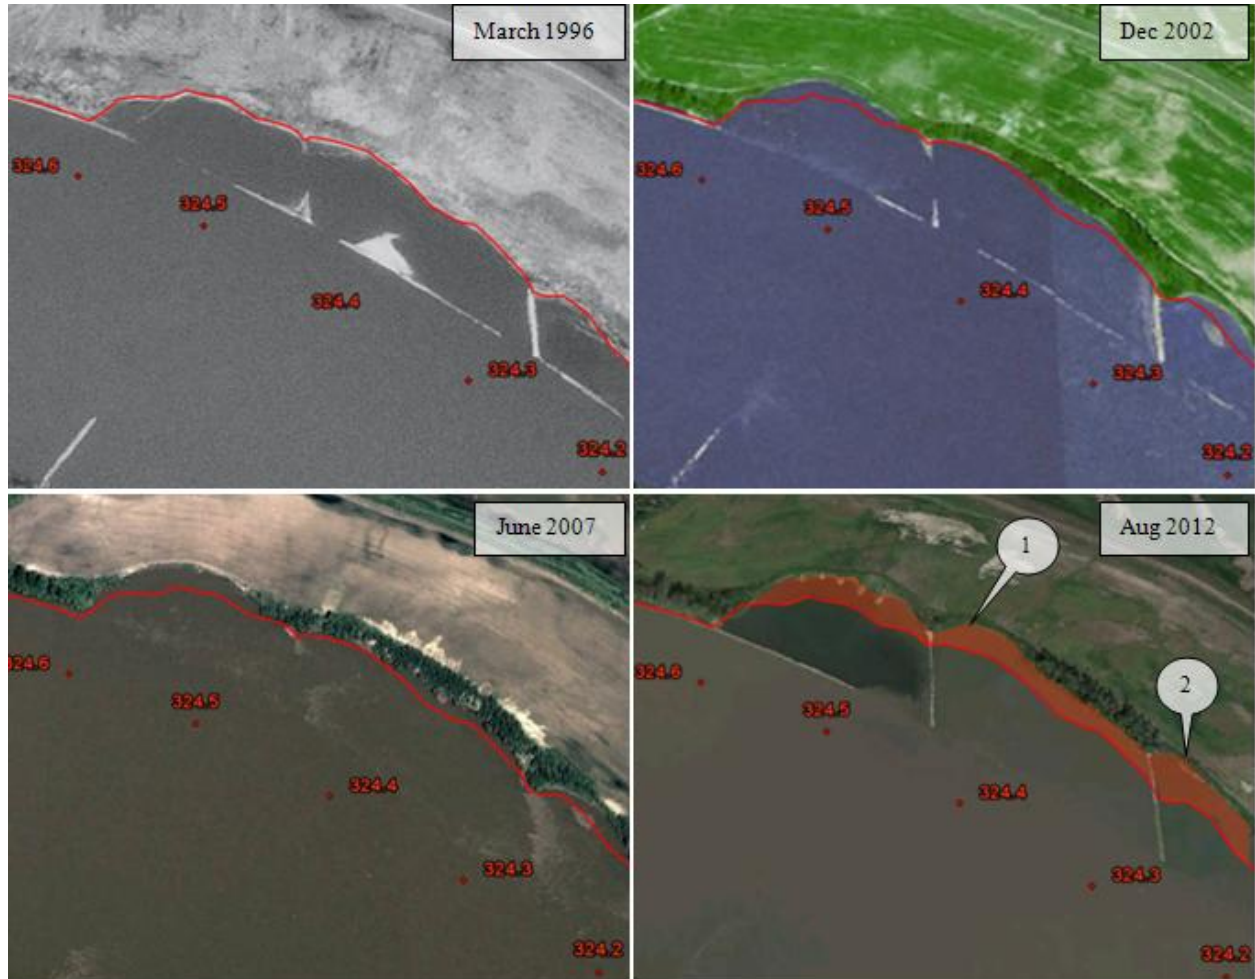
Figure 4-2(c) Aerial Photo Comparison Near Area of Concern from 1996 to 2012

Aerial photos from March 1996 to August 2012 were compared to determine bank movement. Bank erosion first started to occur sometime between 1996 and 2002. Erosion was more noticeable in 2007. The most significant bank movement occurred between 2007 and 2012, probably during the high flow event of 2011. The red shaded area in Figure 4-2(c) indicates bank movement over 16 years from March 1996 to August 2012.

The bank has experienced significant erosion. Due to the widespread nature of the erosion, small size of the notches, and distance from the bank, it is unlikely the erosion is caused by the notches. Structure D330.7 is listed as a deficient structure and will be repaired as soon as possible. This rock should aid in protecting the bank from additional erosion.

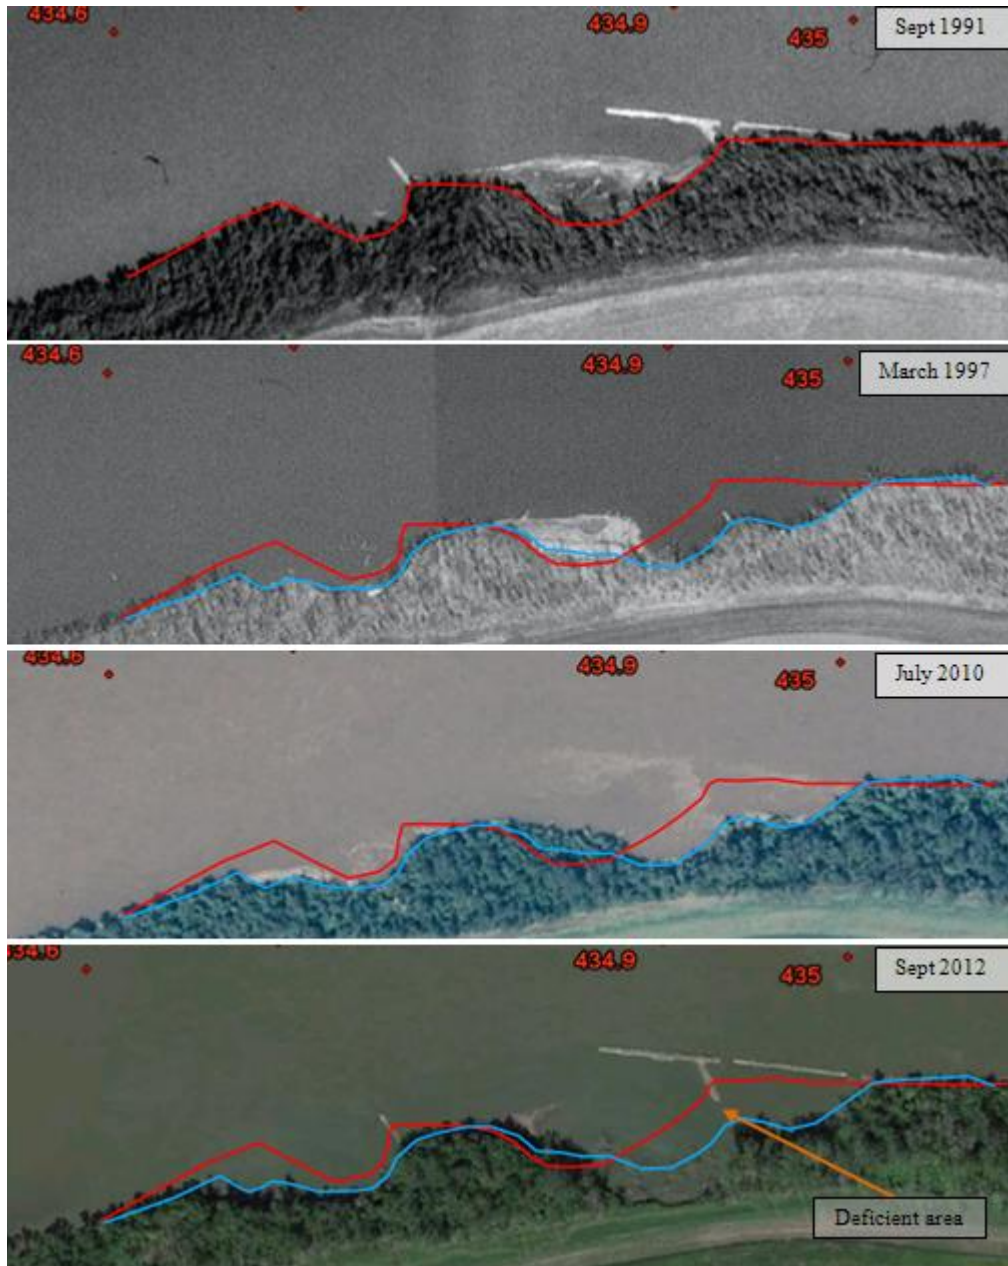
Figure 4-3(b): Aerial Photo Comparison Near Area of Concern from 1997 to 2012

Aerial photos were compared from September 1991 to September 2012 as seen in Figure 4-3(b). The red line indicates the bank line from 1991. The bank moved significantly due to the high water events in 1993 and 1995. The blue line indicates the bank line from 1997. There was minimal bank movement from 1997 to 2010. However, since 2010, the bank has moved approximately 100 feet.

Bank movement in this area has been significant. Corps staff have met on-site with representatives of the Levee District to inspect the site. Structure D467.2-G was heavily damaged during the 2011 flood and is scheduled to be repaired in early 2013. The orange arrow in Figure 4-3(b), indicates the area where repair rock will be placed.

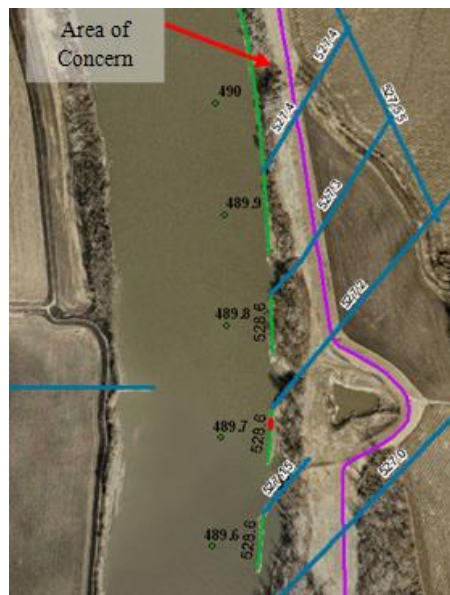
Figure 4-4(a): Overview of Location of concern near River Mile 490

It is 50 feet wide and set to an elevation of 0 CRP. The structure names and locations are seen in Figure 4-4(a).

The one notch in this location has been in place since 1982. It is apparent the high water of 1997 and the 2011 flood caused the damage in the area. Structure R528.6 is listed on the deficiency list and will be repaired in 2013.

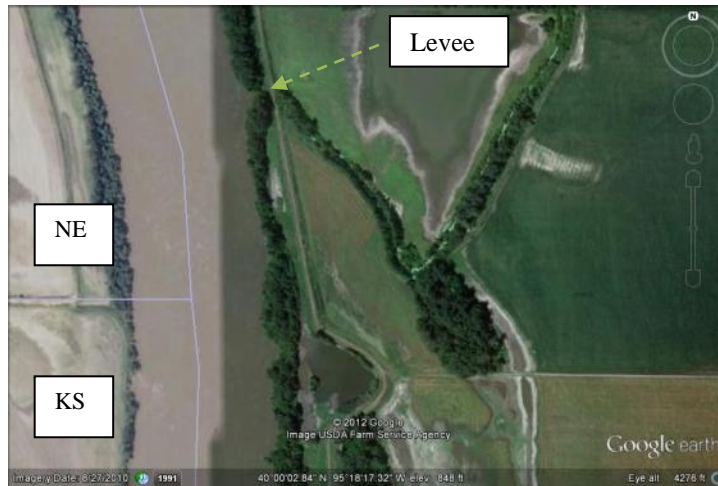
**Figure 4-4(b): Submitted Pre-Flood Photo near Location of Concern**

Mr. Derks submitted an aerial photo of the location taken before the flood event, as seen in Figure 4-4(b).

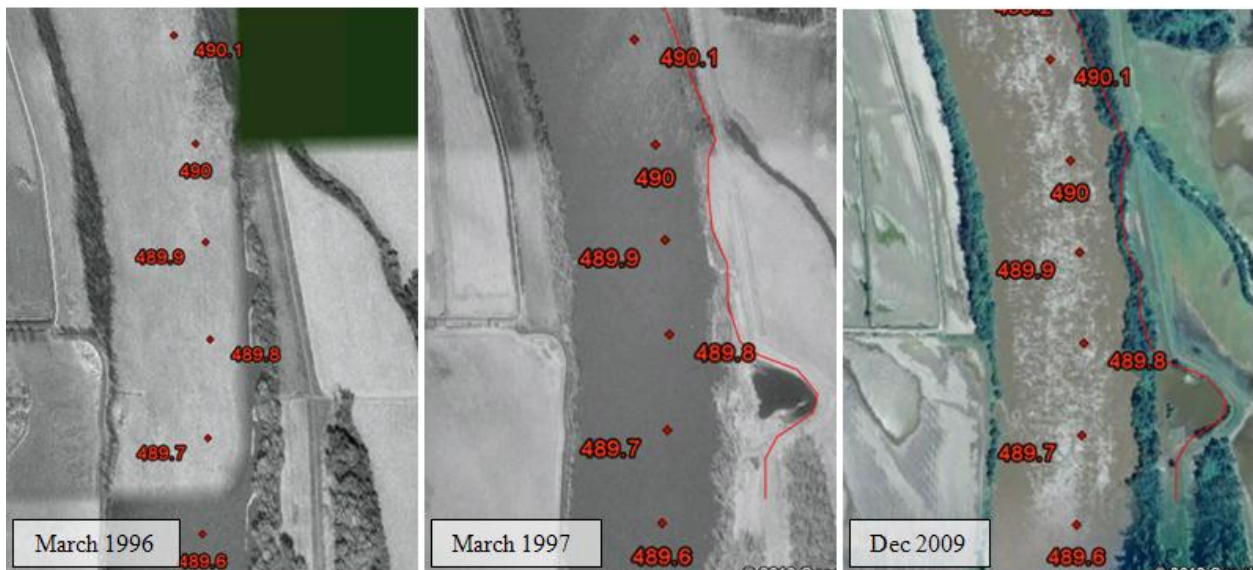
**Figure 4-4(c): Aerial Photo Comparison for Area of Concern from 1996 to 2009**

The levee was relocated between 1996 and 1997, as seen in the aerial photos in figure 4-4(c). There is no aerial photography available since 2009.
