**US Army Corps  
of Engineers** ®  
Kansas City District

# **Evaluation of Reported Notch Problem Locations Below Rulo, Nebraska**

**April 2013**

## **FINAL REPORT**

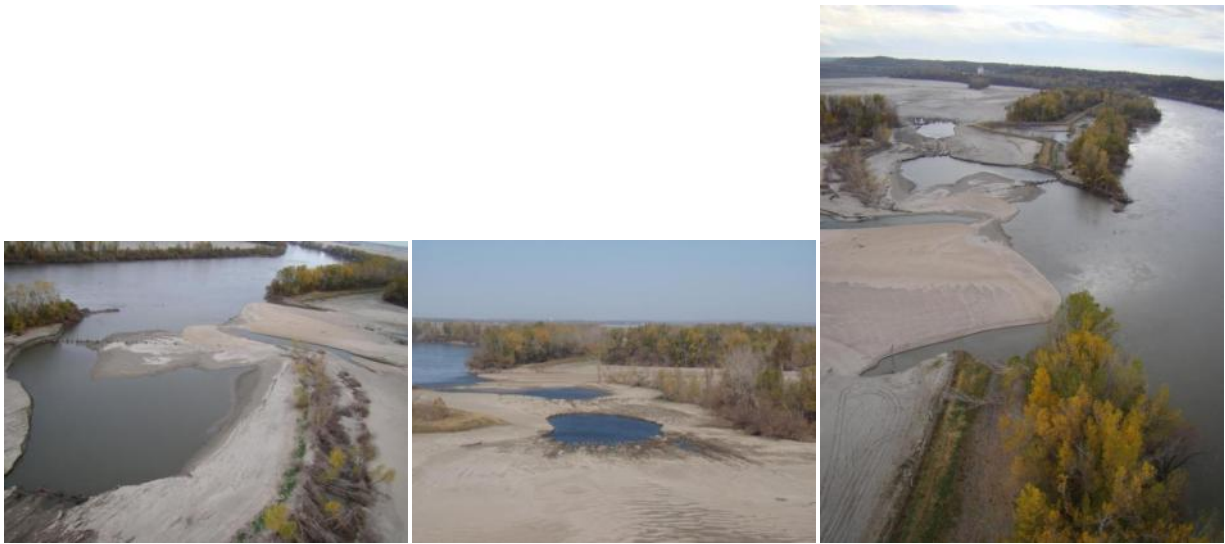
**Figure 4-4(d): Aerial Photos of Flood Damage Submitted by Mr. Derks**

Mr. Derks submitted aerial photos of the damage caused from the 2011 flood. These can be seen in Figure 4-4(d).

The one notch in this location has been in place since 1982. It is apparent the high water of 1997 and the 2011 flood caused the damage in the area. Structure R528.6 is listed on the deficiency list and will be repaired in 2013.

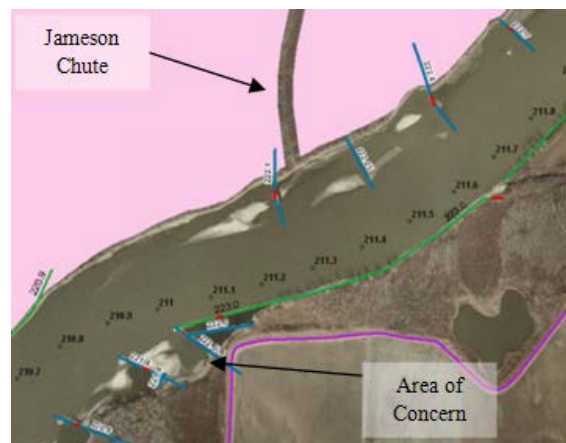
Figure 5-1(a): Location of Concern near River Mile 211

Mark Schupp has a concern at River Mile 211 and believes it is caused by the Jameson Island chute. Structure names and locations in the area are seen below in Figure 5-1(a).

There are four notches near the area of concern. Notch details can be found in Table 5.1. Three of the notches were constructed in 1983 and one notch was constructed in 1994. Jameson chute was constructed in 2007.

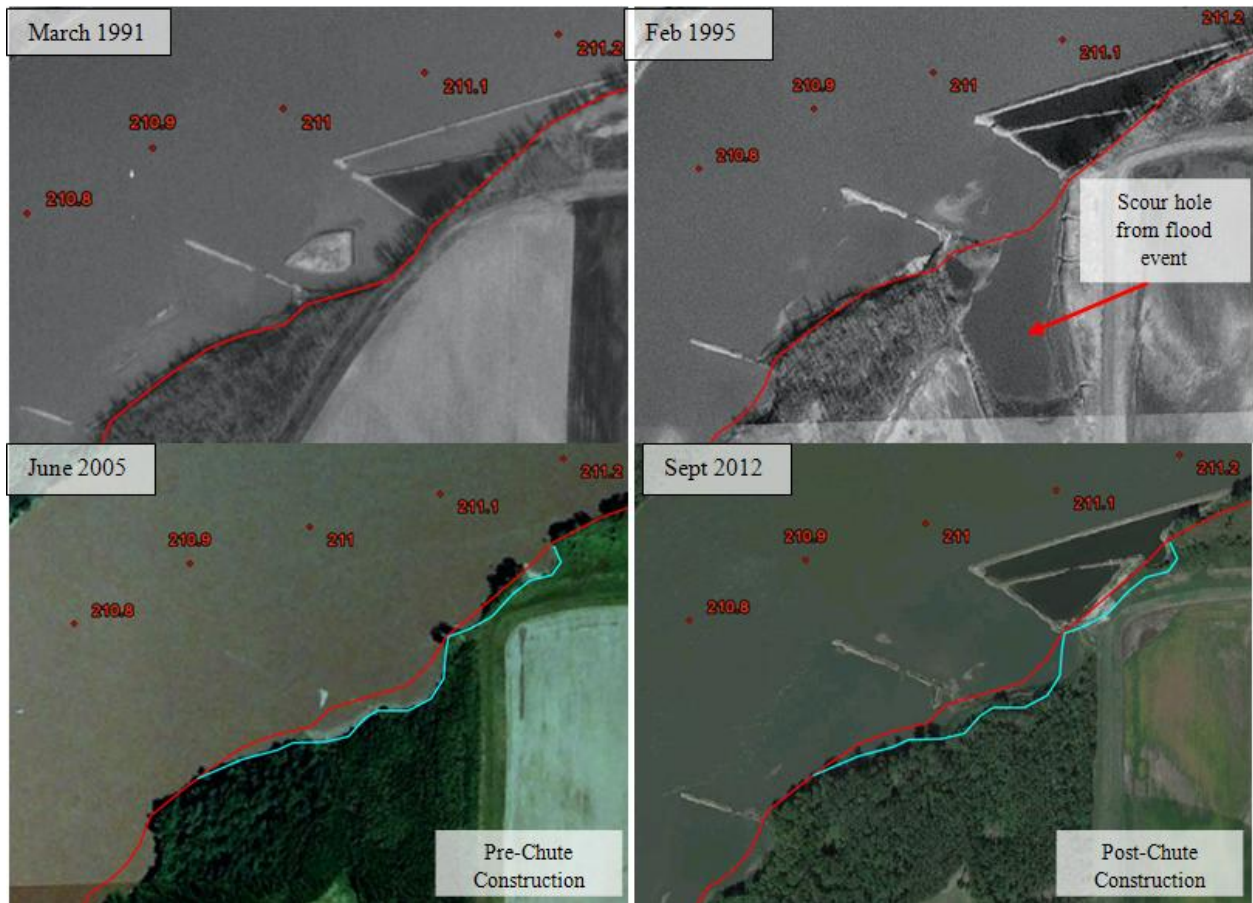
**Figure 5-1(b): Bank Movement near RM 211 over a Period of 21 Years**

Aerial photos were compared near river mile 211 and are shown in Figure 5-1(b). The first photo was taken in March 1991. The next photo, taken in February 1995, shows a scour hole near river mile 211 which occurred during the high water events of 1993/1995. The September 2012 photo, shows the current bank line location relative to the March 1991 bank line (shown in red) and the June 2005 bank line (shown in blue).

The bank has shown no movement since construction of the chute. A model of the location was constructed by the Corps to determine if flow out of the chute can affect flow patterns at the area of concern. The model, seen in Figure 5-2, showed that flow out of the chute quickly turns downstream and does not impact the area of concern. The model results are supported by photos taken during recent flood events. The chute exit is scheduled to be moved downstream sometime in 2013.

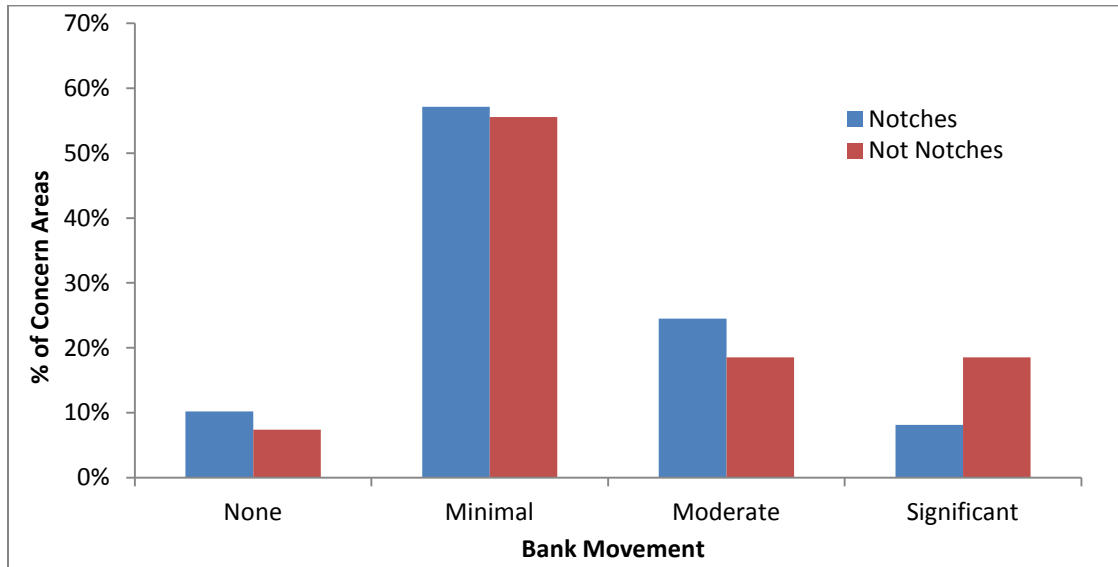
**Figure 6-1: Comparison of notched and un-notched locations.**

Eighteen individuals submitted a total of 82 locations. Of the 82 locations, 52 locations have a notch on a structure in the immediate area. Figure 6.0 below compares degree of erosion for notched and un-notched locations. As indicated in the figure, there is no trend or apparent difference in erosion between notched and un-notched locations.

*Minimal bank movement: less than 75 feet over 20 years. Moderate bank movement: between 75 – 150 feet over 20 years. Significant bank movement: Greater than 150 feet over 20 years.*

Locations with significant erosion, both notched and un-notched, will be evaluated for actions within the authority of the BSNP that might slow or halt further erosion. Possible actions include, but are not limited to; repair of existing structures to design elevation if the existing structure is low, raising the existing structure above design elevation if the erosion is a threat to the structure, construction of a new structure if the erosion is a threat to the proper functioning of existing structures. A total of 18 locations are listed on the current task order for repair. An additional 6 locations could be added for future repair. A summary of each landowner submittal can be seen in Table 6.1.
