Bureau of
Safety and
Environmental
Enforcement

QC-FIT EVALUATION OF CONNECTOR AND BOLT FAILURES SUMMARY OF FINDINGS

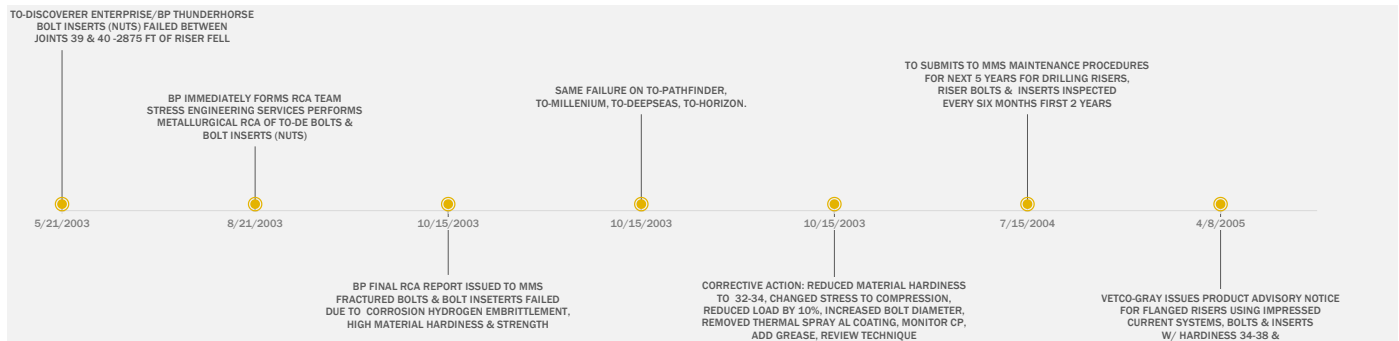
Figure H.1 - 2003-2005 Transocean–Discoverer Enterprise/BP Thunderhorse and Affected Vessels Timeline

A bolt insert failure occurred on May 21, 2003 on Transocean’s Discoverer Enterprise (TO-DE) drilling riser (BP-Thunderhorse) (see Figure H.1 for overview detail of TO-Discoverer Enterprise Bolt Event Timeline). The bolts’ inserts (nuts) that secure the drilling riser failed between joints 39 and 40 resulting in the riser parting to approximately 3,200 feet below sea level and the release of 2,450 bbl of Accolade synthetic based drilling fluid. The bolt insert and bolt fractured due to severe, accelerated, environmentally assisted corrosion. The 2003 TO-DE bolt insert/bolt failure impacted five TO rigs: Discoverer Enterprise, Pathfinder, Horizon, Millennium, and Deepseas.

On October 15, 2003, an RCA report on the TO-DE riser inserts (and bolts) failure was issued to the Minerals Management Service (MMS). A third party performed the metallurgical RCA for the inserts and the bolts that were also AISI 4340 with a material hardness design specification 34-38 HRC. The inserts and bolts for TO-DE and TO-Discoverer Pathfinder (examined for comparison) had yield strength values of 135 ksi for inserts and 145 ksi for bolts. The material hardness values were in the range of 34-40 HRC for the inserts and 34-38 HRC for the bolts that did not fail. For the failed inserts the hardness values were 34-39 HRC, and 35-37 HRC for the failed bolts. The RCA stated the immediate cause for failure was due to the identified failure mechanism of environmentally assisted cracking fracture of the AISI 4340 inserts. This report also identified several factors as potential correlated factors contributing to the cause of hydrogen-related failure, as follows: high material hardness, high material yield strength of the inserts (and bolts), seawater salinity, fluid, thermal spray aluminum coating, potential stray direct current (DC) induced electrical currents, type of cathodic protection system, material compatibility (use of dissimilar metals in close proximity), and combined charging effects.

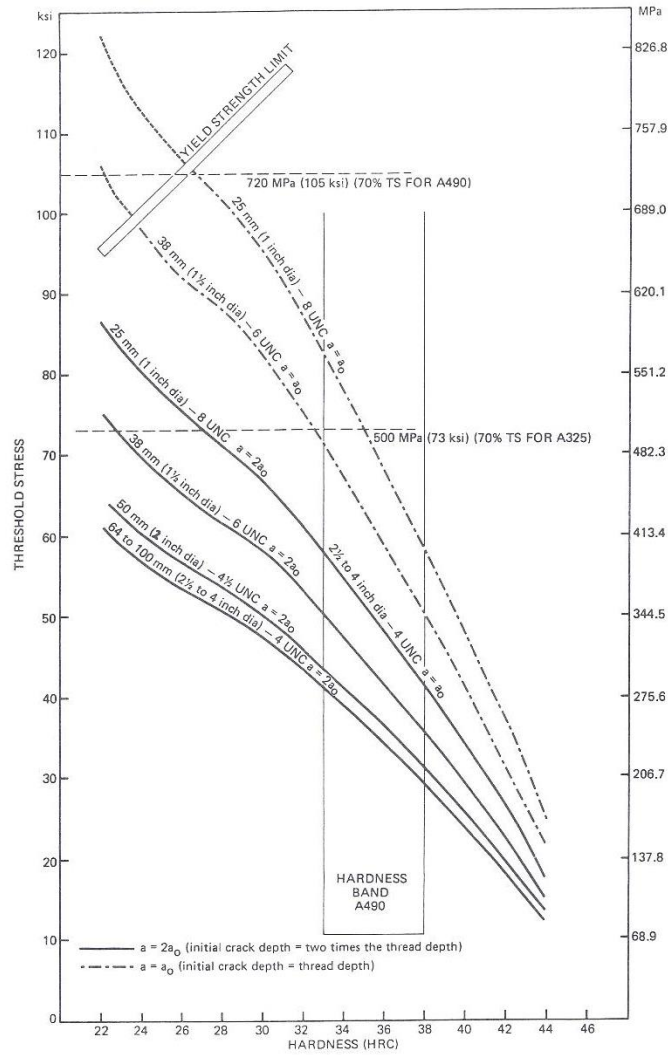
Low-Alloy Bolts: Threshold Stress for Stress-Corrosion Cracking

Plot of threshold stresses for stress-corrosion cracking in low-alloy quenched and tempered bolting materials with different hardness levels. Note: UNC denotes unified coarse thread.

Based on curve above, when bolts are subjected to stresses in the range of approximately 28,000 to 35,000 psi with diameters in the range of 2.5-4 inches, and hardness 34-38 HRC, they will likely fracture due to stress corrosion cracking. For example, bolts with a hardness of 34 HRC, will likely fracture due to stress corrosion cracking (SCC) at approximately 35,000 psi. When subjected to an applied stress of approximately 28,000 psi. Bolts with a material hardness value greater than 38 HRC, will likely fracture due to SCC. Therefore, the higher the bolts' material hardness value, the lower threshold stress they can withstand before fracturing due to SCC. The lower the bolts' material hardness (more ductile its material strength properties), the higher the threshold stress they can withstand before fracturing due to SCC.

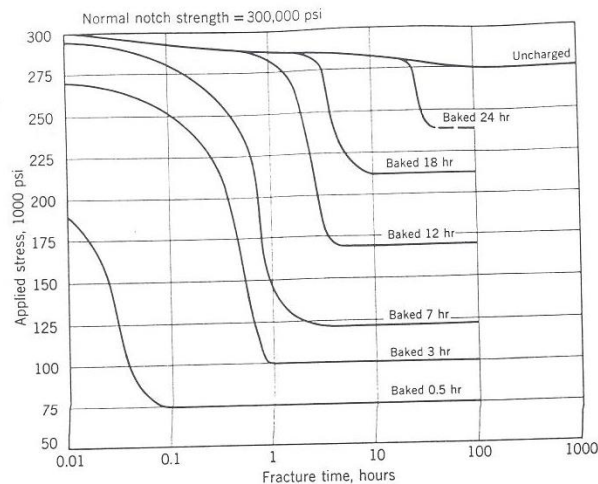
4340 Alloy Steel: Fracture Time as a Function of Hydrogen Content

Delayed fracture times and minimum stress for cracking of 0.4% carbon steel as a function of hydrogen content. Specimen initially charged cathodically, baked at 150 °C for varying times to reduce hydrogen content.

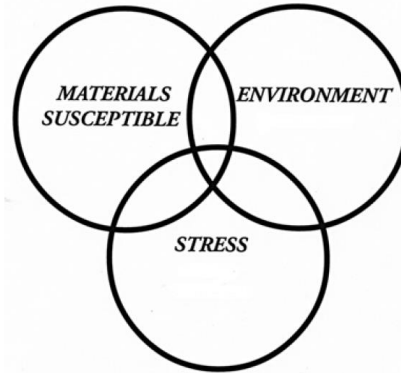
Fig. 1 — Factors contributing to hydrogen embrittlement.

Of these, hydrogen embrittlement is responsible for a surprising number of delayed failures and problems with products produced from wire, especially if they undergo secondary processing operations such as plating. The factors (see **Figure 1**) responsible for this type of failure include having a susceptible material, an environment conducive to attack and the presence of stress (internal or applied). Once two of these three factors are present, failure is inevitable.

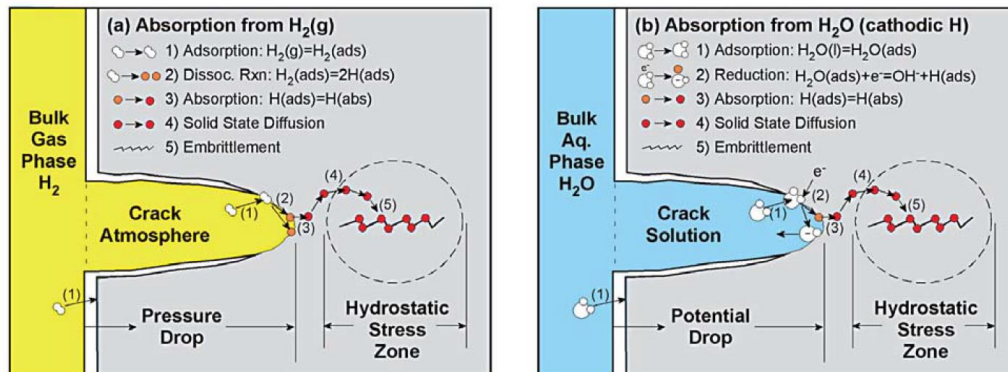
Fig. 2 — Hydrogen embrittlement mechanisms.

Hydrogen embrittlement is also known as hydrogen induced cracking or hydrogen attack. Materials that are most vulnerable include high-strength steels, titanium and aluminum alloys and electrolytic tough pitch copper. Hydrogen embrittlement mechanisms (see **Figure 2**) can be aqueous or gaseous and involve the ingress of hydrogen into the metal, reducing its ductility and load bearing capacity. Stress below the yield stress of the susceptible material then causes subsequent cracking and catastrophic brittle failures (see **Figure 3**).
