**TASK ONE:
ECONOMIC ANALYSIS
OF HANGARS 113, 114, AND 115
NAVAL AIR STATION (NAS)
JACKSONVILLE, FL**

**SUB-TASK 4:
FINAL ECONOMIC
ANALYSIS**

**Prepared for:
NAVAL FACILITIES AND ENGINEERING COMMAND
SOUTHEAST
NAVAL AIR STATION JACKSONVILLE
JACKSONVILLE, FLORIDA**

SEPTEMBER 2013

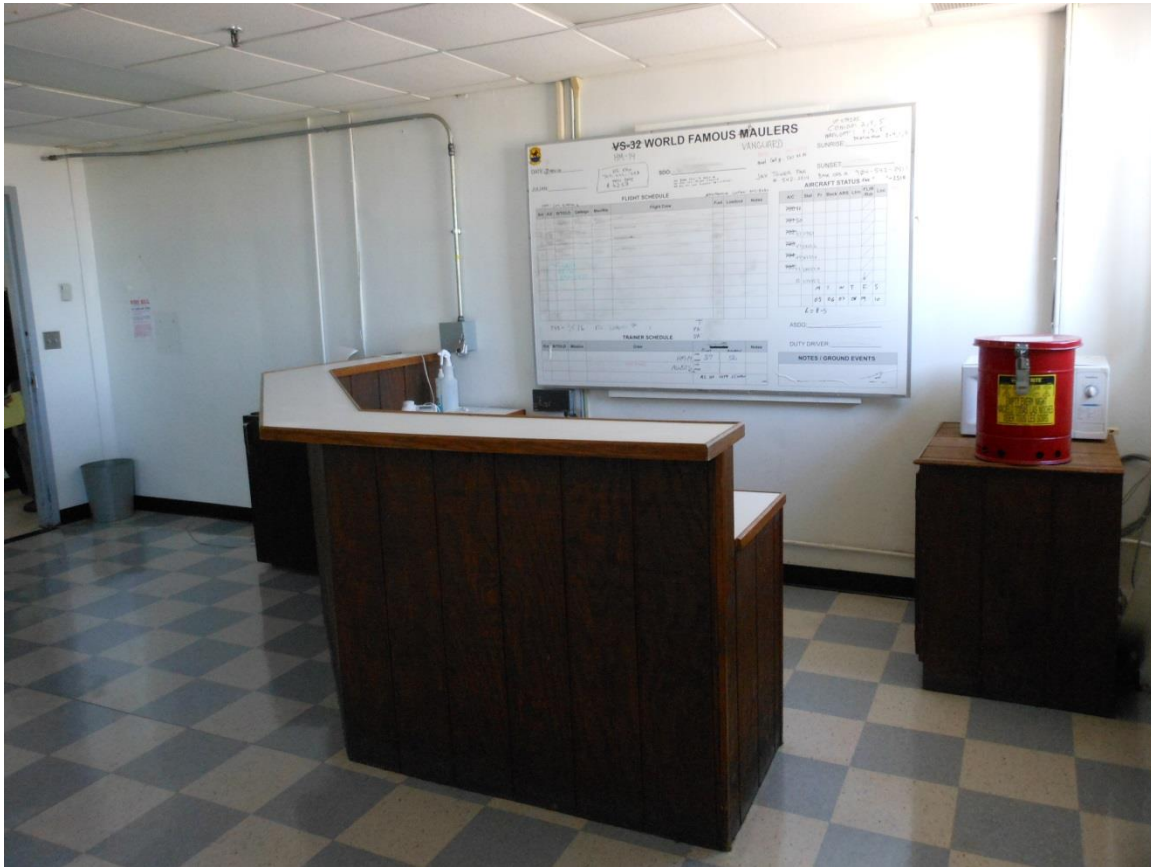
Figure 7. Swing space created for the VS-32 World Famous Maulers Squadron is still in place in Hangar 113 until another group needs the space (Ms. Kelly Nolte, 2013).

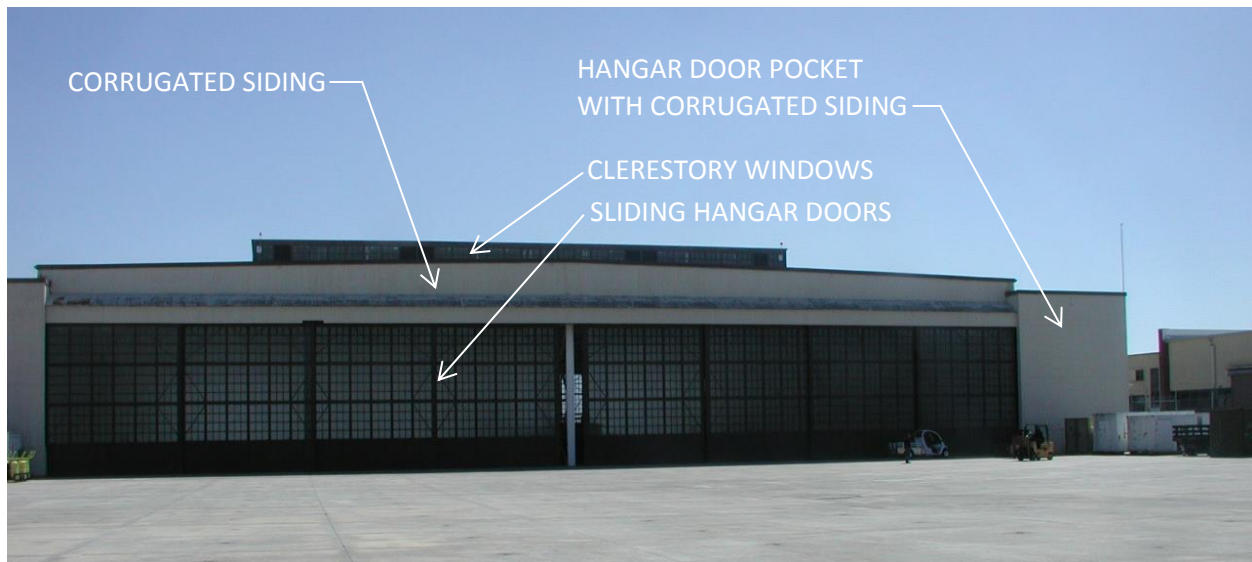
The east and west ends of the hangar bays are enclosed by the hangar bay doors and door pockets (Figure 19). The construction of the hangar door pockets on the east and west ends of the hangars consists of steel girts supporting tongue-and-groove wood planks that are covered on the exterior with corrugated wall panels. Spotted corrosion is visible of the steel framing members (Figure 20). Note that on other hangars of this design, the steel framing in the hangar pockets has been subject to severe corrosion—particularly at the top of the door pockets. These areas should be carefully inspected by a structural engineer to evaluate their condition. The wood plank substrate appears to be in generally good condition, but there are isolated areas with damaged or rotted wood (see Figure 20).

Figure 19. Typical building elements at east and west ends of aircraft bays (Mr. Richard Simonton, 2013).

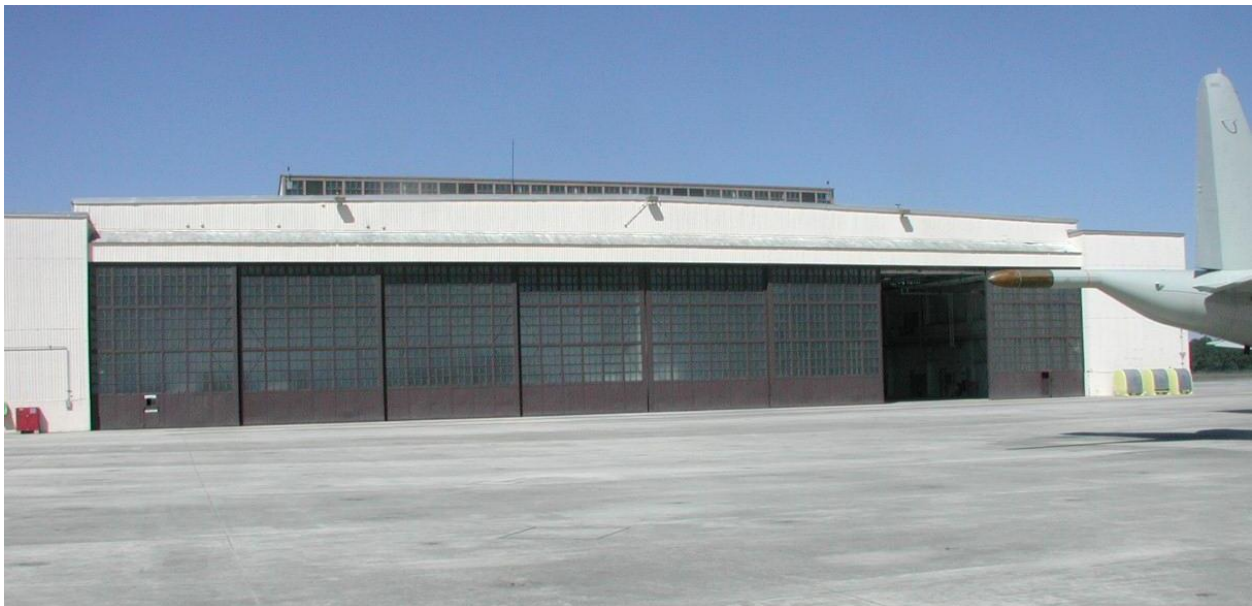
The large glazed hangar doors are a key historic element in these hangars (Figures 23 and 24). The weight of these hangar doors is supported by steel rollers that move along a steel track that is recessed in the concrete floor slab (Figure 25). The doors appear to be in good condition, but there are issues with the steel rails. All of the steel rails exhibit pitting or some degree of section loss as a result of rusting (Figure 26). Section loss is a severe problem inside the hangar door storage pockets where rails are submerged in standing water for long periods (Figure 27). Deterioration of these rails prevents the hangar doors from fully recessing in the storage pockets.

Figure 23. Typical hangar door configuration at east and west ends of hangar buildings (Mr. Richard Simonton, 2013).

Because of the deteriorated bottom tracks and uncertain condition of the upper track supports, these hangar doors pose potential safety issues. If the hangars continue to be used, a structural engineer should be engaged to evaluate the structural integrity of the entire hangar door support system including the rails, upper tracks, track supports and rollers.

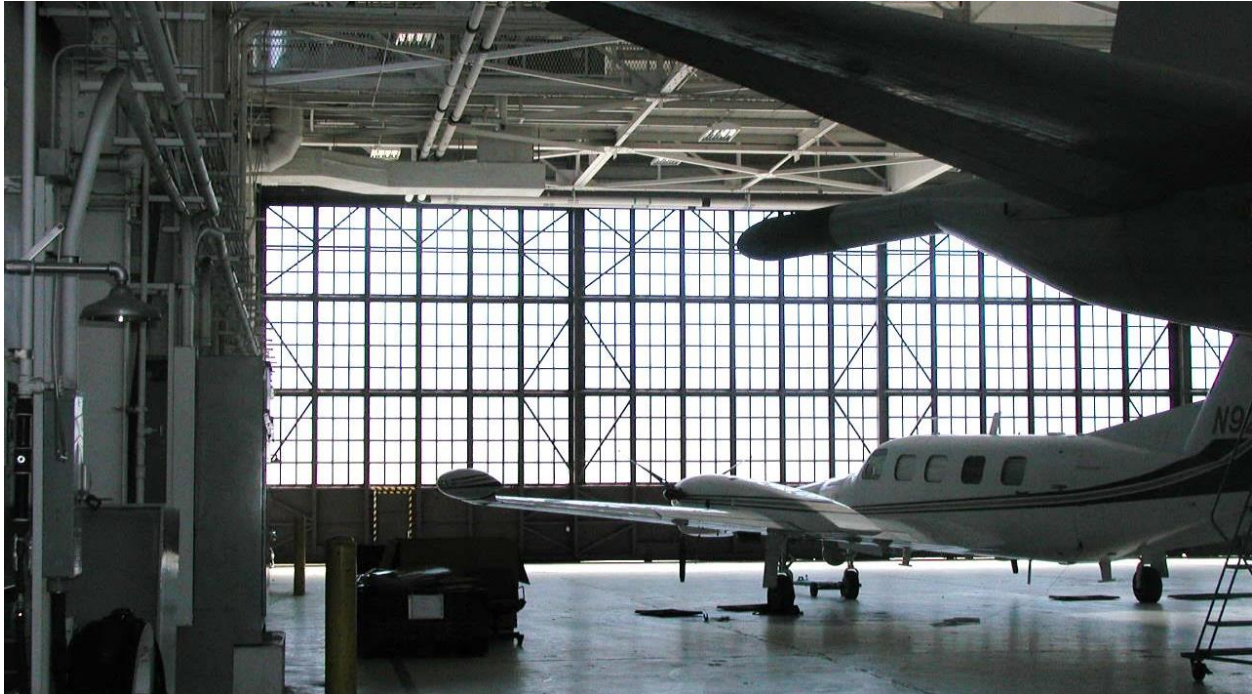
Figure 24. Interior view of hangar looking toward glazed hangar doors (Mr. Richard Simonton, 2013).

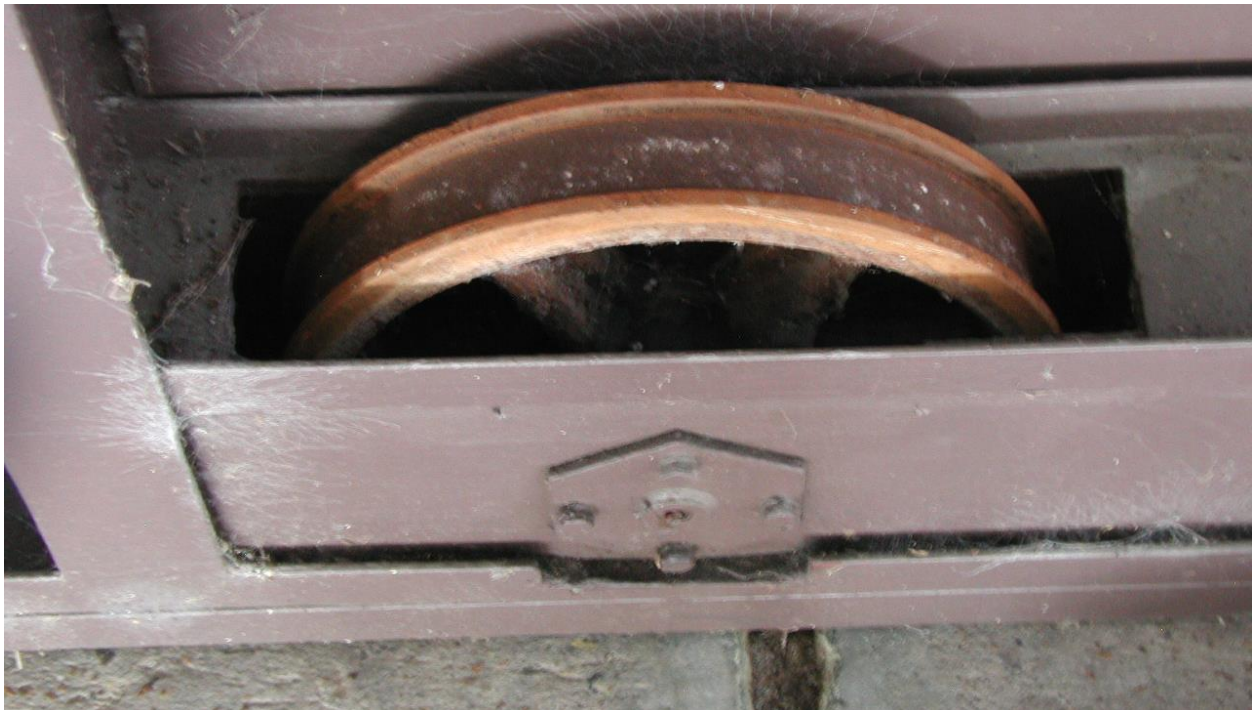
Figure 25. Typical hangar door roller (Mr. Richard Simonton, 2013).

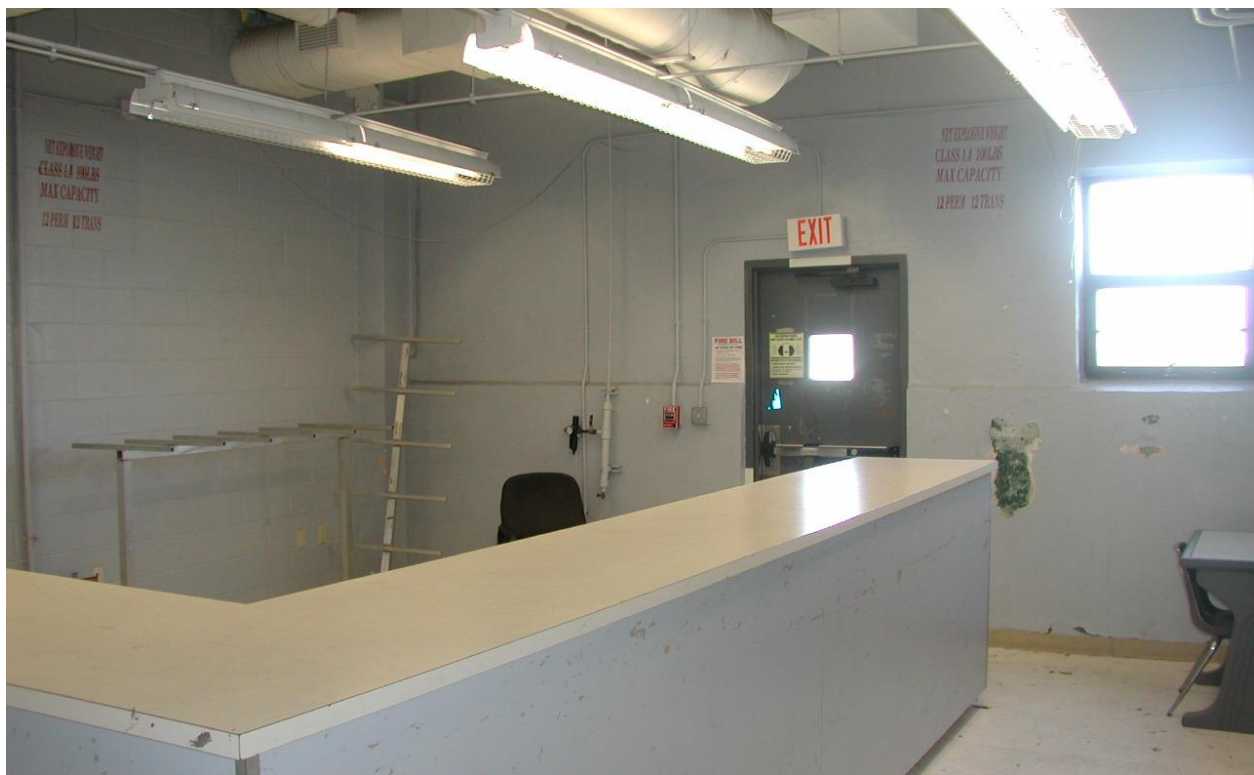
Interior Construction. Interior construction includes fixed partitions, demountable partitions, interior windows, doors, chalk/tack boards, signs, lockers, shelving, handrails, and toilet partitions. The interior spaces on each side of the aircraft hangar bays have been configured as shop, office, and meeting space as needed to accommodate varying swing-space requirements (Figure 28 and 29). This interior fit-out construction is generally of moderate quality and in fair to poor condition. Interior doors are in better condition than exterior doors, but could still use replacement.

Figure 28. Typical first floor interior fit-out (Mr. Richard Simonton, 2013).

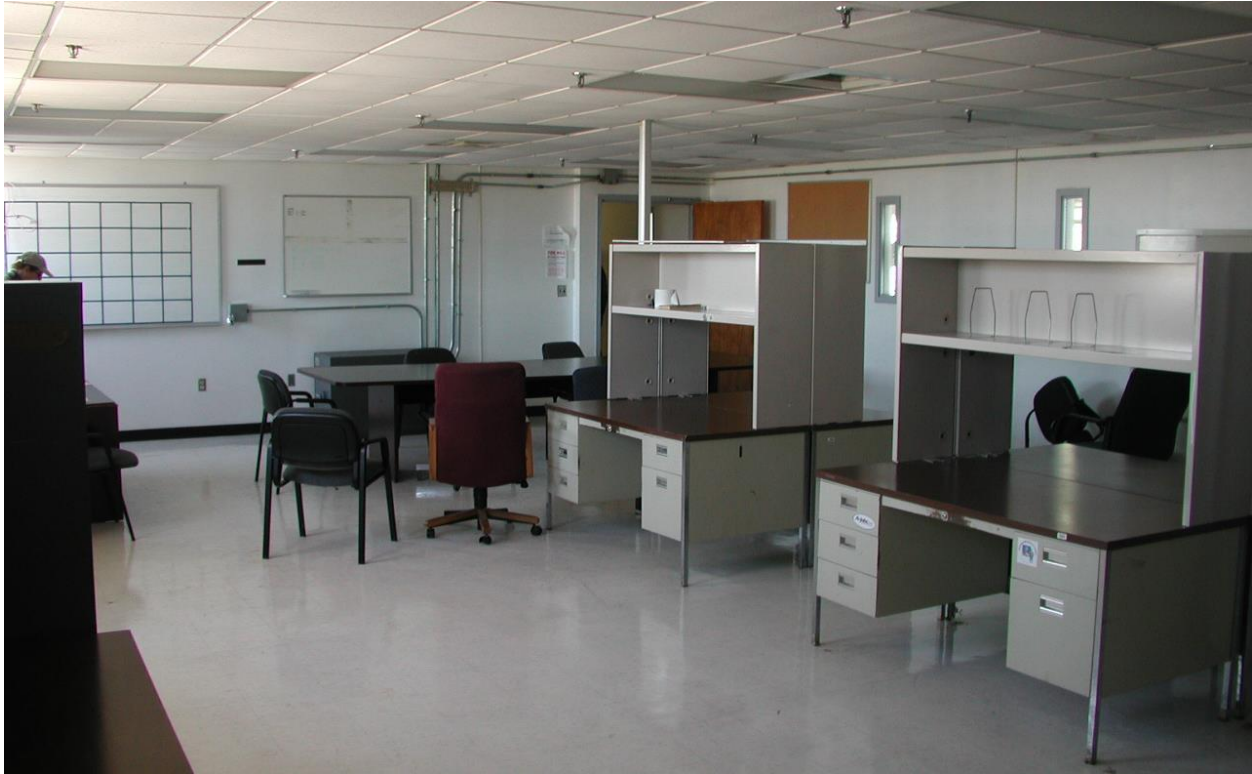
Figure 29. Typical second floor interior fit-out (Mr. Richard Simonton, 2013).

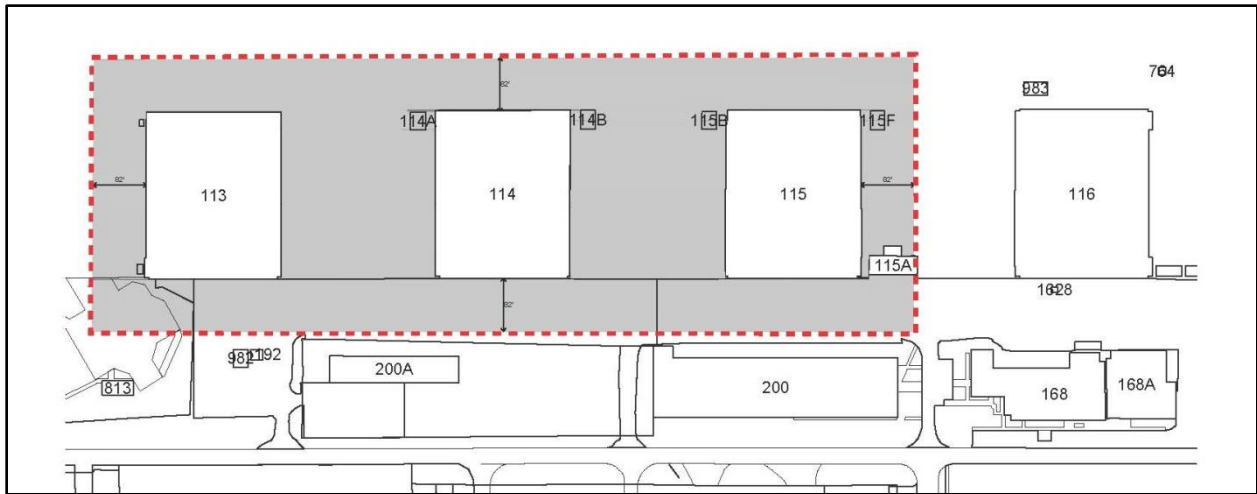
The minimum standoff distance required in locations without a controlled perimeter or parking is 82 feet (Figure 33). Keeping this clear distance would displace the Albermarle Avenue parking lot on the south side of the hangars. If the parking lot was changed to controlled access then the standoff distance could be reduced to 33 feet.

Figure 33. Shaded area depicting required 82-foot standoff distance (Simonton Swaika Black 2013).

The glazing provisions of the ATFP standards must be followed whenever doors or windows are replaced (DoD, UFC 4-010-1). All glazing, including the historic glass in the hangar doors and clerestory windows, would have to be replaced with laminated glazing with a PVB interlayer.
