4 Career Fire Fighters Killed and 16 Fire Fighters Injured at Commercial Structure Fire - Texas

Executive Summary

A summary of a NIOSH fire fighter fatality investigation

July 15, 2015

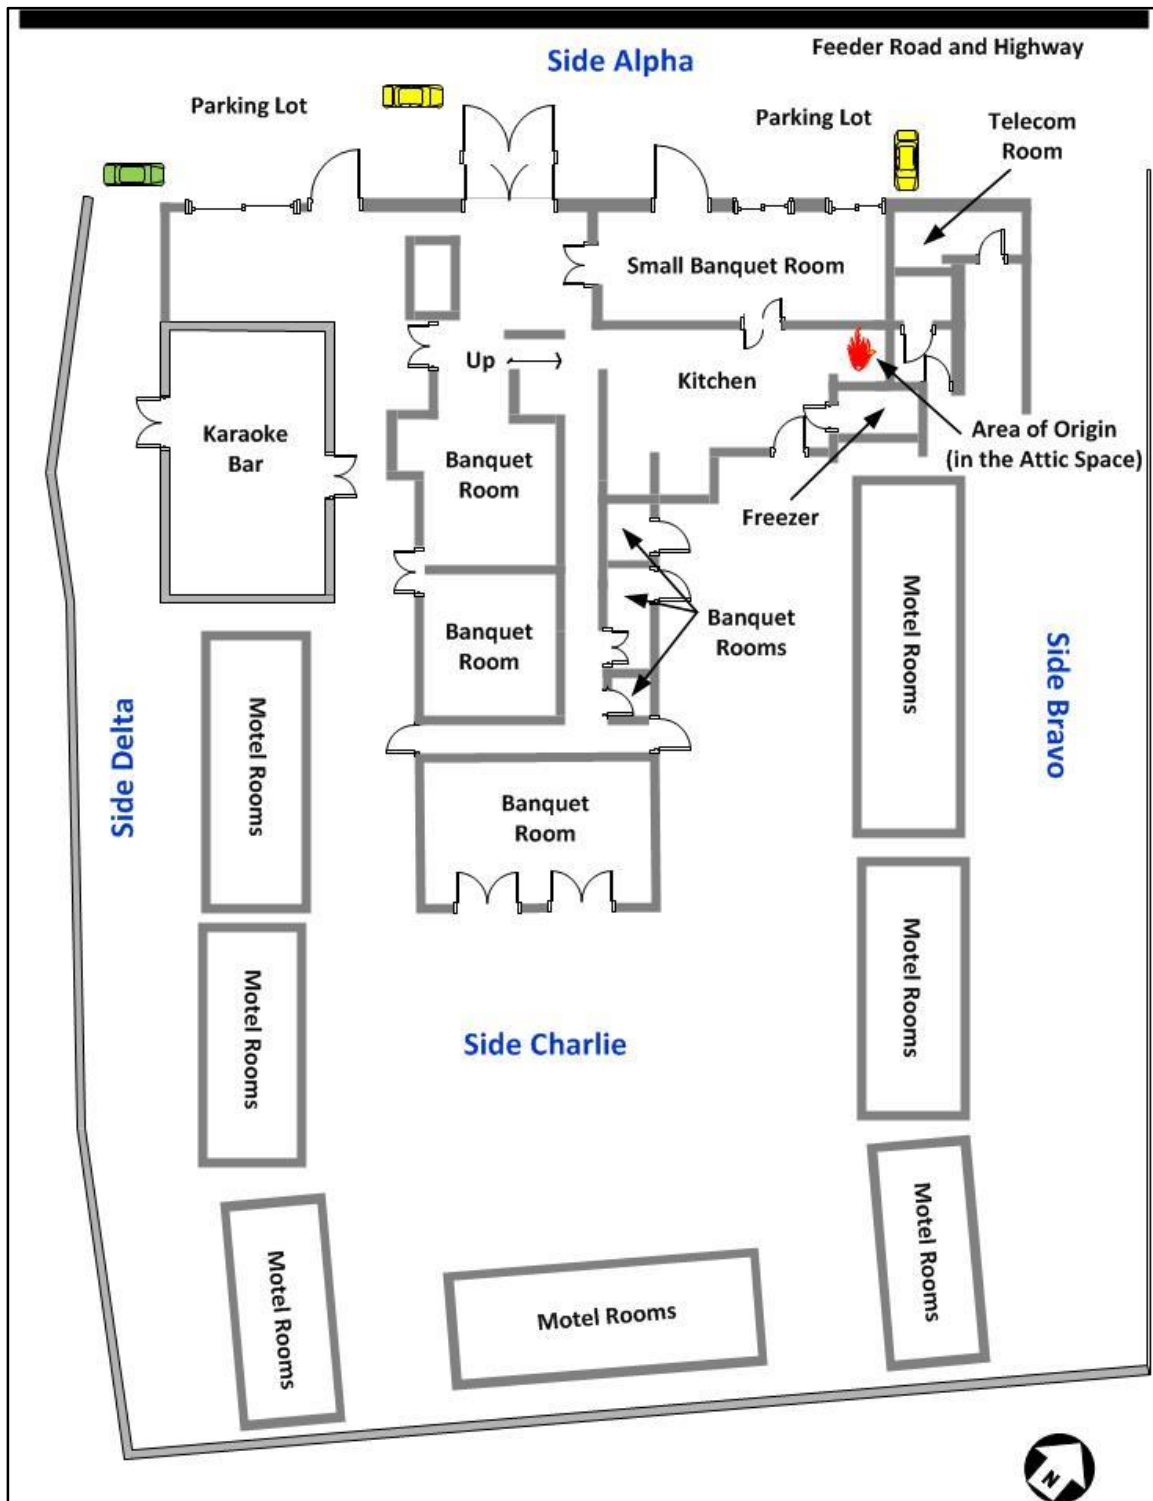
Diagram 1. The site plan for the motel, restaurant, and bar. The area of origin was determined to be in the attic/crawlspace above the kitchen.

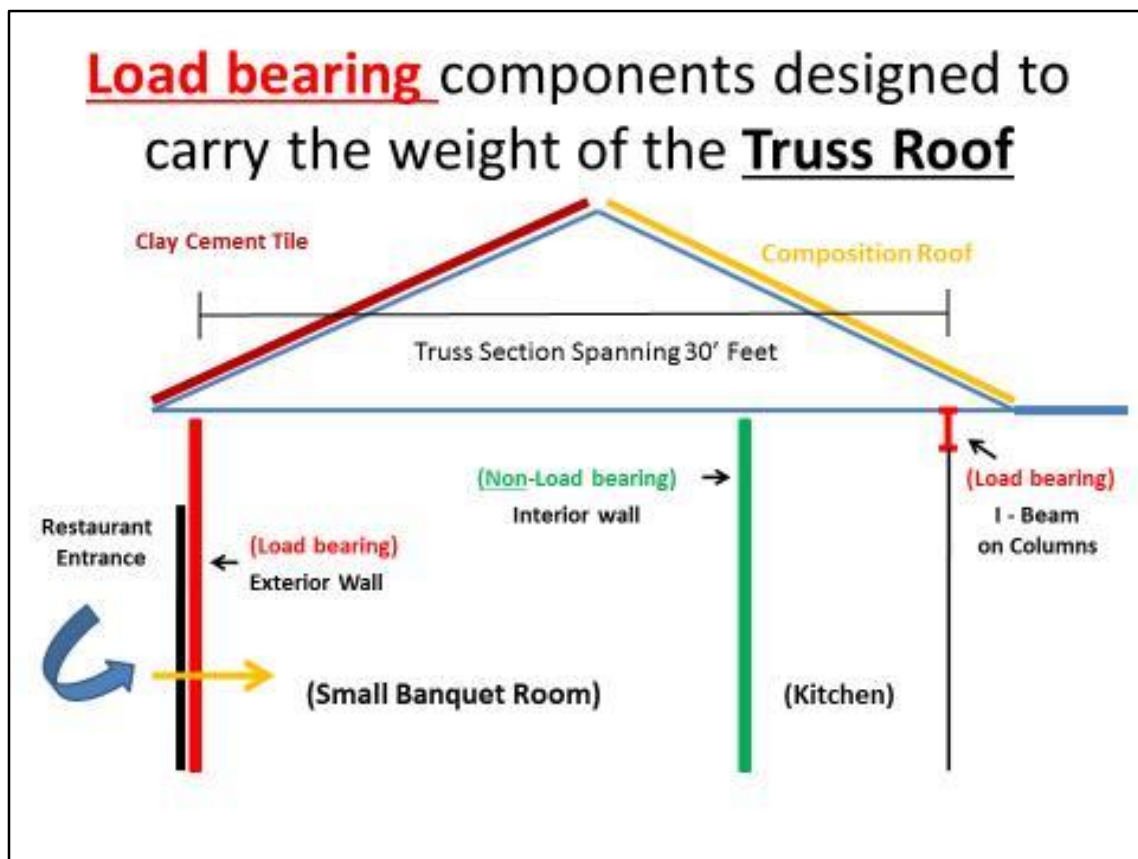
The restaurant facility located at the east side of the main entrance (lobby building) with its main entrance on Division Alpha, had a gable-style roof assembly constructed of an engineered wood truss components incorporating a lap-nailed truss configuration. This type of truss configuration is not commonly found or referenced in fire service case studies or incidents. Unlike other conventional engineered gable truss systems that utilize sized wood components that are fastened and secured utilizing a metal-plate-connected (MPC) that result in an engineered truss, the lap-nailed wood truss system utilizes nails (versus MPC) as the mechanical fastener to secure the truss components together in an assembly to provide structural support as a configured truss component. The truss webs and cords are configured in their defined orientation and angles and fastened utilizing a defined quality and sized metal nail fasteners and connected on the vertical face of the corresponding truss component.

Diagram 2. The truss roof design of the small Banquet Room and the Kitchen.
(Diagram courtesy of the fire department)

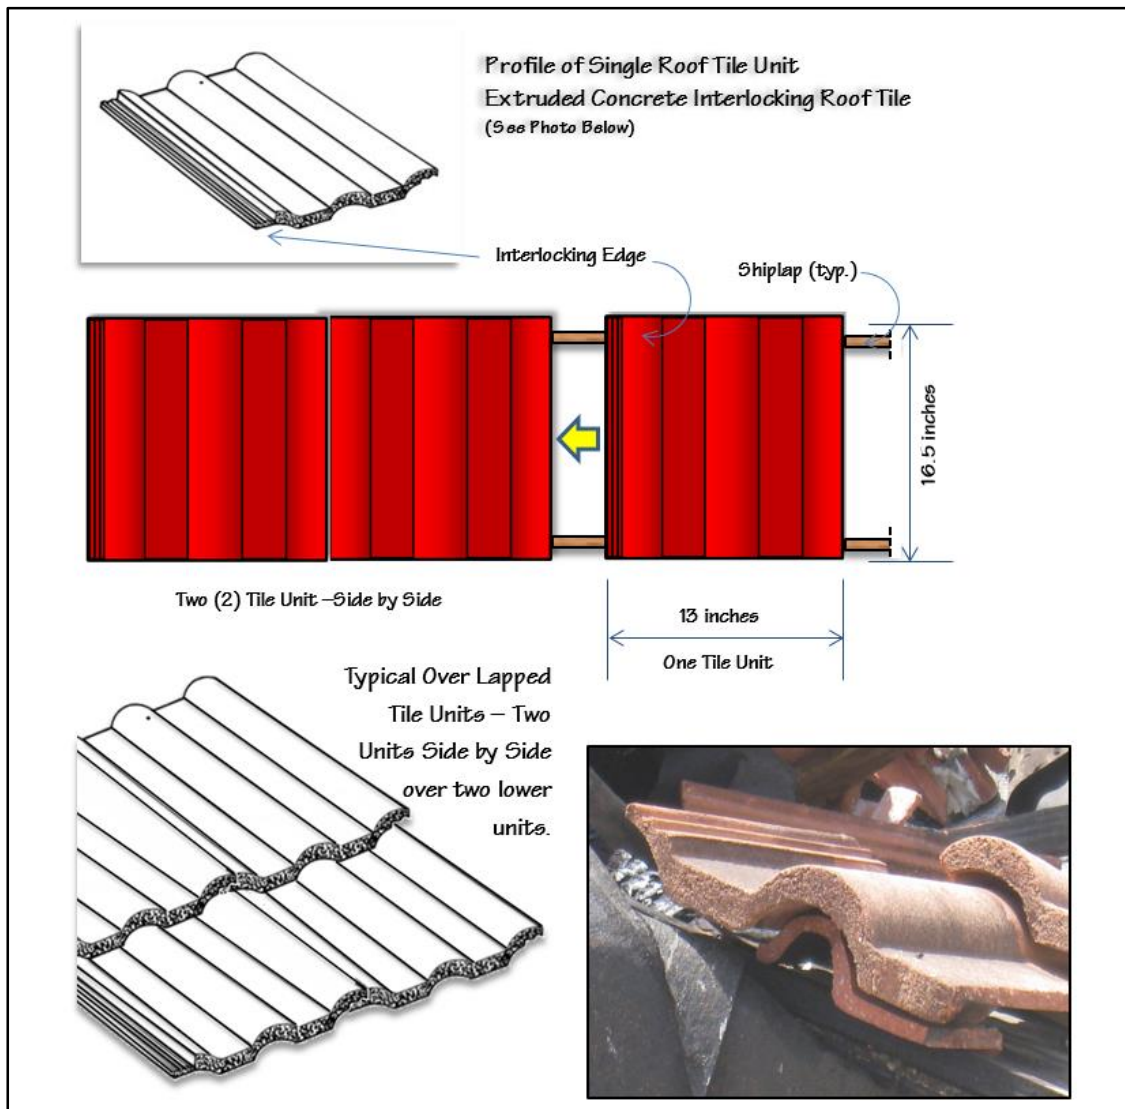
Due to the absence of historical construction records and specifications, the roofing tile was identified based on the roofing tile manufacturer imprint. This is typically found on the underside of each tile unit. A likely tile unit style was identified, which is consistent with the figures developed and specifications.

Diagram 3. The concrete roofing tile details which were on Side Alpha of the Small Banquet Room.

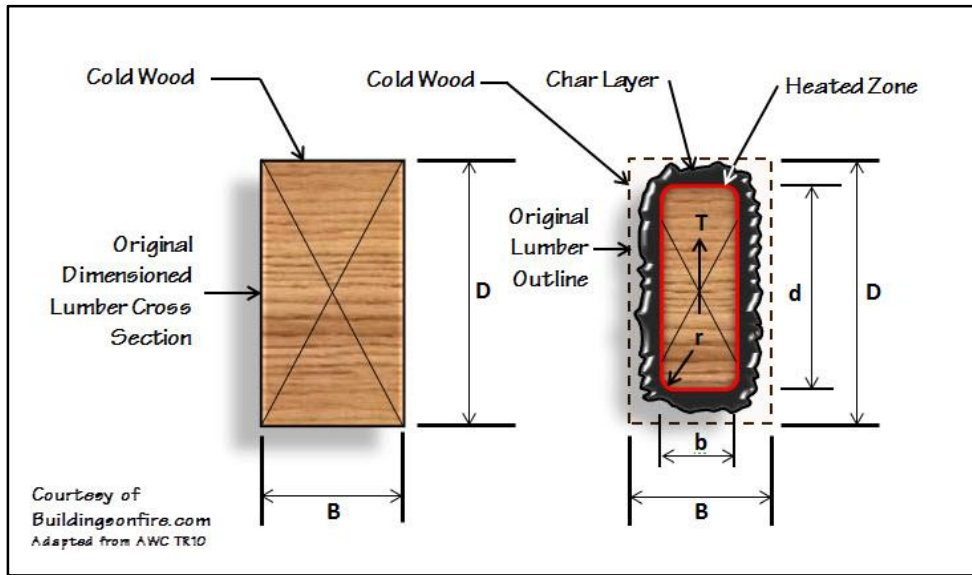
- The surface to mass ratio of the exposed wood truss members with the increased surface area results in increased consumption and degradation of the wood, leading to decreased cross sectional dimensions and decreased load-bearing capacity of the structural components. [8.9.21](#) (See **Diagram 4.**)

Diagram 4. Reduction in Wood Component Breadth and Depth over time, (Diagram Courtesy of Buildingsonfire.com) [Adapted from AWC Technical Report #10 (2012)]

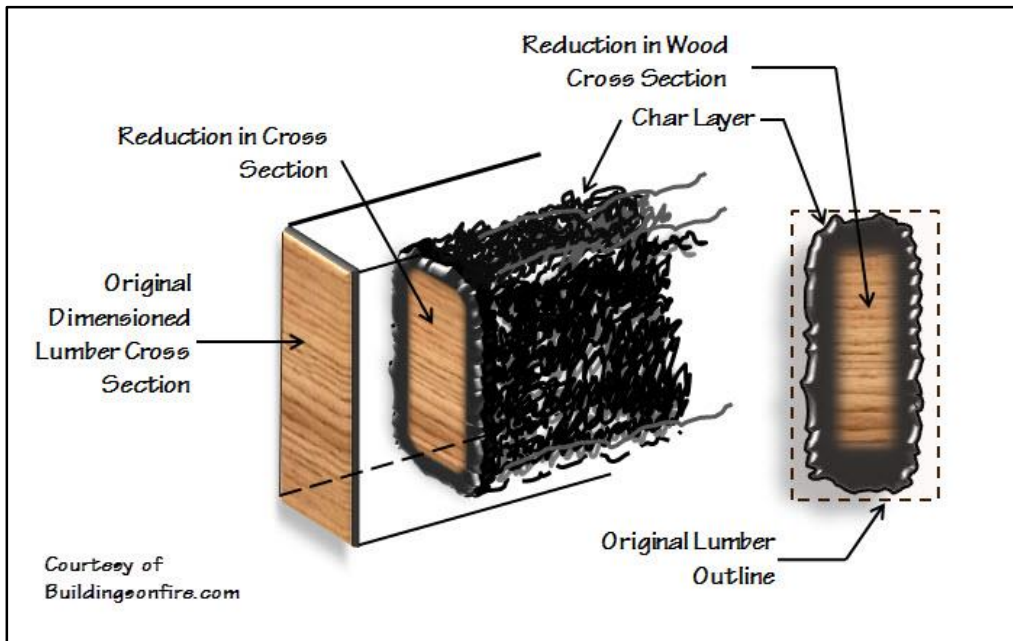
Diagram 5. Charring Effect on Wood Component and Cross Section (Diagram Courtesy of Buildingsonfire.com)

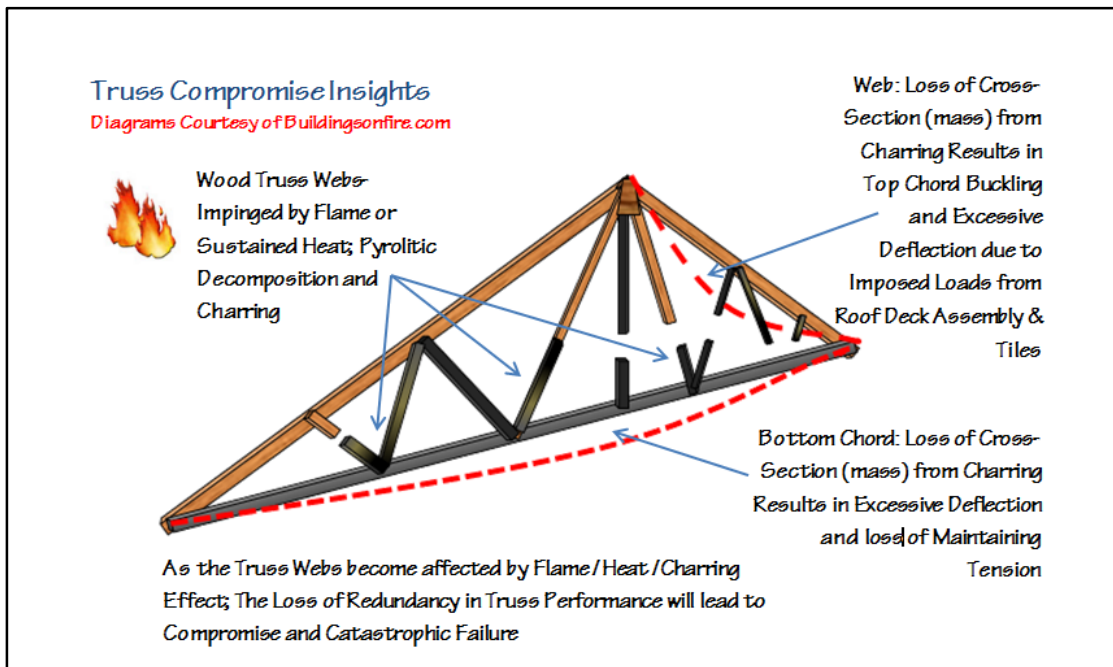
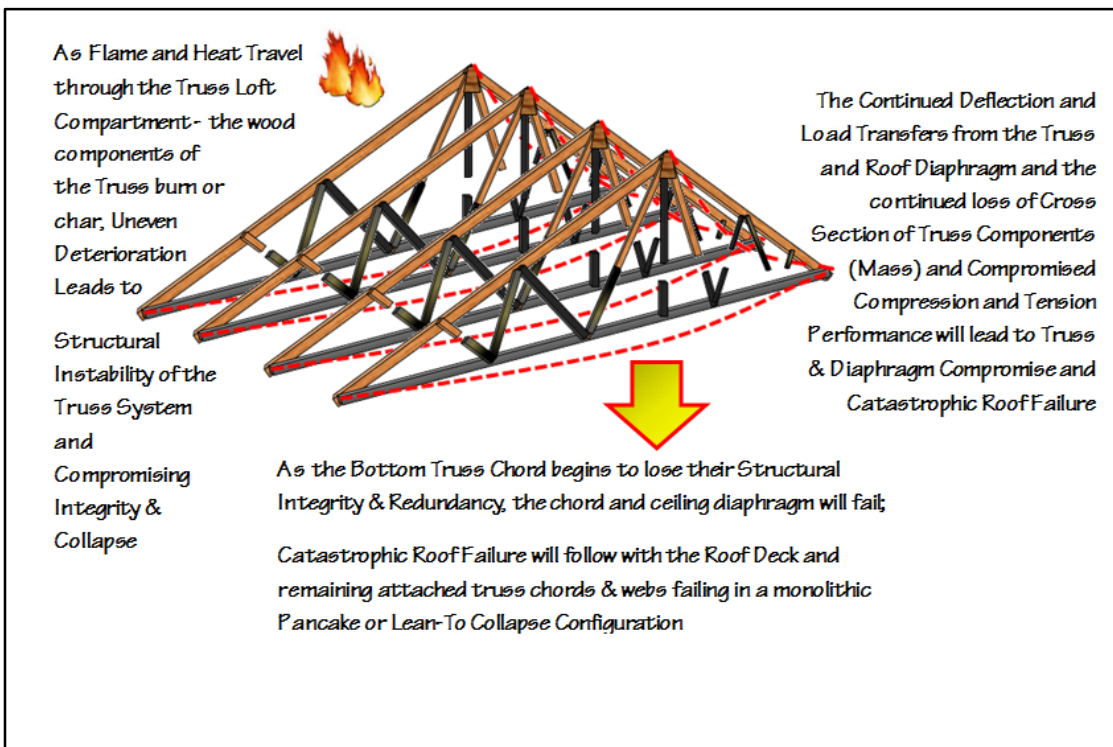
Diagrams 6 and 7. Anatomy of a Truss - Assembly Compromise and Collapse
 (Diagram Courtesy of Buildingsonfire.com)

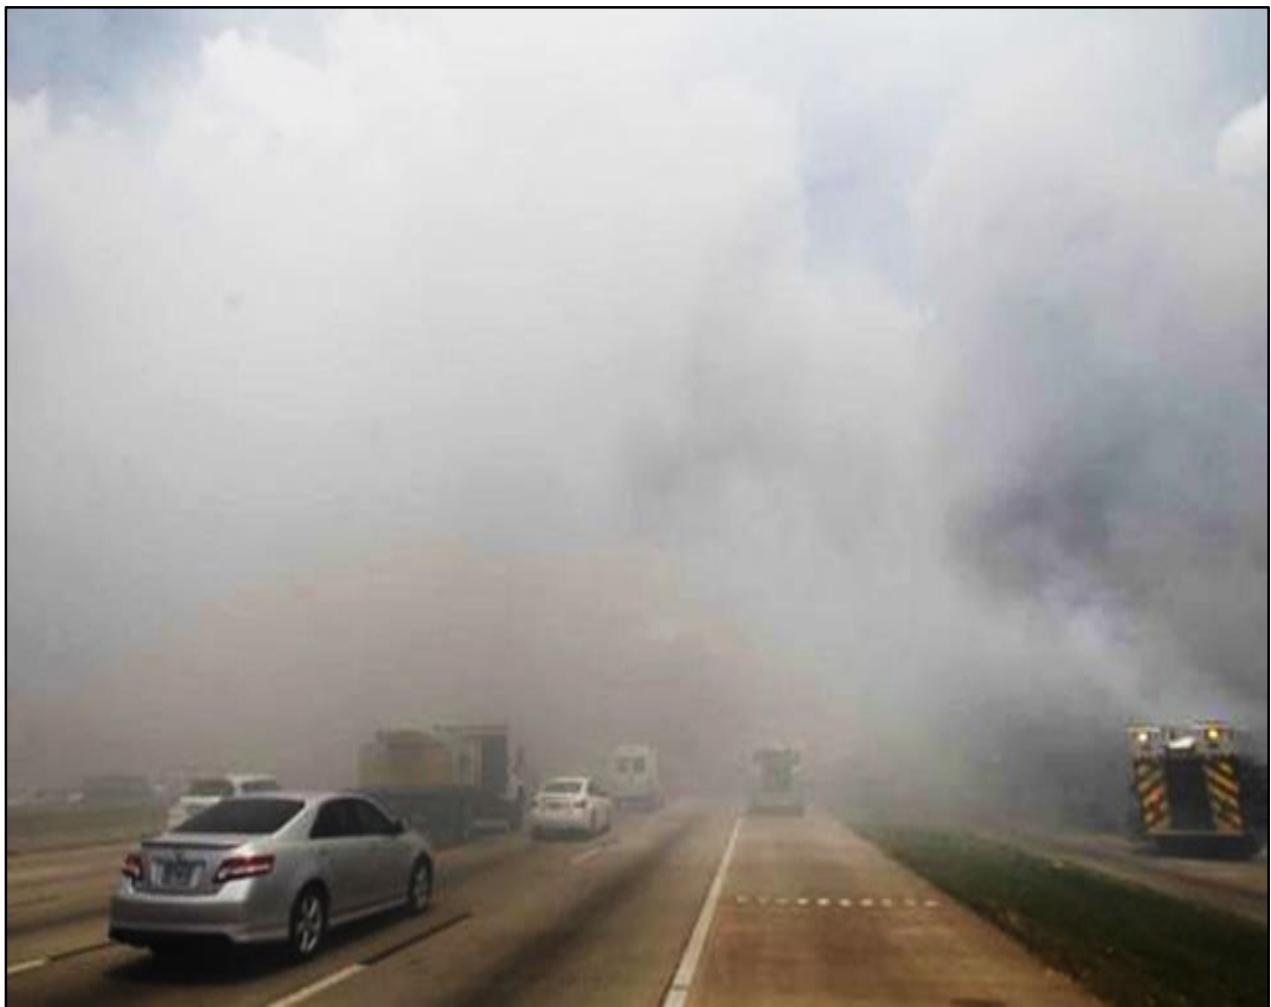
During the initial attack, and well into the rescue, the direction of these strong winds made Division Charlie the intake side of the structure and placed Division Alpha as the exhaust point. The smoke was blowing across the fireground vertically limiting the visibility of members conducting fire attack, ventilation, and rescue. Crews were faced with extreme heat and smoke conditions that would continue to increase and hamper their efforts. (See **Photo 5**.)

Photo 5. The smoke conditions encountered by the 1st Alarm companies. This picture is looking north on the feeder road and the freeway. E82 is parked on the shoulder of the freeway and Rescue 10 is on scene. The time is approximately 1224 hours.

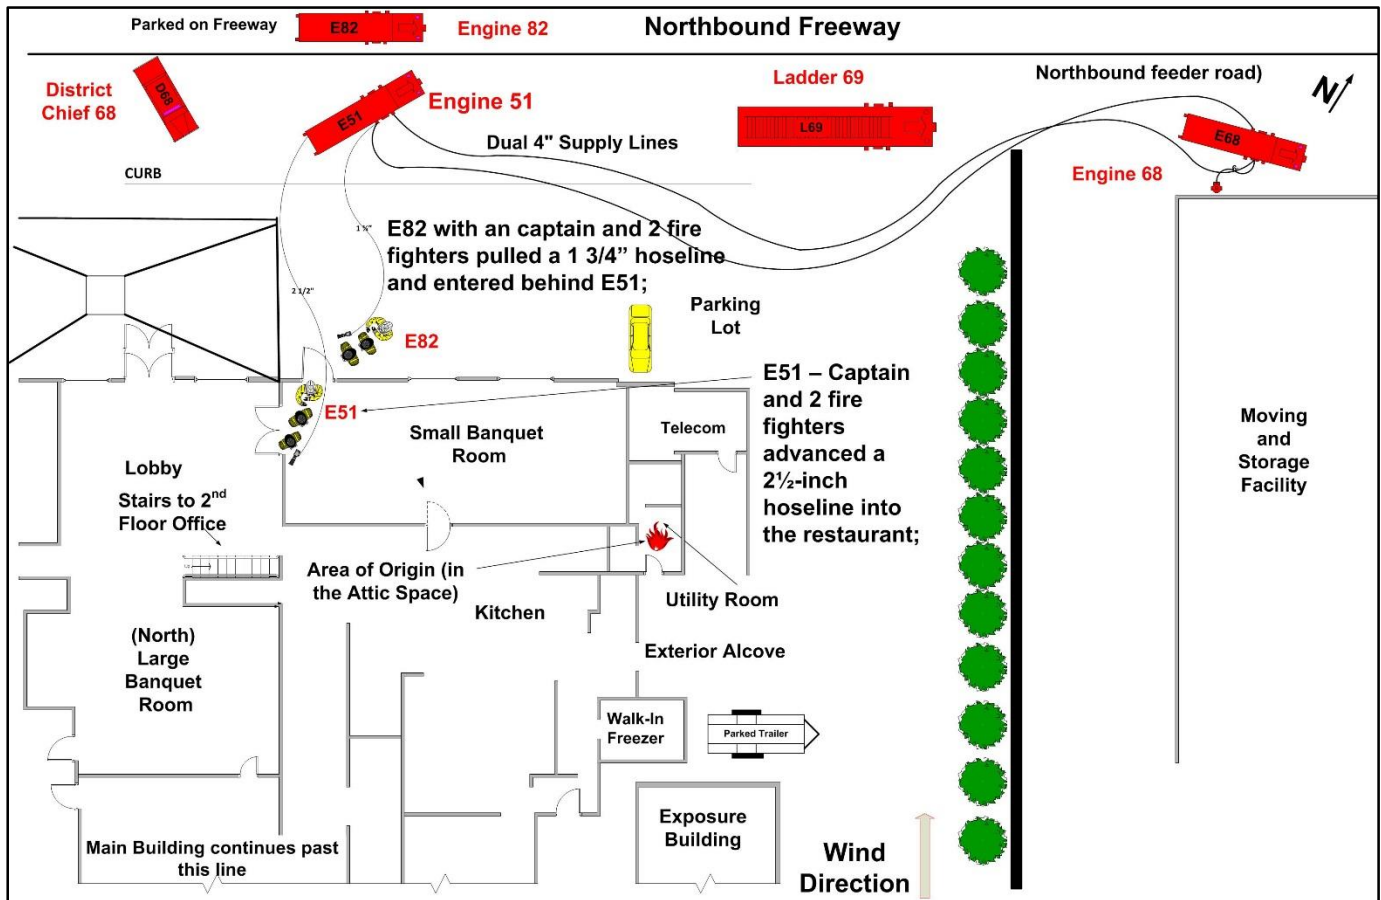
Diagram 12. The initial fire attack by the crews of Engine 51 and Engine 82. The time is approximately 1215 hours.

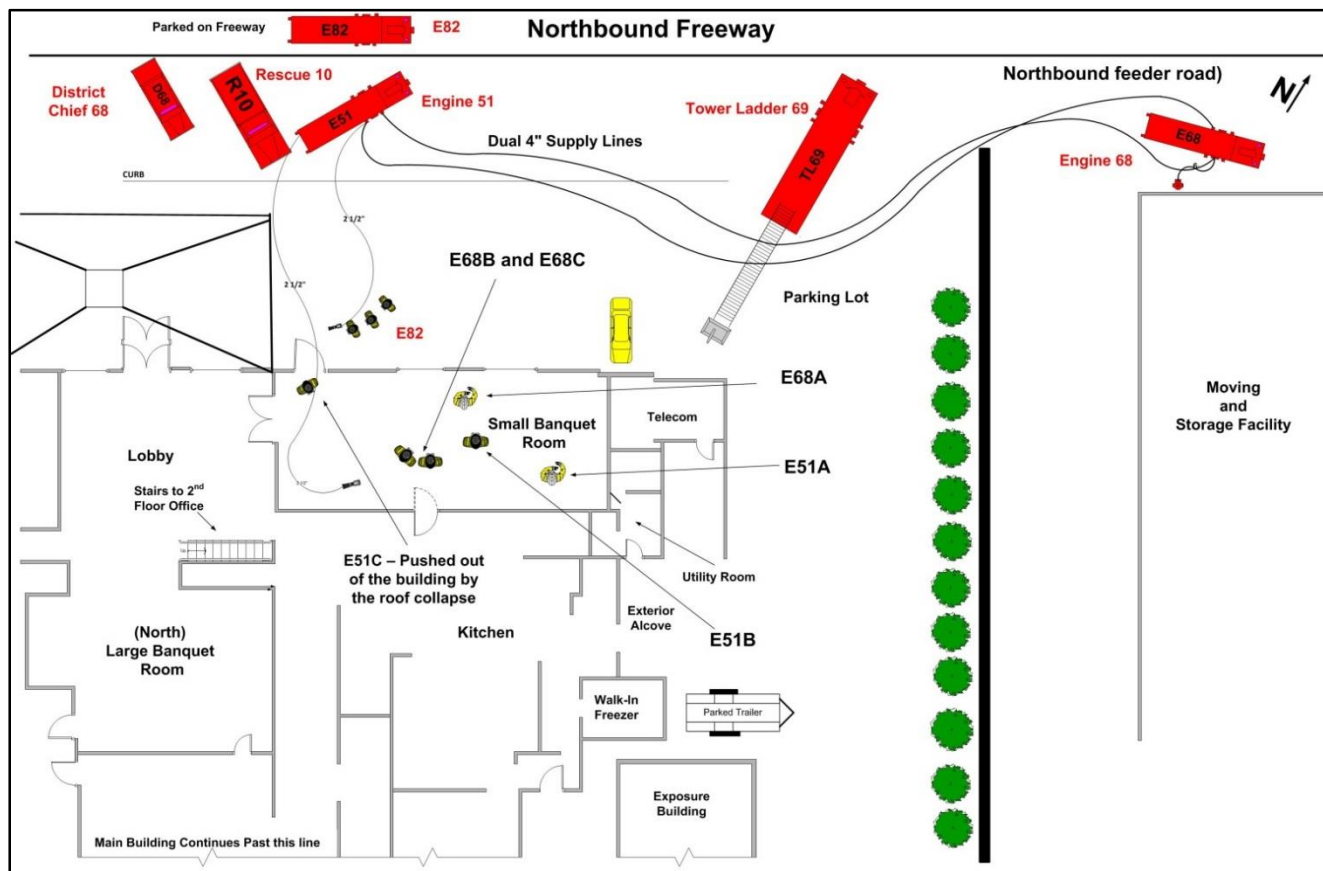
Diagram 13. The location of the officers and fire fighters of Engine 51 and Engine 68 when the roof collapse occurred in the Small Banquet Room and Kitchen area at 12:23:24 hours.

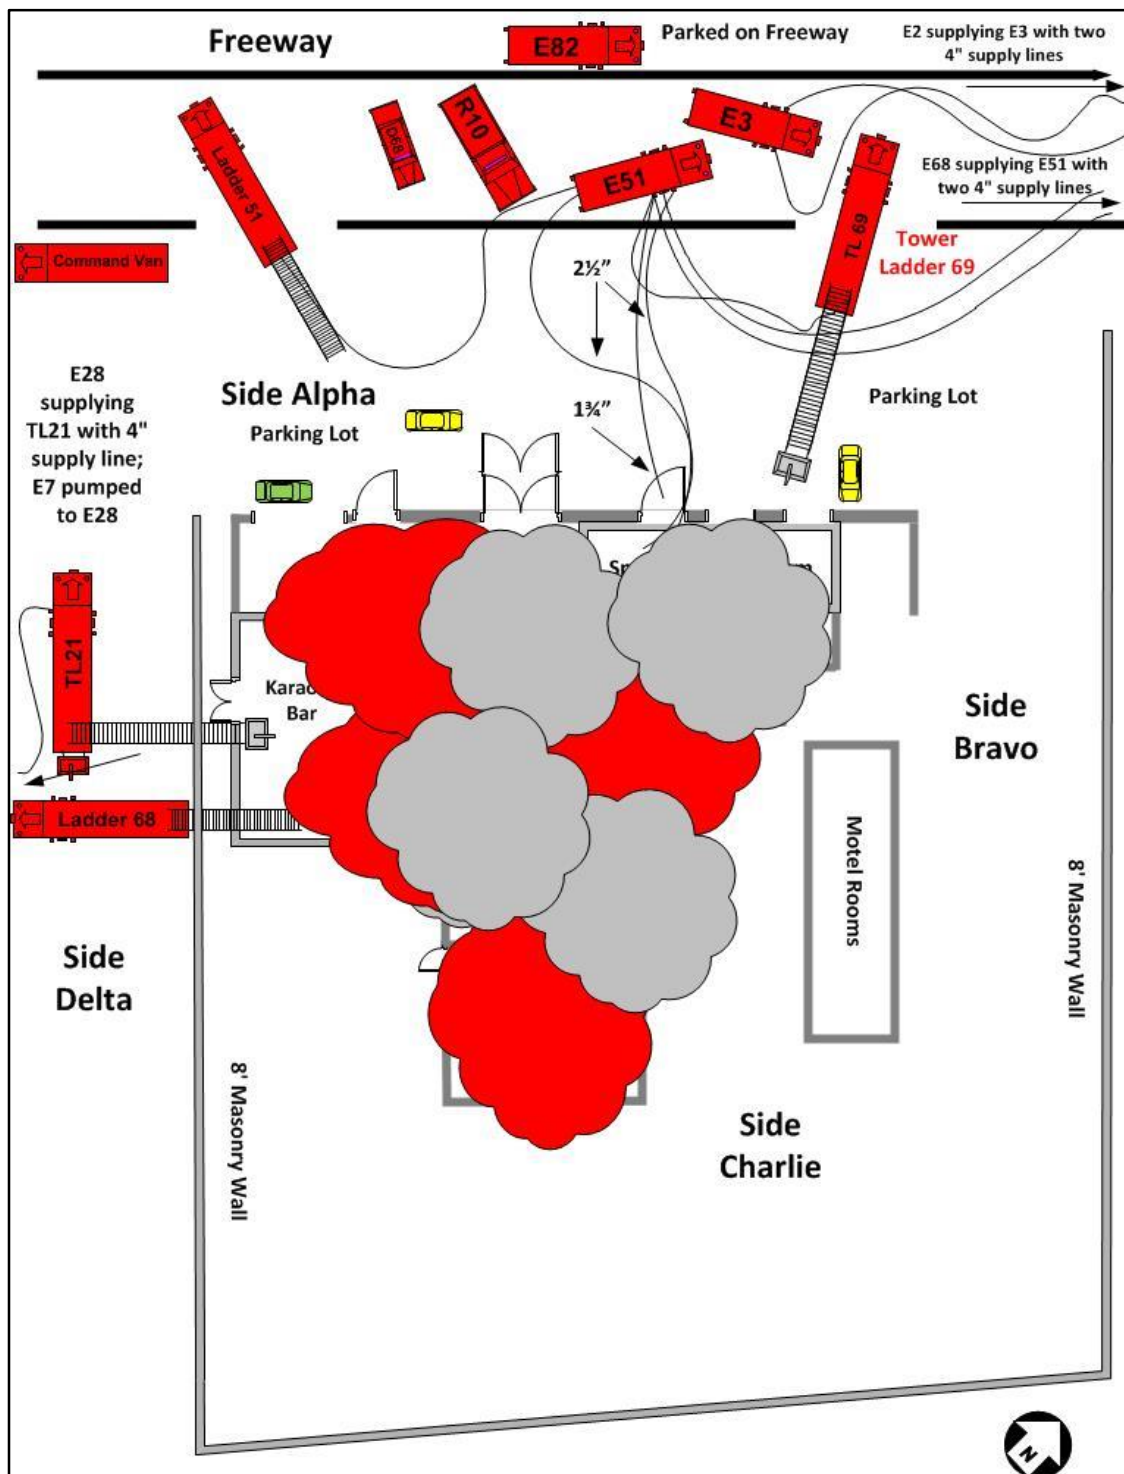
Diagram 15. The placement of apparatus and hoselines on Side Alpha and Side Delta. The hotel, banquet rooms, and sports bar are heavily involved with fire. The time is approximately 1400 hours.

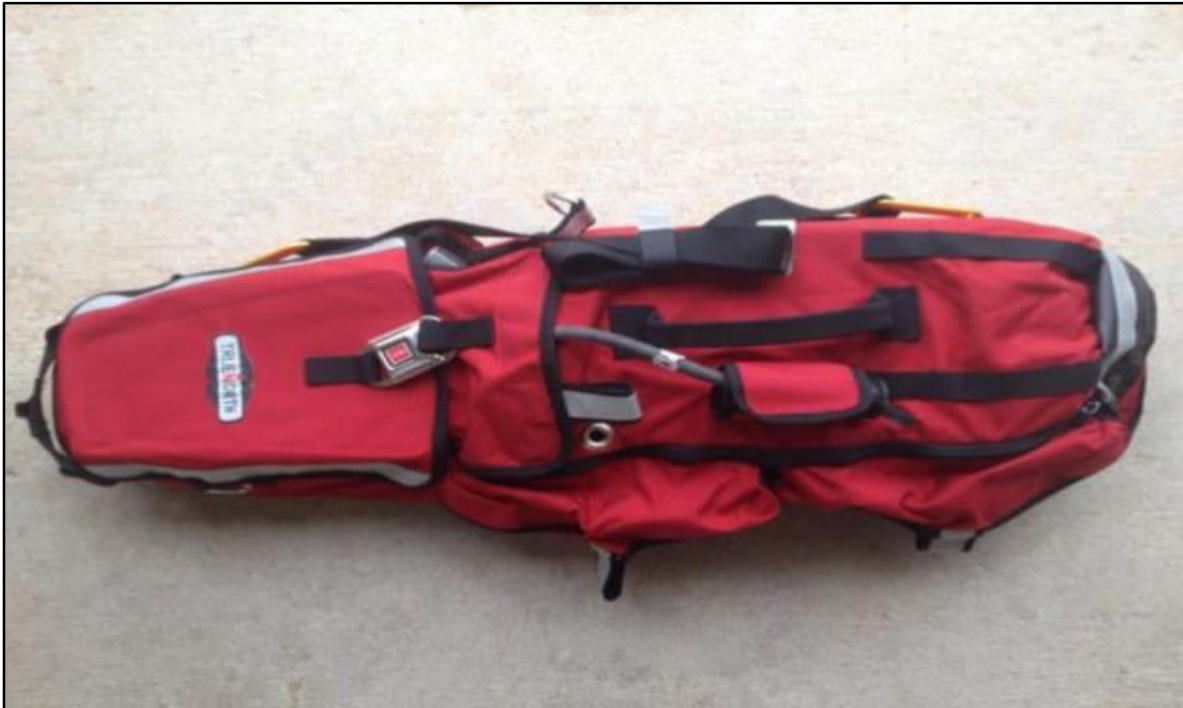
Photo 8. The RIT Pack that the department has redesigned based upon this incident.

- New RIT bags or packs were fitted with two air-lines, which can be stored separately and deployed independently or together based upon the needs of the situation.
- Removing miscellaneous tools from the RIT pack;
- A new style quick disconnect couplings were added;
- RIT masks were upgraded by the department’s Mask Service Unit for easier donning with gloved hands;
- All RIT bags were fitted with one hour air cylinders. (See Photo 8.)

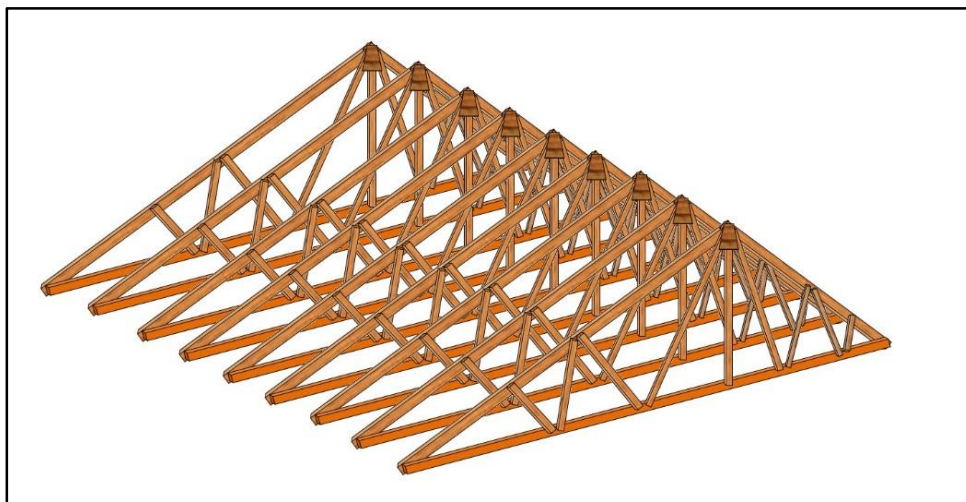
Diagram 17. Lap-Nailed Truss Assembly Configurations (Partial Detail)
(Diagram Courtesy of Buildingsonfire.com)

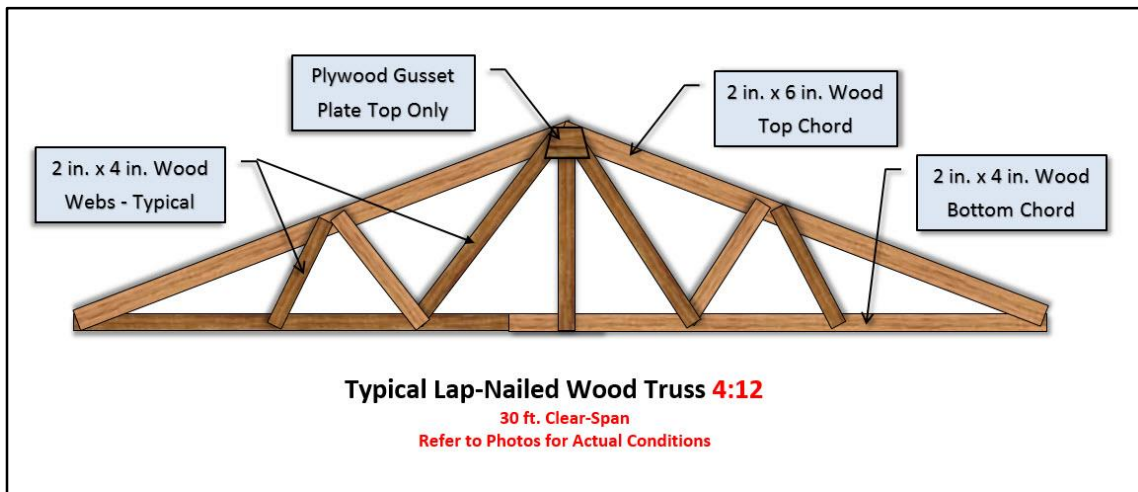
- [1] 2 in. x 4 in. Wood Web;
- [2] 2 in. x 4 in. Wood Web; *Note: See loss of remaining web material*
- [3] 2 in. x 4 in. Wood Bottom Chord;
- [4] 2 in. x 6 in. Wood Top Chord;
- [5] **Circle** depicts the typical surface connection point of the truss webs as they are mechanically fastened with nails to the cord, (absent is any MCP, which is typical of most fabricated truss assemblies of that period, and today).

Diagram 18. Truss Configuration
(Diagram Courtesy of Buildingsonfire.com)

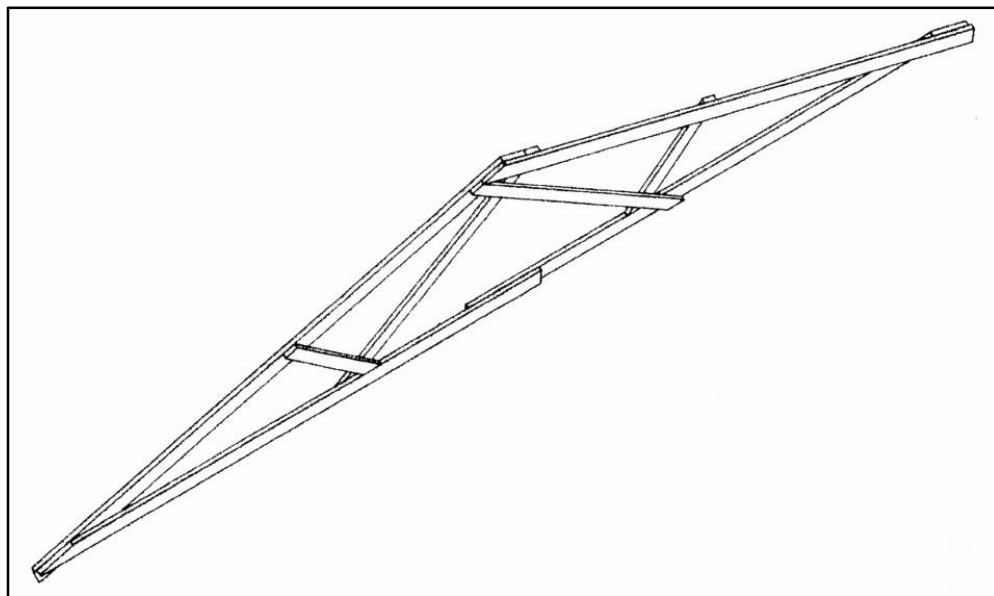
Diagram 19. Typical Lap-Nailed Truss
(Diagram Courtesy of Buildingsonfire.com)
[Adapted from USDA LSU AgCenter Diagram EX5923 circa 1961]

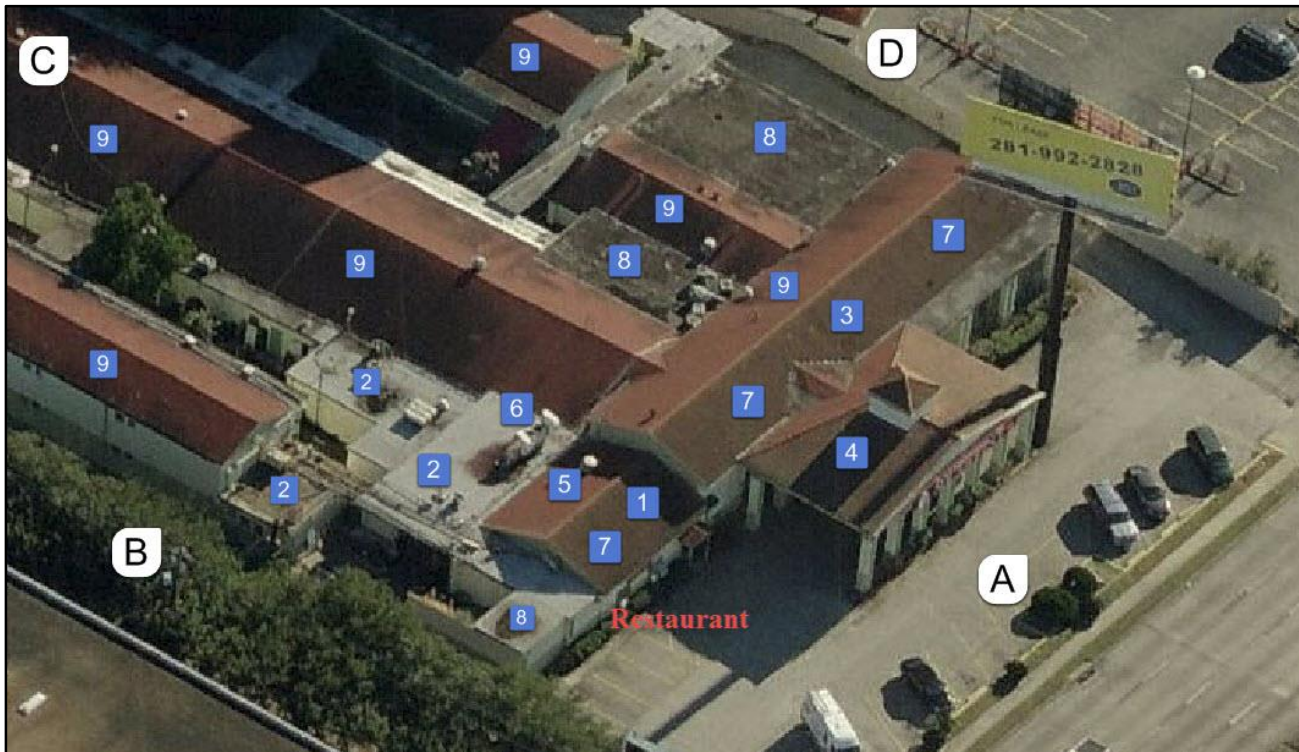
The gable roof profile of the restaurant and the main building can be seen from an aerial view which consists of extruded concrete interlocking roof tiles with shiplap as a roof covering fronting Division Alpha. (See Photo 11).

Photo 11. Pre-fire Aerial View of Building Complex (North-East Geographical/Division Alpha-Bravo)
(Bing.com Maps/ Diagram Courtesy of Buildingsonfire.com)

- [1] Restaurant Gable Roof
- [2] Kitchen Flat Roof
- [3] Main Entrance and Lobby Gable Roof
- [4] Main Portico Canopy Roof
- [5] Ventilation Fan Housing (assumed)
- [6] Roof-top mounted Mechanical Units & Ventilator/Fans (type unknown)
- [7] Extruded Concrete Interlocking Roof Tiles with shiplap as a roof covering
- [8] Flat Roof Areas
- [9] Gable Roofs
