# Evaluation of Exposures at a Pottery Shop

Health Hazard Evaluation Report
HETA 2007-0127-3068
FUNKe Fired Arts (formerly known as Annie's Mud Pie Shop)
Cincinnati, Ohio
August 2008

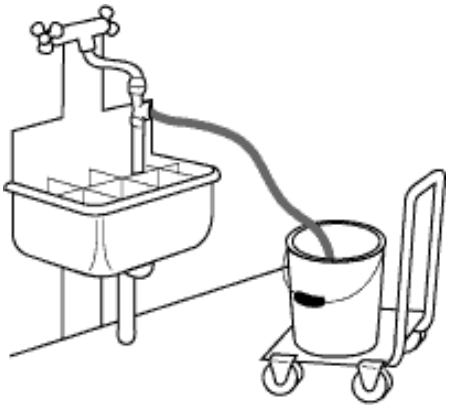
**Figure 8. Recommended hose extension**
[Canadian Centre for Occupational Health and Safety 1998]

- Eliminate lifting and carrying items weighing more than 50 pounds. Always use carts to transport heavy materials long distances.
- Provide a faucet hose extension (see Figure 8) to eliminate lifting buckets into and out of the sink.
