The Aviation Safety Reporting System is a cooperative program established by the Federal Aviation Administration's Office of the Assistant Administrator for System Safety, and administered by NASA

A Review of Altimeter-Setting Incidents Reported to ASRS
...Page 4

An Introduction to Issue Number 9

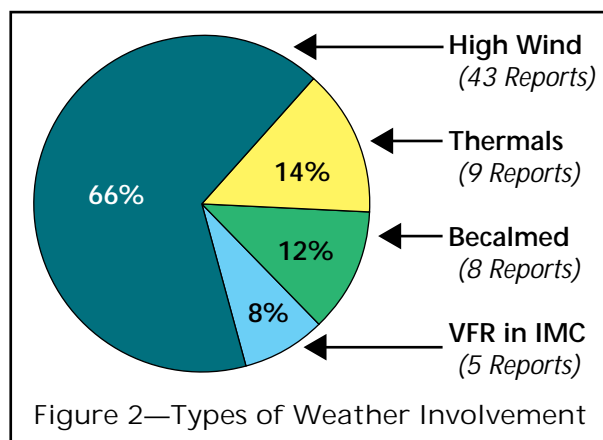
As may be seen in Figure 2 below, forty-three of the weather-involved reporters (66 %) listed unforecast increasing winds as their problem. Nine reports attributed their difficulties to thermals, or other downdrafts, forcing the balloon into the ground. An additional eight reports listed becoming becalmed as the source of their dilemma—not enough wind can be almost as hazardous as too much. One aeronaut became becalmed over trees at sunset, and pulled himself to a clearing by using the treetops. Finally, five reports were received from pilots who found themselves VFR in IMC due to fog or fast-forming clouds underneath.
