Power Systems Development Facility
Technical Progress Report
Gasification Test Run TC07

December 11, 2001 -
April 5, 2002

DOE Cooperative Agreement Number
DE-FC21-90MC25140

GASIFICATION TEST RUN TC07

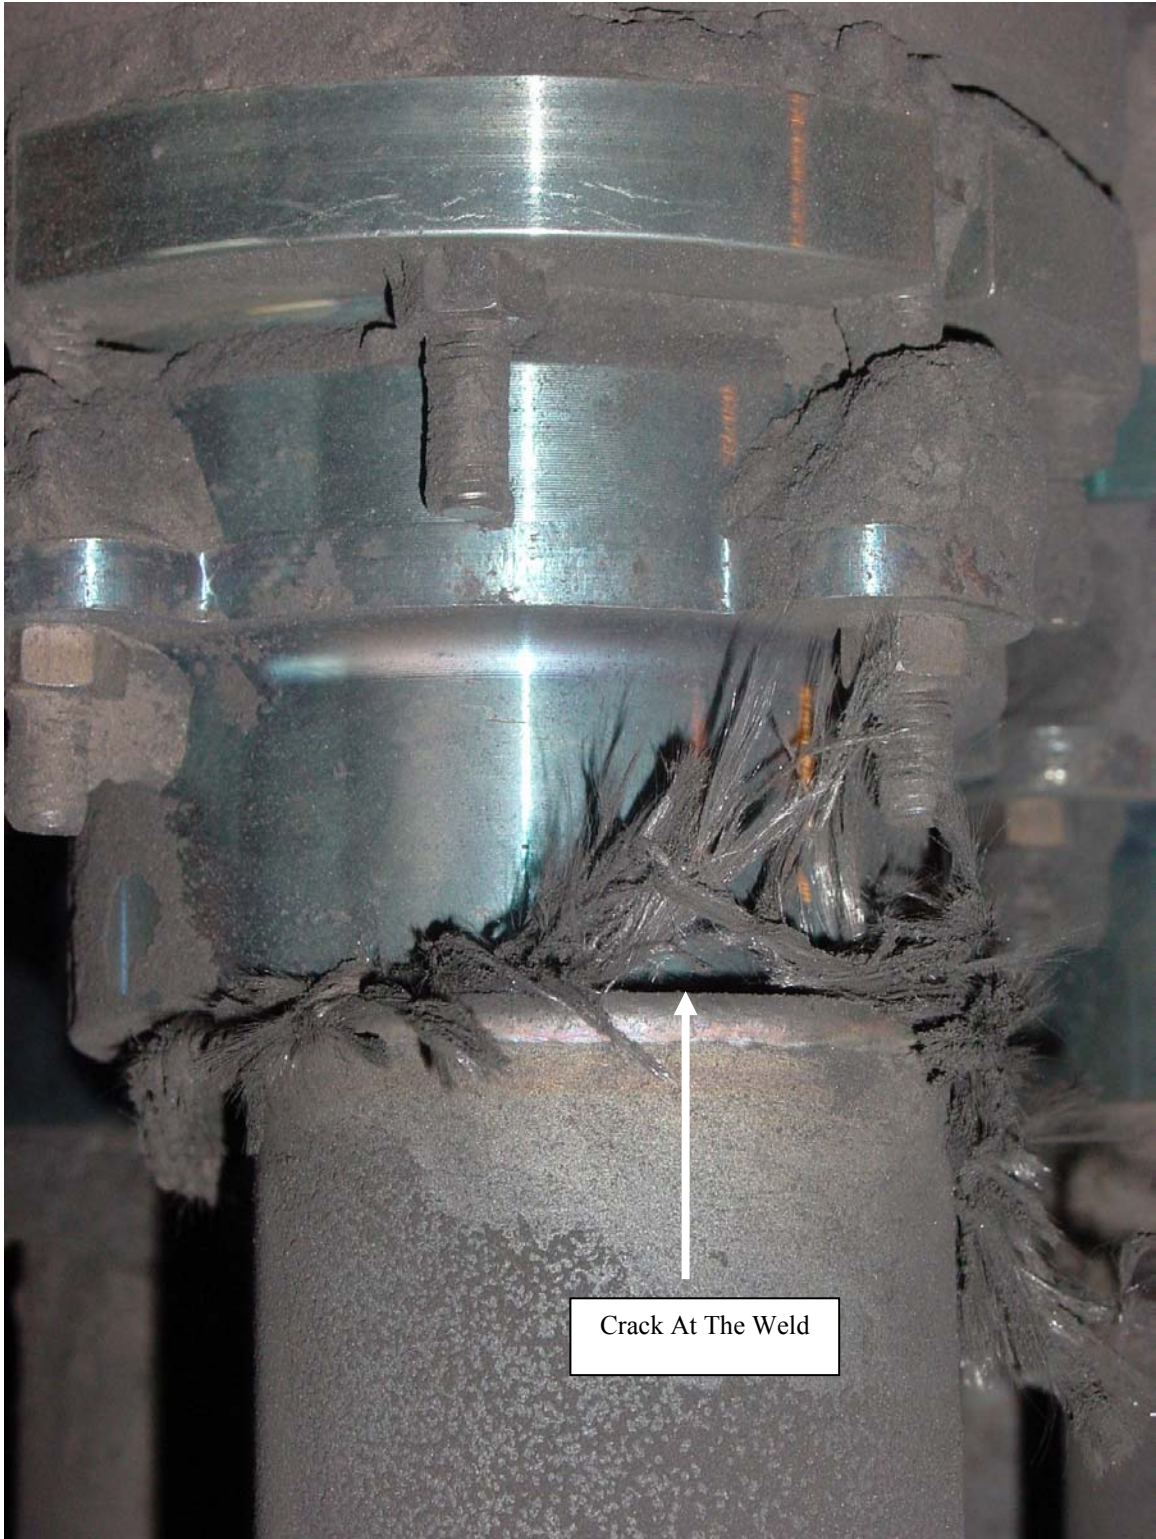
Crack At The Weld

Figure 3.3-1   Failed Filter Element After TC07C (B-12)

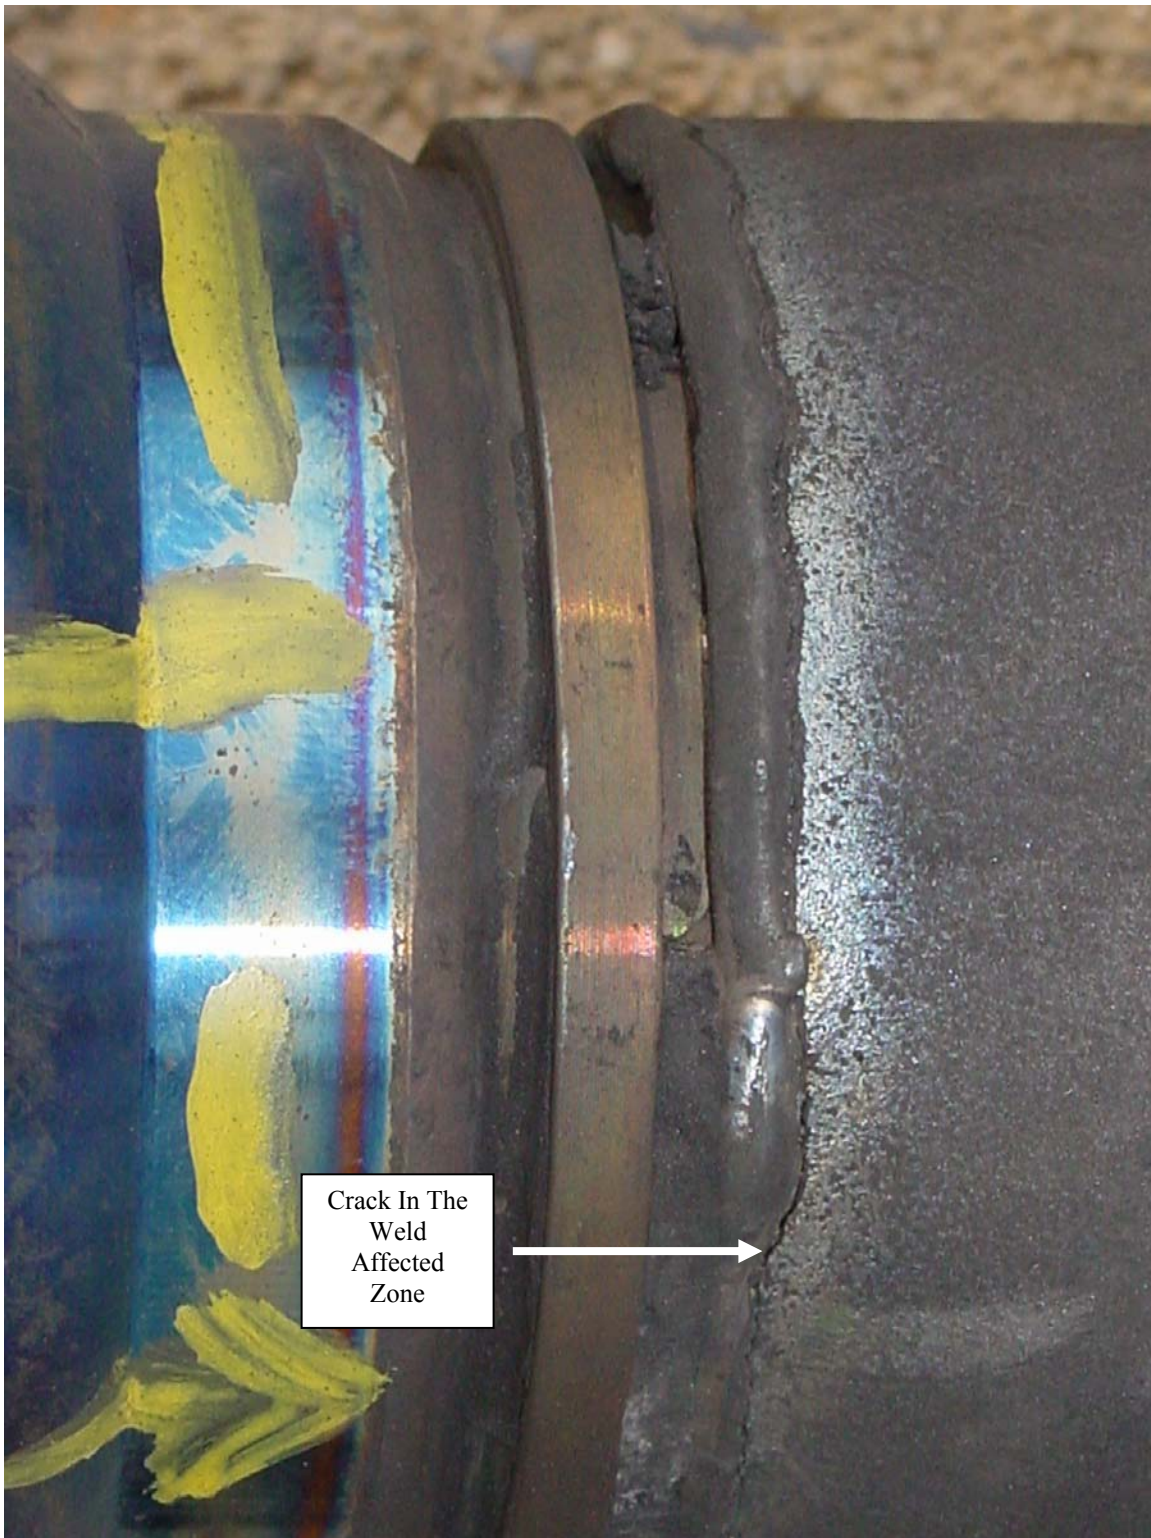
Crack In The Weld Affected Zone

Figure 3.3-2   Failed Filter Element After TC07C (B-14)

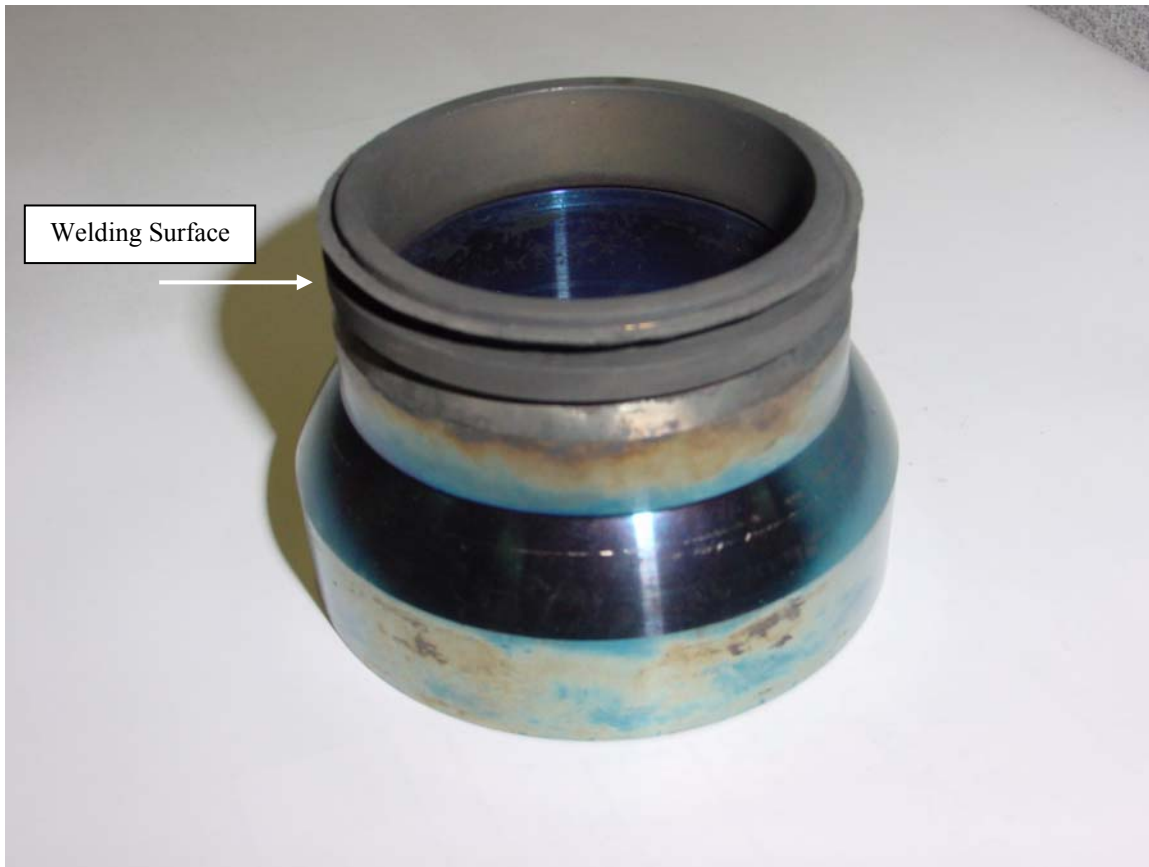
Welding Surface

Figure 3.3-3   B-12 Filter Flange After TC07C

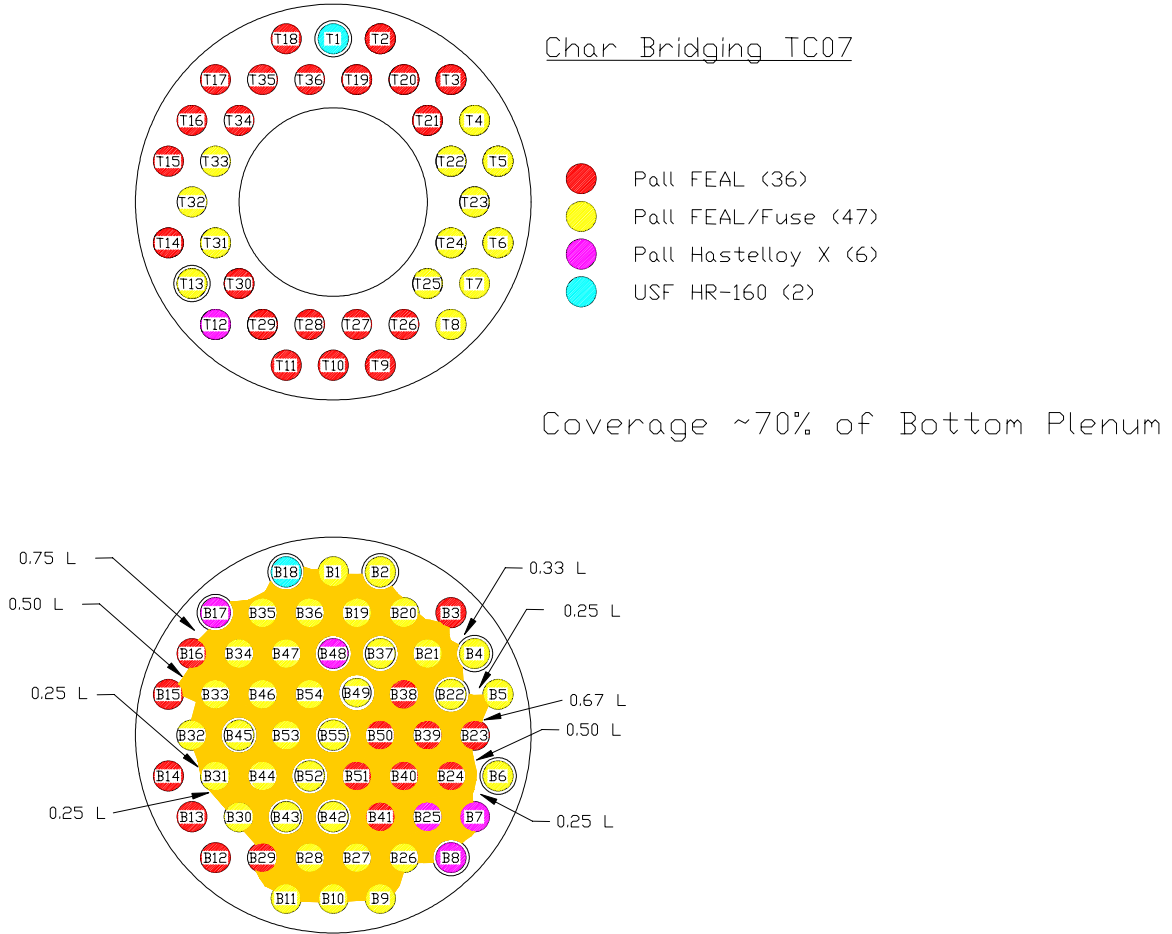
Coverage ~70% of Bottom Plenum

Figure 3.3-5   Location of G-ash Bridging After TC07C

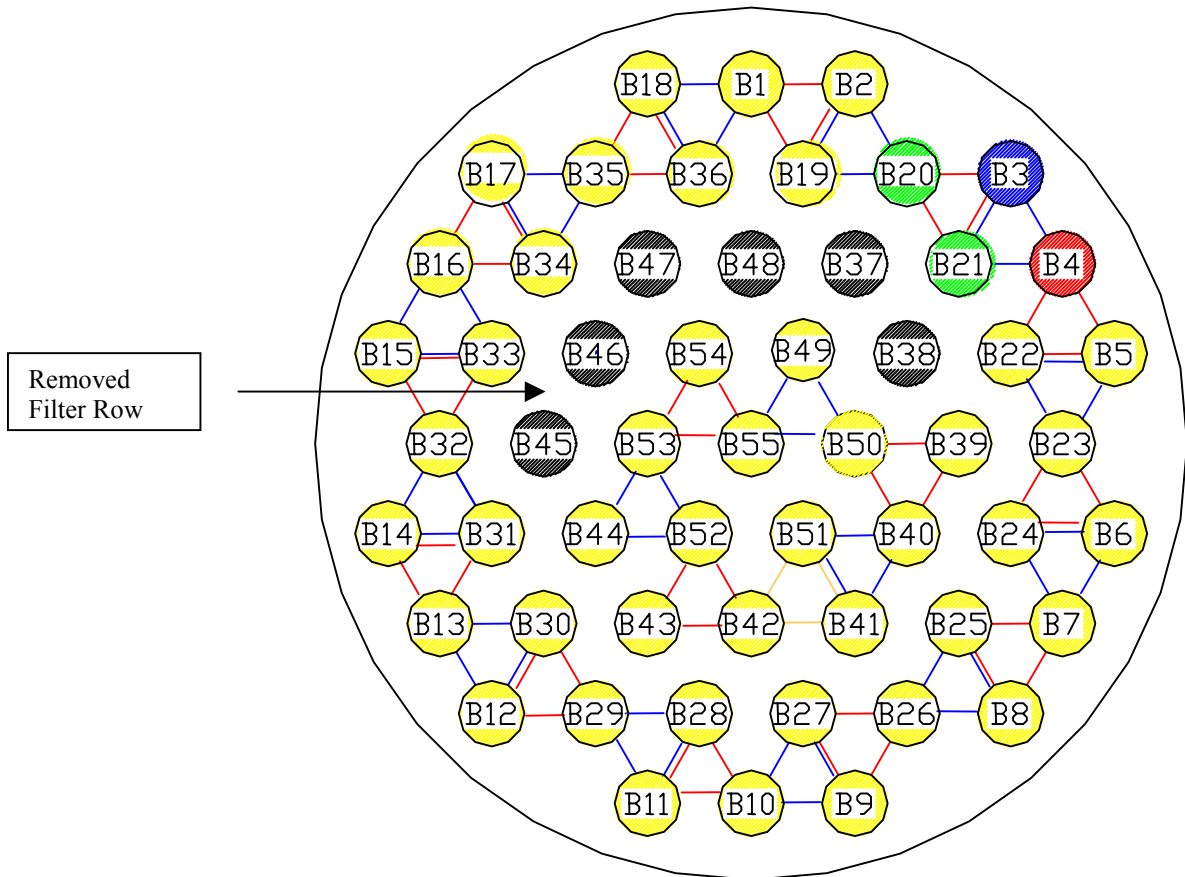
Removed
Filter Row

Figure 3.3-6   Location of Removed Filter Row Before TC07D

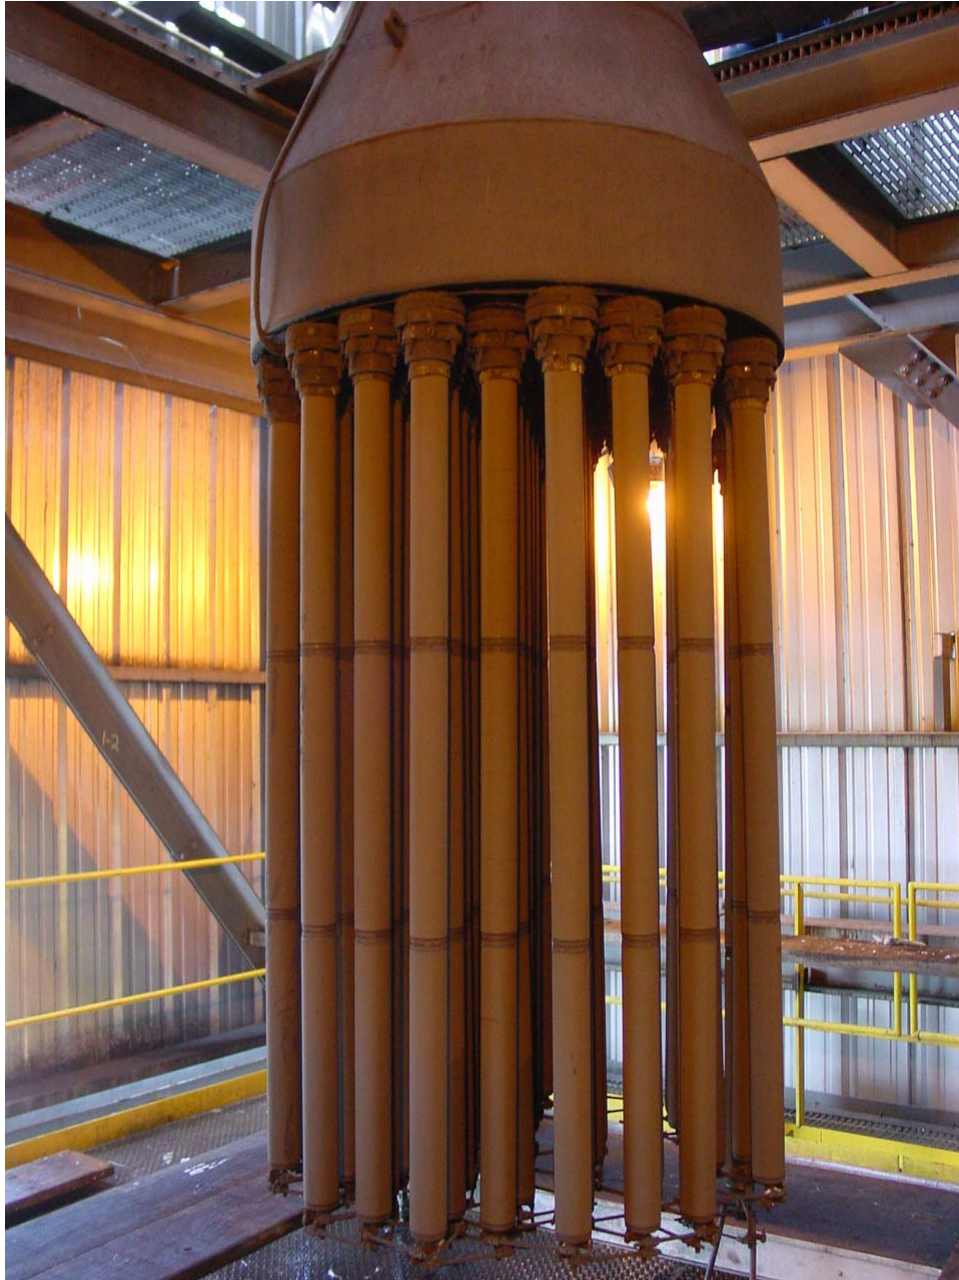
Figure 3.3-12   PCD Lower Plenum After TC07D
