Technical Progress Report
Power Systems Development Facility

Kellogg Brown & Root
Transport Reactor Train and
Siemens Westinghouse
Particulate Control Device

GCT1: September 9 - December 15, 1999

DOE Cooperative Agreement Number
DE-FC21-90MC25140

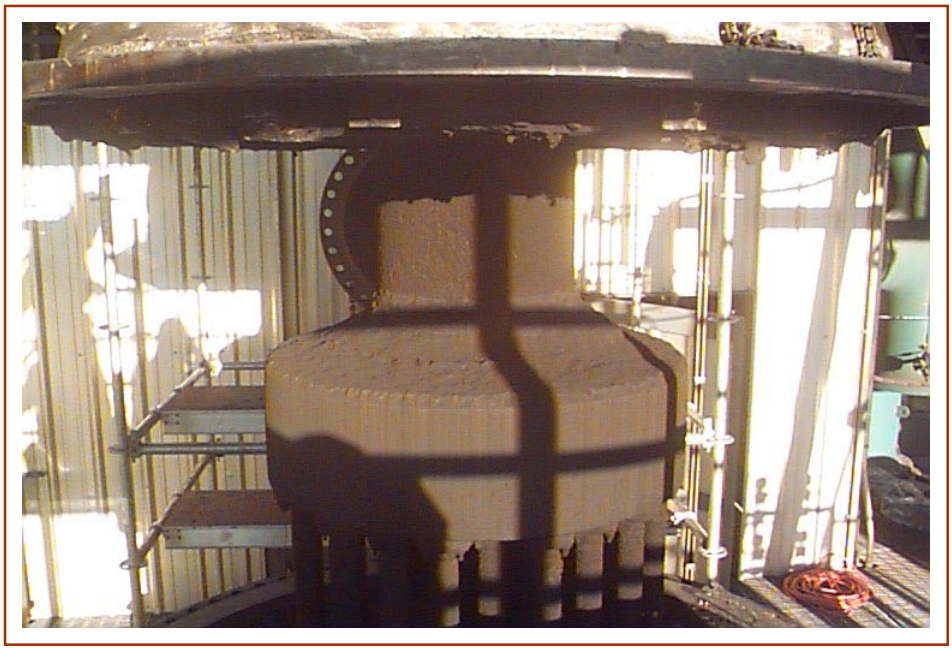
Figure 3.3-4 Char on Top Plenum (GCT1A)

No char bridging was found and the char cake on the elements was generally thin—approximately 0.03 to 0.10 in. In some areas the cake was too thin to obtain meaningful thickness measurements. The char cake was the thickest on the Fairey microfiltrex metal elements. The outer screens on these elements appeared to be "plugged" with char. It was suspected that the char packed into the screens and caused the back-pulse cleaning to be less effective. There were slight char deposits on the filter holder flanges. The shroud and liner sections were generally clean (see Figure 3.3-3) and there was a shallow pile of char on the top plenum (see Figure 3.3-4).

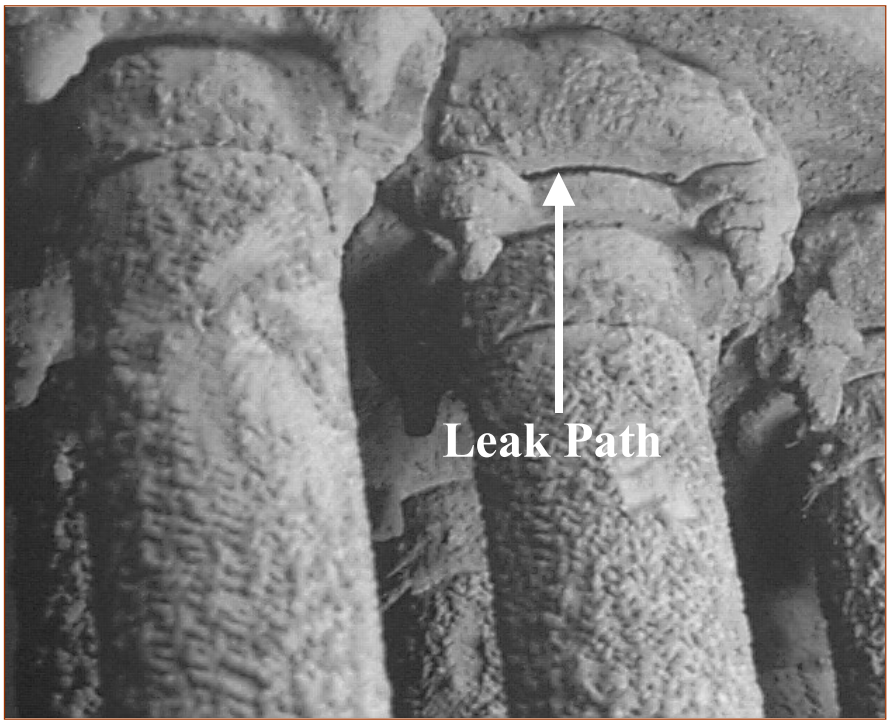
Figure 3.3-5 Potential Leak Paths Around Filter Nut Flanges

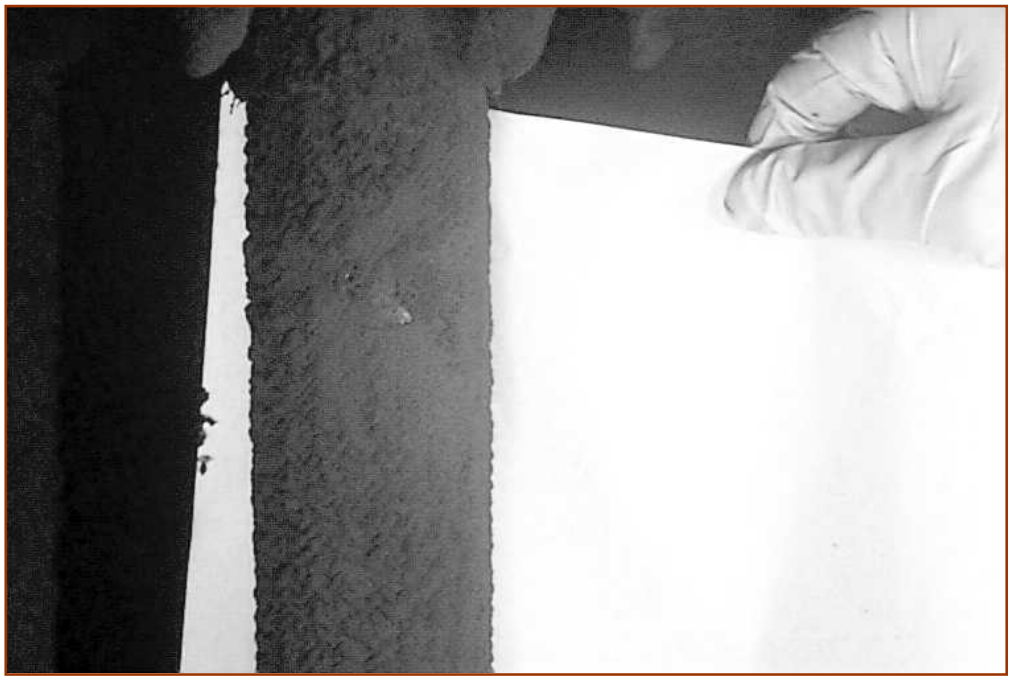
Figure 3.3-6 Potential Leak Paths on 3M Oxide Composite Filter Element (T14)

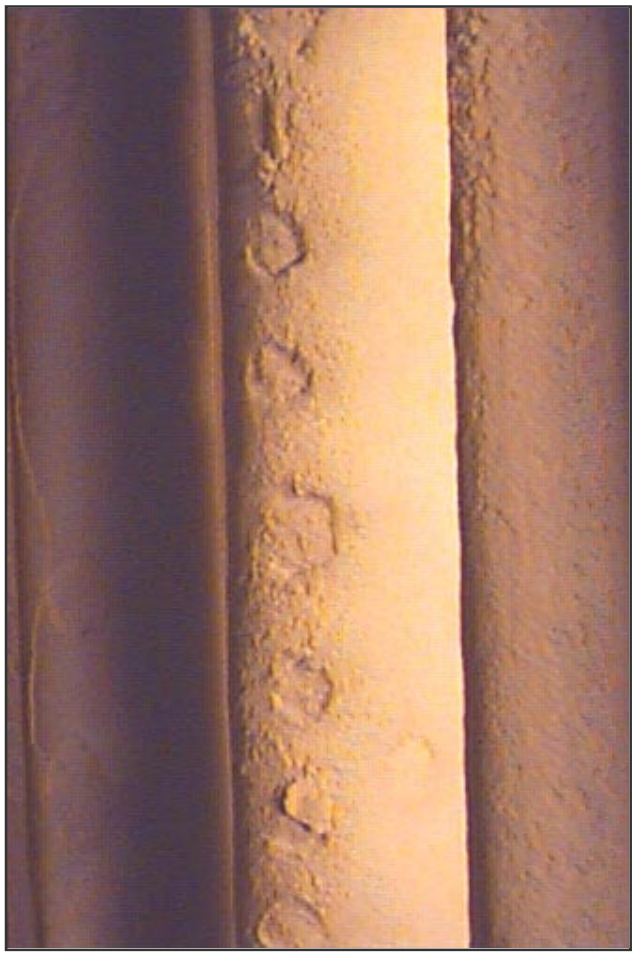
Figure 3.3-7 Membrane Spalling on Honeywell PRD-66 Composite Element (T16)

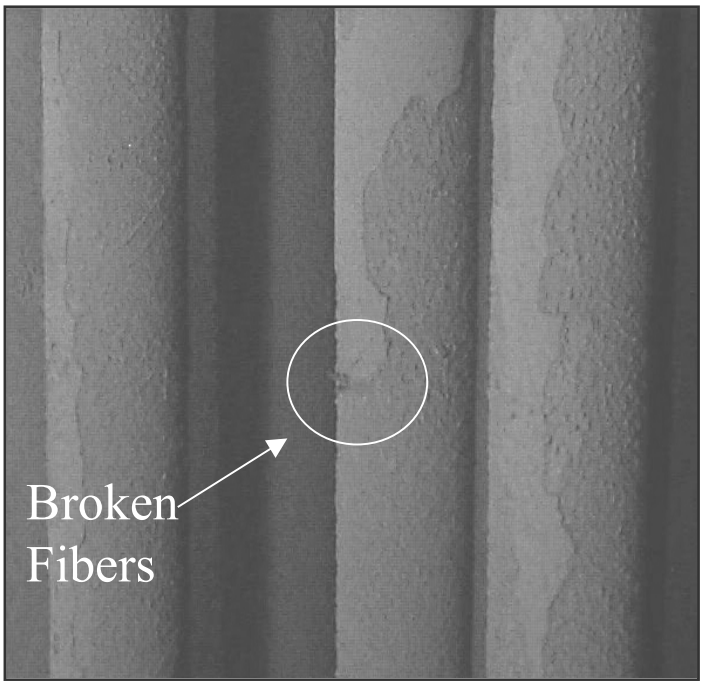
Figure 3.3-9 Broken Fibers on McDermott Composite Filter Element (T26)

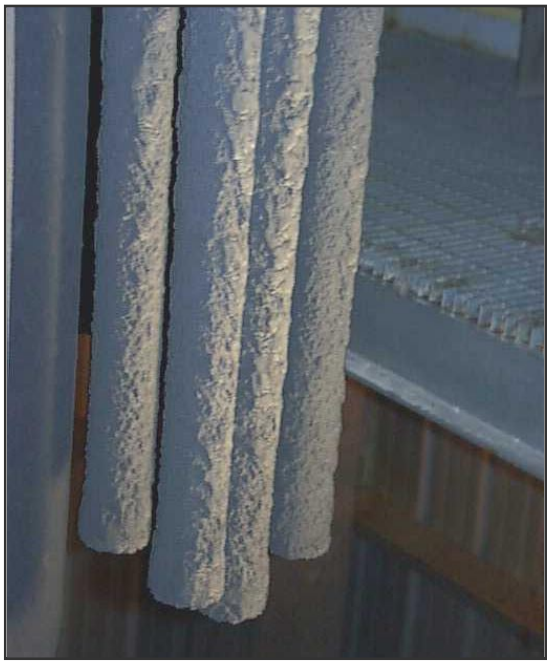
Figure 3.3-17 Top Plenum Filter Element Char Cake (GCT1B Through D)

No char bridging was found. The char cake on the filter elements was relatively thin.

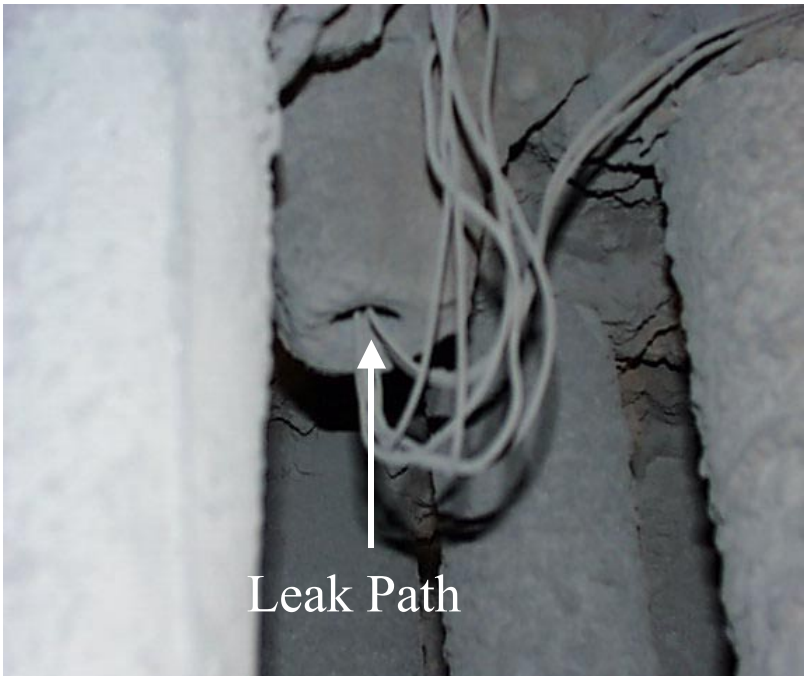
Figure 3.3-23 Potential Leak Paths on Conax Fittings

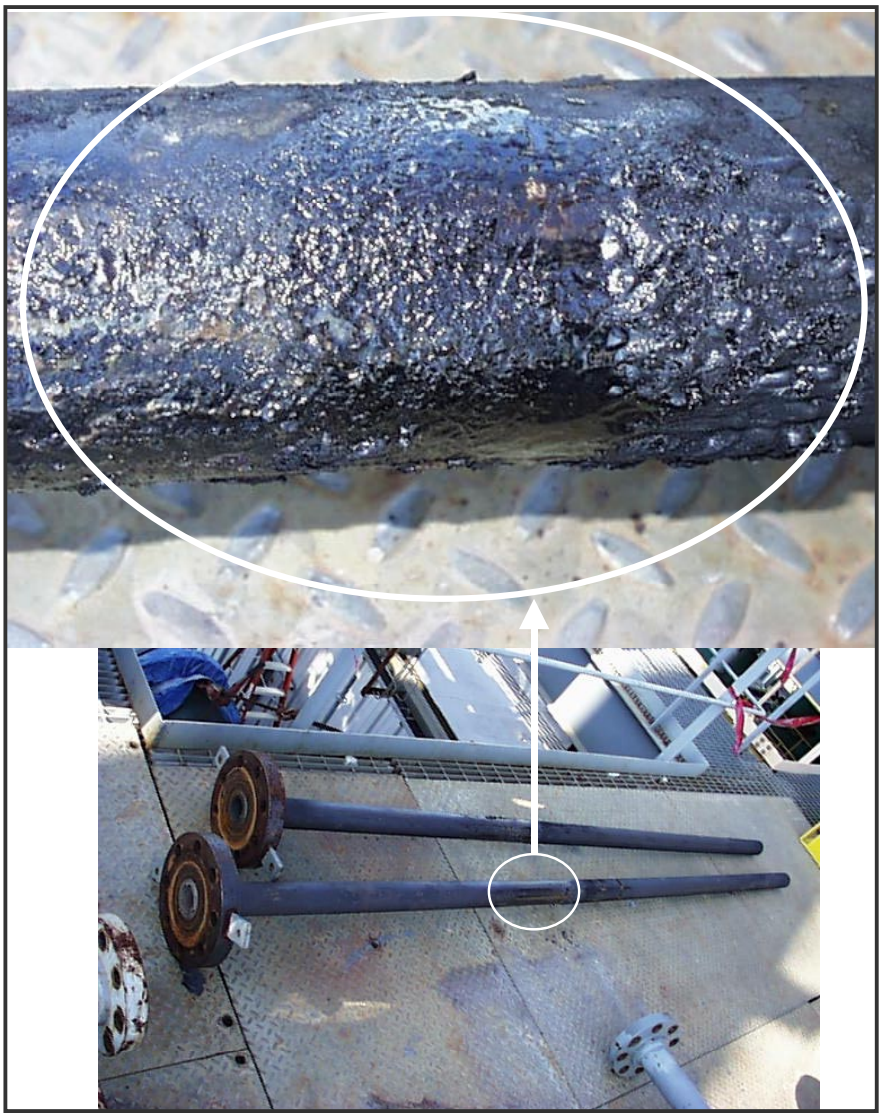
Figure 3.3-24 Tar Accumulation on Back-Pulse Pipes (GCT1B Through D)

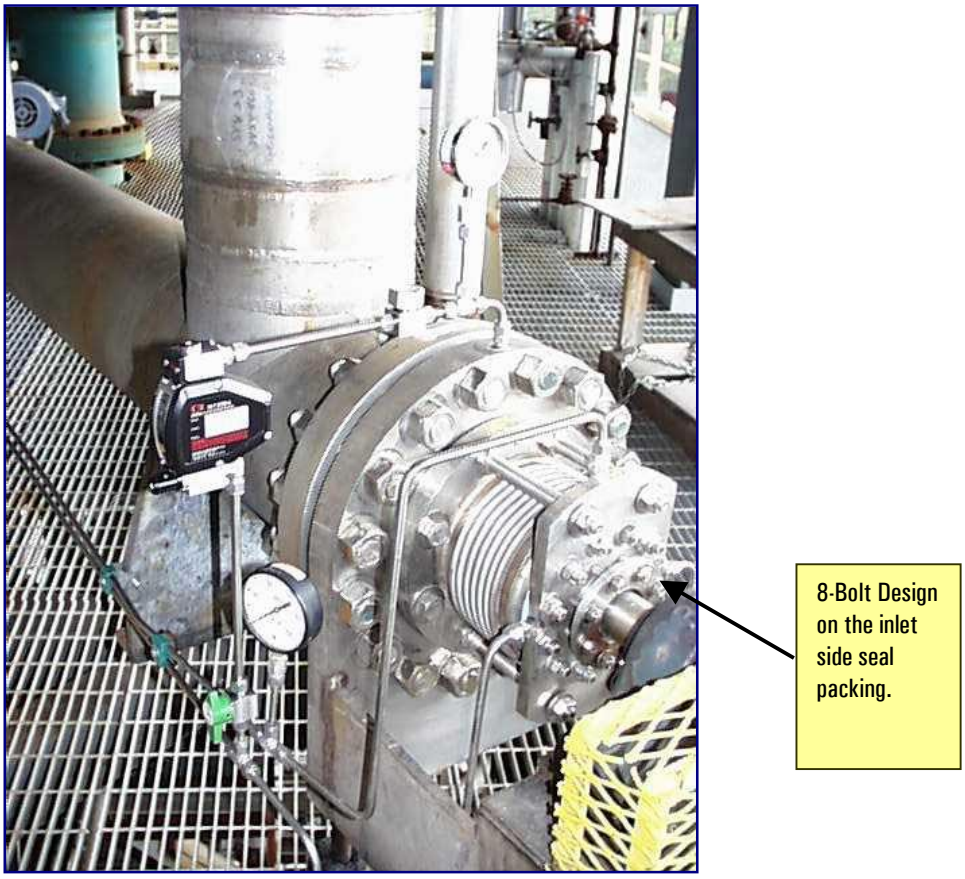
Figure 3.5-4 Inlet-Side Seal Packing Follower (Eight-Bolt)

After the GCT1A run it was decided to replace the four-bolt (see Figure 3.5-3) drive-side seal-packing follower with a new eight-bolt design as shown in Figure 3.5-8. The new design significantly reduced leakage by applying uniform compression on the seal packing and placing less stress on a single bolt, which allowed more room for adjustments.

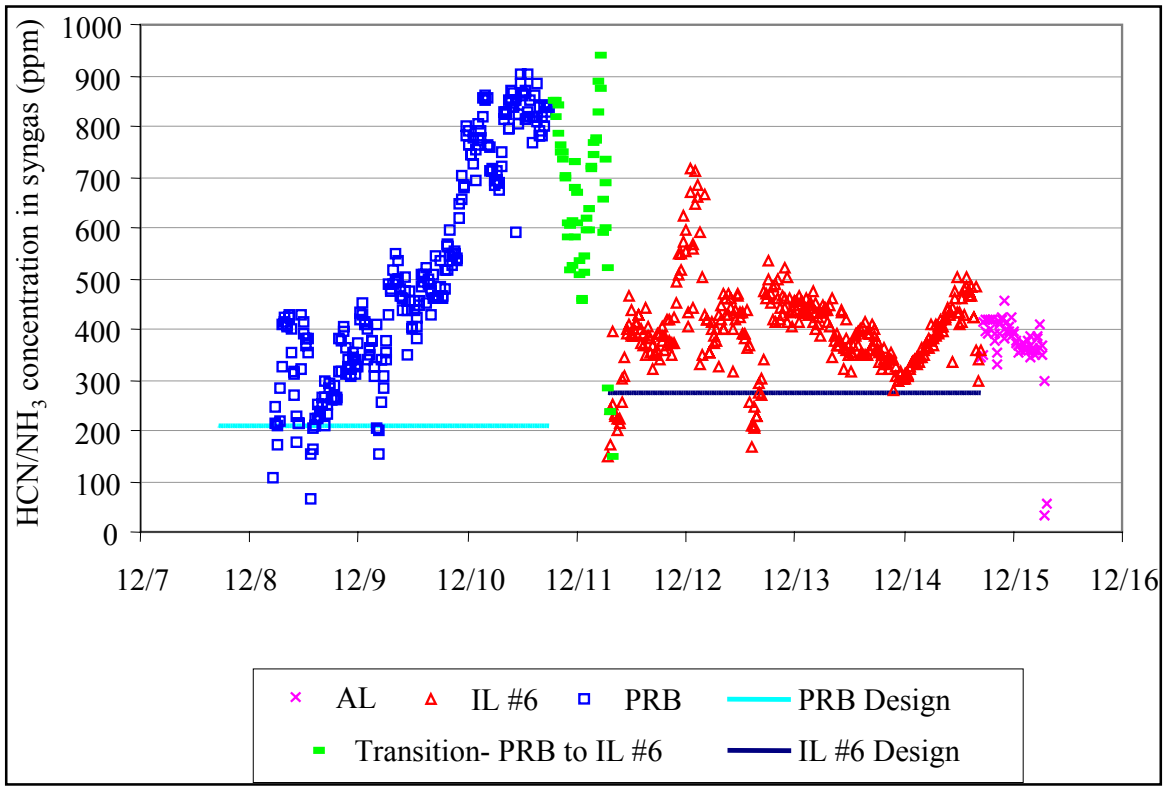
Figure 4.6-1 HCN/NH3 Concentration Versus Time

Figure 4.6-1 shows the combined HCN and NH_3 concentration versus time. During the first day of operation with the Powder River Basin coal the concentrations of HCN and NH_3 were close to design at 300 ppm. However, HCN and NH_3 concentrations increased to 900 ppm before transitioning to Illinois No. 6 coal. With Illinois No. 6 bituminous coal the concentrations of HCN and NH_3 varied from 300 to 500 ppm, which was slightly higher than design. The HCN and NH_3 concentrations with the Alabama coal averaged around 400 ppm. Multiple plots were created to correlate the HCN/NH_3 concentrations with other reactor parameters. The best correlation was achieved by comparing the HCN/NH_3 concentrations to the CO concentration in the syngas (see Figure 4.6-2). The plot shows an almost linear relationship between the HCN/NH_3 and CO concentrations.

During future test runs gas bomb samples will be analyzed to evaluate the actual HCN and NH_3 concentrations in the syngas stream.

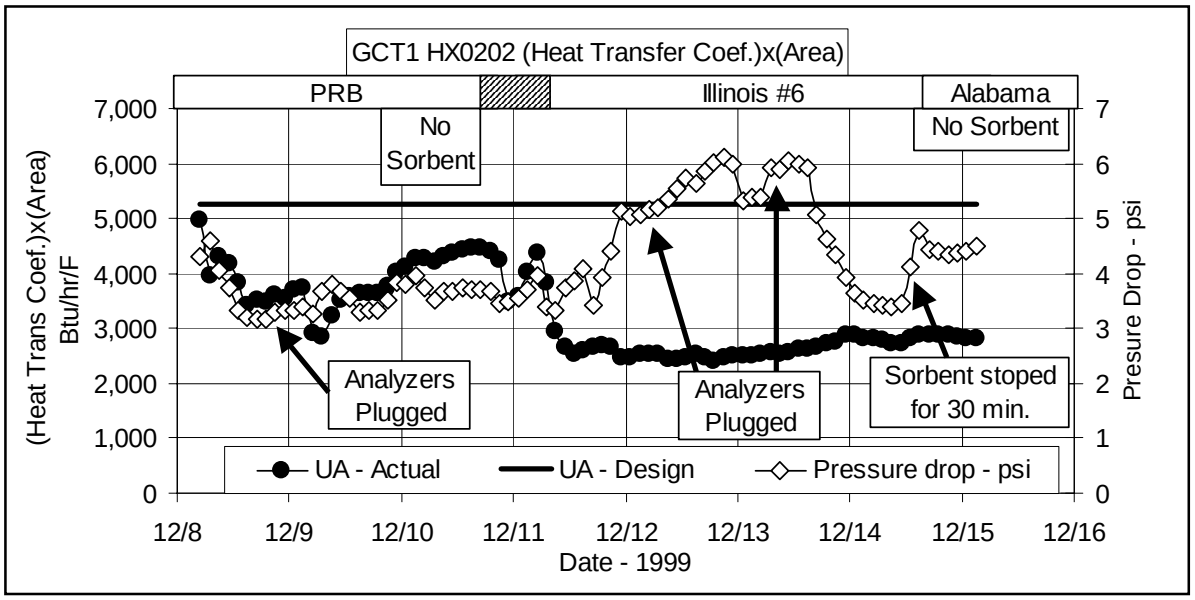
Figure 4.7-1 GCT1 HX0202 Heat-Transfer Coefficient - Area and Pressure Drop

Using equations (1), (2), and (3) and the process data the product of the heat transfer coefficient and the heat exchanger area (UA) can be calculated. The UA for GCT1B through D is shown in Figure 4.7-1 as hourly averages along with the design UA and the pressure drop across HX0202. If HX0202 is plugging the UA should decrease and the pressure drop should increase. The UA deterioration is a better indication of heat exchanger plugging because the pressure drop is calculated by the difference of two numbers of about the same size (usually from 160 to 220 psig) resulting in pressure drops of 0.5 to 6 psig.

The UA decreased during the first day of Powder River Basin (PRB) coal testing from nearly the design value of 5,200 Btu/hr/°F to 3,500 Btu/hr/°F. The pressure drop followed this trend from 4.5 psi down to 3.5 psi, likely due to unsteady-state operation at the start of the test run. The gas analyzer system plugged with tar at 21:00 December 8. This tar formation appeared to cause some plugging of HX0202 at 05:00 December 9 as UA decreased and the pressure drop increased. This condition corrected itself by 13:00 December 9 and the heat exchanger performance improved for the rest of December 9. For the last day of PRB coal testing UA increased from 3,700 to 4,500 Btu/hr/°F and the pressure drop leveled out at 3.7 psi.

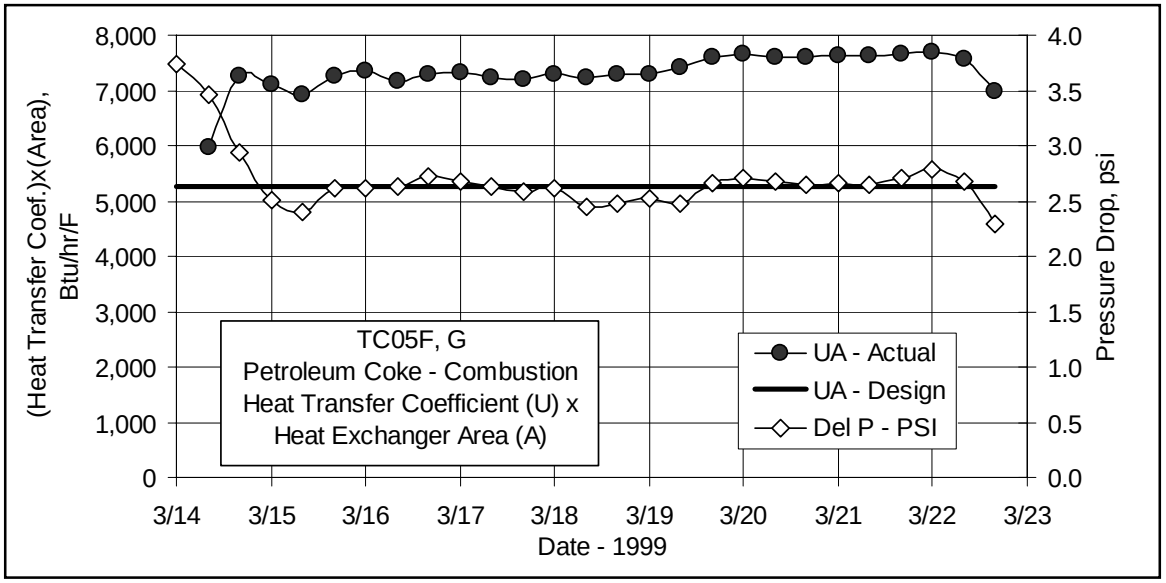
Figure 4.7-2 TC05F/G HX0202 Heat-Transfer Coefficient - Area and Pressure Drop

HX0202 data from two other periods are included for comparison with the GCT1B through D data. Figure 4.7-2 shows the plot of the HX0202 UA and pressure drop combustion for tests TC05F and G when the transport reactor was in combustion mode firing petroleum coke. This was the only time during TC05 that the full flow from the transport reactor was sent to HX0202. Other TC05 testing was operated either at total or partial heat exchanger bypass. The UA was at

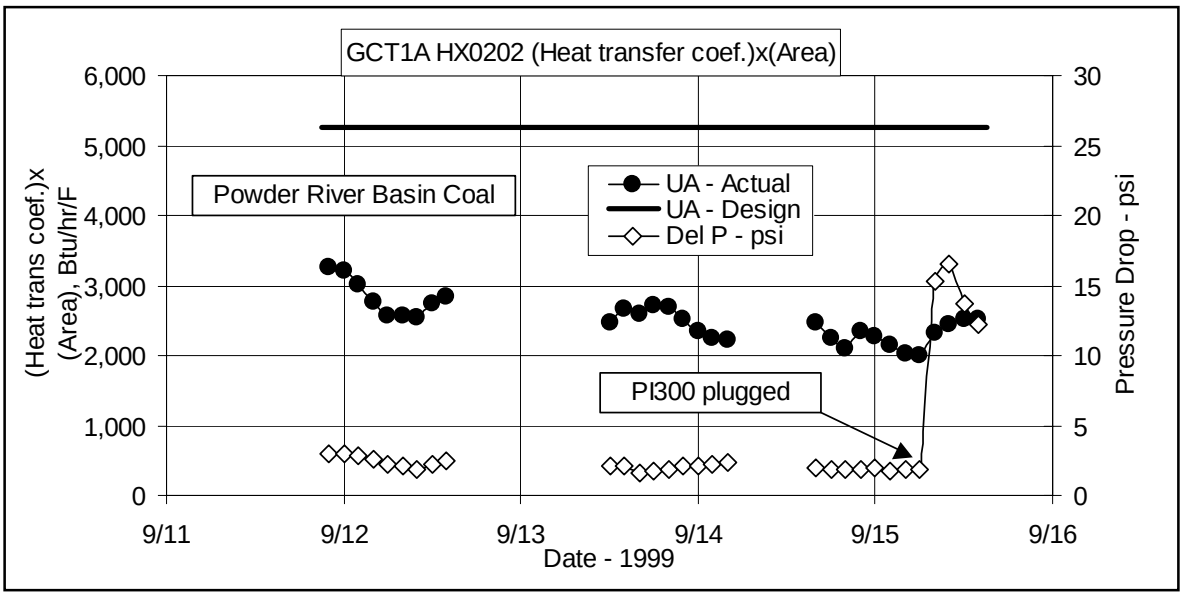
Figure 4.7-3 HX0202 GCT1A Heat-Transfer Coefficient - Area and Pressure Drop

Figure 4.7-3 shows the plot of the HX0202 UA and pressure drop for the gasification run GCT1A. The heat transfer coefficient was less than design values, generally decreasing during the entire run, which indicates some plugging. The pressure drop was fairly constant during the first two periods of operation at 1 to 2 psi. The third-period pressure drop was very constant but then suddenly increased from 2 to 15 psi and then started decreasing to 12 psi at the end of the run. The higher pressure drop was caused by the downstream PI (PI300) plugging (and reading low). PI300 decreased while the system pressure increased and seemed to lose the response to the PCD back pulsing. The PI downstream of PI300 (PI301) did not indicate the pressure decrease/pressure drop increase that PI300 indicated. This higher pressure drop on September 15 is a false reading and is not an indication of HX0202 plugging. Note the UA slightly increased during the apparent pressure drop increase.

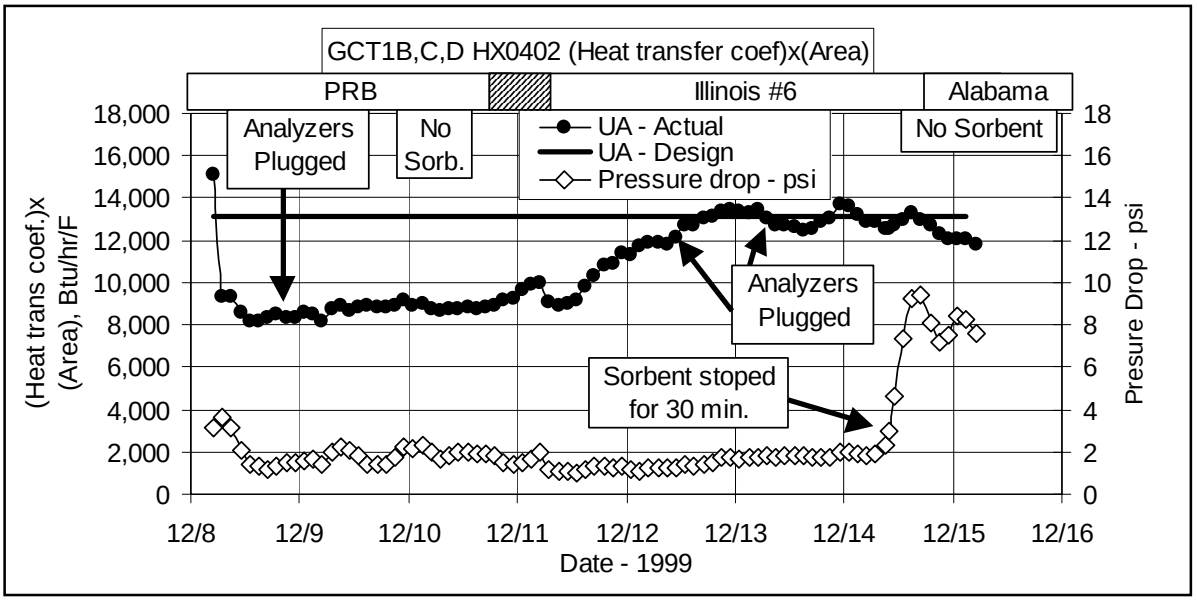
Figure 4.7-4 HX0402 GCT1B Through D Heat-Transfer Coefficient - Area and Pressure Drop

Using equations (1), (2), and (3) and the process data, the product of the heat-transfer coefficient and the heat exchanger area (UA) can be calculated. The UA for the GCT1B through D testing is shown in Figure 4.7-4 as hourly averages along with the design UA and the pressure drop across HX0402. If HX0402 is plugging the UA should decrease and the pressure drop should increase. The UA was steady during the PRB coal testing, slightly increasing from 8,000 to 9,000 Btu/hr/°F (design 13,100 Btu/hr/°F). The HX0402 pressure drop was also very constant at around 2 psi.

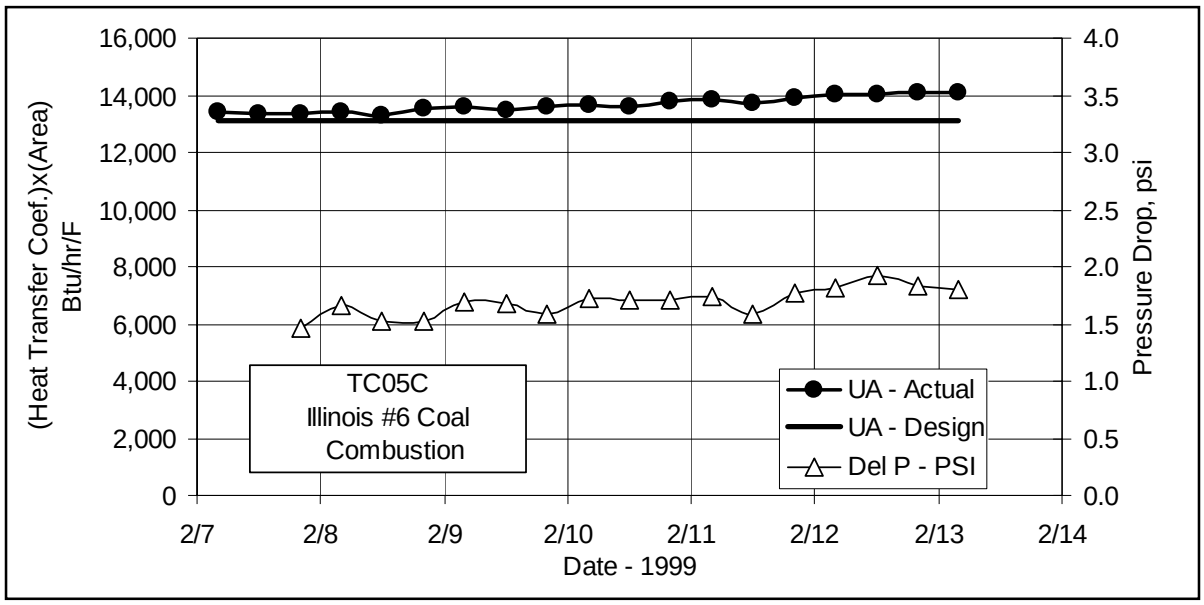
Figure 4.7-5 HX0402 TC05C Heat-Transfer Coefficient - Area and Pressure Drop

HX0402 data from two other periods are included for comparison with the GCT1B through D data. Figure 4.7-5 shows the plot of the HX0402 UA for test TC05C when the transport reactor was in combustion mode firing Illinois No. 6 coal. The heat-transfer coefficient was at the design values and the pressure drop was at about 1.75 psi and slowly rising during the run. Figure 4.7-6 shows the plot of the data for the GCT1A gasification run. A small amount of solid tar was found at the bottom of HX0402 at the end of GCT1A. The heat-transfer coefficient was less than design values, generally decreasing during each testing period, which indicates some potential for plugging. Each period was really too brief to permit HX0402 to reach the design heat-transfer coefficient. The pressure drop was fairly constant during the first two periods of operation at 1 to 2 psi, and then increased for the third period of operation. At the end of each period the pressure drop was slightly increasing. The last 10 hours of operation on September 15 seemed to show some heat exchanger plugging as shown by the increase in heat-exchanger pressure drop.

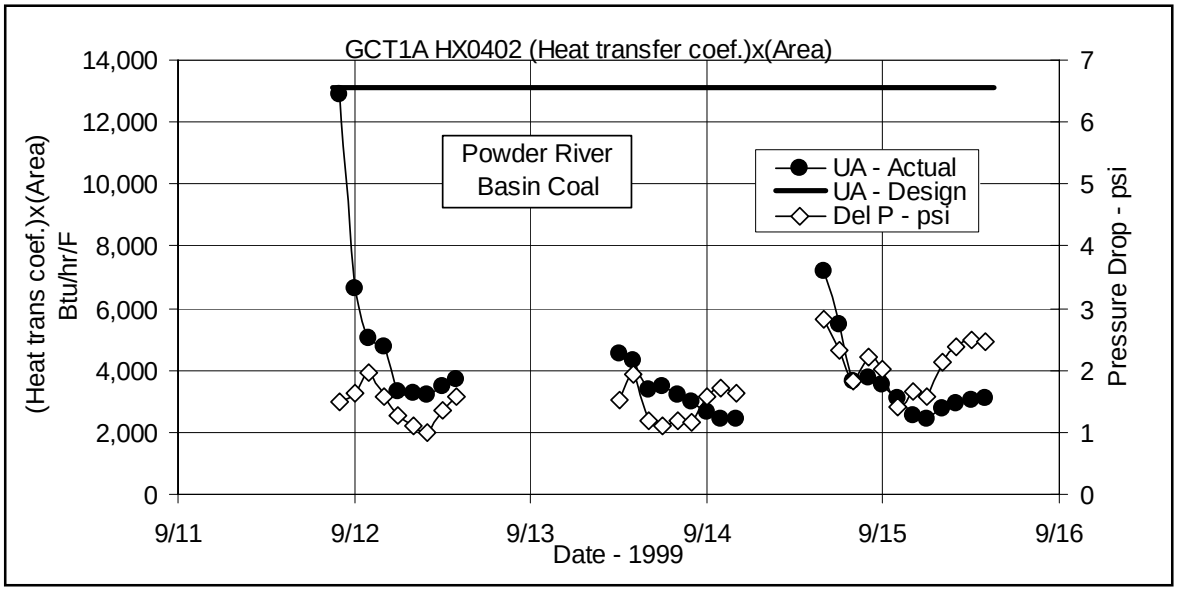
Figure 4.7-6 HX0402 GCT1A Heat-Transfer Coefficient - Area and Pressure Drop

December 14, which seemed to slightly decrease the HX0402 pressure drop to 8 psi, where it remained until shutdown. The pressure drop data would indicate that the heat exchanger started plugging when the sorbent was turned off. Since the tar was collected at the bottom of the heat exchanger it could be coincidence in that the heat exchanger bottom was slowly filling up during the testing and just happened to start blocking the gas path when the sorbent was turned off.

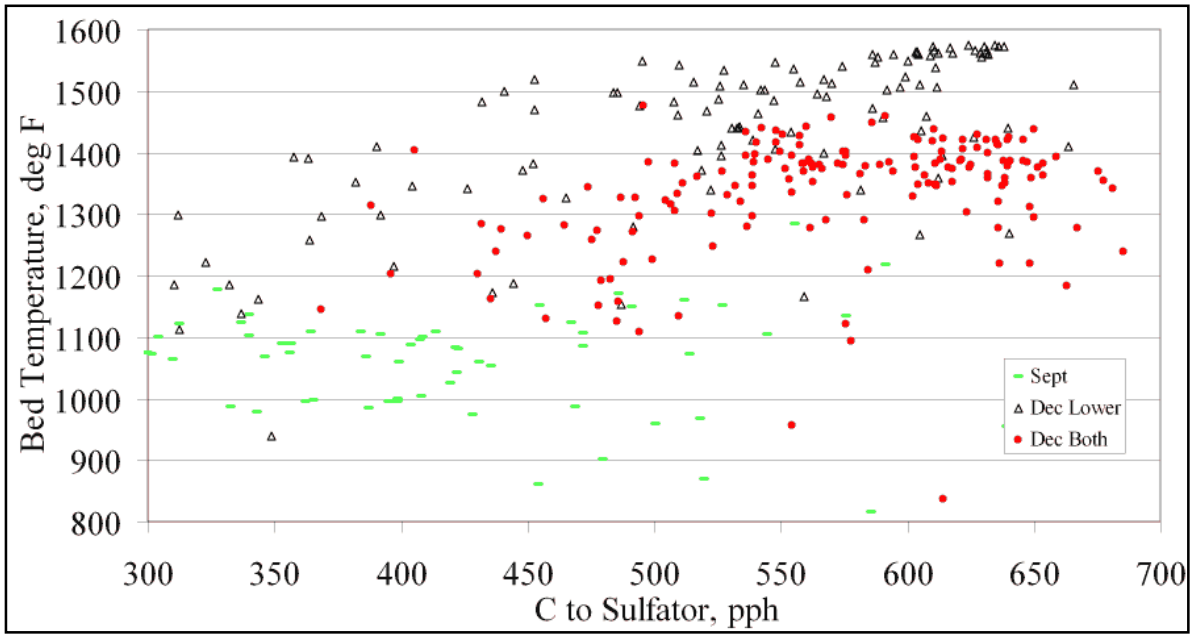
Figure 4.8-1 Changes in Bed Temperature as Various Surface Areas of Superheating Coils Are Covered

Before the start of GCT1B about 35 percent of the surface of the coils was removed in order to raise the sulfator-bed temperature and to lower the superheated-steam temperature. During the first 3 days of GCT1B this modification allowed the sulfator to operate with a bed temperature of 1,500 to 1,625°F. After 3 days of operation the bed level became sufficient to cover the upper set of superheating coils and the bed temperature dropped to 1,250 to 1,450°F for the remainder of the run. Figure 4.8-1 shows the bed temperature and char feed to the sulfator versus lb of carbon per hour for GCT1A before the modification, GCT1B when only the lower set of superheating-steam coils were covered, and for GCT1B through D when both the upper- and lower-superheating coils were covered. The bed temperature that could be achieved for a given char feed is shown to increase appreciably as the surface area of the coils exposed to the sulfator bed decreases.

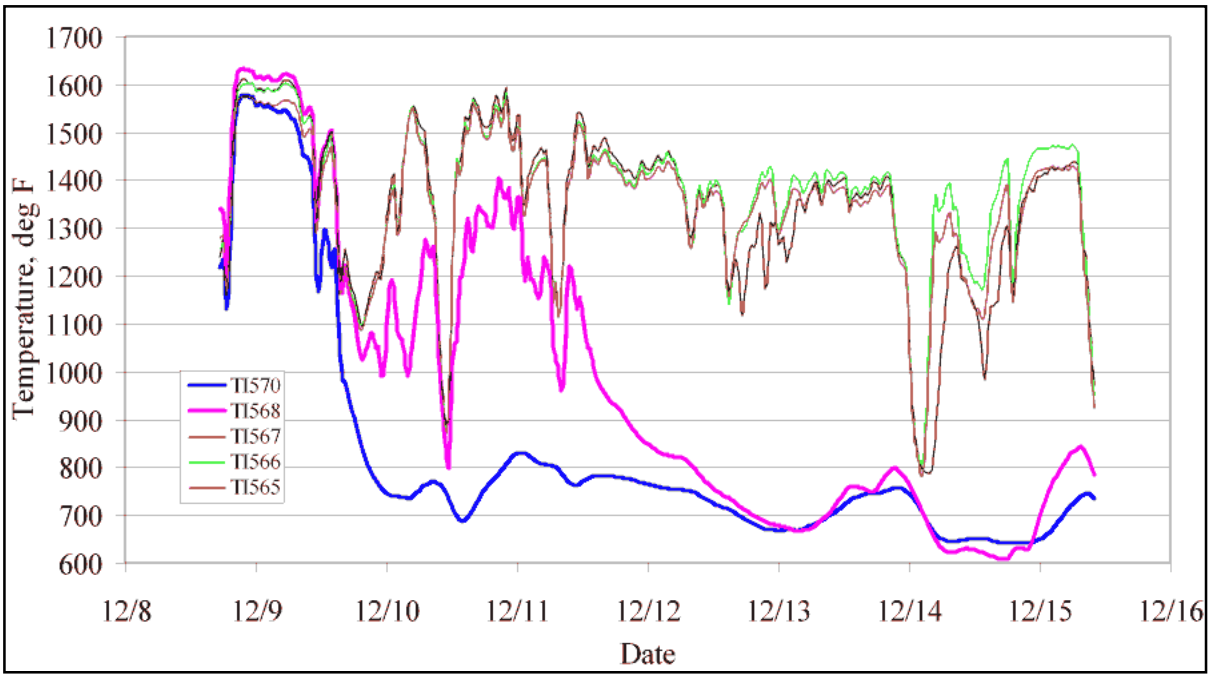
Figure 4.8-2 Bed Temperatures During GCT1 Showing Segregation of the Bed

The sulfator-temperature profile shows that the bed was well mixed initially; however, it became less mixed as the run progressed. During September testing the sulfator did not operate enough hours to show any problems with poor bed mixing. During December the sulfator bed began to show evidence of poor mixing after 30 to 40 hours of operation. By the end of GCT1 the two lowest thermocouples in the bed indicated temperatures at least 600°F lower than the other bed temperatures. (Figure 4.8-2 shows the bed temperatures for runs GCT1B, C, and D.) The most likely cause is segregation of the bed. The start-up bed material is sand with a mean particle size of over 100 μm. The feed from the PCD has a mean particle size of around 25 μm. In lab scale testing the PCD material did not fluidize well and segregated when mixed with sand.

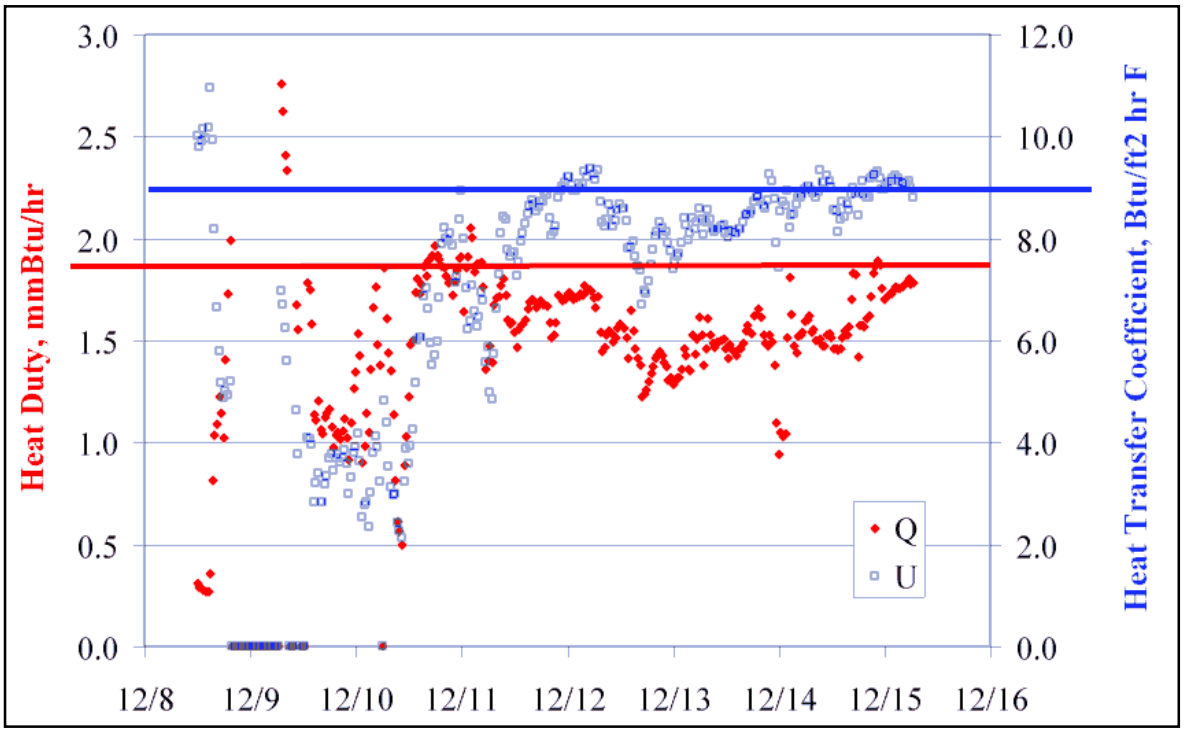
Figure 4.8-3 Heat-Duty and Overall-Heat-Transfer Coefficient of the Sulfator-Heat-Recovery Exchanger are Lower Than Normal

The sulfator waste-heat-recovery boiler does not remove as much heat as designed (it may be undersized). The design gas-exit temperature is 490°F while the actual gas-exit temperatures during GCT1 were 410 to 900°F. The period of time where exit temperatures were below design was after the top superheating coils were covered and the sulfator was operating well below normal-bed temperatures. The performance of the heat exchanger was decreased because of a higher-than-design gas flow of 8,000 to 9,000 lb per hr. Design-gas flow is 6,000 lb per hr. Figure 4.8-3 shows the heat-duty and the overall heat-transfer coefficient for the heat exchanger during GCT1B through D. Even with the additional gas flow the actual values were below the design values for most of the run, as indicated by the solid, horizontal lines in Figure 4.8-3. During GCT1A the heat exchanger also suffered from plugged tubes due to ash collecting in the cone until a large number of the tubes were filled with ash. (For GCT2 the exit piping will be reconfigured to prevent ash from settling by moving the flue gas exit to the bottom of the cone from the existing side exit.)

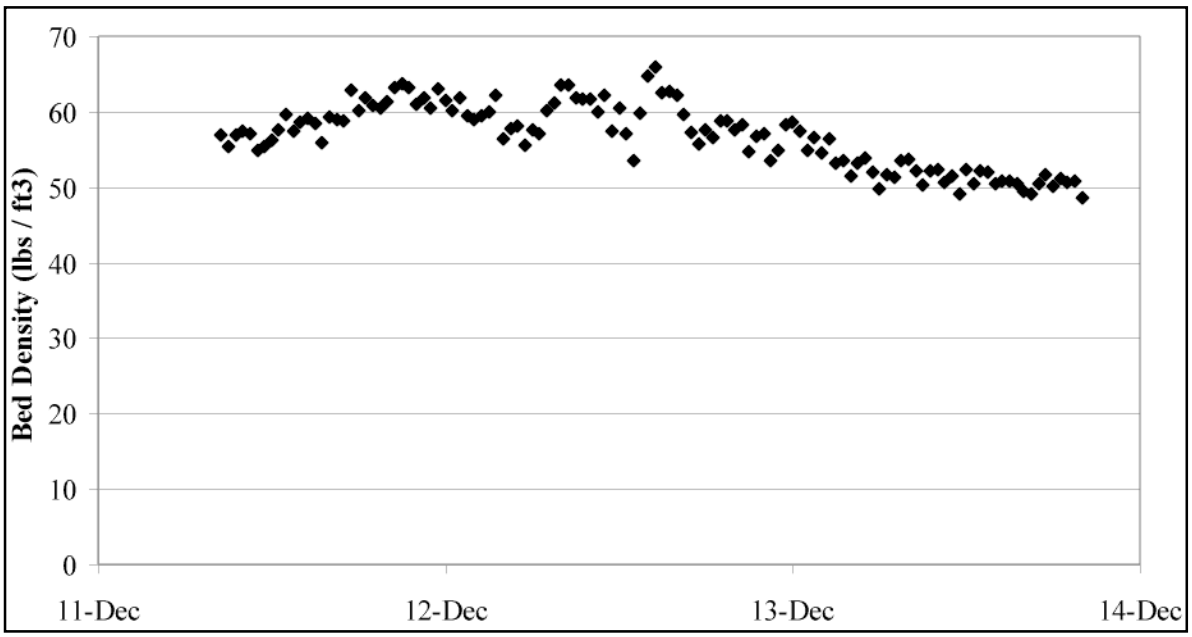
Figure 4.8-4 Density of the Sulfator Bed During GCT1

By using the two differential pressure gauges in the sulfator bed it is possible to calculate the bed density once the level achieves sufficient height to cover the high-pressure leg of the upper gauge. Figure 4.8-4 shows the sulfator-bed density for much of GCT1. The bed density ranges from 50 to 60 lb/ft^3. The density declines with time, indicating that some of the higher density sand that was used as a start-up bed was being lost and replaced with lighter ash from the char.
