**The Ohio State University
Eighth International Symposium on Aviation Psychology**

***Airport Ramp Safety and Crew
Performance Issues***

Airport Ramp Safety and Crew Performance Issues

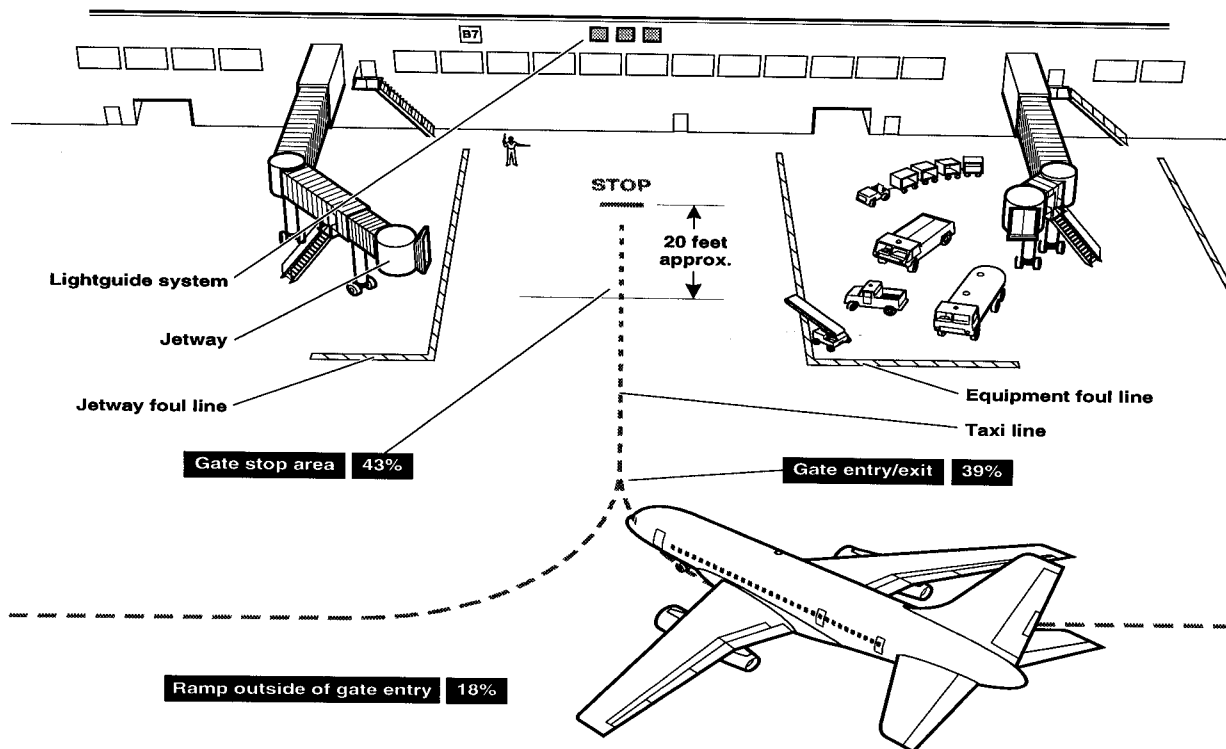
As shown in Figure 1, the Ramp Entry or Exit Area, the area adjacent to a taxiway and leading to or from a company ramp, was the site of the incident in 18% of the reports. Aircraft operating in this area are usually in communication with and under the control of ATC. Another 39% of the incidents occurred at the Gate Entry or Exit Area, where taxi lines converge, leading into or out of the gate area. In this area, an aircraft is less likely to be in communication with some controlling agency, and may now be relying on a company ramp control procedure or ground crew input for guidance. The largest percentage of the incidents, 43%, occurred within the Gate Stop Area, that is, within 20 feet of the nosewheel parking line. At this point, the flight crew is usually relying entirely on visual signals for clearance from equipment and for final taxi instructions. This guidance may be in the form of hand signals from ground crew personnel or signals from parking or guidance light systems mounted on the terminal building.

Figure 1. Generic Airport Ramp (ASRS Ramp Study Incident Frequencies Noted)

It is interesting to note that there were more incidents in the gate stop area during arrival (48% of reports) than during departure (31% of reports). A possible explanation is that there are more obstacles to encounter when entering what is usually a progressively more congested area next to gates and terminal buildings. Further, it was noted that there were *fewer* incident occurrences (13% of reports) on the ramp fringe areas during arrivals than during departures (30% of reports). This may be related to the large number of pushback, power-out, and power turn procedures during departures.

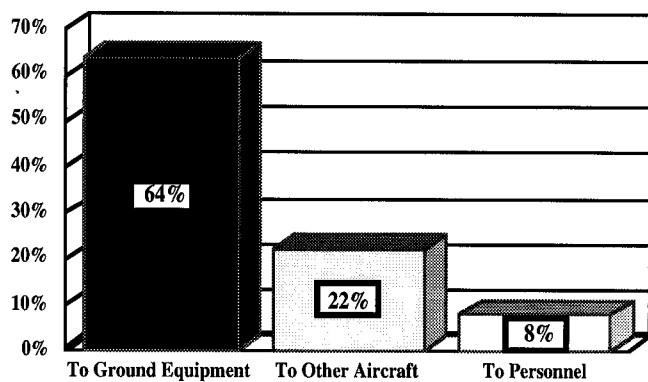
Ground equipment, and by association, ground personnel, appear to be most vulnerable to damage or injury in ramp operation incidents. Ground equipment in general was the clear "loser" in the reported incidents, as depicted in Figure 2. Damage to ground equipment occurred most often in the gate stop area, less so in the gate entry/exit areas, and rarely on the ramp fringes.

Figure 2. Types of Ramp Damage and Injury

Damage to another aircraft was cited in 22% of the reports. Interestingly, other aircraft were usually damaged in the ramp and gate entry/exit areas, where the taxiing aircraft were sharing a common maneuvering area and were likely to be in radio contact with a controlling agency. Damage at the gate stop area was less common.

Injury to personnel was reported in 8% of the incidents, and two-thirds of those injured were specified as ground crew members. Fortunately, this is a small percentage. Although it is not a substantial-looking number, it obviously represents a substantial impact in the lives of the persons who were injured. This number also represents a

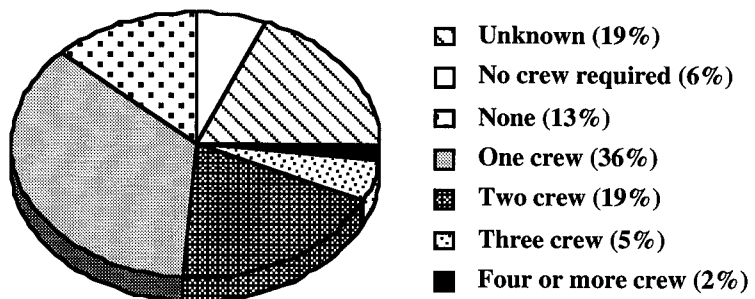
Are More Ground Crew Better? Figure 3 shows the number of ground crew personnel present at the time of the reported incident. These numbers may suggest that “more are better,” but this is not always the case. A small four- or six-passenger Part 135 aircraft on a spacious ramp may have little need for a large ground crew. On the other hand, a Boeing 747 making its way into a crowded gate may require three, four, or more ground personnel to navigate safely. In practice, many companies assign only one or two ground crew to an aircraft, at the most. However, the fact remains that the study set contained few reports that cited three or more ground crew as being present.

Figure 3. Number of Ground Personnel at Time of Incident
