LeCroy 1440 System Manual

Fermi National Accelerator Laboratory

Equipment Support Department

July 11, 2003

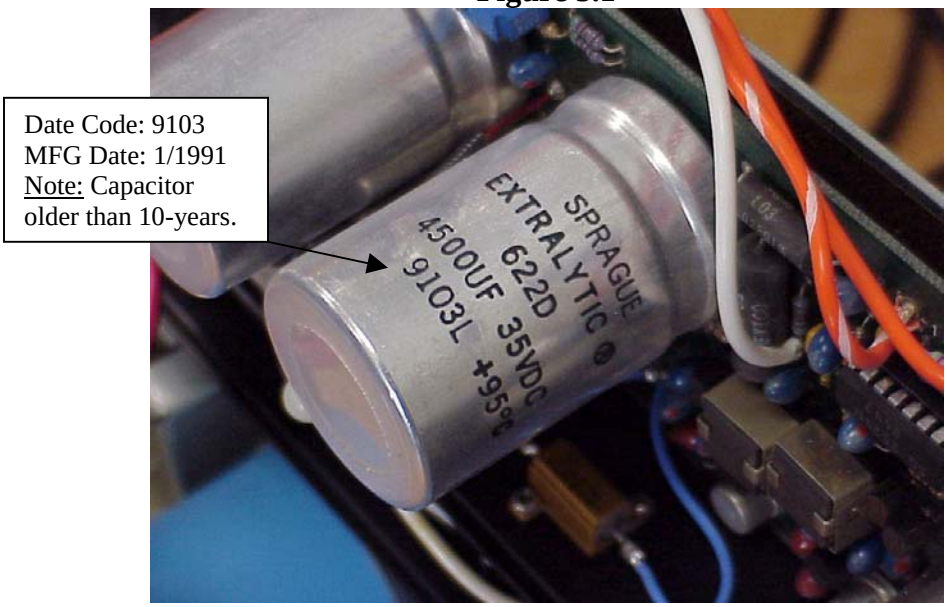
Figure 5.1

Date Code: Actual manufacturing (MFG) date printed on the electrolytic capacitor. Example: Date code 9705 stands for the 5th week of the year 1997 or MFG Date of 2/97.

Expired Date: The Electrolytic capacitor has an approximate 10-year service life. The Expired Date is a 10-year date assigned from the date of manufacture.

1. Spare Electrolytic Capacitors not issued into service within 4 years from date of manufacture cannot be used and should be disposed of.
2. **Replace the filter caps if the manufacturer's Date Markings are not readable, not present, expired, or over 4-years old.**

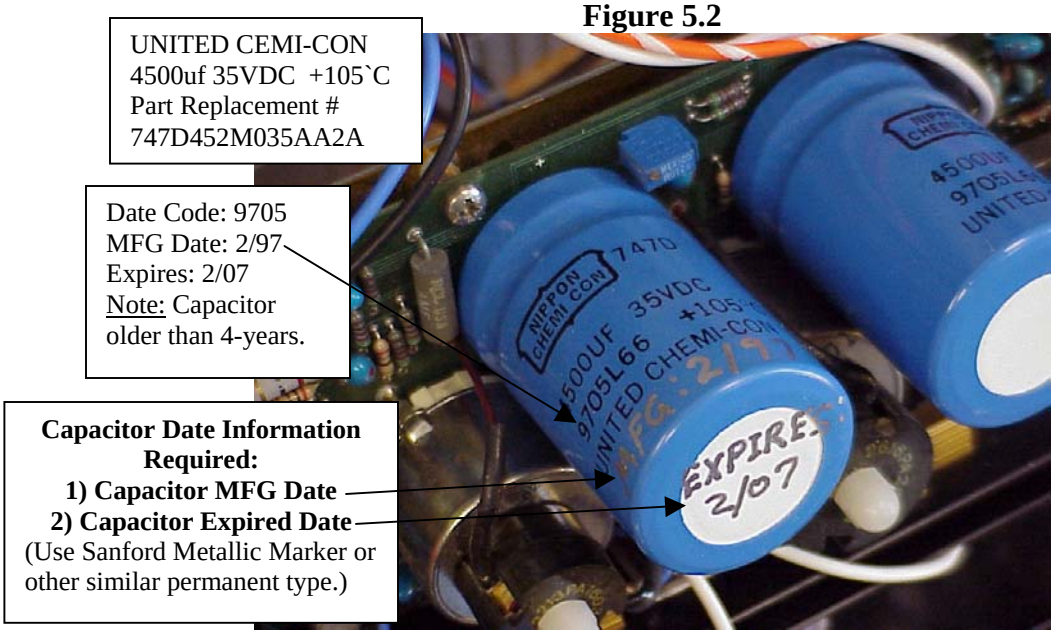
Figure 5.2

Note: Expired Date and Manufacture Date are to be written on the capacitor.

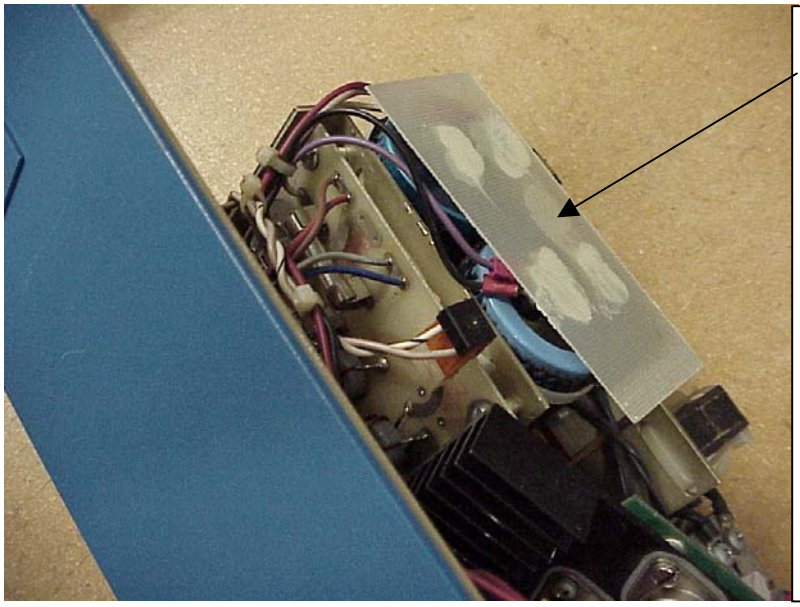
Verify the presence of insulating covers on the 1442 filter capacitors. Covers should be present to prevent the capacitor terminals from shorting to the chassis. Newer power supplies may have clear plexiglass installed by LRS.

Verify 1442 filter capacitors have insulating cover attached.
2”X4”, .035”, Fiber Glass G10 board.
Use High Temp Silicone Adhesive.
GE Part #
RTV102(white)
RTV103(black)
Fermi Part #
1940-0750(white)
1940-0775(black)

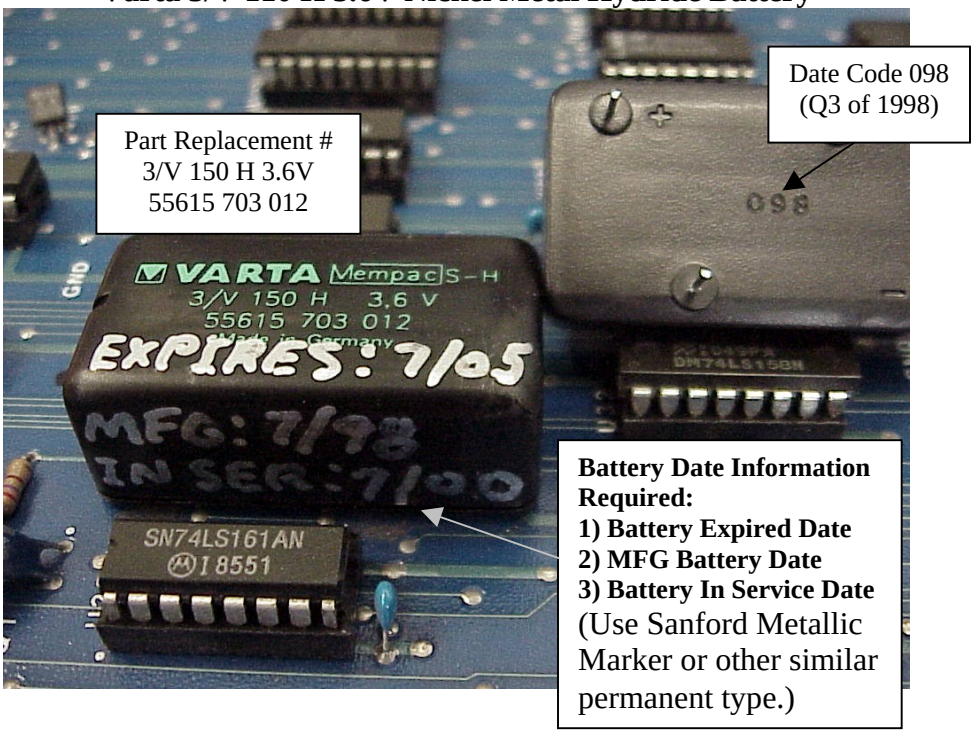
Figure 5.3
Varta 3/V 110 H 3.6V Nickel Metal Hydride Battery

The LRS 1445 controller uses a NiMH battery to backup controller setting in the random access memory. Due to battery aging, the system could drop out of operation. The NiMH battery has an approximate 7-year total service life. The Equipment Support Department has elected to replace the NiMH battery with a "In Service Date" over 5 years, as a routine and preventative maintenance item as the systems pass through the repair cycle. This is because LRS 1440 systems are often issued to research experiments for 8 years or more. See Figure 5.3

1. Spare NiMH Batteries not issued into service within 2 years from date of manufacture cannot be used and should be disposed of. (2-year shelf life)
2. **Replace the battery if the manufacturer's Date Markings are not readable, not present, or expired.**

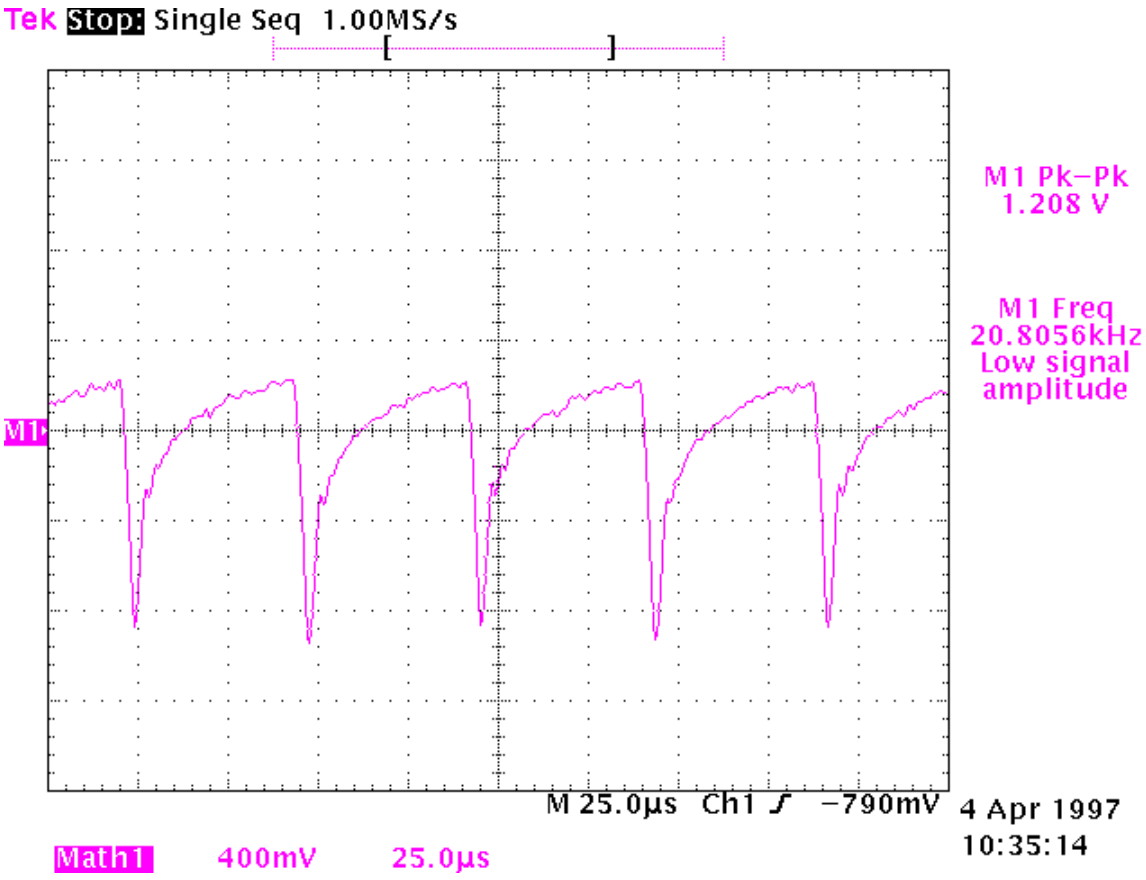
Figure 9 shows a typical "Bad" unit. Note that the Peak to Peak amplitude is 1.208V and exceeds the specification of <150 mV.

9. Measure the peak to peak voltage displayed on the Oscilloscope. If the peak to peak voltage exceeds 150mV the LRS 1441 should be exchanged with PREP. You can reference the "**good**" and "**bad**" Oscilloscope displays at the end of this document.

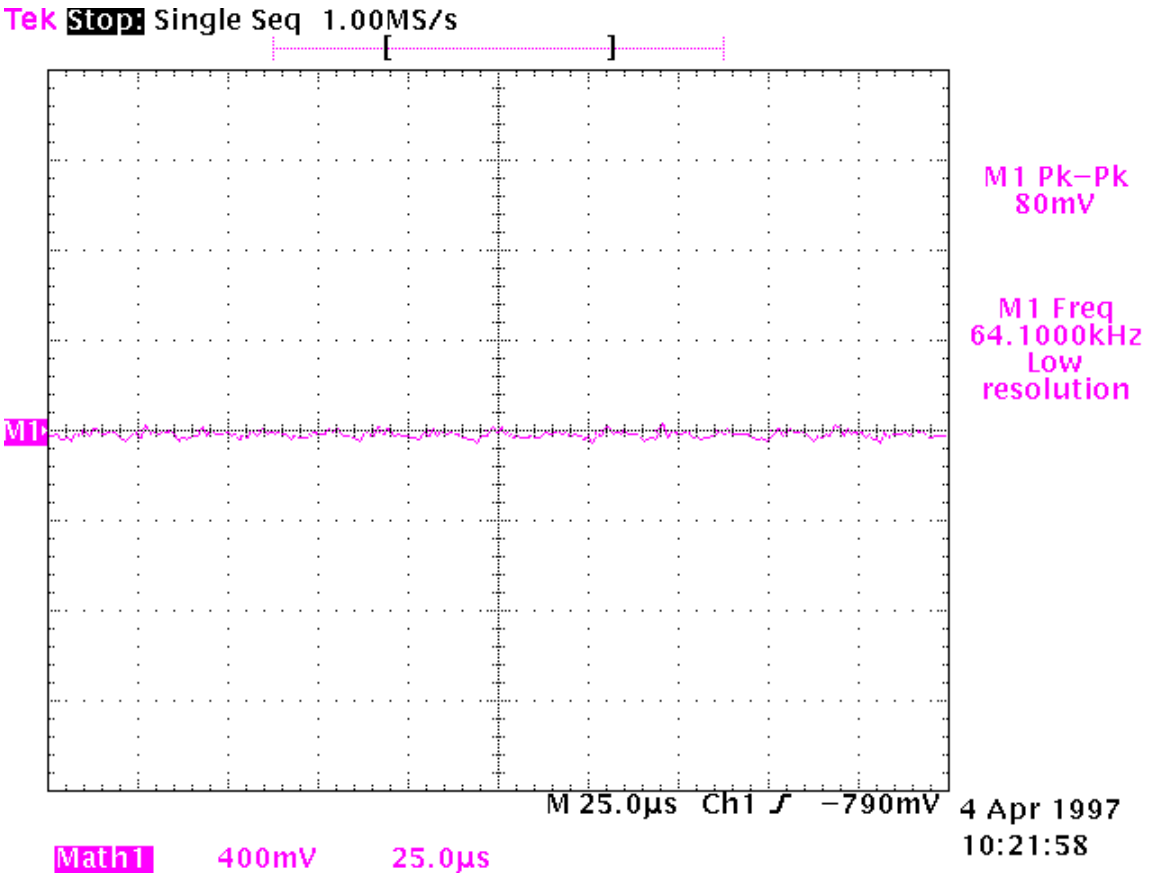
Figure 10

Below is an example of a good waveform, (Figure 10). Note that the peak to peak amplitude is 80mV which is less than the specification of <150mV.

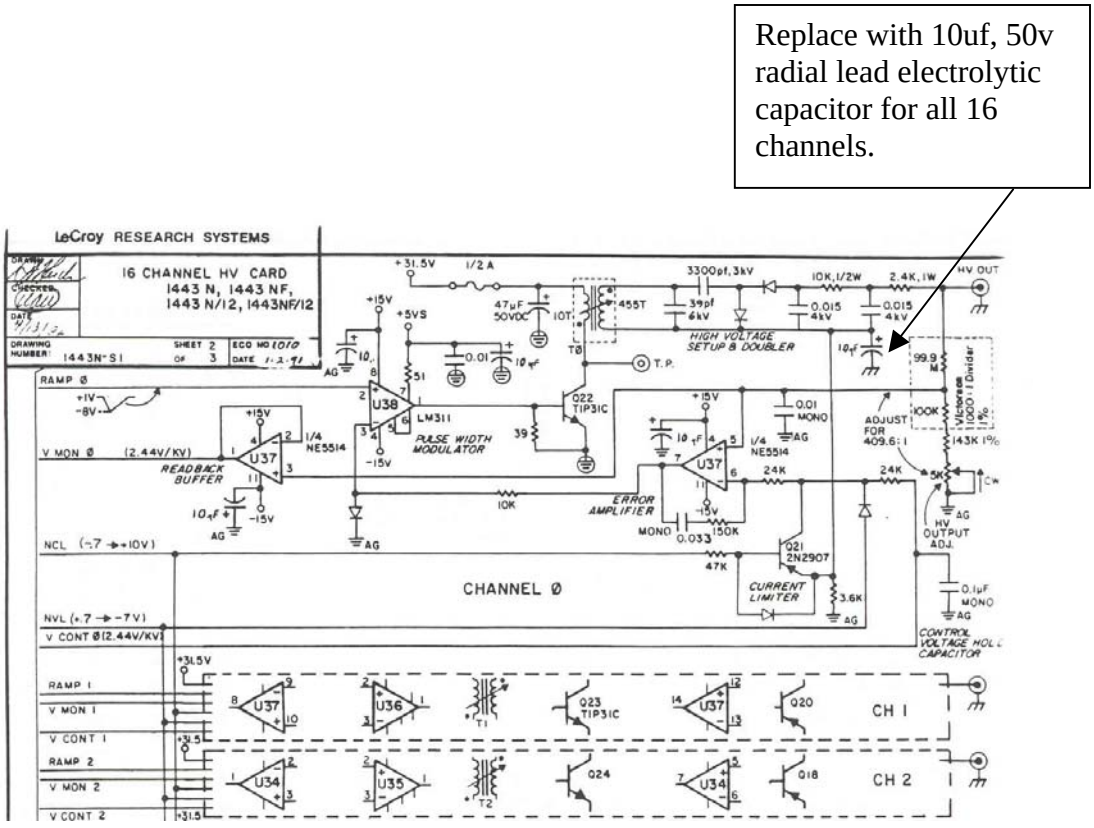
Schematic of the LRS 1443 High Voltage Card

Aging of certain capacitors on the LRS 1443 HV card caused instability in HV output. The output voltage was measured to fluctuate as much as 50V with load and 5V level without load. The specific capacitor is referenced in ECO 1002 and ECO 1010. Prior to 1982 the capacitor was a 6.8uf tantalum. ECO 1002 (July 1, 1982) changed the capacitor to a 10uf 16v electrolytic. ECO 1010 (January 1, 1991) effectively called for the capacitor to be replaced with a radial lead 10uf, 35v electrolytic capacitor. The capacitor shown below is the cause of the voltage instability and is routinely checked and upgraded with a 10uf 50v radial lead electrolytic. The capacitor is replaced in all 16 channels.

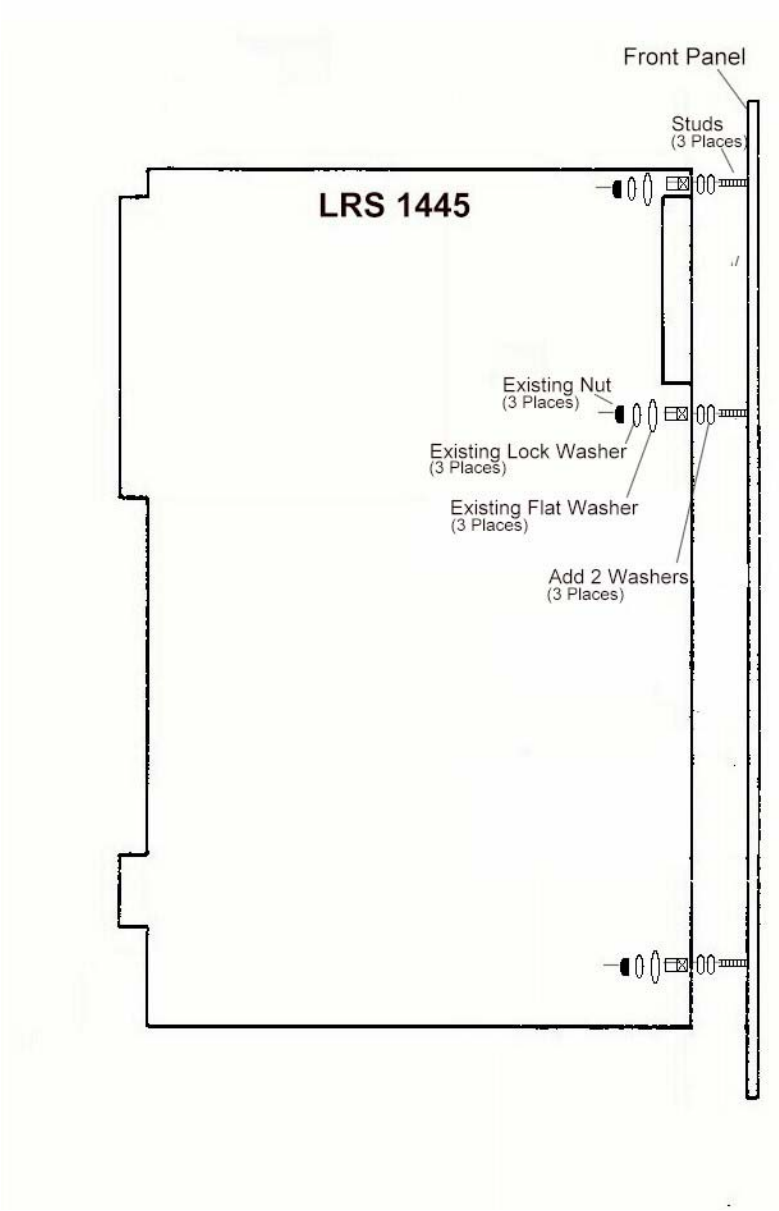
A problem has been identified that causes intermittent communication, high voltage trips and other assorted quirks in the 1440 system. This has been traced to bad connections between the controller and the 1449 backplane connector. This modification adds washers behind the front panel on the 1445 controller to get the controller to seat farther into the backplane connector. The tools needed for this fix are a ¼ inch nut driver and 6 #4 flat steel washers available in the stockroom. The Fermilab Stockroom part number for the washers is 1218-0540.
Note: This modification is installed on all Fermilab systems as a routine and preventative maintenance item.
The procedure is as follows:

1. Turn power off and remove line cord to the mainframe.
2. Remove the 1445 controller from the mainframe and lay on a flat surface.
3. Locate the 3 studs that secure the front panel to the circuit board.
4. Remove the ¼ nuts, the lock washer and the flat washer that are holding the front panel on.
5. Pull on the front panel to get it to slide out of the brackets that hold it to the circuit board.
6. Place 2 #4 flat steel washers on each of the three studs that extend from the front panel.
7. Insert the front panel back into the brackets that secure the front panel to the circuit board
8. Reinstall the flat washers and lock washers and ¼ inch nut and tighten securely.
9. Reinstall the controller into the mainframe and test.

Note: do not use more than 2 washers on each stud or it could cause permanent damage.

Front Panel
Studs
(3 Places)
LRS 1445
Existing Nut
(3 Places)
Existing Lock Washer
(3 Places)
Existing Flat Washer
(3 Places)
Add 2 Washers
(3 Places)
