REPORT OF APOLLO 204 REVIEW BOARD

**APPENDIX D
PANELS 6 thru 10**

**REPORT OF PANEL 6
HISTORICAL DATA
APPENDIX D-6
TO
FINAL REPORT OF
APOLLO 204 REVIEW BOARD .**

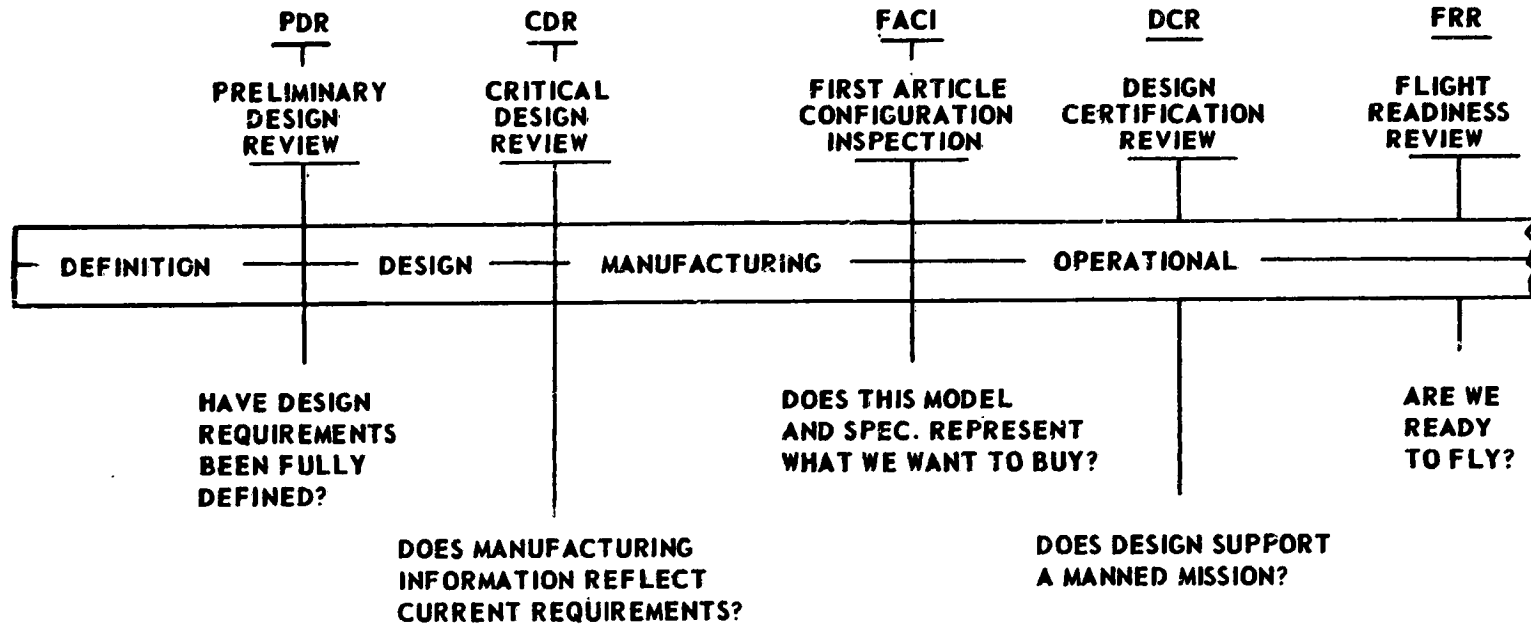
ENCLOSURE 6-6

**DEVELOPMENT/REVIEW PROCESS
(APO DEFINED)**
