Incidents Associated with Oil and Gas Operations

Outer Continental Shelf 1999

Foreword

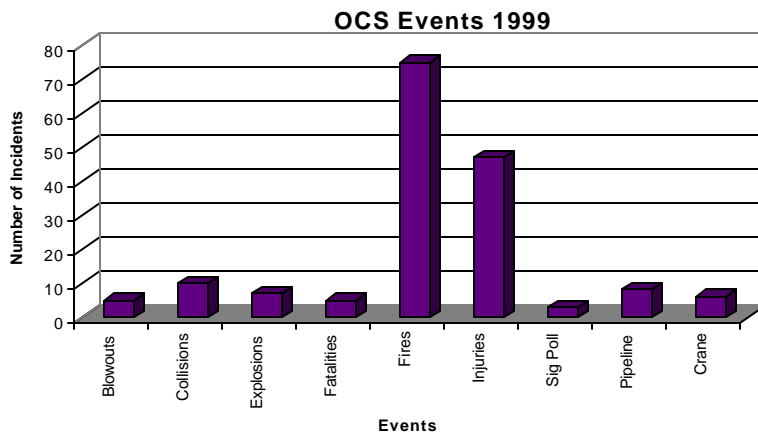
Events

- The most common event on the OCS in 1999 was fires. Of the 75 fires reported, 49 (61%) were caused by equipment failure and 20 (25%) were caused by human error.
- The second most common event was injuries. There were 47 reported from 35 separate incidents; human error caused 23 (48%) and equipment failure caused 9 (19%) injuries.

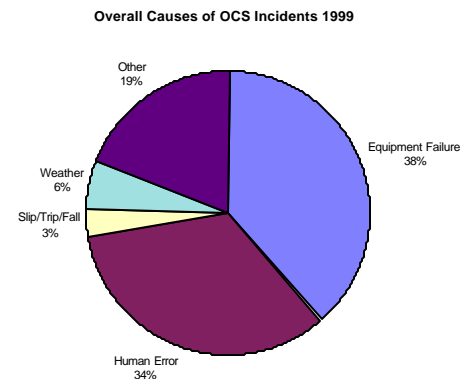
Causes

- Overall, equipment failure was the main cause of incidents in 1999. It was responsible for 69 incidents (38%), followed by human error in 61 incidents (34%).
- In 1998, 72 incidents (37%) were due to equipment failure and 75 (38%) were caused by human error.
- Two of the 5 fatalities in 1999 were caused by human error and equipment failure; two are still under investigation.
- Human error was responsible for 48% of the injuries. Other causes comprised 21% of the injuries and equipment failure was a cause in 19%.
- Human error contributed to five of the seven explosions and equipment failure was a factor in four. The explosions occurred primarily during production operations.

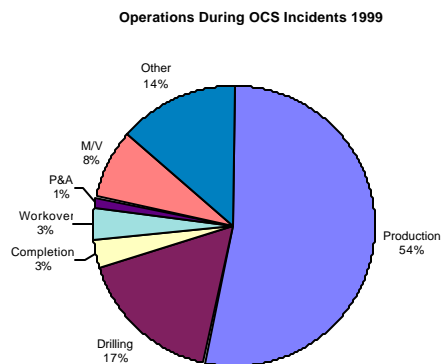
Operations

- Ninety four (54%) of incidents that occurred in 1999 happened during production operations, 29 incidents (17%) occurred during drilling operations, and 14 (8%) incidents involved motor vessel operations.

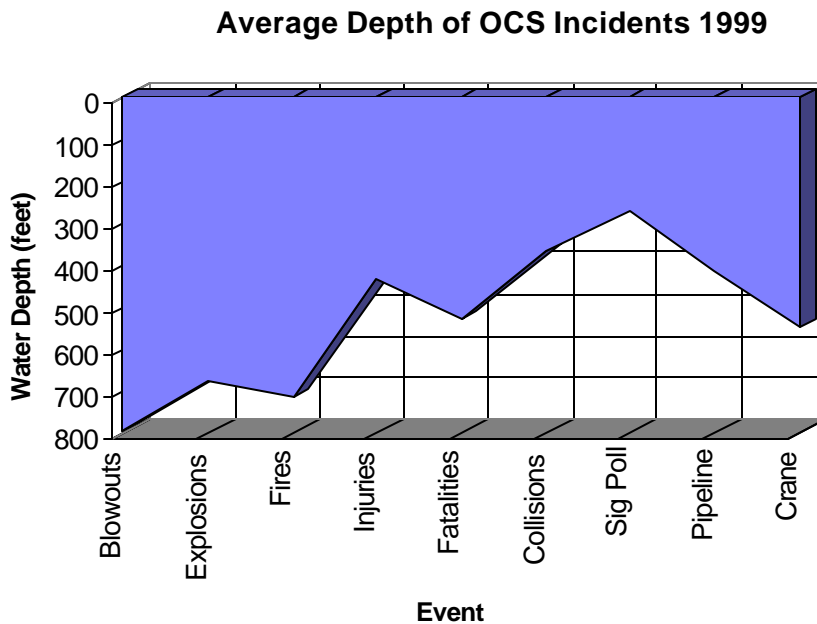
The chart below shows the average water depth of each of the types of incidents on the OCS in 1999. The average depth for deepwater incidents was 2,448 feet, as compared with an average depth of 526 feet for all incidents.
