**International Boundary and Water Commission
United States Section**

**Work Plan
Rio Grande Flood Control System Rehabilitation Program
at Lower Rio Grande Valley**

January 25, 2006

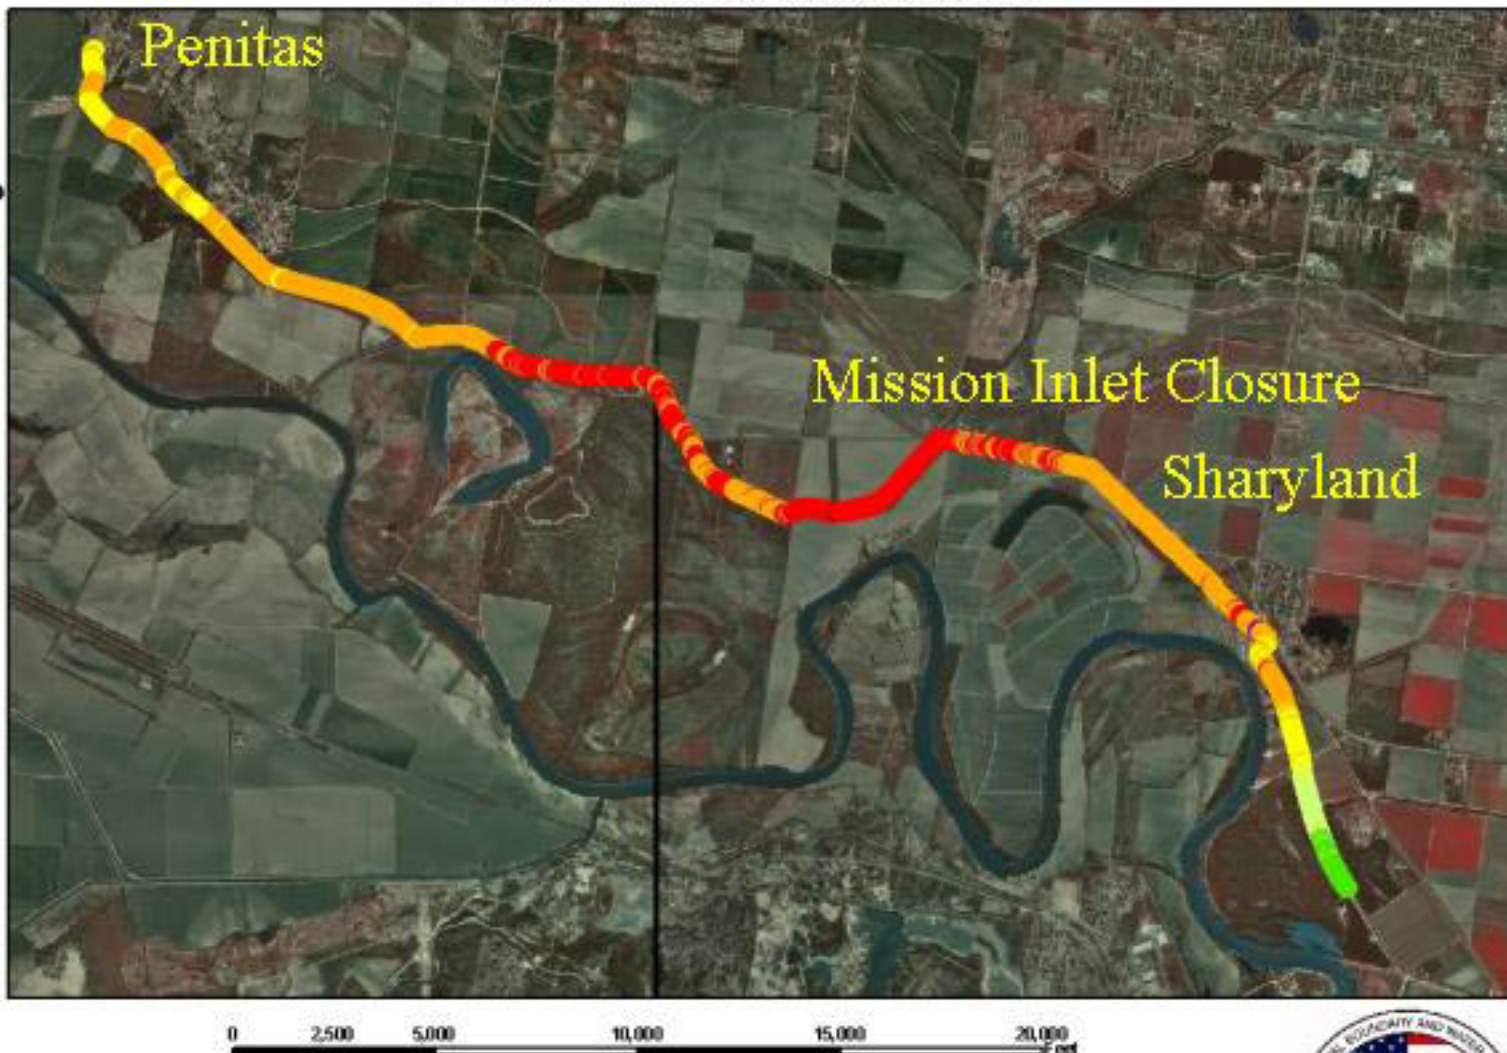
Lower Rio Grande Valley Levee Rehabilitation Penitas to Anzalduas Dam

The levee within this 12 mile reach is approximately 5 feet deficient in height. Levee protects several communities from Penitas to Anzalduas Dam including the residential/industrial interests of Sharyland. Marginal geology (subsurface) concerns exist within this reach of the levee. Estimated Construction Cost - \$ 21.1 million

Description - The levee within this 12 - mile reach is approximately 5 feet deficient in height. Levee protects several communities from Penitas to Anzalduas dam including

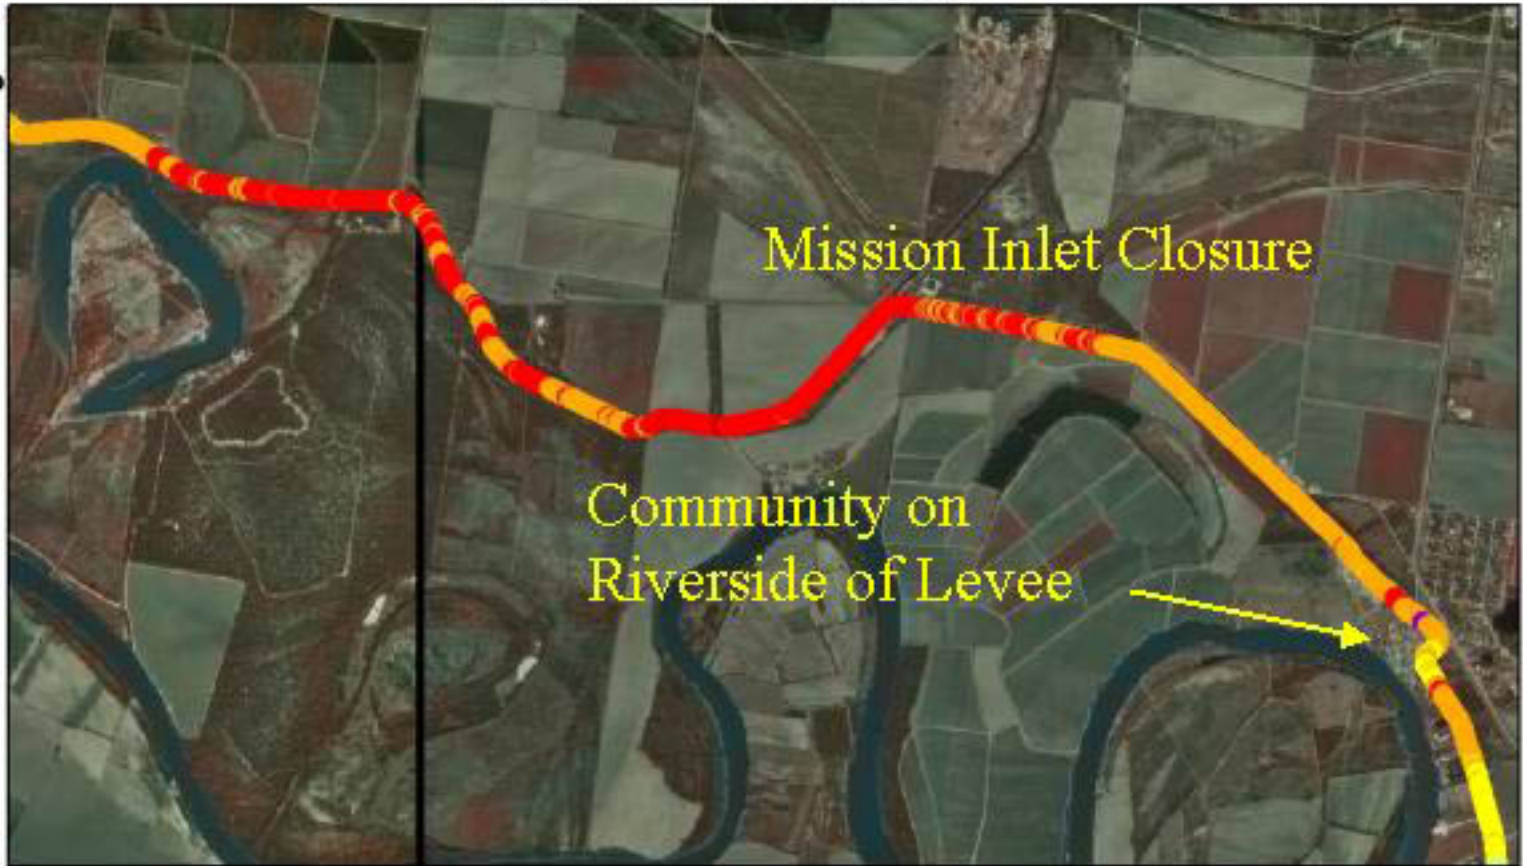
Lower Rio Grande Valley Levee Rehabilitation Mission Inlet Closure

Initial investigations categorize the geology in the Mission Inlet closure vicinity as poor, thus warranting additional investigations. This area also has historical borrow areas located immediately adjacent to the levee toe. Since its closure, a development boom has occurred in the old Mission Floodway. Should the levee breach in this reach, extensive flood damages could be expected. If additional geotechnical investigations suggest corrective action, a subsurface barrier (slurry trench, sheet pilings) will most likely be the proposed alternative. Note: TXDOT has a project in this vicinity. Estimated Construction Cost - \$9.4 million

Description - Initial investigations categorize the geology in the Mission Inlet closure vicinity as poor, thus warranting additional investigations. This area also has historical borrow areas located immediately adjacent to the levee toe. Since its closure, significant development has occurred in the old Mission Floodway. Should the levee breach in this reach, extensive flood damages can be expected. If additional geotechnical investigations suggest corrective action, a subsurface barrier (slurry trench, sheet pilings) will most likely be the proposed alternative. Note: TXDOT has a project in this vicinity.

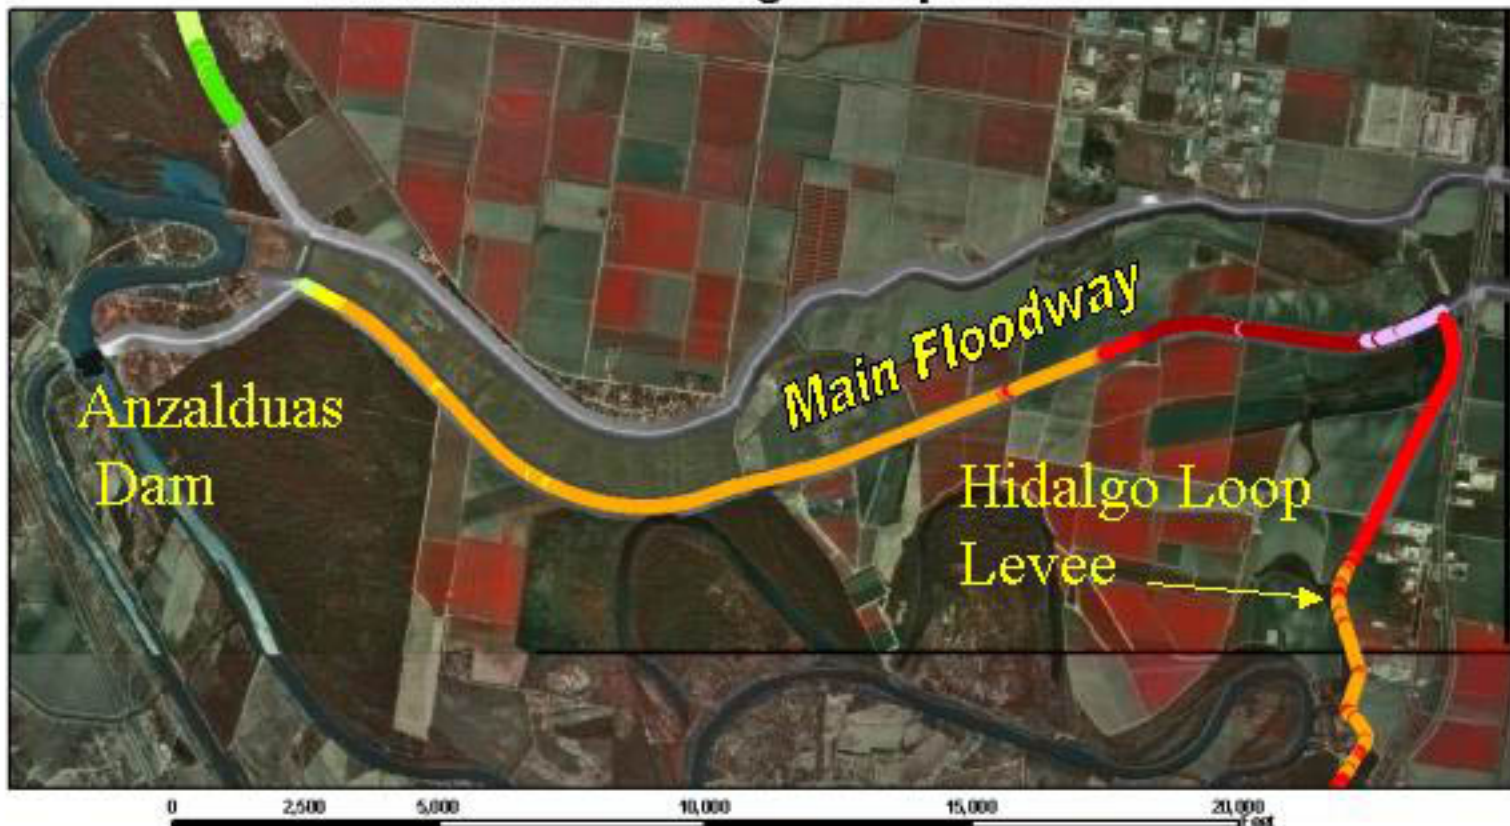
Lower Rio Grande Valley Levee Rehabilitation South Levee Banker Floodway Anzalduas to Hidalgo Loop Levee

This levee reach is referred to as the Common Levee and ties into Anzalduas Dam. The purpose of Anzalduas Dam is to divert the U.S. allocation of floodwaters into the Main Floodway. The Common Levee serves as the southern levee of the Main Floodway and also provides protection from the mainstem flows of the Rio Grande. The Common Levee will have water on both sides of the levee during a flood event. Failure of the Common Levee will result in uncontrolled flows within the Main Floodway and along the Rio Grande below Anzalduas Dam. The Common Levee is approximately 6 feet deficient in height and has marginal structural problems. It is assumed that 1.5 miles of this levee will require slurry trench rehabilitation. Estimated Construction Cost - \$16.5 million

Description - This levee reach is referred to as the Common Levee and ties into Anzalduas Dam. The purpose of Anzalduas Dam is to divert the U.S allocation of floodwaters into the Main floodway. The Common Levee serves as the southern levee of the Main Floodway and also provides protection from mainstem flows of the Rio Grande. The Common Levee will have water on both sides of the levee during a flood event. Failure of the Common levee will result in uncontrolled flows below Anzalduas Dam. The Common Levee is approximately 6 feet deficient in height and has marginal structure problems. It is assumed that 1.5 miles of this levee will require rehabilitation using slurry trench techniques.

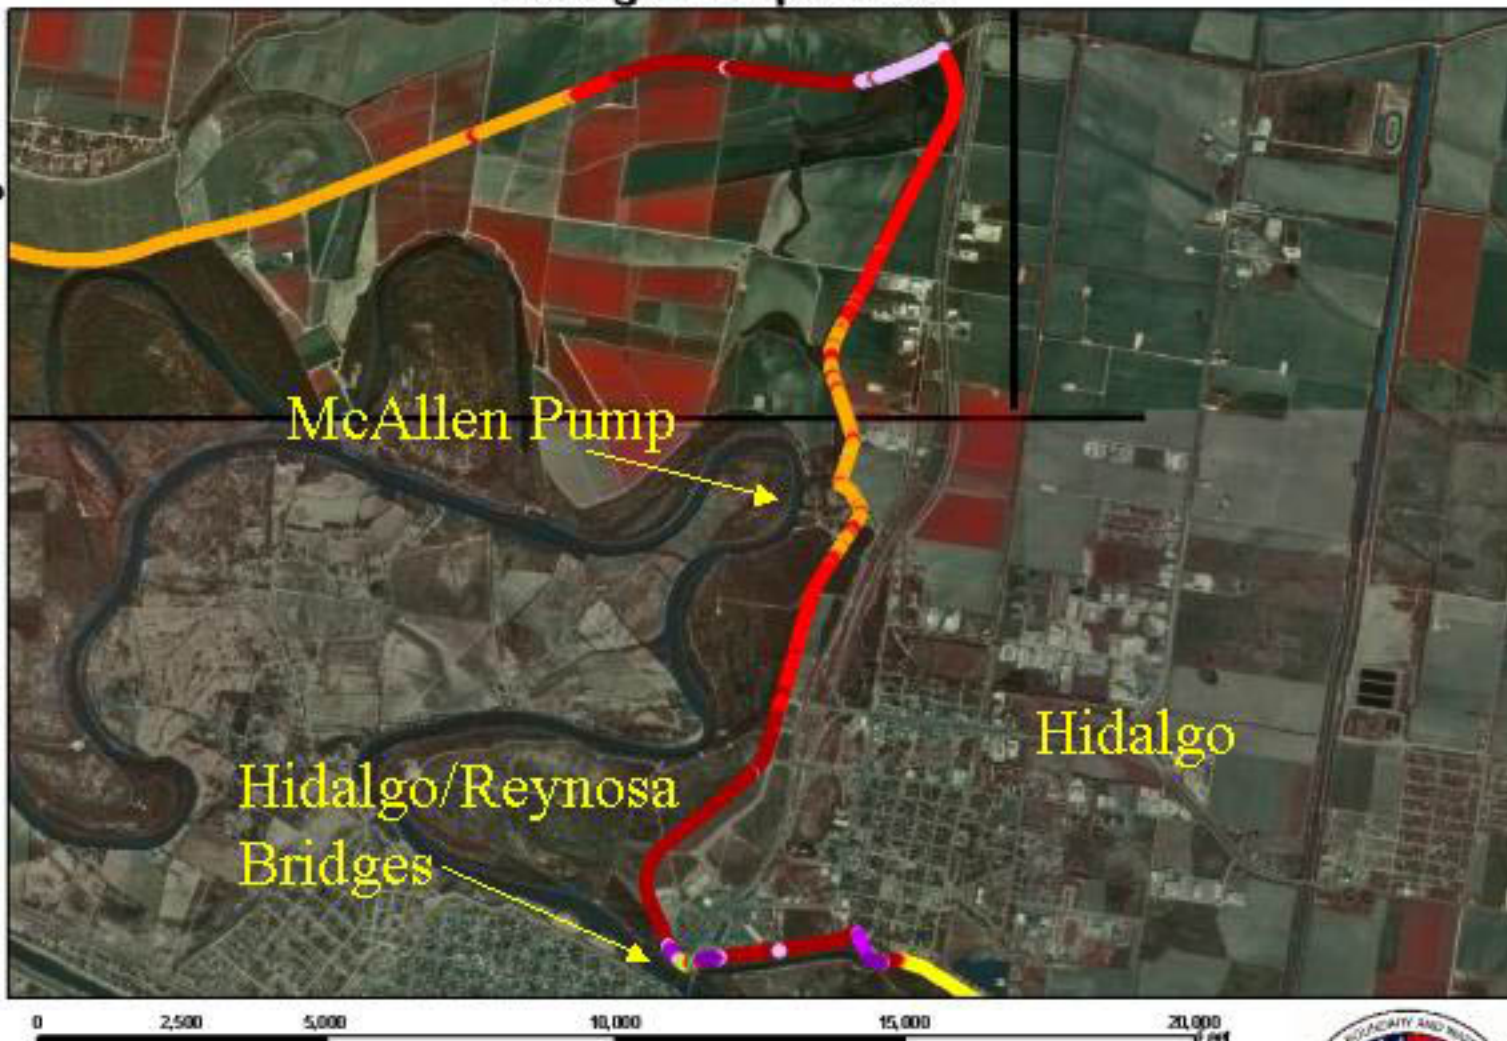
Lower Rio Grande Valley Levee Rehabilitation Hidalgo Loop Levee

Levee reach, commonly referred to as the Hidalgo Loop levee, ties into the south levee of the Main Floodway and continues in a southerly direction for 3.3 miles to the Hidalgo/Reynosa bridges. Levee protects the city of Hidalgo from flooding. Levee is approximately 6 feet deficient in height throughout the reach, with only marginal structural integrity problems. Estimated Construction Cost - \$6.7 million

Description - Levee reach, commonly referred to as the Hidalgo Loop levee, ties into the south levee of the Main Floodway and continues in a southerly direction for 3.3 miles to the Hidalgo/Reynosa bridges. Levee protects the city of Hidalgo from flooding. Levee is approximately 6 feet deficient in height throughout the reach, with only marginal structural integrity problems.

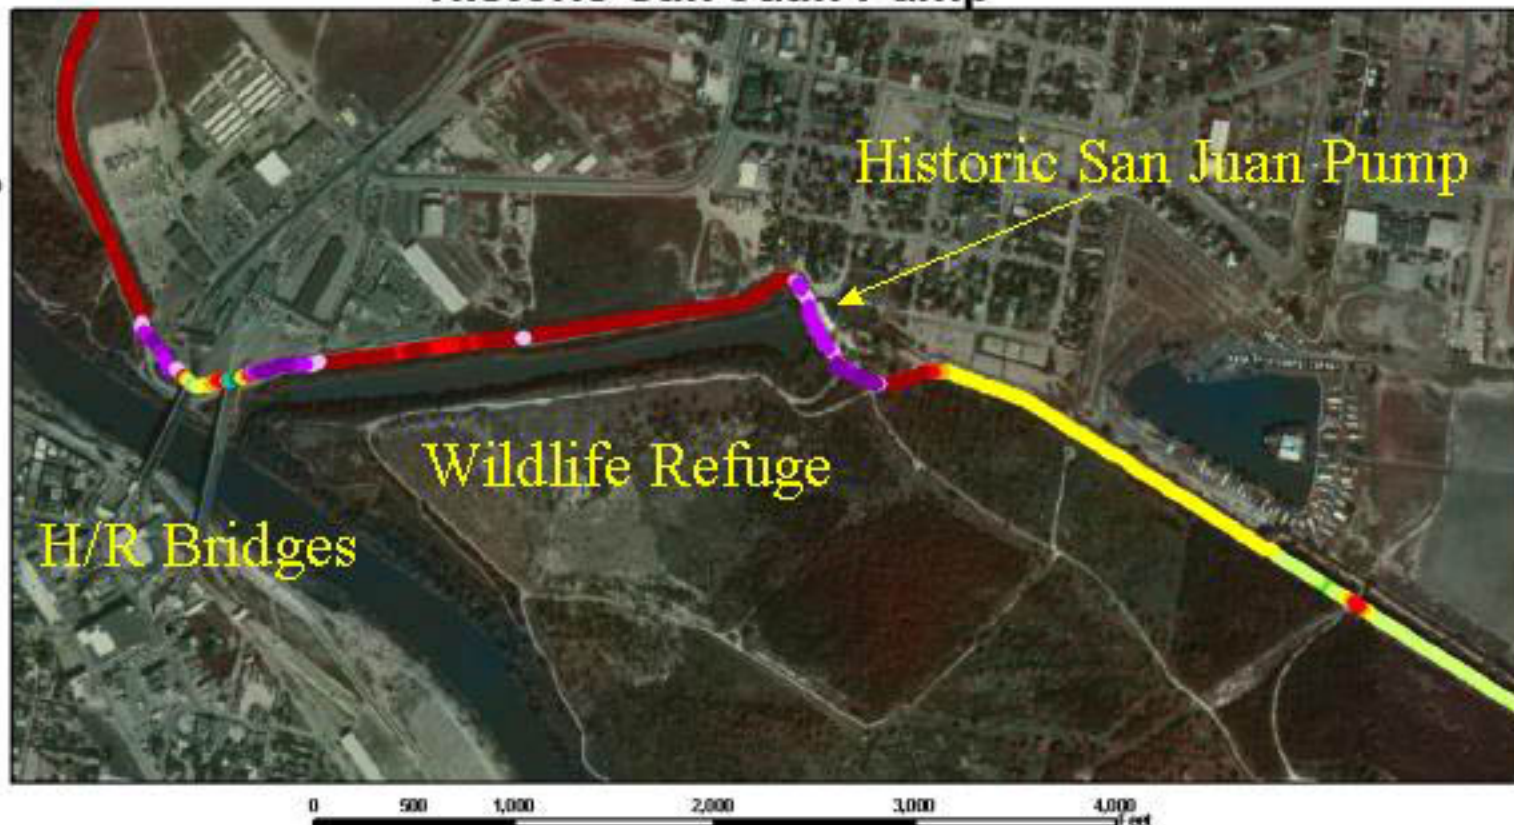
Lower Rio Grande Valley Levee Rehabilitation Historic San Juan Pump

Existing levee extends from the Hidalgo/Reynosa bridges east to beyond the historic San Juan pumping station. The middle segment of the levee reach is approximately 6 feet deficient in height and considered primarily a levee raising project.

However, flood protection is approximately 9 feet deficient in height near the bridges and the historic pump house. These areas will require alternative flood protection methods such as retaining walls due to limited ROW and historic considerations. One alternative would be to relocate the levee from the north side of the historic pump intake canal to the south side of the canal adjacent to the wildlife refuge. This would require construction of 0.70 mile of new levee, 0.55 mile of levee raising and special consideration at the canal crossing and in the vicinity of the bridges. This alternative would reduce adverse impacts to the hike and bike trail and historic area. Estimated Construction Cost - \$ 4.71 million.

Description - Existing levee extends approximately from the Hidalgo/Reynosa bridges east to beyond the historic San Juan pumping station. The middle segment of the levee reach is approximately 6 feet deficient in height and considered primarily a levee raising project. However, flood protection is approximately 9 feet deficient in height near the historic pump house. The preferred alternative is to relocate the levee to the south side of the historic pump intake canal and cross the intake channel midway between the Hidalgo Reynosa Bridge and the historic pump station. This would require construction of 0.70 miles of new levee on the south side of the old intake channel, and the channel would be crossed to tie the new structure to the existing levee system. Floodwall placement would be required in the vicinity of the Hidalgo Reynosa Bridges.

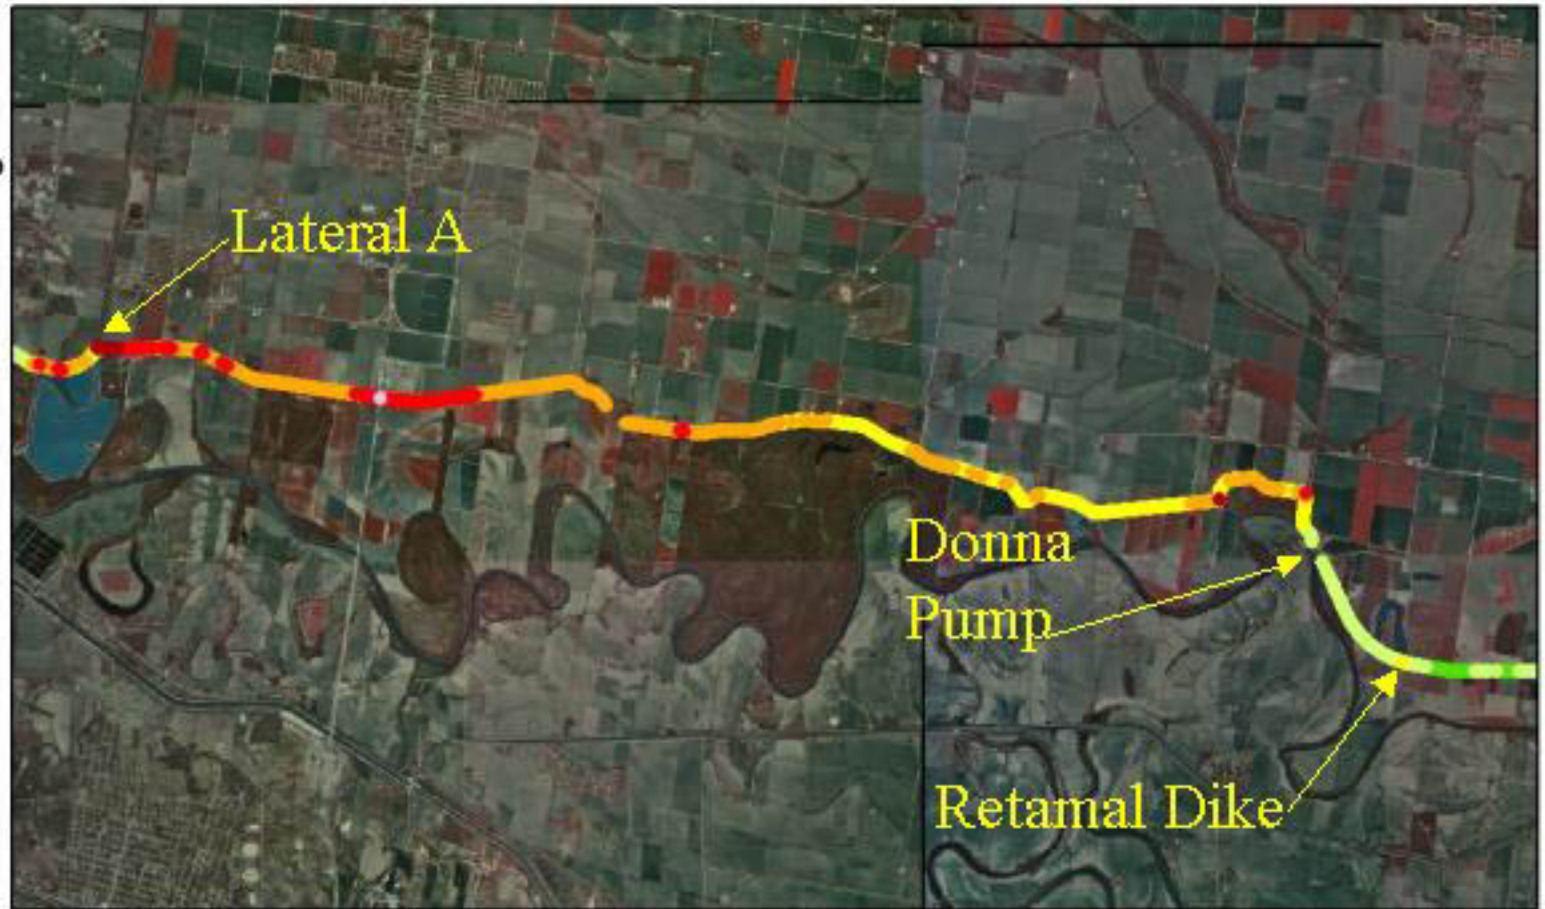
Lower Rio Grande Valley Levee Rehabilitation Lateral A to Donna Pump Station

The levee is approximately 4.5 feet deficient in height with little structural problems within this reach.
Estimated Construction Cost - \$ 22.9 million

Description - The levee is approximately 4.5 feet deficient in height with little structural problems within this reach.

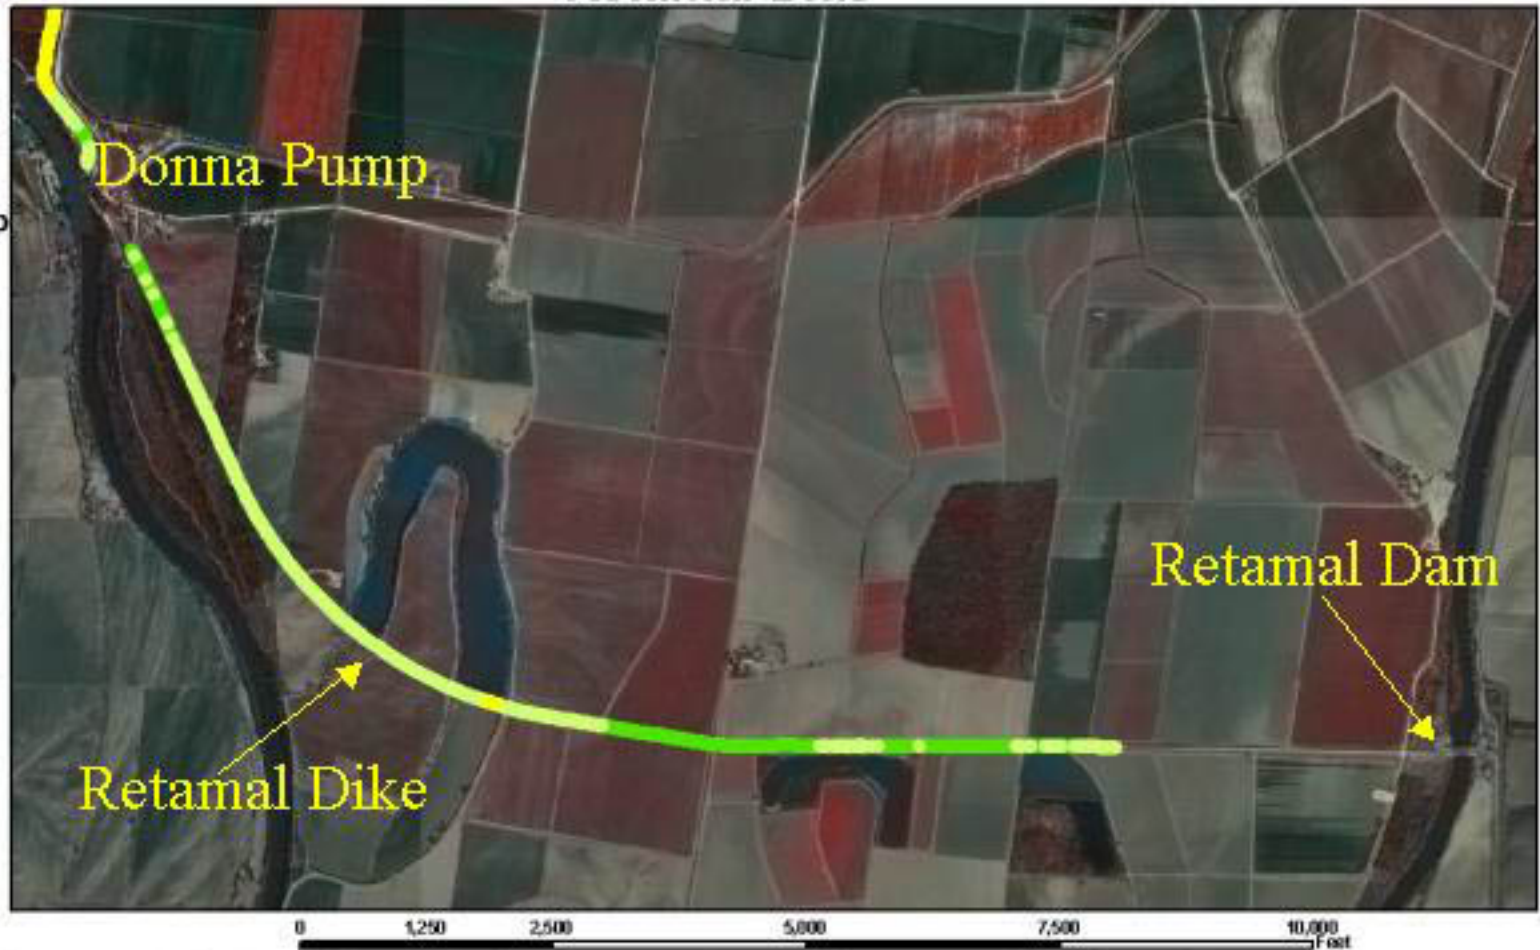
Lower Rio Grande Valley Levee Rehabilitation Retamal Dike

The levee reach connects Retamal Dam into the levee system and is commonly referred to as Retamal Dike. The purpose of Retamal Dam is to divert flood flows into the Mexican floodway. Failure of Retamal Dike would result in uncontrolled flows downstream of Retamal Dam. Investigations have indicated clay layers that dehydrate and hydrate; an insitu ponding test showed little seepage. Levee needs to be raised 2 feet on average. Estimated Construction Costs - \$ 8.8 million

Description - This levee reach connects Retamal Dam into the levee system and is commonly referred to as Retamal Dike. The purpose of Retamal Dam is to divert flood flows into the Mexican floodway. Failure of Retamal Dike would result in uncontrolled flows downstream of Retamal Dam. Initial geotechnical investigations indicated structural integrity problems with Retamal Dike. Large cracks exist on the surface and within the core of the levee. Additional investigations have been conducted and indicate that the presence of clay layers that were severely dehydrated caused these problems. A test pond simulating an in situ test in November 2004 showed little leakage under a typical flood hydrograph scenario.

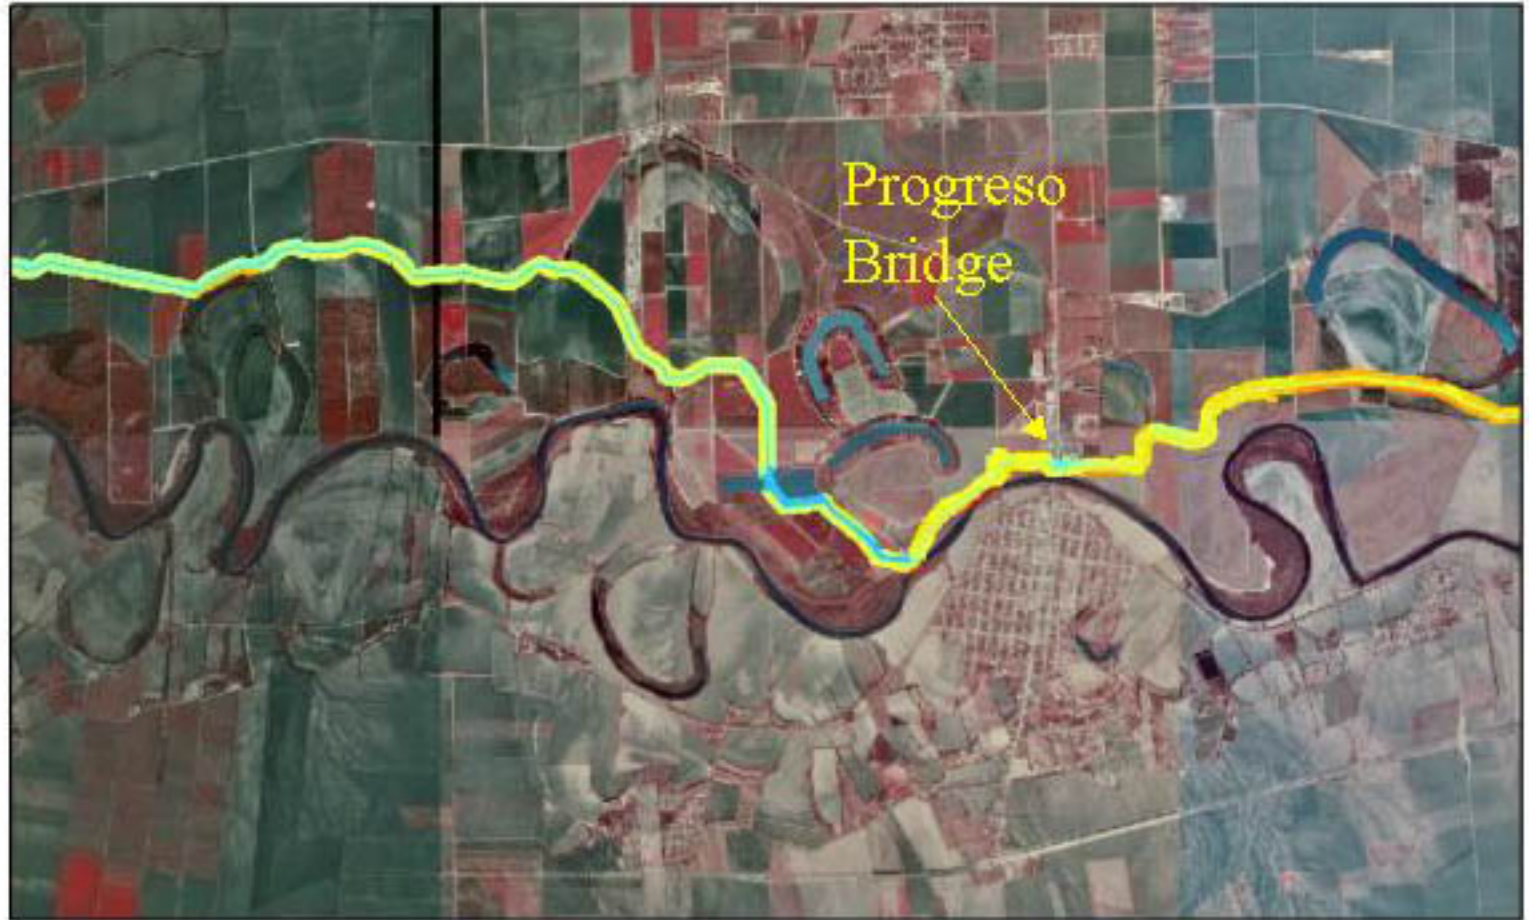
Lower Rio Grande Valley Levee Rehabilitation Progreso Bridge Reach (NO RAISING, STRUCTURAL IMPROVEMENTS ONLY)

Initial geotechnical investigations indicated levee structural integrity concerns both upstream and downstream of Progreso bridge which may warrant further geotechnical investigations. Estimated Construction Cost - \$13.7 million

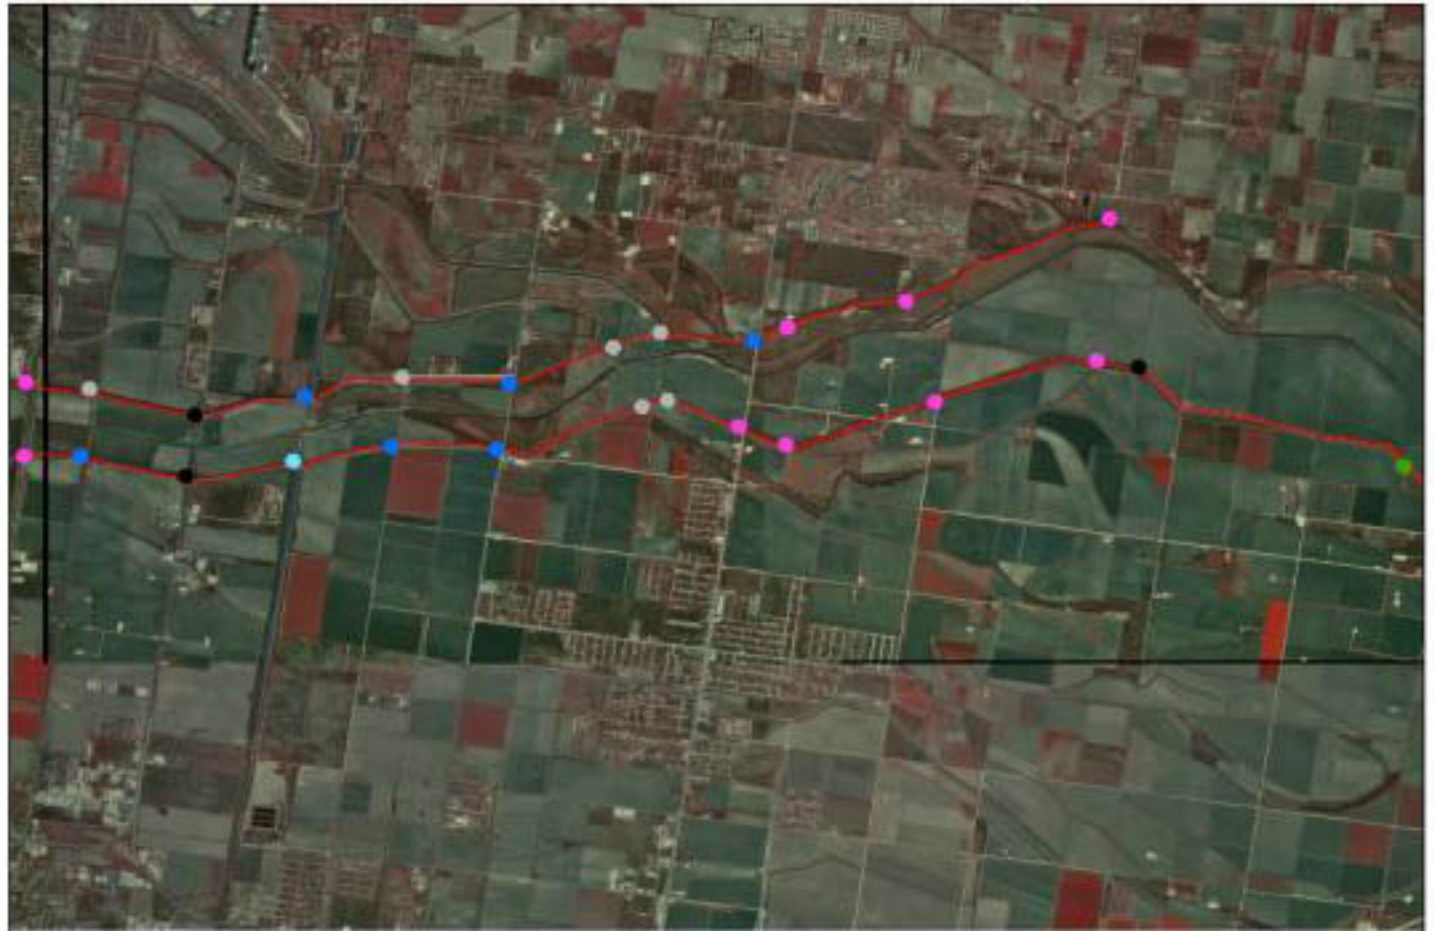
Lower Rio Grande Valley Levee Rehabilitation Main Floodway

The levees within this reach vary from 0.2 feet to 3.5 feet deficient in height. A total of 4.5 miles of levee will need to be raised. Estimated construction cost - \$3.9M

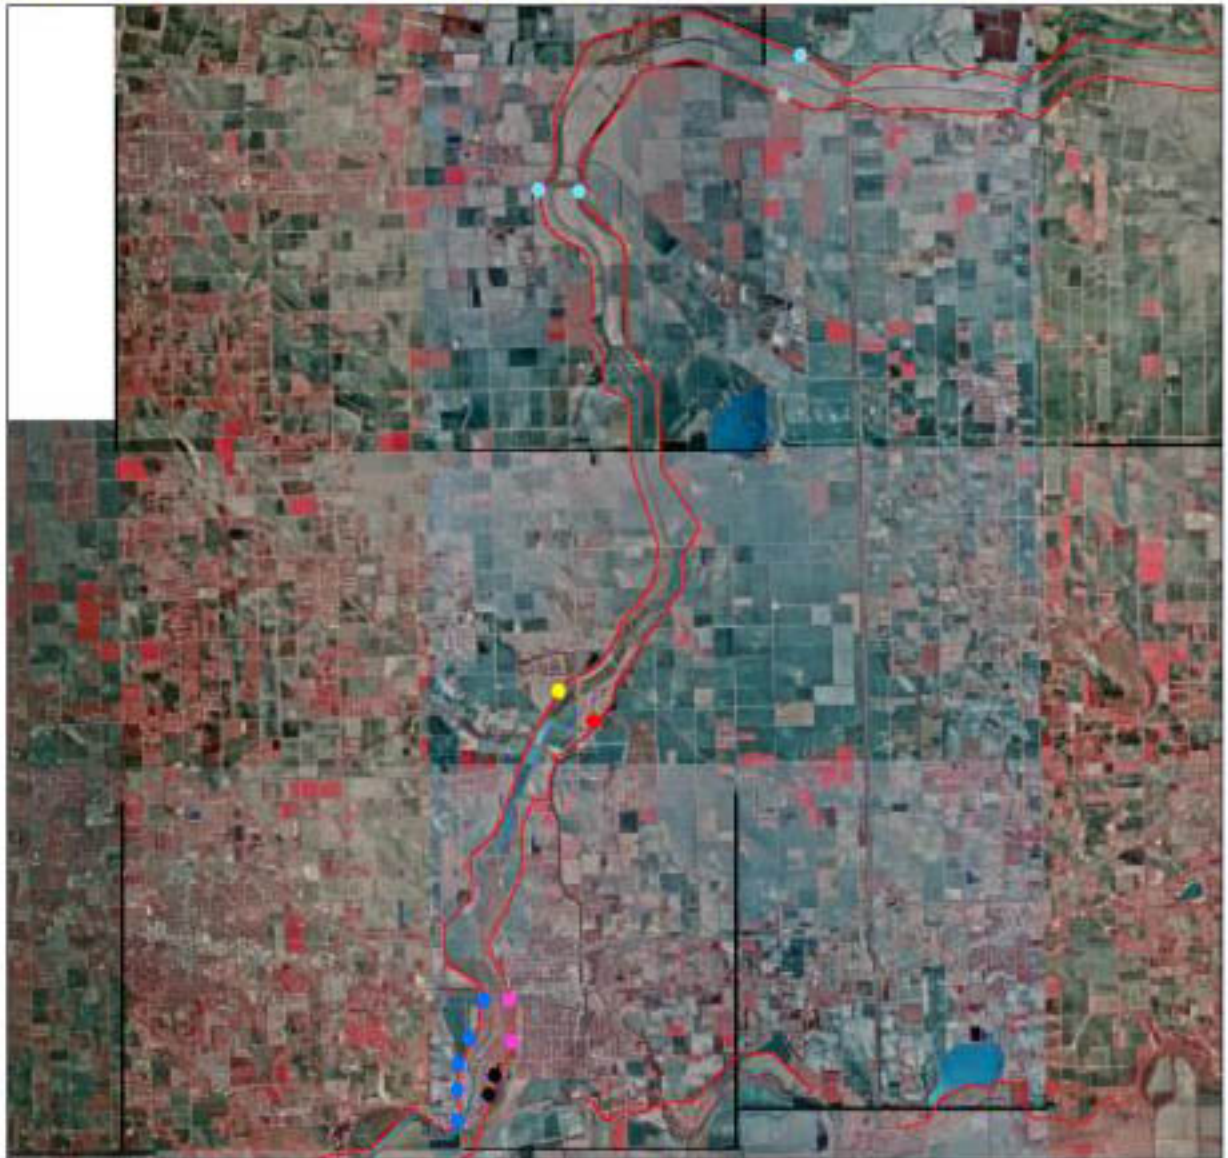
Lower Rio Grande Valley Levee Rehabilitation North Floodway Upper Reach

The levees within this reach vary from 0.1 feet to 4.4 feet deficient in height. A total of 8.7 miles require raising.
Estimated construction cost - \$6.0 M
