# **FY-2004 Safety Report**

**FOR MARITIME OPERATIONAL FORCES –  
CUTTERS.  
CUTTER BOATS,  
SHORE-BASED BOATS,  
AND MARINE SAFETY UNITS**

**Commandant (CG-1134)  
Afloat and Marine Safety Division  
Office of Safety and Environmental Health**

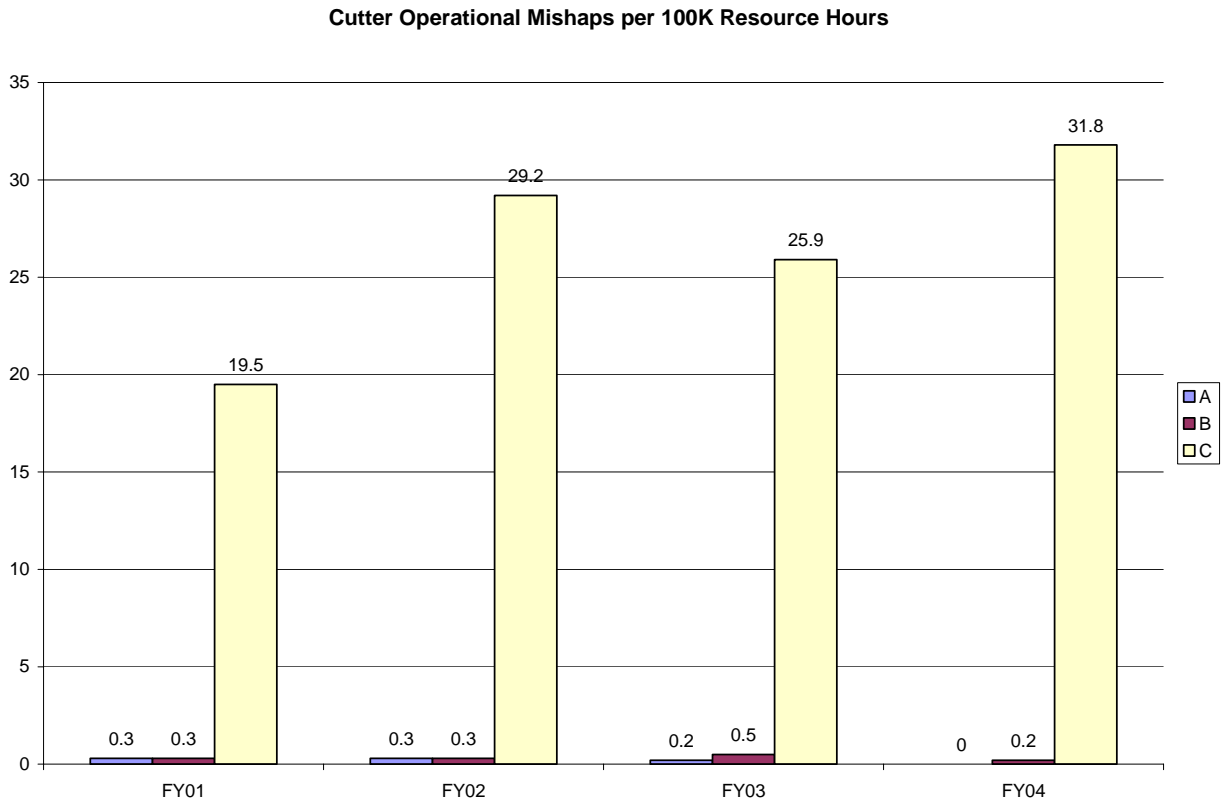
**GRAPH 1: Cutter Mishap per 100K Operating Hours**

FY 2004 saw minor but statistically insignificant changes in overall mishap rates for the cutter fleet. (See Graph 1)

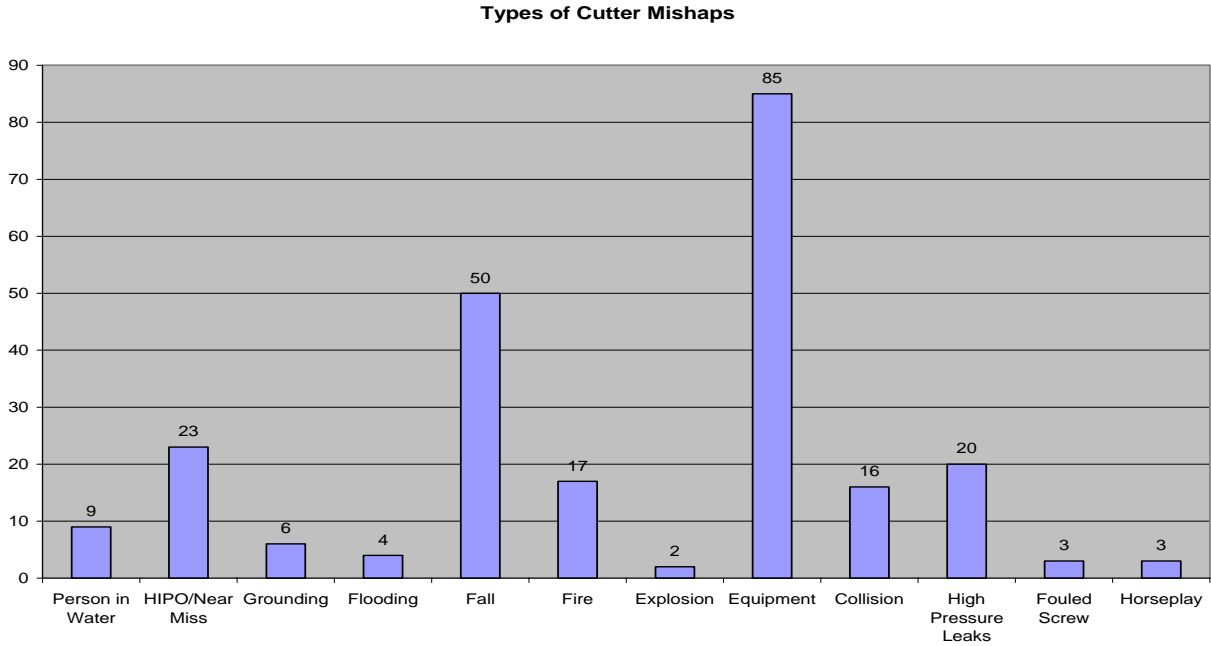
## GRAPH 2: Cutter Mishaps by Mishap Type

The vast majority of operational cutter mishaps in FY2004 were equipment related (See Graph 2) with many of them engineering-related, including 17 instances of fire and 20 of high pressure fluid leaks. These mishaps could be indicative of rapidly aging cutter fleet.

However, in contrast to the focus upon equipment & engineering issues, FY04 also saw 50 instances of falls, making them the second most prevalent type of cutter mishap. Our cutter sailors need to remain constantly aware of their surroundings and their supervisors must exercise and enforce proper risk management, even for the most mundane of tasks.

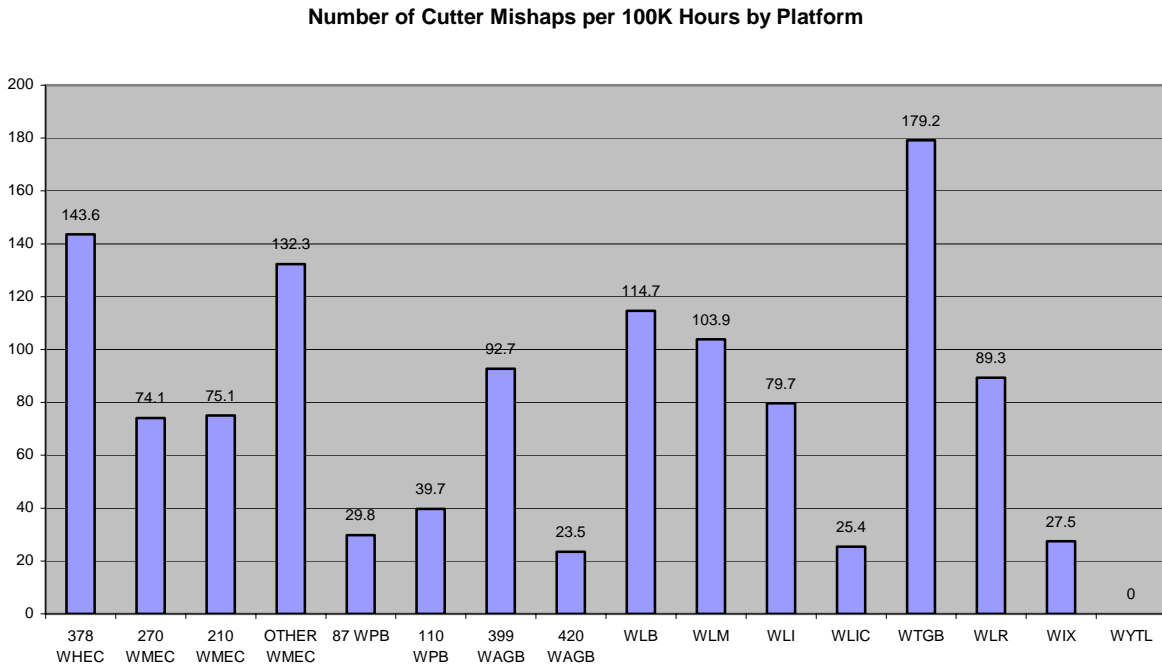
## GRAPH 3: Cutter Mishaps per 100K Operating Hour by Cutter Type

As noted above regarding the types of mishaps, there are ongoing concerns about replacement of our aging platforms. As seen below (Graph 3), the older platform-types did have a tendency for higher numbers of mishaps.

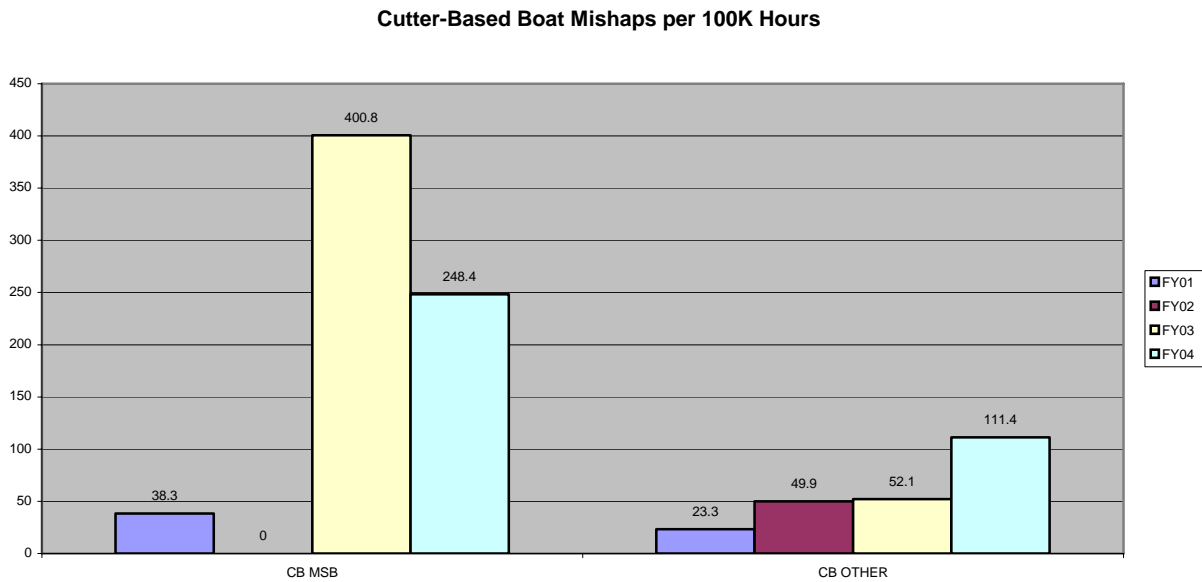
### GRAPH 4: Cutter-based Boat Mishaps per 100K Operating Hours

Cutter-based boat mishaps for non-MSB's saw an overall increase in FY04. MSB mishap rates decreased but still remained high. Much of the high rates for MSB's are an artifact of the low numbers--there were only three MSB mishaps in FY04—and the continued reduction in MSB hours since 2001

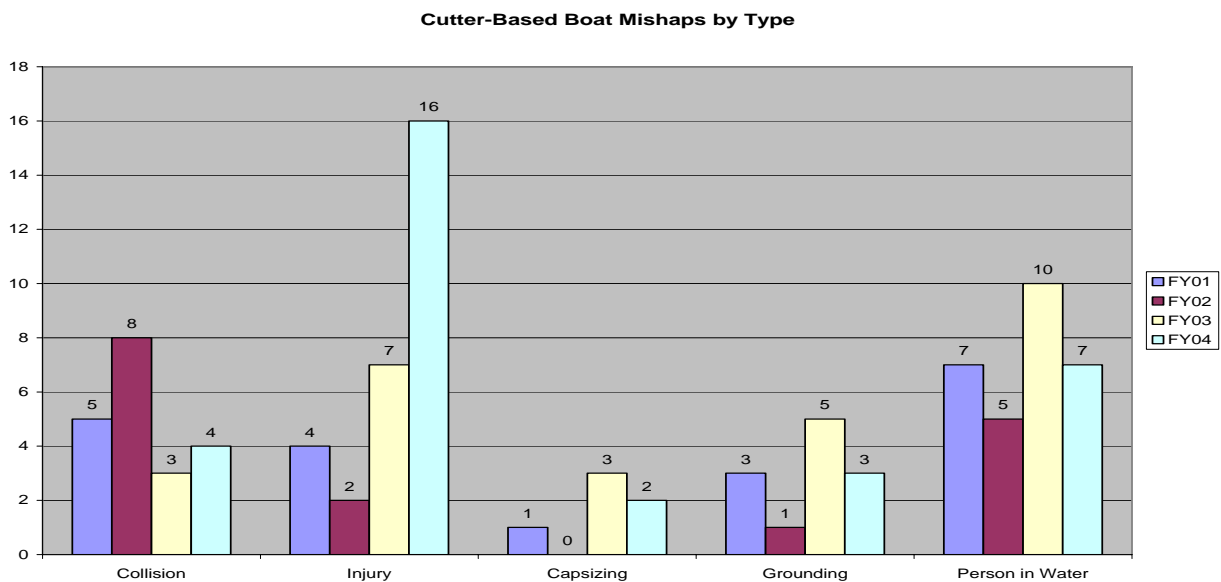
### GRAPH 5: Cutter-based Boat Mishaps by Boat Type

FY04 saw a large increase in the number of injuries reported in cutter-based small boat operations (Graph 5). Most injuries occurred during routine boarding operations and small boat retrieval. Other types of mishaps were generally reduced.

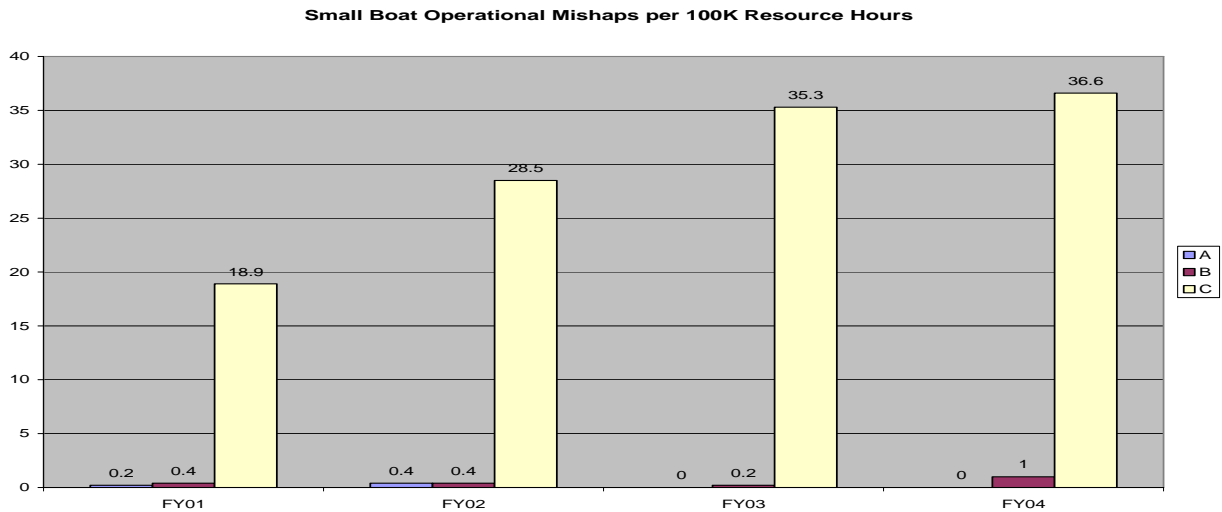
**GRAPH 6: Boat Mishaps per 100K Operating Hour**

FY04 continued the trend of constant evolution and change to the missions and composition of the Coast Guard’s shore-based boat forces. Despite the many changes, for the second year in a row, the shore-based small boat fleet experienced no class A mishaps and there were only slight, but statistically insignificant increases in both B and C mishaps. (See Graph 6)

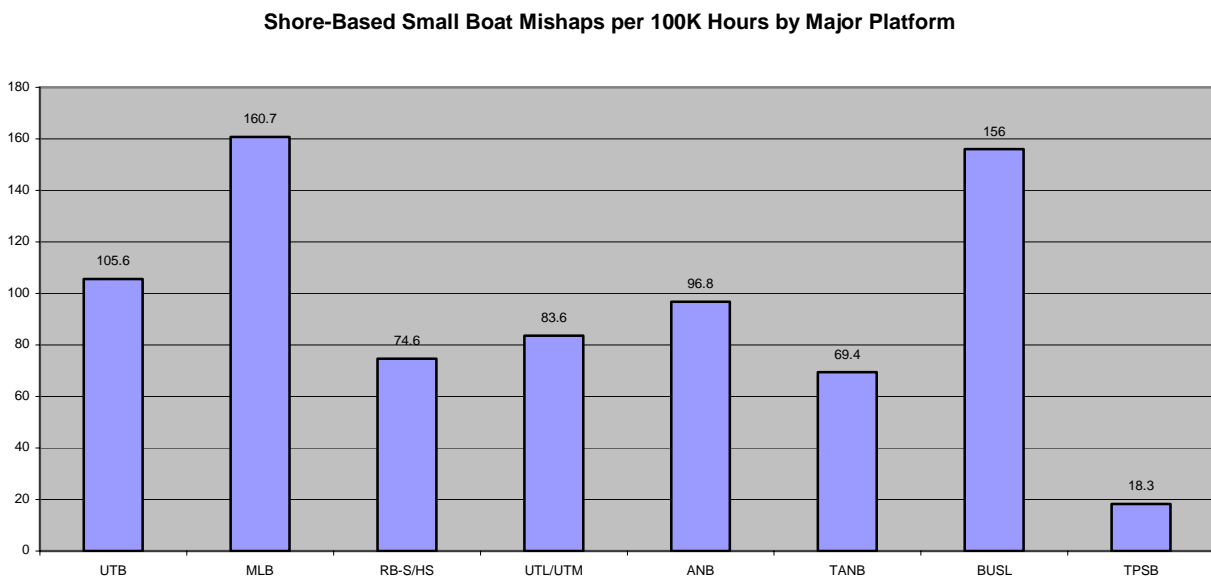
**GRAPH 7: Boat Mishap per 100K Operating Hours by Boat Type**

The MLB had the highest mishap rate of all shore-based boats in FY04. (See Graph 7). However, many mishaps were minor boat damages resulting from routine surf operations. The BUSL also saw a relatively high mishap rate with most of these occurring during actual ATON operations.

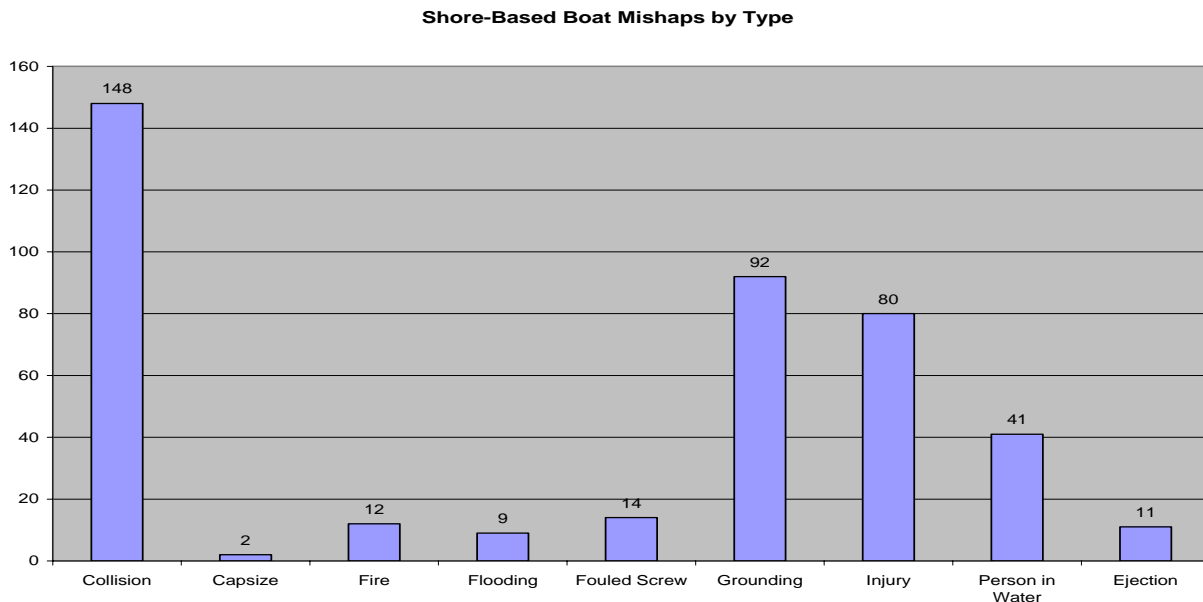
**GRAPH 8: Boat Mishaps by Mishap Type**

The majority of boat mishaps in FY04 were due to collisions and groundings. (See Graph 8) Many of the collisions occurred during boarding and towing evolutions when our boats are operating in very close proximity to other vessels. Many of the groundings occurred aboard non-standard UTL/UTM platforms which have been the selected platform for operating in shallow and shifting AORs.

E-MISHAP now allows ejections to be listed as a specific mishap type; emphasis has been placed upon this type of mishap given our newer, faster, high-performance boats such as the RB-S. Among all boat types, there were 11 ejections reported in FY04.

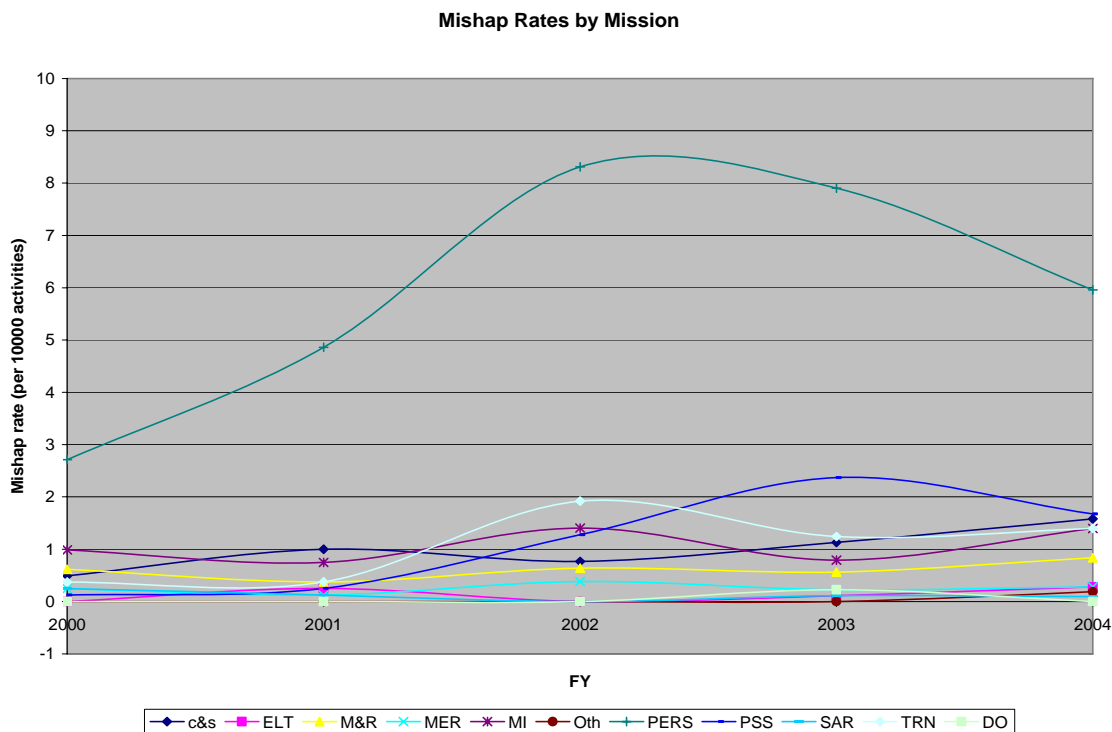
**Graph 9: Mishap Rate per 10,000 Marine Safety Activities by Mission Area**

Unlike the cutter and boat mishaps for which operating hour data is available, marine safety activities do not have longevity of mission data; thus to look at rates, use of a single specific activity is used to normalize the data. For example, in FY 2000 there were 81,150 specific activities reported for Marine Safety units; this was up to 107,409 in FY 2004. The largest number of mishaps in FY04 for Marine Safety units occurred during the PERSONal or “off-duty” times (See Graph 9). However, since MISLE does not track these, generation of a true rate is impossible. The rate shown uses the total number of activities as a surrogate to normalize the data. Regardless of the potential inaccuracy of this methodology, it tells us is that more mishaps occur as a result of sports related and motor vehicle (non-duty) related incidents and is an area that commands should focus their risk management efforts.

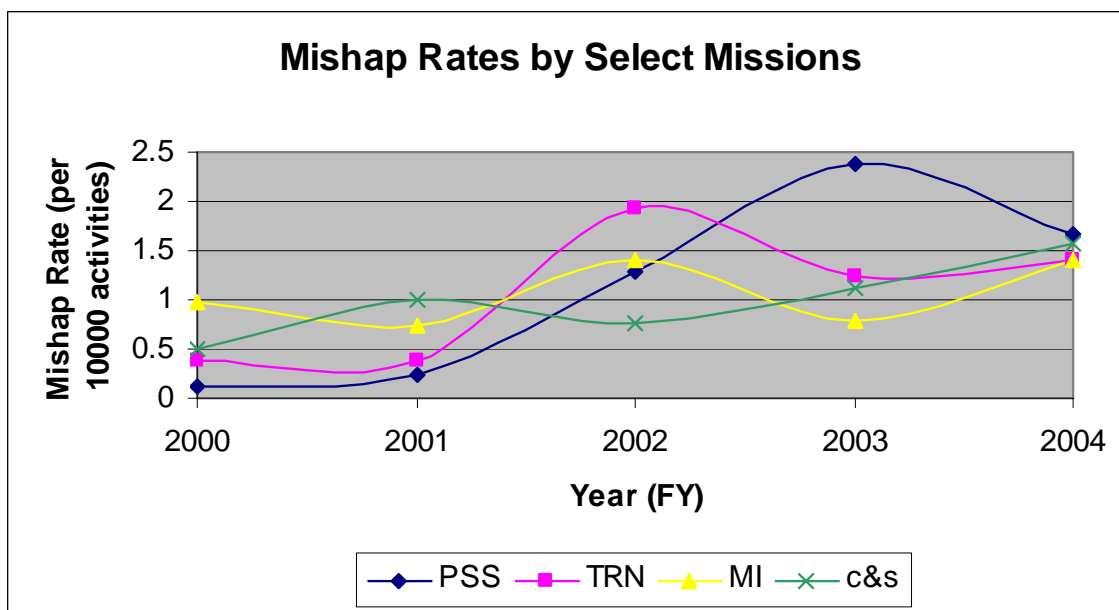
**Graph 10: Mishap Rates per 10,000 Marine Safety Activities by Selected Mission Area**

When examining all of the missions reported via the e-MISHAP system, there are four which display an increasing trend over the past 5 years (See Graph 10). These are Port Safety and Security Operations (PSS), Training Related (TRN), Marine Inspection (MI), and Command and Support (C&S) as indicated on Graph 2: Mishap Rates by Select Missions.

Port Safety and Security has showed the greatest increase over this time period with the greatest increase immediately following FY 2001. This appears to be directly related to the increase in PSS missions following the events of 9-11-2001. This is compounded by an increase in activities and change from traditional MS missions to more LE and security missions.

Command and Support mishaps have shown a slight increase over the past five years; however this may be artificially induced due to mis-reporting. A review of mishaps over the past several years indicate that many of command and support related mishaps were actually sports related or motor vehicle mishaps which may better be classified as personnel related missions, as previously noted.. Care in proper classification of mishaps is expected to help eliminate this upward trend in Command and Support mishaps.

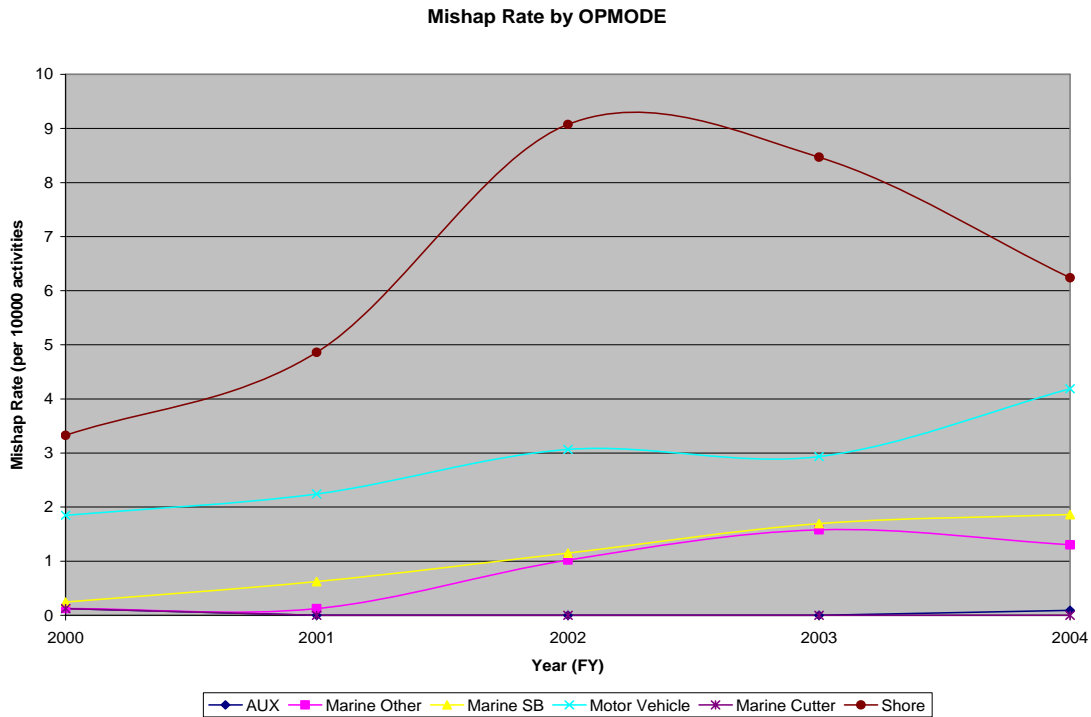
**Graph 11: Mishaps per 10,000 Marine Safety Activities by Operating Mode**

Analyzing mishaps by platform and/or mode of transportation indicates that mishaps related to motor vehicles, Small Boat, and other marine platforms (other than cutters or small boats) have been increasing over the past five years. (See Graph 11) This is countered by a marked decrease in “shore” related mishaps. This would be expected due to the increase in security missions and the increase in associated small boat or vessel operations.

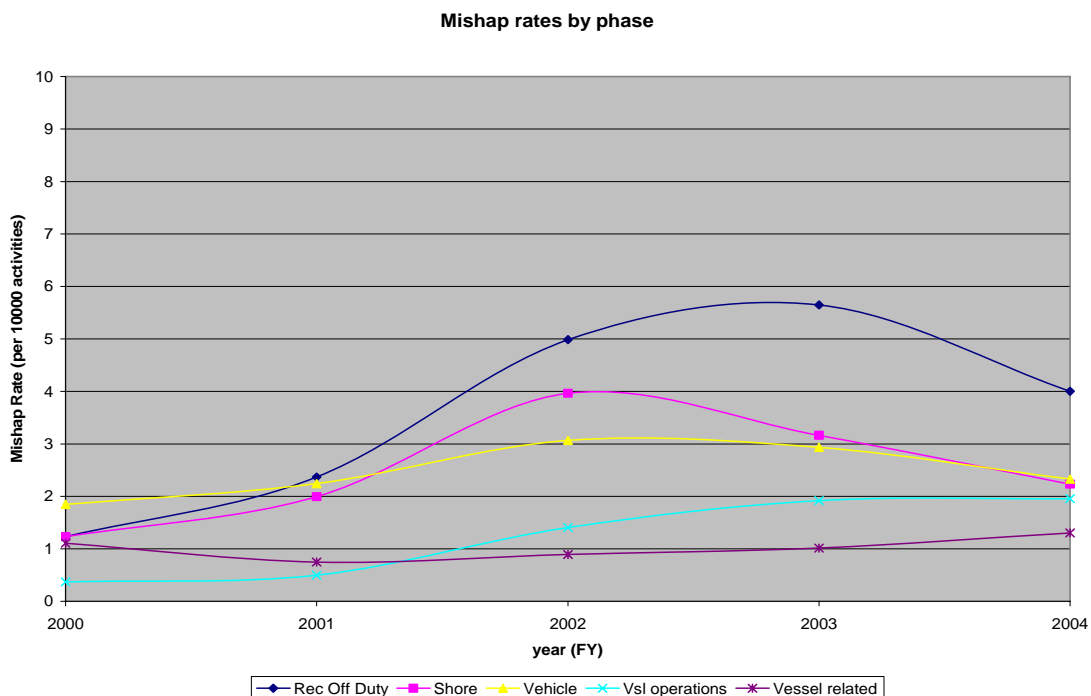
**Graph 12: Mishap Rates per 10,000 Marine Safety Activities by Phase**

By looking at mishaps by phase, it can be seen that work related vehicle mishaps have begun to decline, inferring that the rise in motor vehicle mishaps is primarily due to non-operational or personal incidents. Vessel operation mishap rates are increasing, likely reflecting the recent change in missions, increased optempo, and change in platforms. This will likely plateau or even decline in the future as new training takes hold and experience levels increase.
