APPENDIX 2
Site Activity Report

Site Activity Report

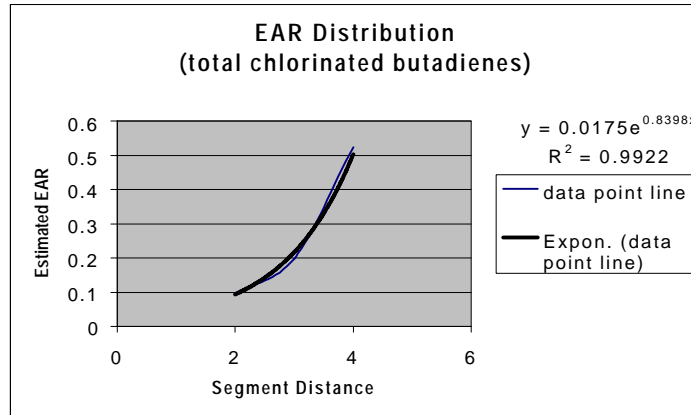
Figure A5-1

REGRESSION ANALYSIS OF TOTAL CHLORINATED BUTADIENE DATA

As shown in the EAR distribution graph for total chlorinated butadienes (**Figure A5-1**), the non-linear (exponential) regression line displays a close fit with the data points. The R squared value of 0.9922 represents a high level of correlation between the data points and the imposed trendline. The formula generated by this analysis (displayed in the graph legend) is henceforth considered the non-linear distribution formula.

Non-Linear Distribution Formula: $y = 0.0175e^{0.8398x}$
