Safety Evaluation Report

Related to the License Renewal of
the Millstone Power Station,
Units 2 and 3

Docket Nos. 50-336 and 50-423

Dominion Nuclear Connecticut, Inc.

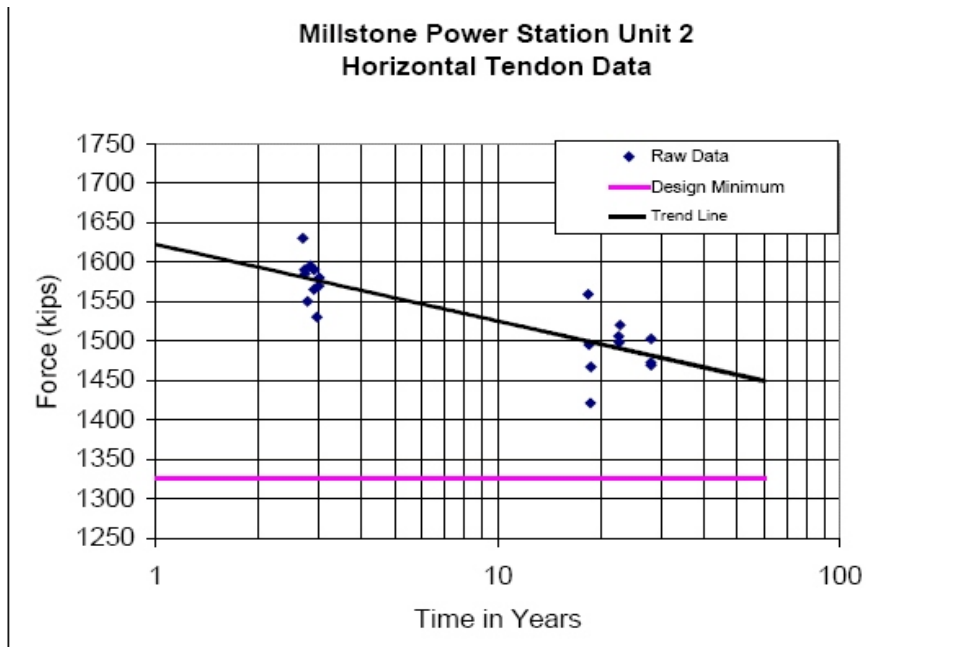
each group of tendons. In response to the staff's follow-up question as to why 3-, 5-, and 10-year data are missing from the tables, the applicant stated that as these tendons went through repeated tensioning and detensioning, the data were not reliable. The measurements taken during the 1-, 15-, 20-, and 25-year inspections were used for developing the trend lines. In Figures 1, 2, and 3 of the revised response (dated January, 11 2005), the applicant provided the trend lines and the measured tendon force data. Figure A, showing the trend line related to horizontal tendons, is reproduced below:

Figure A: Trend Line Relationship with Horizontal Tendons

In its response, in a letter dated January 11, 2005, the applicant confirmed that it is using procedures for monitoring and trending prestressing force consistent with the recommendations in RG 1.35.1 and NRC Information Notice 99-10. Therefore, the staff finds the process acceptable, as the use of RG 1.35.1 for estimating the target prestressing forces, and Information Notice 99-10 for projecting the actual measured prestressing forces (as illustrated in the figure above), provides the elements needed for an adequate TLAA.
