# RESIDENTIAL FIRE SPRINKLERS RETROFIT DEMONSTRATION PROJECT

Final Report

Phase II:  
Single-Family  
Structures  
Case Studies

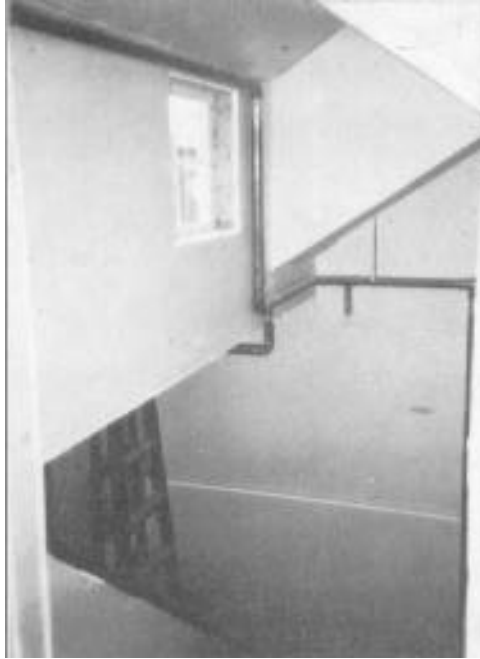
Pendent Sidewall Sprinkler Head Located in Staircase to Upper Apartments

The water pressure in the building was sufficient to allow use of pendent sidewall sprinkler heads in all rooms other than the laundry and storage areas. Ceiling pendent heads were used in the laundry and storage areas. The system design team also had to consider that the rehabilitation plan for the building did not include demolition of existing walls. Customarily, piping is concealed by walls and ceilings, but to do so in this project would have required work not planned and would, according to the project team, have significantly raised the cost of the system. Instead, the team

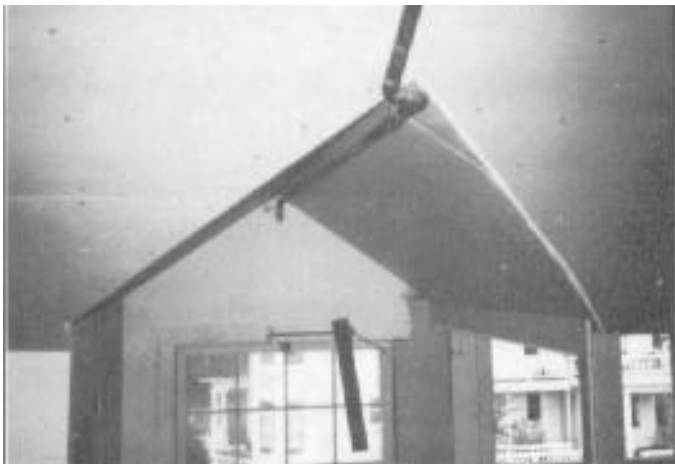
Sprinkler in Dormer in Top Floor Apartment. This unit was deemed a habitable space-by SFD because of the installation of fire sprinklers.

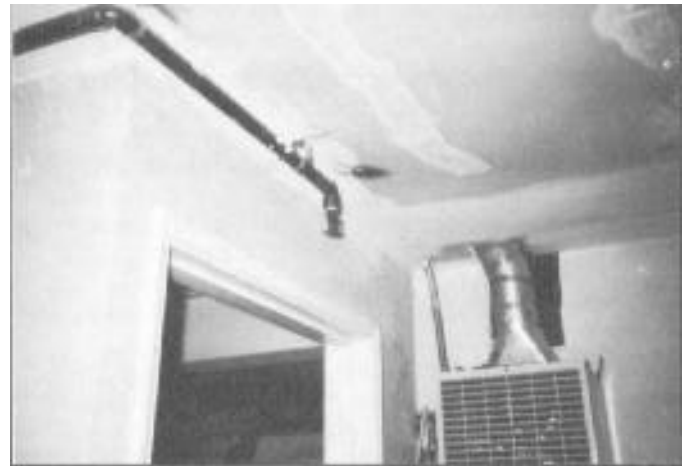
Pendent Sidewall Sprinkler Head in Furnace Area. Pendent sidewall heads were used throughout most of the Victoria Apartments.

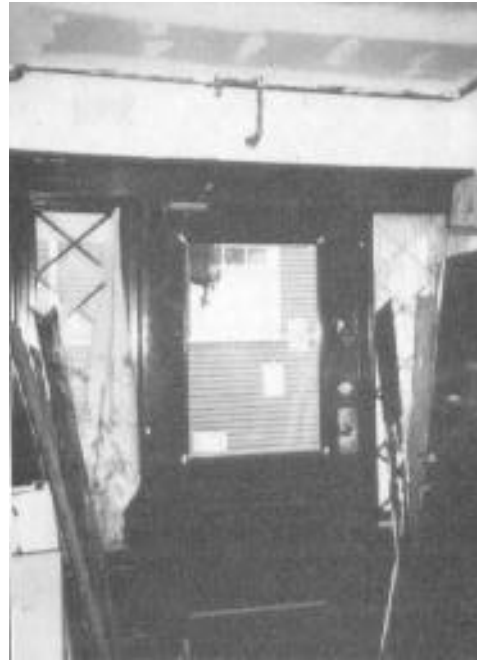
View of front door depicting branch to front porch where a freeze-proof dry pendent was employed.

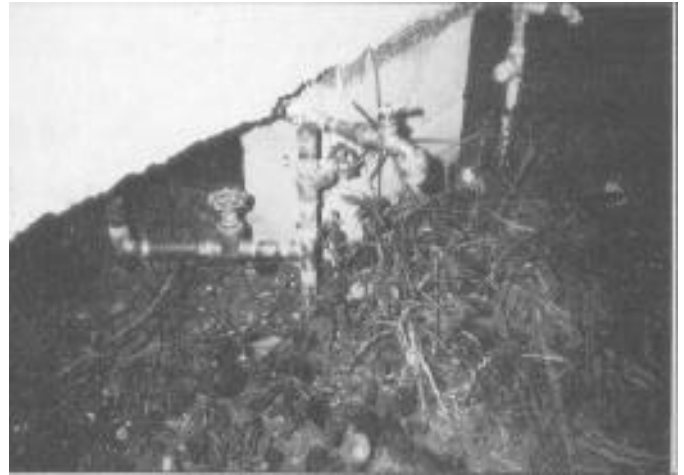
Exterior View of Sprinkler Water Connections at Miller St. Home.

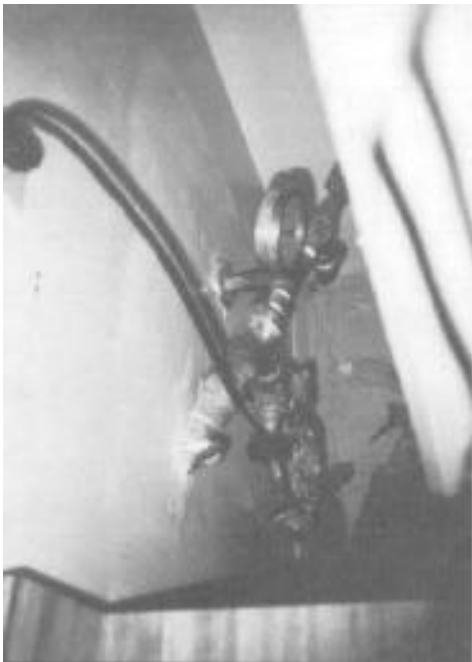
Control Valves at Miller St. house were located behind the refrigerator to discourage tampering.

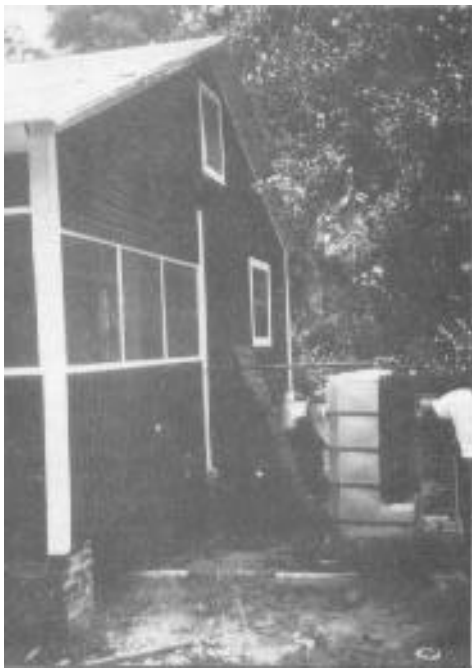
Pump and reservoir system, located behind house.

Annapolis Junction, MD. The system is named "The D System." According to a price list distributed by HFS the components used in this installation, a "D" system with 1.5 horsepower pump and 440-gallon storage tank costs \$2,250.

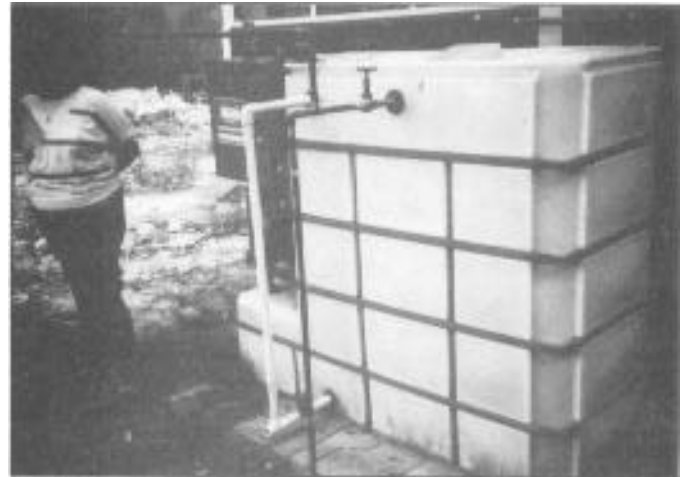
Second View of Pump & Storage System

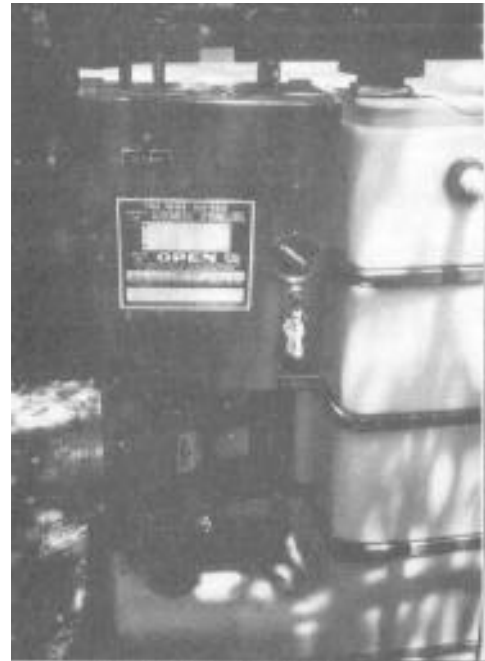
Control panel for pump & storage system.

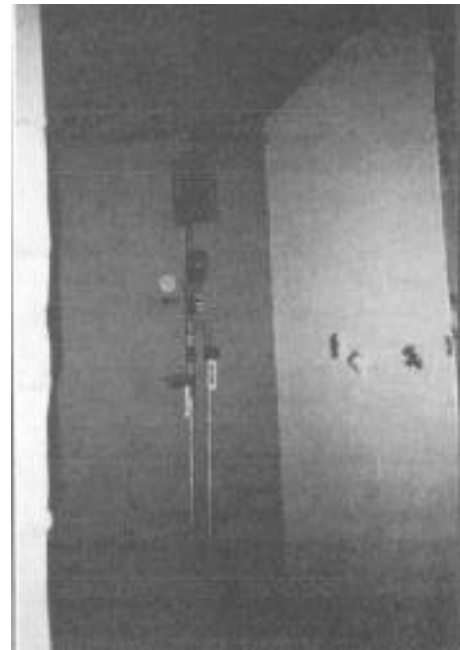
Water service to Sprinkler System, with valve tags and user's guide

The St. Petersburg Water Department charges a monthly base rate in addition to metering water consumption in residential dwellings. The existing water service to this dwelling was not adequate to operate a fire sprinkler system. The size was 5/8-inch by 3/4-inch, and the St. Petersburg Fire Department determined that a 1-inch line would be needed. According to the director of St. Petersburg's Department of Public Utilities, the

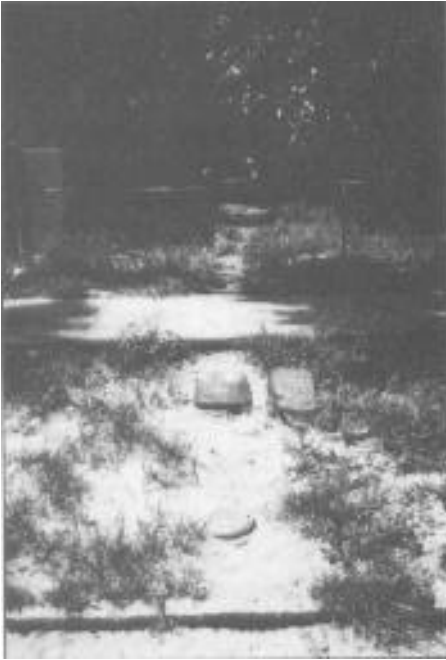
Some Water Departments Require New Metered Water Supplies to Sprinkler Systems. New Meter Box is Shown Here Adjacent to Existing Meter.

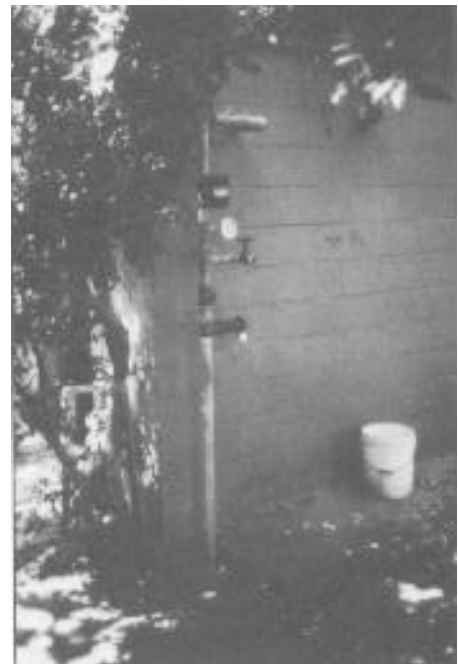
New Water Service for Sprinkler System at 11th Street Home. Supply valve was locked with lock and chain to prevent valve closure.

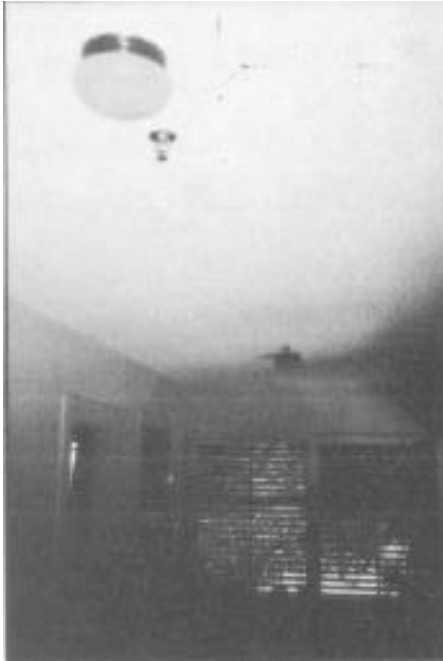
Typical Finished Ceiling with Conventional Pendant-Type Sprinkler Head

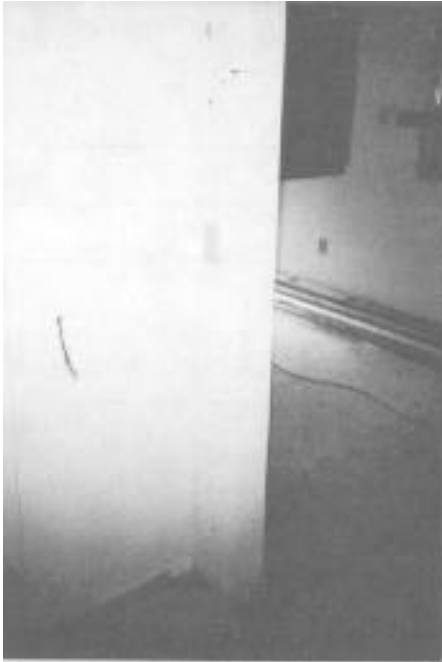
Rehabilitation of North Marks Street House included measures taken to enhance accessibility to wheelchair occupant. Shown here is a wall switch lowered to 42 inches.
