Energy Code Compliance Study

Honolulu and Hawaii Counties

January 15, 1999

State of Hawaii
Department of Business, Economic Development, and Tourism
Energy, Resources, and Technology Division

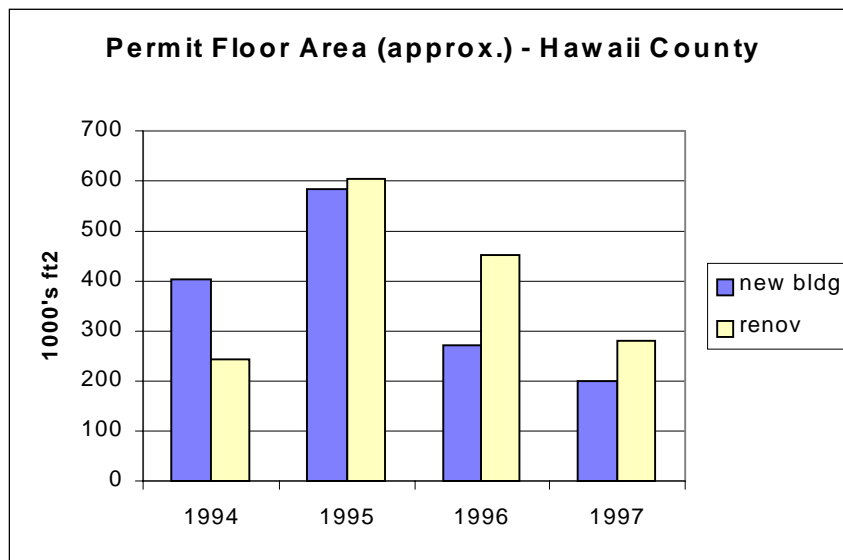
Figure 8
Floor Area Estimates,
Hawaii County

Source: calculations of floor area based on permit value reported in *Construction in Hawaii 1998*, Bank of Hawaii.

Floor area estimates are shown in the following two charts. These are approximate estimates based on the permit value illustrated in the previous graphs. Construction cost is assumed to be about \$150/ft² for new buildings and \$75/ft² for renovations.
