RATIONALIZATION AND OPTIMIZATION OF UNDERWATER INSPECTION PLANNING CONSISTENT WITH API RP2A SECTION 14

FINAL REPORT

DOC REF CH104R006 Rev 0 November 2000

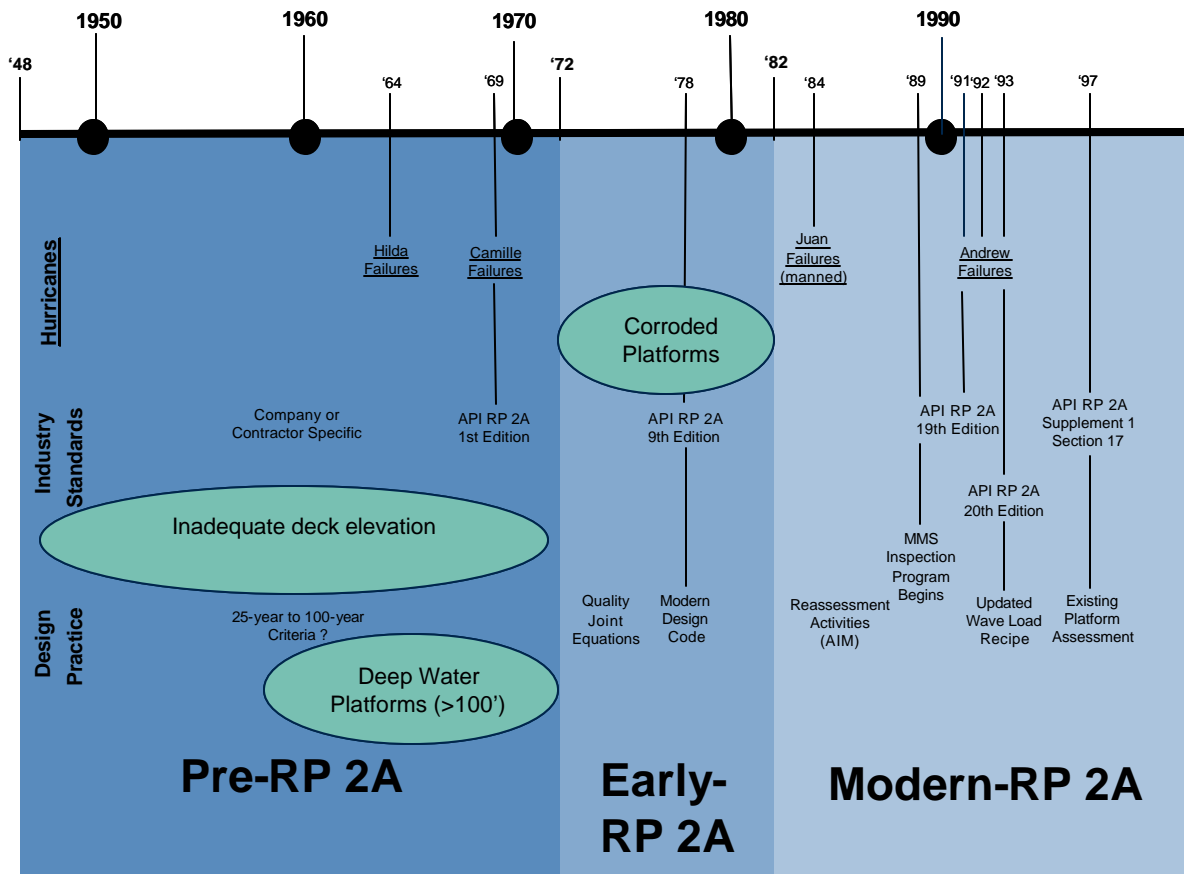
Gulf of Mexico Platform Vintage Categories

Weld/joint defects consist of cracks, fabrication defects and joint overload failures. Defects of this type correlate closely to platform vintage, and to identifiable subsets of platforms within vintages as defined in the figure below.

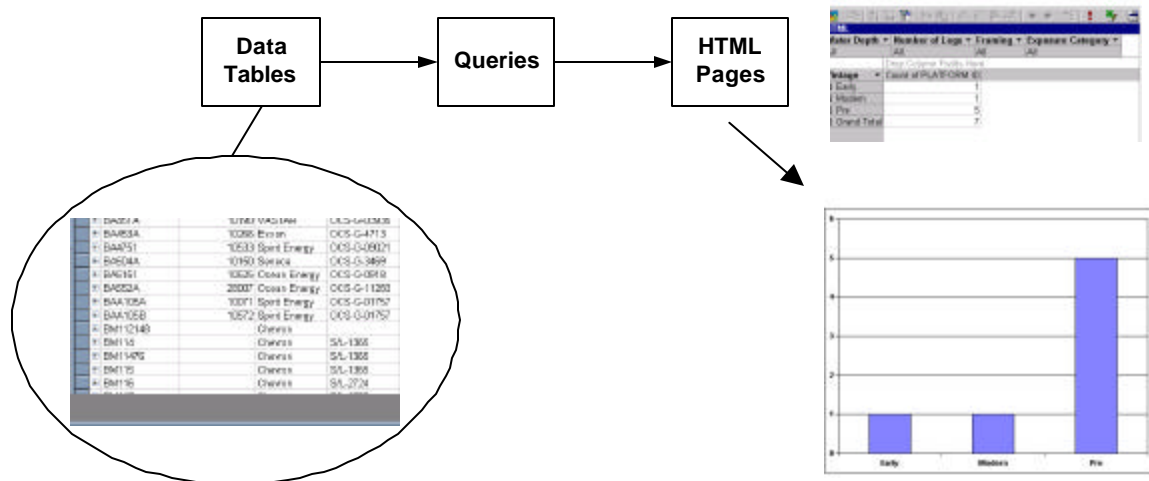
Figure 4.2: Database Configuration

In addition to the data-tables, the database includes a number of other objects. These include queries and HTML Pages. Queries are used to cross-reference and interrogate data from any combination of data-tables. The results are presented in a new query-table. This offers the advantage that if the source data in a specific data-table is modified then the query automatically updates. HTML Pages are used to analyze data either in data-tables or in queries or any combination thereof. Pivot tables are typically to facilitate the analysis. The data from the pivot table/s can be presented graphically and the Pages permit user interaction for investigation of what-if scenarios without affecting the source data, as illustrated in Figure 4.2.

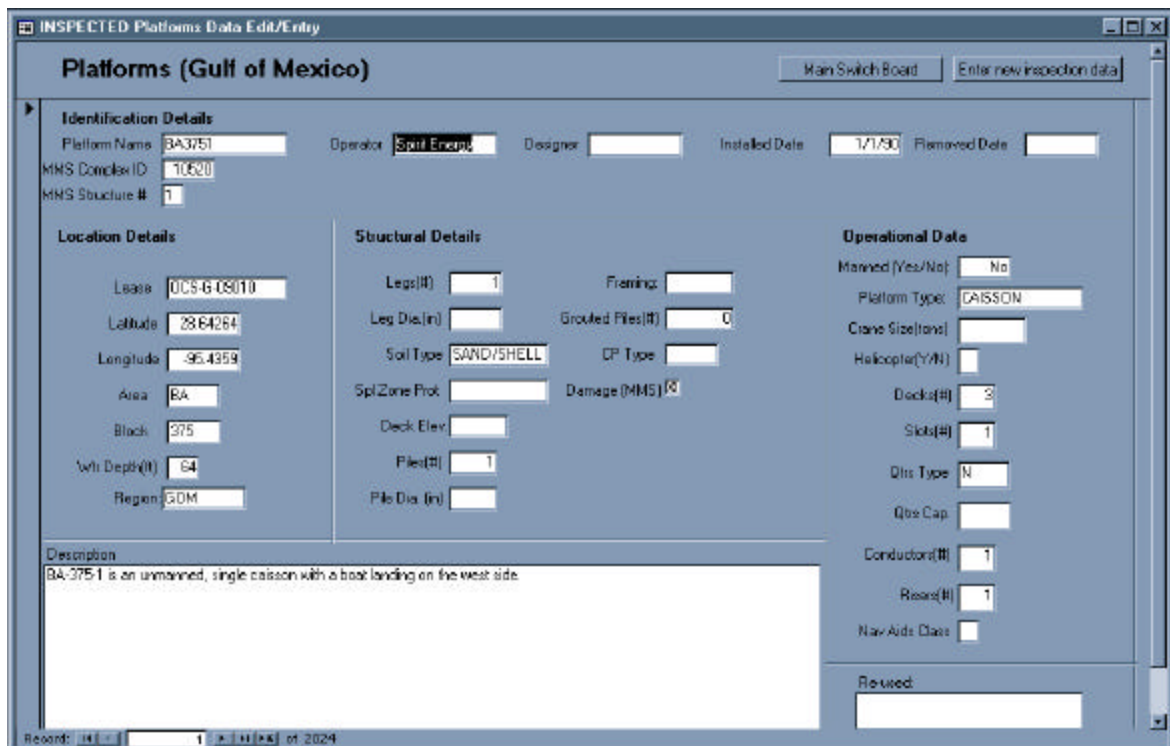
The platform data-table contains fields for the inclusion platform data relevant to its structural integrity management. The data-table includes platform identification details, structural details and selected operational data. The platform data-table includes referential links to five MMS databases, which contain information relating to the complex, the structure, the location, the removal status and reported damage of all Gulf of Mexico OCS installations. In the development of the database and the establishment of the links, each platform was given a unique identifier, consistent with that used in the MMS databases, essentially a concatenation of the complex ID number and the structure number. Also provided was a name formed from the Area, Block and Platform number; the identification commonly used by operators. The platform identification details and all other details that identify specific platforms have been removed in the delivered database, to fully de-sensitize the data.

The screenshot shows a software window titled "INSPECTED Platforms Data Edit/Entry" with a sub-header "Platforms (Gulf of Mexico)". The interface is divided into several sections:

- Identification Details:** Platform Name: BA375, Operator: Scott Enepps, Designer: [blank], Installed Date: 1/1/90, Removed Date: [blank], MMS Complex ID: 10620, MMS Structure #: 1.
- Location Details:** Lease: OCS-G-08010, Latitude: 28.64264, Longitude: -96.4359, Area: BA, Block: 375, Wht Depth(ft): 64, Region: GDM.
- Structural Details:** Legs(#): 1, Framing: [blank], Leg Dia.(in): [blank], Grouted Piles(#): 0, Soil Type: SAND/SHELL, CP Type: [blank], Spl Zone Prot: [blank], Deck Elev: [blank], Pile(#): 1, Pile Dia. (in): [blank], Damage (MMS): [checked].
- Operational Data:** Manned (Yes/No): No, Platform Type: CAISSON, Crane Size(tons): [blank], Helicopter(Y/N): [blank], Decks(#): 3, Slots(#): 1, Dirs Type: N, Qbs Cap: [blank], Conductors(#): 1, Risers(#): 1, Nav Aids Class: [blank].

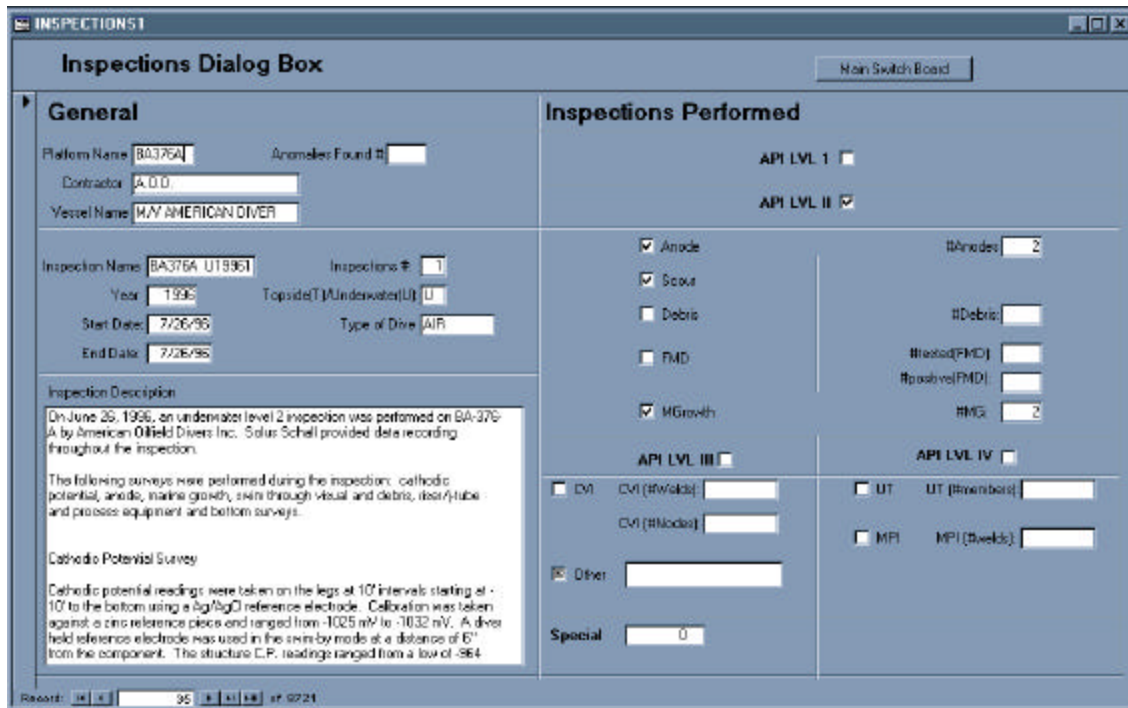
Figure 4.4: Inspection Data

The inspection data-table contains fields for the inclusion of information necessary to describe each platform inspection. General information includes the contractor, vessel and inspector details, the type, API level and the duration of the inspection, the surveys carried out and a summary of the results of each survey. Once again, fields containing platform identification information or other sensitive data have been removed from the delivered database.

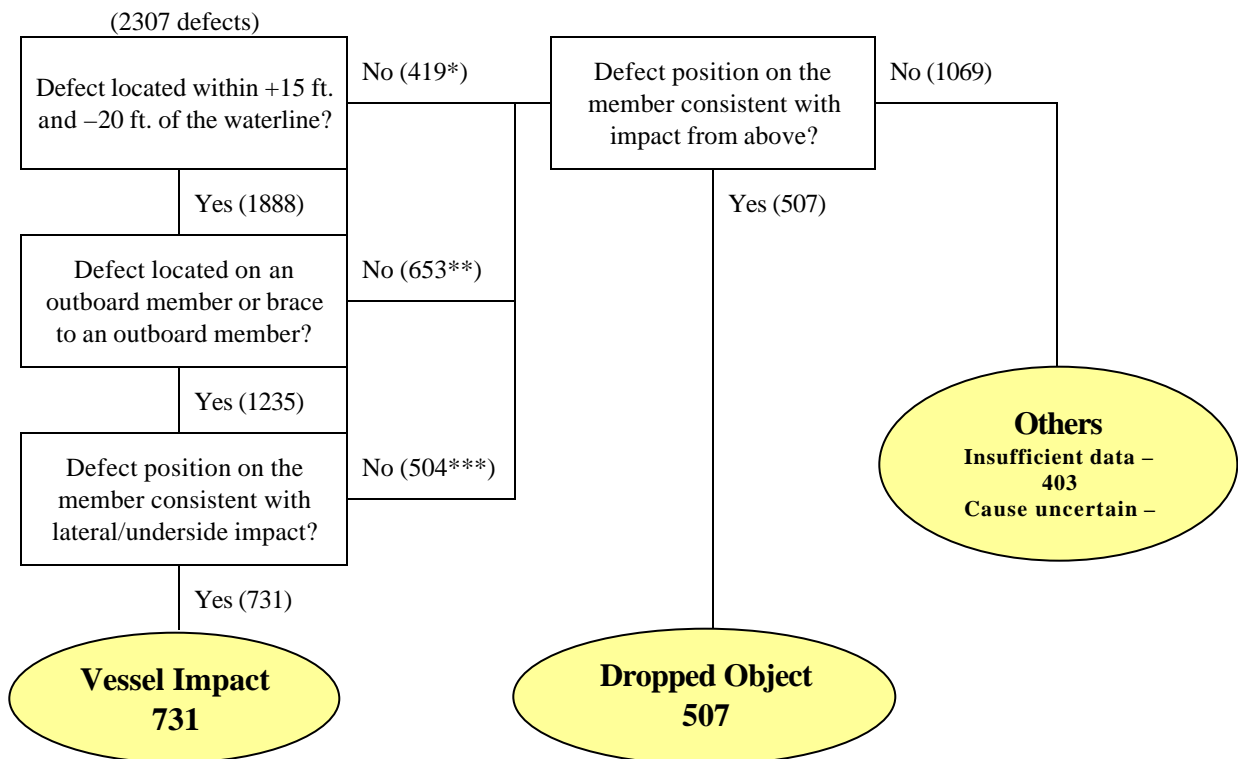
The criteria given above are not intended to be absolute; rather, they are intended to isolate the cause of a sufficient number of defects to provide information on the relative importance of each of the possible causes of mechanical damage. The process of applying the criteria to the mechanical damage defects in the database is illustrated in the flow chart, Figure 5.5. The defects falling into the “other” category were either assigned as installation defects if identified as such in the comment fields in the database or else they were categorized as “cause unknown”.

*No depth information for 5 of these 419 defects

**No defect location information for 95 of these 653 defects

It was not possible to reliably isolate the cause for approximately 50% of the total mechanical damage data. This was due to incomplete defect recording in the source data. The guidelines being generated will endeavor to address the issues of data recording and reporting on a survey-by-survey basis to ensure the suitability and completeness of data for engineering assessment and trend analysis. Nevertheless, due to the quantity of the source data we were able to identify significant populations of data associated with both vessel impact and with dropped object damage as shown in Figure 5.5.

The results of the investigation into the most probable cause of mechanical damage defects are shown in Figure 5.6. The figure indicates that, of the defects for which cause could be reliably estimated, approximately 53% were by vessel impact and 47% by impact from dropped objects. None of the defects could be reliably attributed to installation damage. Of the 666 defects for which cause could not be reliably determined, a large number were suspected to be vessel impact damage due to their location in the splash zone, however, because other data was incomplete the defects did not meet the filter requirements, illustrated in Figure 5.5, and were screened out of the trend analyses.

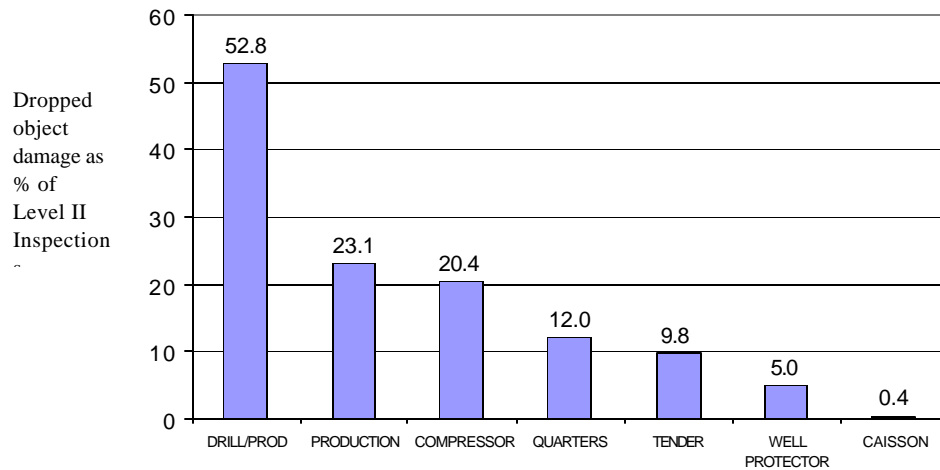
Figure 5.9: Dropped Object Damage by Platform Type

The platforms in the database are divided by their operational function into a number of types. The occurrence of dropped object damage among platforms of different types is illustrated in Figure 5.9. The vertical scale is a ratio of platforms found with dropped object damage to the number of API Level II inspections carried out on platforms of that type (expressed as a percentage). Figure 5.10 shows the same distribution but for vessel impact damage. Figure 5.9 shows that mechanical damage from dropped objects was found in more than half of all inspections of drilling/production platforms. In contrast, the occurrence of dropped object damage to caisson type platforms is extremely rare.

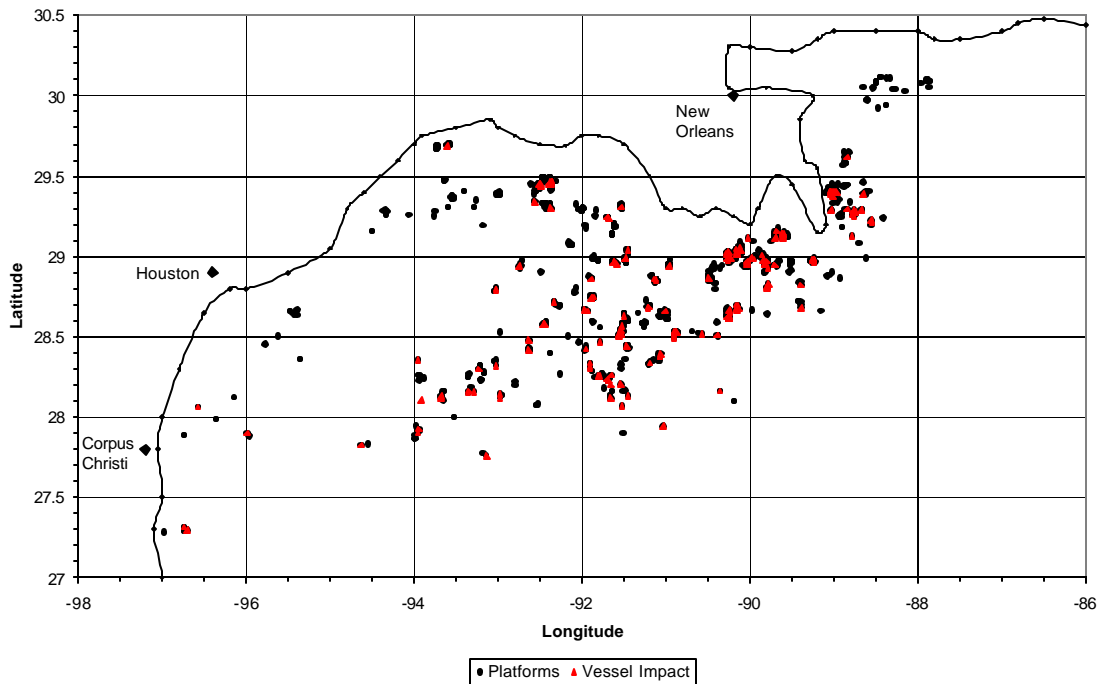
Figure 5.11: Platform Location and Vessel Impact Damage

The influence of the platform location on the likelihood of vessel impact damage was explored. The black circles in Figure 5.11 show the location of platforms in the database that have received at least one API Level II underwater inspection. The red triangles show platforms that have suffered mechanical damage from vessel impact. The figure shows no clear pattern indicating correlation with shipping routes, indicating that platform supply and service vessels are likely responsible for the majority of impacts. This is supported by the fact that most damage is of minor structural significance, consistent with low vessel mass and/or velocity during impact.

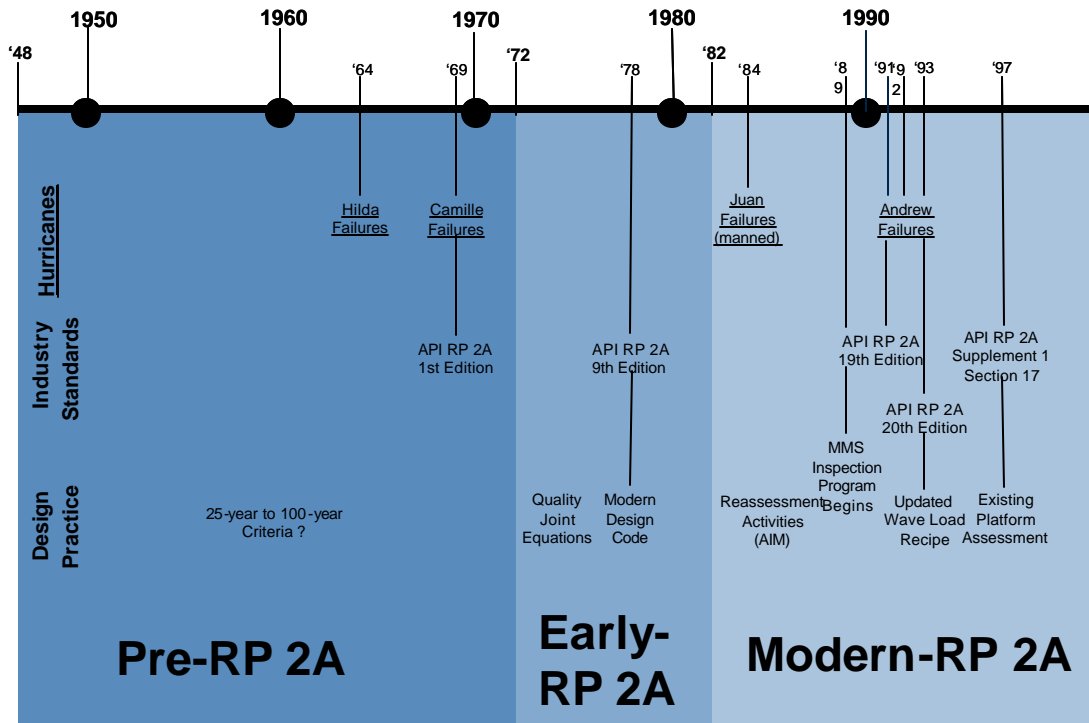
Figure 5.13: Gulf of Mexico Platform Vintage Definitions

Figure 5.13 illustrates the vintage definition in the context of the occurrence of major Gulf of Mexico hurricanes and significant changes in design practice and industry standards.

At the outset of the JIP an attempt was made to define platform categories, within the Gulf of Mexico, to assist with the identification of different platform susceptibilities to various types of damage. This initial categorization of the platform fleet into ‘vintages’ was based largely upon the prevalent design practice at the time of installation. The validity of the initial vintage categories was tested by close examination of reported damage within and across platform vintages and the vintage classification adjusted to accord with the recorded platform damage. Three vintages were identified, as illustrated in Figure 5.13. The basis for their selection is discussed below

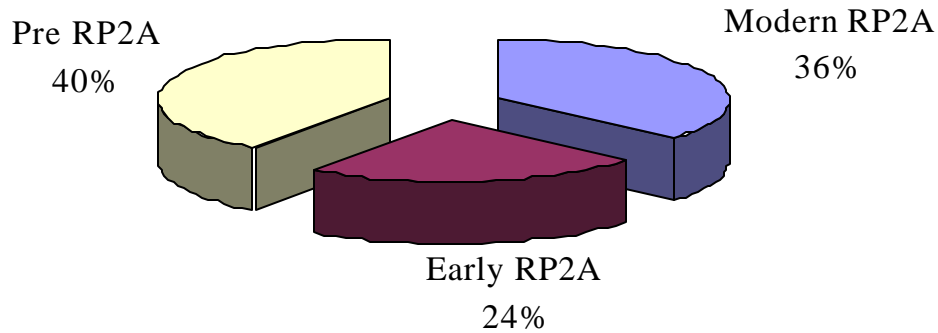
Figure 5.14: Database Platform Population by Vintage

Figure 5.14 shows the proportional distribution of the database platform population by vintage. The figure shows the JIP database contains a sizable population of platforms for each of the three vintages. The numbers and levels of underwater inspections contained in the database for each vintage of platform are shown in Table 5.5.

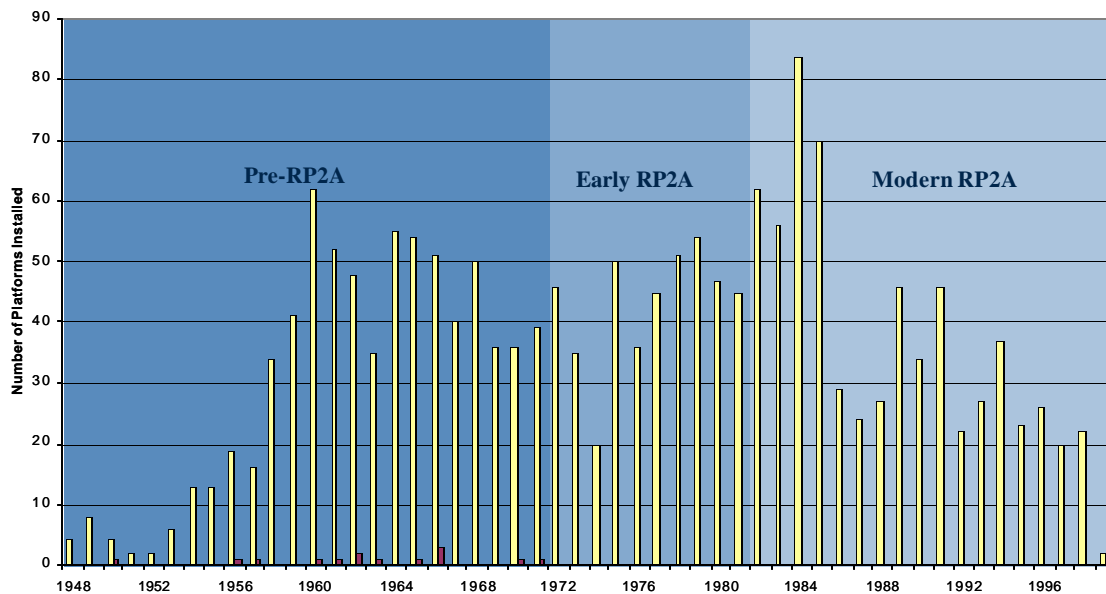
Figure 5.20: Pre-RP2A Vintage Platforms with Multiple Fatigue Cracks

Pre-RP2A platforms are defined as those platforms installed between 1948 and 1971, inclusive. Figure 5.20 shows the number of inspected platforms in the JIP database installed each year in the Gulf of Mexico. Also shown on the figure are those pre-RP2A platforms where suspected general fatigue damage has been found. Since fatigue is a time-dependant phenomenon, it would be expected, all else being equal, that fatigue cracks would be found on the oldest of the platforms in the vintage. The figure shows that, in fact, the platforms installed towards the latter part of the era have a higher susceptibility to general fatigue cracking. This apparent contradiction can be explained by looking at platform water depth.

Yellow (longer) bars show number of platforms installed

Red bars show number of platforms with multiple (>1) suspected general fatigue cracks

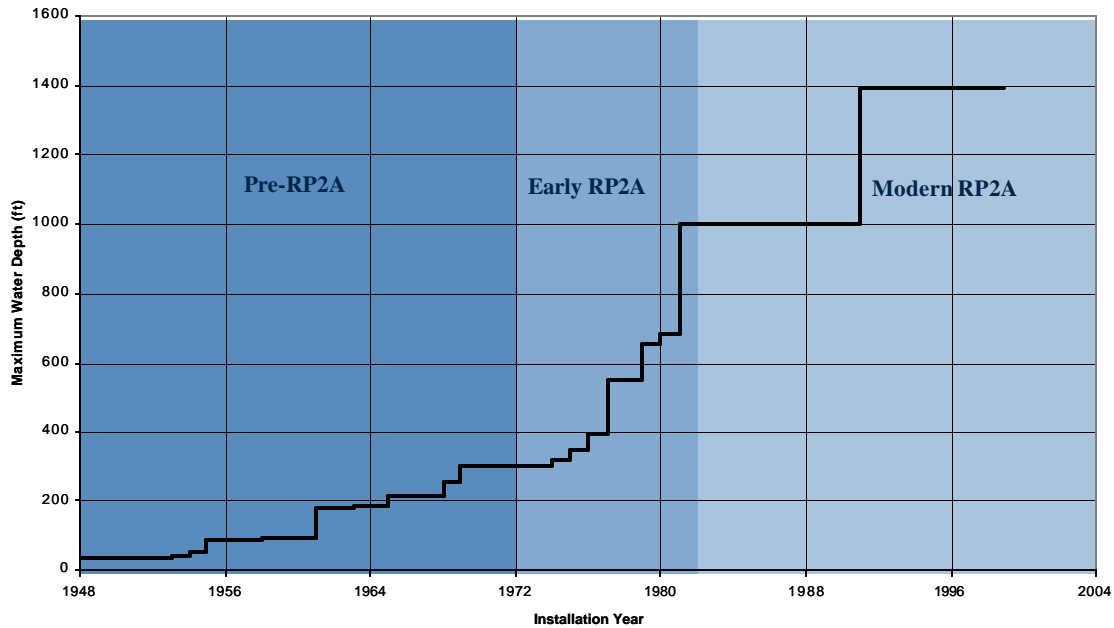
Figure 5.21: Inspected Platforms, Water Depth Increase with Time

The first platform in the Gulf of Mexico was installed in just 38 feet of water. Figure 5.21 shows the gradual increase in platform water depth with time. The figure shows that around 1961 maximum water depth was approaching 200 feet and that this had increased to 300 feet by the time the first Edition of RP2A was issued in 1969. These platforms were designed without the benefit of modern joint strength and/or fatigue capacity formulations. It is likely that the joint designs, although generally adequate for shallow water, became increasingly susceptible to fatigue damage as platforms moved to deeper water.

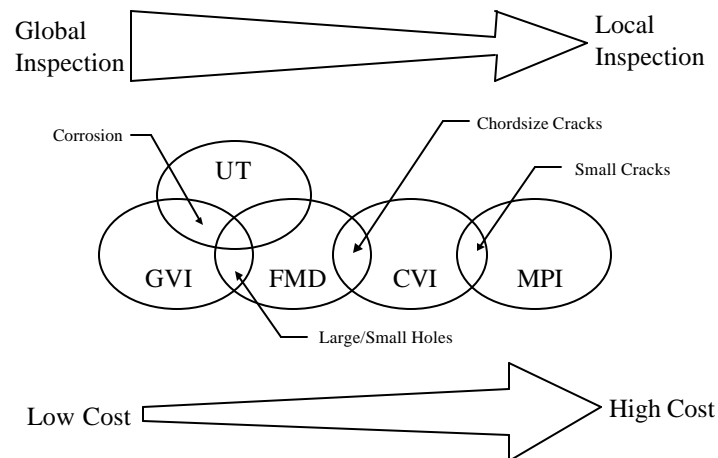
Figure 8.1: Relationships Between GVI, CVI, UT, FMD and MPI

NDE techniques commonly used in the GOM are general visual inspection (GVI), close visual inspection (CVI), flooded member detection (FMD), ultrasonic wall-thickness testing (UT-WT) and magnetic particle inspection (MPI). The general relationships between these five methods are illustrated in Figure 8.1. The range of inspection detail and the relative cost for these methods are also shown in the figure.

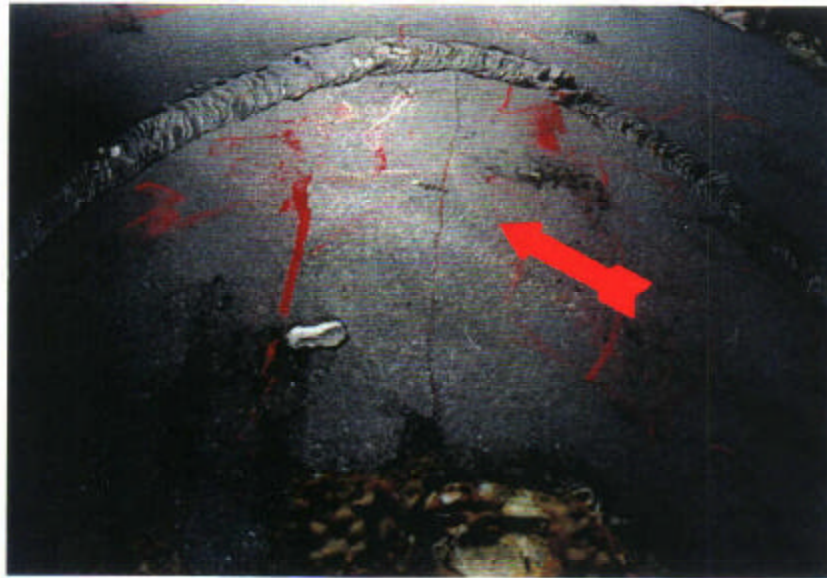
Figure 8.2: Crack that Results in a Flooded Member

The presence of a flooded member on a platform typical indicates an anomaly of some type that has allowed water to ingress to the normally buoyant enclosed region of the member. Examples of anomalies include holes caused by dropped objects, corrosion pitting that has developed into a hole, cracks at a member end (Figure 8.2), or other strength or fatigue prone areas. Thus a flooded member indicates the potential for a structural problem in the platform that needs to be further investigated.

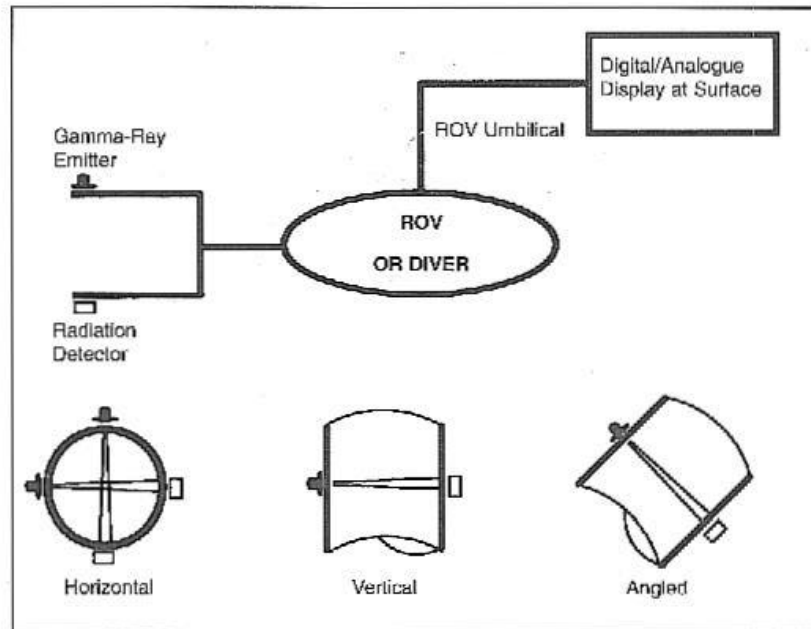
Figure 8.6: Schematic of a Typical Gamma Ray FMD Setup

Figure 8.6 shows a schematic of a typical gamma ray setup. This consists of a device for holding the radioactive source and detector on the member, which is usually an ROV since the radioactive source is hazardous to divers. A diver can only handle such a radioactive source for

less than 1 hour underwater before a hazardous condition exists. An operator for the topside unit makes the reading.
