# FY-2005 Safety Report

**FOR MARITIME OPERATIONAL FORCES –  
CUTTERS.  
CUTTER BOATS,  
SHORE-BASED BOATS,  
AND MARINE SAFETY UNITS**

**Commandant (CG-1134)  
Cutter and Sector Safety Division  
Office of Safety and Environmental Health**

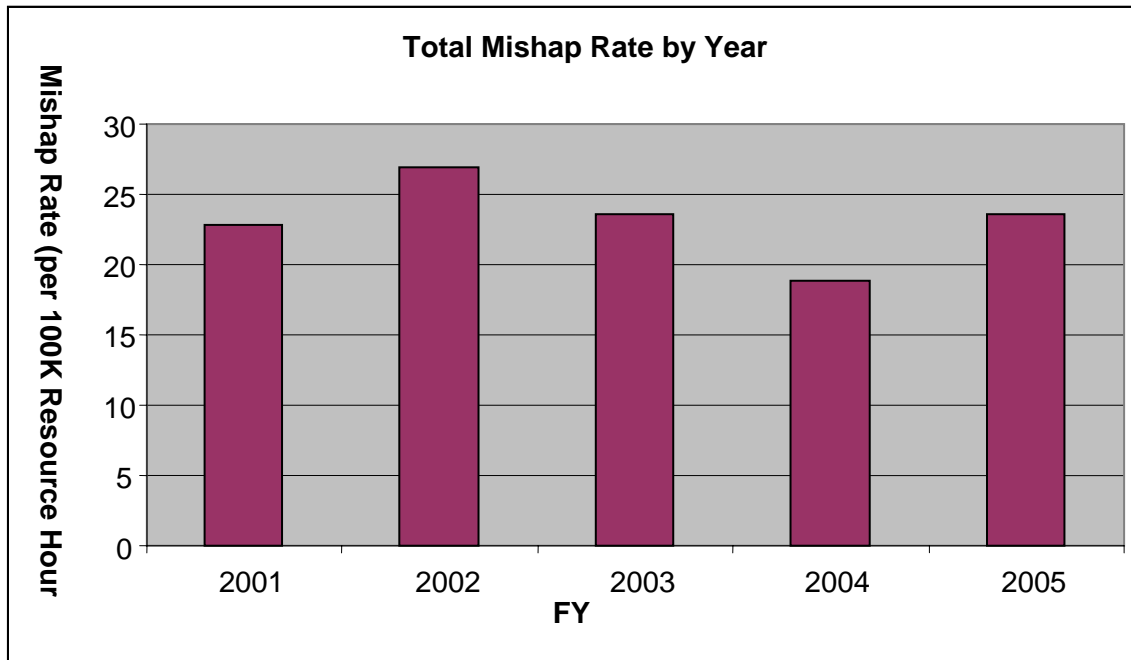
**GRAPH 1: Cutter Mishap per 100K Operating Hours**

FY 2005 saw a slight increase over FY 2004 in overall mishap rates for the cutter fleet. (See Graph 1) While this might simply represent the probabilistic nature of accidents, it could also be a leading indicator of the increasing impact from the aging of the surface fleet.

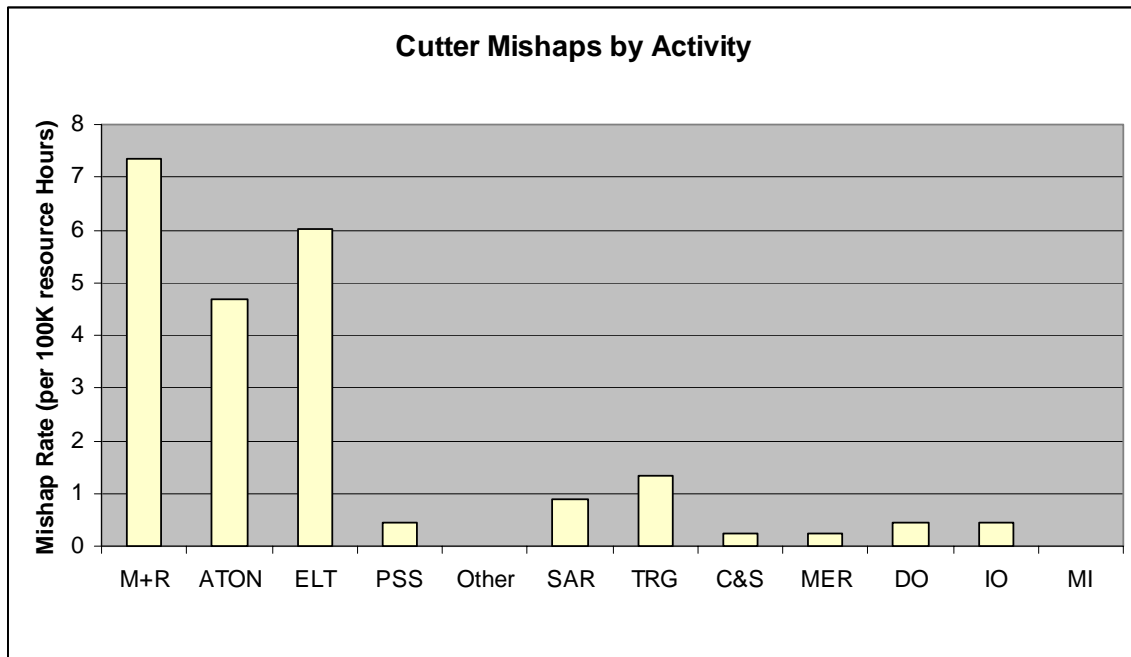
**GRAPH 2: Mishaps by Mission**

The vast majority of operational cutter mishaps in FY2005 occurred during Maintenance and Repair and in conducting Aids to Navigation and Law Enforcement missions. (See Graph 2) This could also be indicative of the contribution of an aging surface fleet is contributing.

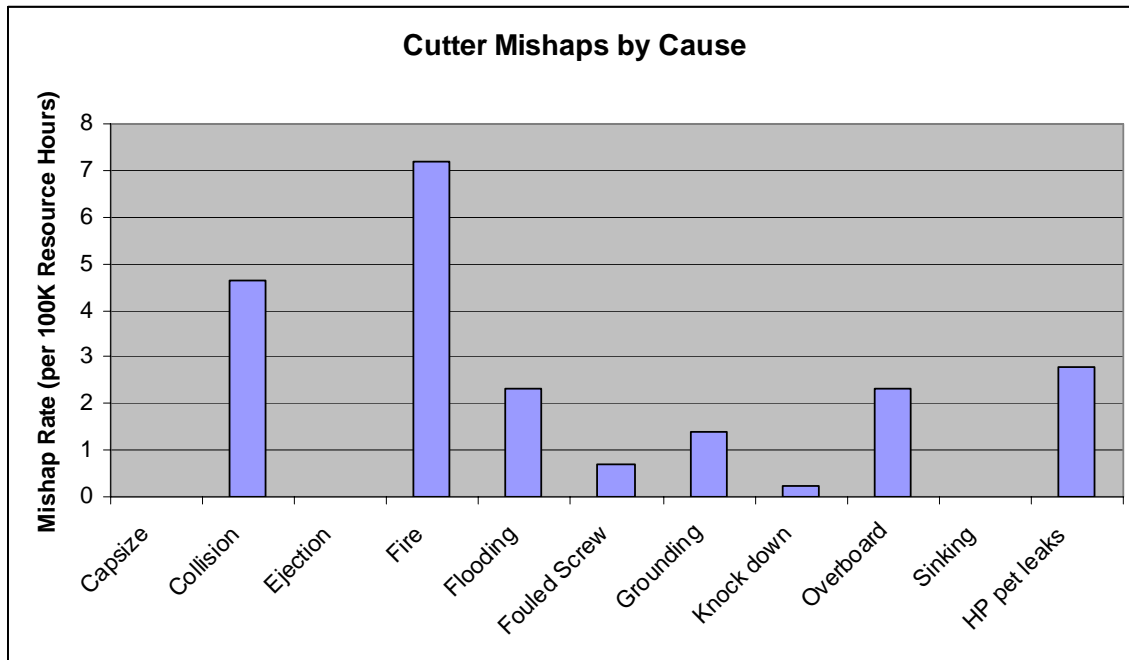
**GRAPH 3: Cutter Mishaps by Mishap Type**

Examining cutter mishaps by cause (Graph 3) we see that the highest rates were associated with fires and collisions. Fires were most commonly seen on WHECs and WMECs, again pointing out the seeming influence of vessels age on mishap rates. Collisions were primary experienced by the WPB community.

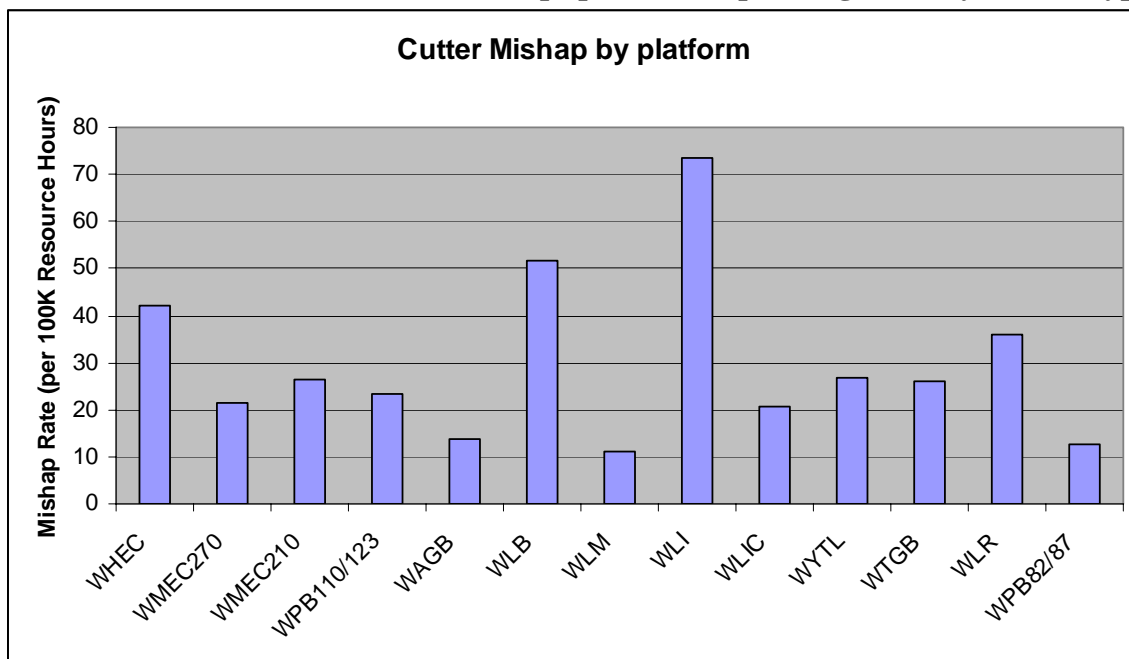
**GRAPH 4: Cutter Mishaps per 100K Operating Hour by Cutter Type**

Examining mishap by platforms finds the highest rates associated with WLI. (See Graph 4) This appears to be driven more by the very low resources hours for this platform; two total mishaps in FY2005 is not indicative of high risk operations. The likely impact of age is again seen in the relatively high rates for WHECs, most of which were caused by fire and high pressure leaks.

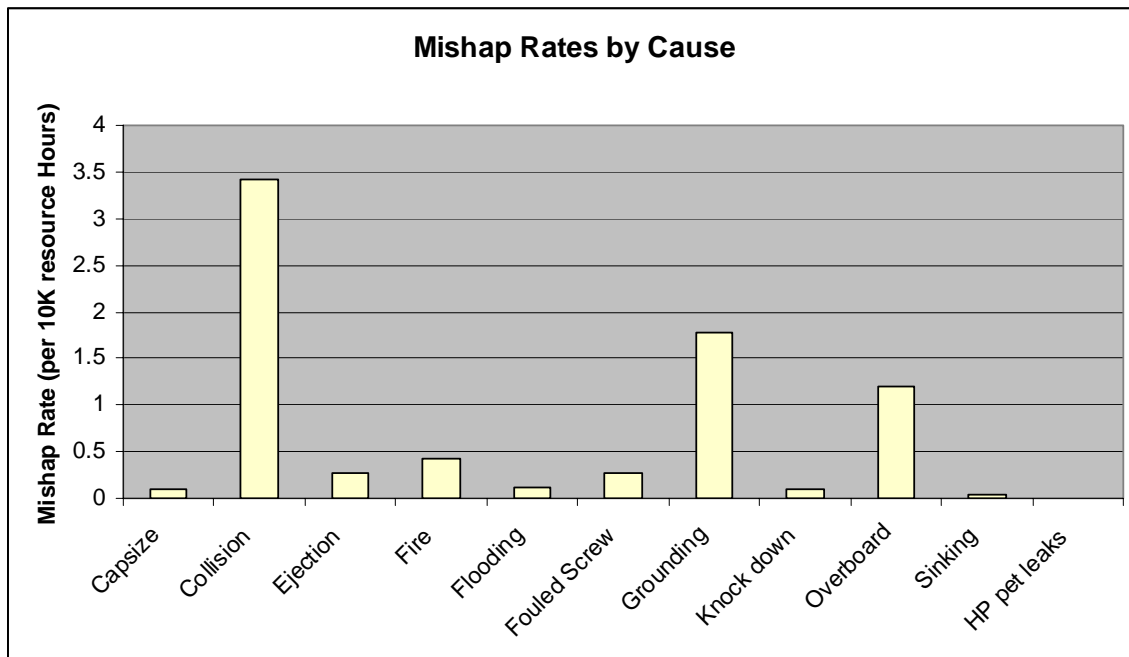
**GRAPH 8: Boat Mishaps by Mishap Type**

These two factors were also the predominant cause for all small boats (See Graph 8) with many of the collisions occurring during boarding and towing evolutions and many of the groundings occurring aboard non-standard platforms, as would be expected. Given the increased percentage of high-performance boats such as the RB-S in the boat fleet, it was also not surprising to see that the overboard numbers included 14 ejections, up from 11 in FY04.
