Return to Flight External Tank, ET-119

Preparing the External Tank

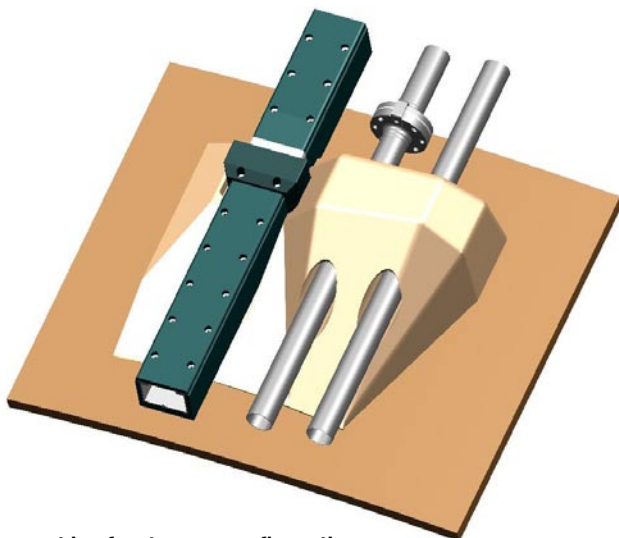
Current ice frost ramp configuration.

The Space Shuttle Program management made a decision in April 2006 to fly the ice/frost ramps in their current configuration. The rationale for doing so was based on several factors including the performance of the ice/frost ramps on previous flights. Any design changes would need to be thoroughly tested and certified before modifying the tank. To do otherwise could result in more uncertainty instead of reducing risk of the tank.

Small foam ramps, called ice/frost ramp extensions, have been added to the ice/frost ramp locations where the PAL ramps were removed. The new extensions were added to make the geometry of these ice/frost ramps consistent with other locations on the tank.
